Applications of Non-Destructive Techniques in the study of a Caribbean historic timber house

Virginia Flores Sasso^{1*}, Esteban Prieto Vicioso², Gabriela Fernandez Flores¹, Raquel Carreras Rivery³

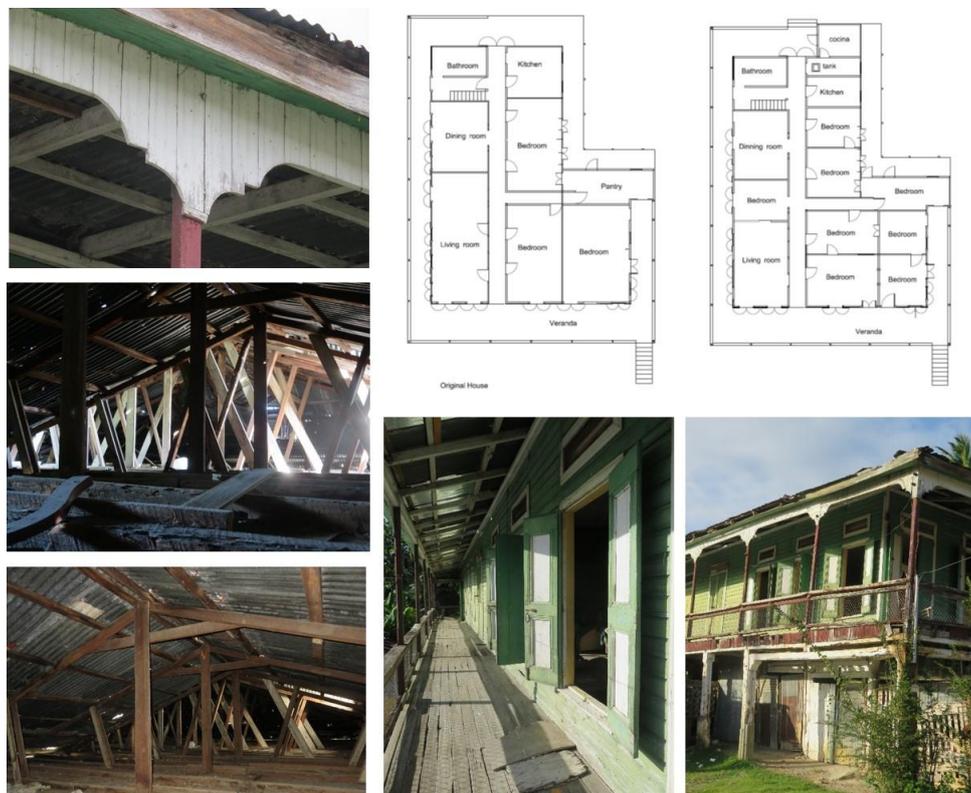
Figure.2. Details of Bodden Leroux's house (Prieto, 2018)

have a catalog house. The house is a simple layout with ornate wooden details, often called Farmhouse, National styles or American Foursquares. Was built on a sloping terrain, so it rose on wooden piles which makes it look bigger. It's a simple farmhouse with rectangular plan, divided into rooms that communicate by a central corridor and has a perimeter gallery where all the doors and windows open. The whole structure is made of wood, with horizontal siding plank pinewood boards of 13.97cm wide (5 1/2 inches). The floor of the house is also made of pinewood boards. The metal roof is hipped with four gabled dormer windows. The house has been modified and expanded. However its appearance has not changed much. Is currently abandoned (fig.2).

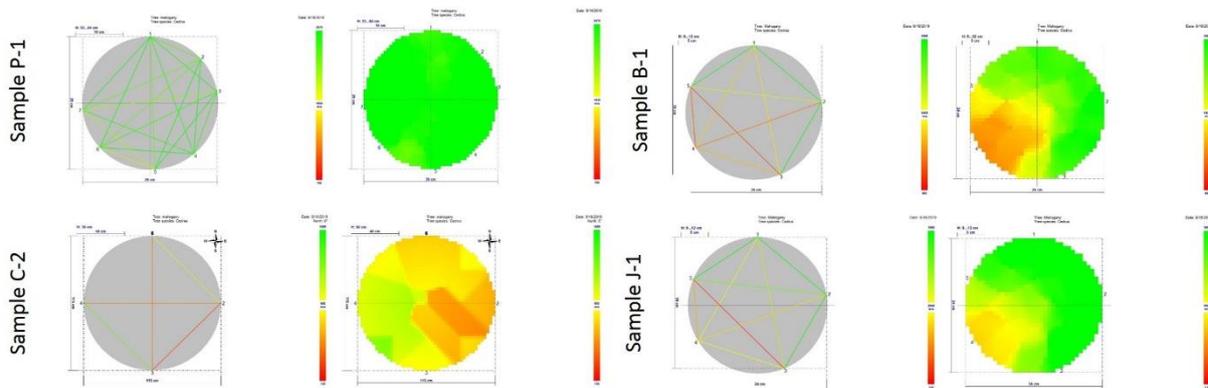
Fig.2. Ultrasonic diagrams of the samples P-1, C-2, B-1 and J-1.

The ultrasonic testing enabled detection of deep and extremely small flaws within the material. In the Ultrasonic diagrams (Fig.2) can be observed that all the piles are in very good conditions (P-1), the column in the veranda (C-2) has some crack and deterioration due to humidity, a beam (B-1) in a roof has deteriorated and the joist present some deterioration. Even though some columns look dry when the tomography is carried out, it could be determined that they are in good condition inside. The same thing happened with the beams. The same thing happened with the elements that conform the frame of the building structure.

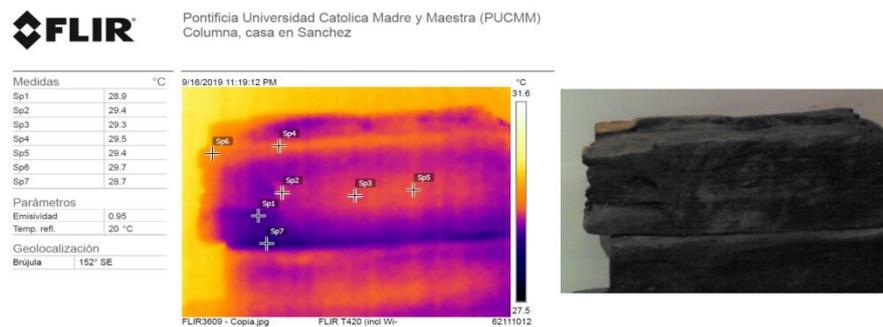
Fig.4. Thermography of a piece of columns.

The thermography indicates that the thermal conductivity of wood is relatively low due to its porosity. As the humidity of the wood increases, so does its thermal conductivity. As the temperature of the wood drops, its strength increases (Fig.4).

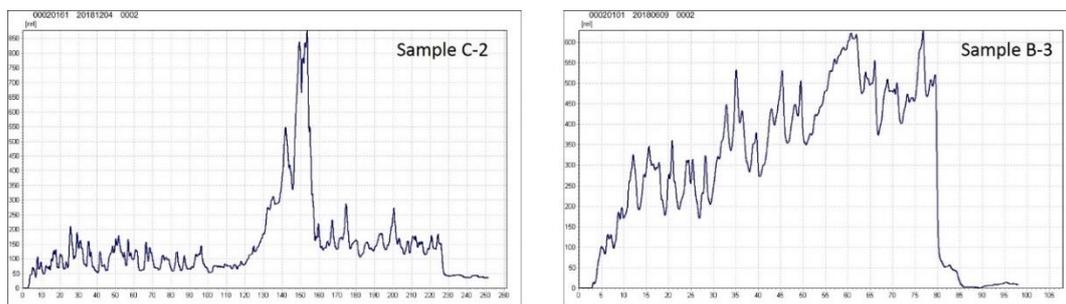
Figure 4. Resistance graphs. On y-axis measured quantity [rel] and on the x-axis the depth (mm).

With the resistograph three drillings were performed in all these 12 pieces (Fig.6). The normal density values of *Pinus Strobus L* is 350-510 kg/m³, *Pinus taeda* is 450-550 kg/m³ and the *Copaifera officinalis L.* is 601-810 kg/m³. The averaged form the average Mean drill resistance [rel] of the samples indicated that the density of the pile are higher than the normal value, the C-1 and C-2 are within the normal range but C-3 is higher. The density of the samples of the beams and joist are higher (Table 2).

In some columns, the effect of the moisture content could be observed by finding little resistance with the drill of the resistograph. The permanence of moisture in the wood could be confirmed visually by the presence of fungi. This is important to know because it influences the mechanical properties of the wood.
