The Great East Japan Earthquake

Report
on the Damage
to the Cultural Heritage

20 November, 2011

Japan ICOMOS National Committee

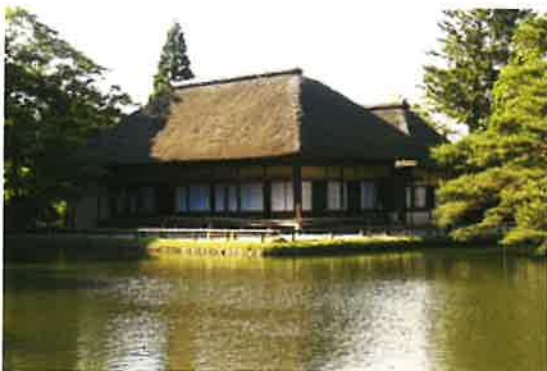
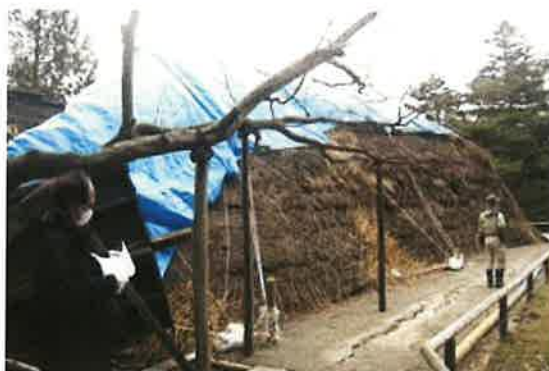
The main building of the old Yubikan (Japan’s oldest school located in Osaki city, Miyagi Prefecture; built in 1691) which is a designated National Historic Site, collapsed (Figure 2.4). It is located in the region with the strongest measured tremor of by the present devastating earthquake. As the main building had little earthquake-resistant elements, it is believed that it was fundamentally lacking in horizontal resistant capacity. This building suffered damage when the Iwate-Miyagi Inland Earthquake struck in 2008.

Figure 2.4 Main building of the historic site, the Yubikan (Left: Before earthquake; Right: After earthquake)

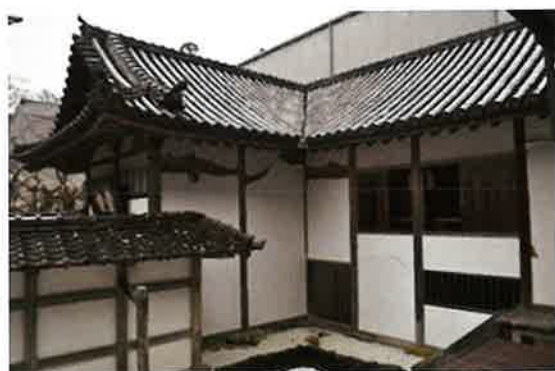
Figure 2.5 The Zuigan-ji temple priest's quarters, which sustained damage to the plaster wall

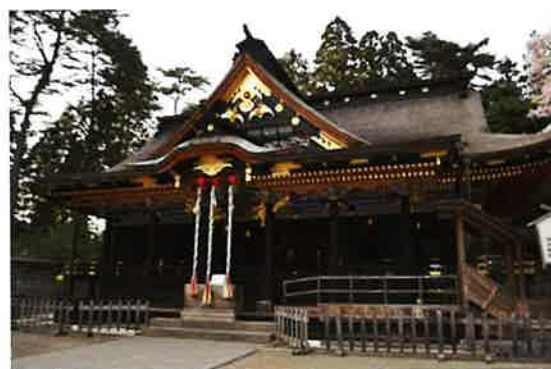
Figure 2.7 The national treasure, the Osaki Hachimangu Shrine - sustained very minor damage

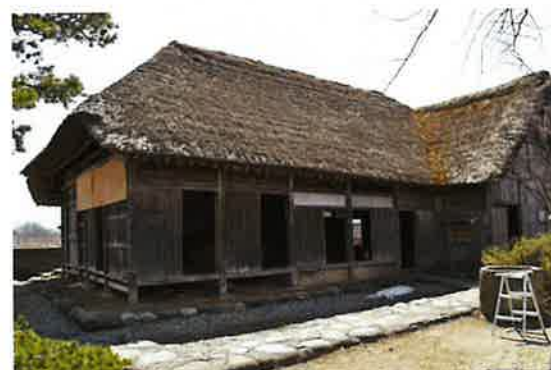
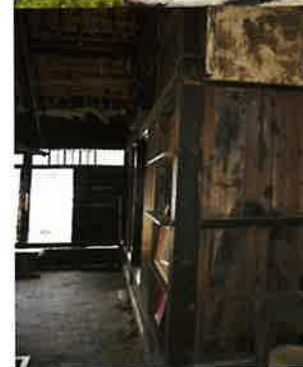
Figure 2.8 The important cultural property, the former Baba Family Residence, which is tilting (Top: Exterior; Bottom: Tilting interior)

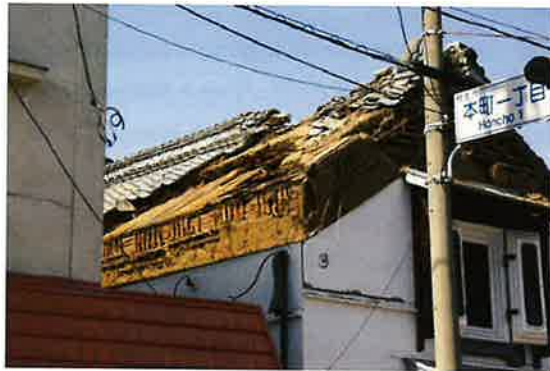
Dozo (mud-wall warehouse) buildings spreading from a wide area from Tohoku to Kanto were damaged. Figure 2.10 shows typical damage to classic *dozo* (the registered tangible cultural property, the Mori Goshi Gaisha storehouse). The eaves have collapsed and the earthen wall is cracked. Figure 2.11 is an example of damage in the Tohoku region (Sekinoichi Shuzo,

Figure 2.10 Damage to classic *dozo* (mud-wall warehouse) - the registered tangible cultural property, the Mori Goshi Gaisha storehouse

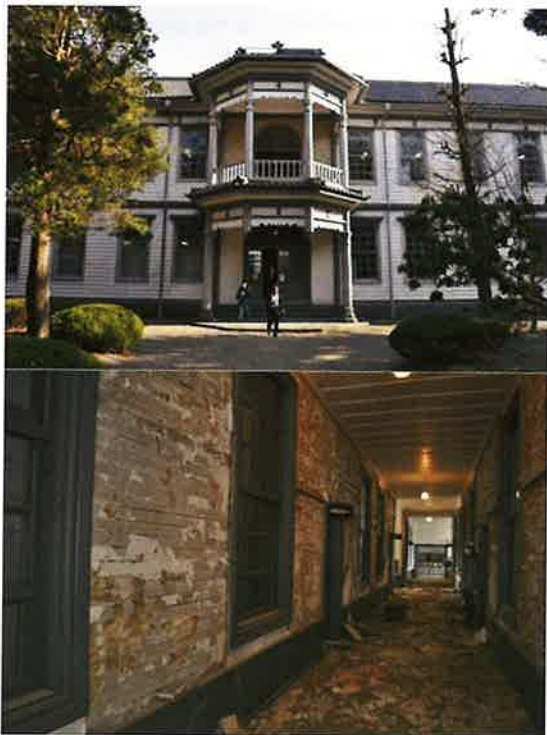
Figure 2.9 Damage to the important cultural property, Fukushima Prefecture Jinjo Junior High School (Top: Building exterior; Bottom: Peeling lath wall)

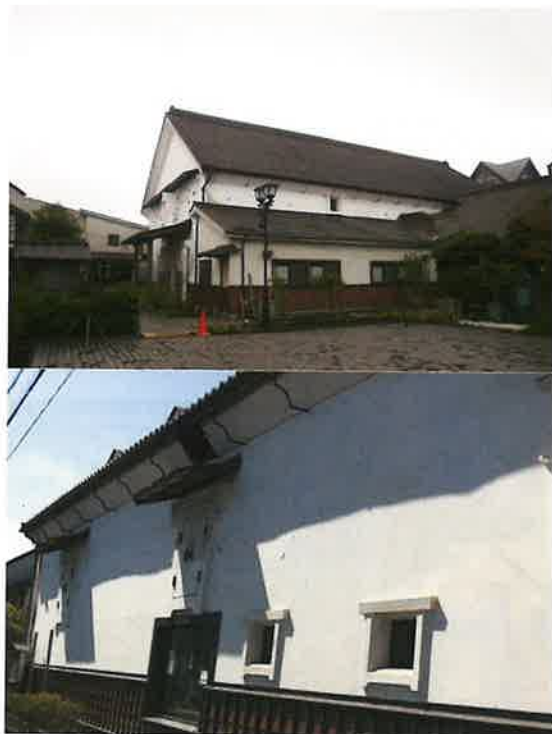
tori-kura (walk-through storehouse)). The building is slanted and the eaves are damaged. It was renovated by a *sake* brewery to be used as a *dozo*, and is a registered cultural property that was still being put to use. This heritage structure is a registered tangible cultural property and is still being put to use. Devising measures to keep utilizing it while securing safety have become a challenge. The registered tangible

Figure 2.11 The registered tangible cultural property, Sekinoichi Shuzo and damage to the *tori-kura* storehouse (mud-wall timber structure)

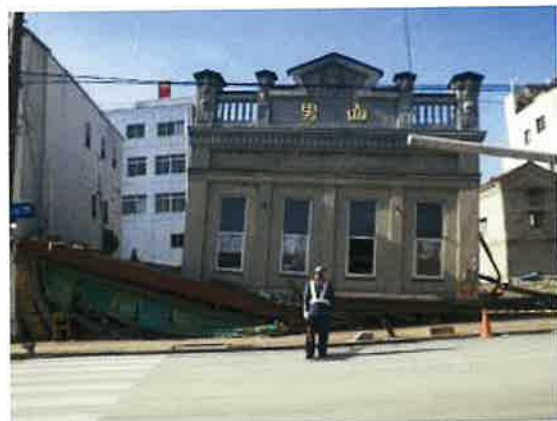
Figure 2.13 Tsunami-caused damage to the registered tangible cultural property, the Otokoyama Shuzo original store

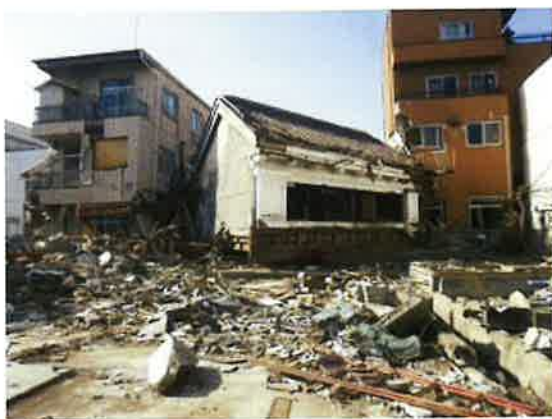
Figure 2.12 The registered tangible cultural property, the Kakuboshi shop, which was swept away by the tsunami

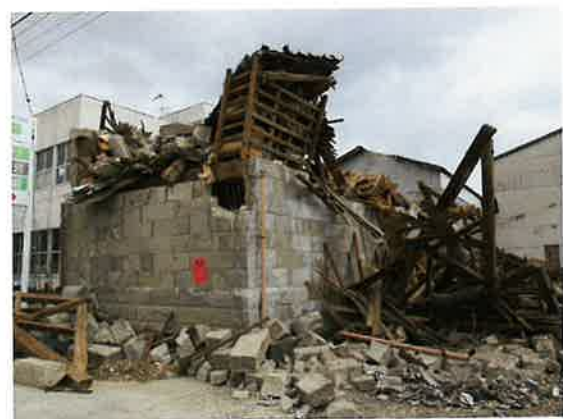
Figure 2.14 Collapse of stone storehouse in Makabe, an Important Preservation District for Groups of Traditional Buildings

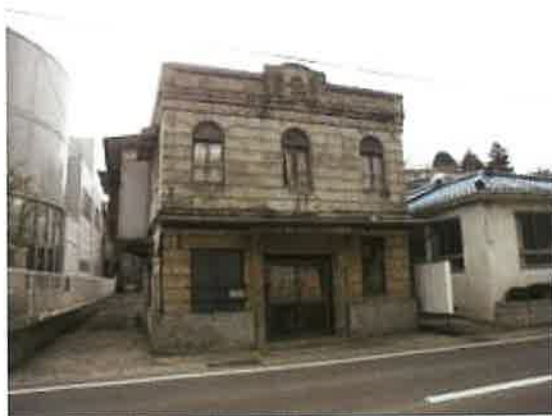
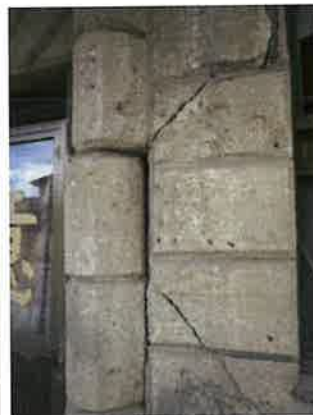
damage such as horizontal cracking starting from the entrance due to ground motions (Figure 2.15). According to a survey of the exterior, damage was concentrated in the two-story building section. The district where the Takahashi Family Residence is located was submerged under a tsunami approximately 1m deep, but the damage was caused by the earthquake ground motions. The dimension of piece of stone was 87cm x 29cm x 27cm. Cement mortar was used for the joints. The building was unreinforced structurally, but according to a survey of buildings (Kesenuma City buildings built with similar stone materials) that collapsed due to the tsunami, it seems that cramp steel bars approximately 6mm in diameter were inserted to connect stones. This implies necessity for conducting more detailed surveys of damage and reinforcement in the future. There are also machiya (traditional wooden townhouses) style buildings surrounding in the area surrounding the Takahashi Family Residence. While some buildings have stone walls between adjacent residential buildings, no damage was sustained by the strong ground motions. At the Hashino Blast Furnace (Kamaishi City, Iwate Prefecture, 1958), which is Japan's oldest western-style blast furnace and a nationally-designated historic site, there was damaged such as displacement of the ashlar stone that made up the furnace (Figure 2.16). Generally, many stone constructions, such as stone lanterns vulnerable to ground motion, were affected by the strong ground motions. In the case of the Shiogama Shrine in Shiogama City where strong 6 on the JMA intensity scale was recorded, wooden important cultural property structures including the Migimiya (right shrine) main hall, the Hidarimiya (left shrine) main hall, and the Betsumiya (separate shrine) main hall (beginning of the 18th century) were not affected externally (Figure 2.17), but there was damage to many stone monuments such as stone lanterns. This damage included displaced stones and fallen top stones.

Figure 2.15 Damage to the Takahashi Family Residence, a registered tangible cultural property

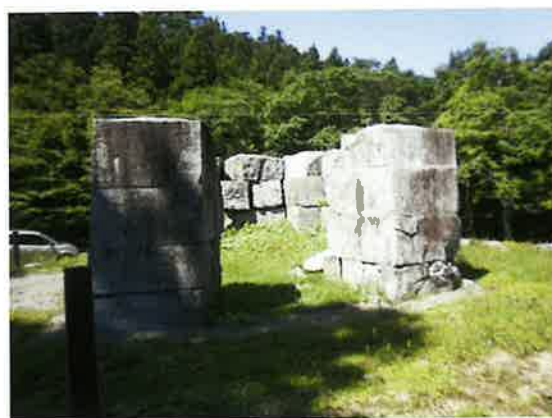
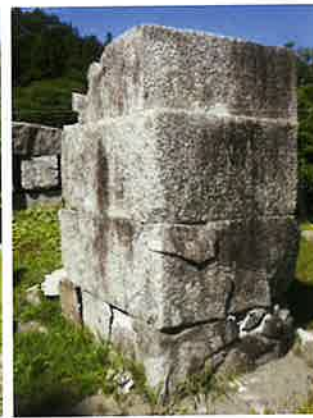
Figure 2.16 Displaced and cracked stone masonry at the Hashino Blast Furnace, a historic site in a Kamaishi City

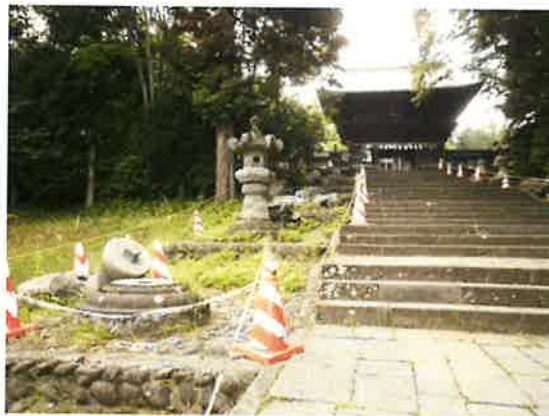
Damage to stone pagodas vulnerable to ground motions could be seen in various regions. Many stone pagodas designated as important cultural property collapsed at the Toshogu Shrine in Sendai City (Figure 2.18).

Figure 2.18 Collapse of stone lanterns at the Toshogu Shrine, Sendai City, an important cultural property

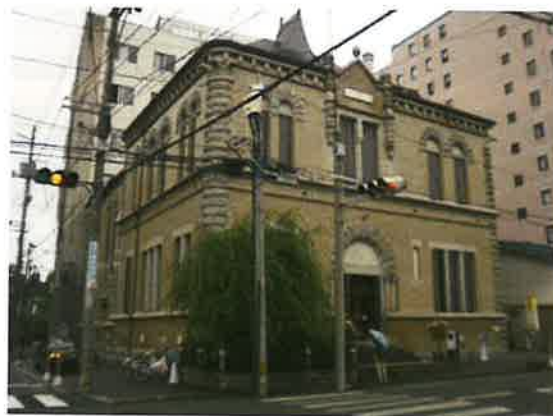
Figure 2.19 Former 99 Bank Head Office, an important cultural property: Minor damage to internal walls and ceiling

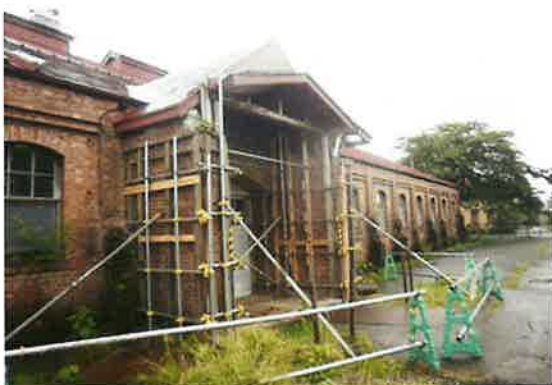
Figure 2.20) is a brick structure that has been nominated as a modern heritage, but cracks appeared in the entrance area and emergency measures are being taken to prevent the building from collapsing. In Sendai City, the 3-story brick architectural museum in the Tohoku University campus (before 1910) sustained damage such as cracks in brick walls. In Fukushima City, the brick-constructed and registered tangible cultural property, the United Church of Christ in Japan, was damaged by the disaster. It was subsequently demolished and removed by the owners due to concerns for the safety of the church goers¹⁾. In North Kanto, there was no structural damage to the timber framed brick structure, the former Tomioka Silk Mill, which is registered as an important cultural property. The Kiryu City-designated cultural property, the Yurinkan, sustained some damage to the roof tiles and the brick wall was slightly cracked. In Tsuchiura City, Ibaraki Prefecture, there is a district

Figure 2.20 Disaster-affected modern heritage, the former covered parade ground building

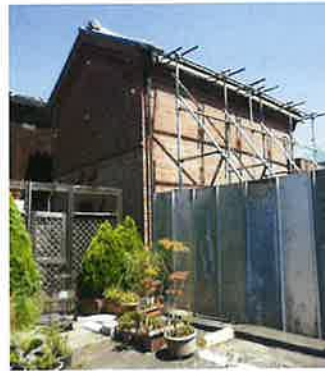
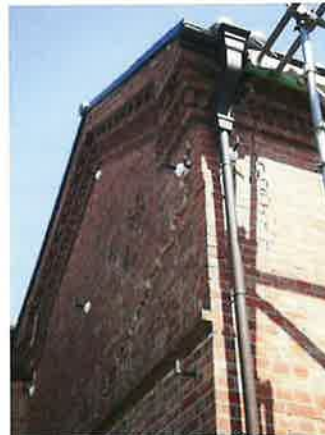
Figure 2.21 Disaster-affected brick storehouse, the Machikado Kura Nomura (Top: Building exterior; Bottom: Cracked gable wall)

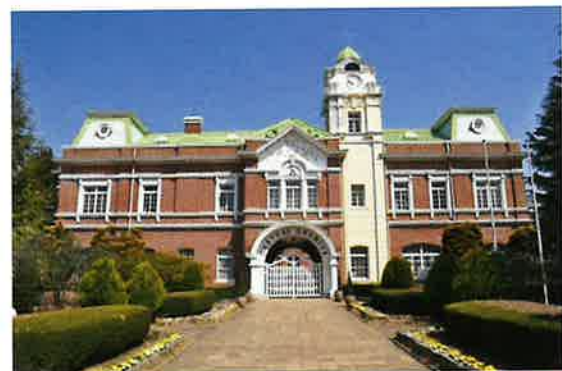
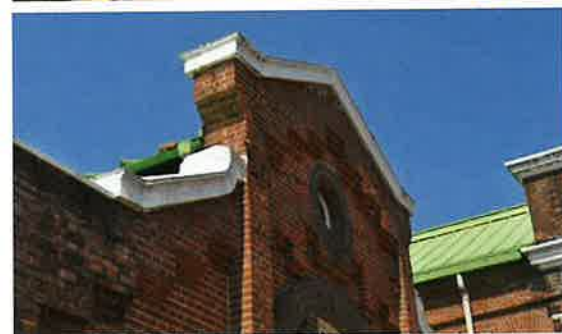
Figure 2.22 Disaster-affected Chateau Kamiya winery building, an important cultural property Top: Building exterior; Bottom: Cracked gable wall)

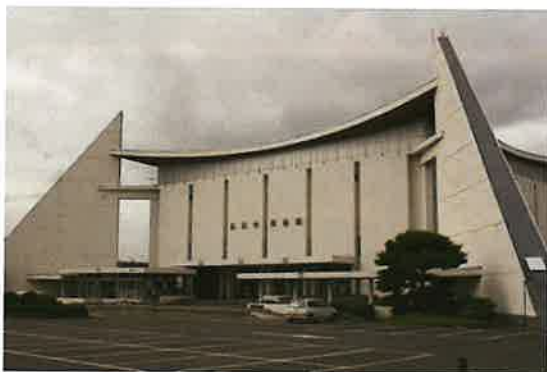
Figure 2.23 Furukawa Civic Hall which underwent damage to its non-structural components (from Furukawa city homepage³⁾)

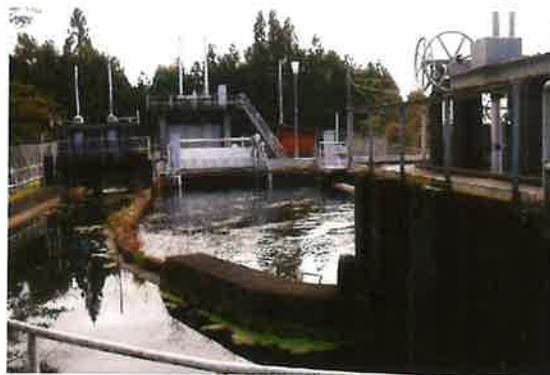
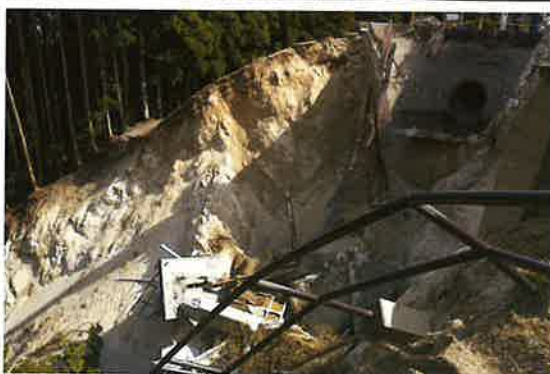
The Ishioka No.1 Power Plant in Ibaraki Prefecture is a conduit type power plant that was completed in 1911 and is in operation even today. It was designated as a nationally important cultural property in 2008 for its high value in terms of Japanese industrial technology, and because it was the first facility to make use of reinforced concrete technology in Japan. It consists of 10 places: a diversion weir, grit chamber, No.1 and No.2 aqueduct bridges, water tank, water tank spillway, pressure-controlled tank, main building's dynamo room, main building's former transformer room, and the main building's switchgear room. Of these, the water tank collapsed three and a half hours after the earthquake occurred (Figure 2.24). The structure itself was not destroyed, but the virgin soil that supports the bottom of the tank collapsed and the tank was unable to hold out. Since

Figure 2.24 Ishioka Electric Power Plant (Top: Before earthquake; Bottom: After earthquake) (Ishioka city, Ibaraki Prefecture)

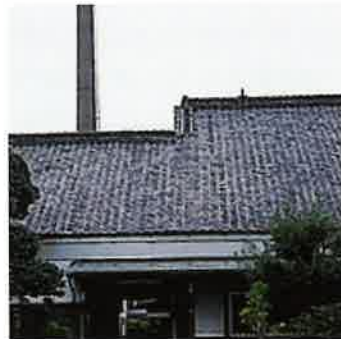
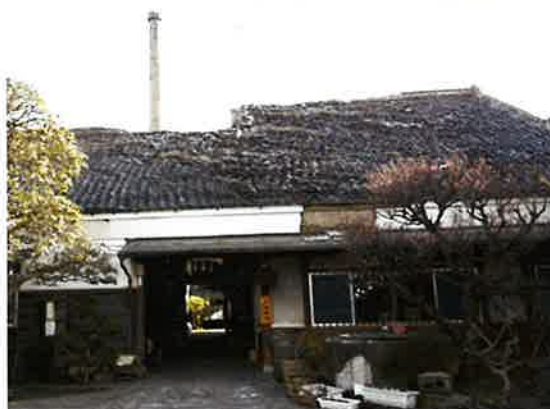
Figure 2.25 A traditional building in Makabe (Top: Before earthquake; Bottom: After earthquake)

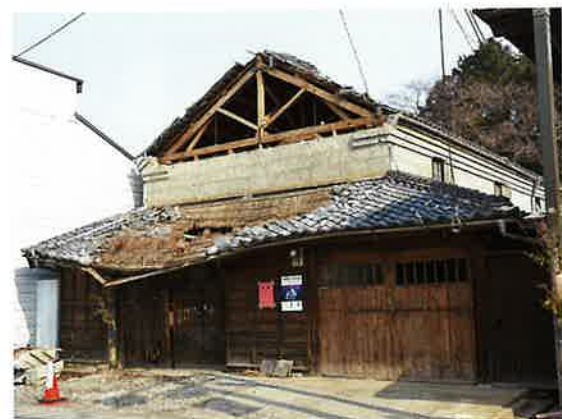
Figure 2.26 A damaged house in Makabe

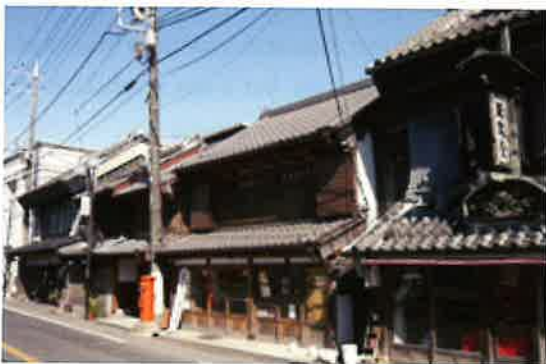
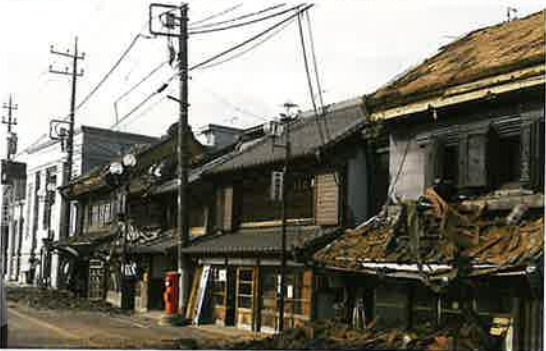
This district is on soft ground and liquefaction has occurred, so the embankment of the river that flows through the center of the district caved-in, and substantial damage was caused by the movement of wood-framing due to uneven settlements along the river. (Figure 2.27, 2.28)

Figure 2.27 Traditional buildings in Sawara (Top: Before earthquake; Bottom: After earthquake)

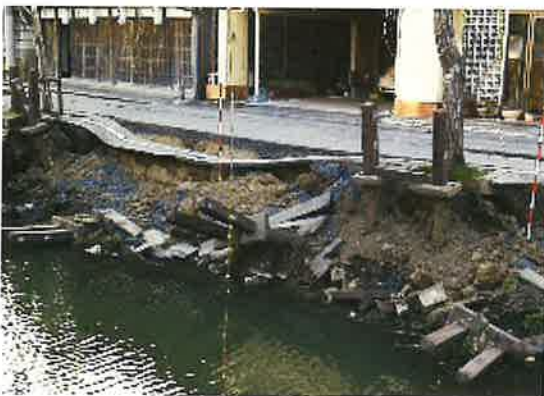
Figure 2.28 Historic riverside damaged

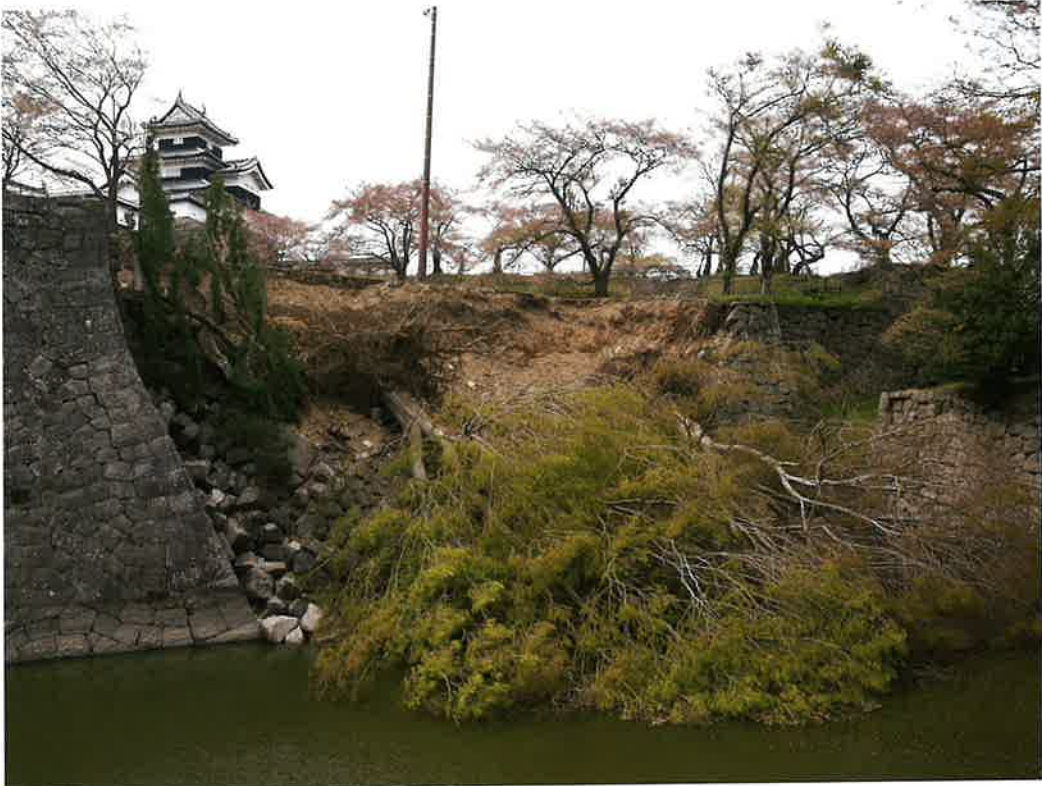
In particular, the masonry walls of Komine Castle sustained heavy damage, and collapsed in ten places

Figure 2.29 Collapsed masonry walls of Komine Castle

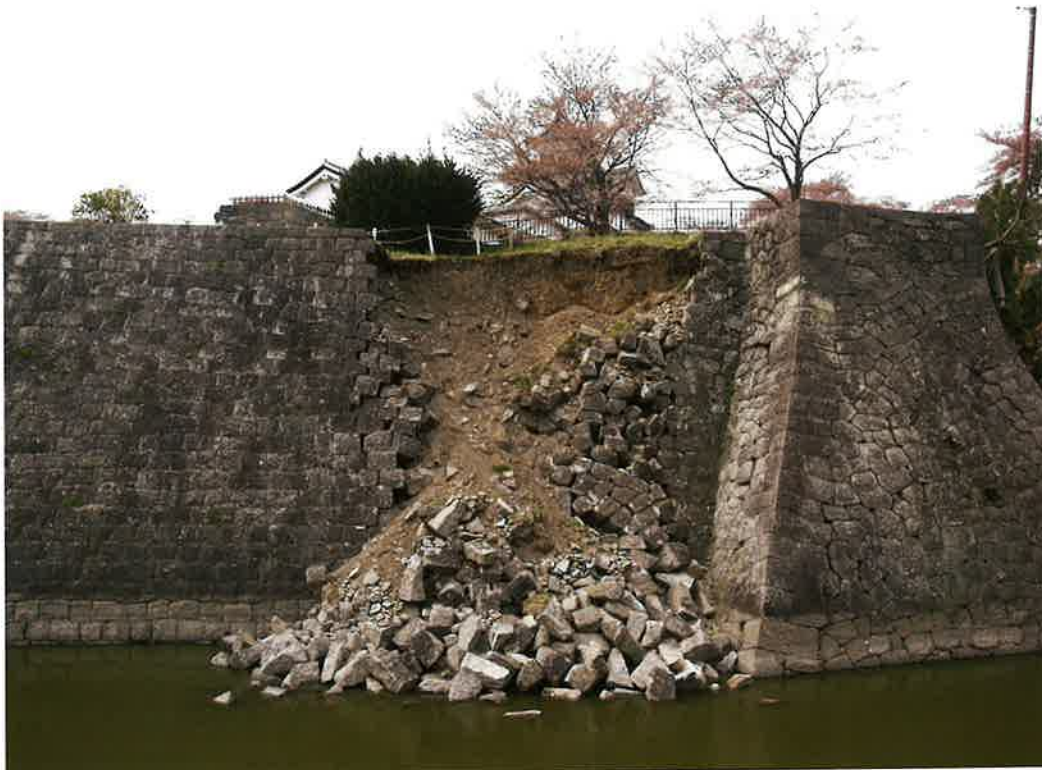
Figure 2.30 Collapsed masonry walls of Komine Castle

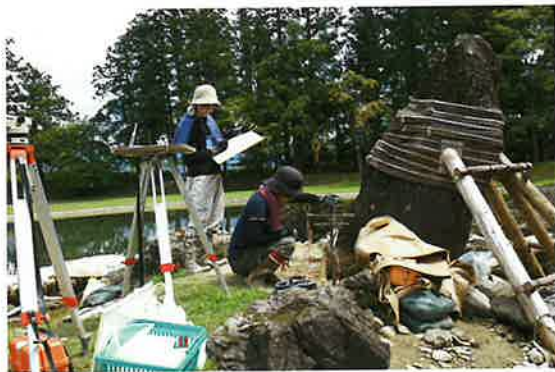
It is said that the Motsu-ji Temple Buddhist monk noticed in May that the standing rocks in the garden's pond were tilting more than before as a result of the earthquake and an aftershock (7th April). In late May, the place in question was looked over, and then fixed

Figure 2.31 Test trench at the base of the standing rocks (Photo provided by the Center of the Cultural Heritage to Hiraizumi)

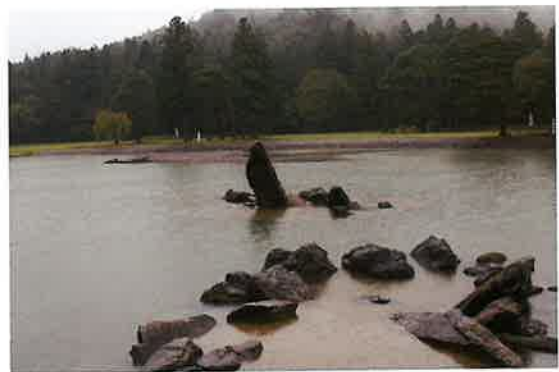
Figure 2.32 Condition of the rocks on 20th September following repairs (Photo provided by the Center of the Cultural Heritage to Hiraizumi)

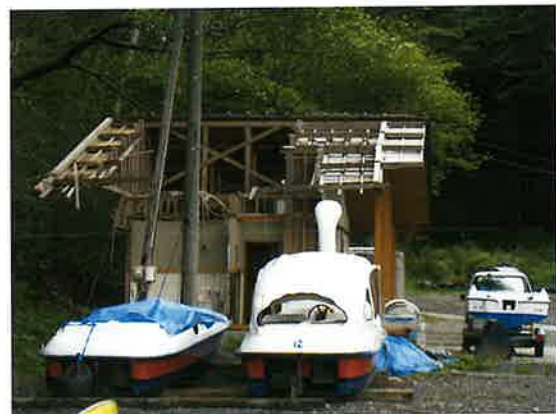
Figure 2.35 Facilities destroyed by the tsunami (Jodogahama)

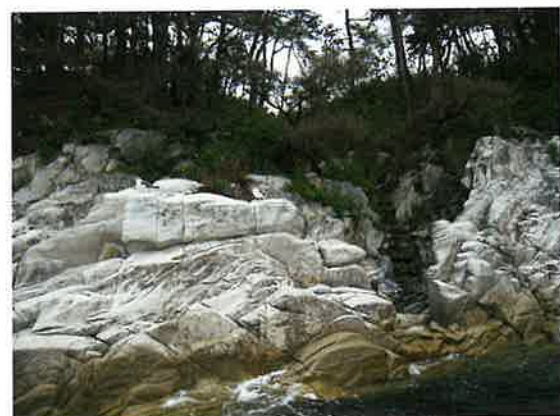
Figure 2.36 The conspicuous dying of pine trees that were engulfed by the tsunami

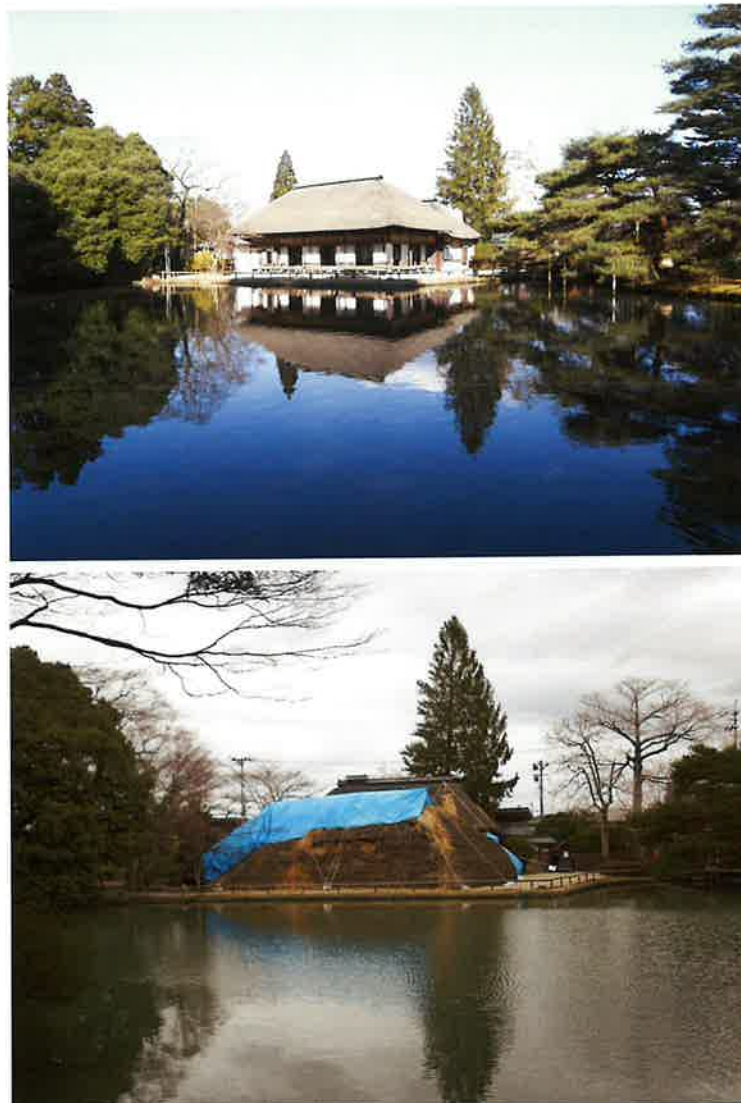
Figure 2.39 Yubikan (Top: Before earthquake; Bottom: After earthquake)

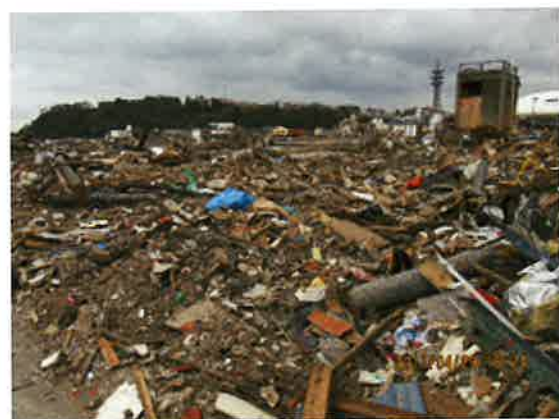
Figure 4.2 Damage caused by the tsunami around the Ishinomaki St. John the Apostle Orthodox Church

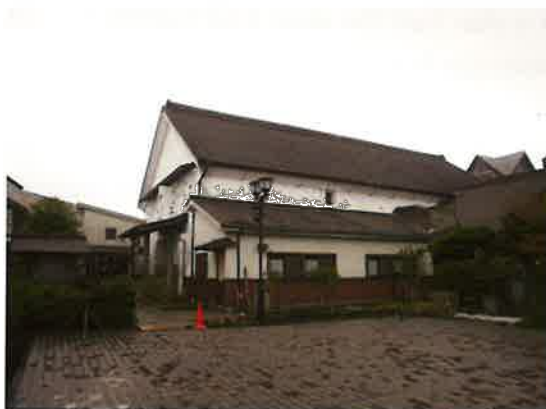
Figure 4.3 Collapsed stone gable wall
