The Kumamoto Earthquake

Report on the Damage
to the Cultural Heritage

1 December 2017

Japan ICOMOS National Committee

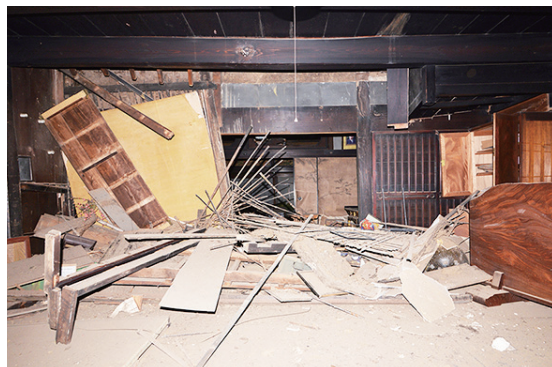
earth walls of the central storehouse. Effects of the main-shock earthquake extended to the main building: the building inclined up to more than 1/8 towards the west side, roof tiles and earth walls fell down. As for the interior, parts of the ceiling above the large room (*hiroma*) fell, the reception room (*zashiki*) inclined towards the south, and the walls attached to the alcove were damaged. In terms of structure, the main building is divided into three buildings: one centered on the earth floor *doma*, another on the south side centered on the *zashiki* reception room, and another comparatively new one to the north side; it is the connections between these buildings that broke, with fractures up to some 50cm where large. The stable's west side outer wall fell and the building inclined greatly towards the road on the west side. At the central storehouse, the pillars came off their foundation stones and the structural frame inclined towards the west side. Also, most of the earth walls fell. The rear gate collapsed onto the road on the west side. Protrusions occurred at parts of the stone wall on the north side of the site. The Eto family home is located to the northeast of the Futagawa River fault, which was the epicenter of the main-shock earthquake. The main building and other buildings on the site inclined to the west side or the west-southwest side due to the main-shock earthquake; this inclination shows a direction similar to the direction of displacement of the Futagawa River fault, which extends from east-northeast to west-southwest.

Photo 3.1.1.8 Interior of the main building, the hiroma (after the earthquakes)

As emergency response measure to prevent collapse, temporary reinforcements were installed to the main building's interior and exterior on the west side, which had acquired a significant incline. Also, because there were concerns that during the rainy season leakage from broken roofs into the interior of the building would seriously damage the pictures on the partition walls, these were removed as a priority and stored separately. The stable had greatly inclined

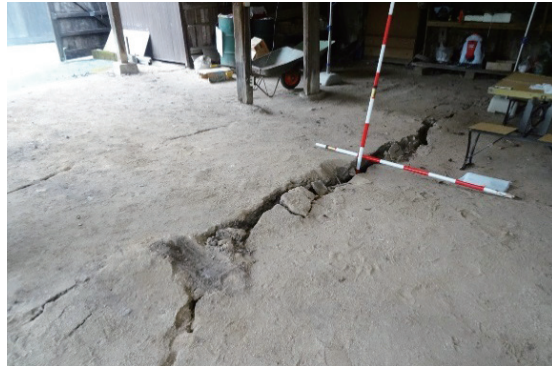
Photo 3.1.2.2 The fissure at the shed of the Yano family home (*Hontaku*)

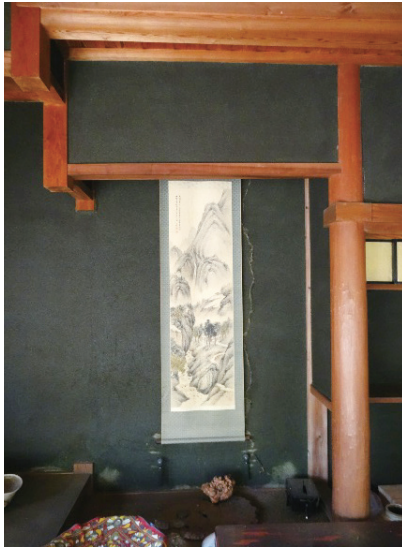
Photo 3.1.2.13 A fissure in the wall of the alcove of the Yano family home (*Shintaku*)

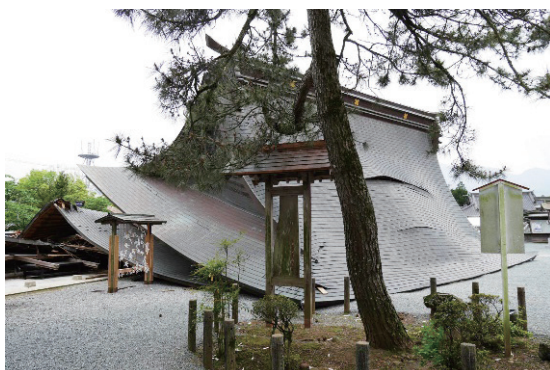
The Romon Gate, which was one of the Three Greatest Romon Gates of Japan, had an upper structure that was extremely impressive. The main-shock earthquake that struck the Aso region on April 16th registered a weak 6 on the Japanese seismic scale and the Romon Gate is considered to have collapsed due to the inclination of the columns caused by the tremors and the P-Δ effects resulting from the heavy weight of its upper part.

Photo 3.1.3.1 The collapsed Romon Gate of the Aso-jinja Shrine (the roadside approach).

The policy for the repair works of these buildings, which have been designated as Important Cultural Properties, is repair through dismantling for the Romon Gate and through partial dismantling for the other damaged buildings. The work began in Heisei 28 (2016) and is scheduled to continue until Heisei 35 (2023). (Photos 3.1.3.1-5 Taken by the author.)

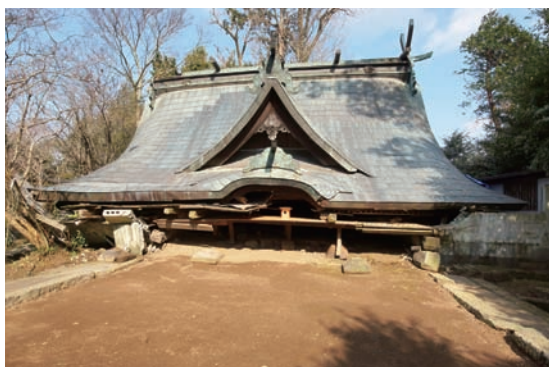
Photo 3.1.5.1 The remaining roof of worship hall of Kiyama Shrine after the earthquake.

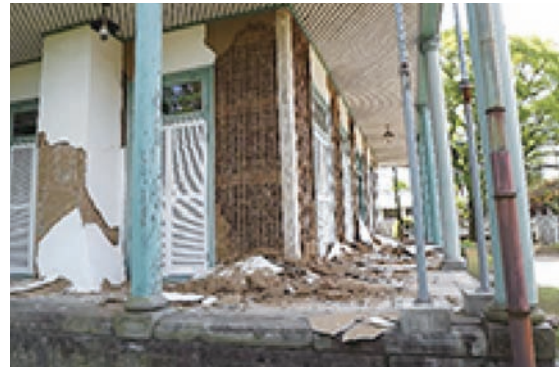
Photo 3.1.6.3 The damage caused by the fore-shock earthquake (left front).

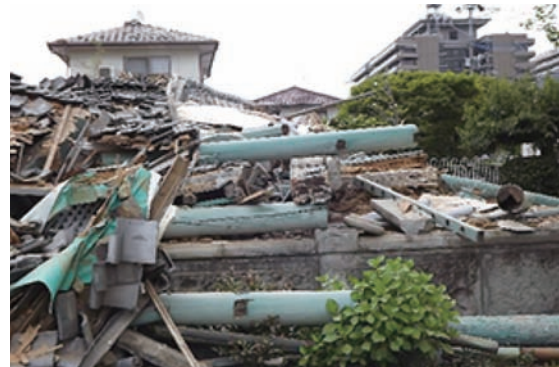
Photo 3.1.6.5 The building was completely destroyed in the main-shock earthquake (1).

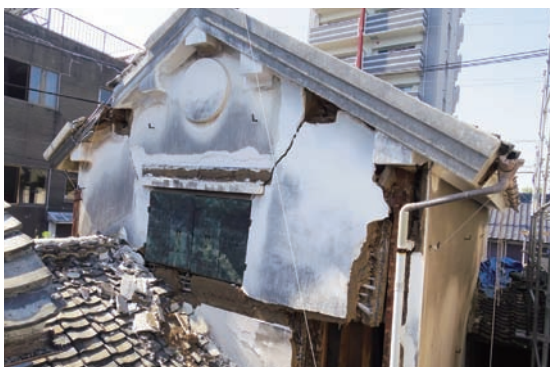
Photo 3.1.7.3 The damage to the warehouse (south side).

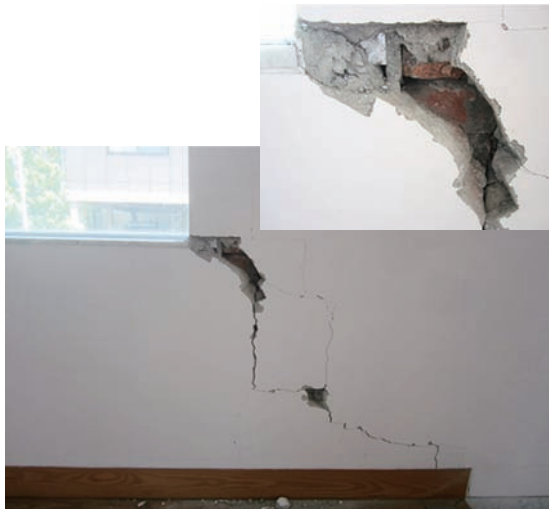
First, cracks appeared in the brick wall (inner side), with cracks appearing around and in the corners of the openings (See Photo 3.2.1.3). One of the characteristic movements of masonry structures during an earthquake has been found to be deformation in the form of expansion toward the outsides of the corners. In this building, too, cracks

Photo 3.2.1.3 Cracks appeared around the openings.

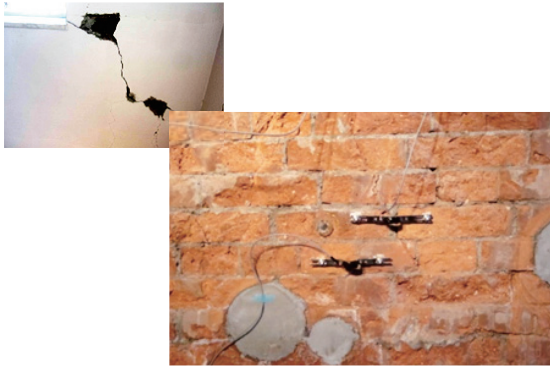
Photo 3.2.1.5 Monitoring the crack displacements in the brick walls.

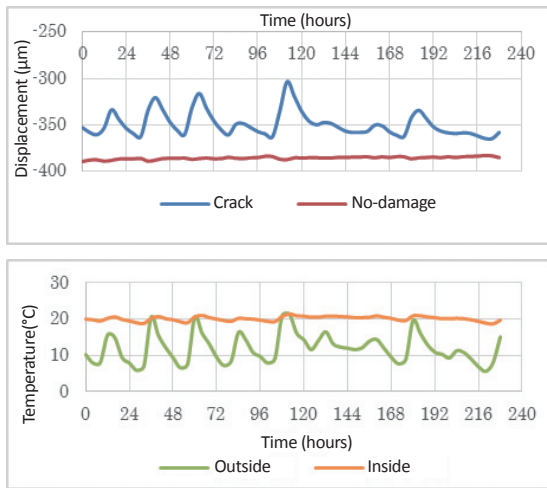
From Figure 3.2.1.6, the structure was judged to be stable, because no significant changes were seen over the day, even though the crack displacement (width) repeatedly fluctuated over a one-day period due to temperature changes. It is useful to have

Figure 3.2.1.6 Monitoring the crack displacements and temperatures (upper: crack displacements µm, lower: temperature in and outside the room).

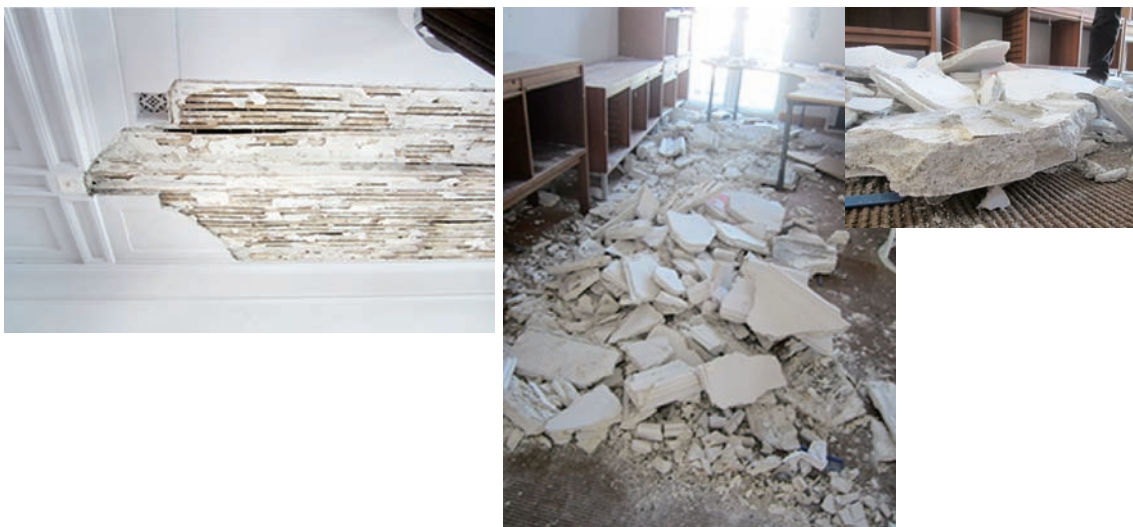
Photo 3.2.1.7 The plaster on the wood-lath ceiling of a second-floor office fell down.

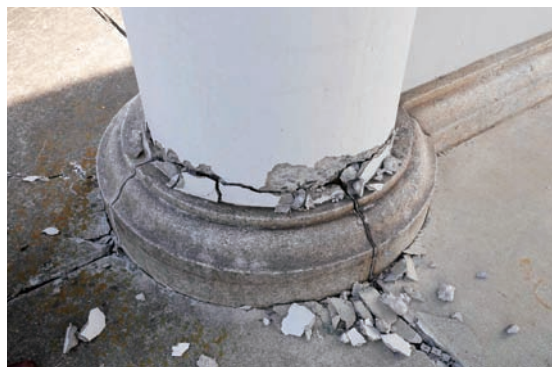
Photo 3.3.1.4 Honmyo-ji Nio-mon: damage to a column base.

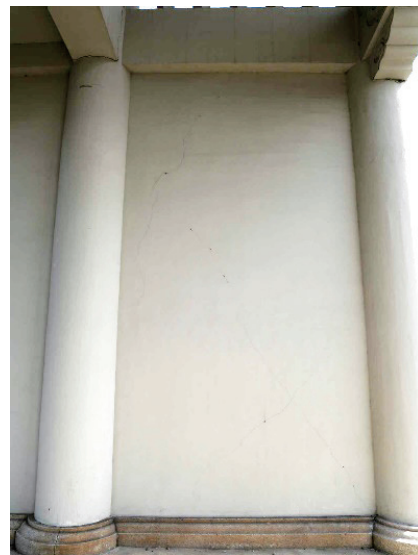
Photo 3.3.1.6 Honmyo-ji Nio-mon: shear cracks in the walls.

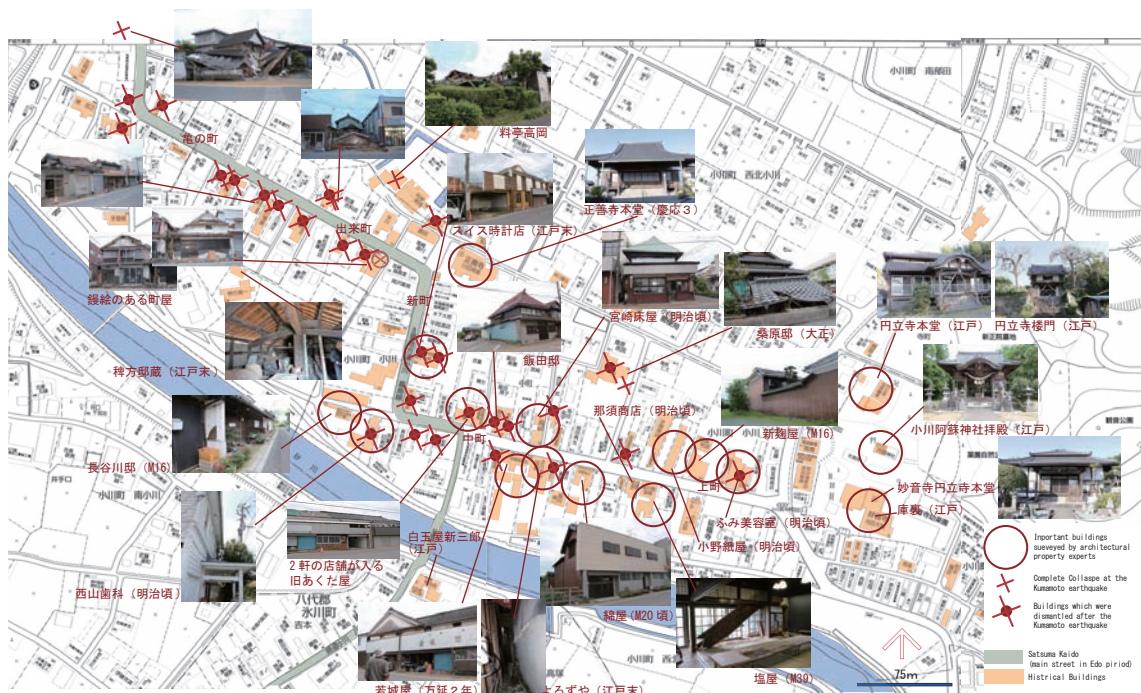
Photo 3.4.3.6 The damage situations at the traditional townhouses in Ogawa Town's commercial district (August 2017).

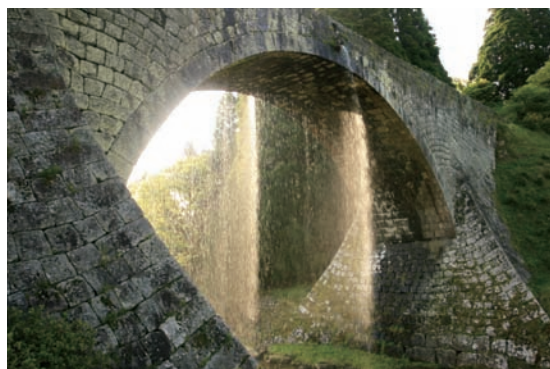
Photo 3.6.1.1 At the Tsujun Bridge, water leaked from the arch stones (Photo by Yamato town)

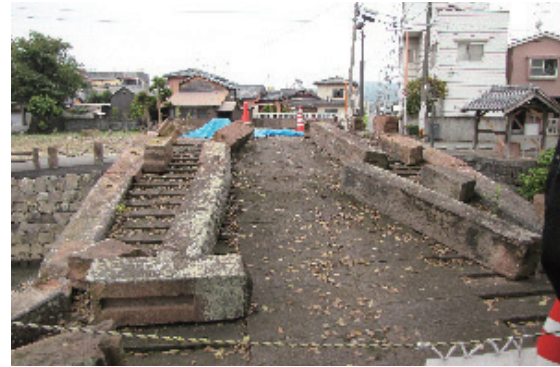
Photo 3.6.1.3 The bridge post collapsed at the Senba Bridge

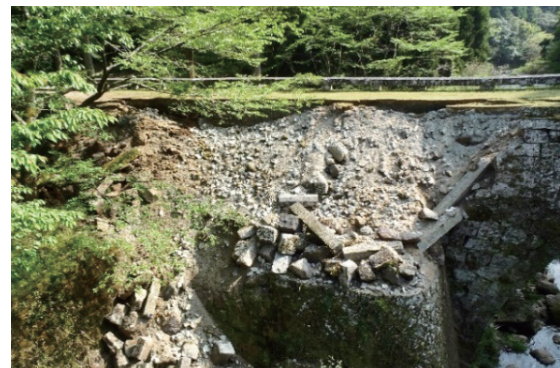
Photo 3.6.1.4 The stone wall on the upstream side collapsed at the Yasemegane Bridge (Photo by Mifune town)

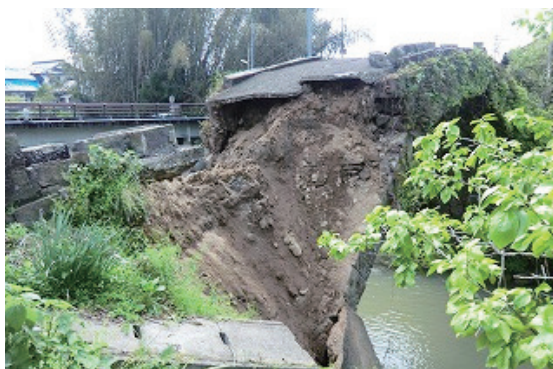
Photo 3.6.1.5 The stone wall collapsed at the Yasumi-shimoduru Bridge (Photo by Uki city)

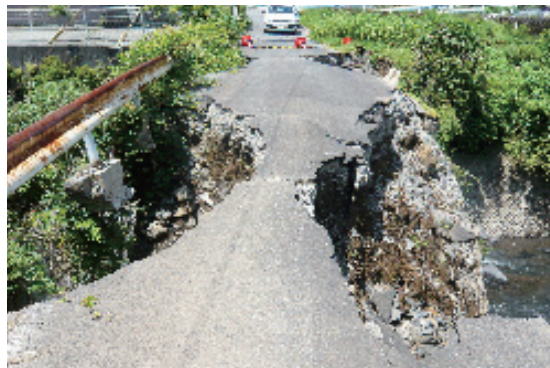
Photo 3.6.1.6 The stone wall on the upstream and downstream sides collapsed at the Zenigame Bridge

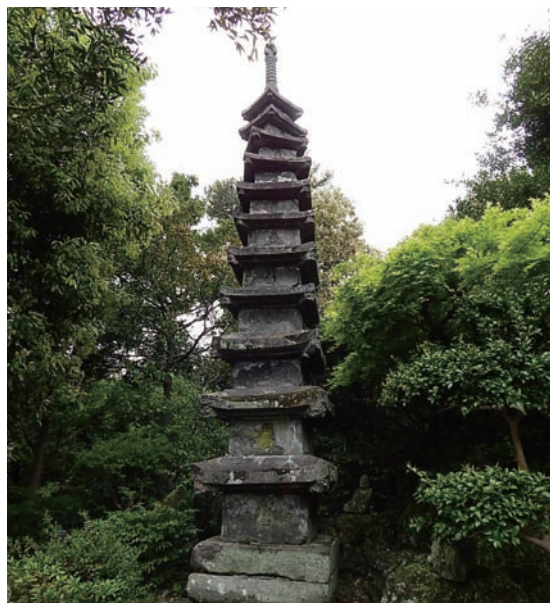
Photo 3.6.2.1 The thirteen-storied pagoda after the disaster

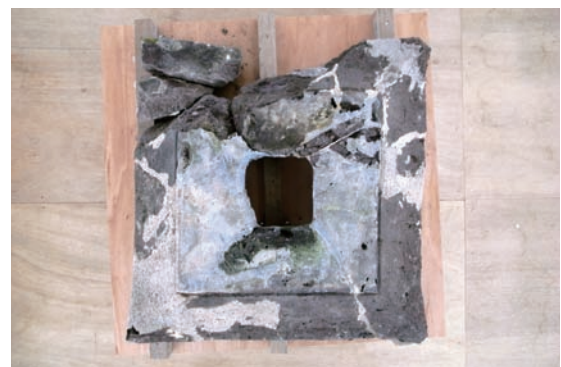
Photo 3.6.2.5 The ninth story roof with fragmented eave-ends

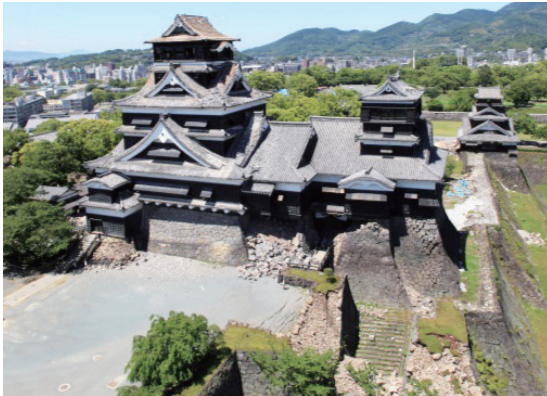
Photo 3.7.1.2 The damaged castle main keep

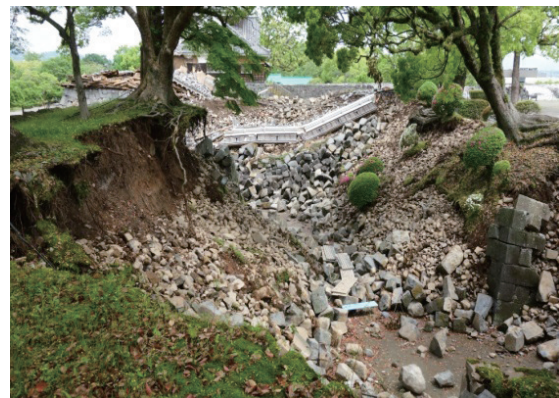
Photo 3.7.1.3 The damaged Sukiymaru Gate site (from the South)

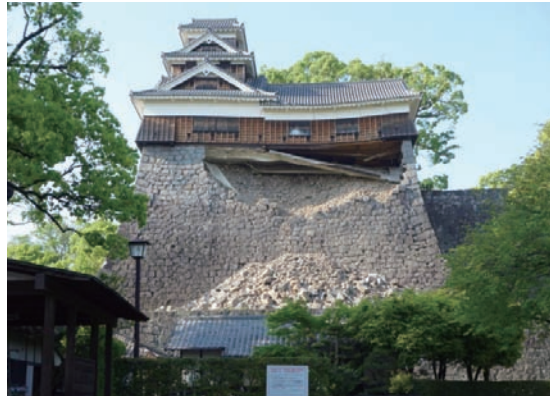
Photo 3.7.1.5 The damaged lidamaru Five-storied turret

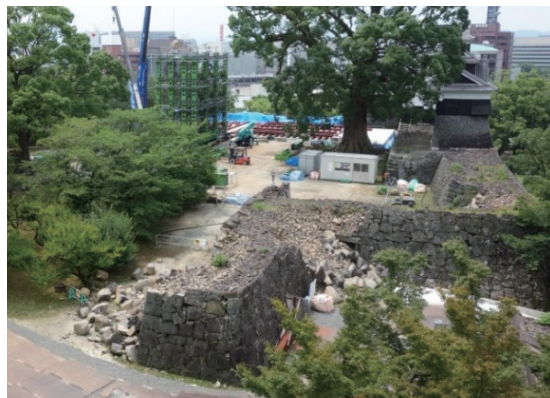
Photo 3.7.1.6 The damaged the West Turret Gate site

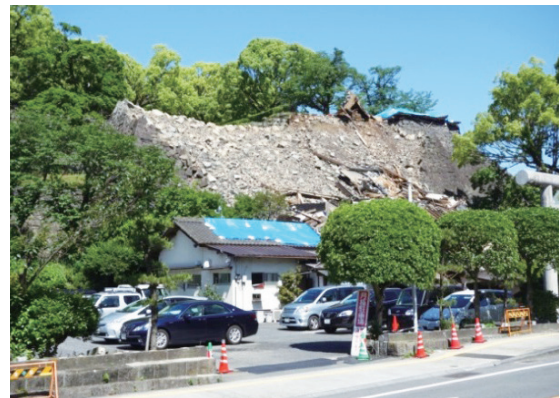
Photo 3.7.1.8 The Higashi Juhachiken Turret after the damage

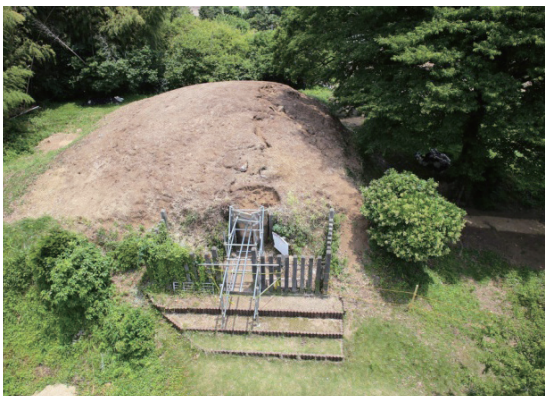
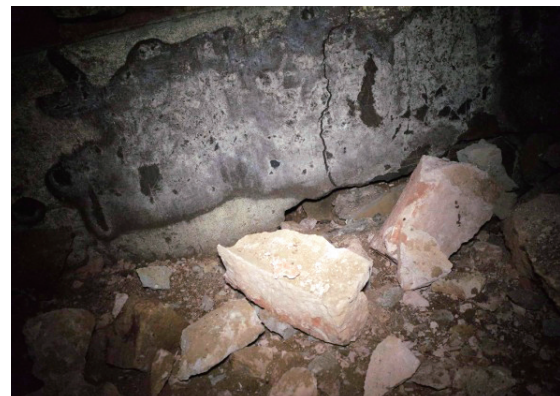
Photos 3.7.2.1 The Idera Kofun: Fissure in the mound and damaged stone chamber (courtesy of Kashima Town Board of Education).

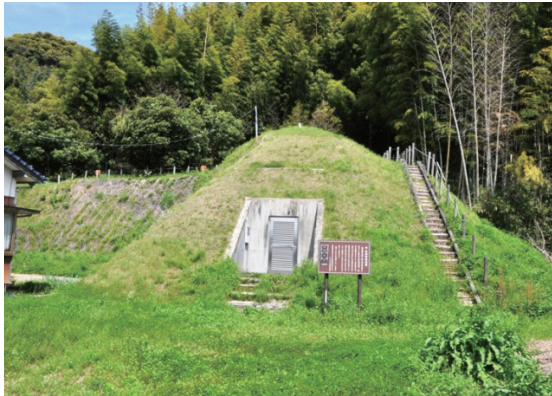
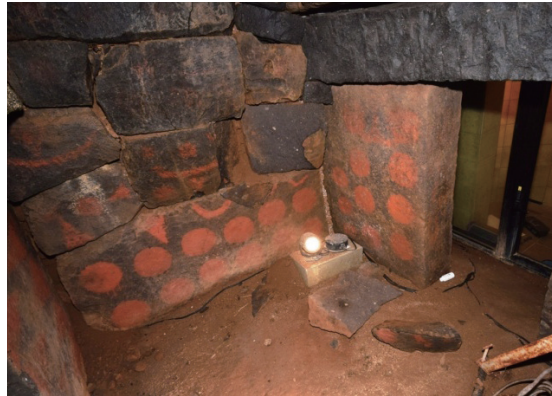
Photos 3.7.2.2 The Eianji Higashi Kofun: The damaged mound and stone chamber (courtesy of Tamana City Board of Education).

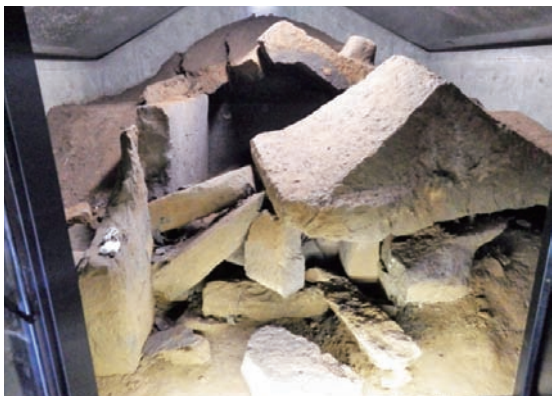
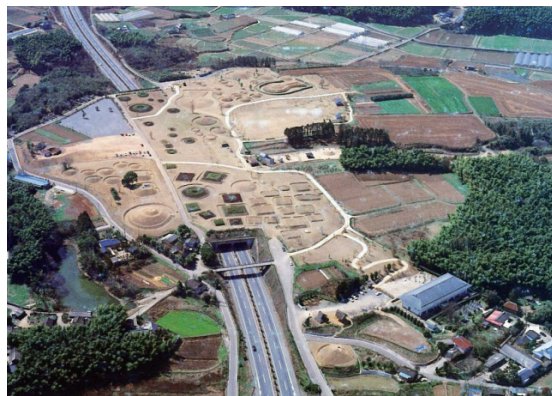
Photos 3.7.2.3 The damage in the Ishinomuro Kofun stone chamber and an aerial photo of the Tsukahara Kofun Group (courtesy of Kumamoto City).
