RESULTS OF ENGINEERING ANALYSIS FOR THE RESTORATION OF ST. BASIL'S CATHEDRAL (TEMPLE OF BLESSED VIRGIN'S COVER ON THE DITCH) IN THE RED SQUARE, MOSCOW.

Natalia Almazova *

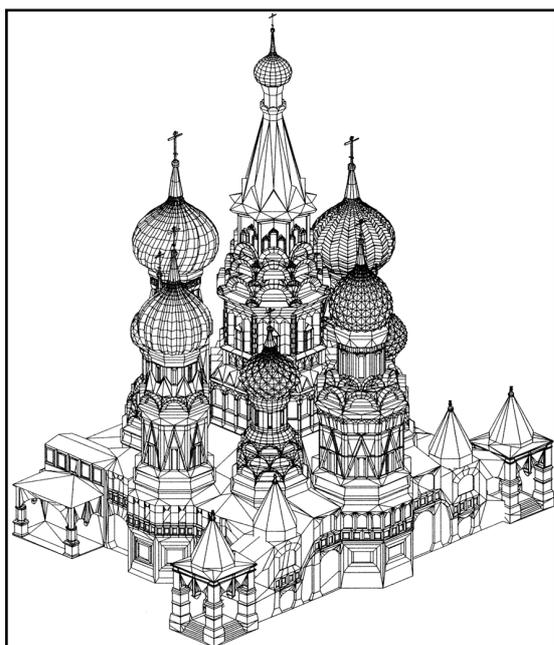
Figure 1

Based on the results of our engineering and land measuring work, we have developed a three-dimensional digital model of the Temple (see Figure 1), which gave us a new vision of the concept based on which the Temple has been built. Primarily, all the surrounding pillars of the temple are slightly inclined towards the central pillar. Secondly, the geometrical centers of the pillars and landing do not coincide. Naturally, we have concluded that it happened due to an inadequate pre-construction layout. However the landing calculation made with due account of the window and door embrasures showed that the pillar axes closely coincide with the gravity centers of the landing sections. Therefore we assumed that in the 15th century builders deliberately shifted the geometrical axes of structures (see Figure 2). We have undertaken a thorough examination of the position of the bell tower, which has a noticeable inclination. In 1951 Mosgorgeotrustcom tried to determine the degree of the inclination; the obtained result was that the shift from the stylobata cornice axis up to the "apple" made 790 mm and 2° verticality deviation. The results obtained by KREAL basically coincide with the results of Mosgorgeotrustcom (2°09'); so, a conclusion was that, at present, the belfry position has stabilized.
