EARTHQUAKE DISASTER PREVENTION OF CULTURAL HERITAGES - EXPERIENCE AND DEVELOPMENT IN JAPAN -

**August, 2023
ICOMOS Japan**

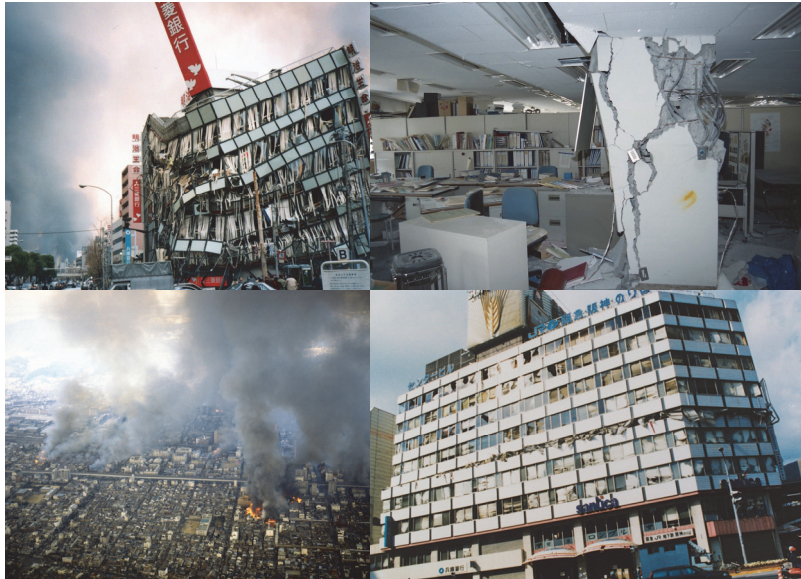
Photo 2.11 Situation of Damage
(Photo provided by Kobe City)

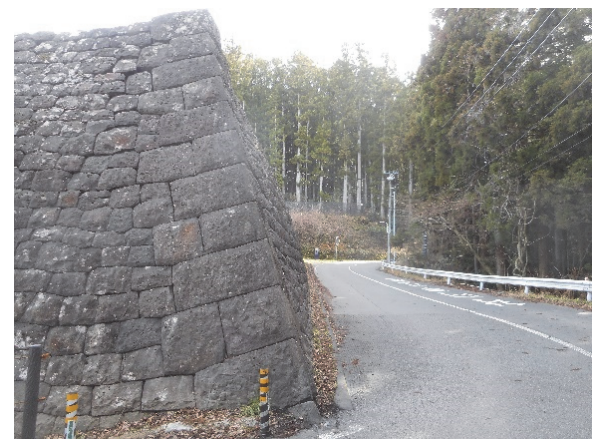
Deformation of the C-side stone wall northwest of the central compound caused by the Earthquake off the coast of Fukushima Prefecture in 2022

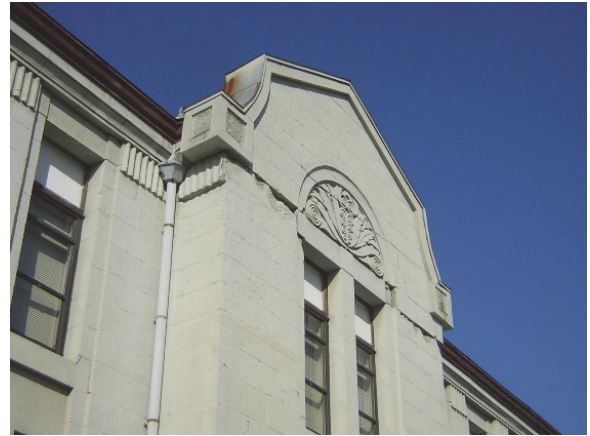
Damage of the pediment

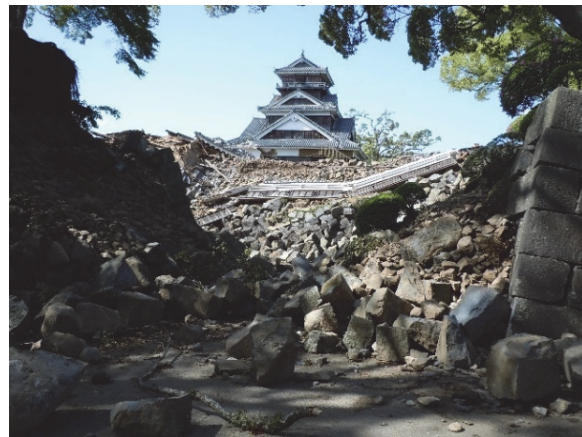
Damage to stone walls

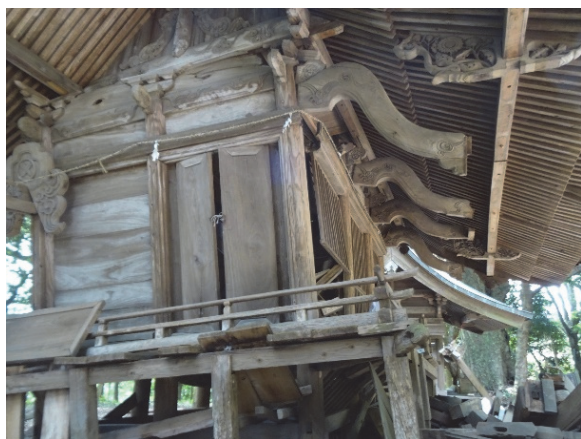
Damage right after the earthquake:
Hachio-sha Shrine main frame

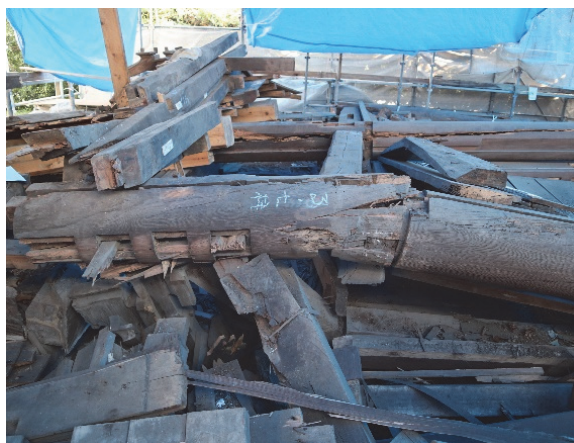
Damage condition: fallen posts

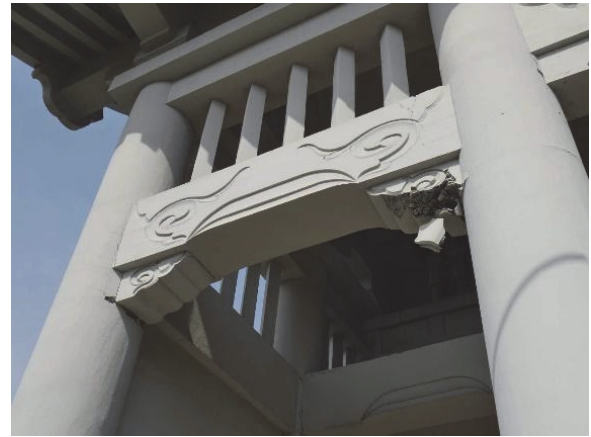
Damage to the column head, intermediate beam, and elbow section (east side: south side)

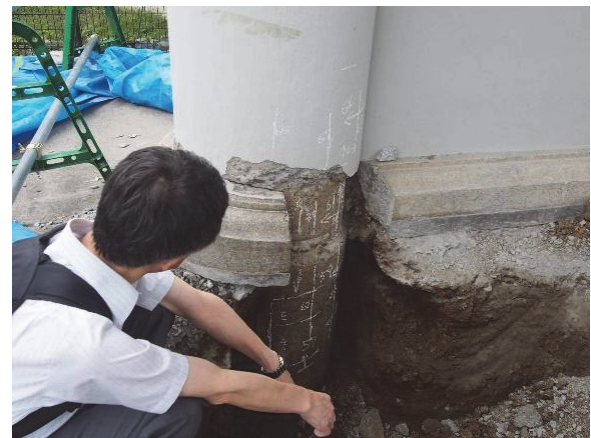
**Underground conditions around the column bases
(columns in the northwest corner)
(Photo courtesy of Mariko Nishijima)**

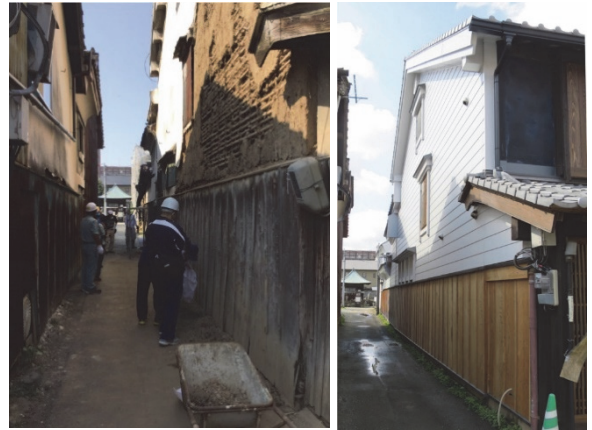
Damage to the alley side wall (left) and after restoration was completed (right)
