Case study

In situ assessment of superficial moisture condition in façades of historic building using non-destructive techniques

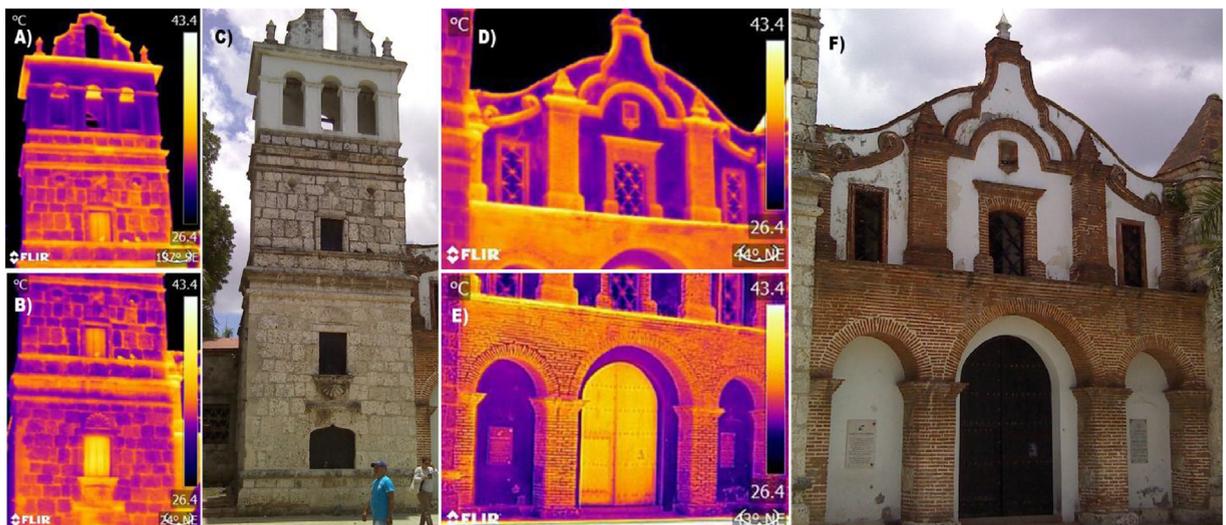
Fig. 6. A,B) Thermograms bell tower; C) Visual image of bell tower; D, E) Thermograms of main façade; F) Visual image of main façade.

In the Main Façade (south) the thermal images (Fig. 6E) show that in the middle of the columns there is an area that is wet while the base is dry. This humidity is originated when rainwater and runoff water penetrate. Also in the upper part (Fig. 6D) there is moisture in a large area due to a) when rainwater and runoff water penetrate; b) humidity penetrates through cracks and through the loss of the lining or paneling c) rammed earth wall hygroscopicity, even though we can observe this humidity in the visual image (Fig. 6F).

While in the Bell Tower the thermal images indicate: a) Moisture originating from the subsoil due to the capillary action at the base of the bell tower when rainwater and runoff water penetrate; b) humidity penetrates through cracks and through the loss of the lining or paneling in some areas of the bell tower; c) rammed earth wall hygroscopicity. (Fig. 6A, B).

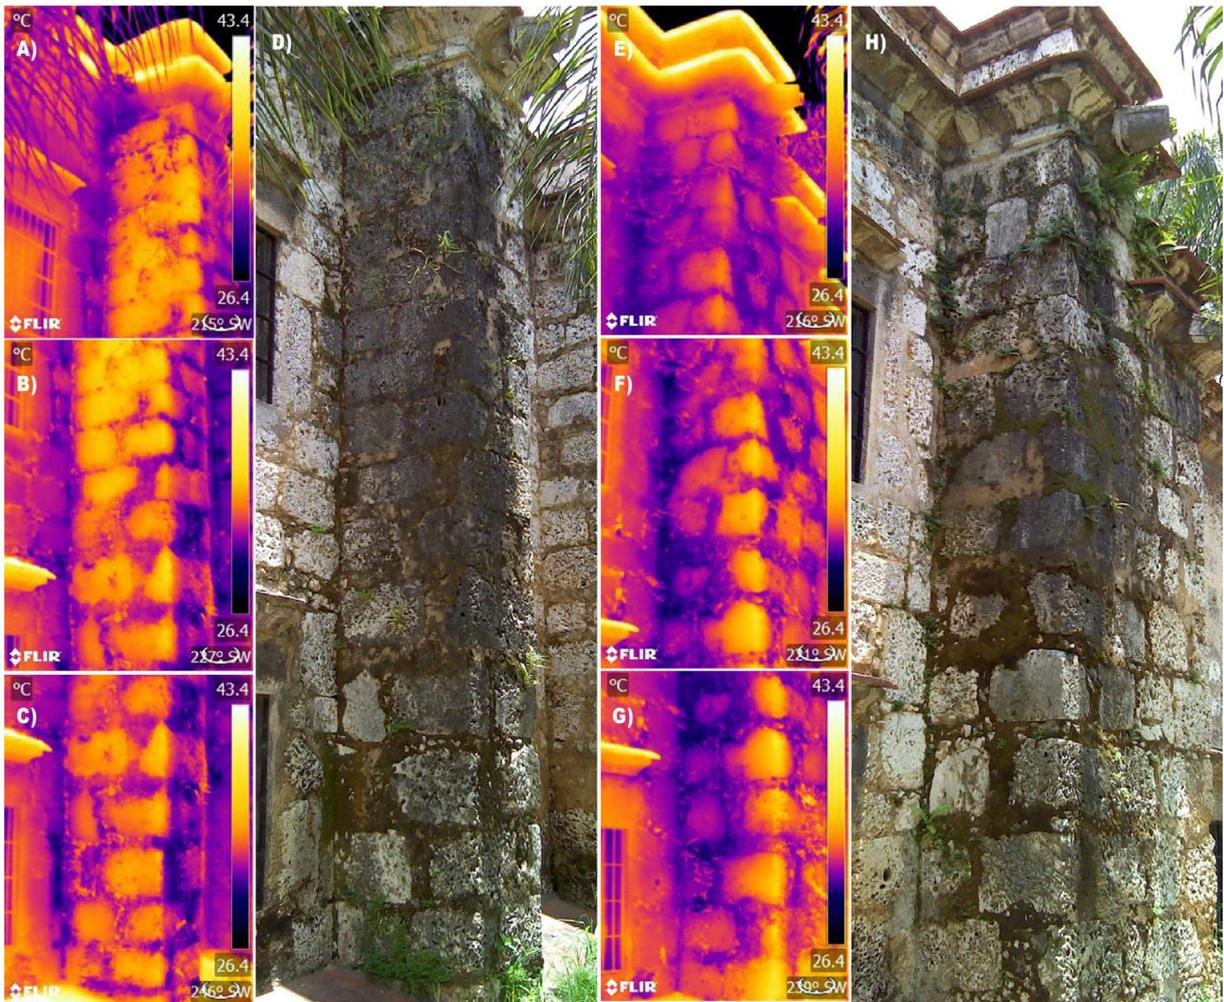
Fig. 7. A,B,C) Thermograms First buttress; D) Visual image first buttress; E,F,G) Thermograms Third buttress; H) Visual image of third buttress in north façade.

The North Façade presents dampness in both walls and buttresses, caused by: a) ascending capillarity when penetrating rainwater runoff from facades; b) Moisture by filtration when the water penetrates the stone due to poor drainage in roofs, allowing the growth of vegetation and the formation of the black crust. (Fig. 7).

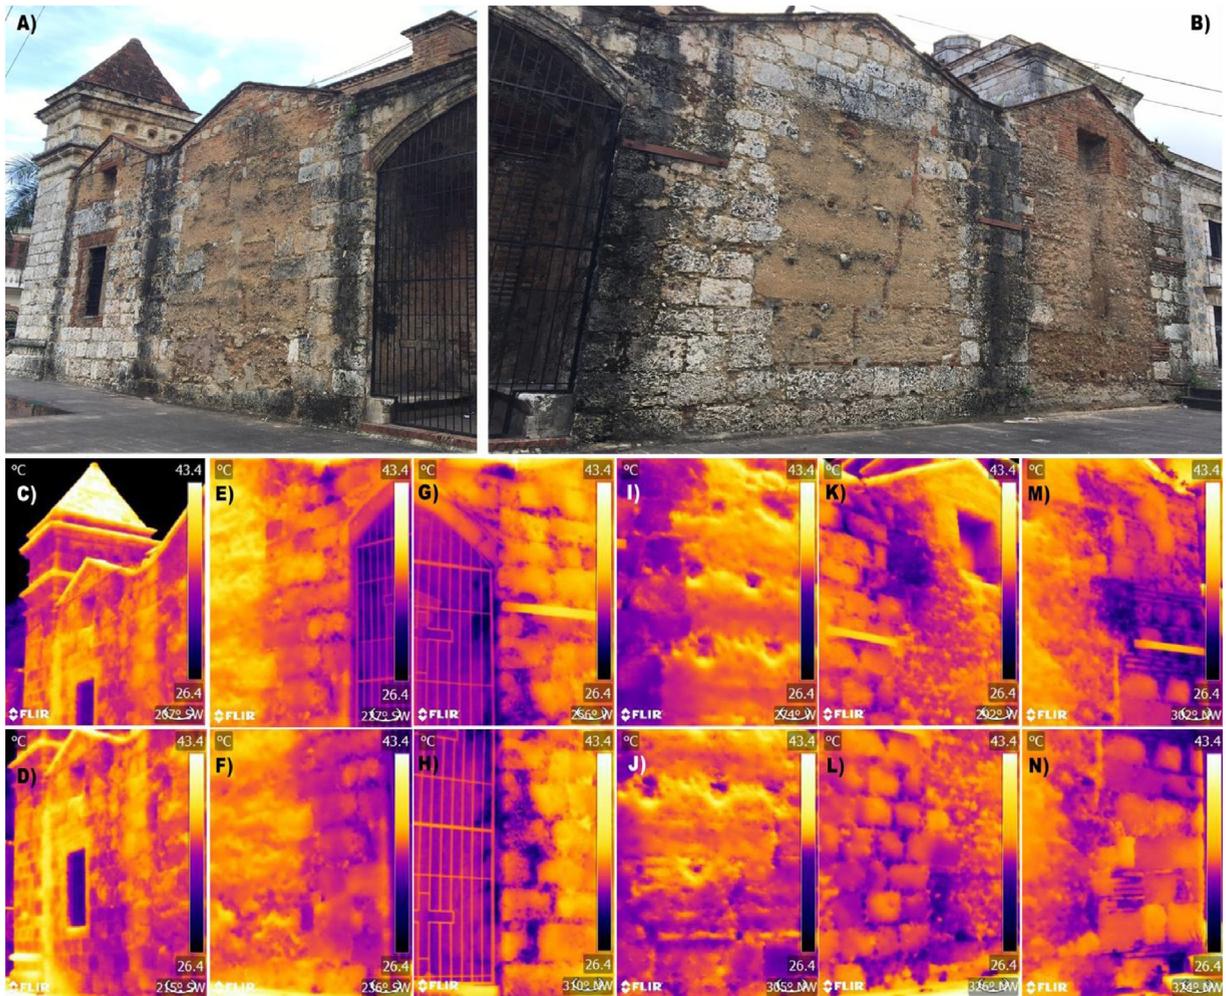
Fig. 8. A,B) Visual images of east façade; C-N) Thermograms of east façade.

In East façade observed a dampness in the walls caused by: a) ascending capillarity when penetrate rainwater runoff from facades; b) Moisture by filtration when penetrating the water through wall due to damage drainage in roofs and by the loss of plaster, allowing the growth of vegetation in some zones and formation of the black crust; c) rammed earth wall hygroscopicity. (Fig. 8). Most of the humidities are identify in the areas where the drainages are located, deteriorating the rammed earth and the coralina limestone.

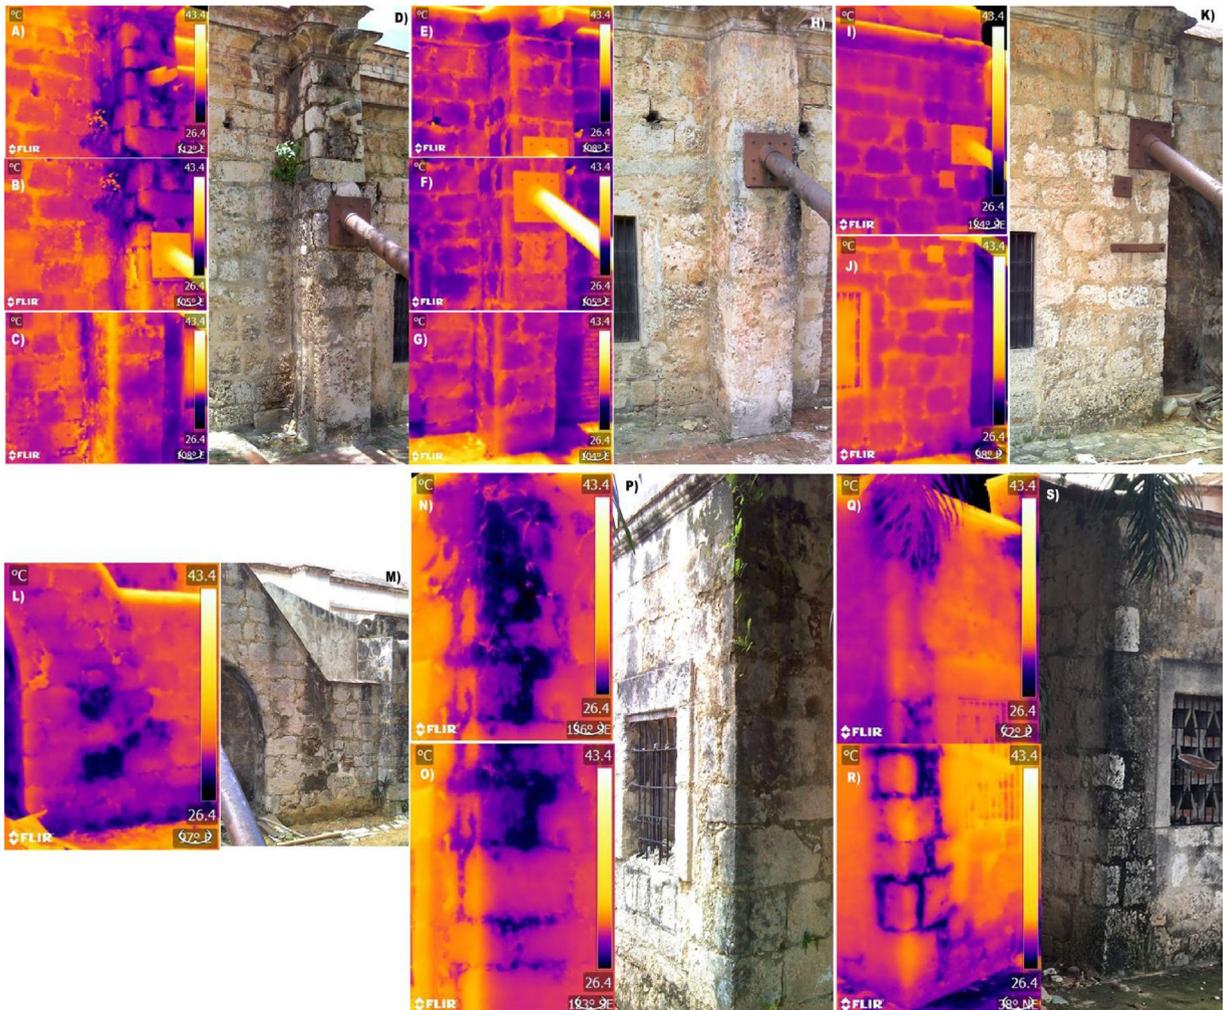
Fig. 9. A,B,C) Thermograms First buttress; D) Visual image first buttress; E,F,G) Thermograms Second buttress; H) Visual image second buttress; I,J) Thermograms Corner in west façade; K) Visual image of corner; L) Thermograms Stairs; M) Visual image of stairs; N, O) Thermograms Corner in west façade; P) Visual image of corner; Q, R) Thermograms Corner; S) Visual image of corner in west façade.

In West façade was observed dampness in both walls and buttresses, caused by: a) ascending capillarity when penetrate rainwater runoff from facades; b) Moisture by filtration when the water penetrates the stone due to damage drainage in roofs, allowing the growth of vegetation in some areas and the formation of the black crust. (Fig. 9). This humidities are deteriorating the façade with the consequence of major damages such as structural problems.

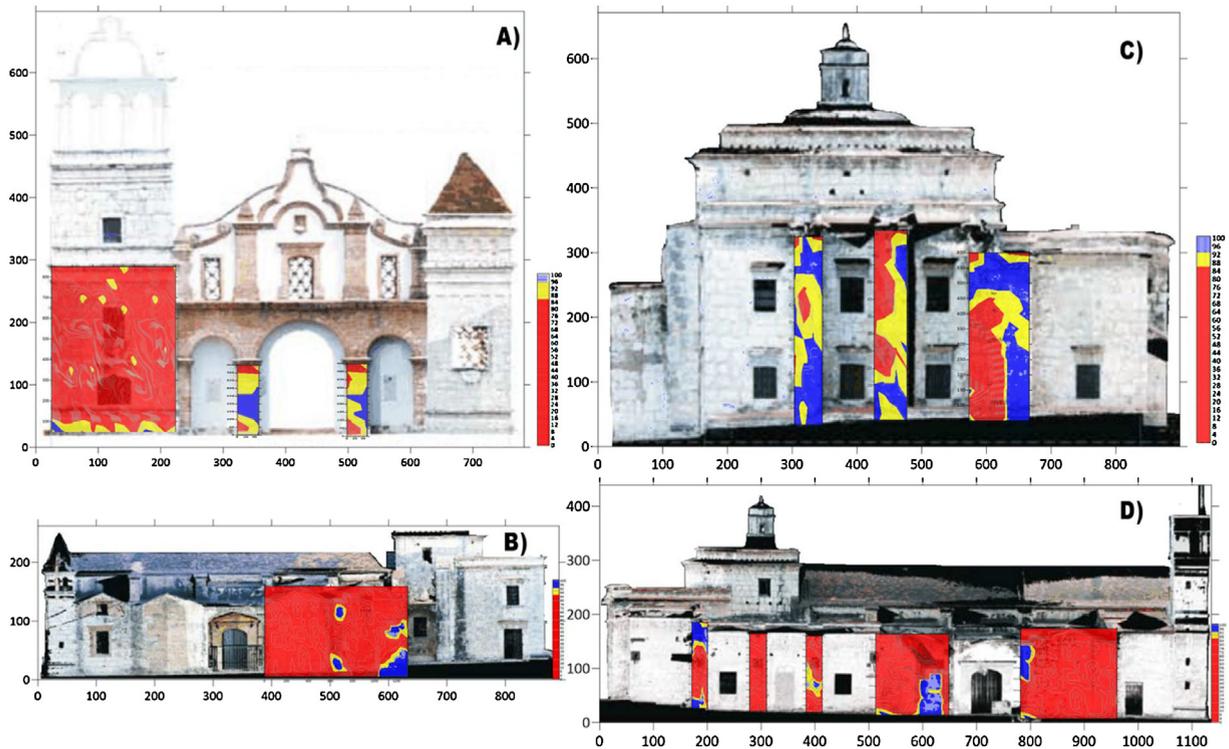
Fig. 10. A) Moisture in Main Façade (South); B) East Façade; C) Back Façade (North); D) West Façade.

The Moisture mapping shows the main façade (south), where the extent of wet and dry areas can be identified with different colors (blue color indicates a surface too wet (>95), whereas red color indicates a sufficiently dry moisture level (0–85) and yellow color indicates a borderline situation (85–95)). Fig. 10A) shows a great area sufficiently dry moisture in the bell tower with a few areas too wet in the base, whereas in the two columns there are an area too wet located in the middle and a few areas sufficiently dry moisture. Fig. 10B) shows a great area sufficiently dry moisture, also we can observe a blue zones located in the base and in some parts of the façade. Fig. 10C) shows a great surface too wet in the three buttress located

in different areas (base, top, middle), also there are areas with borderline situation (yellow) and sufficiently dry moisture (red). Fig. 10D) shows a great areas sufficiently dry moisture, also we can observed some areas too wet located in the base and the top of the façade.

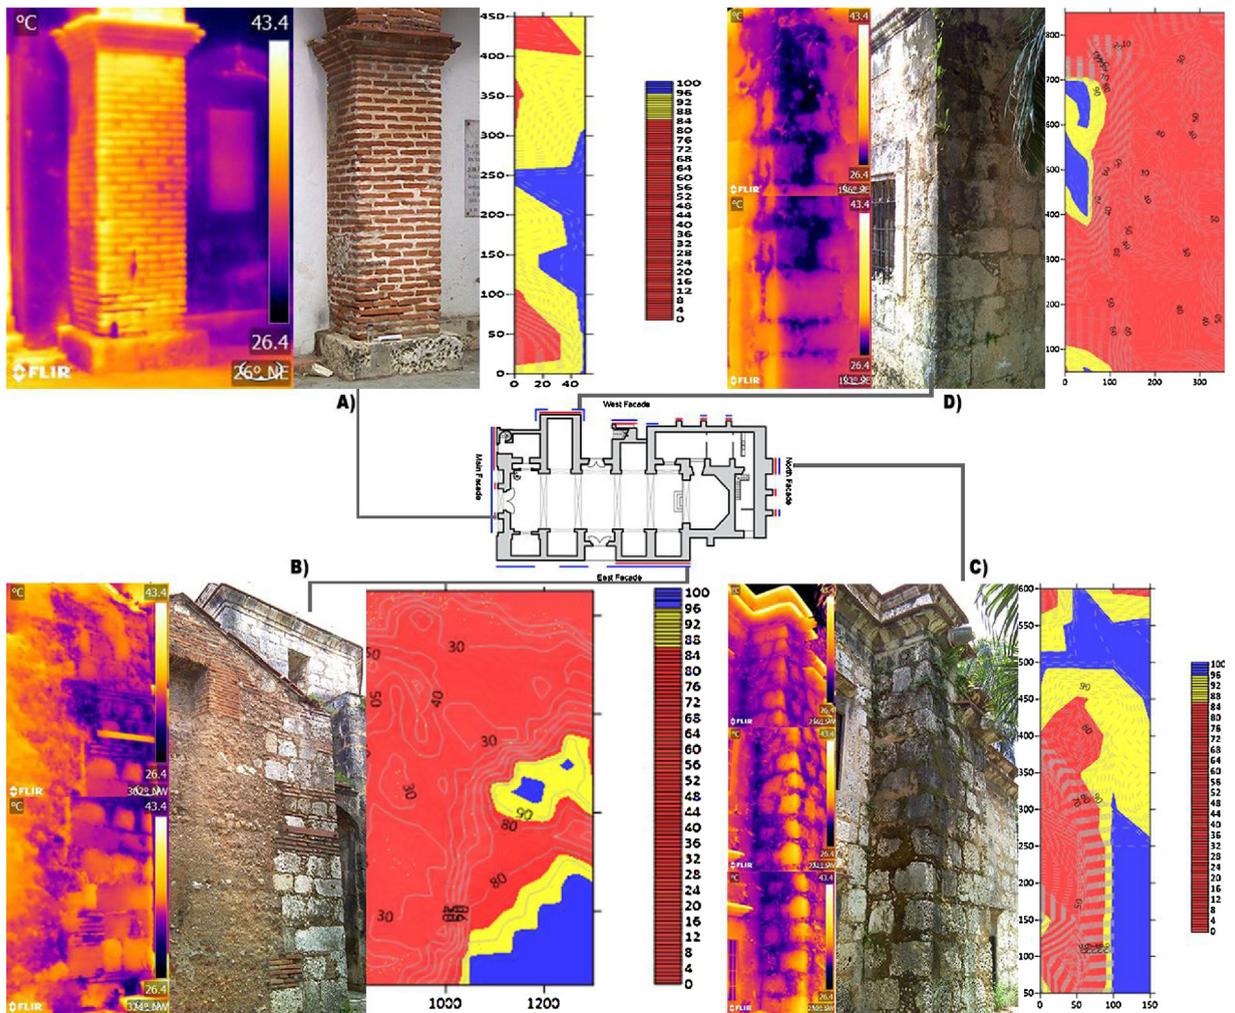
Fig. 11. A) Column in main façade (South); B) Corner in east façade; C) Buttress in back façade (North); D) Corner in west façade.

Fig. 11 shows a comparative between IRT and ERM of small part of each façades. Fig. 11A) shows a column located in the main façade where we can observe in both methods that there is a wet area in the middle of the column. Fig. 11B) shows a part of east façade where there are two areas too wet (>95) perfectly identify in the middle and in the base of the corner. Fig. 11C) shows a buttress in back façade where we can observe areas too wet in part of the base and top, also there are areas in the borderline situation (85–95) and others areas sufficiently dry moisture (0–85). Fig. 11D) shows a corner in west façade where we can observe in both methods that there is a wet area located in the top and in the middle of the corner.

Also in Fig. 11 we can observed that there is a difference in the results between both techniques, because of in ERM there is no difference between the joints and the stone or brick pieces, these occur due to the moisture was measured only in the stone and brick.
