RESTORING THE STATUE OF LIBERTY:

CONSTRUCTION OR CONSERVATION?

E. Lawrence Bellante
and
E. Blaine Cliver

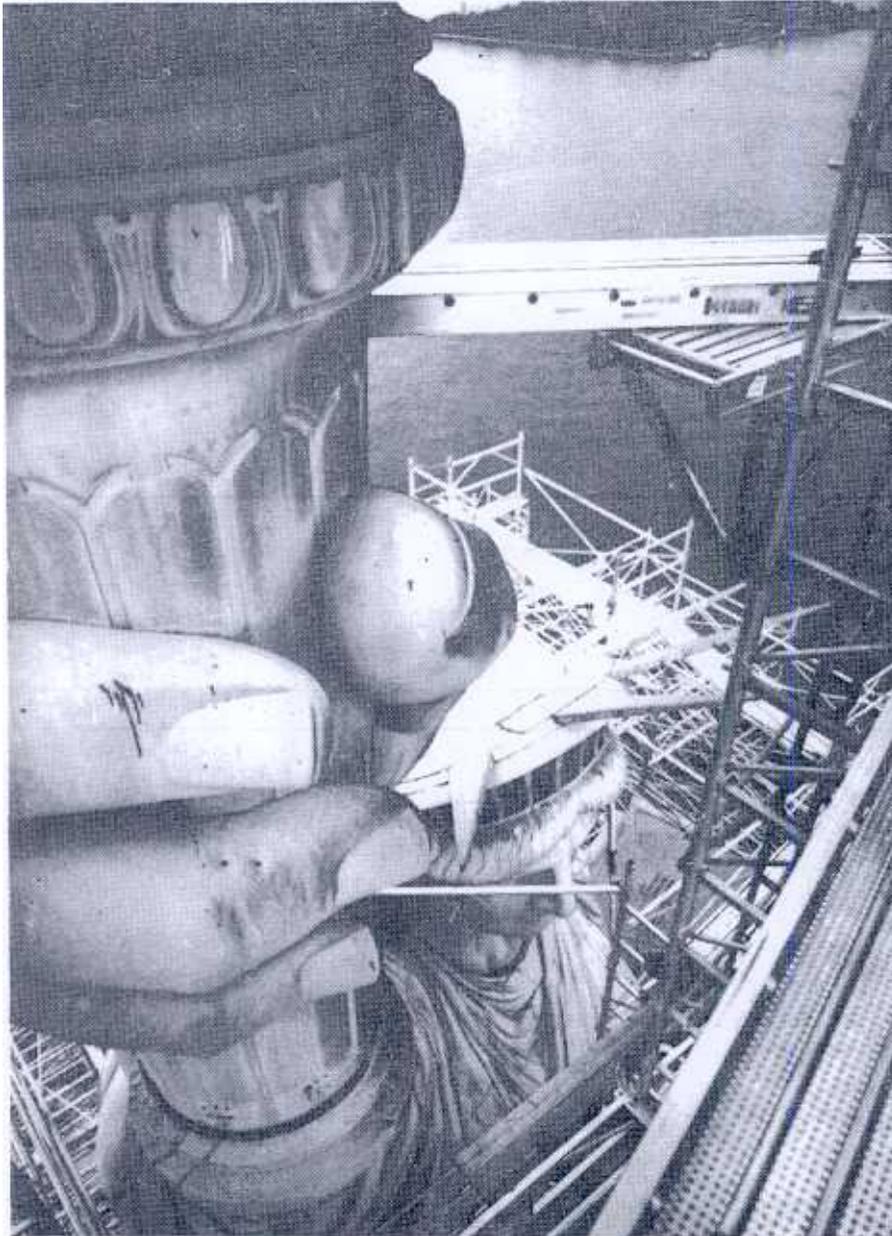
Figure 1
The Statue of Liberty seen from her scaffold
Photo: H.A.B.S. - Jet Lowe

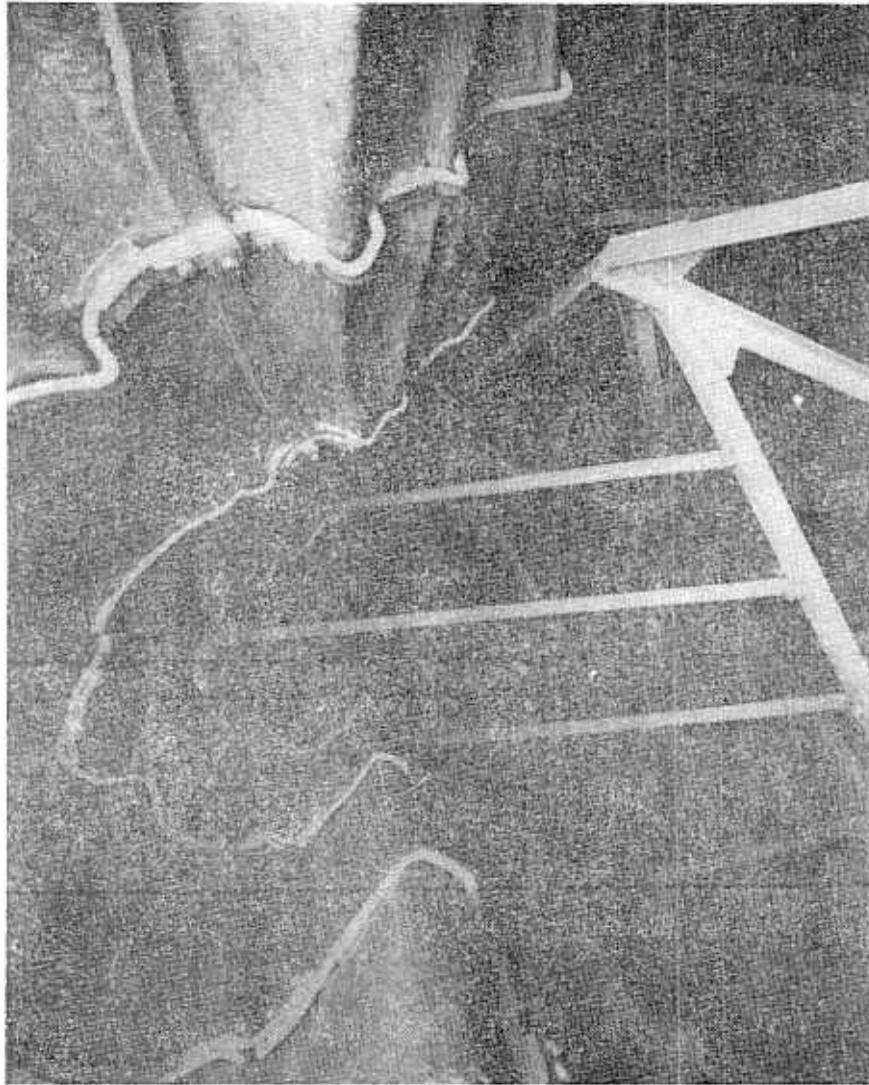
Fortunately for future generations as well as for "Miss Liberty" a more conservation minded approach was taken. The initial survey revealed minor flaws with the copper skin but found extensive problems with the iron grid system (referred to as the armature) supporting the skin. Because of a galvanic reaction between this iron armature and the copper of the skin, the armature, being relatively sacrificial, had lost in many places over half its thickness. This loss was irreversible and necessitated the replacement of the iron grid system. Also of concern was the supporting structure of the raised right arm and the possibility that repairs might require removal of the arm. Replacement of the armature and removal of the arm or any of its parts would require scaffolding as would access to the skin's exterior surface. Rapidly the project was requiring a high degree of engineering.

Figure 2
The interior of the skin showing the armature system.
Photo: H.A.B.S. - Jet Lowe

conservation was to cause elaboration in the construction process. Complexity ensued with the design procedures for replacing the iron armature. The need for continued rigidity meant that only 16 bars of a total of over 1800 could be missing within a 36 hour period at any one time. Fabrication of the new bars required a workshop on the island and, because of environmental concerns, the bars were sent over to Manhattan for cleaning with acid before returning for installation.
