Mémoire du
Diplôme de Spécialisation et d'Approfondissement — Architecture de Terre et Patrimoine,
DSA-Terre 2016 - 2018

**Comparaison de l'architecture vernaculaire en terre
de Goa (ancienne colonie portugaise en Inde) et de l'Alentejo (Portugal):
Cultures constructives locales et approches de conservation**

**Comparison of the vernacular earthen architecture in
Goa (past Portuguese colony in India) and Alentejo (Portugal):
Local building cultures and conservation approaches**

RODRIGUES Chenelle Fatima

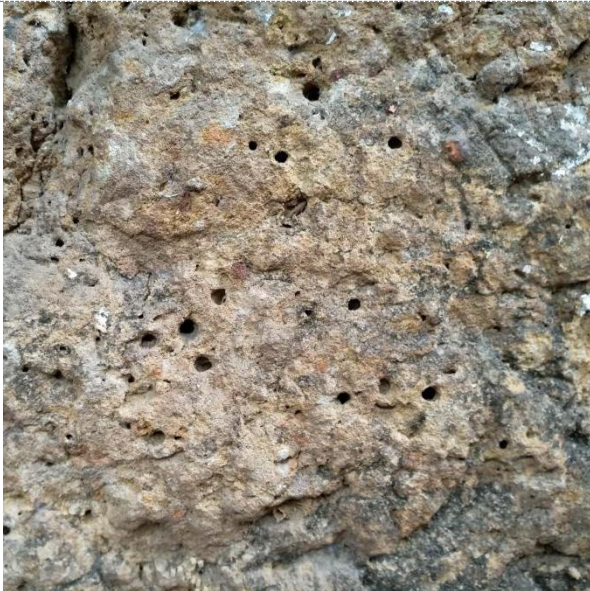
Damages incurred / problems faced: Mason-bee holes.

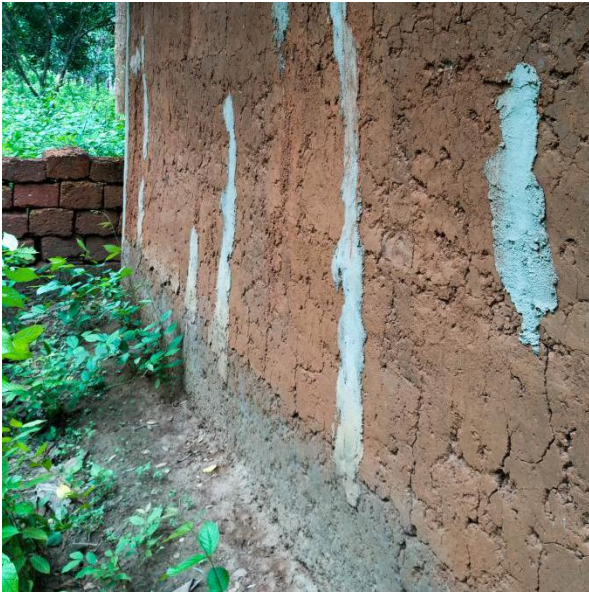
Observations: Base-course is greyish along the one facade.
Repairs: Cracks and and other repairs done in cement.

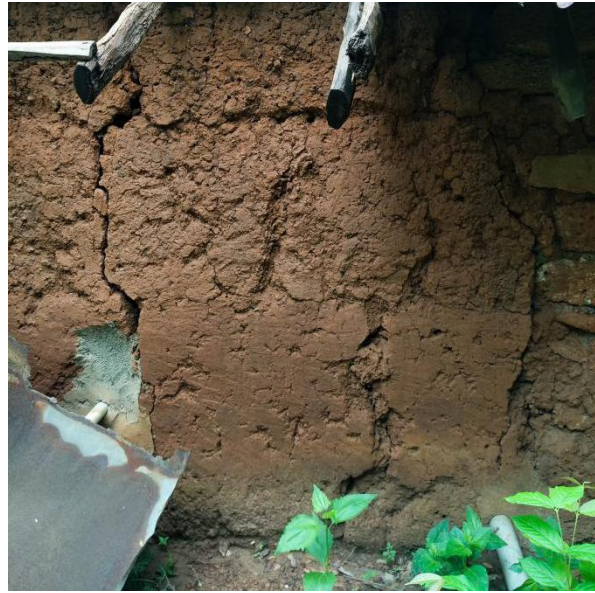
Observations: Some parts of the wall are less eroded than the others.

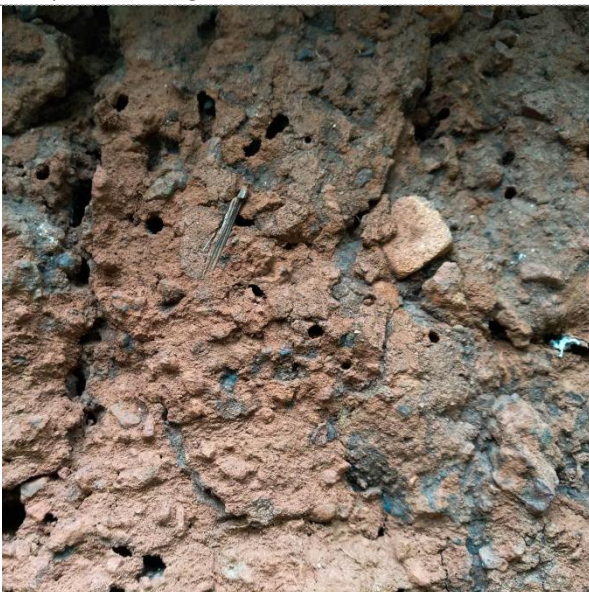
Damages incurred / problems faced: Mason-bee holes

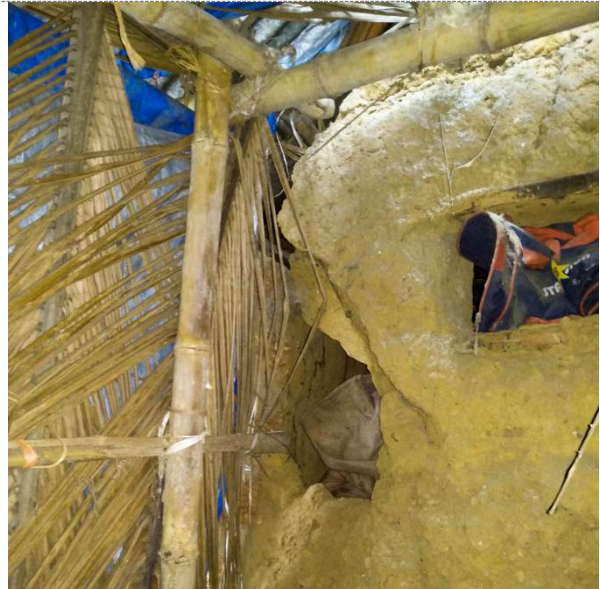
Damages incurred / problems faced: A crack in the roof caused rainwater to seep into the walls and created a hole in the corner.

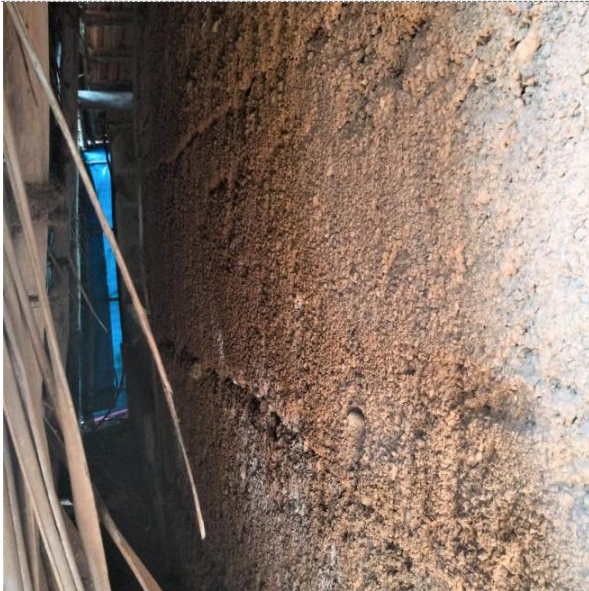
(South wall.)

Maintenance and repairs: The entire south facade is protected by a coconut-palm barrier to protect the wall from rainwater. The south wall is thus less eroded than the north.

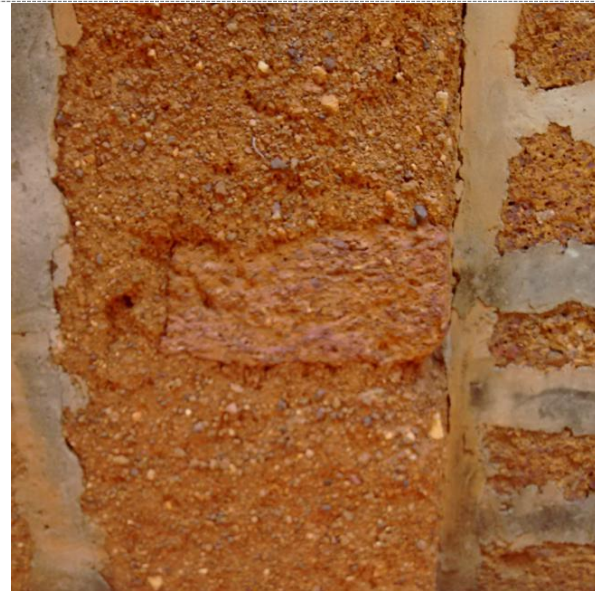
(North wall.)

Damages incurred / problems faced: Cracks.

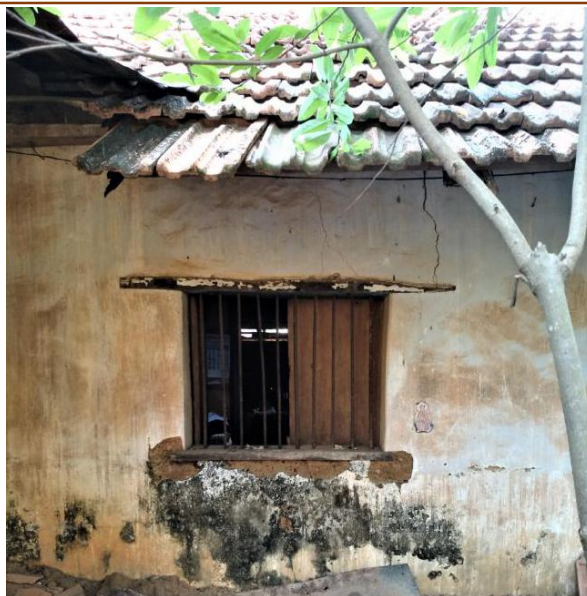
Damages incurred / problems faced: Cracks, especially near lintels.

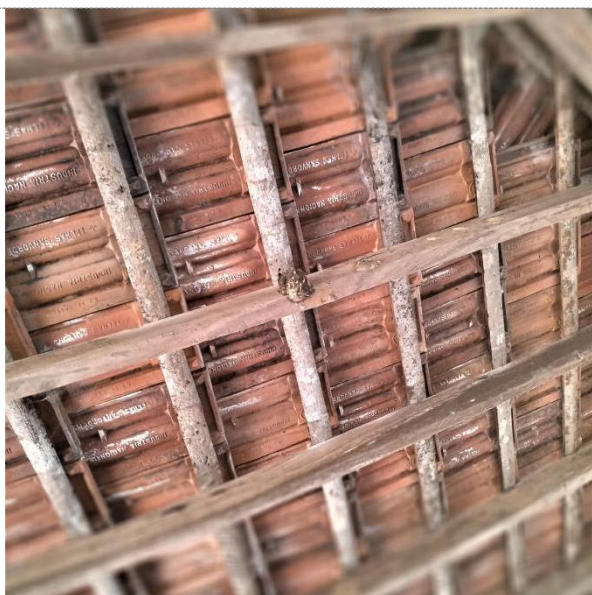
Damages incurred / problems faced: Insects called 'bateen' make nests out of mud on roofs.

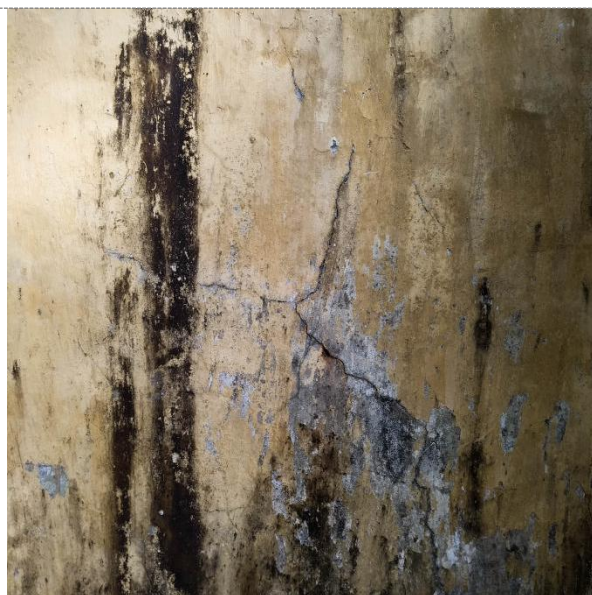
Damages incurred / problems faced: Cracks and dampness

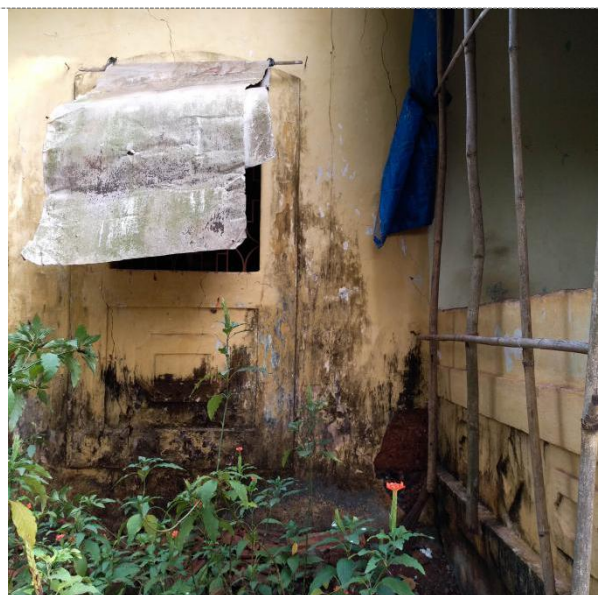
Maintenance and repairs: A make-shift overhang covers the window on the front facade.

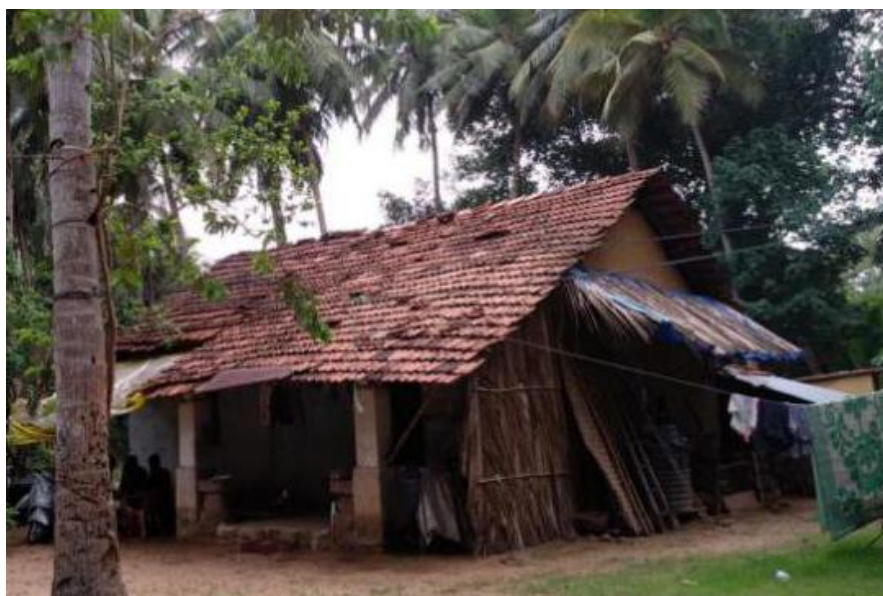
Image 133: Palm-leaf barriers poised parallel to earthen walls protected the walls from rainwater (Survey no. 1).

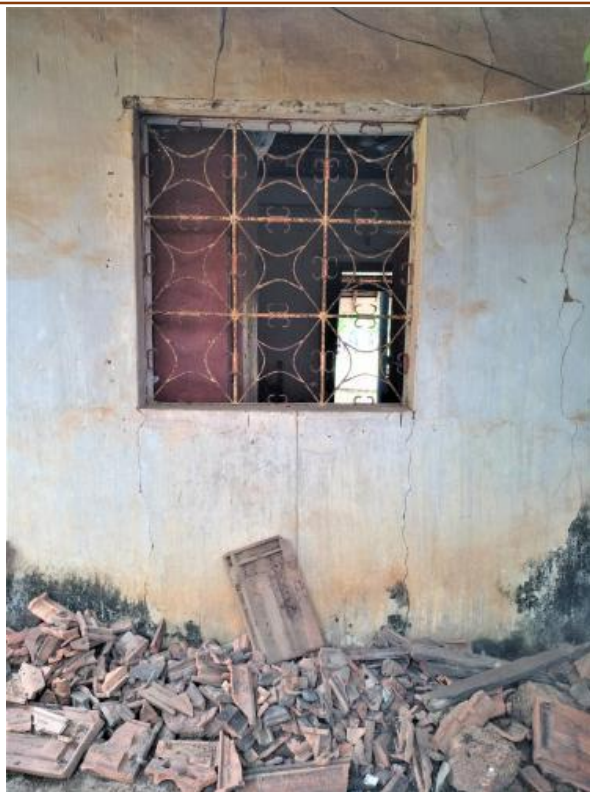
Image 138: The lack of support provided by rotting lintels caused the roof to put pressure on the wall, and created many cracks around the window (Survey no. 7).

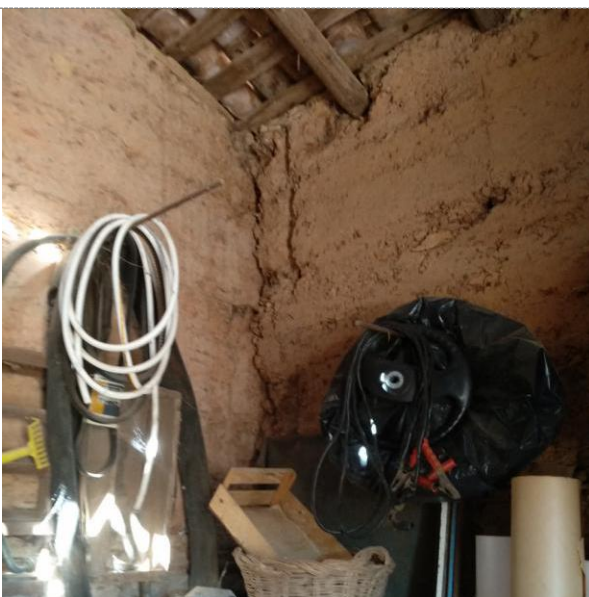
Damages incurred / problems faced: Cracks in corners.

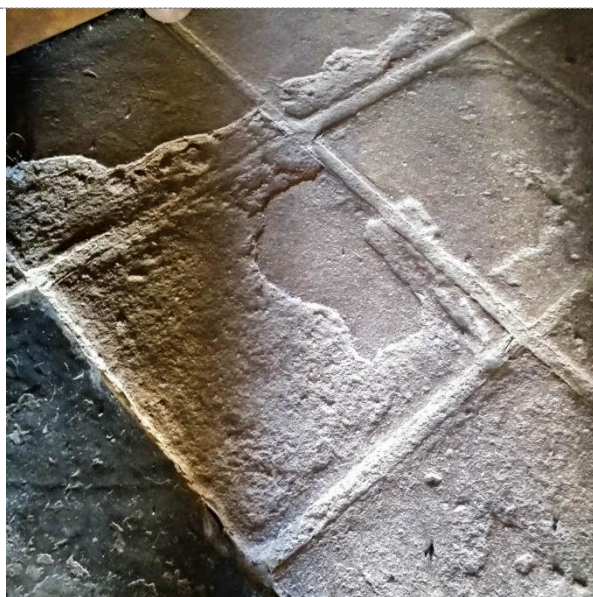
Damages incurred / problems faced: Clay 'baldosa' floor-tiles are chipped-off in some places.

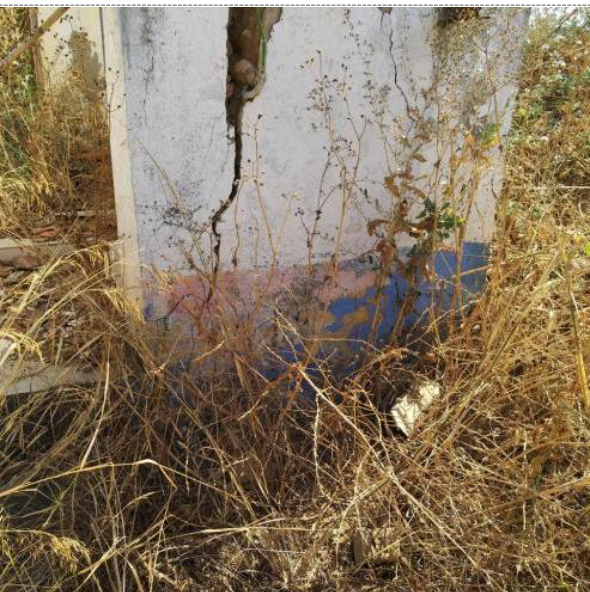
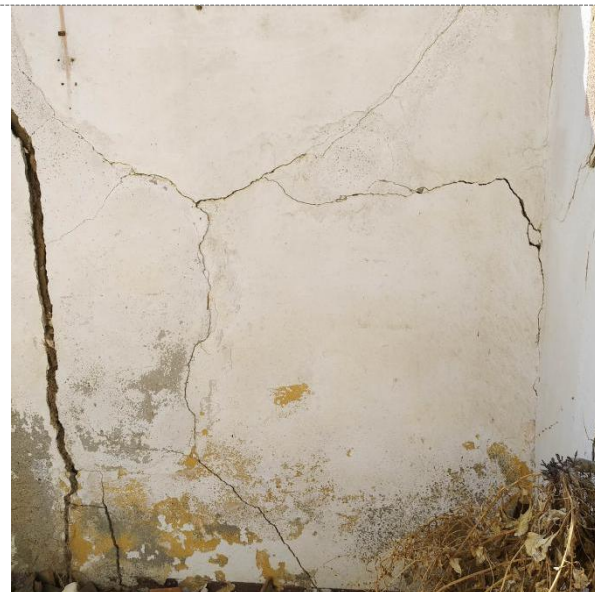
Damages incurred / problems faced: Cracks appeared and the walls began falling apart.
