## ***Reawakening the spirit: St. John's Church of Tartu, Estonia***

Kari Avellan  
KAREG Consulting Engineers  
Töölöntorinkatu 11 B  
FI-00260 Helsinki  
Finland  
[kari.avellan@kareg.com](mailto:kari.avellan@kareg.com)

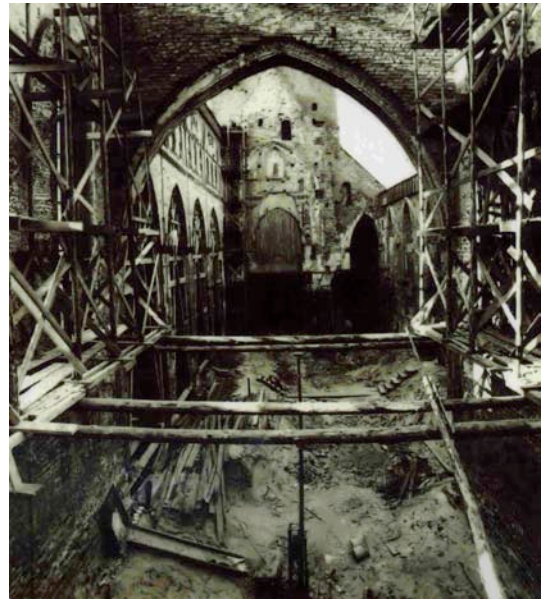
Picture 1. State of Church before restoration.

The story of the church in the post-medieval period is a history of multiple destruction and rebuilding, loosing many of the original features through the process. During World War II, in 1944, the church burned down and remained in ruins for the whole period of Soviet occupation (Picture 1).

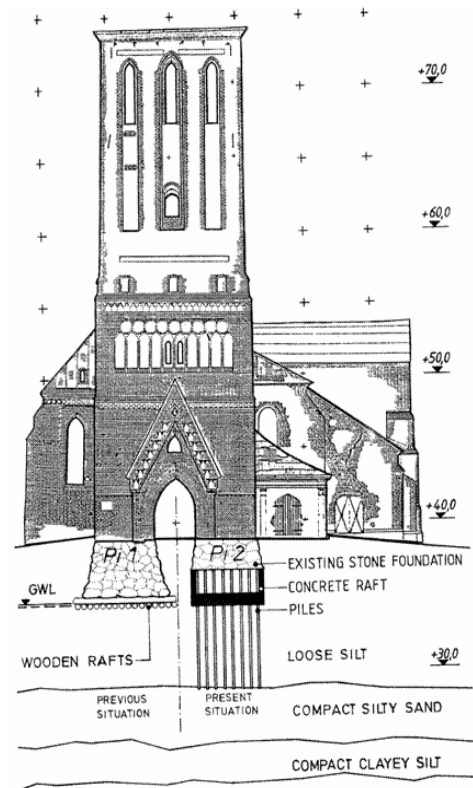
Figure 2. Underpinning of Tower.

The foundations of St. John's Church were strengthened by method of underpinning, using jacked steel piles and spiral drilled piles. In its actual state, the building could not tolerate the vibrations caused by driven piles. The top layer of the compact silty sands which begins at 6 meters below of the existing foundation was chosen as the bearing stratum. The reason for this choice was simply that the loose silt of the first 6 meters did not have the needed bearing capacity and is technically still settling. Furthermore jacking piles through the silty sand would have necessitated forces beyond the capacity of the old block foundation.

A simple and practical technique was devised to screw the spiral drilled piles in a very confined working space. Steel tube piles were jacked down under the existing structure, using it as a counterweight. Spiral drilled piles were used in those walls without a counterweight condition. The underpinning of the tower proceeded step by step while concrete was poured to make a monolithic floating pile raft foundation (Figure 3). Reinforced beams were also constructed on both sides of the wall foundations, and pressed with post-tensioned anchorage against the structure. A field load test was performed on all piles and the rate of settlement measured. Between the old stone and new concrete structure, a viewing space was kept to give archaeologists and engineers the opportunity to study the foundation "in situ" in the future (Picture 2).

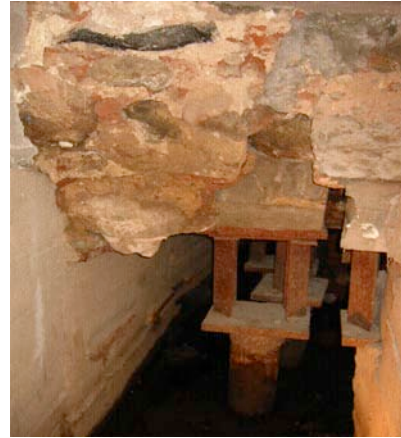
Figure 3. Monolithic floating pile raft foundation .  
Picture 2. Viewing space.

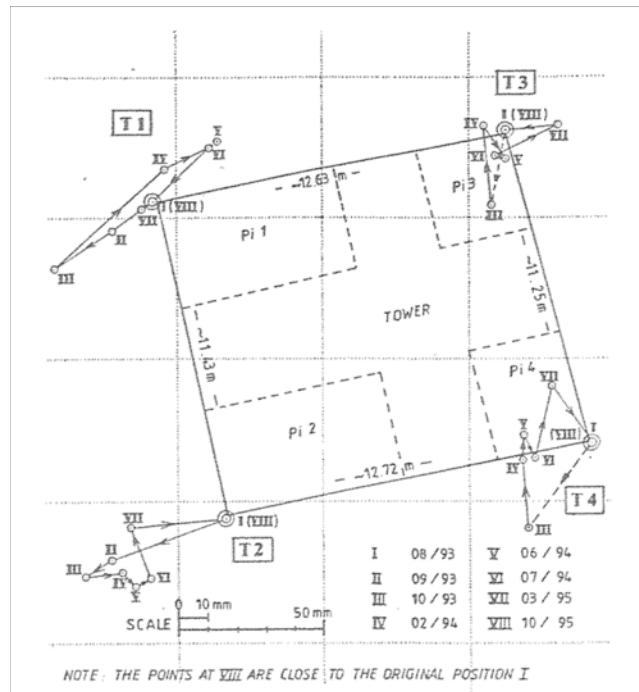
The rate of settlement and horizontal displacements, particularly of the tower, were measured throughout the process. Due to the construction technique, the overall settlement of the tower was only 18 to 20 mm. The horizontal displacement was registered at a maximum of 50 mm during work, and measured at 20 mm after the work completion (Figure 4).

Figure 4. Horizontal displacements of Tower.
