Thermal assessment of internal shutters and window film applied to traditional single glazed sash and case windows

This Technical Paper should be quoted as:
Historic Scotland Technical Paper 23

The building selected for the study is a detached 18th century cottage, Wee Causeway, located in Culross. It is a dwelling of traditional construction (solid stone wall) where some energy efficiency refurbishment works were completed in 2012 (wall and ceiling insulation). In the summer of 2013, glazing film, designed to improve thermal performance, was installed on all rear windows of the building, except the bathroom window. The textured translucent glass of the bathroom window proved unsuitable for the application of the glazing film. Thermally insulated timber shutters were applied to the interior side of the front facing window openings. The heat transfer through the bathroom glass and a front window pane was subsequently measured to provide a reference benchmark, to compare with the improved windows.

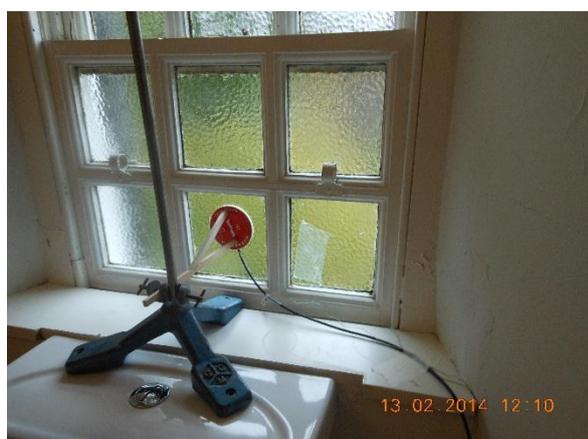
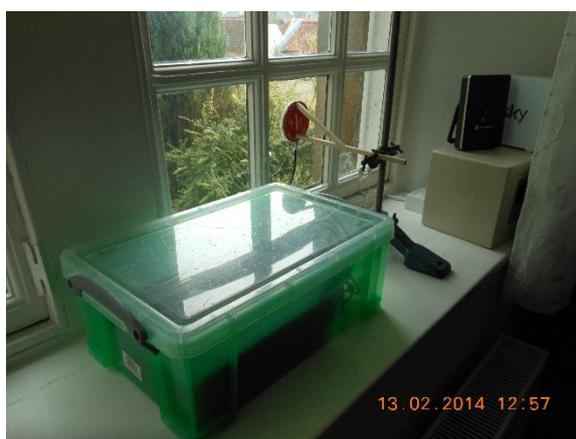
The in-situ U-value measurements were taken using Hukseflux HFP01 thermopile-based heat flux transducers (Fig. 1a and 1b) of 80 mm diameter and 5 mm thickness. These were attached to windows throughout the monitoring period (2 week duration). Four thermally improved windows were measured. Two windows were selected from the rear of the building and two on the front. An untreated single glass pane in a rear bathroom window, and a single glass pane with low-emissivity film from a rear bedroom window were selected. An untreated single glass pane in the landing window, and a window with a closed thermally improved shutter in a bedroom were selected from the front of the building. Single glass panes were measured on both orientations to provide a benchmark by which to measure any thermal improvements.

Fig. 1a Rear window baseline

Fig. 1b Rear window with glazing film

Particular precautions were taken to ensure that the low-emissivity window film was not damaged by the application of the heat flow mats. Several different methods of mechanically, rather than chemically fixing the heat flow mat to the window were trialled at Edinburgh Napier University. Prior to the installation of the sensors and loggers, an experiment was undertaken to identify any potential impact that the mechanical fixation methods would have on the final results. Details of this experiment are displayed in Appendix 1. The results showed that the measured U-value was not influenced by the addition of mechanical supports to the internal facing side of the heat flow mat. This allowed for the fixing type shown in Fig. 1a and 1b to be selected.

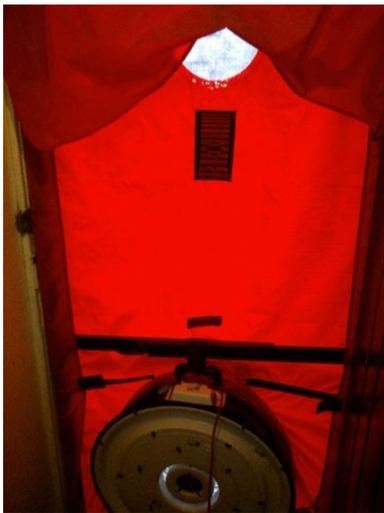
The air-permeability of a building was determined by positively and negatively pressurising the building envelope using a fan inserted to the front door of the property (Fig. 2a). Measurements of the air flow rate and corresponding indoor and outdoor pressure difference were used to create a building leakage curve over a range of fan flows. Before and after the measurements, recordings are made of the static pressure, the barometric pressure and the internal and external air temperatures. Air flow rates are adjusted accordingly and the air leakage rate can then be calculated at a given reference pressure relative to the internal envelope area. The reference building pressure used is 50 Pa. Temporary seals were applied to the active part of ventilation openings that could not be manually closed, this included the:

Fig. 2a Blower door fitted on front entrance

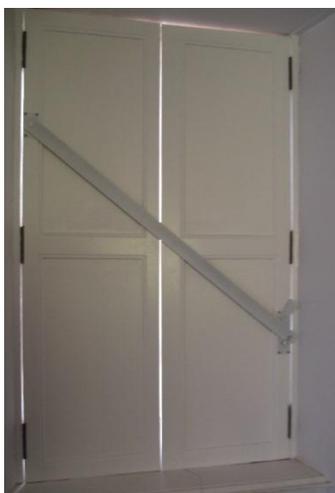
Source: National Trust for Scotland. Insulation marked as solid, softwood timber frame marked as diagonal hatching

Fig. 3 Top, Shutter plan view section drawing. Bottom, picture of Culross shutter measured for U-value

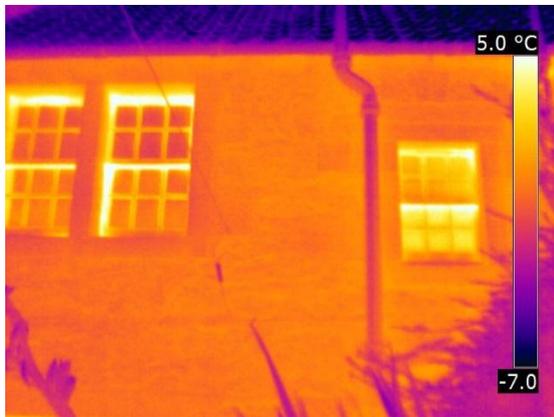
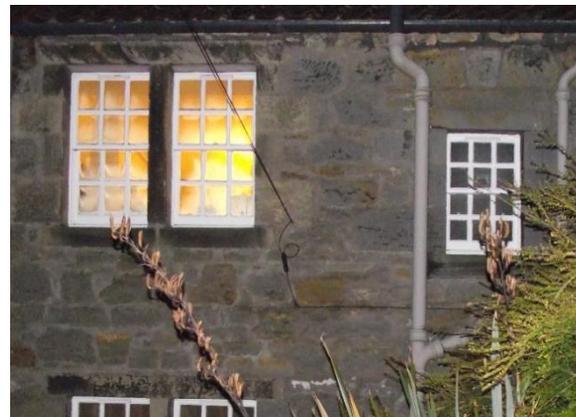
This IR image (Fig. 4a), shows different temperature profiles for window glazing with low-e film applied, and an untreated single glazed window. The window to the left in Fig. 4a and 4b are on the south room of the first floor which was treated with low-e film. The smaller window to the right (Fig. 4a and 4b) is the bathroom window which is the benchmark window with no film treatment or shutters. The darker colours of the window panes on the left in Fig. 4a indicate lower heat loss through the glazing when compared to the reference window on the right. The bright colours on the external thermograms represent larger amounts of heat transferring from the warmer internal environment to the colder external environment. Both windows are reflective of the same clear night sky and the internal temperature for both rooms was recorded to be the same (19°C).

Fig. 4a Thermogram of first floor south room and bathroom window

Fig. 4b Photograph of first floor south room and bathroom window

Characteristics	Bathroom window	First floor window
Orientation	Rear (south)	Rear (south)
Window improvement	None	Low-e film
Average surface temperature (°C)	2.2	0.8

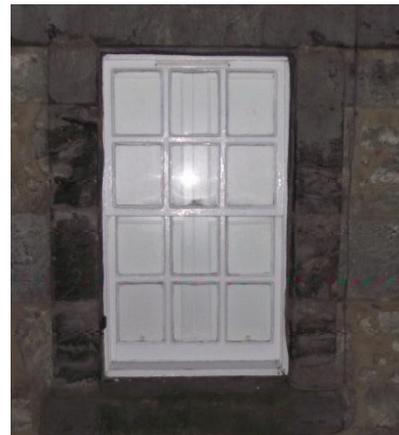
A front window was thermographed to demonstrate the impact of the thermally improved shutter. The first set of images (Fig. 5a and 5b) is of the ground floor south room. In Fig. 5a the window has the shutter closed. In Fig. 6a and 6b, the same window has the shutter open. The shutter is an effective barrier to thermal transmittance through the glass. Therefore, the surface temperature in Fig. 5a is lower than in Fig. 6a. The higher temperature zone on the top panes of the window in Fig. 5a is due to heat movements within the airspace between the shutter and the glazing. Fig. 6a shows temperature stratification vertically within the whole room.

Fig. 5a Thermogram of a front window with shutter closed

Fig. 5b Photograph of a front window with shutter closed

Characteristics	Fig. 5a and 5b	Fig. 6a and 6b
Orientation	Front	Front
Window improvement	Shutter closed	None
Minimum surface temperature (°C)	-0.8	3.3

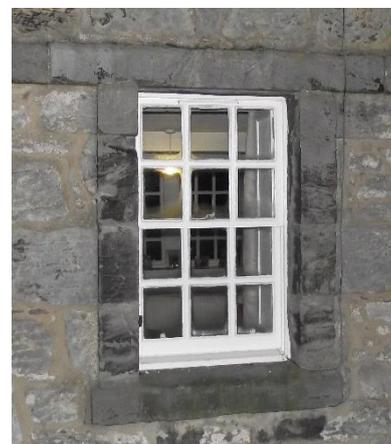
Fig. 6a Thermogram of a front window with shutter open

Fig. 6b Photograph of a front window with shutter open

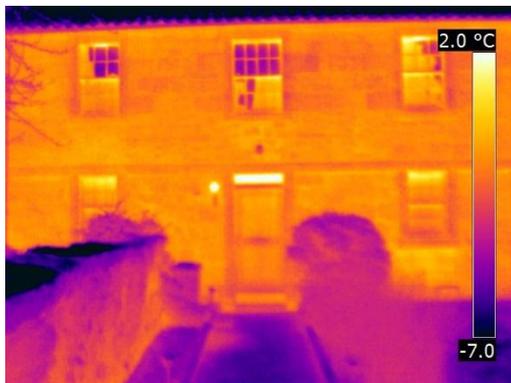
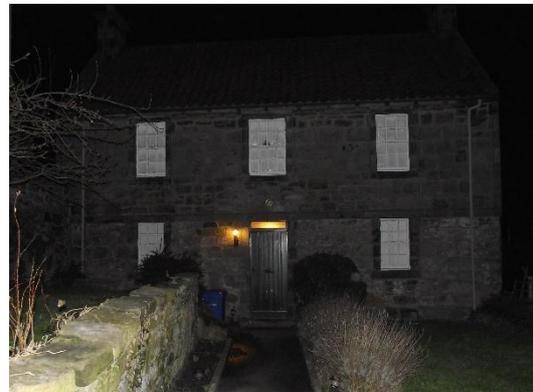
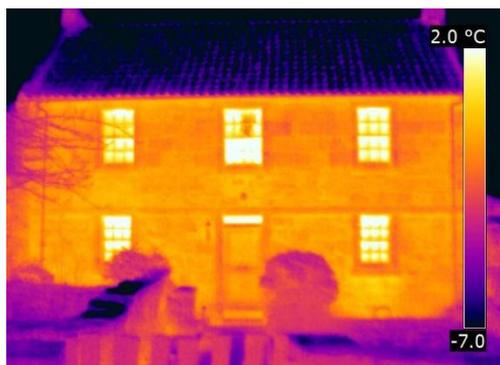
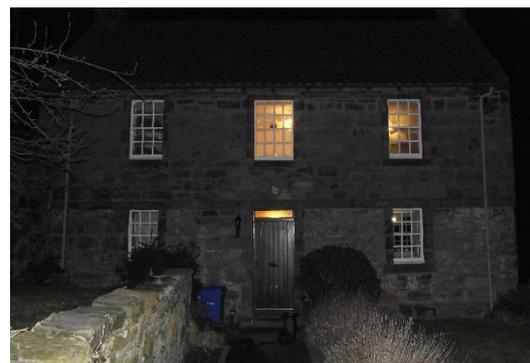
The images in Fig. 7a, 7b, 8a and 8b provide an overview of thermal heat loss via the front windows of the house with shutters closed and opened. The top three windows are not representative of the

impact of the shutter, as the thermogram displays darker colours on the top panes. This is due in part to the reflection of the clear night sky (-296°K). Consequently, this is obscuring the temperature profile across those glass panes for comparison to the rest of the windows. However, the thermal signature of the windows with the shutter open is so large that it masks any reflection of the night sky. For the purpose of Table 8, the surface temperature comparison has been calculated for the bottom right window with the shutter closed and the same window with the shutter opened.

Fig. 7a Thermogram of the house front with shutter closed

Fig. 7b Photograph of the house front with shutter closed

Fig. 8a Thermogram of the house front with shutter opened

Fig. 8b Photograph of the house front with shutter opened

Characteristics	Fig. 7a & 7b – lower right window	Fig. 8a & 8b – lower right window
Orientation	Front	Front
Window improvement	Shutter closed	None
Average surface temperature (°C)	-1.3	1.3

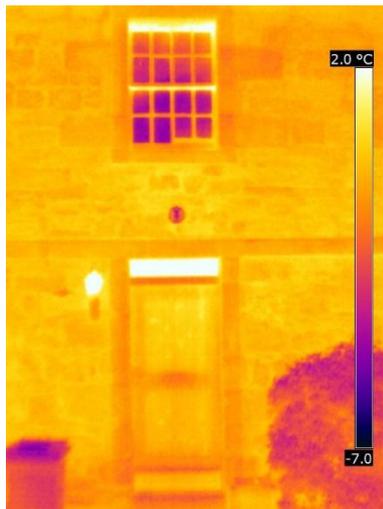
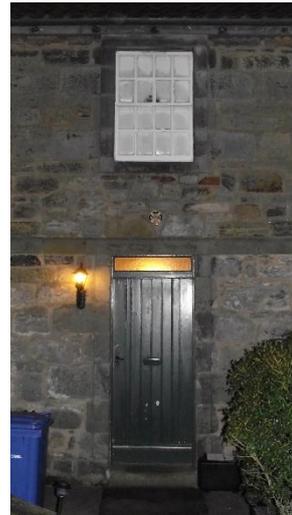
The thermogram below provides a comparison between a front facing window with the shutters closed and the single glazed panel above the door on the ground floor, which has no shuttering. The bright thermal signature of the glazed panel above the door compared with the shuttered window above (Fig. 9a) demonstrates the thermal resistance of the shutters. The angle of this thermogram has been chosen to reduce the effect of sky reflection.

Fig. 9a Thermogram of the house front with shutter closed

Fig. 9b Photograph of the house front with shutter closed

Characteristics	Window above the door	First floor window
Orientation	Front	Front
Window improvement	None	Shutter closed
Average surface temperature (°C)	2.4	-1.8

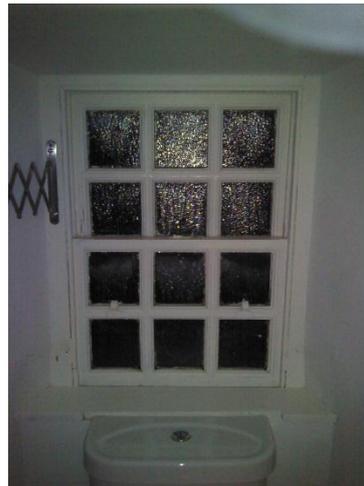
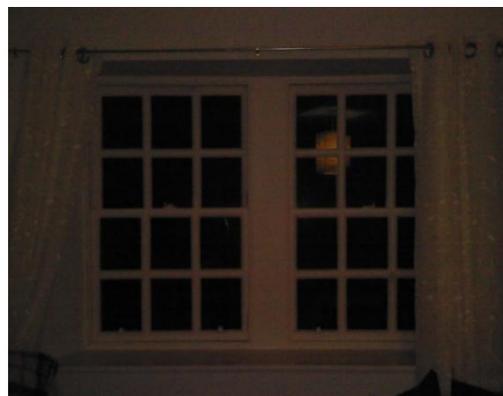
Visual comparison between improved and original glass from the internal perspective is challenging. Thermograms taken from the interior sides of windows could not be taken side-by-side in the same image; therefore the same thermal range has been selected for all internal thermograms. Both rooms were heated to the same internal temperature (18°C). As mentioned previously, the bathroom window is the only rear facing window with no improvement and has been nominated as the benchmark image (Fig. 10a and 10b). The temperature profile for the internal images represent heat loss to the exterior; darker colours represent colder areas and therefore higher rates of heat transfer through the element. The thermogram in Fig. 11a shows the impact of the film on the surface temperature of the glass in the first floor north room. Compared to the benchmark temperature of the bathroom window (Fig. 10a and 10b), the window in the north first floor room appears to have a much higher temperature.

Fig. 10a Thermogram of bathroom window

Fig. 10b Photograph of the bathroom window

Fig. 11a Thermogram of rear facing window in north room first floor

Fig. 11b Photograph of rear facing window in north room first floor

Characteristics	Bathroom	North first floor room
Orientation	Rear	Rear
Window improvement	None	Film

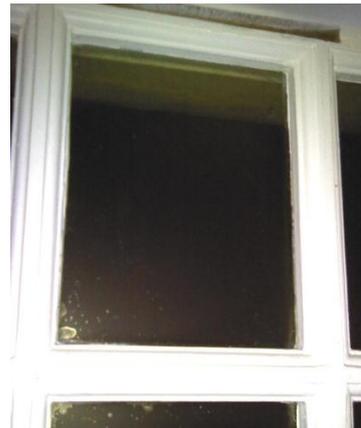
Fig. 12a and 12b shows a thermogram of the film as applied to a single glass pane in the window of the north first floor room. The camera has been focused on the window film and especially on the boundary between the film and the glazing.

As way of a comparison, the thermogram presents two points, A and B. Point A is located on the window film, point B is on the uncovered single glazing. There is a visual temperature difference between the points in the thermogram. The thermogram shows a lot of reflection from other parts of room (Fig. 12a).

Fig. 12a Thermogram of pane with film

Fig. 12b Photograph of pane with film

Characteristics	Point A	Point B
Orientation	Rear	Rear
Window improvement	Film	None

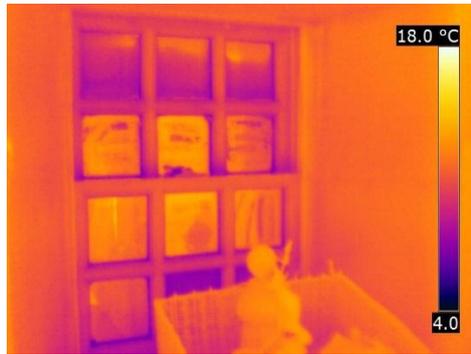
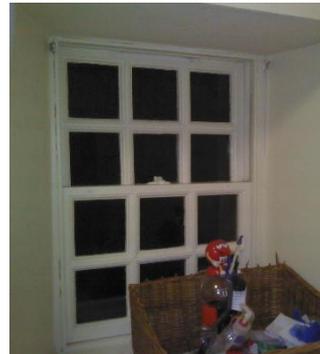
During the thermographic survey, excessive condensation had manifested on the glass of many of the windows. In order to demonstrate the impact this has on the thermographic survey, researchers removed the condensation from 7 panes of one window. The thermogram in Fig. 13a shows the difference between wet and dry windows. When there is condensation on the pane, the water distorts the thermogram and presents lower temperatures (purple colour). However, the dry middle panes in yellow are comparable to the previous windows with film.

Fig. 13a Thermogram of the kitchen window

Fig. 13b Photograph of the kitchen window

Characteristics	Kitchen
Orientation	Rear
Window improvement	Film

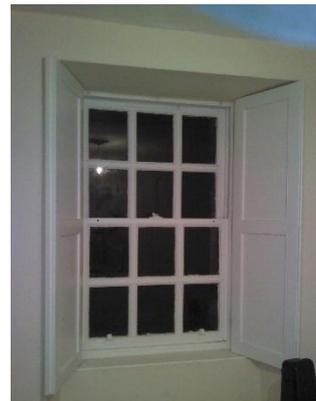
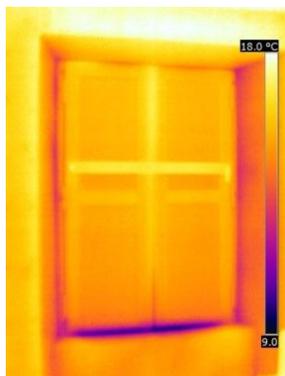
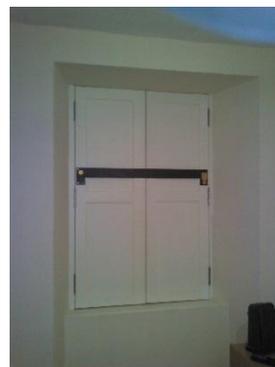
The thermographs in Fig. 14a and 15a demonstrate the impact of the shutter on front windows compared to an untreated single glazed window. The first image, Fig. 14a and 14b, shows the window on the first floor landing with the shutter open. Fig. 15a and 15b shows the same window with the shutter closed. The dark coloured areas below the shutter on Fig. 15a are due to gaps around the frame of the shutter, allowing for the transmission of heat and ventilation heat loss under the shutter. The average surface temperatures shown in Table 13 were calculated omitting the area of heat loss below the shutter.

Fig. 14a. Thermogram of window in first floor landing with shutter opened

Fig. 14b Photograph of window in first floor landing with shutter opened

Fig. 15a Thermogram of window in first floor landing with shutter closed

Fig. 15b Photograph of window in first floor landing with shutter closed

Characteristics	Fig. 14a and 14b	Fig. 15a and 15b
Orientation	Front	Front
Window improvement	None	Shutter
Average surface temperature (°C)	7	15

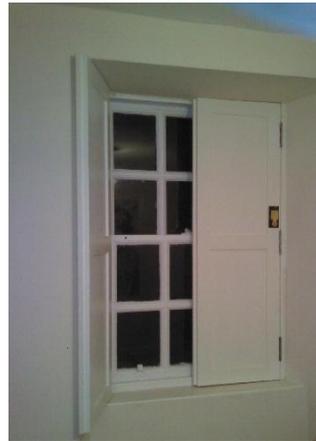
The following images, Fig. 16a and 16b, show the window in the ground floor north room. The thermogram shows the window with one half of the shutter in the closed position. Two points, A and B, were analysed. Point A is located on the single glazing; point B is on the shutter. The surface temperature calculation on these points shows a difference of 9°C.

Fig. 16a Thermogram of ground floor north room with shutter half opened

Fig. 16b Photograph of ground floor north room with shutter half opened

Characteristics	Point A	Point B
Orientation	Front	Front
Window protection	Shutter	None
Surface temperature (°C)	15	6

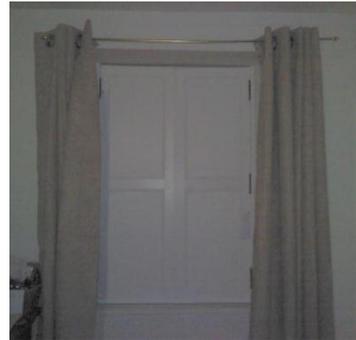
This thermogram, Fig. 17a, shows thermal irregularities along the horizontal and vertical joints of the shutters in the ground floor south room. This is attributed to adventitious ventilation heat loss. The average surface temperature on this zone is 13.2 °C, whereas the average surface temperature of the whole window is 16.2 °C, indicating that heat loss is occurring at the joints. Consequently the thermal bypass around the shutter is not one of great significance, but it does break the continuity of the thermal envelope.

Fig. 17a Thermogram of the ground floor south window shutter closed

Fig. 17b Photograph ground floor south window shutter closed

Characteristics	Fig. 17a and 17b - Ground floor south window
Orientation	Front
Window protection	Shutter
Average surface temperature (°C)	16

This thermogram, Fig. 20a, shows a similar heat profile to that in the ground floor south room (Fig. 17a). The shutter improves the thermal resistance of the window, however, areas of irregularity and thermal bypass are observed in the bottom portion of the shutter joints and are likely due to adventitious ventilation.

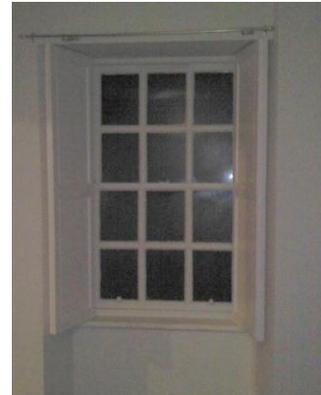
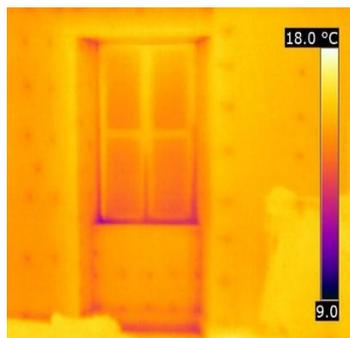
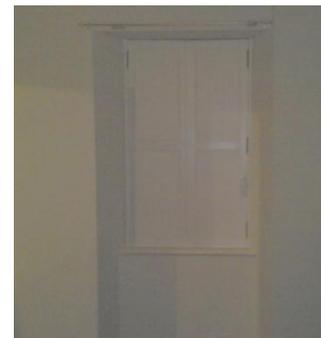
These thermograms, Fig. 18a and 19a, show the thermal signature of the window in the first floor north room, with the shutter open (Fig. 18a) and the same window with the shutter closed (Fig. 19a). The shutter allows an improvement of 7°C in the surface temperature. The thermal continuity across and around the shutter is good with little obvious temperature difference around its perimeter.

Fig. 18a Thermogram of the first floor north room with shutter opened

Fig. 18b Photograph first floor north room with shutter opened

Fig. 19a Thermogram of first floor north room with shutter closed

Fig. 19b Photograph first floor north room with shutter closed

Characteristics	Window 1	Window 2
Orientation	Front	Front
Window protection	None	Shutter
Average surface temperature (°C)	7	14

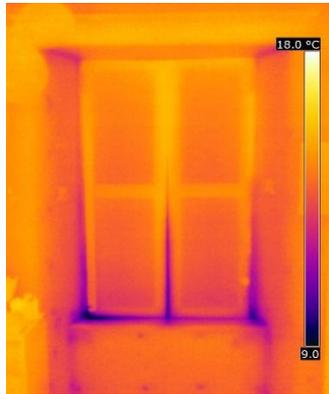
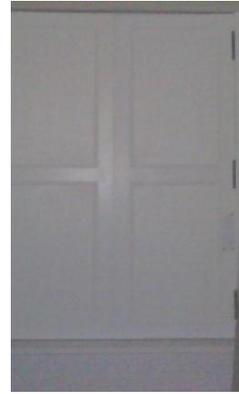
Fig. 20a Thermogram of first floor south room shutter closed

Fig. 20b Photograph first floor south room shutter closed

Characteristics	First floor south room
Orientation	Front
Window protection	Shutter
Average surface temperature (°C)	14

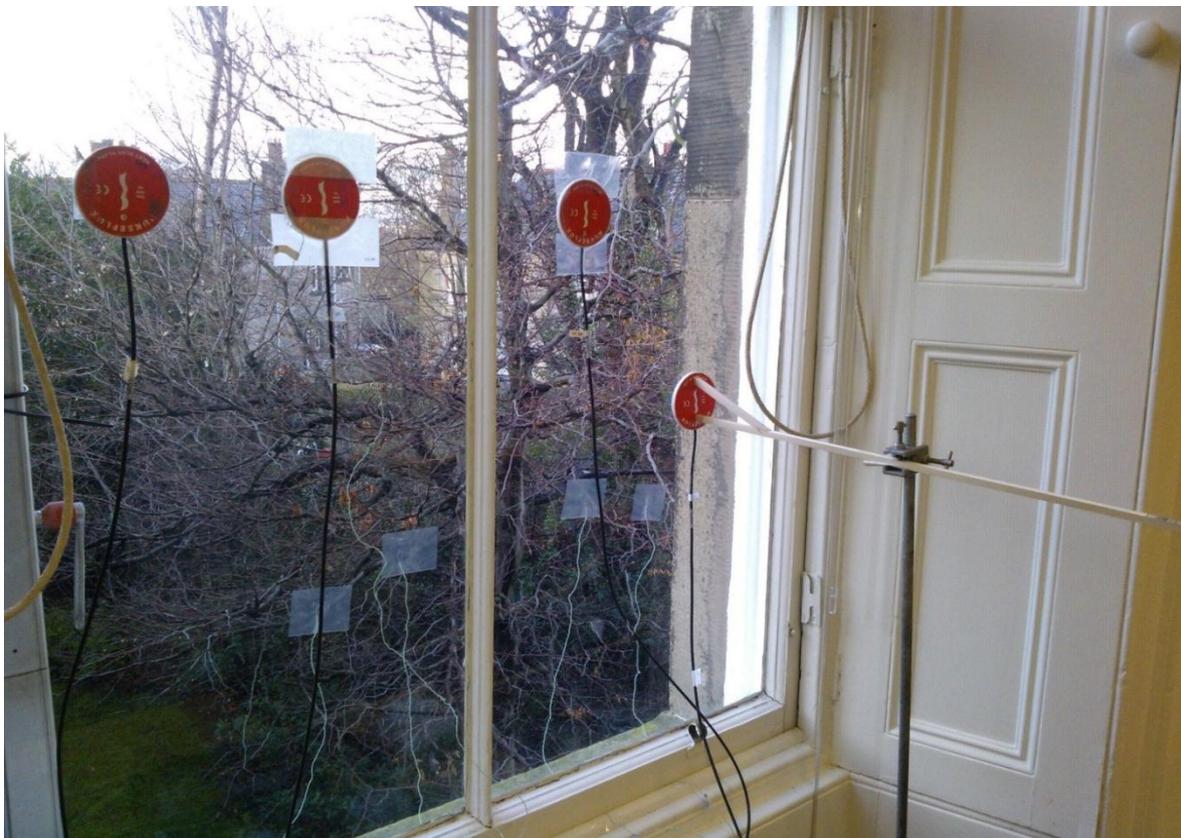
Fig. 23 Fixation types used for testing.

From left to right: double tape, masking tape, low tack tape and wood support

Type of fixation	Measured U-value (W/m ² K)
Double tape	4.5
Supporting rig in balsa wood [<i>method elected for use in Wee Causeway</i>]	4.5
Masking tape	4.5
Low tack transparent tape [<i>typical method of securing sensor to element</i>]	4.5
