Maurizio Berti

A heritage of coral stone

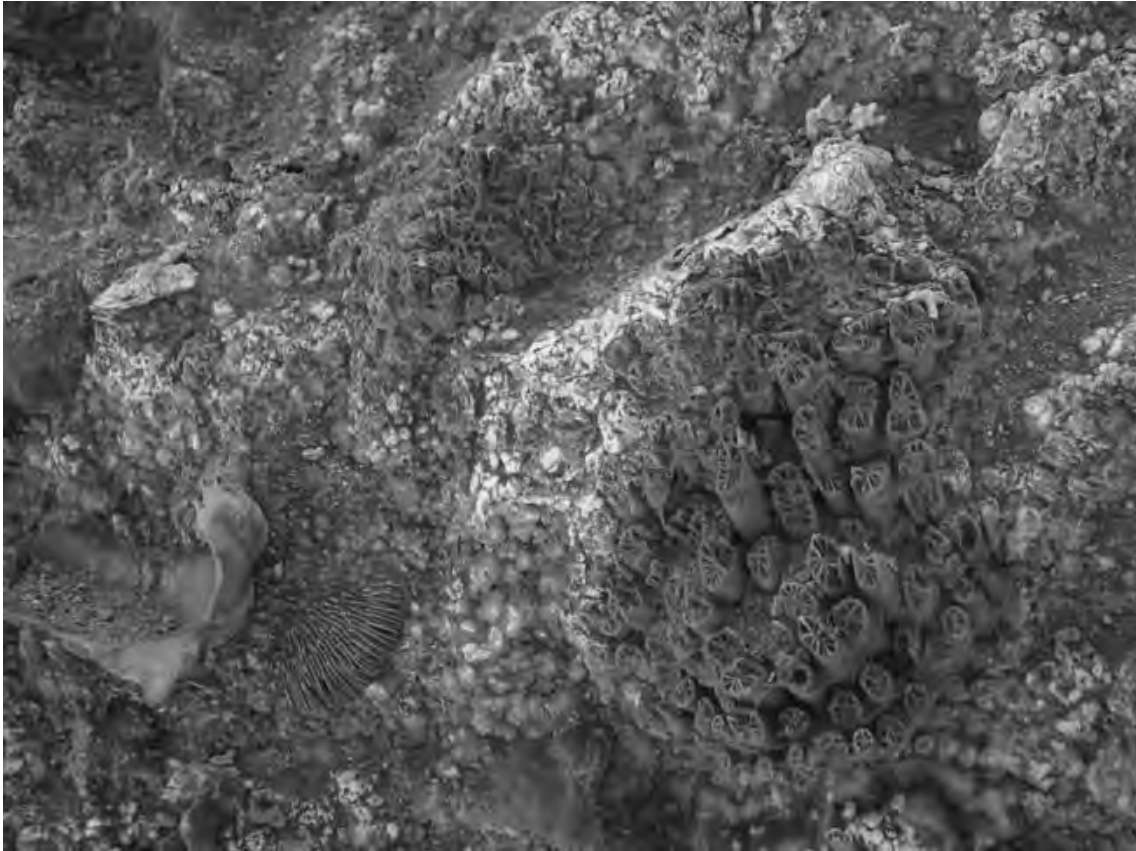
Figure 1.3.: Coral formations on the Red Sea [Photo by Marina De Gregoris, 2008.].

Past coral formations, above the present sea level. Marsa Alam, Red Sea.

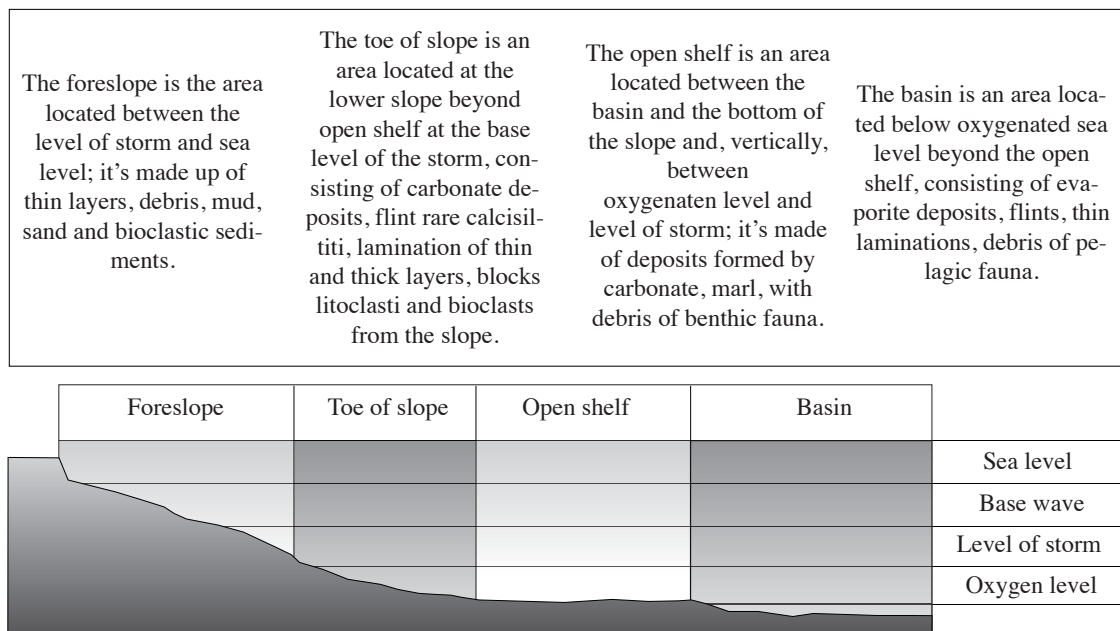
The zoning of a cliff from its basin to the mainland is a useful model to simplify the understanding of a complex biological activity in the coastal environment. It's necessary to keep in mind the provisional nature of the environment. The surface layers of the newer platforms are based on previous layers of sediment that can be also characterised by erosion caused by meteorological phenomena occurred during past periods of air exposure. The study of erosion on the banks of past sedimentation is of great interest as the structures the coast will take in the future can be predicted.

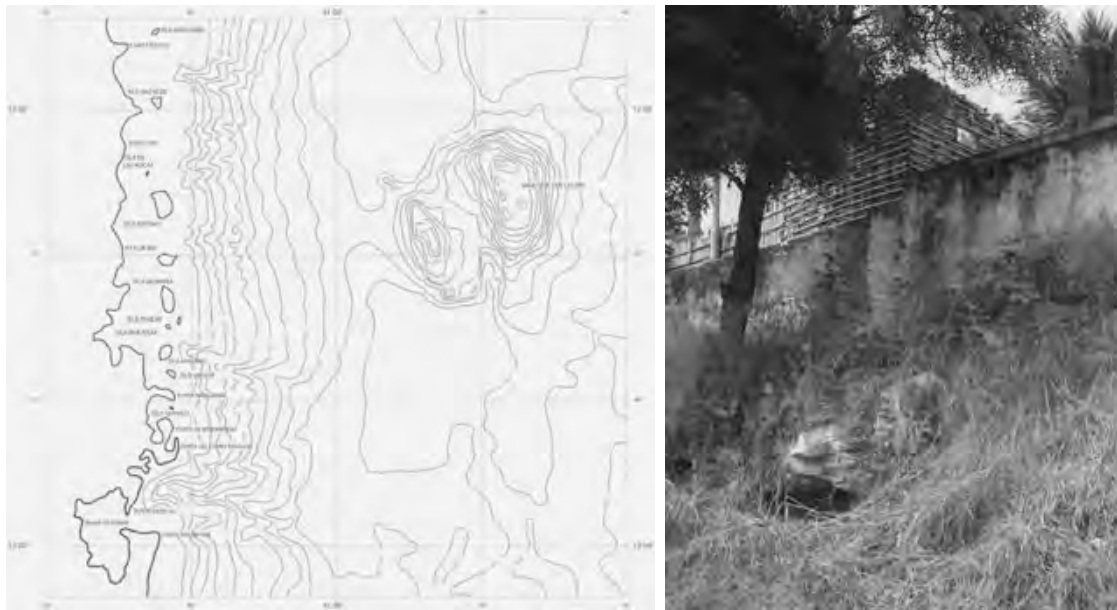
Figure 1.8.: Preliminary study journey to Ibo, May 2007. Observations on the sediment reefs in Pemba [M.B.].

A coral reef was observed in Pemba, 14m above the sea level, at an altitude well above the ones granted by Ramsay along the last 9000 years. The level was measured through the geographical coordinates of Google Earth – 15/01/2009.

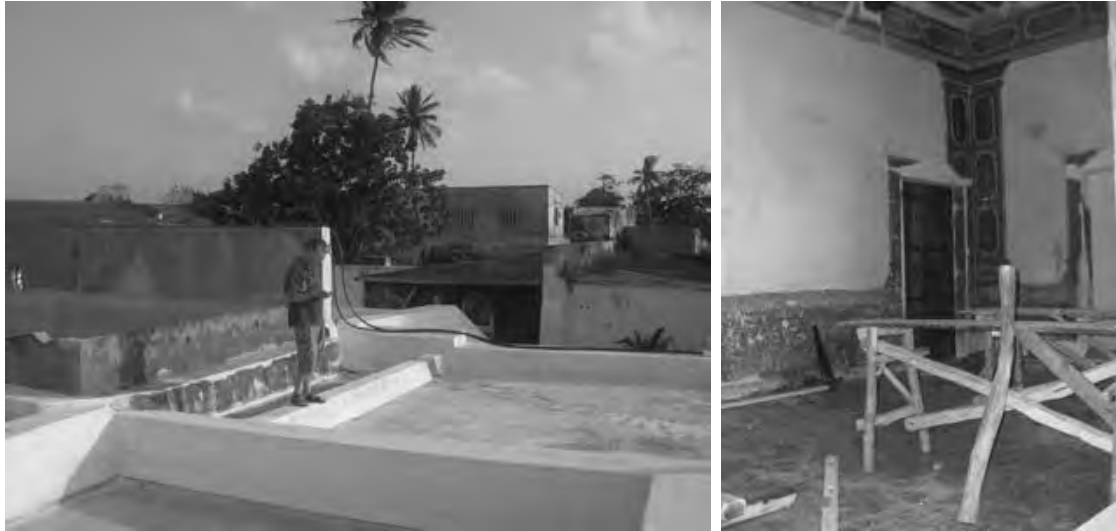
Left: the restoration of the flat roof and the renovation of the rainwater system for getting drinking water.

Right: the demanding restoration of a mansion with faux marble or *marmorino* decorations.

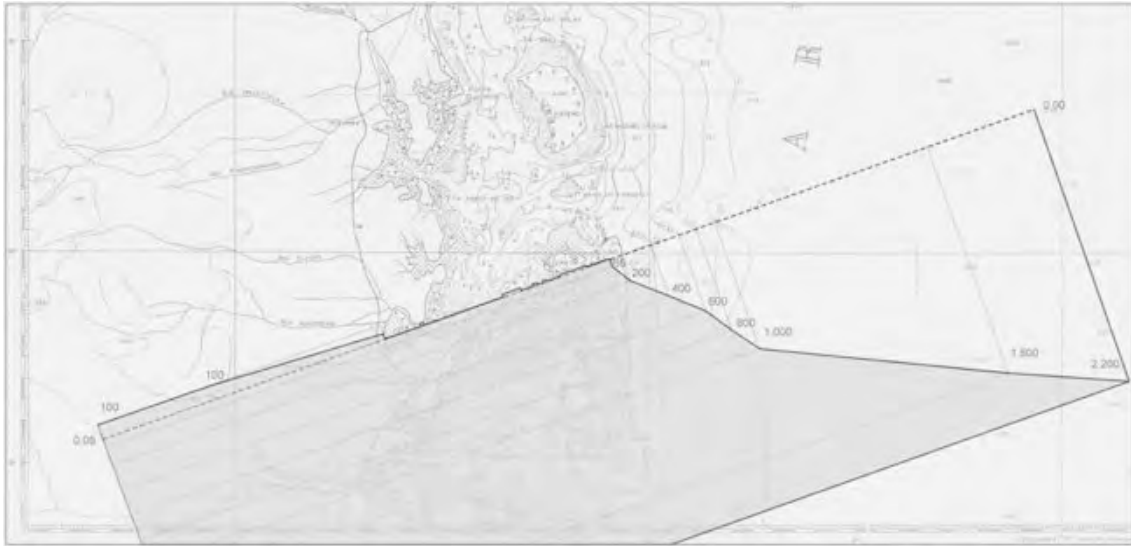
I designed a section extending between the mainland and the continental edge on a track crossing Ibo, combining data from two maps: the *Carta Hidrográfica da Foz do Rovuma ao Ibo* of the Instituto Hidrográfico de Lisboa, 1964 (work copy by courtesy of Patricia Oberreuter) and the *Plano Topográfico base, hoja 1 e 2*, 1997 in the *Libro Blanco de los recursos naturales de la provincia de Cabo Delgado (Mozambique)* - Agencia Española de Cooperación Internacional - Union Europea (copy at the Arquitectura e Planeamento Físico in Maputo).

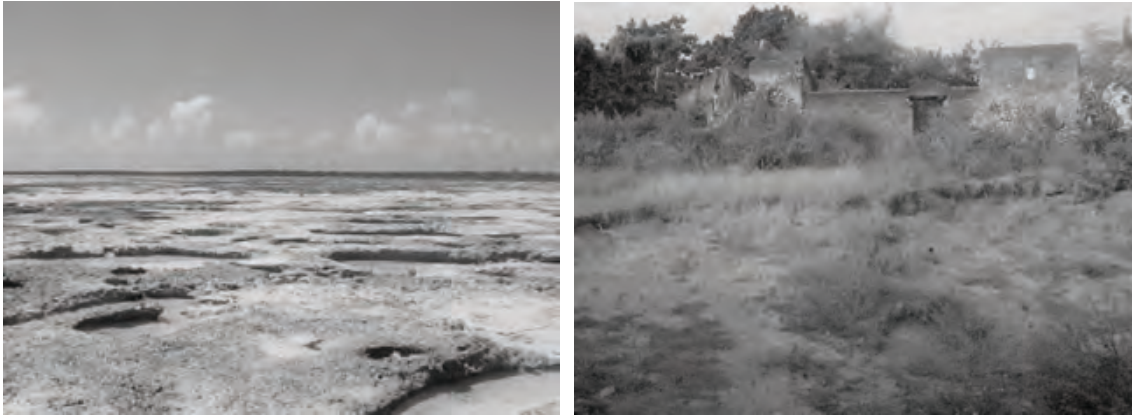
Figure 2.8.: Bank of limestone on the west side of the island and sand quarry located in the urban area [M.B., 2007].

Sedimentary bank of coral limestone giving the material for making mortar.
The sand quarry located in the urban area, now closed.

After the prohibition of extracting sand near the houses for safety reasons, the Administration has authorized excavations in an area next to the Catholic cemetery on the edge of the sea. It was not possible to visit the new pit, but we examined the extracted sand. The sand excavated in a now closed pit – probably a marine deposit – is different from the sand of the new pit, probably coming from a river deposit; in fact, it is grey and full of granules of silica and quartz. A thorough understanding of this material and of the place of its extraction is important both for preparing the mixtures of mortar required for the construction or repairing of the buildings and for improving the knowledge of the soil taking into account the presence of ground water at superficial or deep layers. The presence of water layers at different levels influences the problems

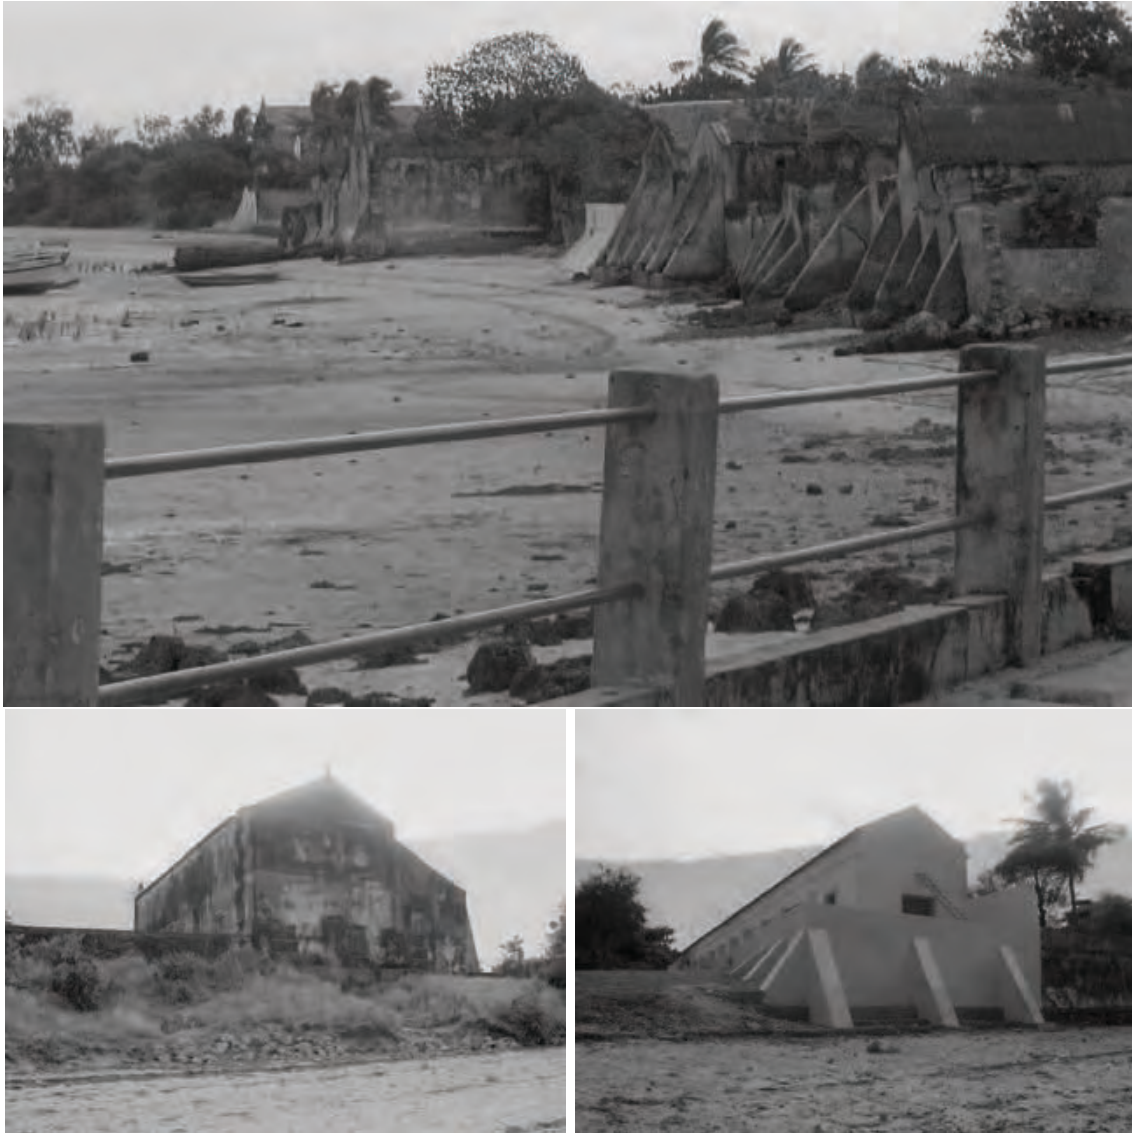
Figure 2.11.: Front of the port of Ibo. The buttresses are designed to prevent the rotating movement of the walls [M.B., 2007].

In Ibo we can witness an ongoing phenomenon on a major urban scale. The west front of the formal city is the side of the inner harbour where the public and private docks insisted. In his studies on the island Carlos Lopez Bento found that the structural sinking of this part of the city has an important historical precedent in 1788 with the collapse of Fortim de São José, which subsequently had to be rebuilt. This serious and obvious phenomenon of collapse affecting almost all the buildings of that front should be a priority for action, in the physical interest of the part of town positioned further back.

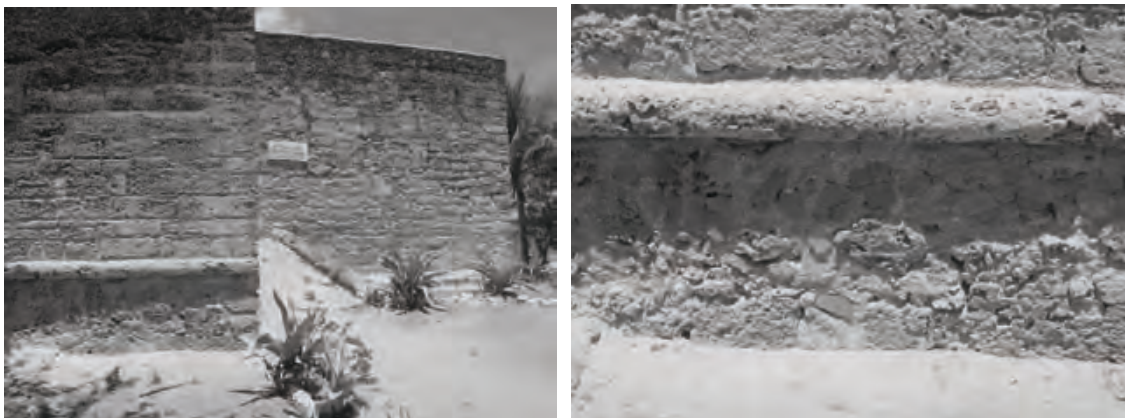
Figure 2.14.: Fortim de São José. Grouting tests after two years from work [M.B., 2007.].

Nowadays in Fortim de Sao Jose, two tests of grouting on the walls on either side of the entrance door can still be seen after two years from their application. We agree that tests should be done to check a technology before its widespread application but it is necessary to emphasize what the test itself reveals - these stucco works should not be repeated. The mortar applied at the time has gradu-

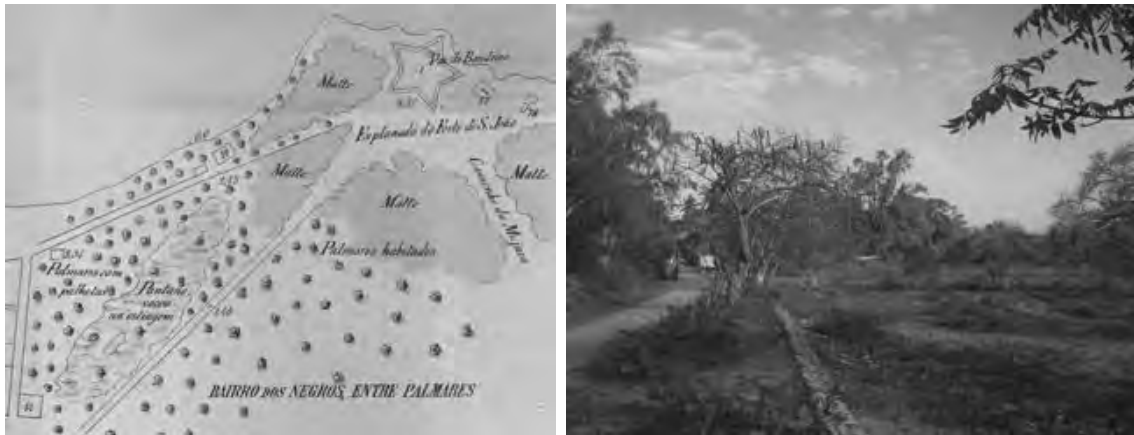
From: *Planta Cotada de Villa Ibo Compreendendo apenas o bairro dos Europeus*, Sociedade de Geographia de Lisboa, Portugal 1886 (as a source of bibliographical references: <http://africanmapimages.grainger.illinois.edu/afm0001295.jp2>).

At the fortress of São João Baptista in Ibo there is a depression in the soil called *Pântano secco na estiagem* in the historical maps. Accurate observations were conducted with the aim of recognizing convincing traces of excavation, but to no result. There is, however, a strong possibility that this depression may actually have been produced by the excavations made for preparing the construction and supply of the building material of the fortress.

As to the stone quarry used to build the great fortress of São João Baptista, the depression of the soil nearby was thoroughly searched; in the historical maps it is called *Pântano secco na estiagem*, but no convincing traces of excavations have been found. There is still a strong possibility that the depression may actually have been produced by the excavations for the construction and supply of the building materials. Bento's quotation, here fully reported, is very clear and deserves to be taken into account in future observations:

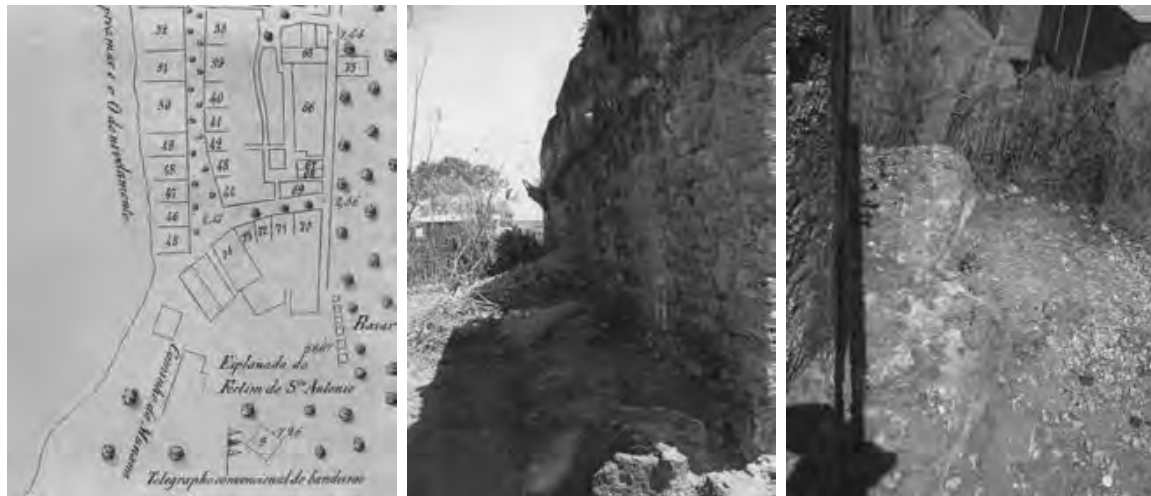
Figure 2.16.: The Fortim de Santo António in the 1886 map. The profile of the cuts on the reef [M.B., 2009].

Traces of excavation are very clear around the Fortim de Santo António. The sediment of this artefact is a large layer of compact coral limestone. The rock cuttings on the north and east sides behind the building show the limits of the flattened area around. Probably even the more pronounced depression north of the fort is the result of the excavation carried out to extract the building material.
From: *Planta Cotada*, 1886.

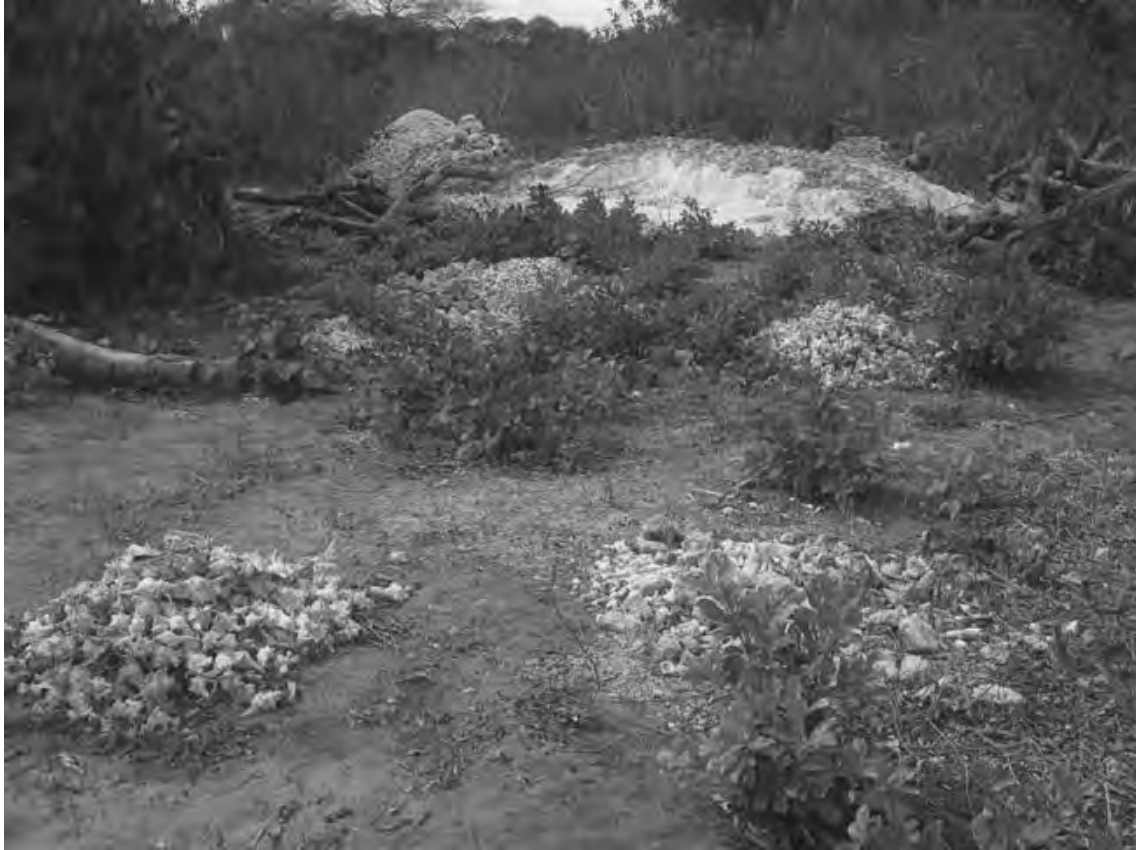
This kiln, examined in August 2009 at the entrance of the new *Tikidiri* Community hotel of the Aga Khan Foundation in Ibo, shows the original materials and the shape of a traditional outdoor kiln. Two kinds of load are prepared for the cooking: shells (more precisely here: murex shells; *Phyllonotus*, a mollusc of the gastropod family) and fragments of mineralised coral limestone where portions of the skeletons of coral colonies can be seen. Lime is used for regular whitewashing, essential as a protective coating of coral walls, and for making mortars and plasters. It is known in Ibo as well as in Ilha de Moçambique that the lime produced from burnt shells is of higher quality and is used in preference for interiors or paintings. The same practices are in use on the Red Sea coast. Aylin Orbasli relates of their use on the east coast and especially in Al Wejh, the place where walls are treated with lime made from shells (Orbasli, 2009.).

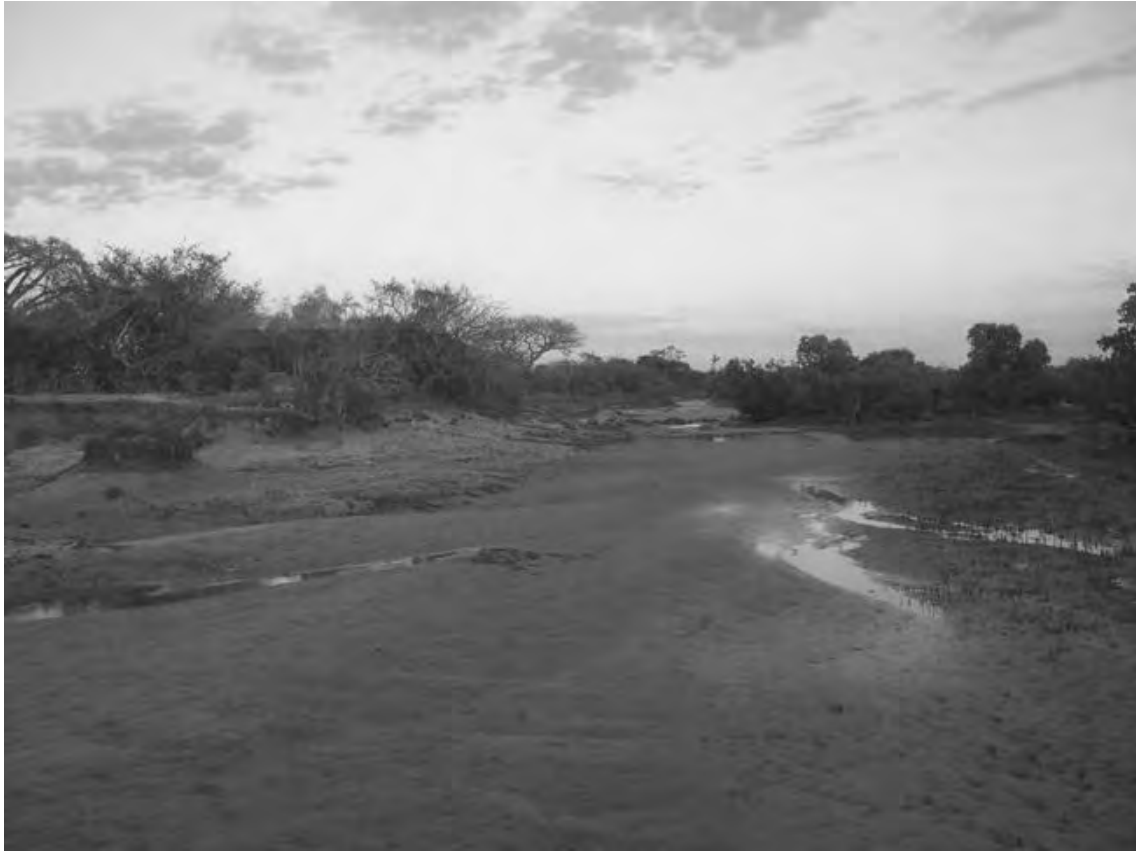
Figure 2.19.: Overview of the canal bordering the area of the cemetery, east of the island of Ibo [M.B., 2009.].

From the very first observations on the sands used in constructions it was evident that they were silica sands rather than limestone. The experts would say the material was not imported from the coast by boat, but taken from the island itself. Hence the idea of studying the reasons for the presence on the island of river sand deposits in the absence of rivers and near the sea. The studies led to the knowledge of significant changes of the soil as a result of recent fluctuations in the sea level leading to the deposition of river sands and the presence of ancient coral reefs.

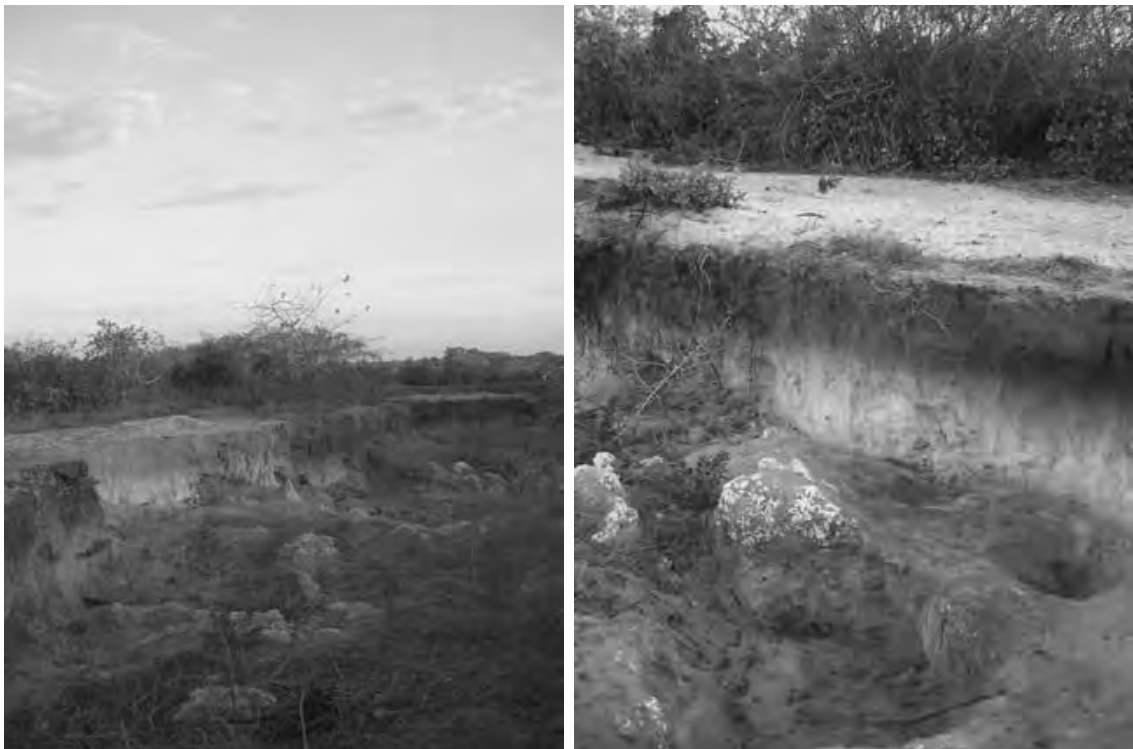
Figure 2.20.: The sand pit in the cemetery areas east of Ibo [*M.B., 2009.*].

Between 2008 and 2009 a new and important restoration activity in the urban core of Ibo was launched. To meet the needs of the new construction sites, the sand pits in areas outside the town were expanded. In particular, the two most important ones are located close to two cemeteries, the Hindu in the north and the Muslim in the south. The sandy cap covers the ridges of the coral reef of the recent past.

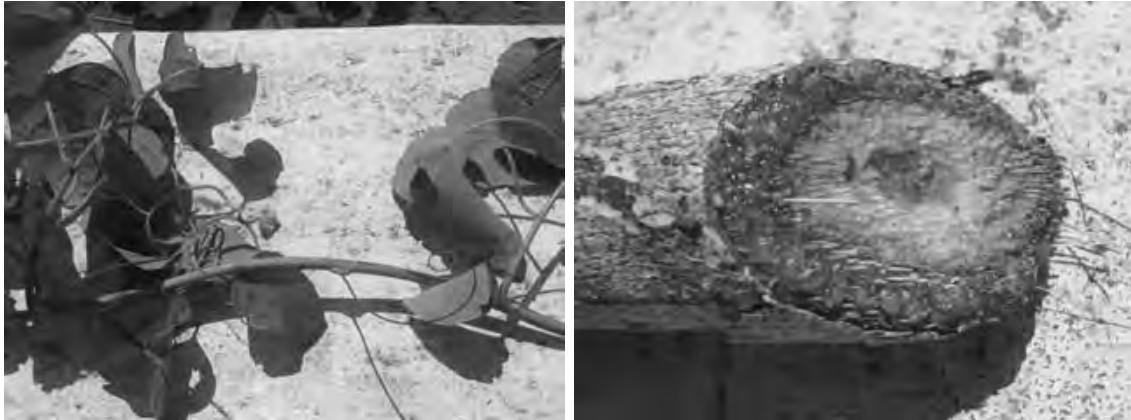
Figure 2.21.: A branch with leaves and stem of *murrapa* about half an hour after cutting [M.B., 2009.].

When we cut the stem of *murrapa* an abundant colourless and odourless liquid drips, similar to water. After a few minutes the liquid thickens and coagulates; in this way the holes of the smaller stems forming the bulk of the plant are closed.

The use of natural substances as binders, as binding materials in the mixture or as a protection should be studied as a specific theme. We know that the substance produced by the *murrapa* logs is used as a binder in lime mortar, as recommended by traditional practice, but there is no evidence as to the quality of the effects. It is well known, generically, the liquid produced by this creeper increases the hardening of the mortar.

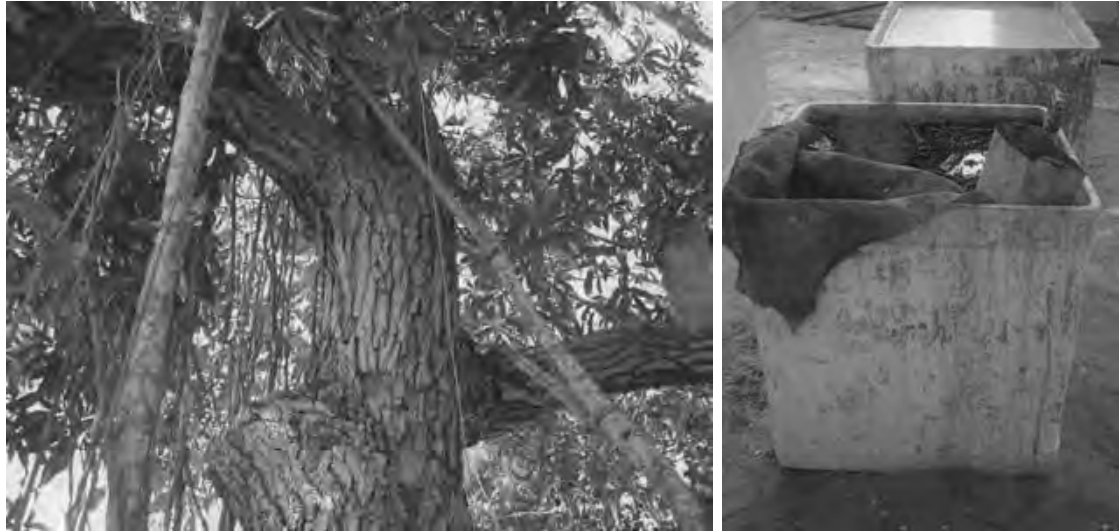
Figure 2.22.: Plant of *murrapa* and soaking site [M.B., 2009].

A *murrapa* plant on the coast of Lumbo, near the Ilha de Moçambique. The trunks of *murrapa* are being soaked on the site restoration of the fortress of São João Baptista in Ibo.

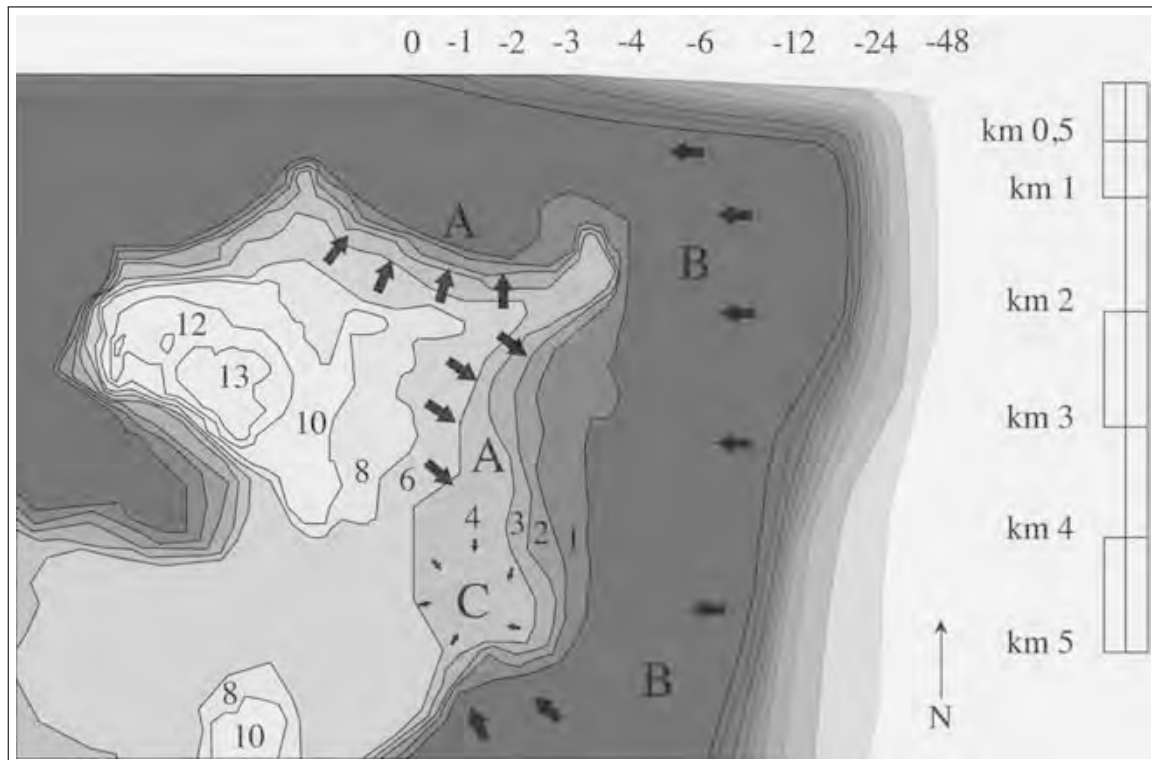
Figure 3.3.: Diagram showing the direction of water flow in Ibo. A: flow of rainwater; B: flow of the tides; C: open grassy plain [M.B., 2009].

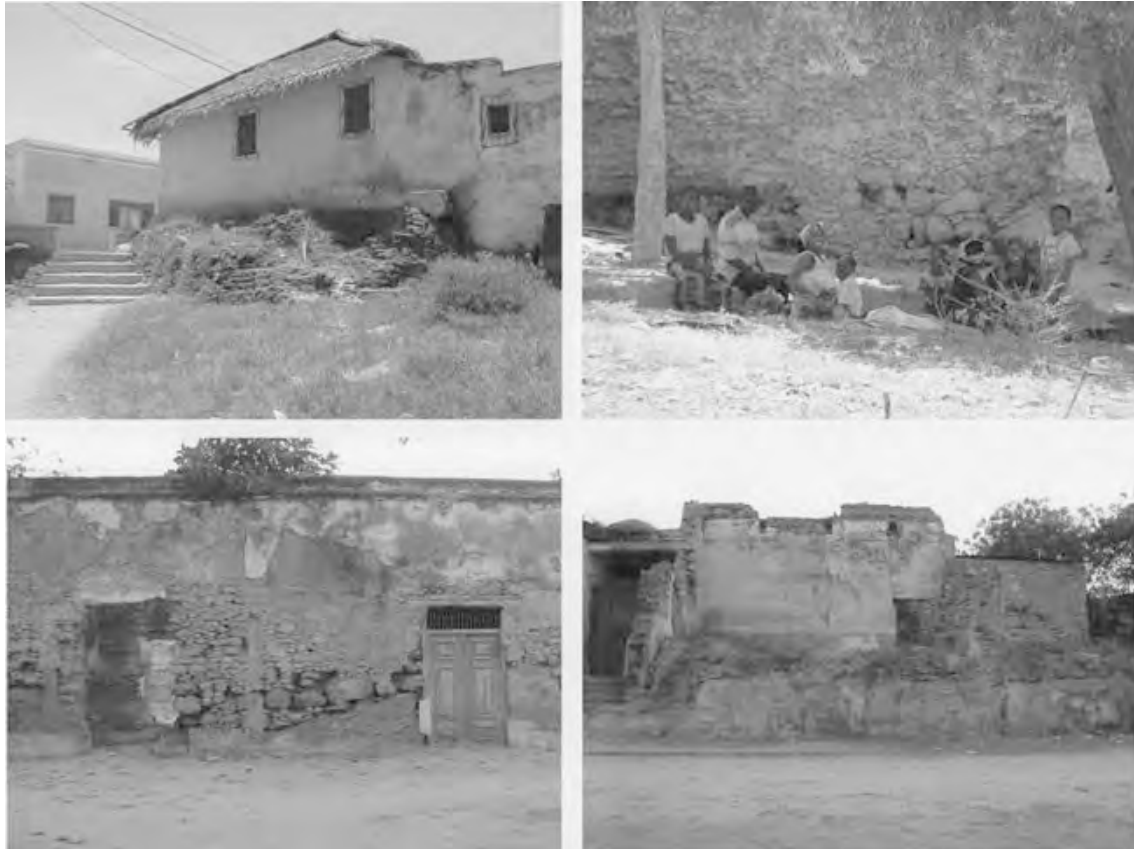
Figure 3.13.: Houses in Ilha de Moçambique resting directly on coral limestone [Photo by Mohamad Arif e M.B., 2004 e 2009].

blocks in the town of *macuti*. The reason why there is no rising dampness may simply lie in the fact that these houses are located above the sea level. In any case, the delaying effect of capillary rising should be evaluated in the buildings where the walls have large pores and cavities preventing or substantially reducing the tensions required by capillarity.

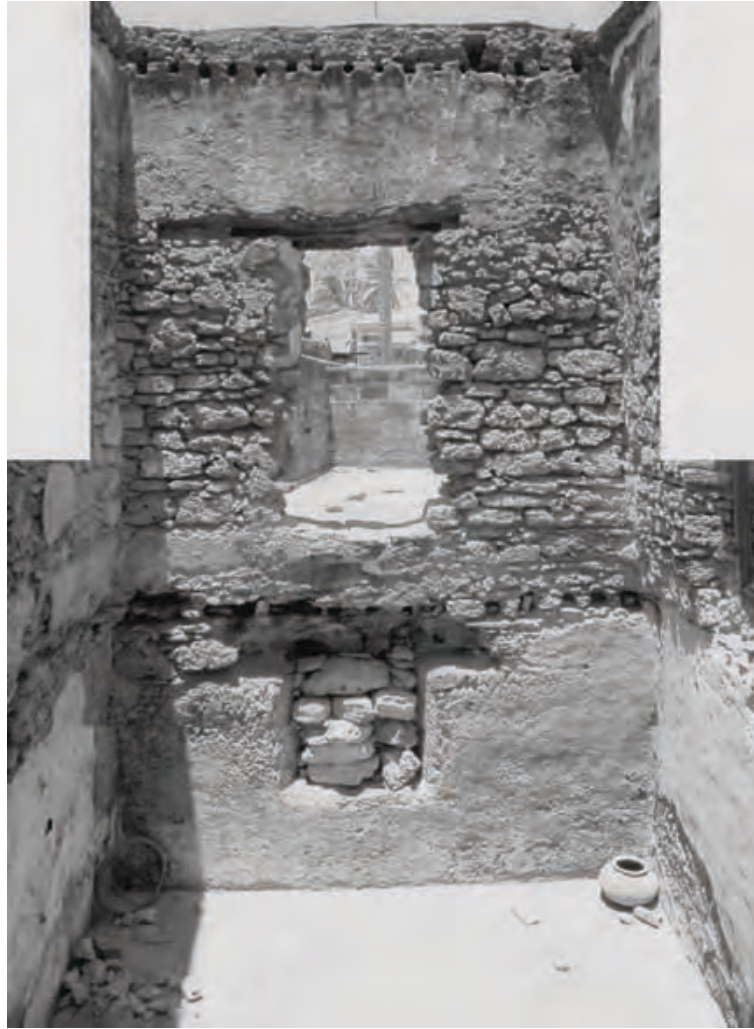
Figure 3.14.: Old coral stone house, now abandoned, in Ilha de Moçambique [*Photo by Mohamad Arif e M.B., 2004.*].

more than two meters above the average sea. In some places of Ilha de Moçambique the foundations of the walls were built directly with coral reef stones, cut out in the required thickness, both in civil buildings and in the fortress of São Sebastião.

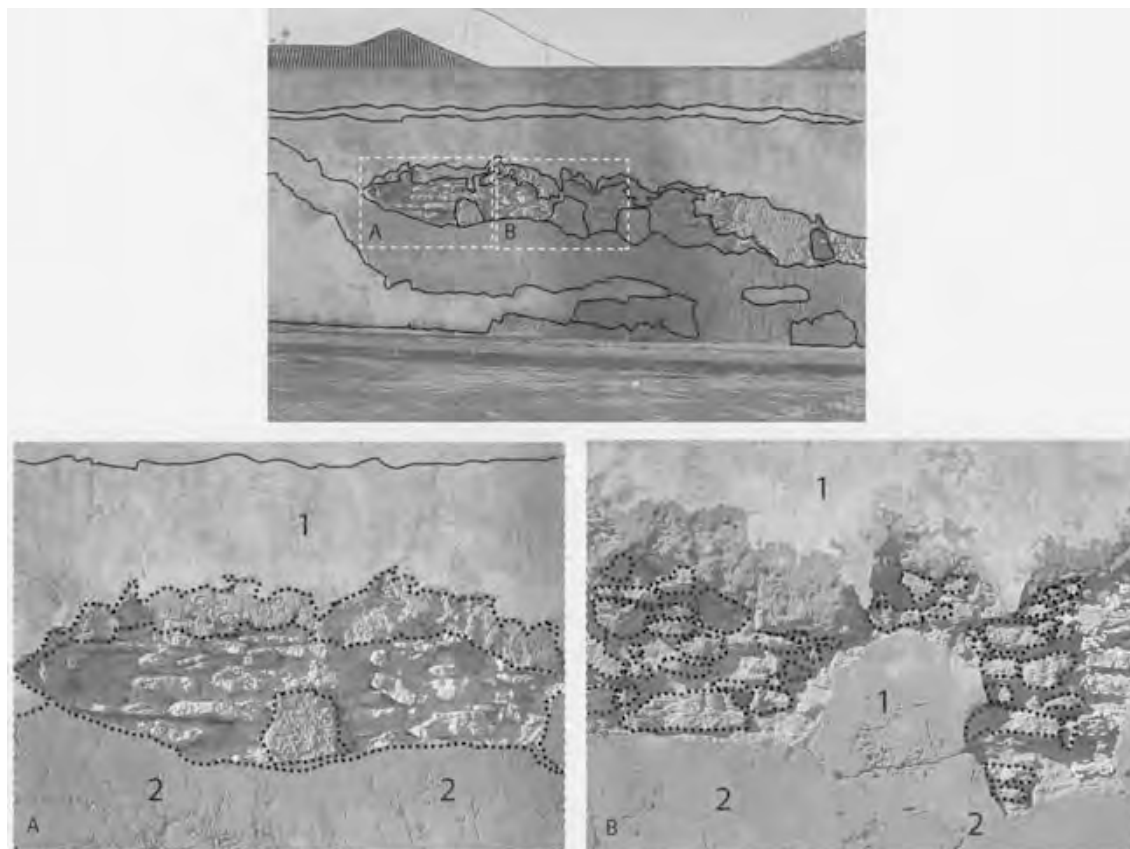
Disruptive effect caused by the cyclic reformation of salts in a wall adjoining the old Catholic church in Inhambane. A survey was performed on this wall which has the same plan as the church. The method and purpose of the survey can be summed up as follows:

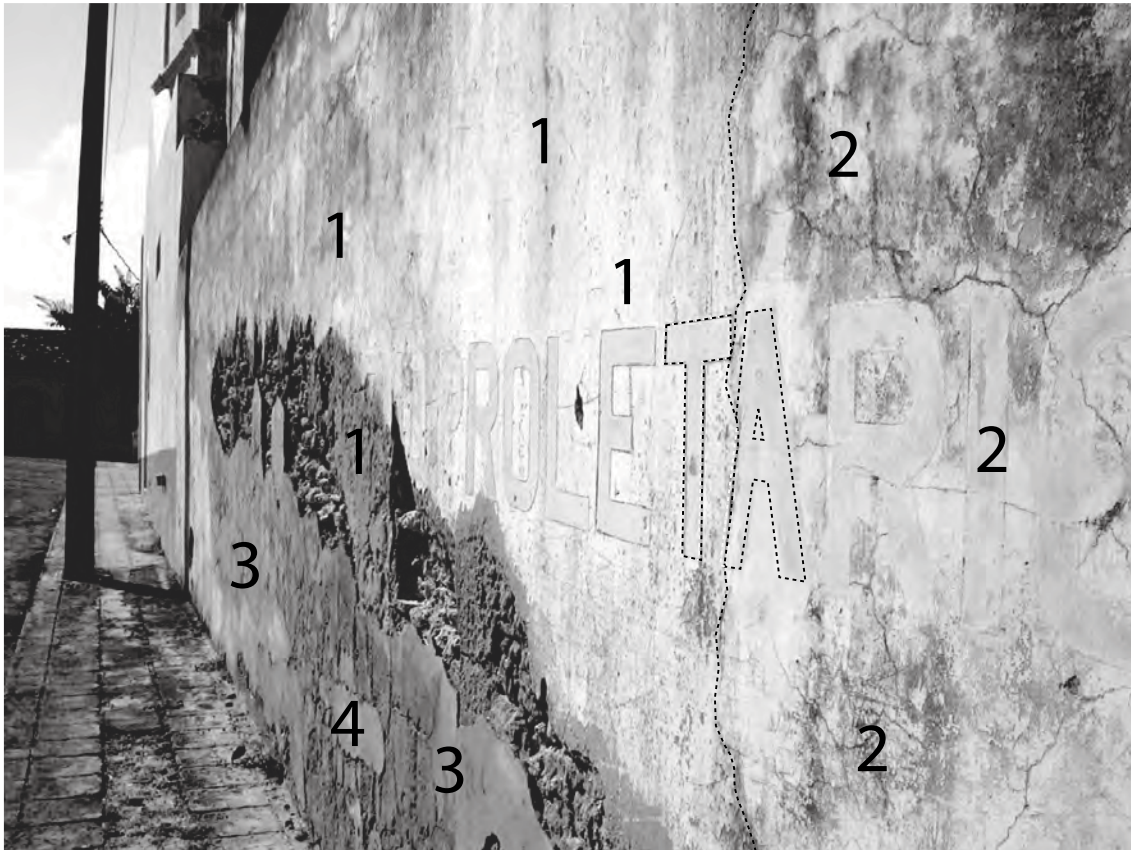
The presence of graffiti makes clear the sequential order of plaster patching and, consequently, gives a time dimension to the disintegration cycle of the plaster and the wall. We can't make any attempt at determining at least one cycle of the reformation of the salt crystals with a substantial disruptive effect. The maximum length should be of about twenty-five years, the age of the graffiti.

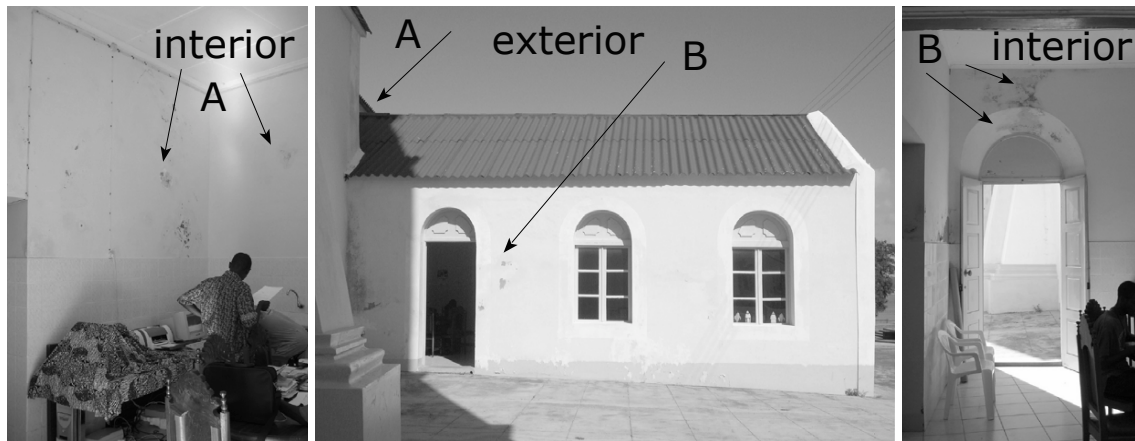
The cause of humidity found in (A) seems to be simply the wrong layout of the fiber-cement sheets used to cover the sacristy, in particular along the join line in the wall of the church. The problem will be solved simply by a maintenance check.

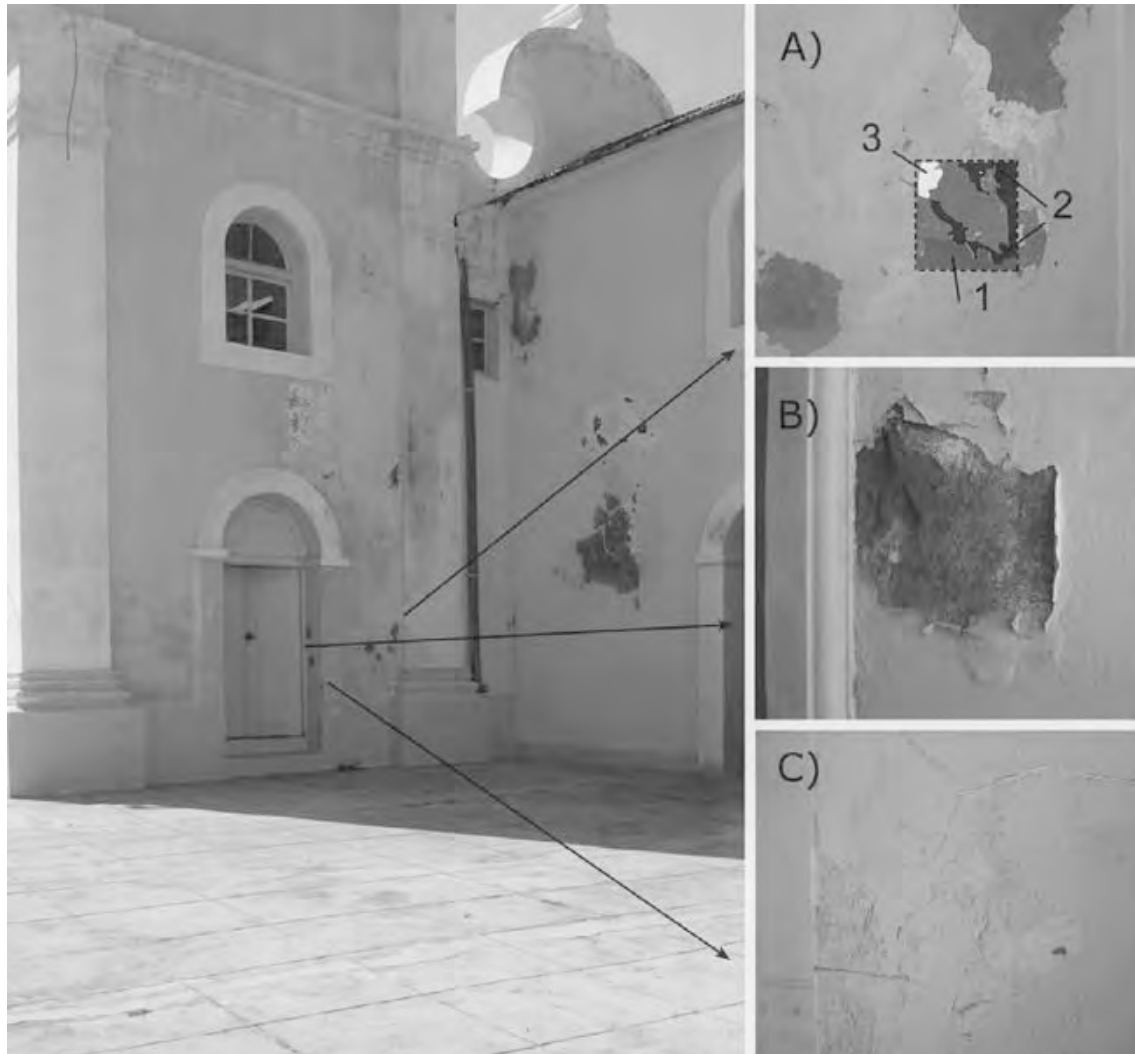
Three layers of repainting over a plaster; at first sight, it seems a patch but its extension on the entire wall can't be determined.

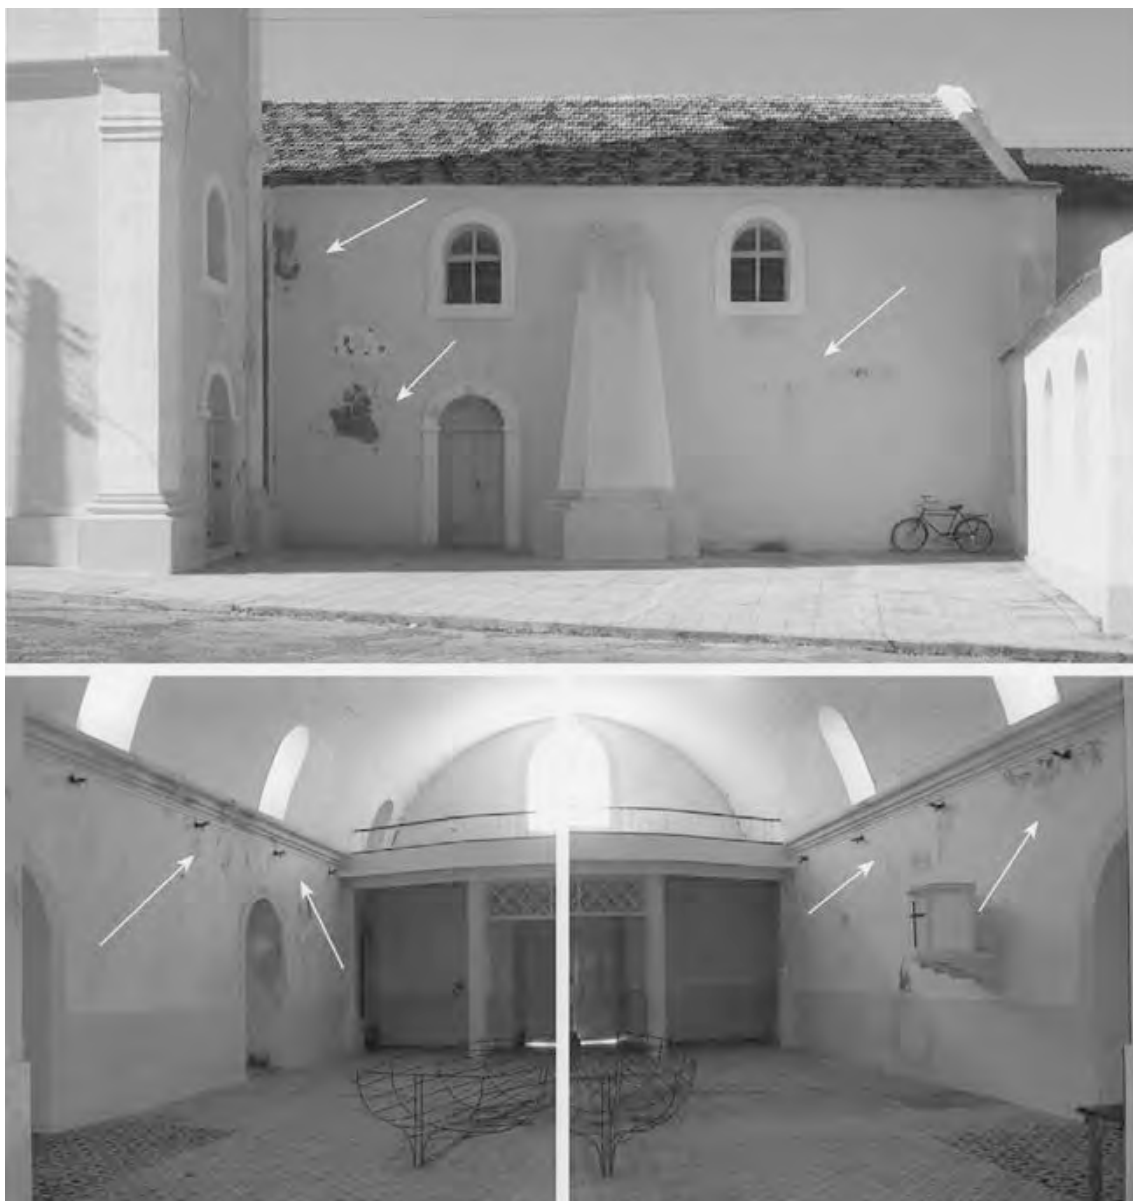
Inside, the temperature being lower than outside, the salts will only be present on the wall surface in a state of efflorescence. Here the more recent synthetic layer is detached from the plaster, because of salts and vapour. The fact that these film lifts are present near the windows suggests that rainwater gets into the wall directly from the windowsill.

Figure 3.19.: Igreja de Nossa Senhora da Conceição, the outside and inside of the south-east [M.B., 2004.].

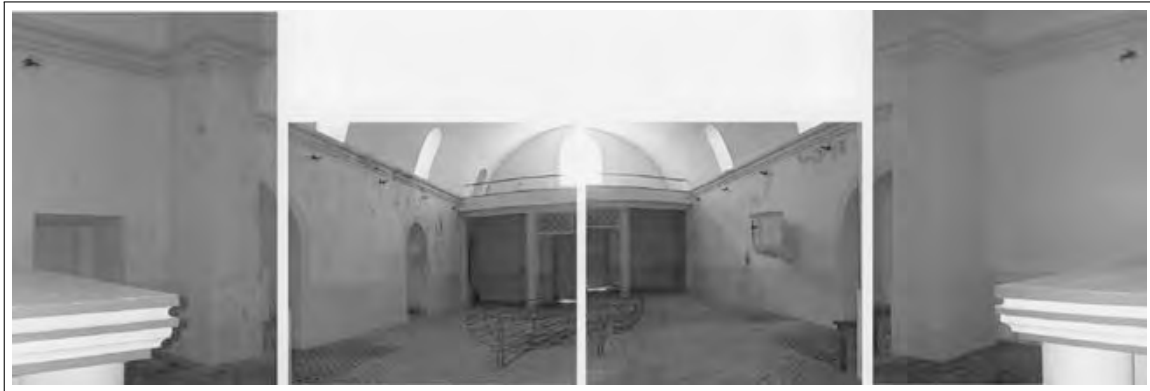
Suspended vaults formed of wooden strips are also used in Ilha de Moçambique, as in the Igreja da Saúde. This solution gives the environment a comfortable climate.

Left: even if protected by an adjoining room, this wall is affected by the phenomenon because the rain enters from the roof brim resting on the east wall of the church. Once the sealing of the windows will efficiently protect from rain, the problem of salt efflorescence will be drastically reduced.

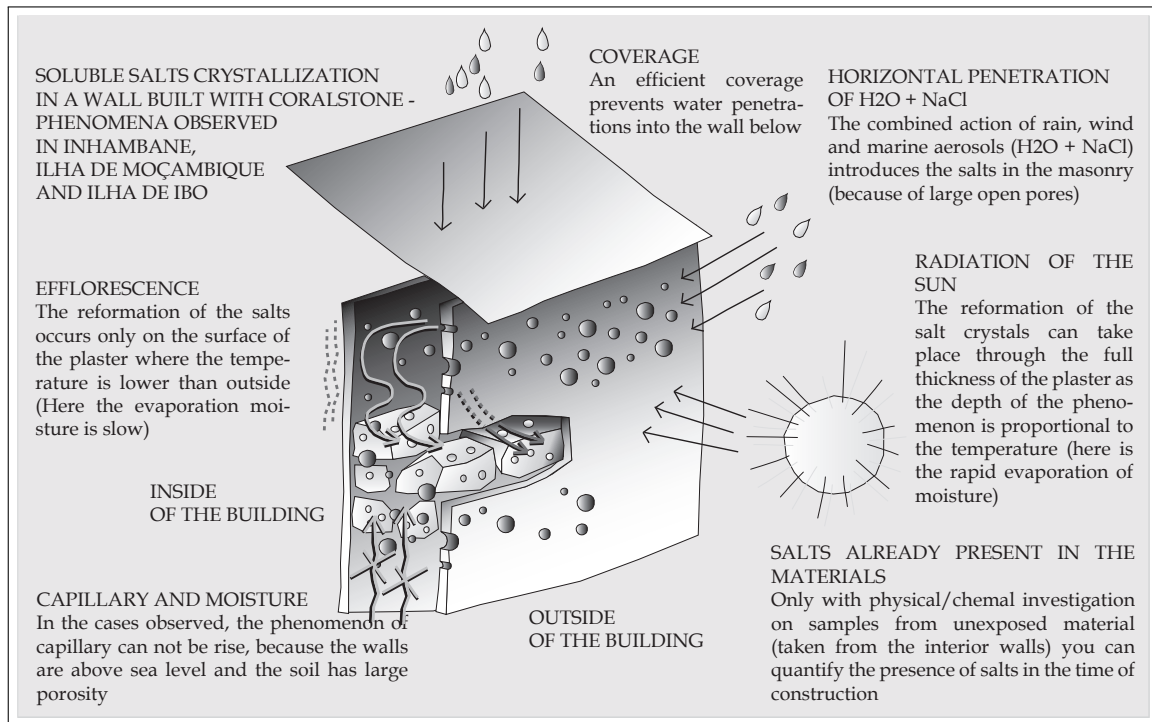
Schematic illustration of the phenomenon of the coral limestone disintegration due to the regeneration of soluble salts. The phenomenon was observed in Inhambane, Ilha de Moçambique and Ilha de Ibo.
