Maurizio Berti

A heritage of coral stone

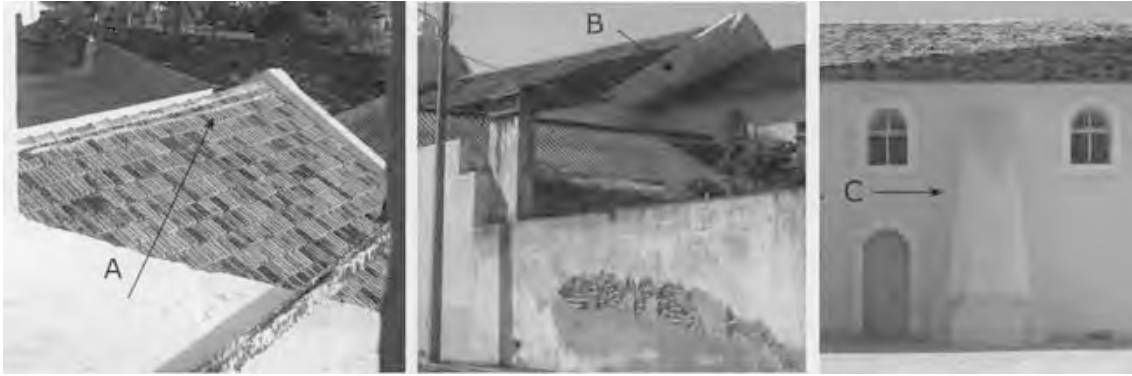
The irregularity of the perimeter of this roof slope (A), the deformation of the top of the back wall of the church (B) and the buttress placed on the longitudinal wall of the church (C) can reasonably be related to each other.

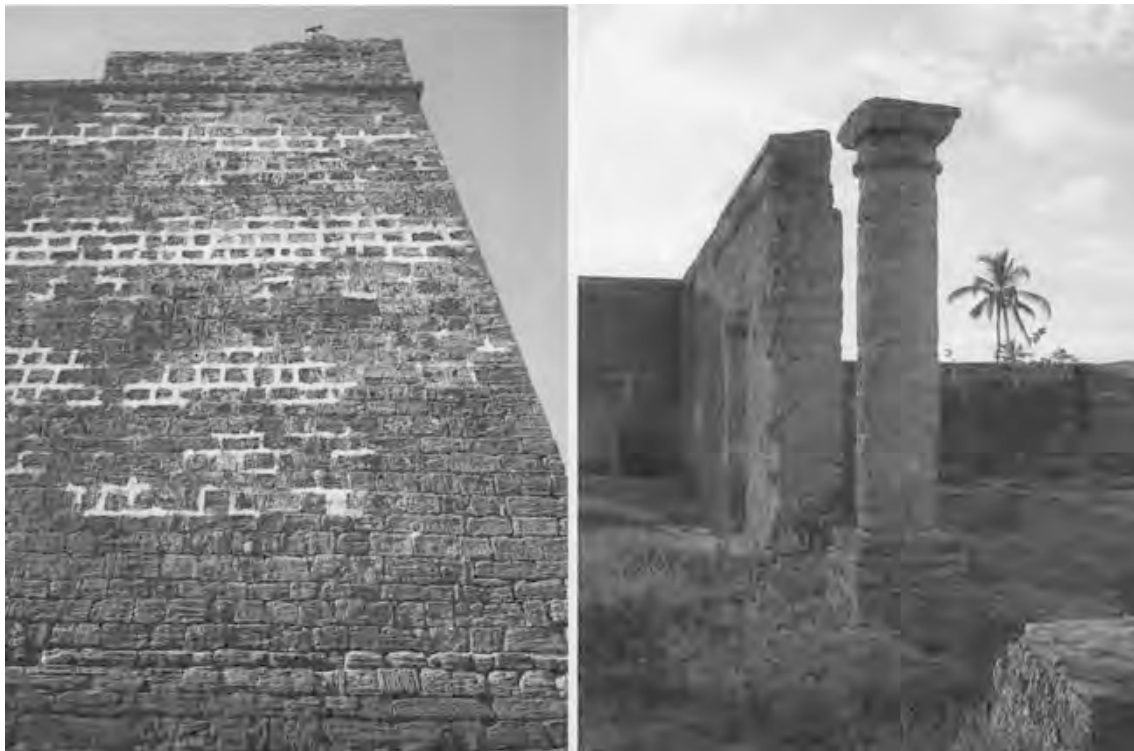
Figure 3.23.: Ilha de Moçambique. The front of a bastion built in limestone blocks of the Tertiary-Quaternary period (*Bioclastic rock*). Column and wall of the ruins of a small house constructed with limestone blocks in a limited stage of diagenesis (*Bioherm rock*) [M.B., 2009.].

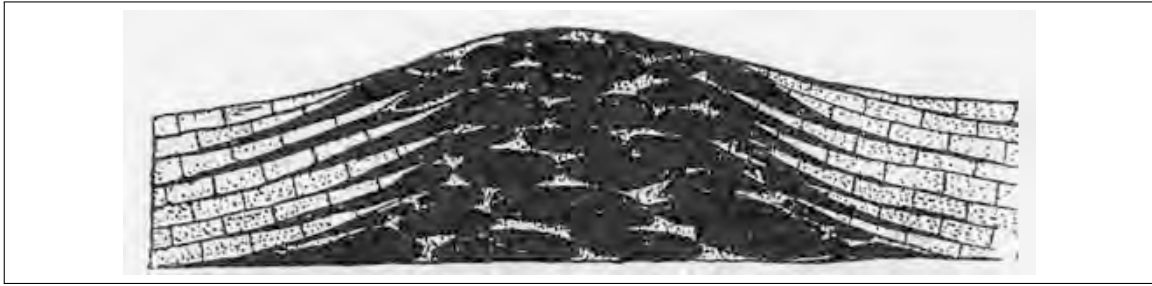
Figure 3.24.: Diagram of the reef structure in the Traverse (Middle Devonian) limestones of Alpena, Mich. [Grabau, 1913, p. 427; 1920, 304.].

even completely overturned. The fine coral-mud resulting from the grinding will be carried out to deeper or quieter water, though it may also be caught in protected cavities within the reef. The coral-sand remains in shallow water to form bedded deposits. Along the margins of the reef-mounds the bedded deposits of coral sand will often lie at a steep angle, which is sometimes as high as 45 or even more. Frequently a layer of small corals will grow upon such a bedded deposit, and this in turn may be covered by other lime-sands. Thus an interfingering of the organic lime structures, the corals, etc., with the clastic lime, the coral-sand, will result, and this is one of the most characteristic features of the margins of the reef-mound²².

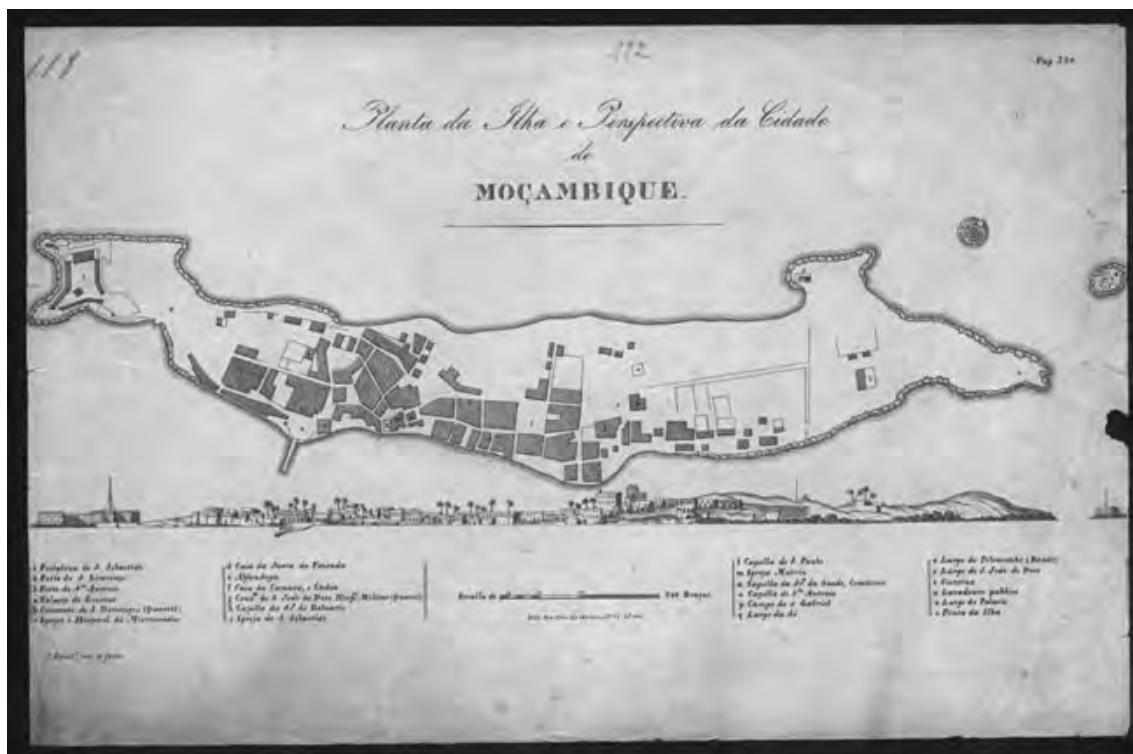
With reference to the *Planta da ilha e perspectiva da cidade de Moçambique* by J. Faustino, around 1835, it is thought that the southern part of the island was levelled in relatively recent times; a considerable amount of rocks was taken away.

Figure 3.25.: The soil profile of Ilha de Moçambique in the first half of the 19th century [*Faustino, ca 1835.*].

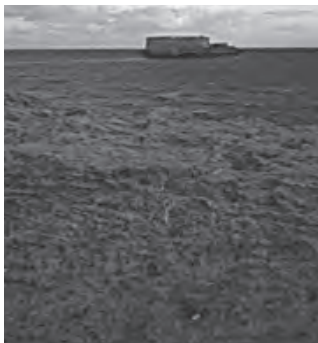
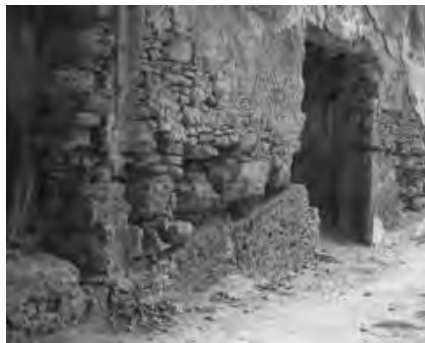
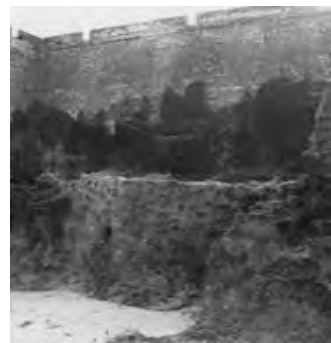
The rocks observed on three different areas in Ilha (A, B, C) show different hardnesses. From a morphological exam the rocks in the three areas should have had the same genesis, but the cohesion of the sheets of sedimentary limestone is different from the outcrops in the centre of the island (B) compared to the rocks in contact with the sea (A and B).

The importance of this aspect in the state of coral rock in different parts brings back to the subject of salty or sweet water action on limestone.

Figure 3.26.: Contour lines in Ilha de Moçambique and in its coastal environment. The rocks in three different areas of Ilha de Moçambique [M.B., 2009].

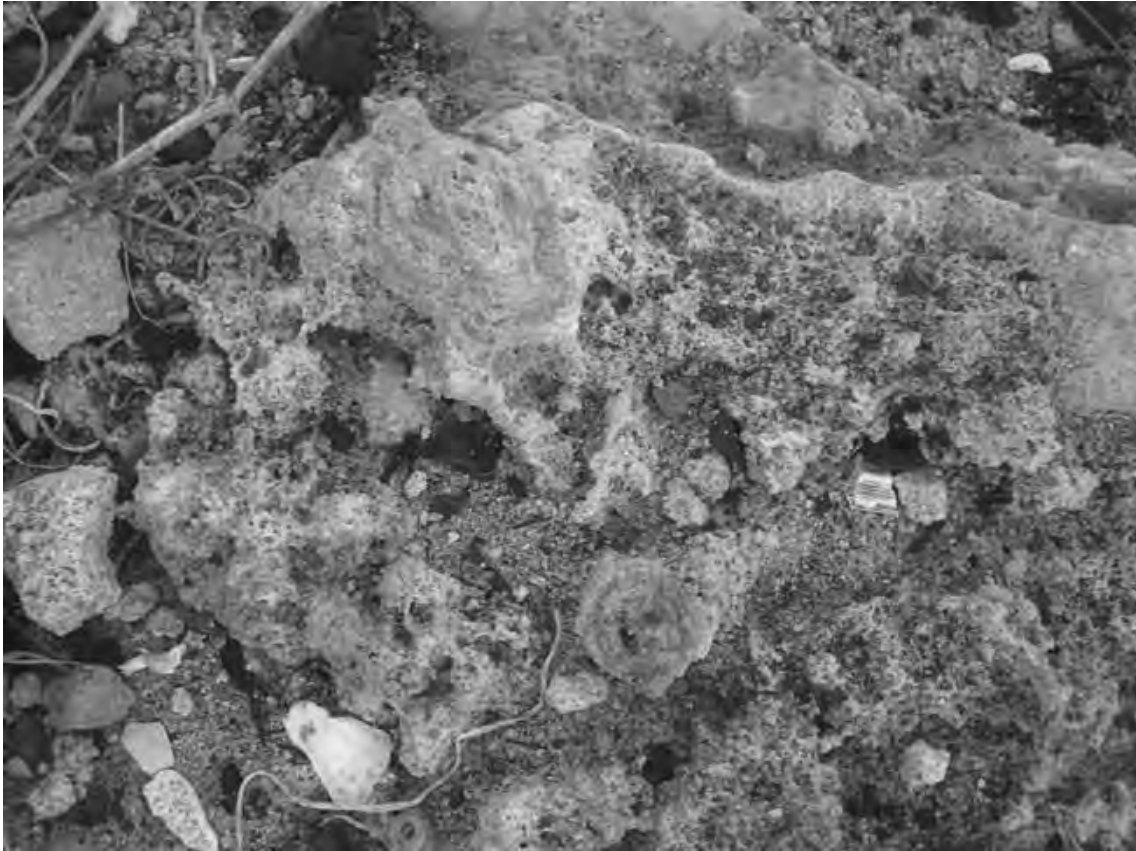
Figure 3.27.: The skeleton of coral colonies growing among the calcareous sediments in the southern promontory of Ilha [M.B., 2009.].

compact at first sight; the lack of crackings under the significant weight of the fortress above, demonstrates the high degree of mechanical resistance to compression.

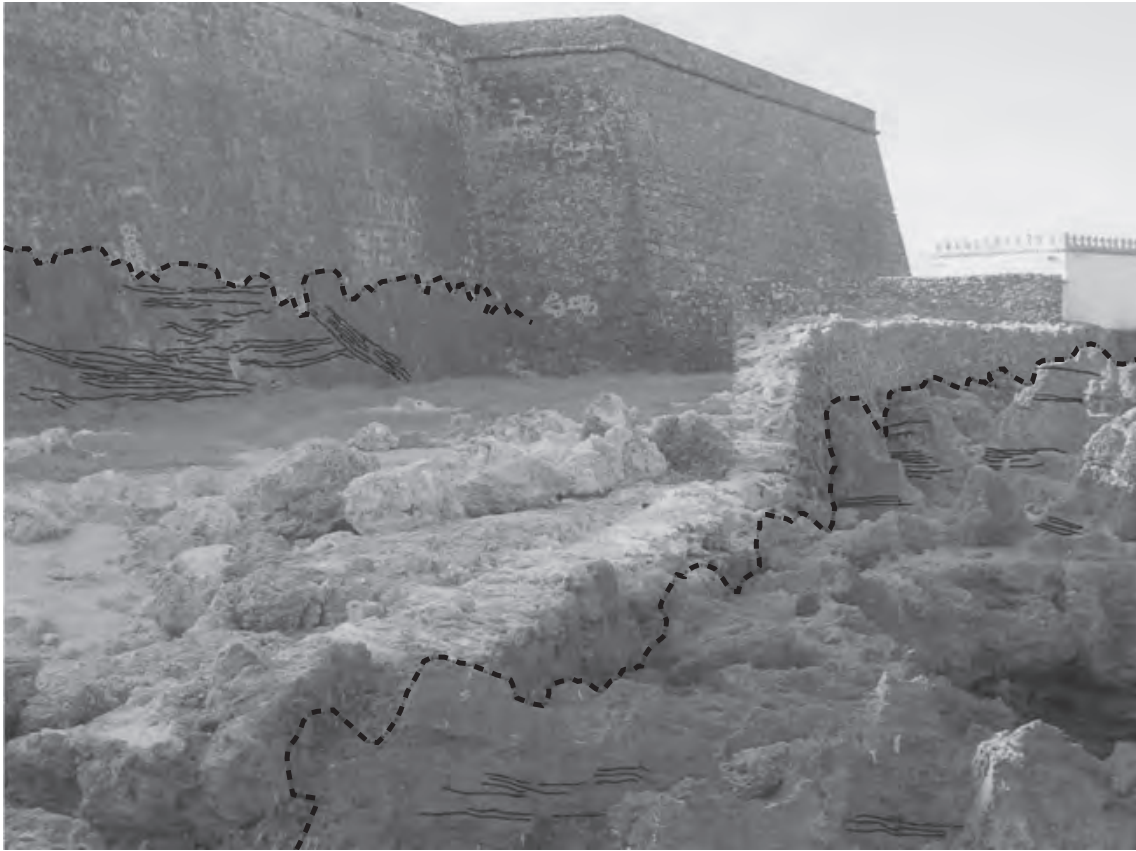
Figure 3.28.: Checking Grabau's diagram at the Fortaleza de São Sebastião [M.B., 2009].

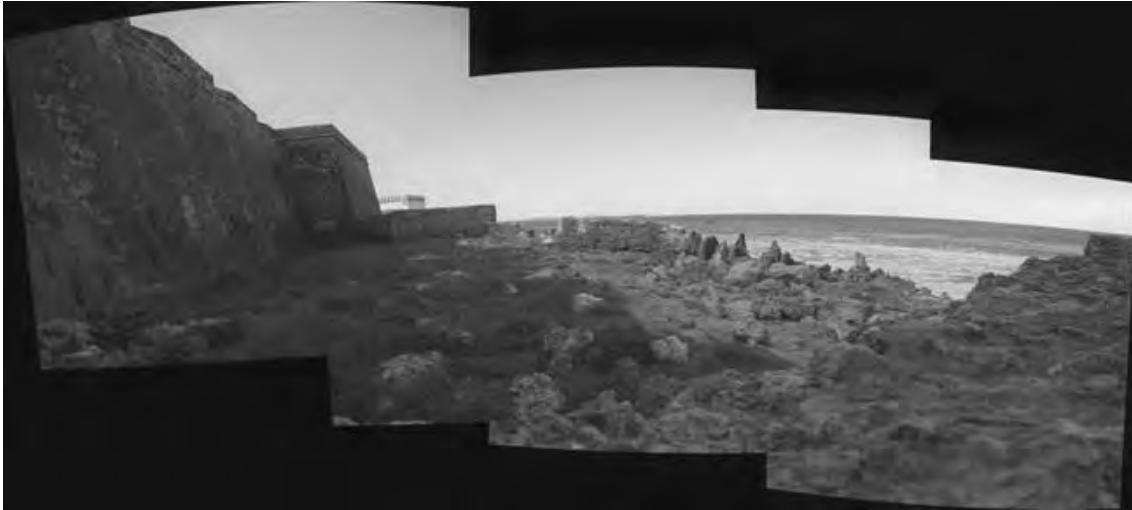
Figure 3.30.: Firing platform, called *campo de tiro* or *cemetery*. The effects of the cyclone Jokwe, 7-8 March 2008 [M.B., 2009].

At ICOMOS (International Council on Monuments and Sites) I heard the news of the damages caused by Cyclone Jokwe, on 7-8 March 2008, on some structures of the fortress of São Sebastião, Ilha. I read two technical reports on the consistency of the damage, and during my last study visit, I wanted to inspect it for a better knowledge.

The picture shows one of the places where the damage wasn't so relevant. I found damages only on the outer wall of the low square which had been built directly on the reef. In the same point, however, a collapse had already occurred in the past. An examination of the collapsed material made evident that what had collapsed during the Cyclone Jokwe was a rebuilt, but reinforced wall. The new wall was equipped with a sort of buttress: a second parallel wall had been built in adherence to best oppose the waves. Analysing the underlying rock, that point is clearly much battered by the waves due to its geographical and environmental conditions and the coral rocks are more worn than the ones nearby.

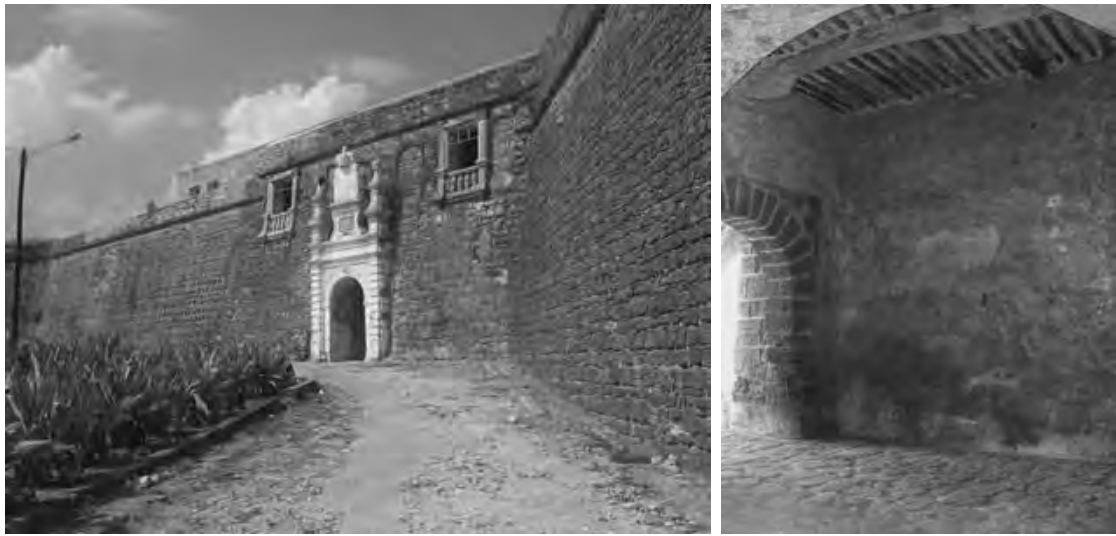
The entrance to the fortress of São Sebastião still retains a traditional structure with a ceiling of wooden beams and slabs of coral conglomerate. The flat roofs of the fortress had been replaced for decades with beams and slabs of concrete. This system has been improved during the most recent works.

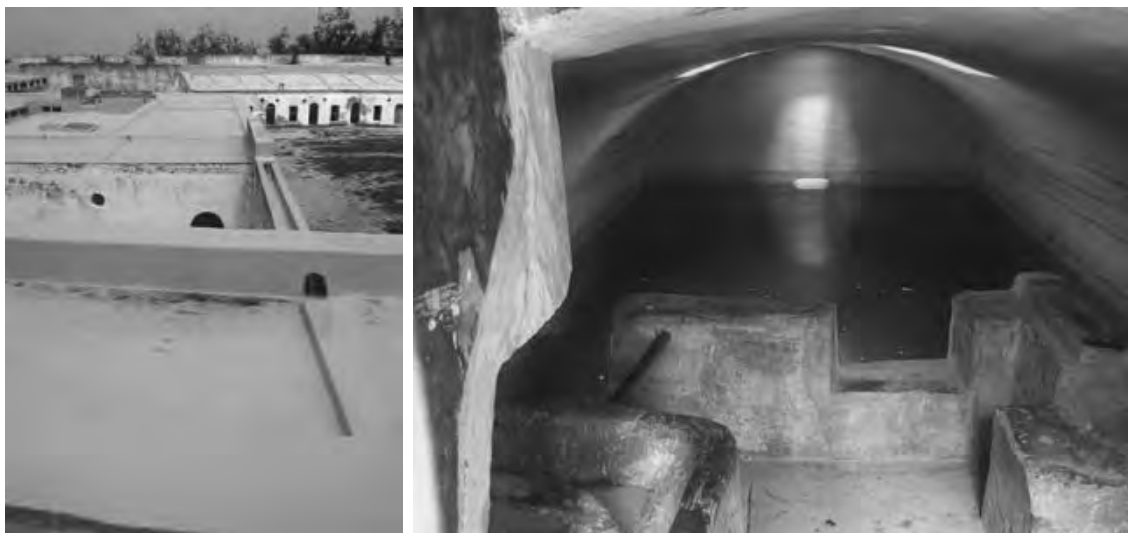
Figure 3.32.: The system for collecting rainwater in the Fortress São Sebastião [M.B., 2009].

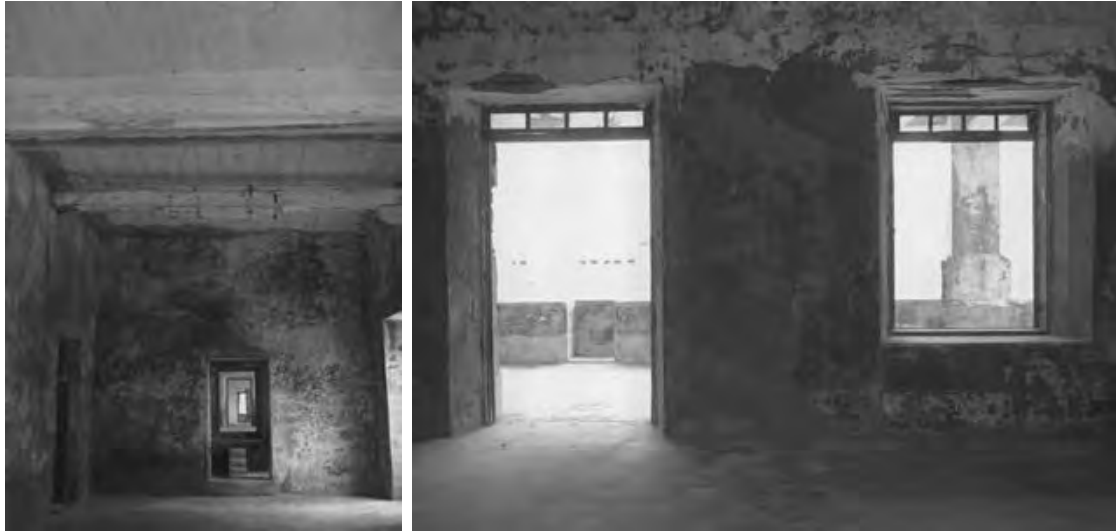
Door and window concrete lintels where iron has broken due to oxidation or corrosion in a normally wet environment and subject to marine aerosol.

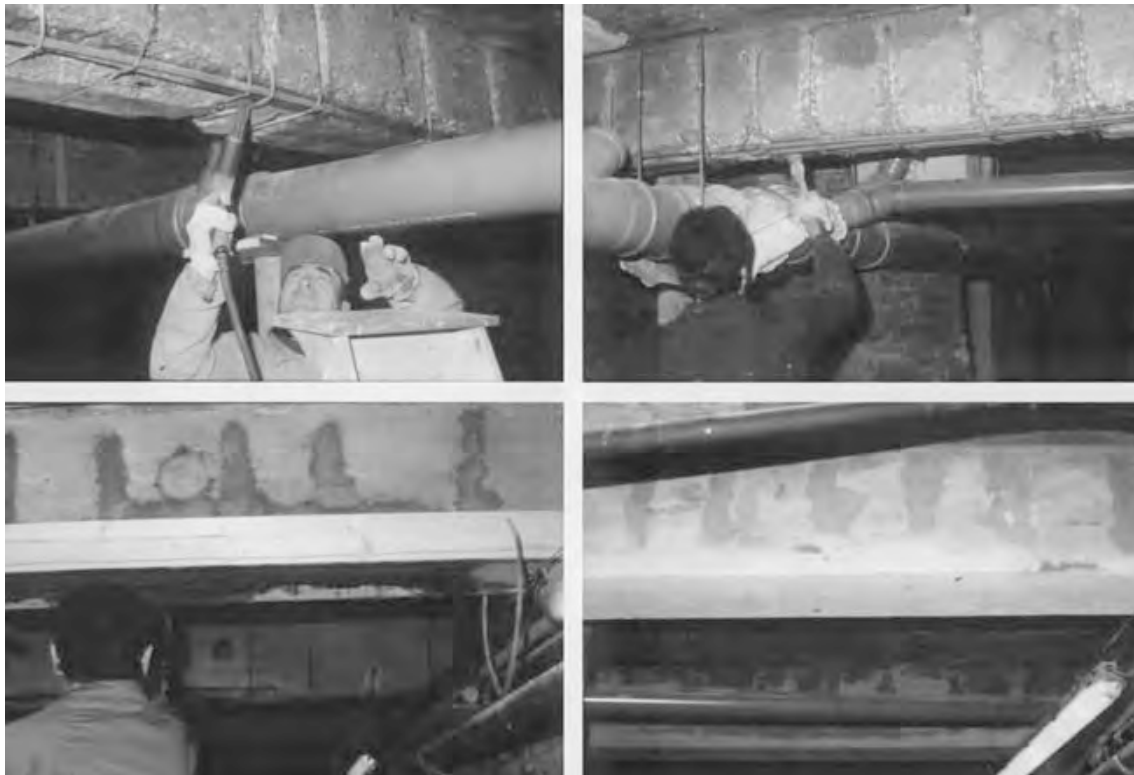
Figure 3.37.: C - Procedures for the restoration of a beam or a slab of concrete – Photos 8, 9, 10, 11 clockwise [M.B., 1994].

Paintings with acrylic resin for iron protection and the improvement of the adjoining between the iron and concrete prepared through cleaning; integration of the concrete gaps with mortar of plastic cement added with acrylic resin. The application is effected in two or three subsequent layers.

- Localization of iron reinforcement of beams;
- Sampling in order to determine the mechanical properties of the concrete cast;
- Cleaning of the oxidized layers to get the clean iron;
- Installation and fixing of new pieces of iron or brackets, where deemed necessary by engineers' calculation;
- Paintings with acrylic resin for protection and improvement of the binding between iron and concrete, as prepared by cleaning;
- Integration of the concrete cracks with mortar added with acrylic resin. The application is effected in two or three successive layers.

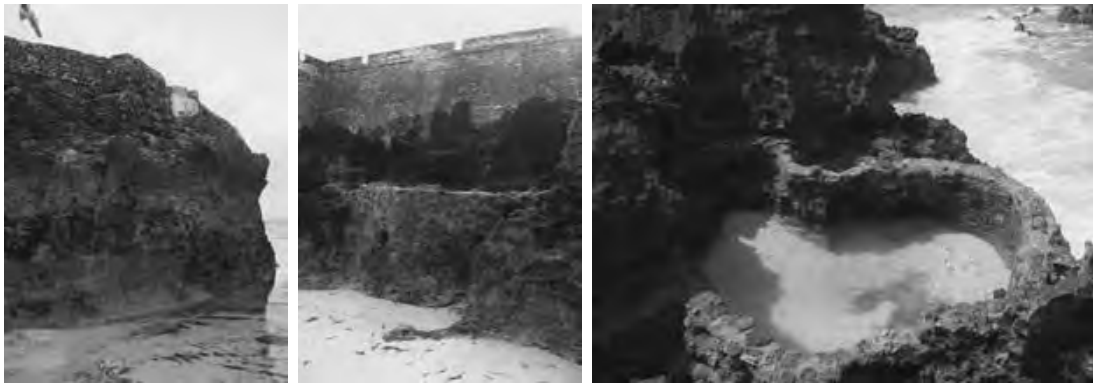
The reconstruction and integration of the cliff, here and in other nearby points, show that the ancient keepers had already protected and repaired the parts of the reef more eroded by ocean waves, as they are today.

Figure 3.39.: Erosion pots with artificial additions [M.B., 2009].

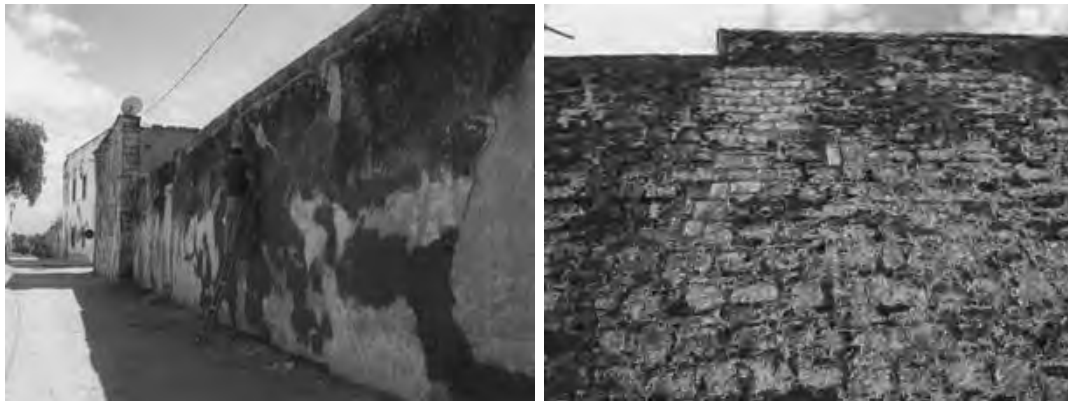
The coral stone buildings require a constant care of the plasters which, together with the covers, ensure the necessary level of protection of the walls to avoid the phenomenon of disintegration due to salt. The practice of patching may be performed as in the past, using slightly porous plasters to avoid the penetration of marine aerosol and rain.

As it can be seen in the pictures below, the fortress was plastered in the past; that is a restoration issue to be faced with special care for formal, historic and material reasons.

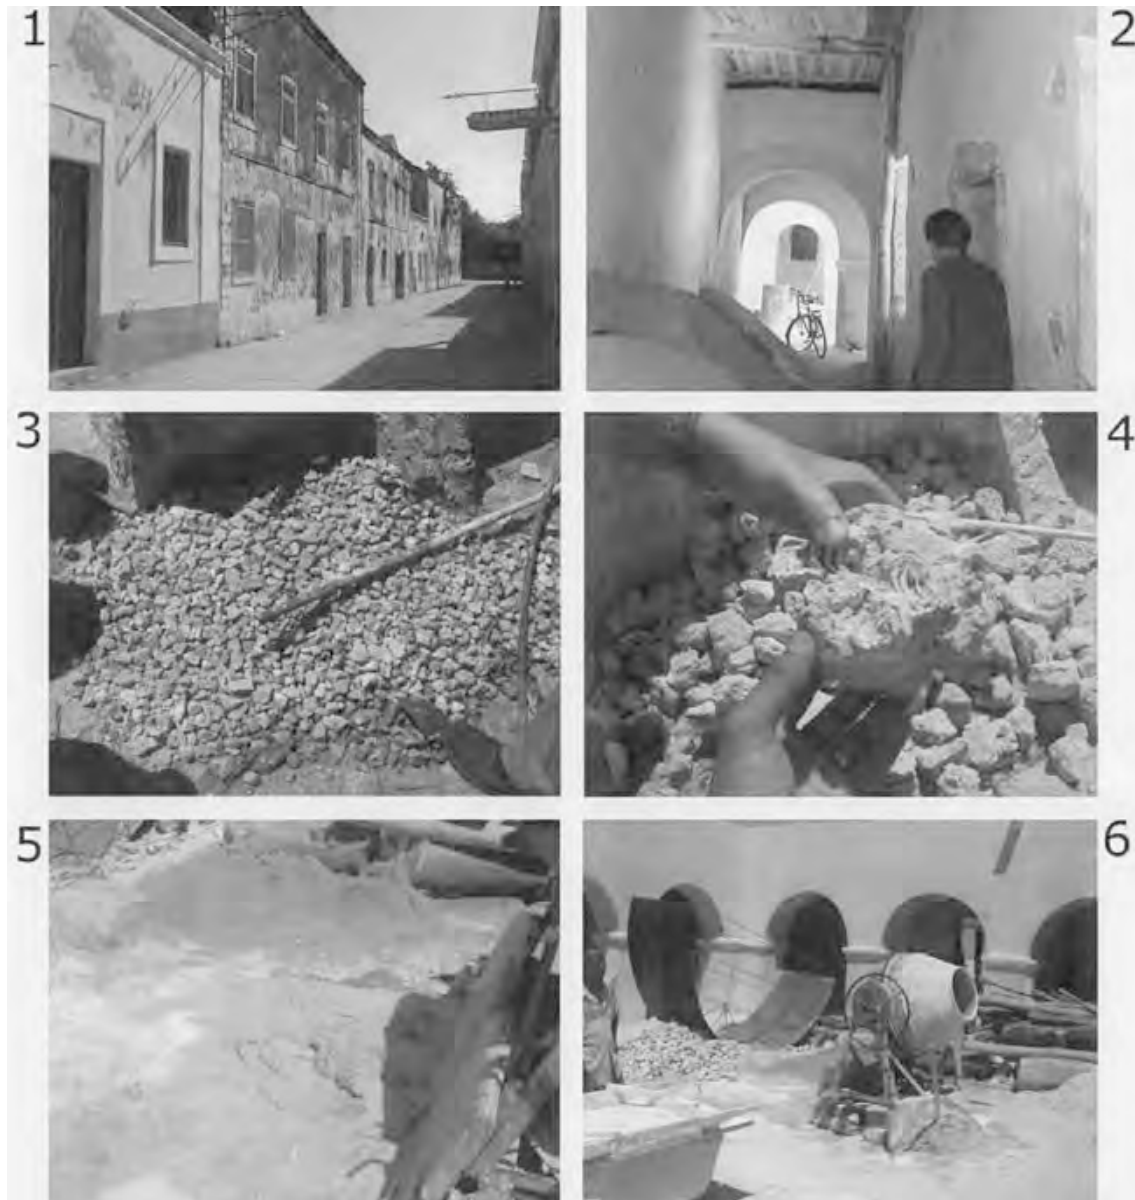
The outside and the passage to the house (Figures. 1 and 2).

Before restoration, many sections of the house walls were in dilapidated conditions and therefore extensive additions were necessary to make up for loss and dispersed material. Stones from an old limestone quarry in an ancient coral reef on the mainland coast were used.

The material was cut into pieces of varying sizes, according to the plan necessities. The larger pieces were used in the missing wall blocks (Figure. 4), while the smaller pieces were used to reduce the small cavities caused by the dissolution of the mortar as a result of the reformation of cyclic salts (Figure 3). The need for mortar enticements in shooting walls, the deep stucco work and the finishings were made on site using river sand, lime from the national industrial production and fresh water (Figures. 5 and 6).

According to the project, the material was cut into pieces of larger and smaller sizes; the larger pieces were used to supplement the missing blocks of the walls, while the smaller pieces were used to reduce the cavities produced by the dissolution of mortar, due to salts, and also to reduce the thickness of the new grout. The mortar needed for enticements in walls and the deep stucco finish were packaged on site using river sand, common lime of national production and fresh water.

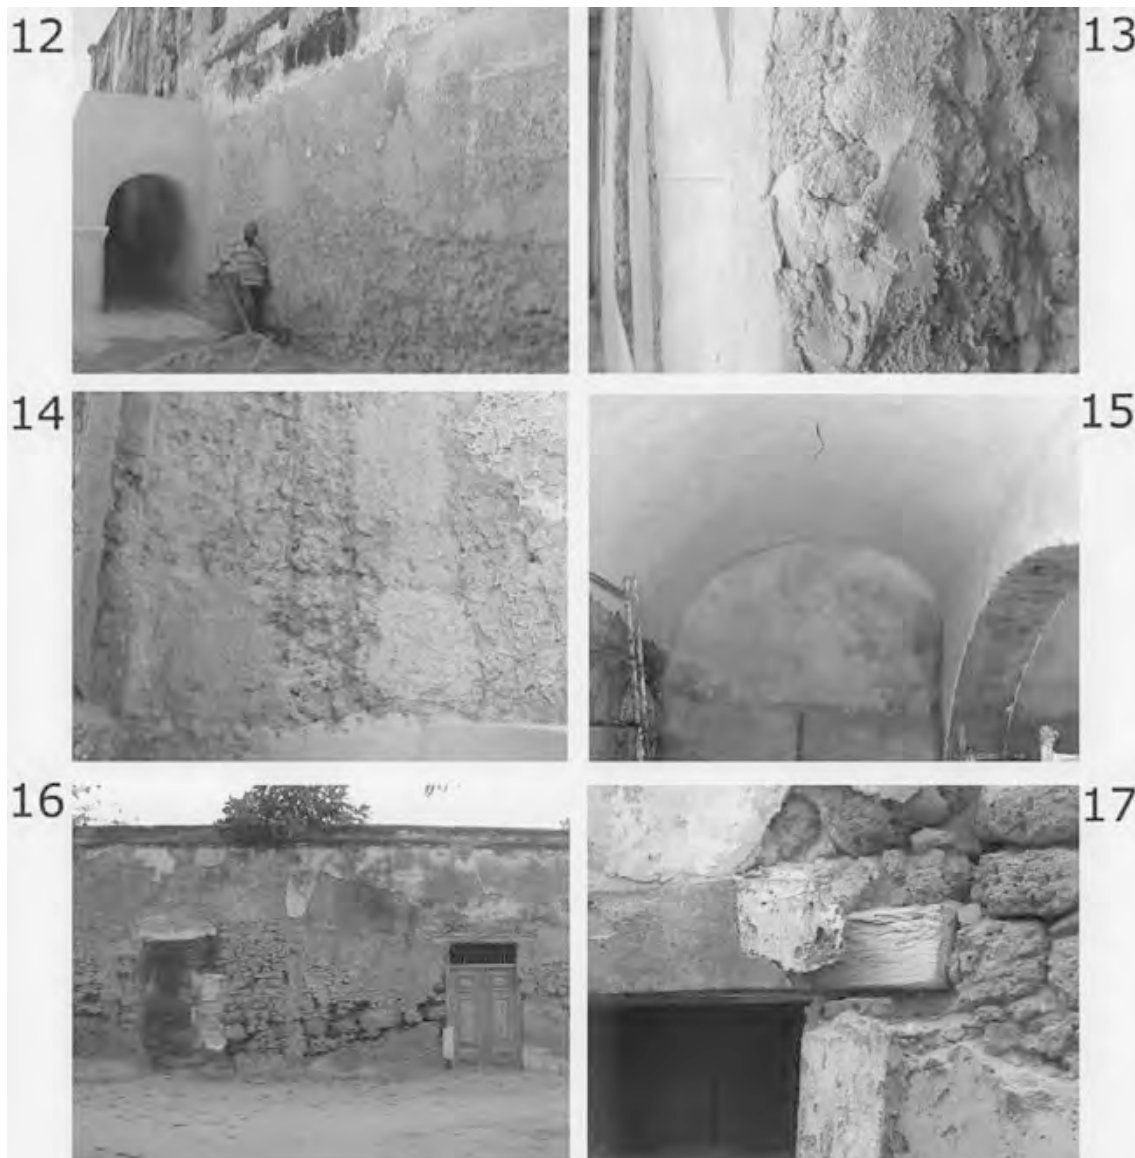
When repairing a wall, the concentration of loads which could damage the whole static balance is carefully avoided (Figure 16).

Localized simple washing with fresh water, using drainage cannulas at the base makes easier the removal of salts (Figure 12.)

First, a deep wash with simple fresh water is necessary, if the still existing plaster and the wall itself allow the operation. Drainage cannulas can be temporarily placed at the base of the wall in order to facilitate the removal of the salts. Plaster is laid out in two or more layers according to the type of masonry. The final goal is to protect masonry from outside moisture, still maintaining a high degree of transpiration. A very thin plaster porosity prevents rainwater infiltrations and, at the same time, allows transpiration.

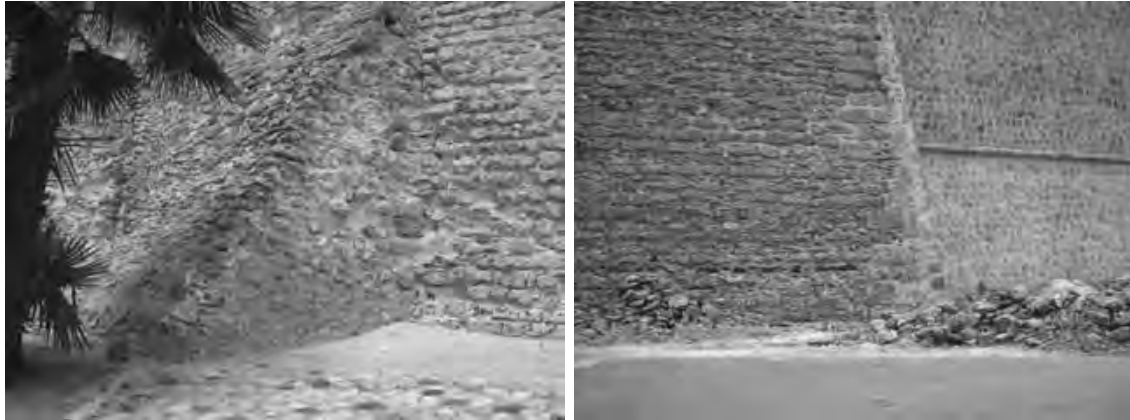
Figure 4.3.: The disruptive effect of salt crystals in the buttress on the side of the Archaeological Museum entrance; the unfinished cladding of the Southwest bastion [M.B., 2006].

Desalinate and whitewashing. As to the case and application studies on coral limestone already mentioned, desalination treatments are suggested only where there is a real need, to be determined during following studies. As a matter of fact, the presence of a moderate amount of salts in masonry can be

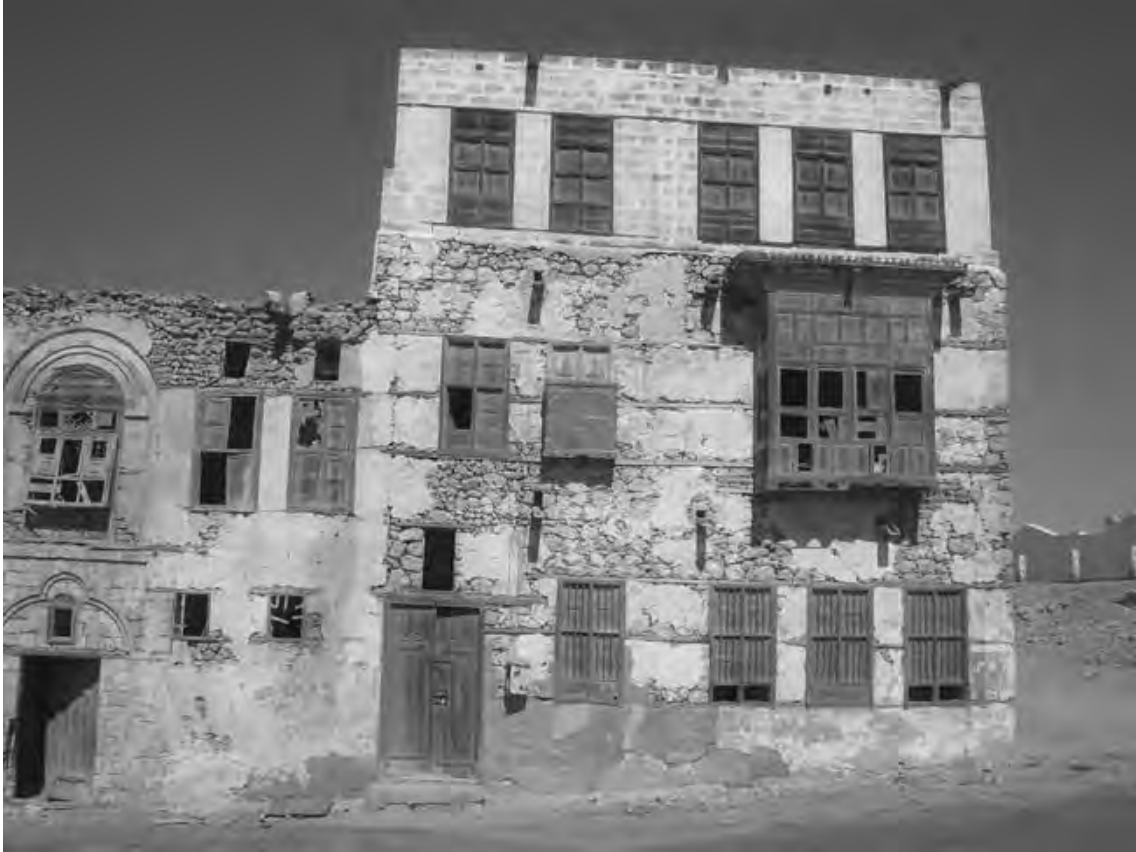
According to the Aylin Orbasli observations, Arab houses along the Red Sea coast are structured with wooden chains arranged in the thickness of the wall. The bearing walls are built of coral stone courses by placing allurements of lime mortar. Each cm of meter twenty rising, they settle down a rail of wood, which are called in Saudi Arabia *taglilat*. It is believed that the use of this wooden structure can increase the elasticity of whole masonry.

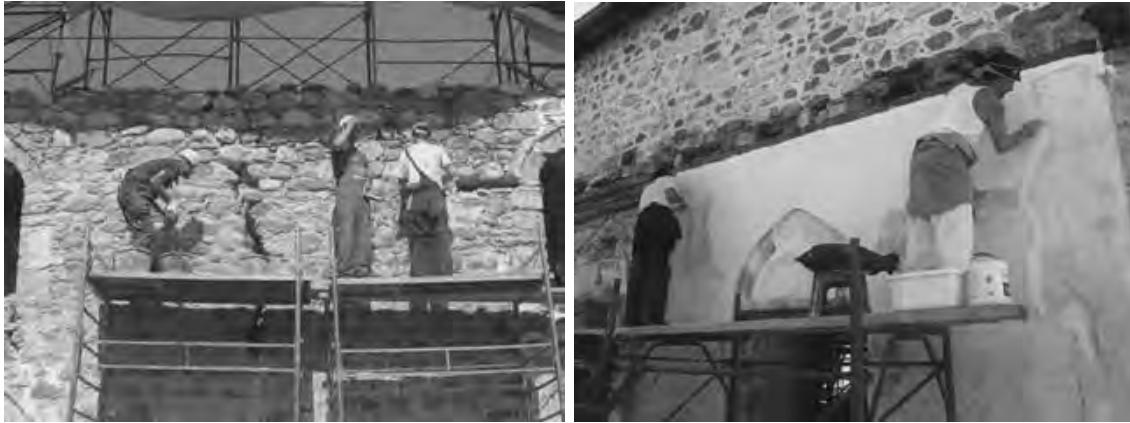
Restoration of Defterdar mosque. Left: a phase of partial replacement of the chestnut chain in the outer perimeter wall of the mosque, in the rail on the fourth level. Right: the same wooden chain already repaired, but on the main prospect. The description of project and works can be found later under the title: The restoration of Defterdar mosque in Pejë/Peć.

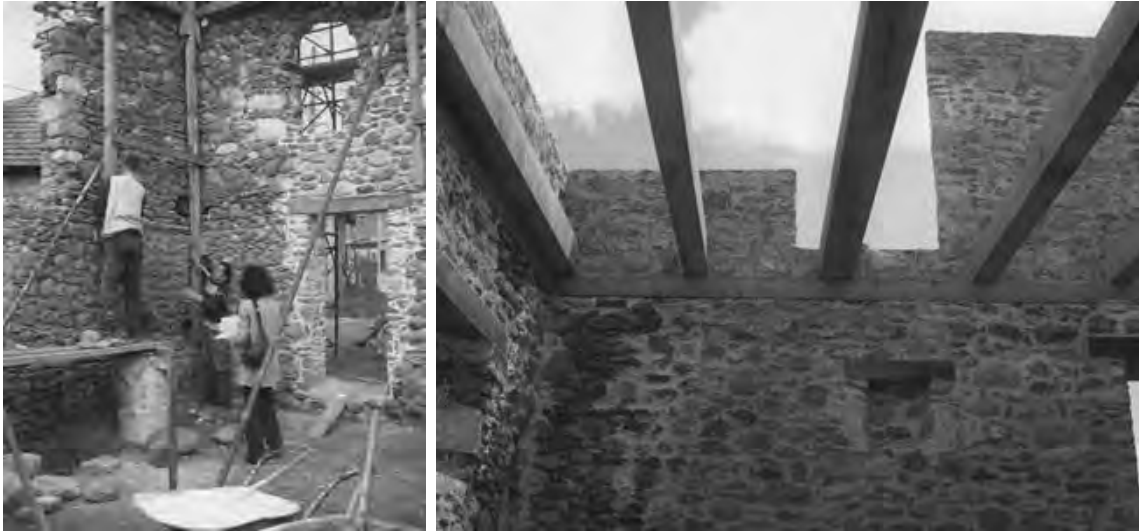
Figure 4.9.: Fir chains in Mushkolaj Kulla, Decan/Decani [M.B., 2009].

Restoration and reconstruction of Mushkolaj Kulla in Decan/Decani. Left: The final phase of the work conservation of ruins survived the fire of 1999 and ten years of total abandon. Right: reconstruction of the destroyed parts with the traditional use of wood as a structural element. The system allows the thick walls of river stones and lime mortar to take moderate deformation when stressed mechanically. In our case, the traditional use of wood has been reinterpreted in a critical way, following Professor Predrag Gavrilovic design. Now the building can resist the most severe earthquake.

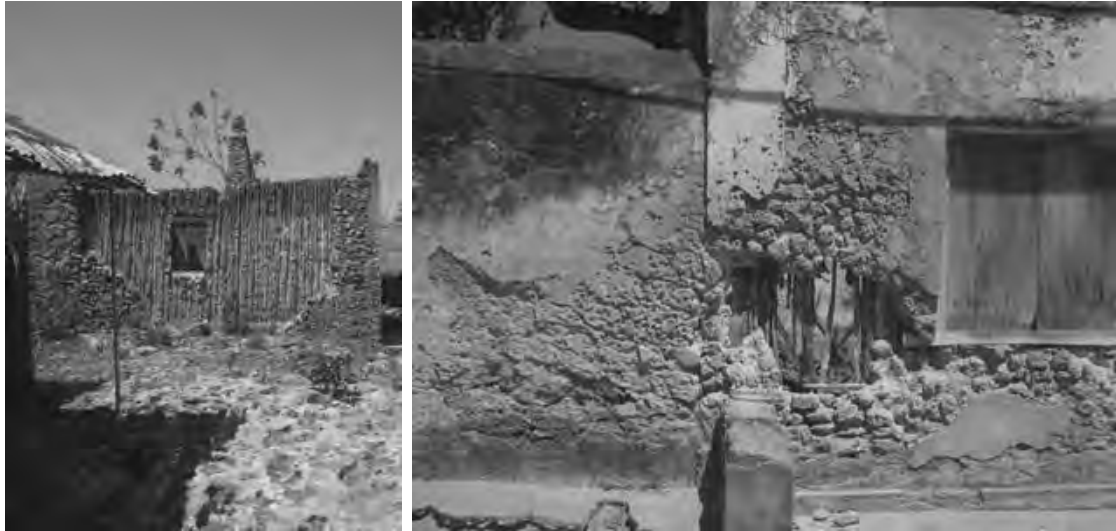
In Ibo, a variant of the construction technique *pau a pique* can be found. The construction of walls is made by putting together a conglomerate of coral on both sides of a trellis of wood stuck in the ground. In this work is not need for formworks because the pieces of rock can be placed one by one in mortar, according to their size. In the past, this technique has been adopted in both formal and informal areas of the town. It is believed that is not the construction a replica of the model imported during the colonial period. Not be excluded, however, that it is a corruption of the late Portuguese model adopted in Lisbon in Baixa Pombalina, once in contact with the local traditional practice of *pau a pique*.

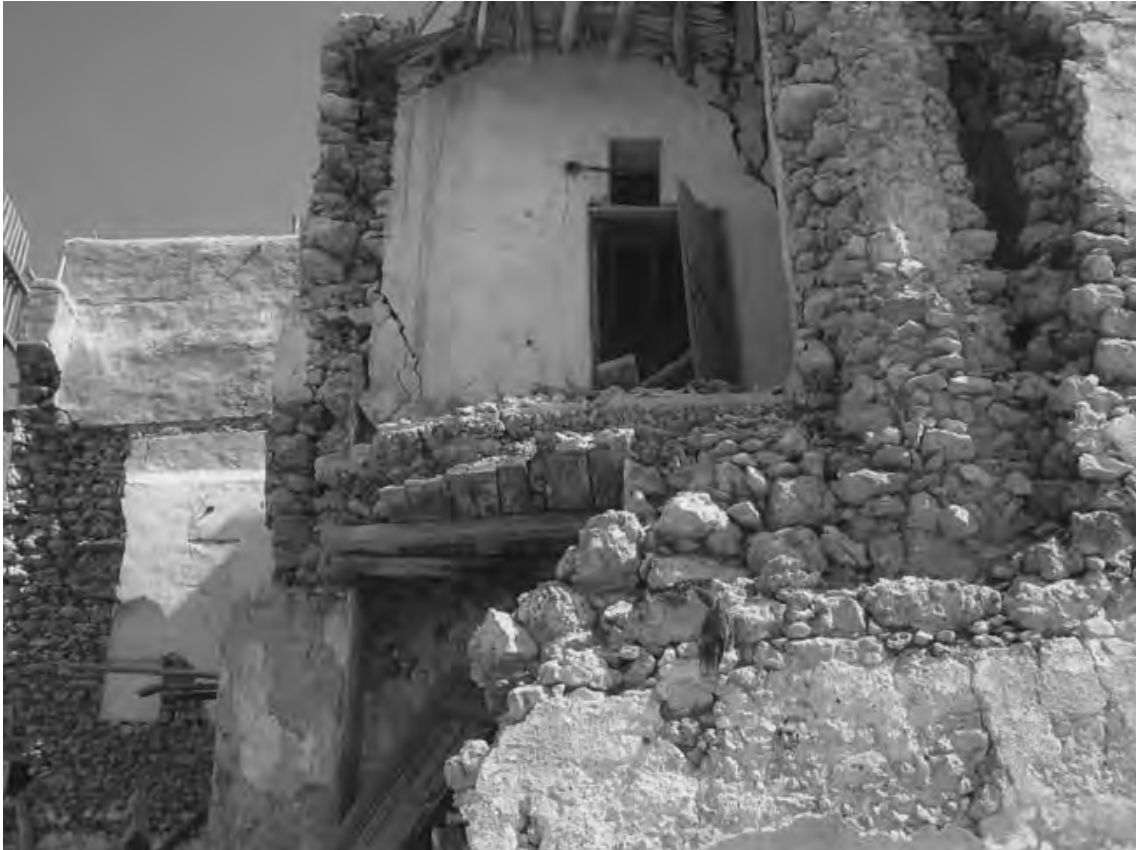
This ruined house in Al Wajh, on the east coast of the Red Sea, shows the same construction type of the floors and terraces as found in the houses on the west coast of Zanzibar. In the handbook *Conservation and Design Guidelines for Zanzibar Stone Town*, some specific technical features are examined in order to identify the most suitable methods for restoration and maintenance practices. For instance, we noticed that in the constructions on both sides the floor is usually completed - both the wood structure and the bed of coral limestone with its finish - before proceeding with the construction of the wall upstairs.

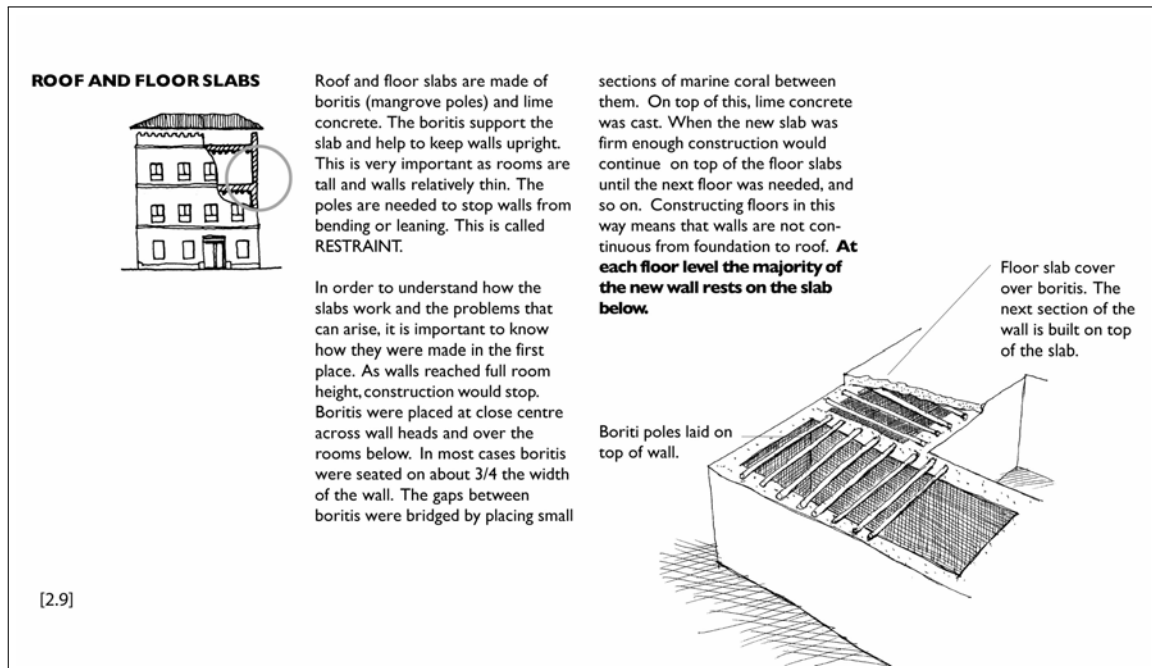
Figure 4.12.: Conservation and Design Guidelines for Zanzibar Stone Town. Roof and floor slabs.
Tab 2.9. [Battle and Steel, 2001.]

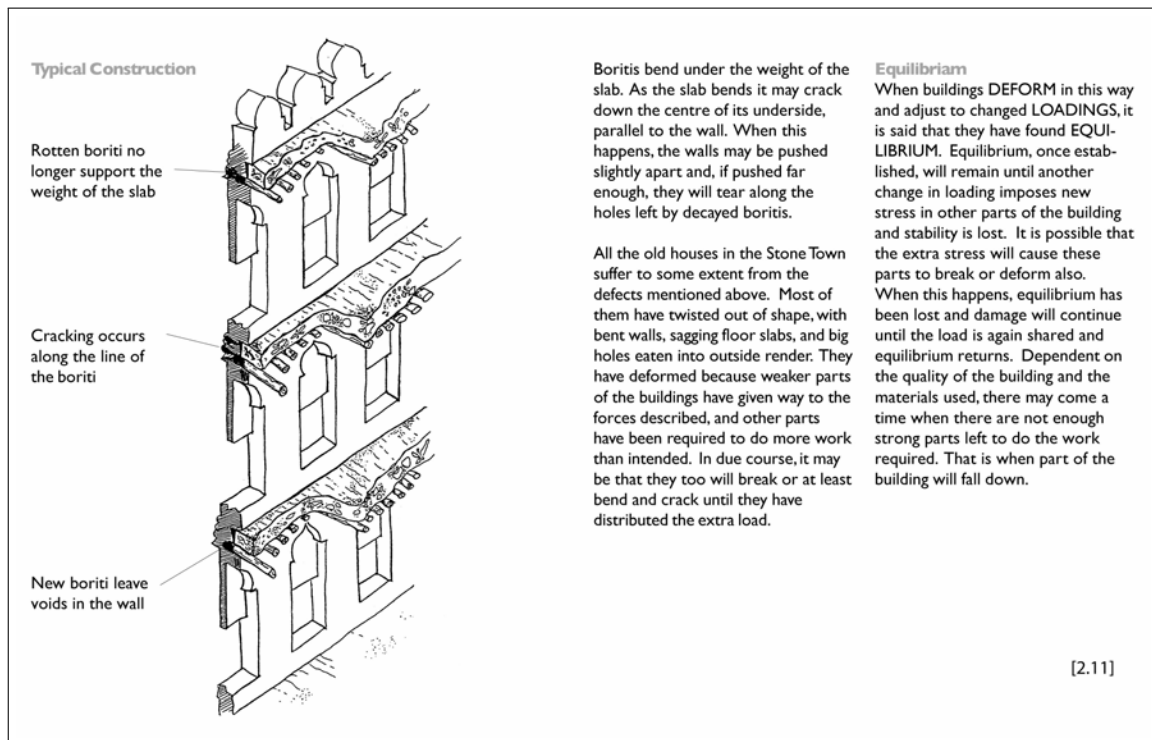
Figure 4.13.: Conservation and Design Guidelines for Zanzibar Stone Town. Roof and floor slabs. Tab 2.11. [Battle and Steel, 2001.]

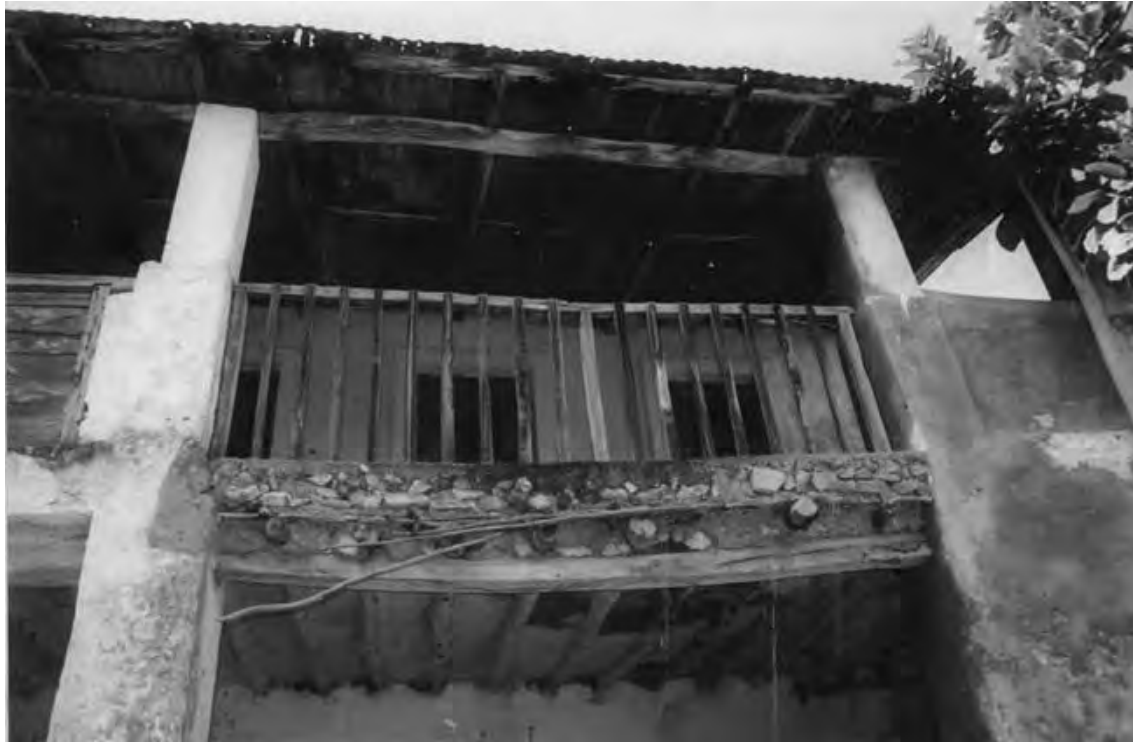
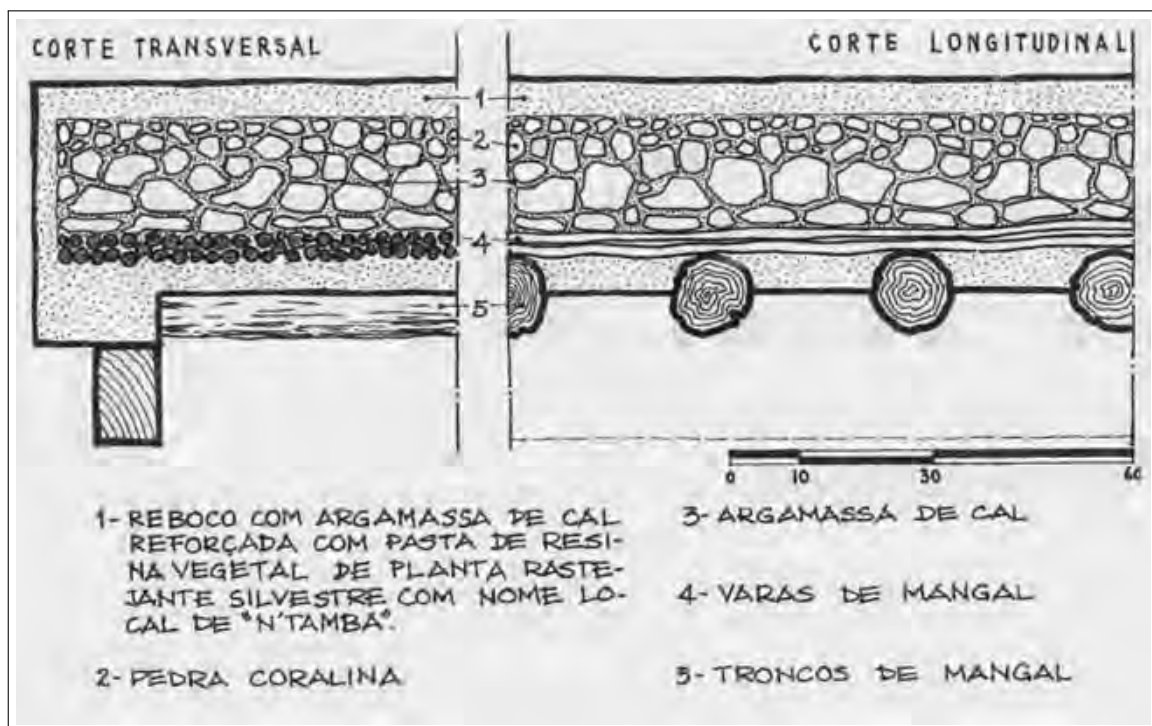
Restoration of a floor or a flat roof, using traditional techniques swahili.
