Maurizio Berti

A heritage of coral stone

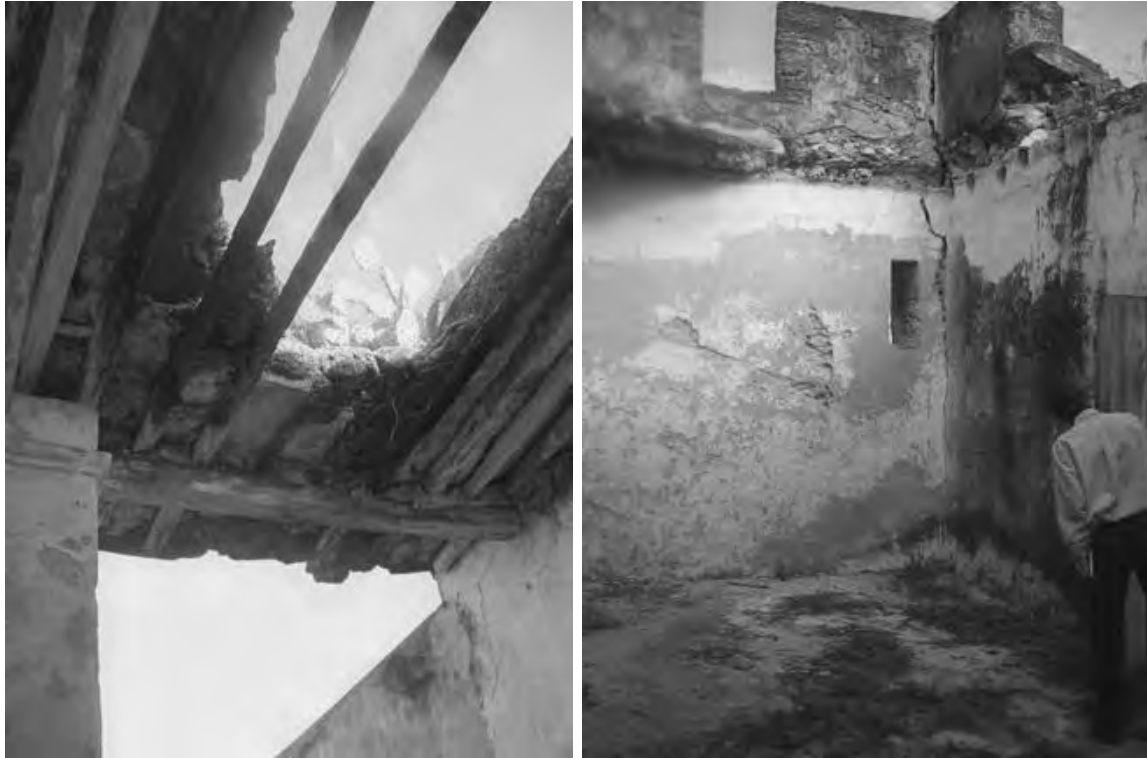
Restoration of a floor or a flat roof, according to traditional Swahili techniques.

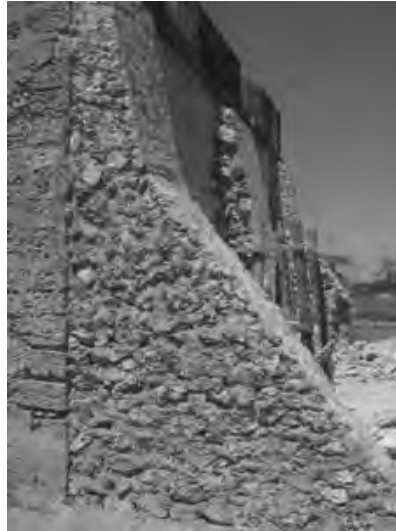
Figure 4.17.: Fallen flat roofs. A house in Ilha de Moçambique and Fortim de Santo António in Ibo [Photo by Simone Vicini, 2004; M.B., 2007.].

Restoration of a floor or a flat roof, according to traditional Swahili techniques.

The traditional plates and the most recent, when built for function as flat roofs are highly perishable, since they are exposed to the elements, thus they need yearly maintenance, as opposed to the ones with a sloping roof with vegetation cover, or brick or fiber cement, where routine maintenance can be done with multi-year cycles. Without maintenance, the time required for the almost complete disappearance of the traditional flat roof and concrete slabs in marine environments, it is almost the same, that is approximately thirty years.

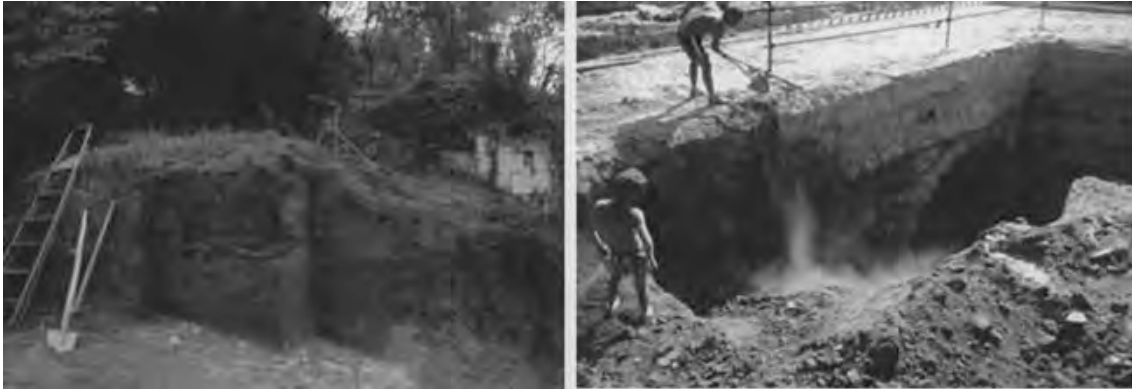
Figure 4.22.: Surveys on the final form of the parapet of the bastion of Santa Croce; traces of bricks in the initial condition of the parapet of the bastion.[M.B., 1989].

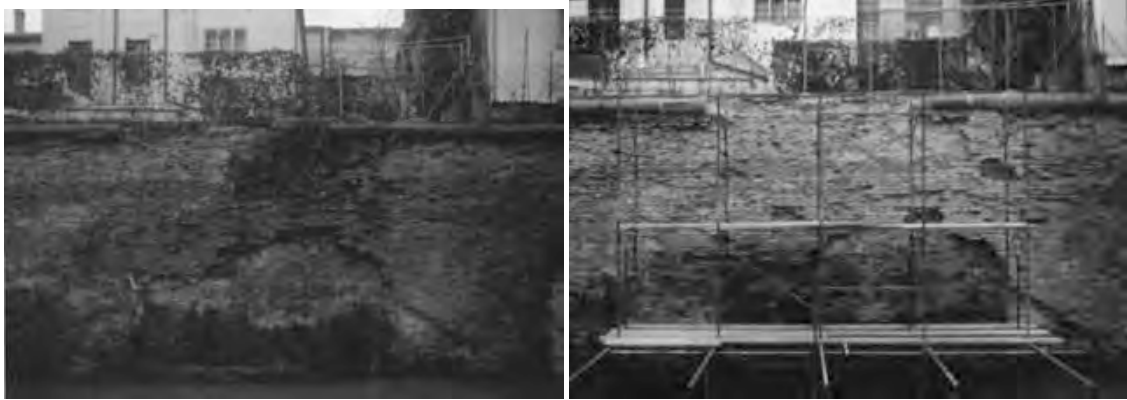
Identification, cleaning and re-adhesion of the surface layers is the bastion San Giovanni. The cycle of decay that causes the vertical fracture of the bricks of the curtain has not yet been established. The photographs show that an unstable condition may last for several decades. This phenomenon was not considered serious until it was carried out the disinfection of the weeds.

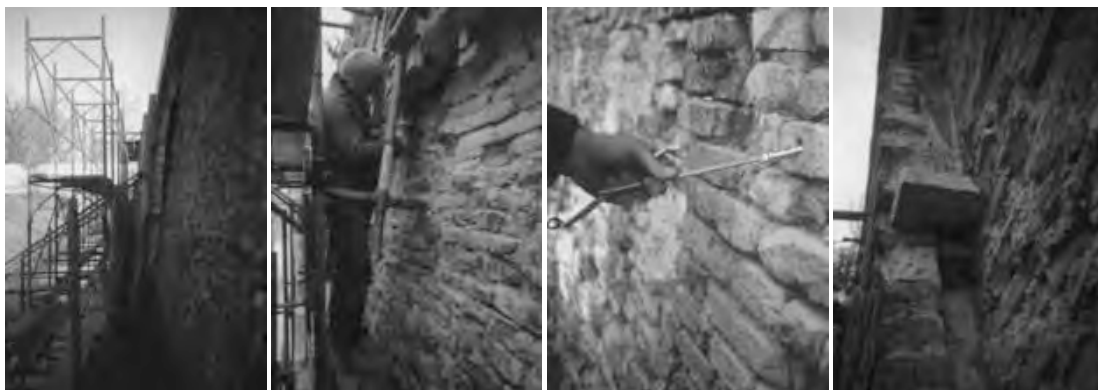
Some steps of the techniques used to make surface layers adhere to masonry; they generally are about 12-15 cms thick. During the works, it was preferred the use of simple bricks. Steel bolts were used where the detachment had overpassed the length of a brick. Cavities were filled with natural hydraulic lime mixed with inert expanded clay, starting from the bottom.

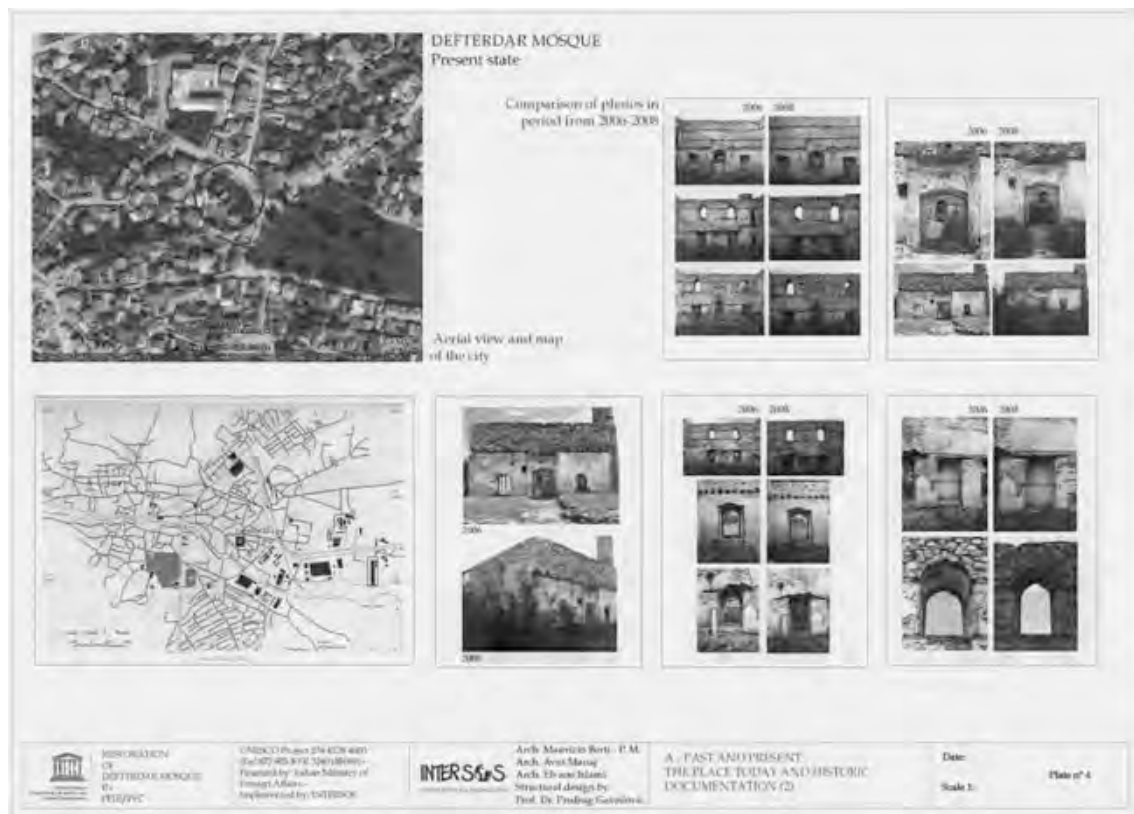
Figure 4.25.: Restoration of Defterdar Mosque. A - Past and present. The place today and historic documentation. Plate n. 4 [*M.B., 2008.*].

Location of the monument in the urban context and conditions of the artefacts. Aerial view and map of the city. Photos have been compared in the period from 2006 to 2008.

During the preparatory steps in September and October, Intersos engineering team carried out a number of on site surveys. New photos were shot using the same visual angle as 2006 photos'; when they were compared, it was detected where and how the deterioration had worsened. The comparison clearly showed that the exposure of the bare walls to weathering, after two winters only, had resulted in a significant further deterioration of the ruins neglected for about eight years; then, it was decided to protect them against the impending winter without delay.

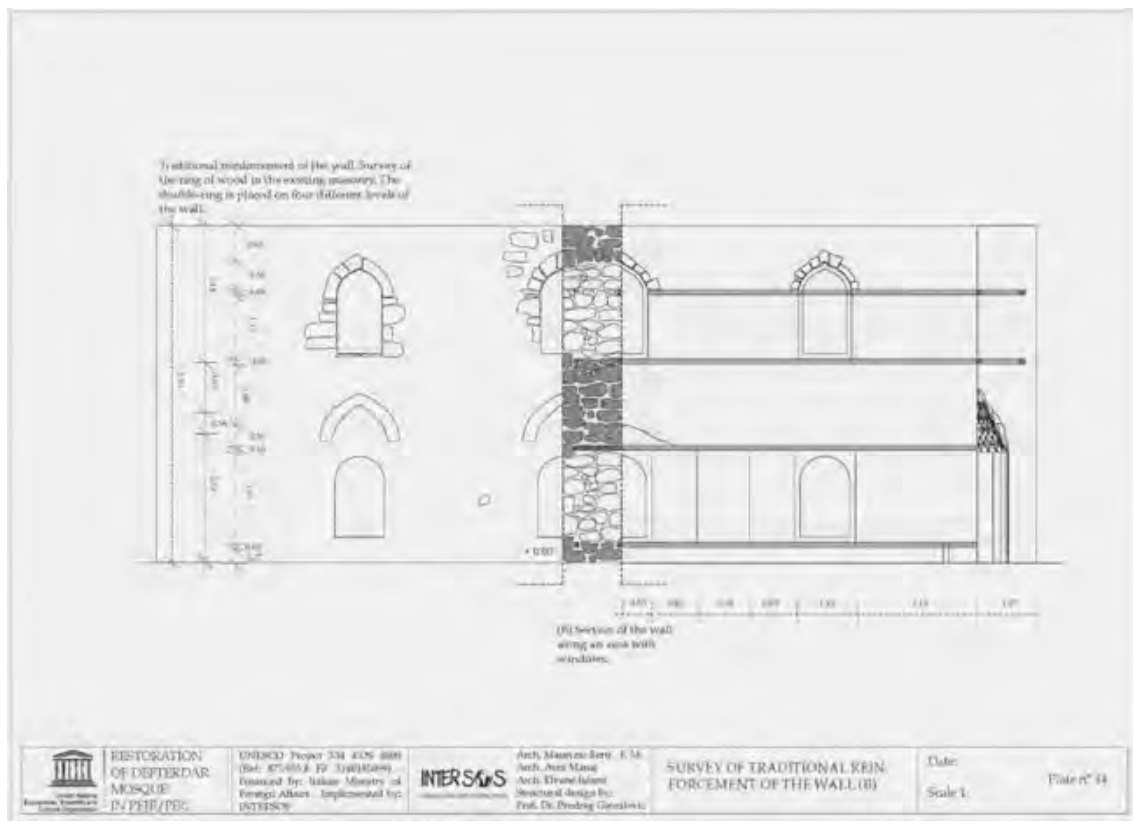
Traditional reinforcement of the wall. (B) Section of the wall along an area with windows.

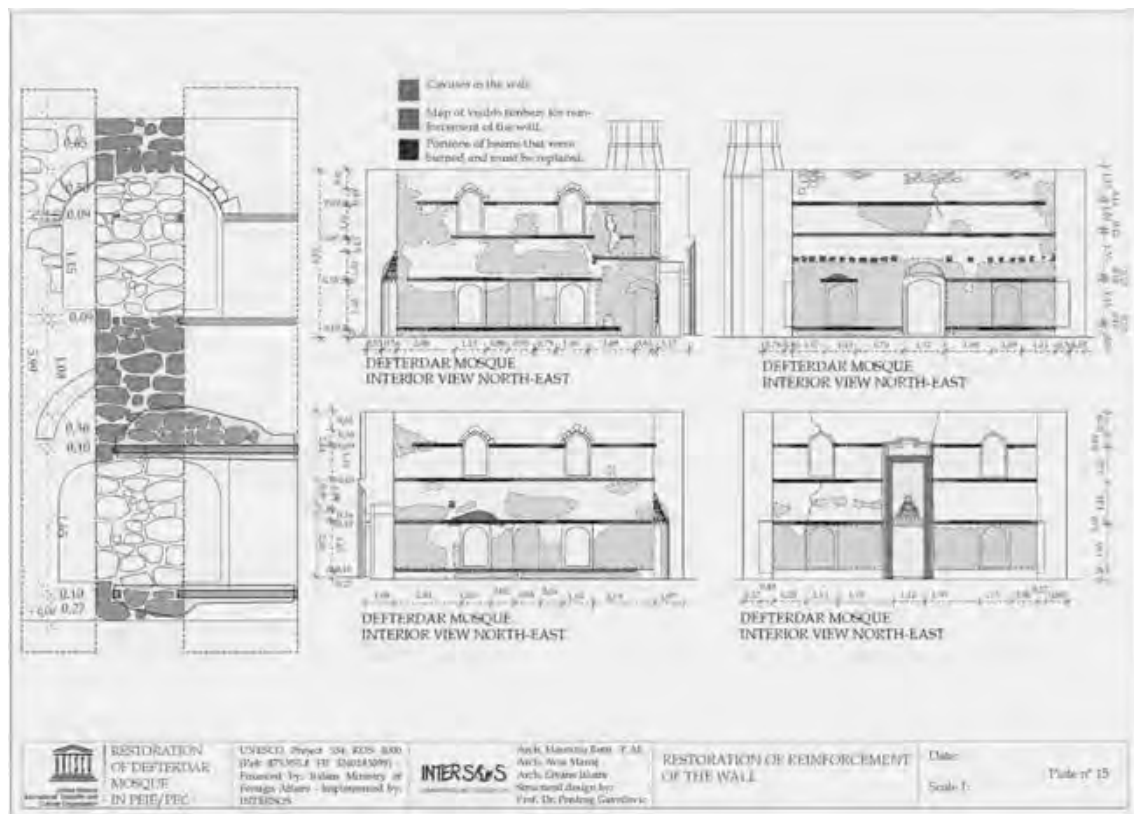
Cavities in the wall. Map of visible timbers for reinforcement of the wall. Portions of beams that were burned and must be replaced. Section and four interior prospects of the mosque before works.

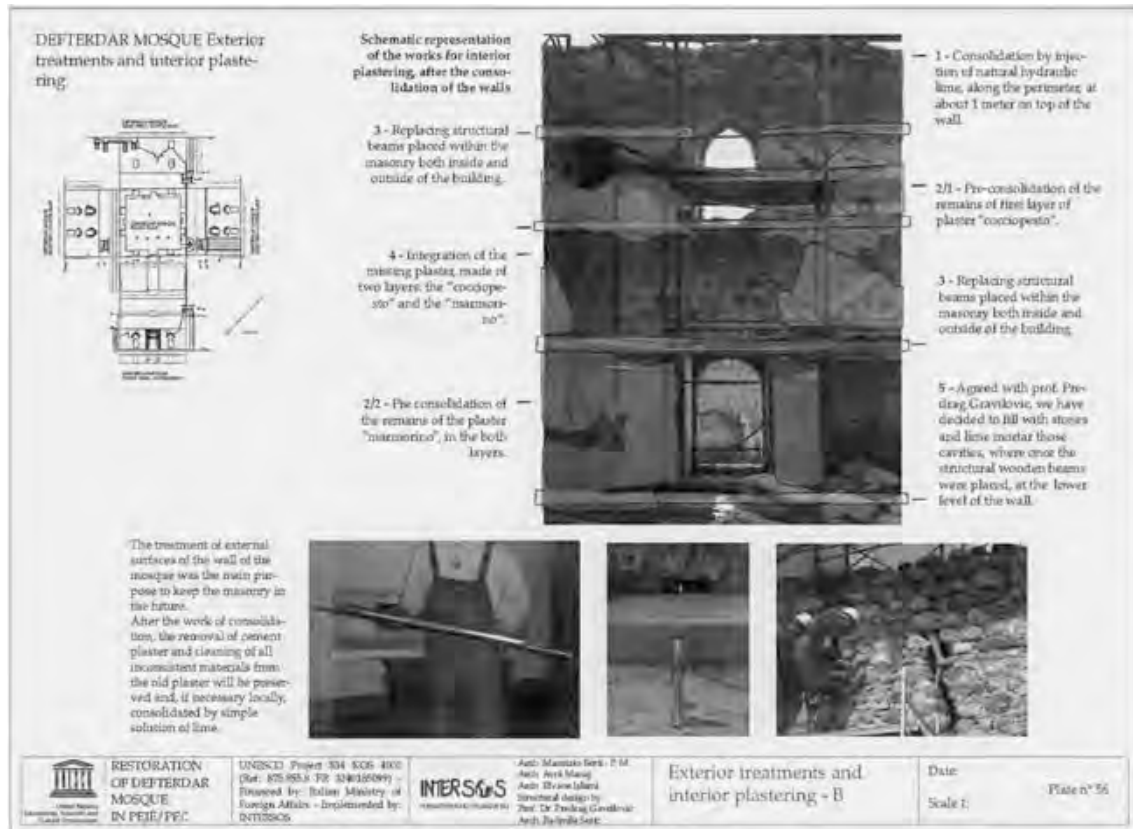
Replacement of the four rings of chestnut beams - internal and external - lying inside the wall. The condition of the walls forced to combine a traditional wooden track system with a mechanism of two coaxial iron elements specifically designed to replace the wooden ties mostly missing because of ten years exposure to weathering.

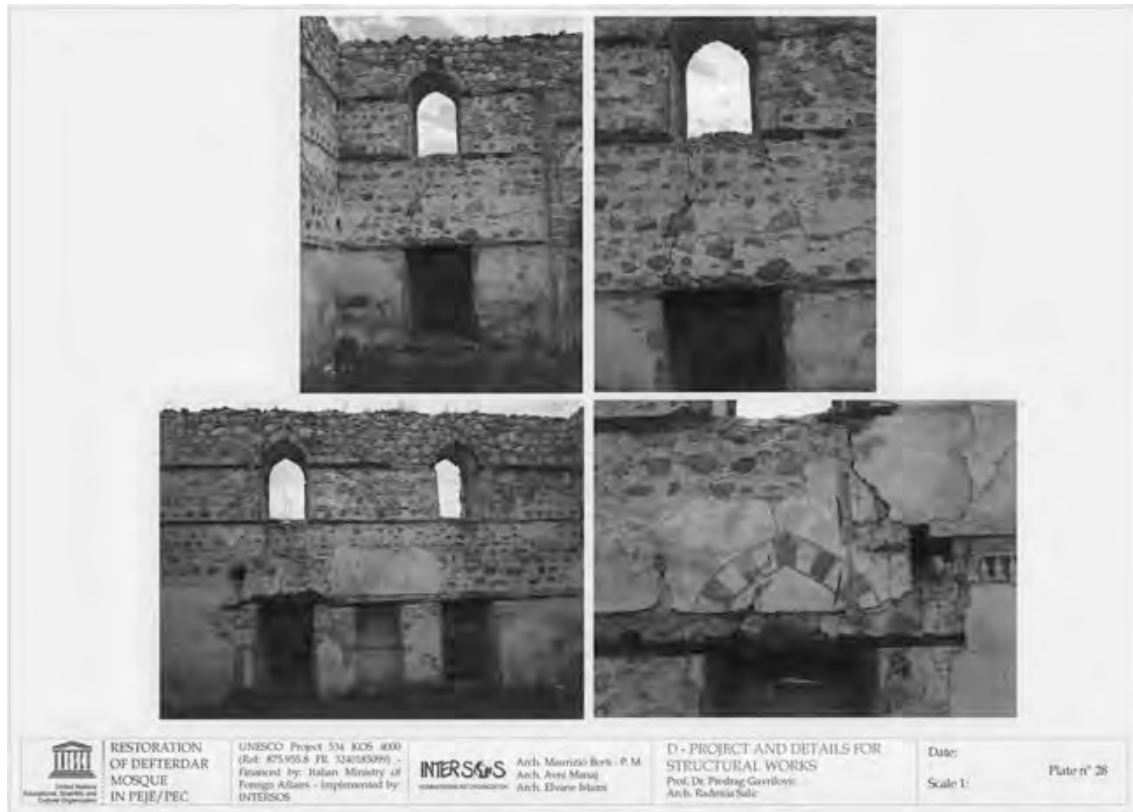
Structural Design of Reconstructions, Repair and Strengthening of Defterdar Mosque in Pejë/Peć, Kosovo - Vol.1. Structural design by: Predrag GAVRILOVIC, Radmila SARIC from Skopje. Principal designers of reconstructions: Maurizio Berti, Avni Manaj, Elvane Islami from INTERSOS Kosovo, Office Pejë/Peć. November, 2008. Views of the interior prospects of the mosque before the works.

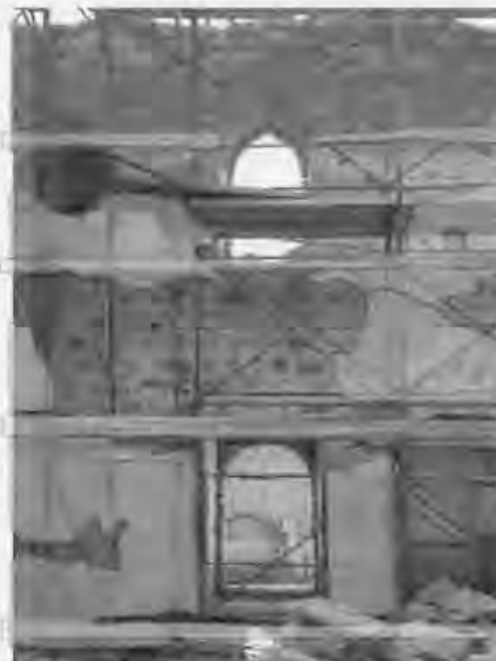
1 - Consolidation by injection of natural hydraulic lime. Work done, as per project, along the perimeter, at about 1 meter on top of the wall.

2/1 - Pre-consolidation of the remains of first layer of plaster "cocciopesto".

injecting device. The drills shall be minimum 2/3 of the wall deep. The injecting device shall be constructed for continuous mixing and pressurization of the mass, without halting or stopping the process. The walls shall be injected with mixture consisting of 50% of lime slurry, 40% of filler and 10% of microsilica. The injection mass shall be prepared with lime mortar. In the lowest parts of the wall, a hydrophobic additive shall be added. Injecting shall be performed after washing and soaking the wall with clean water which is entered into the wall through injectors. The injecting shall be started at the lowest point to enable driving air and water out of the wall. It shall be performed under 1 atm pressure, to be increased to 2 atm when the wall stops taking any more injection mixture, which pressure shall be maintained for 10 minutes (defiltration time). After this, new injector shall be filled, always the lowest one. During the defiltration period, the surplus water is evacuated from mortar and mortar therefore reaches greater strength. Expansion of injection mass shall be monitored at the neighboring injectors. Those that leak shall be plugged to prevent the mass to leak. The mixture shall be cleaned from walls immediately since they shall be pointed and visible. After injecting, injectors shall be removed from the wall and mortar used for fixing them at the wall shall be cleaned. After this, the wall shall be pointed again and harmonized with the surrounding walls. Injecting shall be performed by a company specialized for this kind of works.

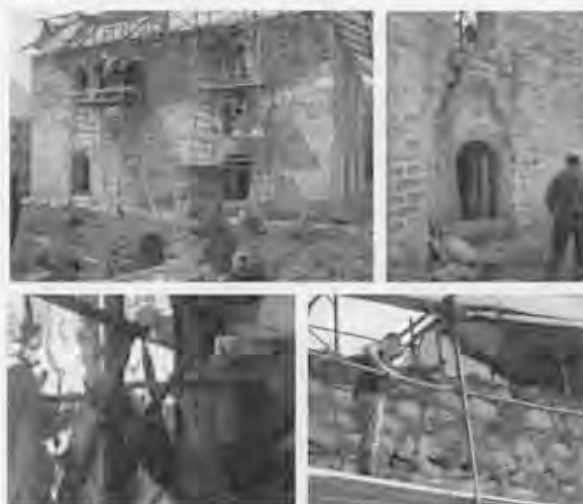
The consolidation operations by injection of lime and replacement of chestnut beams in the walls.

d) Replacement of the, internal and external, four rings of chestnut beams sunk into the masonry. Replacement of wooden lintels of the windows and integration both elements in wood and in stones in above part of masonry. The type and the static condition of the wall forced us to combine parallel beams with a mechanism of iron designed ad hoc in place of traditional wood stringers, in most cases, missing.

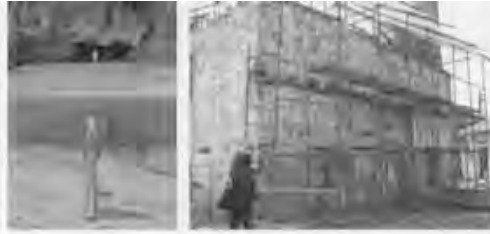
The mechanism of iron designed ad hoc in place of traditional wood stringers, because of conditions of the walls.

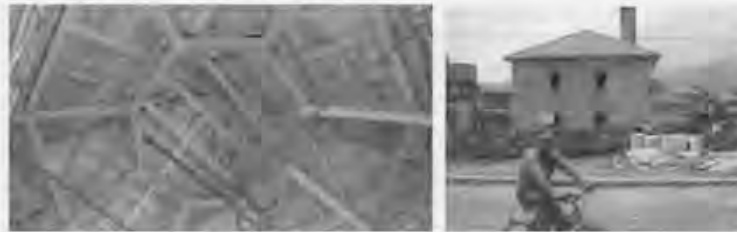
The final fase of the construction of roof, inside and outside.

e) Preparation of the elements of wood for the roof structure. Regarding the structure of the roof, we decided to use beams (for the primary and secondary structures) of the first category of fir wood. The use of this type of wood has been suggested both by traces of burnt wood that we found on the top of the wall and by the constructive tradition of this region. The use of the fir for the roof, as well as the chestnut wood for the structural parts of the wall, was discussed and agreed upon during the visits to the site of the Unesco Delegation.

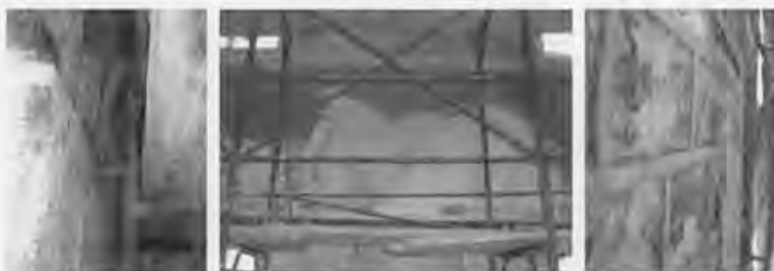
Integration of the missing parts of the "marmorino" plaster in the interior surface of the wall and around the windows at the second order.

k) Integration of the missing parts around the windows at the second order, recovery of original decoration elements, restoration of damaged stone elements.

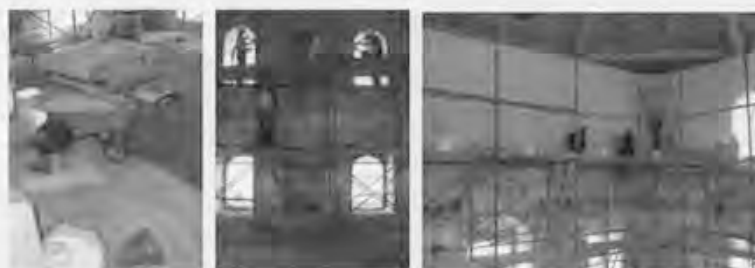
Making new internal plaster "marmorino" (marble-plaster).

m) Making new internal plaster "marmorino" (marble-plaster) for the integrations of the missing parts and the integration of the remains of ancient marble plaster. In this works were employed four local restoration specialists, an assistant on training stage and three students. The other local reconstruction workers were engaged in supporting the plaster works.

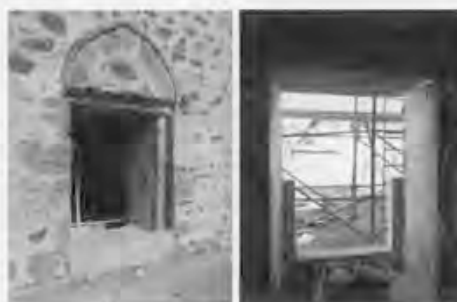
Remaking of the frames of the windows in the same way of the traditional practice.

o) In accordance with the project (second phase of works) as proposed and approved by UNESCO, at the ground floor level, were removed from the windows the recent brick arches and were finalized the restoration works of eight windows remaking the frames with traditional material and technology.

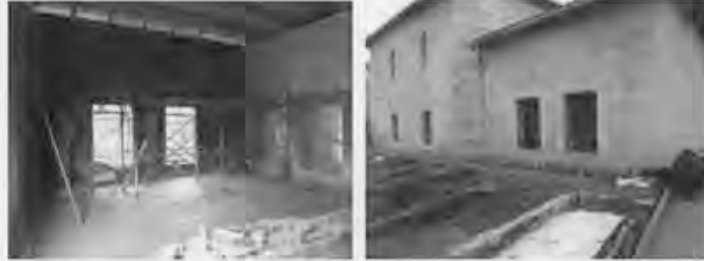
Phases of the porch construction.

p) Construction of the porch of mosque. The new porch was built in accordance with the project, over the foundations of the existing one in the past and with same materials. We used stones for paving the entrance through the porch and for the application of the new wall base. The roof, ceiling and the floor of the new porch were completed as per project..

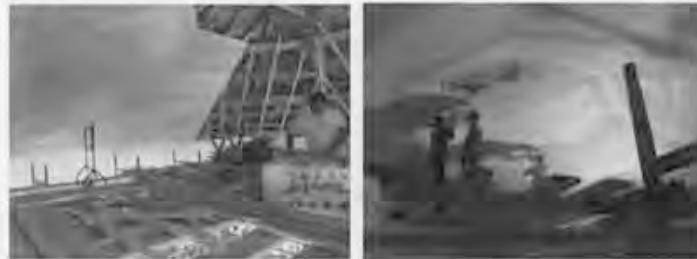
The final phases of the ceiling construction.

q) Construction of the ceiling of the mosque. The construction of the wooden ceiling has been completed in accordance with the approved design details.

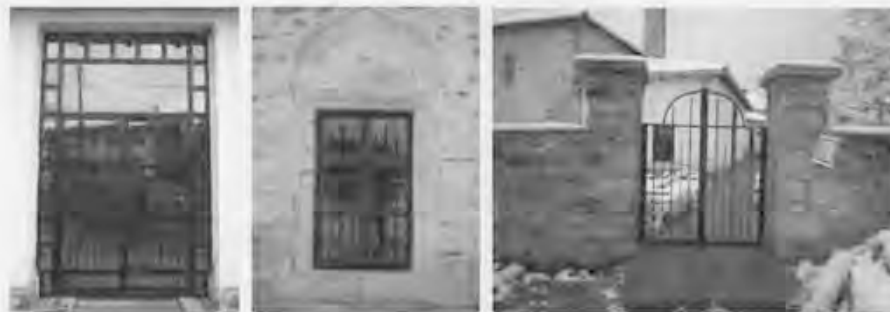
The portal of the new porch; the window of the lower level; the gate in the wall of the mosque area.

r) Construction of the doors and the windows. The construction of the 18 wooden windows and the door was executed by the company contracted in accordance with the approved design details.

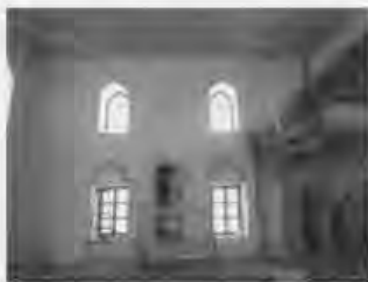
Reconstruction of the Mimber, Cyrsa and Mahvili.

s) Reconstruction of inner elements in wood (Mimber, Cyrsa and Mahvili). The Mahvili of the mosque Defterdar has been copied from the model used in the reconstruction of the mosque Kurshumli, also in Peja / Peć. The timbers, the boards and decorative elements are composed of oak wood. The Mimber and the Cyrsa of the mosque Defterdar, also, have been copied from the model used in the mosque Kurshumli. The timbers, the boards and decorative elements are also composed using oak wood.

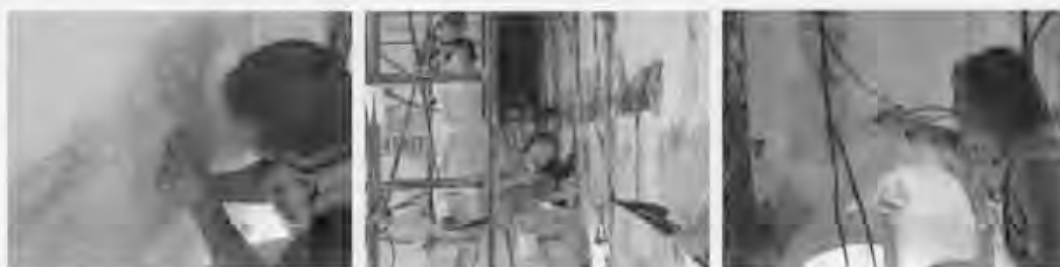
Exterior and interior treatments of the plasters. Integrations of decorative works.

t) Exterior and interior treatments of the plasters. After cleaning the interior surfaces, was applied first layer of plaster "cocciopesto". We used a mixture of lime, crushed brick and water. The second layer of plaster ("marmorino") was made by applying a mixture of lime, marble dust, water and hemp fibers. The decorations with the Arabs arches engravings were performed during the drying of the second layer of plaster.

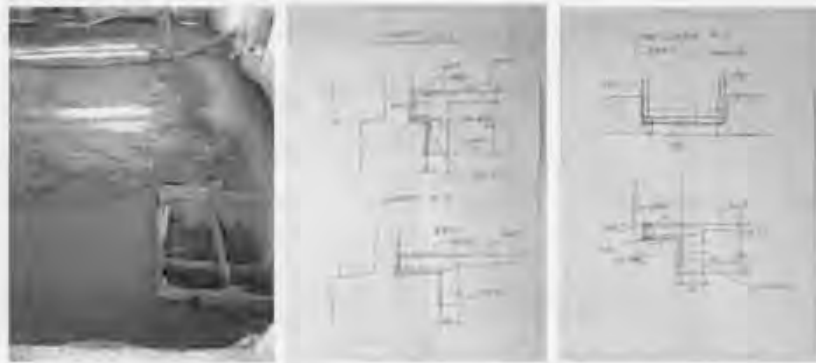
Paving of the concrete slab to reinforce the structure.

v) Paving of the concrete slab, over a thickness of gravel, to reinforce the structure and prepare the floor. Execution of the nivelisation and isolation slab as a base for the wooden floor for the main space of the mosque and for the two side spaces of the porch.

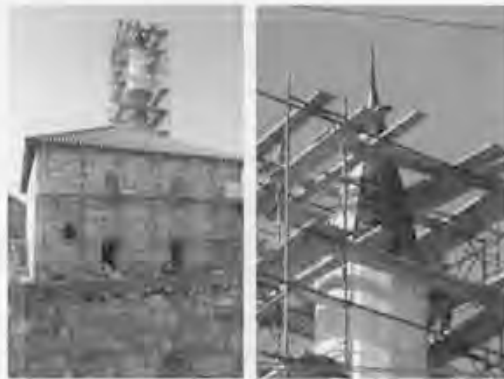
Replacement of wooden elements and installation of new slabs of lead on the cusp of the minaret.

- w) Protective coatings and protective various works of the minaret.
- x) External pavings. Cleaning of external walls, remove irreversibly damaged plaster on cement base of the joints. And re-pointing of the joints with the lime mortar made of burned lime.
- y) Drainage system.
- z) Producing, fixing and painting of the external metal fences of the windows at the first level of the monument and the external metal door of the perimeter external wall..

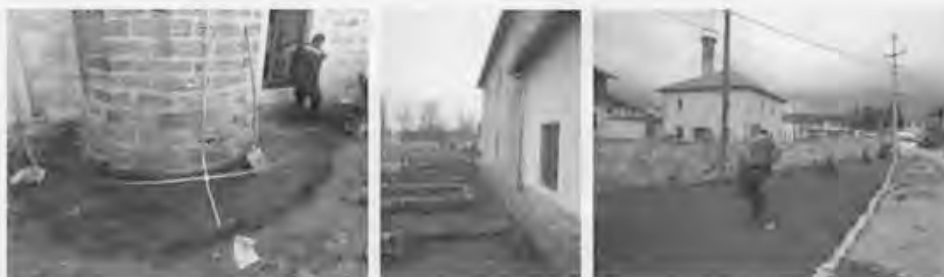
The installation of lightning system; the sidewalk; the external green areas.

- the re-grouting, plastering and painting works of the perimeter walls;
- a sidewalk along the wall of the mosque.

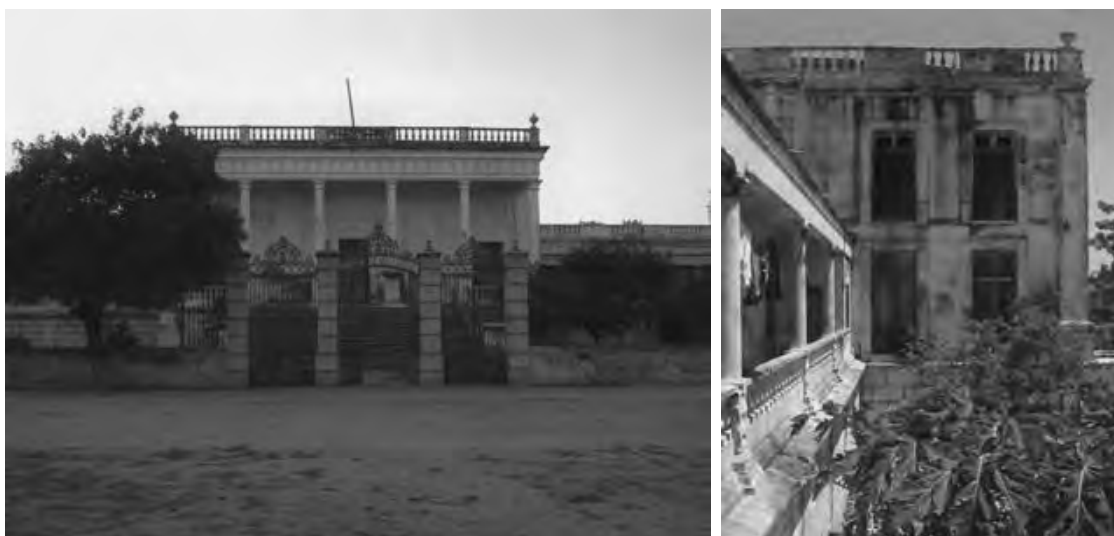
Actualmente o complexo consiste de 15 pavilhões de medidas variáveis entre 12x38, 12x20, 12x16 metros de largura e comprimento variável entre 14 e 20 metros e um corpo de ingresso para a administração em dois andares.

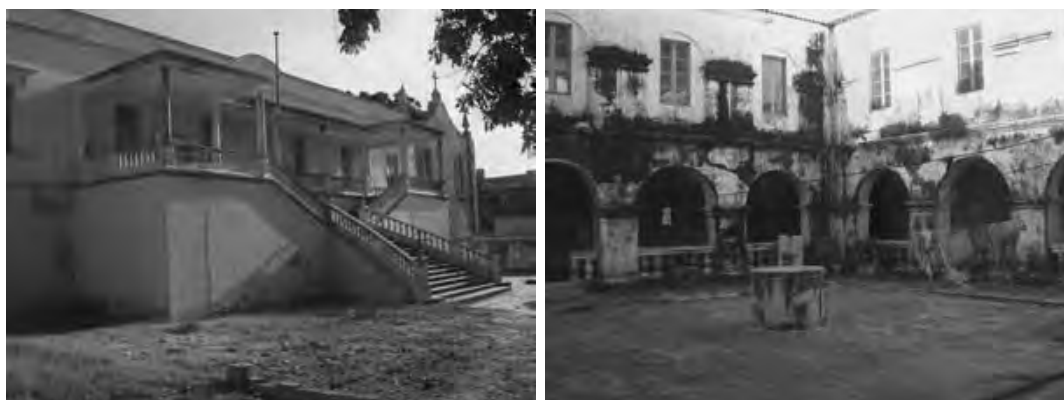
Trata-se de um edifício em patio com um perímetro externo de 28x30 e largura de 8 metros que apresenta um notável carácter monumental. As escadas monumentais da fachada principal e da lateral, que possuem uma varanda colunada, parecem ser de época recente (anos trinta do XX sec.) De estilo genericamente clássico, estas soluções arquitectónicas adaptam-se bem ao volume seiscentesco que se crê seja ainda grande parte existente. De facto o claustro ou pátio no seu interior significa o permanecer da arquitectura seiscentesca. Ao lado direito do Tribunal, ainda existe a ruína da igreja anexa ao Convento. Estima-se que esta parte possa ser do século XVI. Estes muros são escorados por esporões em cimento armado de consolidação provisório, provavelmente, dos anos cinquenta/sessenta do século XX.

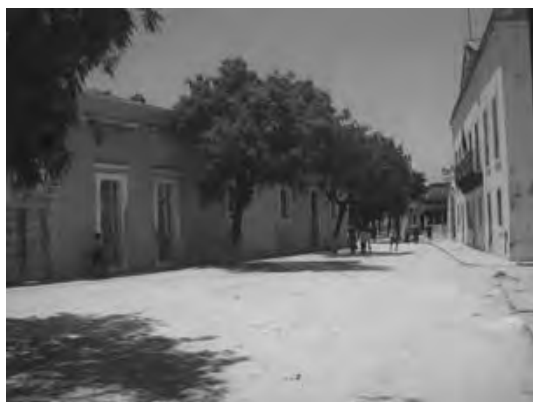
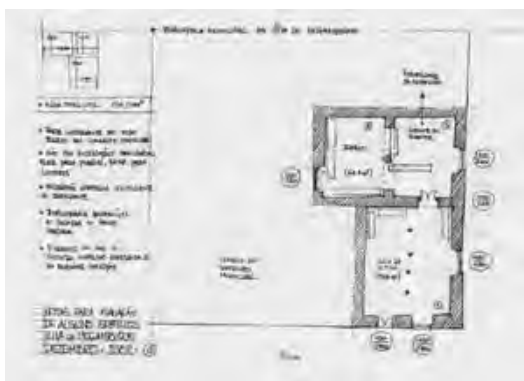
O edifício foi reestruturado nos finais do sec XIX inicio do secXX, utilizando a estrutura preexistente.

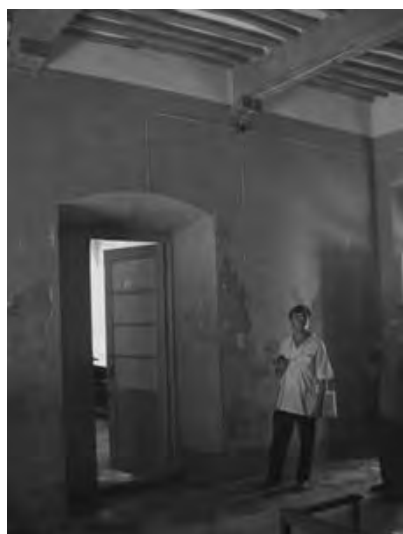
O edificio foi reestruturado nos anos 50 do secXX, utilizando uma estrutura preexistente.

Este edifício é parte de um edifício de uso diferenciado (residencial e administrativo), com diferentes estados de conservação.

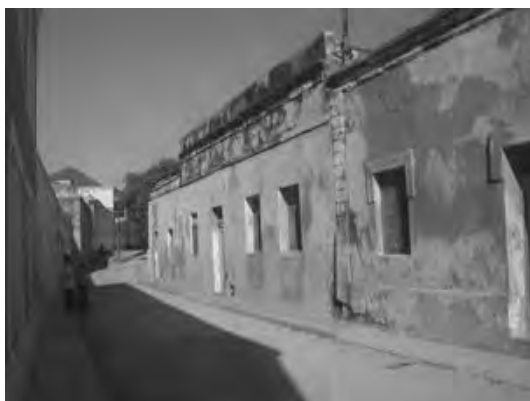
O edifício foi reestruturado nos anos 50 do secXX, utilizando uma estrutura preexistente.

O edifício na sua estrutura original alberga três quartos e uma casa de banho, que é obviamente uma alteração a sua estrutura. No jardim posterior foi muito

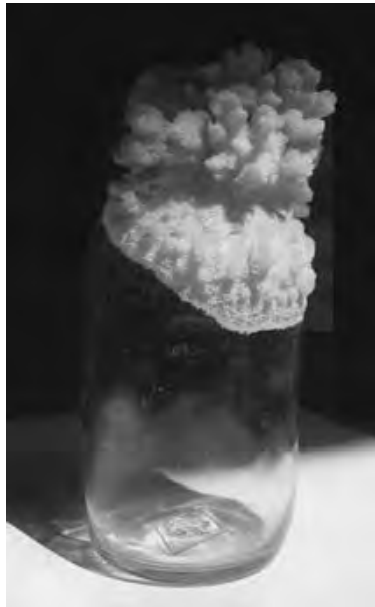
Object found by Alice Costa during a biological test of coral reefs in the north of Mozambique. This is the skeleton of a coral colony, aged in about twenty five years in growth and fixed to the neck of a glass bottle [*M.B.*, 2009].
