TERRA EDUCATION III

International
Scientific
Workshop **02**

TRAINING FOR THE SEISMIC RETROFITTING OF EARTHEN BUILDINGS IN PERU

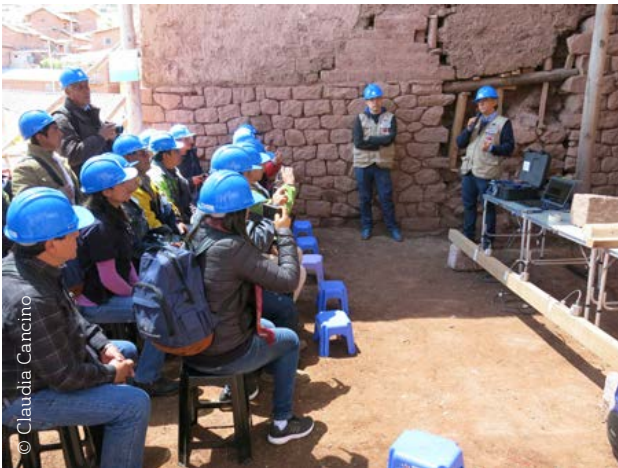
Fig.3 : Non-destructive testing demonstration at Kuñotambo

The non-destructive tests included demonstrations of thermal imaging, sonic testing, and dynamic testing. Engineers from PUCP and University of Minho demonstrated these techniques and participants learned how the tests are applied in the field to develop data for a numerical simulation of seismic movement. Posters showing examples of the use of each technique were displayed on site. Participants then had the opportunity to try the thermal camera, as well as sonic and dynamic tests on samples of adobe, stone and wooden beams.

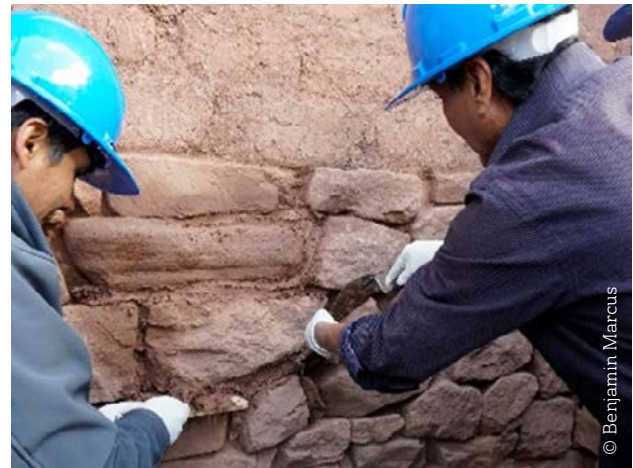
Fig.4 : Workshop Participants repointing a section of masonry wall

Each group was responsible for using their mortar mixture to repoint a one-meter square area of masonry (Fig. 4). They were provided with repointing tools and instructed in proper working techniques for compacting and finishing mortar joints. The practical exercise was followed by a discussion session on mortars to compare the results of the five mixes and answer outstanding questions.
