ENVIRONMENTAL MANAGEMENT AND URBAN PLANNING: THE HALLENGE OF RESTORING TAIWAN'S FAMOUS LIN HOUSE WITH MINIMAL EFFECT ON THE SURROUNDING COMMUNITY

Wen-Chen Lin / China

Associate Professor, Department of Architecture, College of Construction and Development, Feng Chia University

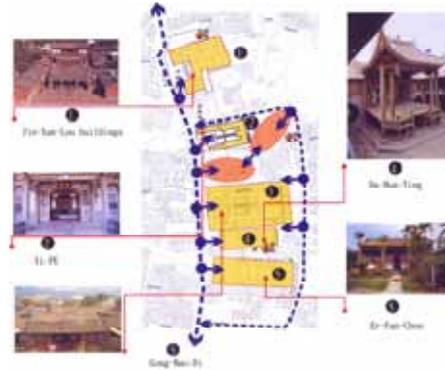
Fig. 2 Conservation area
(Main conservation area is green)

The whole complex consists of three parts: Ding-Cuo is situated at Jin-Rong District, Xia-Cuo at Ben-Tang District and Lai-Yuan at Lai-Yuan District. The main building sites of Din-Cuo and Xia-Cuo can be seen in fig. 2. Lai-Yuan is the smaller area A in fig. 1. The main building sites of each part are summarized below:

On that part of the sidewalk of Lai-Yuan Rd. which passes through the Lin House (fig. 2) placards should be set up that state the history of the Lin House and changes to customs and traditions. When people pass by, they will feel like entering a time tunnel and sense the life of earlier times.

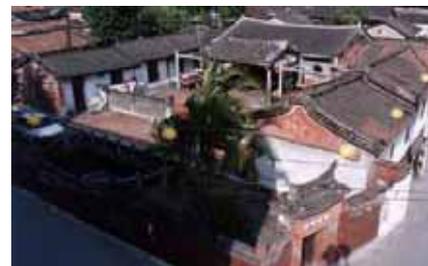
Fig.5 Jing- Xun-Lou buildings

Jing-Xun-Lou (fig. 4 and fig. 5), Rong-Jing-Zai (fig. 6), Yi-Pu (fig. 7), Xin-Cuo, the Old Learning Hall (not existing), Da-Shi-Liao (not existing).

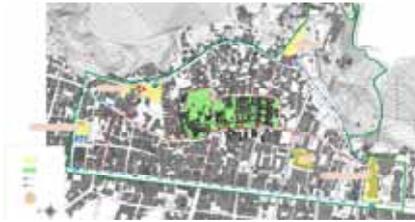
Fig.25 Er-Fang-Cuo reuse plan

Below is the reuse design plan for the Lin House which shows the space, visitor routes, monument safety routes, and the desire of open spaces. The main building complexes of this plan are: Jing-Xun-Lou, Yi-Pu, Gong-Bao-Di, Da-Hua-Ting, and Er-Fang-Chou. (see fig. 21 ~ fig. 25) :
