RESEARCH ON TIMBER FRAME BUILDINGS IN PANAMA CITY

Part 1 A tailored image of national heritage and its influence on conservation

Katti OSORIO *

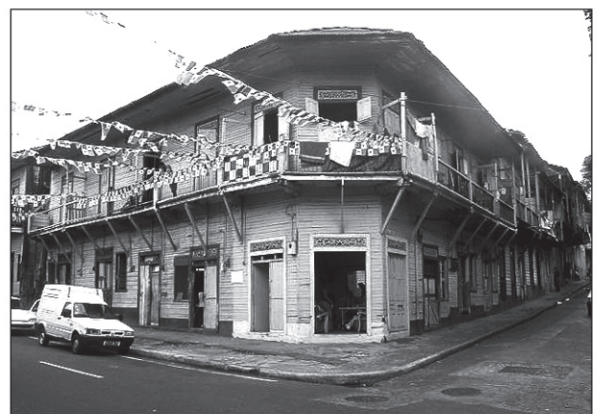
Fig.2 House 57-8 on Block 57, San Felipe

The Panama Canal Administration acquired the Panama Railroad Company after 1903, and with it the Panama Canal Administration acquired the land that the former Panama Railroad Company had bought in Panama City during the 1850s – 1870s. House 57-8 was built in early 20th century on former lands of the Panama

Railroad Company (Fig.2).

Due to a clause in the Treaty of 1903, Panama City and Colón City were to abide by the regulations of sanitation and construction emitted by the Sanitation Employee of the Canal Zone. Decree No.14 of 1913 is the text of such regulation integrally approved by Panama. Title "Regulations for Construction" under Article 1 has 32 articles referring to the minimum requirements for buildings. Given that all buildings from blueprint and construction permit to occupancy permit had to have approval of the Sanitation Employee of the Canal Zone, it appears that timber frame tenant houses were built adhering to the minimum requirements, making the regulations of construction a generic description of timber frame tenant housing. Regulations covered ground leveling to support a building, quality of construction materials, adequate use of concrete in first floors, basements, alleys, foundations and patios; it was required that all masonry walls were plastered to a smooth surface in concrete; minimum distance of tree feet between row houses. Timber walls should only have planks on one side unless a special permit for planks on both sides of walls and or partitions was obtained; no room should be smaller than 10 feet on all length, height and depth with at least one window and an exit door to a circulation area; at least one stair every 12 rooms in ever building of two or more stories; a minimum balcony depth of 2 feet 6 inches and 3 feet minimum width for all corridors; size for bathroom, toilet and kitchen areas, their number and communal accessibility; gutters, fences and in exceptional cases, latrines. Ventilation was strictly contemplated by use of fenestrations in carved wood (Fig.3), lattice or iron bars or forged iron above every door and window as well as on top of inner partitions. Fig.4 shows a typical shared kitchen at the right in the balcony of the inner patio of the house; the door ventilation and balcony railings follow the original members but these were replacements. The door, door frame ceiling and tongue and groove wall cladding are original. Please notice that the height if the balcony railing is about 1 meter tall. Fig. 5 shows the balcony over the street; these balcony railings are original and the inner balcony was similar. It's a simple railing of round iron bars with a wooden handrail and wooden bottom support raised over 10 cm above the floor. I surveyed this house in 1999 for the inventory project of the Old Quarter financed by UNDP.

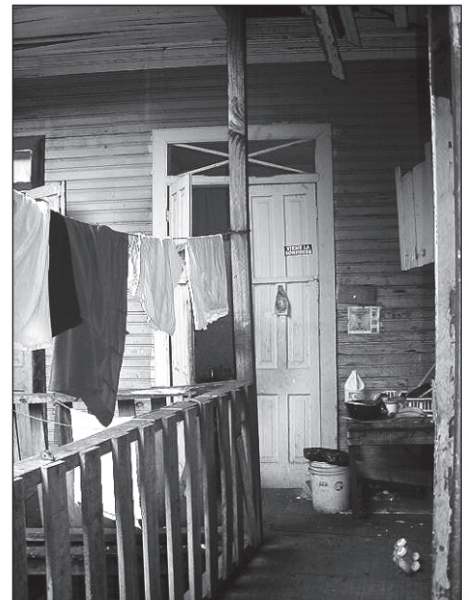
Fig.4 House 57-8 on Block 57, San Felipe; shared
kitchen on balcony

In the second half of the 19th century it was already common to import industrial prefabricated construction elements such as forged ironworks, roof and floor tiles, wood planks, corrugated iron, glass and other ornamental materials. Panama City's exchange with New Orleans followed this context. Imports came from places such as New Orleans, Philadelphia, New York and even from England. Architecturally speaking, tenant house design was not particularly attractive. Common tenant housing was inherently commercial and temporary. Bathrooms were shared, located outside of the rooms as required by Decree No.14 of 1913; kitchens were also shared, generally located in balconies or patios.

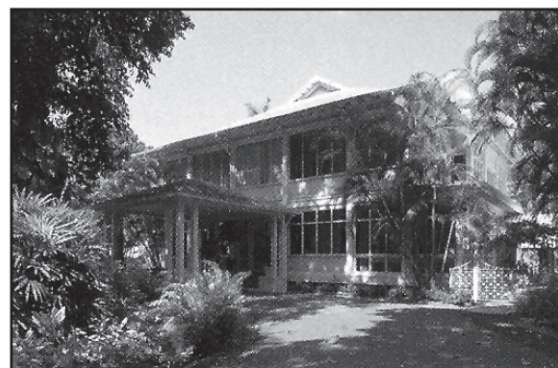
Fig.7 Canal's Administrator House

It is important to note that the timber frame houses for the Gold Roll were built to last, with attractive and functional designs. The timber itself endured the passing of time better than timber used in houses of the Tenancy Belt, and maintenance was done on the houses in the Canal Zone. The Canal Administrator's House, the residence of the governors of the Canal Zone until 1979 and now the house of the Panama Canal Authority administrator is a timber frame house. It was built in Culebra in 1906; it was dismantled for transport and rebuilt in Balboa Heights in 1914, where it remains today as the house of the administrator of the Panama Canal Authority (Fig.7).
