**Safe Guarding the Spirit of the Place:
Conservation and Management of Belgenny Farm,
Camden Park Estate, New South Wales, Australia.**

Bruce Michael Edgar, FRSA,
B. Arch (UNSW), M. Phil. (U. Wales), MICOMOS
*Architecture Classique,
Architecture, Heritage Consultancy and Urban Design
5 Netherby Street, Wahroonga, NSW 2076
Australia*

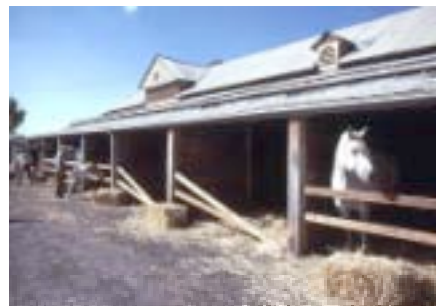
Figure 2. Rear of the stables, still used as part of the live displays.

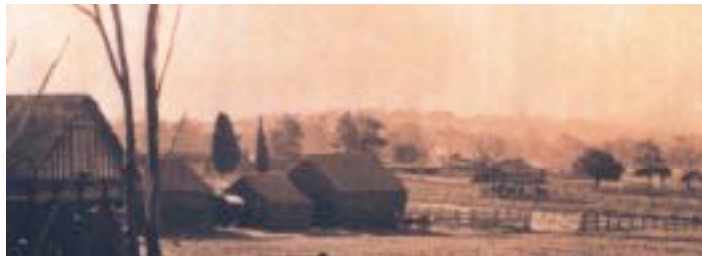
Figure 3. Photograph c. 1890s of original farm (DoA 1977).

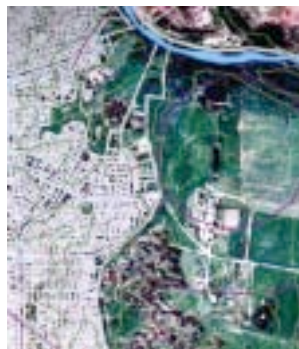
Figure 22. Aerial photo, farm circled, urban sprawl on left.

The rural character of the site is being gradually being impacted on by suburban growth as seen in this aerial photo [Figure 22]. In the 1980s [Figure 23], the farm could be seen from the housing zone, but to address the visual intrusion issue, a screen of trees was planted to hide the modern urban sprawl [Figure 24].
