Message of the President of ISCARSAH Stephen Kelley

International Scientific Committee on the Analysis and Restoration of Structures of Architectural Heritage

Newsletter n. 1
 August, 2012
 ISSN 2306-0182

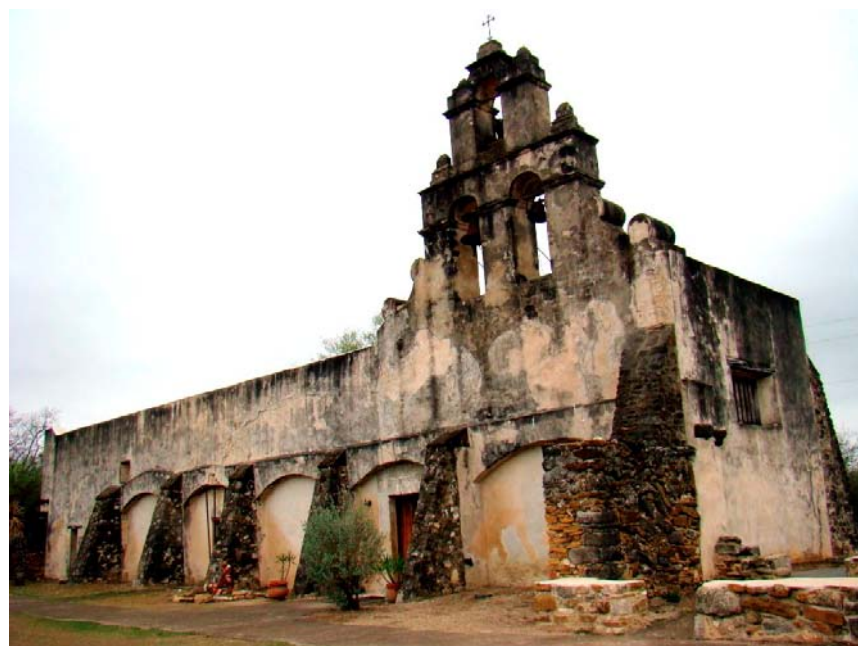
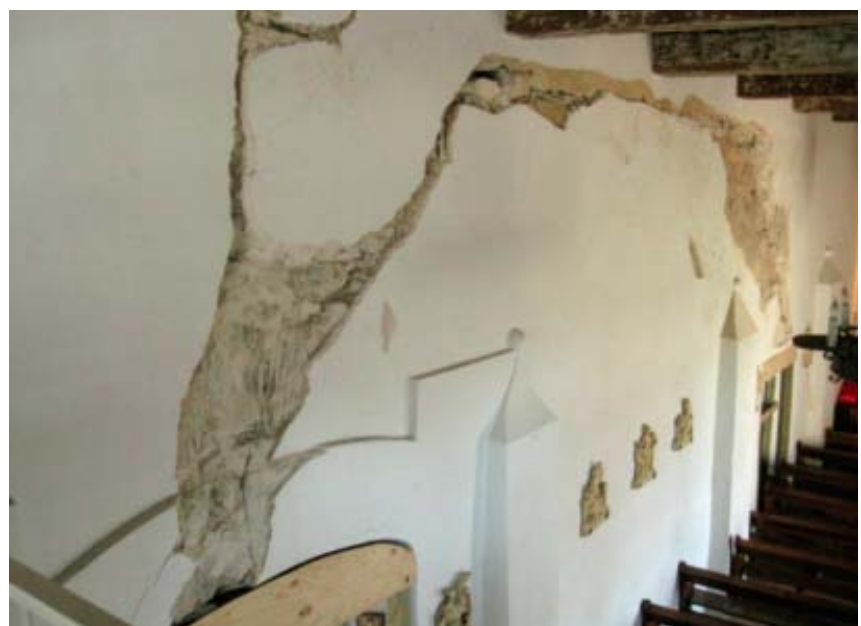
materials-conservation database, along with other diagnostic surveys. A major structural stabilization has been completed at Mission San Juan de Capistrano (1731), after several years of study and monitoring of expansive soil movement. A nearby photo shows the large arching crack that was caused by the movement. Structural monitoring continues at Mission San Francisco de la Espada (1741). Espada and San Juan remain active Catholic churches.

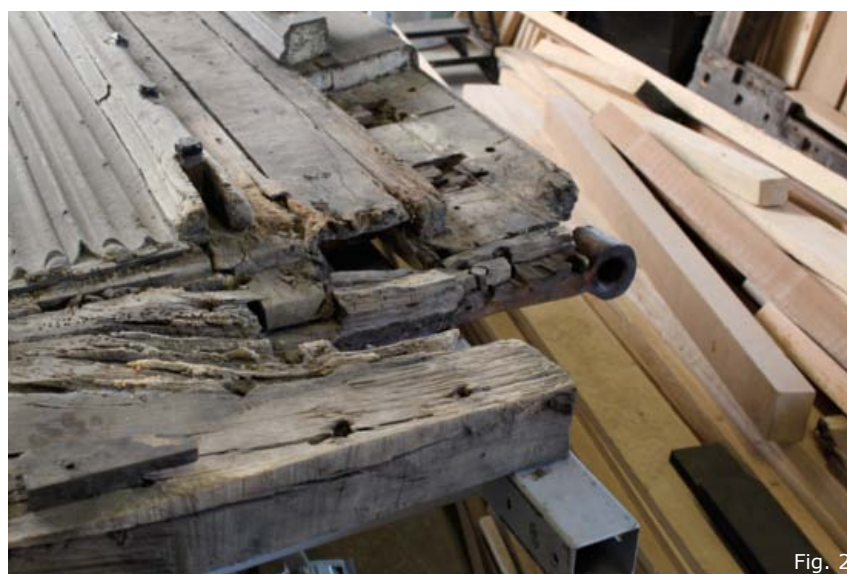
Fig. 2

It was only then that the condition of the gates that must have necessitated the nineteenth century repairs and the extent of the changes then made could be appreciated. Clearly both the bottom rail and the hanging stile of both gates had rotted and had been cut off. Examination of the growth rings on the remaining part of the rail on the south gate showed that approximately half of the rail had been cut away. The new timbers added below the remaining timbers of the bottom rails were held in place by wrought iron straps. The replacement timbers for the bottom of the hanging stiles had been lap jointed onto the original timbers which had been cut back to receive the new pieces. These surfaces offered a means of fixing to the gate without any additional cutting of original timber even though they were clearly not ideal. Figure 2 shows the bottom corner of the north gate and Figure 3 that of the south gate.

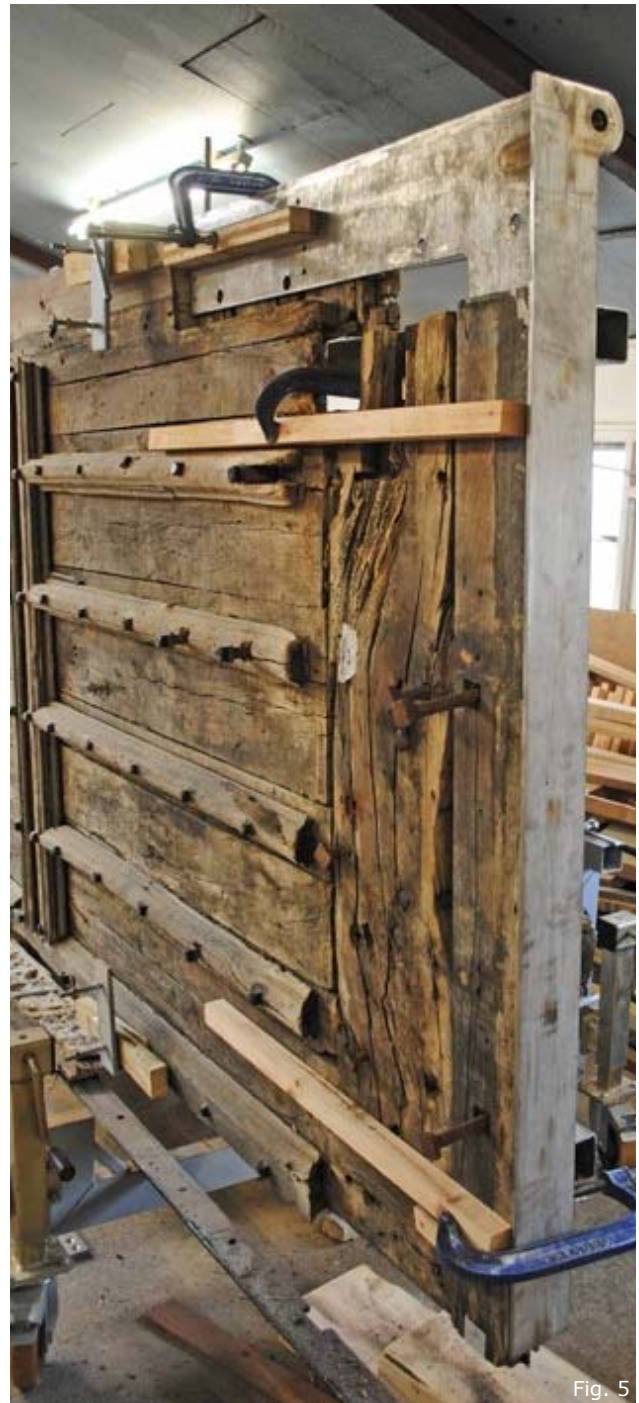
Fig. 5

Design of the steel bracket for each gate was simple. It was a T shaped plate to carry the weight of the gate with a socket at the end into which the bottom hinge pin could be screwed. This hinge pin was to go into a box set in the ground where the receiving socket could be adjusted for position. The position of the plate was dictated by the position of the surface on the hanging stile to which it had to be attached. The basic plan was to use this surface to attach the short leg of the L shaped steel, so that it could then be concealed by the original repair timber. Figure 5 shows the steel in position on the north gate. The design problem was to arrange sufficient fixings to carry transfer the moment from the steel plates into each stile taking account of the condition of the timber. The plate also had to be wrapped round the back face of the stile to stiffen it against the bending moments produced by the eccentricity of the hinge pin.

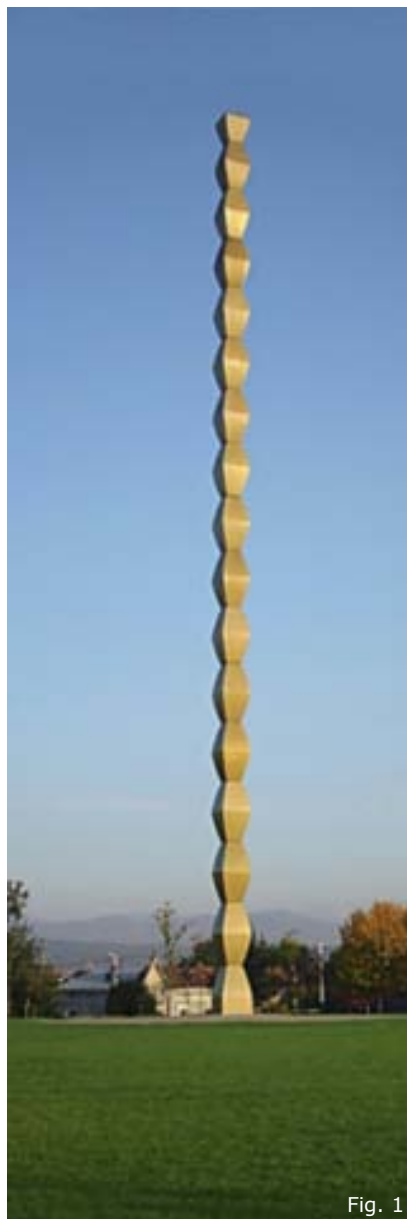
Fig. 1

The Column has been erected 75 years ago in only three months, between 15 August and 15 November 1937, in Targu Jiu, Romania, by the sculptor Constantin Brancusi (1876-1957). It is the only endless column in the World and belongs to the Memorial devoted to the heroes of the First World War 1914-1918 (Fig. 1).

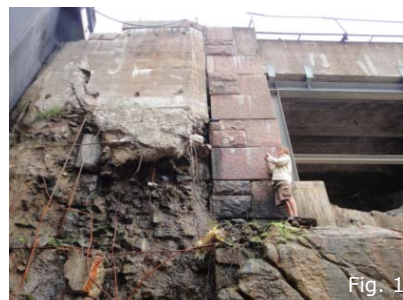
Fig. 1

The shipyard is built partly on Swedish time and partly on Russian time, when Finland was a Grand Duchy of Russia. After the independence of Finland (1917-12-6), just before the World War II the shipyard was deepened by blasting and lots of concrete work done. KAREG is in charge of the quay wall next to the floating door of the lock (Fig. 1, Fig. 2).

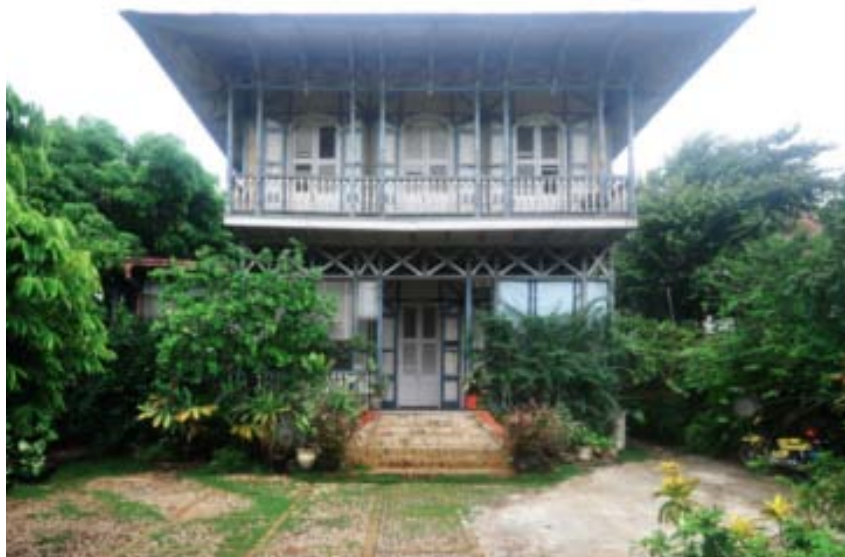
Figure 1 - Madame Vivien Gauthier's Gingerbread House that was not damaged during the earthquake but suffers extensive termite damage (S. Kelley photo).

The 2010 Haiti earthquake was a catastrophic magnitude 7.0 Mw earthquake that occurred on 12 January. Its epicenter was approximately 25 km west of Port-au-Prince, Haiti's capital. The Haitian Government estimates that approximately 230,000 people died, 300,000 were injured, and 1,000,000 were left homeless. It is also estimated that 250,000 residences and 30,000 commercial buildings had either collapsed or were severely damaged. Another casualty of the earthquake was Haiti's cultural heritage in the form of Gingerbread houses (Fig. 1).

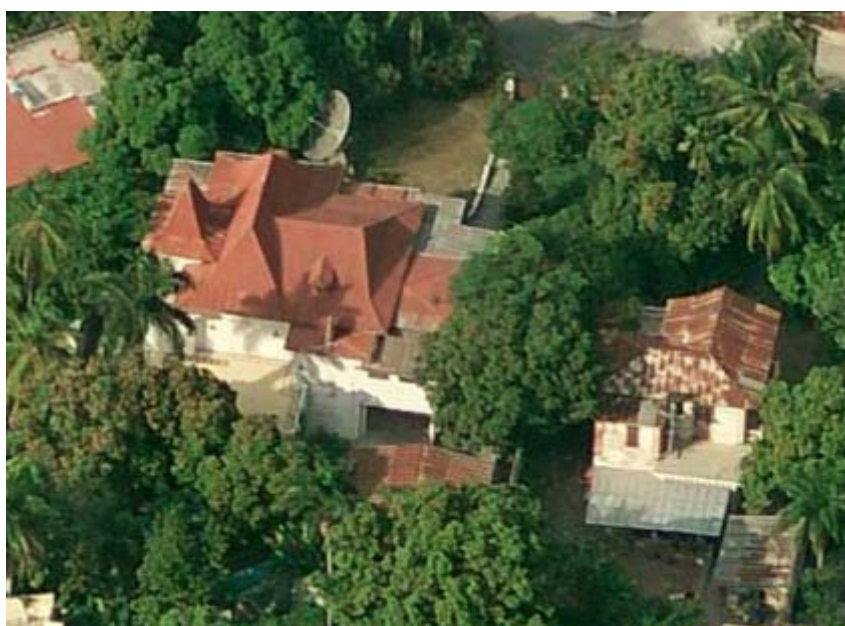
Figure 2 - Pictometry image of a Gingerbread House in Port-au-Prince. Since the historic district was never recorded, these images proved invaluable in identifying each property.

The assessment included more than 200 Gingerbread houses in the district. The assessment was made more efficient by the use of Pictometry which made it easy to map the district using high resolution aerial photography as the locations and quantities of the Gingerbread houses were not previously well defined (Figure 2). The assessment followed a Methodology and damage assessment forms developed by the team exclusively for use in Haiti.

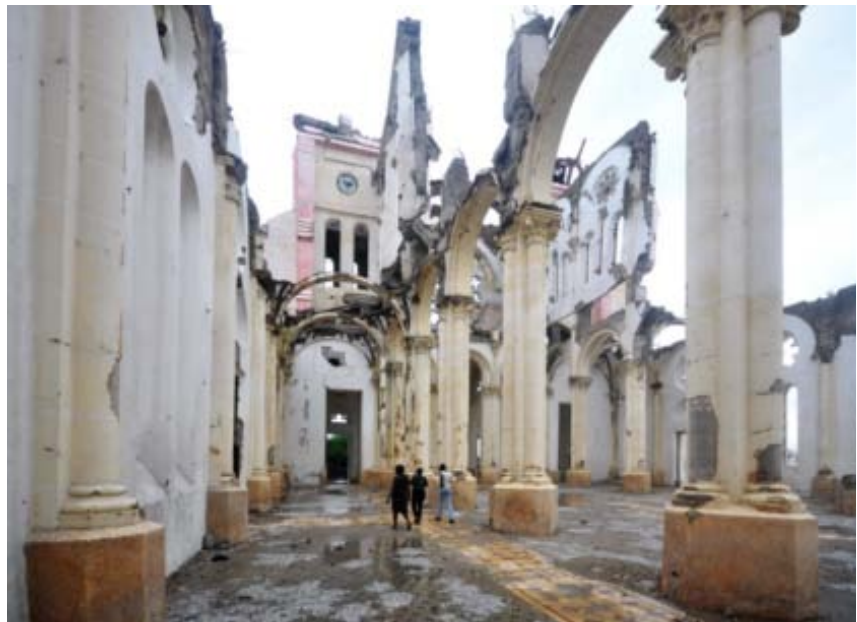
Figure 3 - The Cathedral of Port-au-Prince (1917) constructed of reinforced concrete collapsed during the earthquake (S. Kelley photo).

How did the Gingerbread houses fare during the seismic event? They performed much better than much of the contemporary reinforced concrete construction (Figure 3). Braced frame structures were mostly left standing though frames that were fit with masonry infill lost some of this fill. Much of the severe damage was to unreinforced masonry (URM) that was a part of many of these structures. Vernacular construction techniques, such as lateral iron tie rods, actually enhanced the seismic capabilities of these houses (Figure 4).

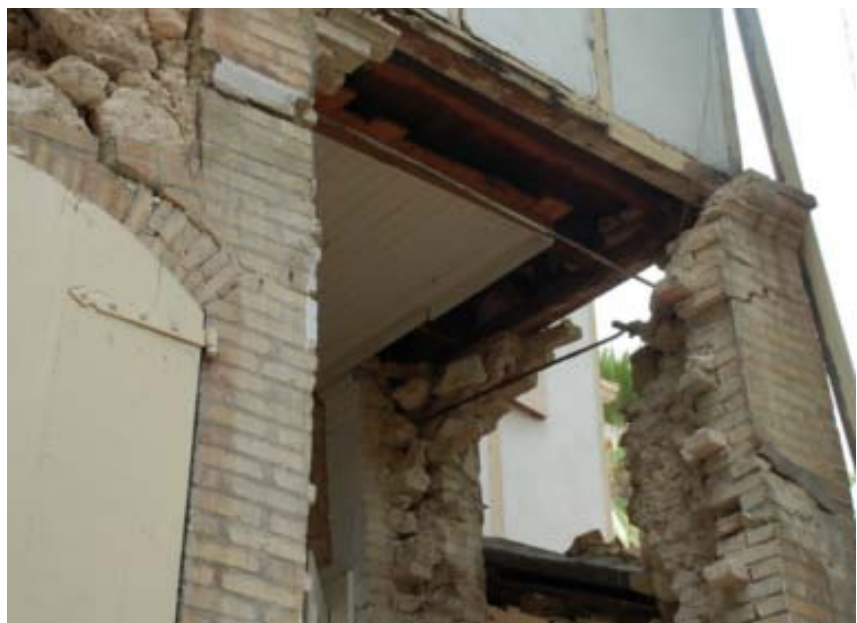
Figure 4 - Lateral metal tie rods at the Maison Dufort kept this masonry pilaster (and the entire house) from collapsing (S. Kelley photo).

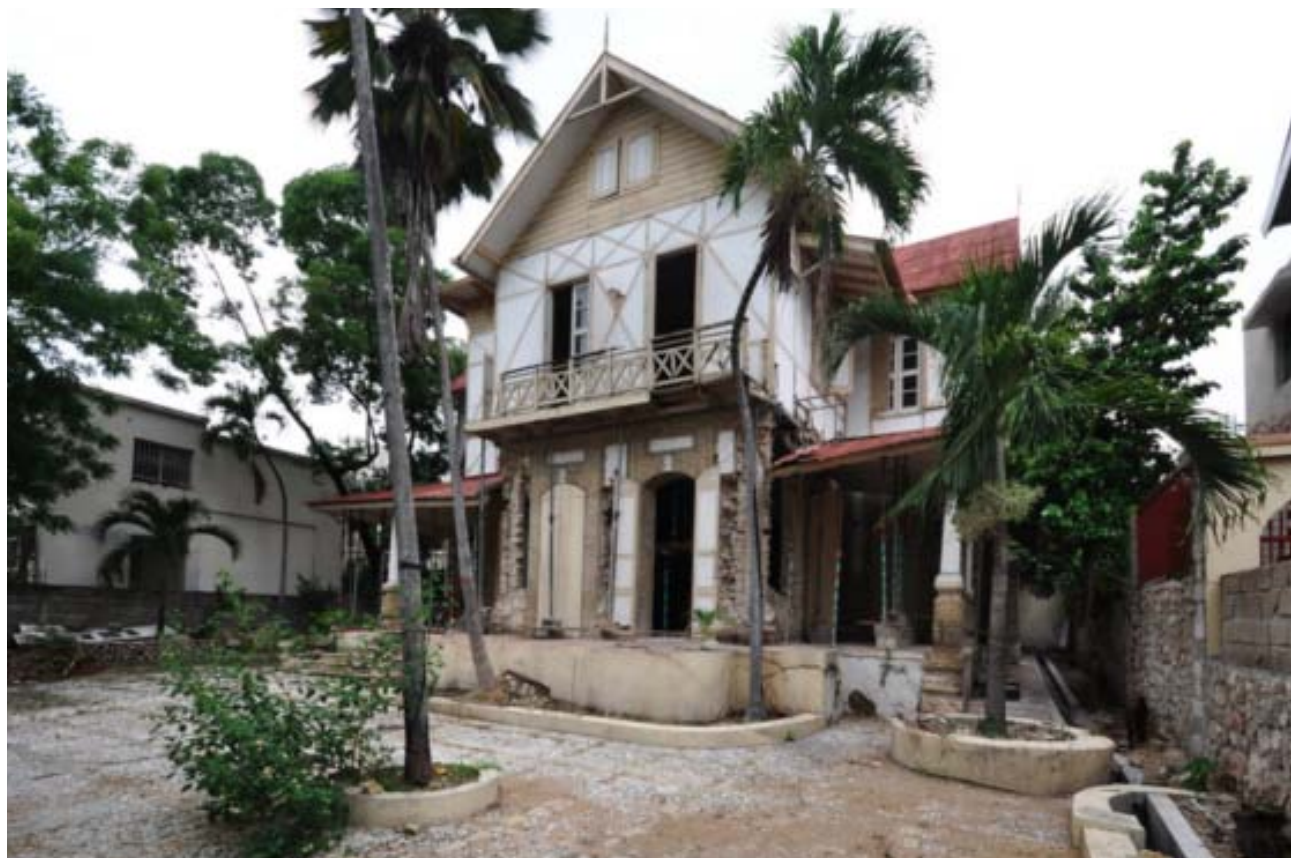
Figure 5 - The Maison Dufort was left standing despite the fact that the first floor had been destroyed (S. Kelley photo).

Following the assessment, our Haitian sponsor, FOKAL, purchased the Dufort House and has embarked on a rehabilitation of the building and site for use as a building crafts training center.

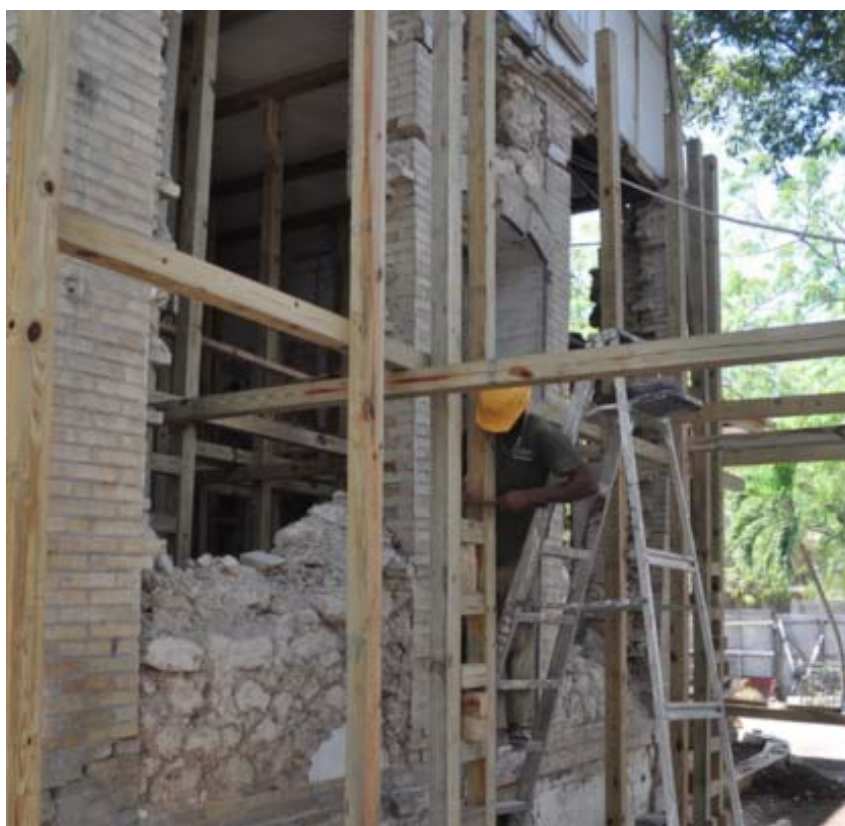
Figure 6 - The Maison Dufort being shored for future reconstruction of the first floor walls (S. Kelley photo).

The Dufort House rehabilitation and seismic retrofit is still in progress.

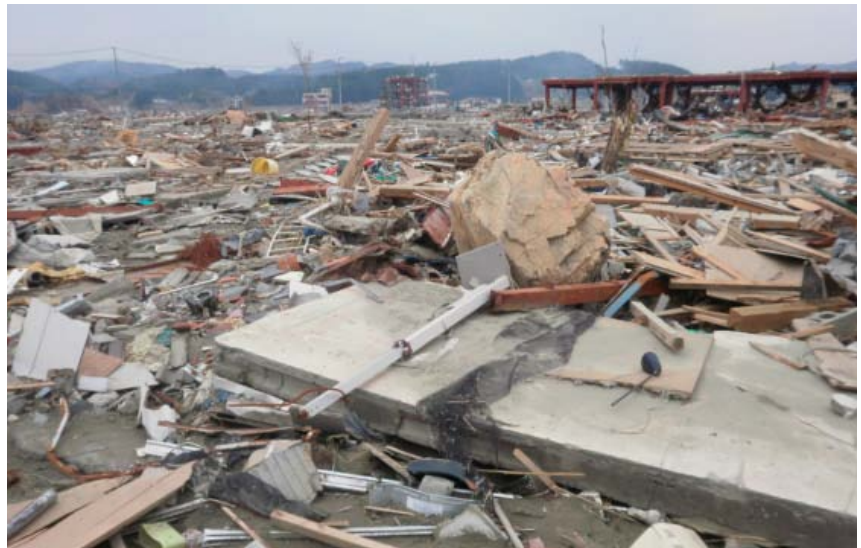
Disaster of Tsunami (Minamisanriku-cho).

For ISCARSAH Newsletter, damage to heritage structures is summarized as followings. In general, the main cause of the great disaster due to this major earthquake of magnitude of 9.0 was the powerful tsunami that hit the coast area of East Japan along the Pacific Ocean. Although there existed not so many heritage structures in the devastating tsunami area, some of traditional townscapes of fisherman's villages were lost, moreover, dozens of architectural heritages were swept away and severely damaged. On the other hand, the earthquake ground motions were characterized by the short predominant period and long duration, having caused serious damage to heritage structures with short natural period such as stone/brick masonry buildings and timber storehouses with thick mud-walls. Most of the traditional timber buildings with rather longer natural period, however, were not structurally affected by the strong ground motions exceeding 0.4G. Only a few vulnerable traditional timber structures collapsed during the earthquake. Furthermore, liquefaction of sandy soils caused serious damage to traditional timber buildings.

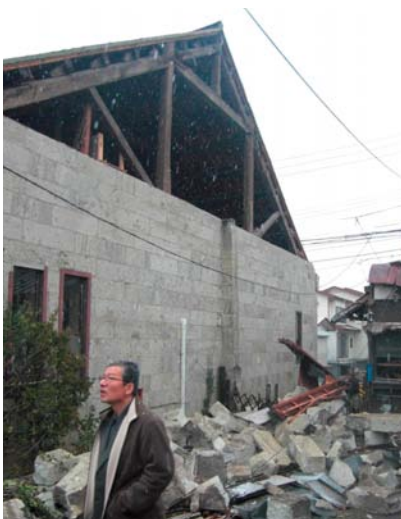
Partial Collapse of Stone Wall (Sekinoichi Sake Brewery).

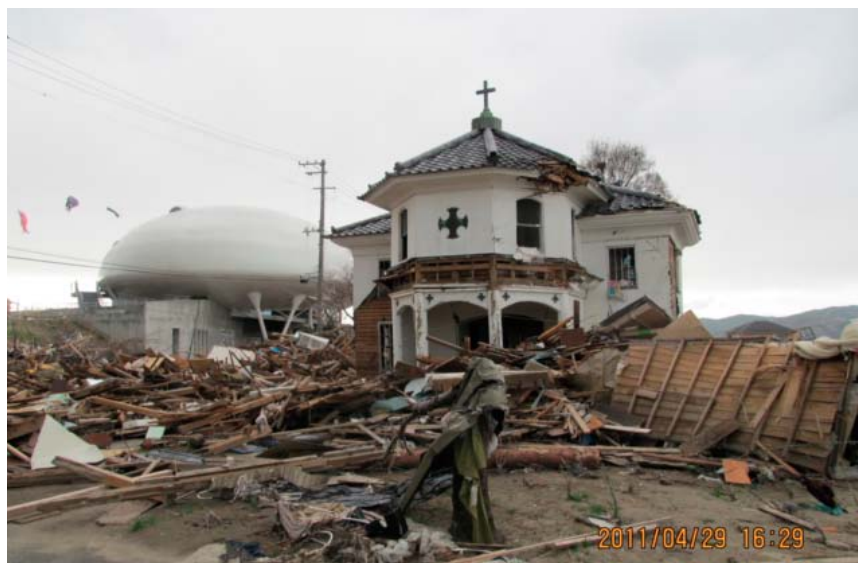
Ishinomaki St. John the Apostle Orthodox Church. Severely damaged but Survived by Tsunami.

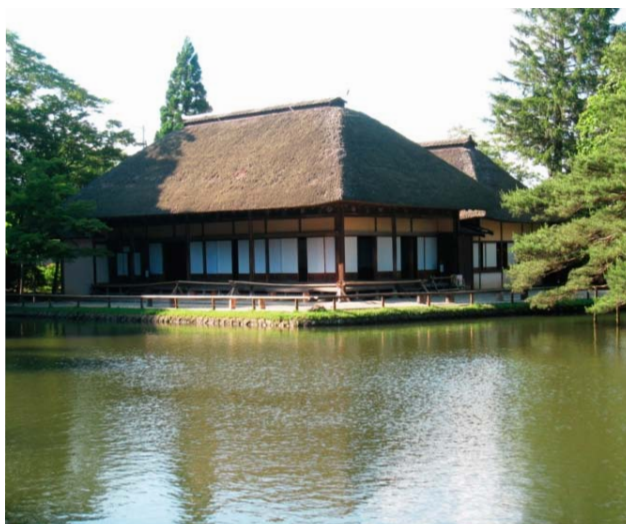
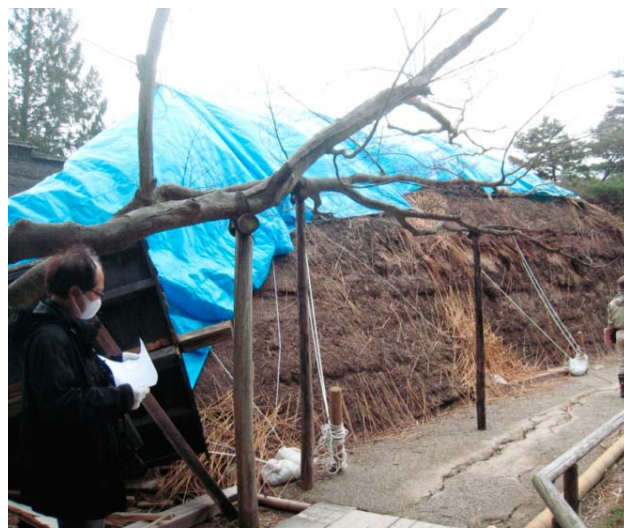
Main Building of Historic Site, Yubikan: left, before Earthquake; right, after Earthquake.

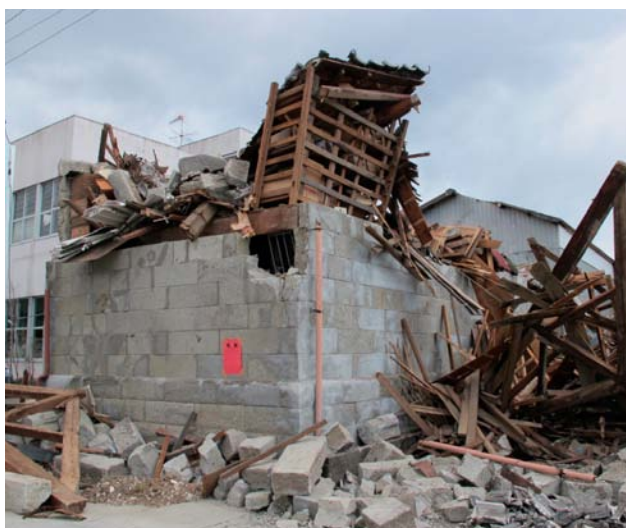
Collapse of Stone Storehouse in Makabe.

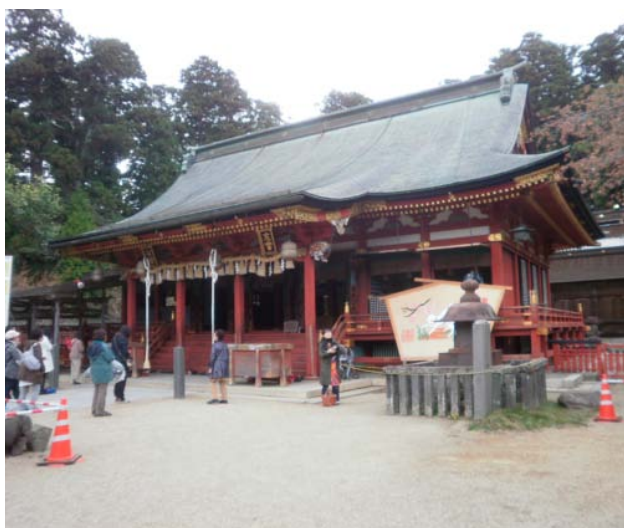
Siogama Shrine, Important Cultural Property Designated: No Damage.

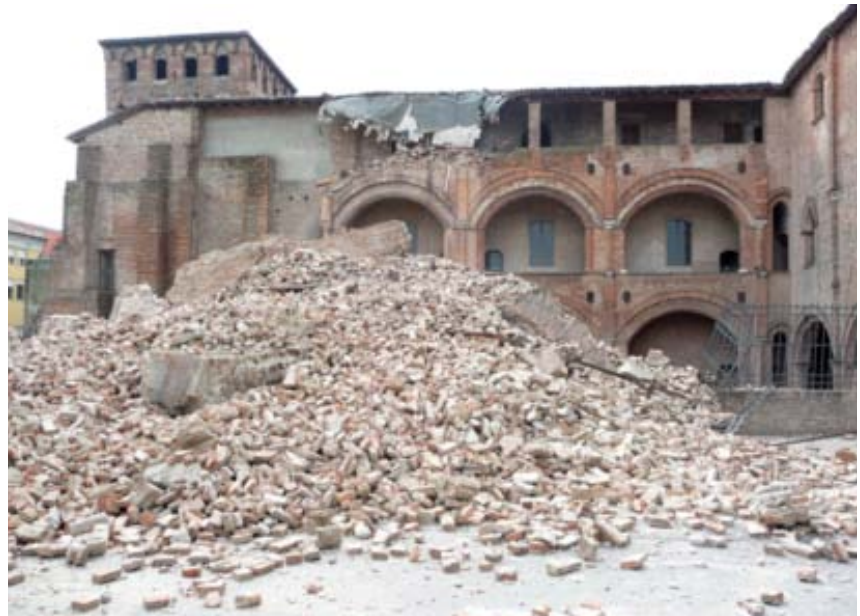
Fig. 1 Estense Castle, Finale Emilia. Collapse of the donjon on the back.

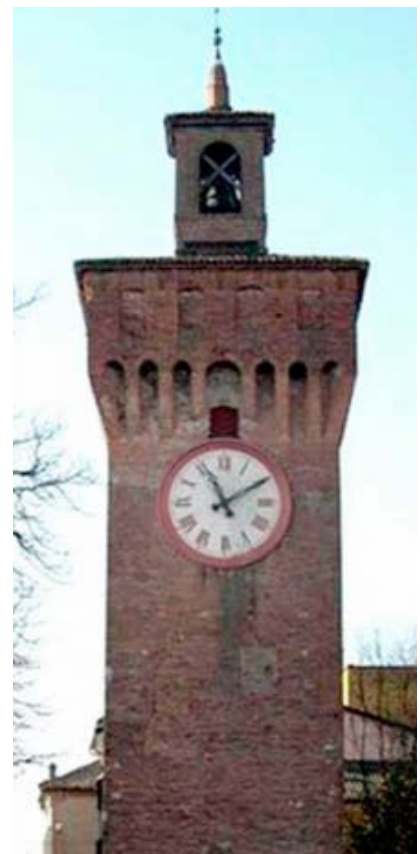
Fig. 2 Finale Emilia. Clock tower before the quake of May, 20.

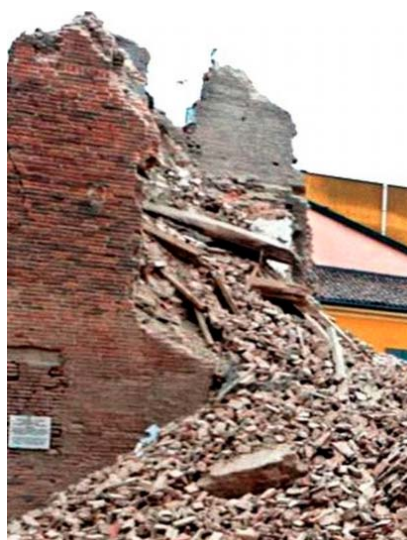
Fig. 3 Finale Emilia. Clock tower after the quake of May, 29.
