ICOA1679: COMMUNITY AND STAKEHOLDERS ENGAGEMENT IN REVIVAL OF URBAN HERITAGE: RESTORATION AND REHABILITATION PROJECT OF THE ROMAN NYMPHAEUM IN AMMAN

Restoration and Rehabilitation of the Roman Nymphaeum in Amman. Phase 2: Nymphaeum Archaeological Park

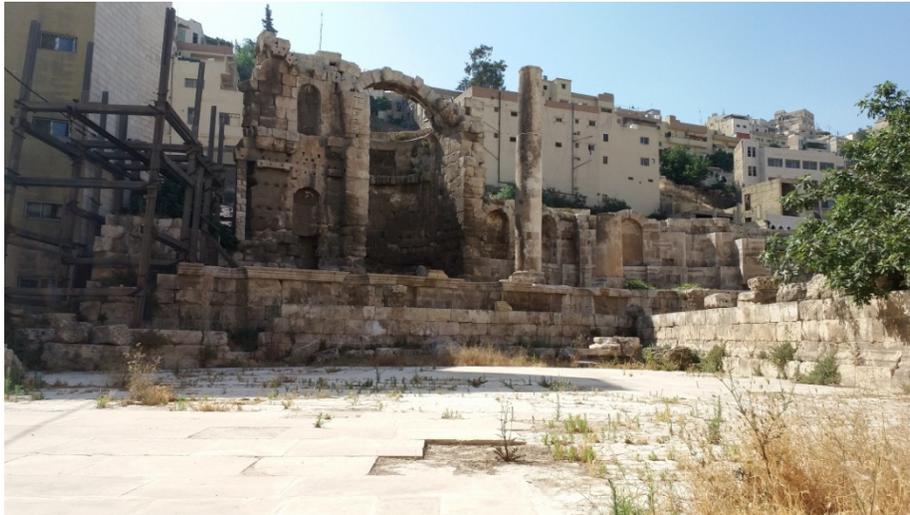
Today the monument is suffering from different deterioration factors and forms that affect its durability and stability. Furthermore, the air pollution deposits caused dis-formation of all whole monument surfaces, which is considered as a visual pollution in the down town and thus it needs urgent solution to restore and conserve the monument and to regenerate its role within the archaeological area (Fig. 1).

Fig.1– A view of the Nymphaeum before the kick off the project, ©Authors.

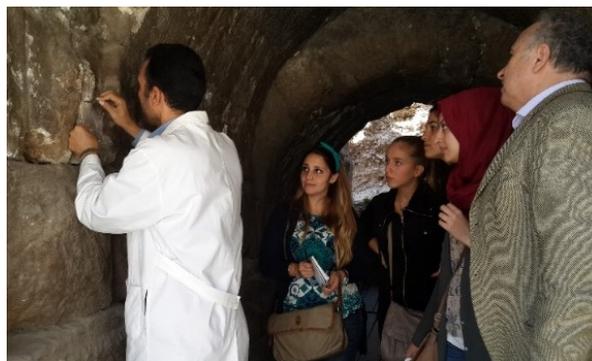
- Preparations for site intervention:
 - Review the conservation plan with the DOA and receive the approvals needed including assigning a DOA representative to follow up and monitor conservation process at the site.
 - The project team worked on preparing a detailed plan for the conservation and restoration of the Nymphaeum based on reviewing previous interventions in the site and through several site visits. Moreover, different samples have been taken from the site to conduct scientific and non-destructive examination and investigation (Fig. 2).

Fig.2– During sampling mission at the site with the project team, ©Authors.

- Based on the conservation plan prepared and based on the review of the literature work and former restoration projects documents the project team has agreed on the detailed set of measures to be taken to conduct appropriate restoration for the site and focusing on using non-destructive techniques. This has been further elaborated based on the results of the analysis for the samples that have been collected from the site and analyzed at the Scientific Labs of the Collage of Science at the University of Jordan and the team prepared XRD-Technical Report, Chemical characterization of Building Materials.

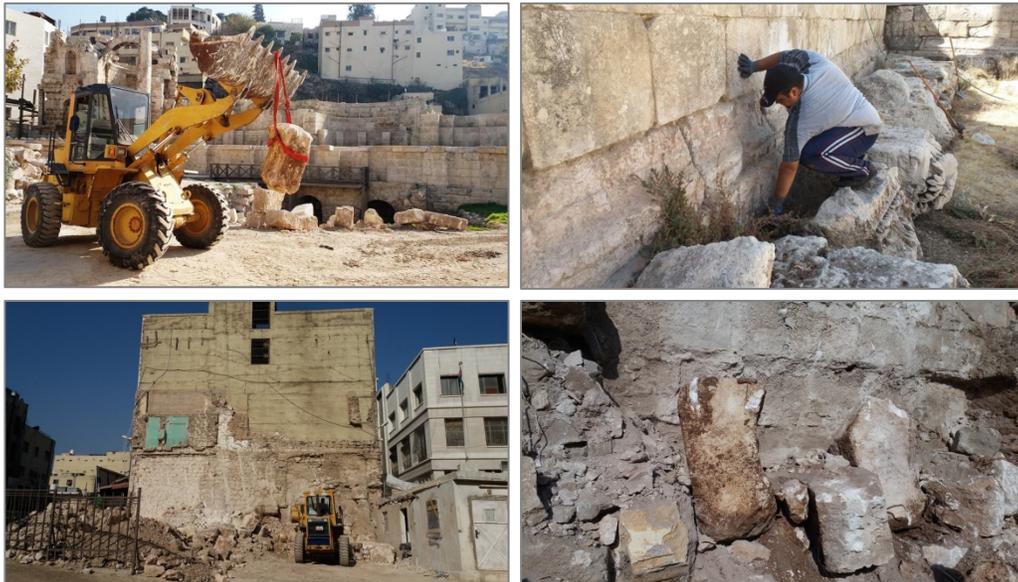
- The project team worked with GAM and the DOA to clean the site from the grass and plants as well as re-organize the drums, stone parts and remains scattered and piled in front of the Nymphaeum and which were blocking the way to the upper level of the building (Fig. 3).

Figure 3– Cleaning process and preparation works at the site, ©Authors.

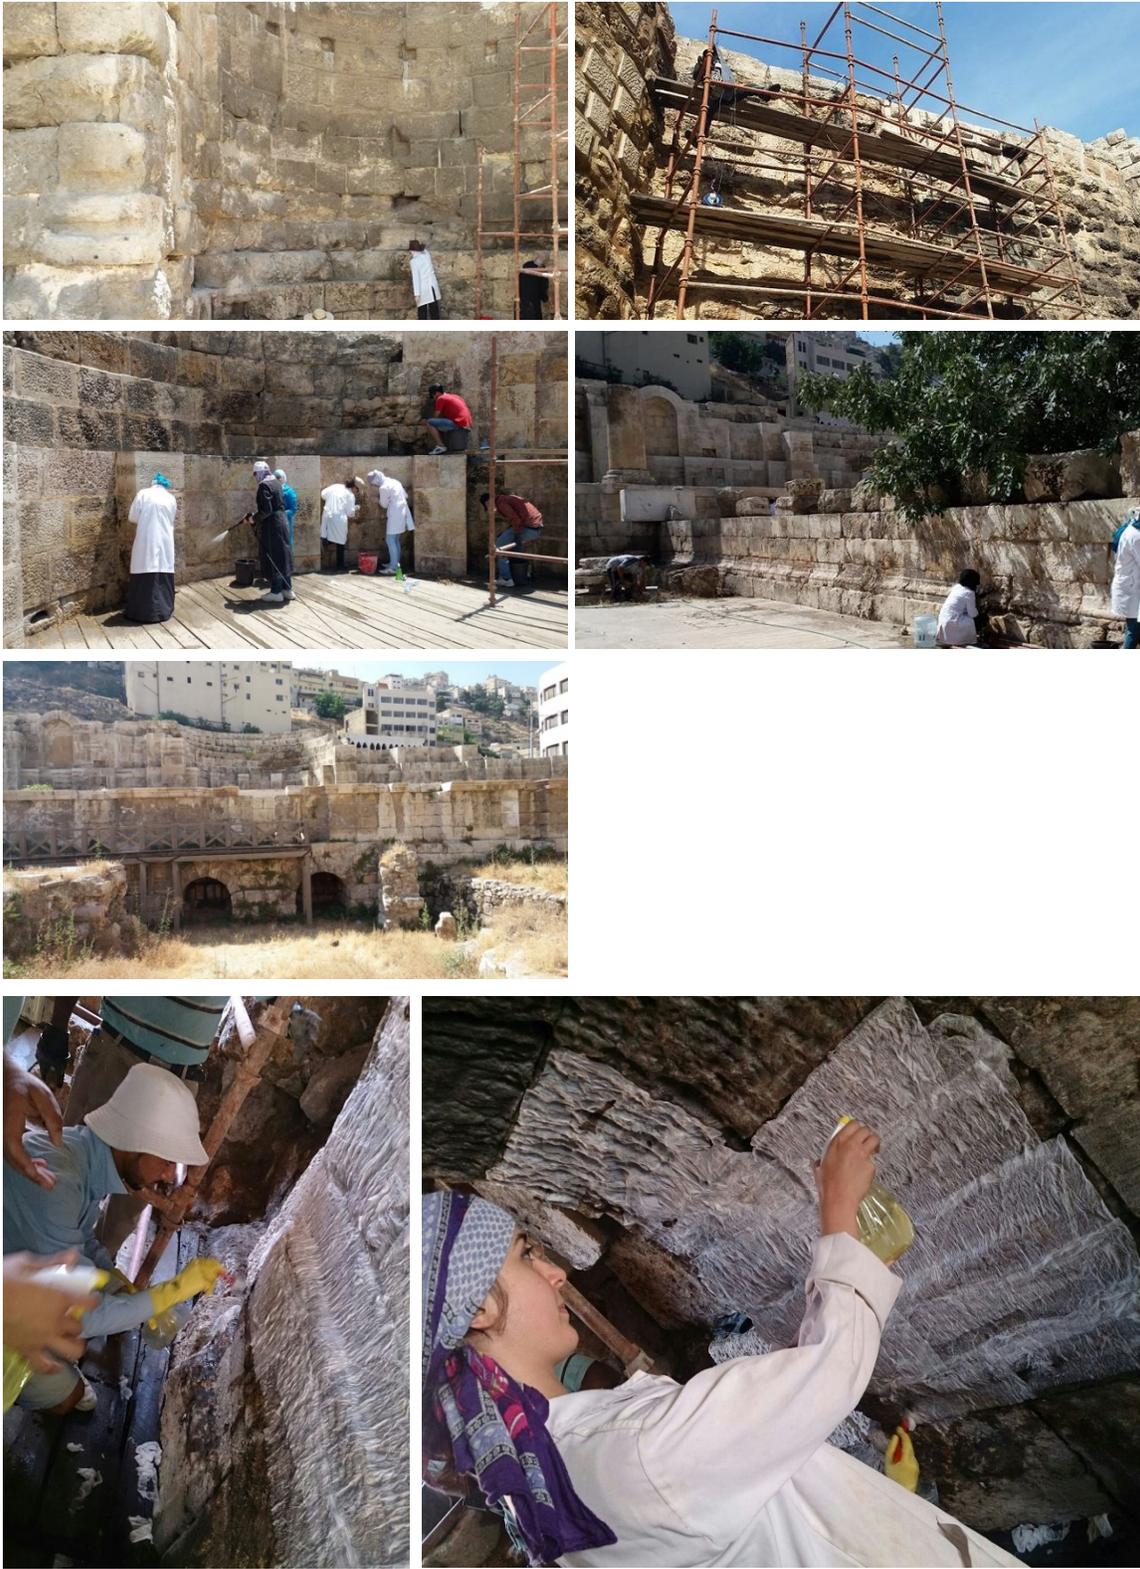
- The cleaning was conducted first to the front façade of the monument and then to the rear façade through using different mechanical techniques.
- Water pumps with low pressure were used to remove all the dirt and rusts accumulated on the façade from the air pollution which was a mandatory procedure to start the conservation intervention.
- Use of different small tools including small brushes to clean the surface of the stone blocks including removing crusts and external crystalized salts, as well as removing any plants and fungi on the surface.
- Limited chemical cleaning technique by using wet bandages for some parts of the monument.

Fig.4– Cleaning process with the trainees and the final results, ©Authors.

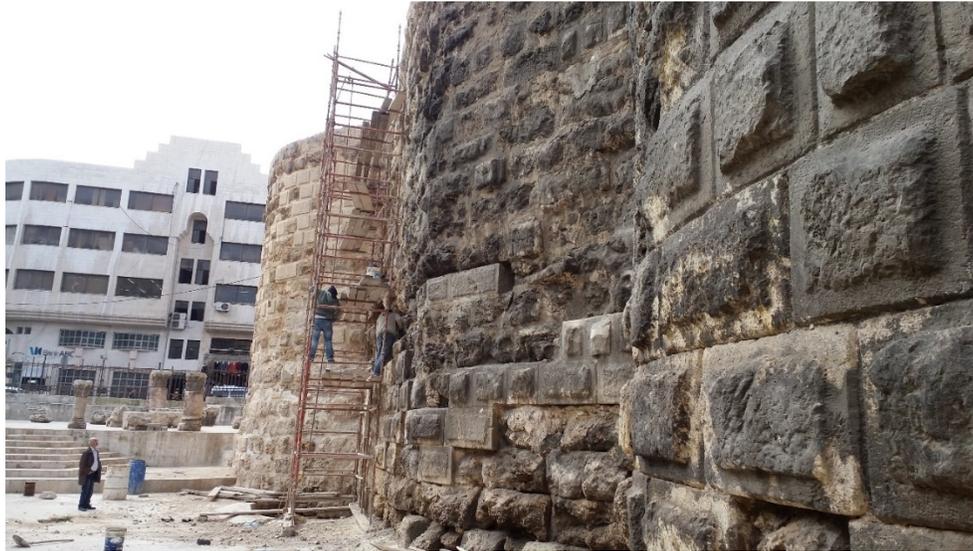
Fig.5- Consolidation works at the back side of the monument ©Authors.

- Filling the joints of the stone blocks with compatible mortar.
- Chemical consolidation and coating conducted using suitable polymers for the very fragile stones.
- Nano technology has been implemented, for the first time in Jordan, at the Nymphaeum with Nano-Calcium Hydroxide, which is injected in limited amounts, penetrates inside the stone, and transforms into Calcium Carbonate that consolidates the delicate internal building parts.

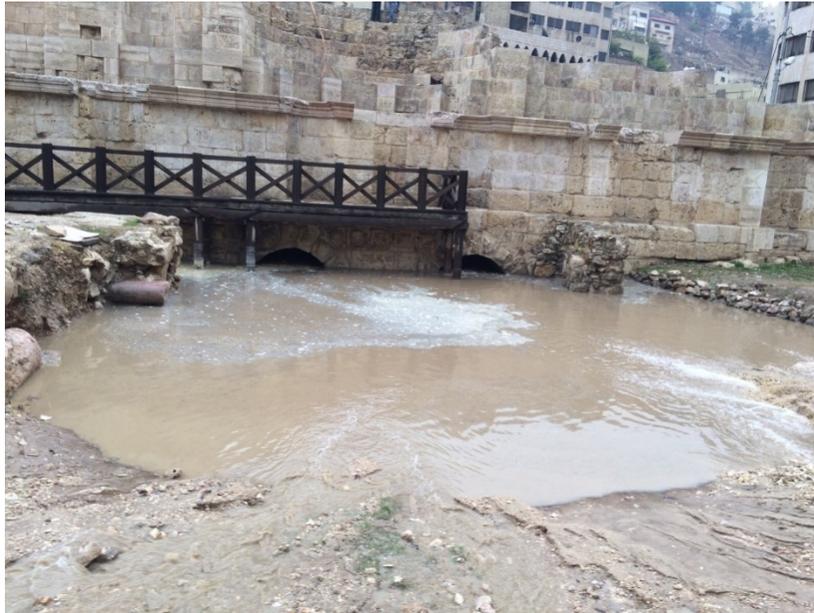
A major flood of November 5, 2015 in Amman severely affected the downtown and the Nymphaeum Site. The flood caused a huge damage at the site and the project had to redo cleaning for several parts and for entire site that worked as a sewer for all the water coming to the downtown. It was very clear that major landscaping is highly needed to prevent soil movement and land sliding.

This measure has been taken at the last stage of the phase by cleaning up the front area from debris and then installing some terraces and compatible landscape works which proved to be effective

during winter in the last quarter of 2016. Another purpose of this intervention was to open the view to connect to the entrance of the monument.

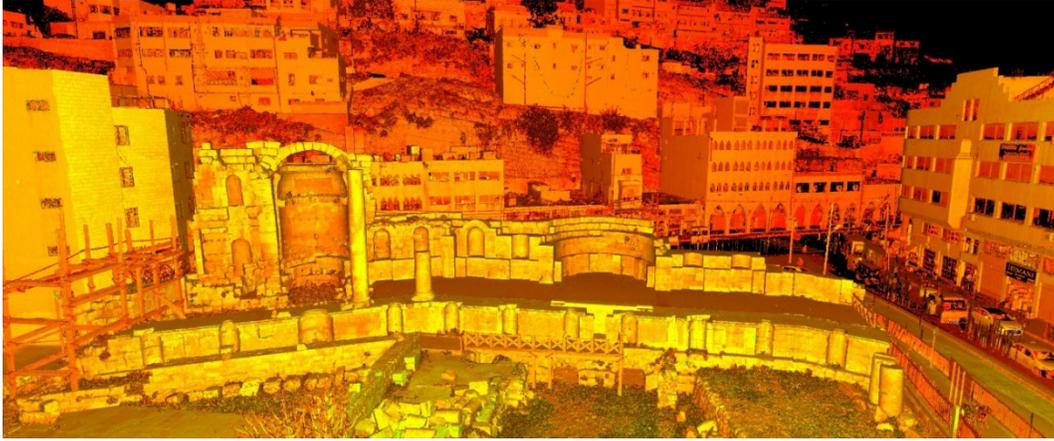
3D Laser scanning and advanced documentation have been conducted in cooperation with the DOA. Several scanning stations have been established and 3D scanning has been performed in millimetre detailed scale as clarified in the following images:

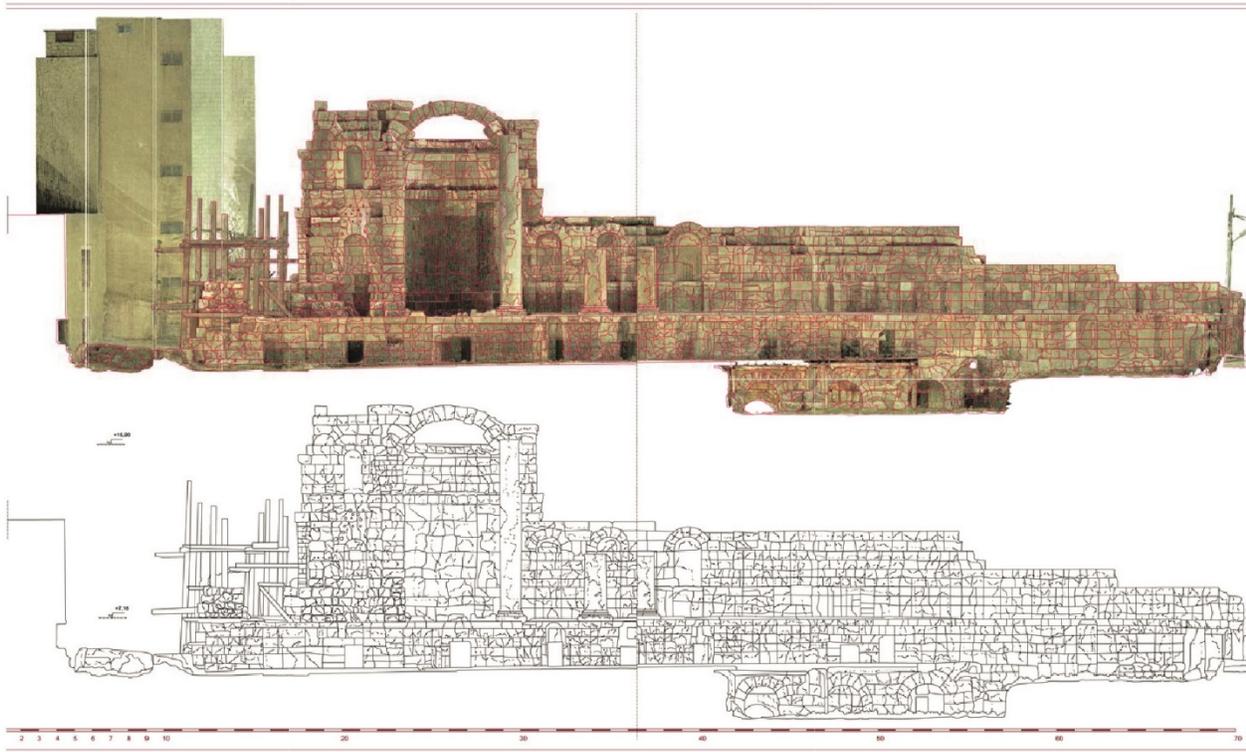
New plans and sections have been developed in partnership with La Sapienza university of Rome through conducting advanced analysis to the point cloud from the 3D Laser scanning. The following drawings and models have been produced:

- 2D geometric and architectural drawings for the site and the monument (Elevation, plans, sections, from all sides) describing the overall geometry, the superficial condition, the deterioration features before and after the intervention. (Scale 1:50 - .dwg/dxf/pdf files).
- Numeric and geometric explorable 3D model of the site and the monument aiming at providing a professional interpretation for the site (.ptx/.3dm/.3ds files).
- Animation of the numeric and geometric 3D model of the site and the monument (.avi file).
