# Roman Nymphaeum in Amman Restoration and Rehabilitation

## **Restoration and Rehabilitation**

The Roman period Nymphaeum in Amman, considered to be the largest monument of its kind in ancient Provincia Arabia, had suffered from different deterioration factors that affected its state of conservation.

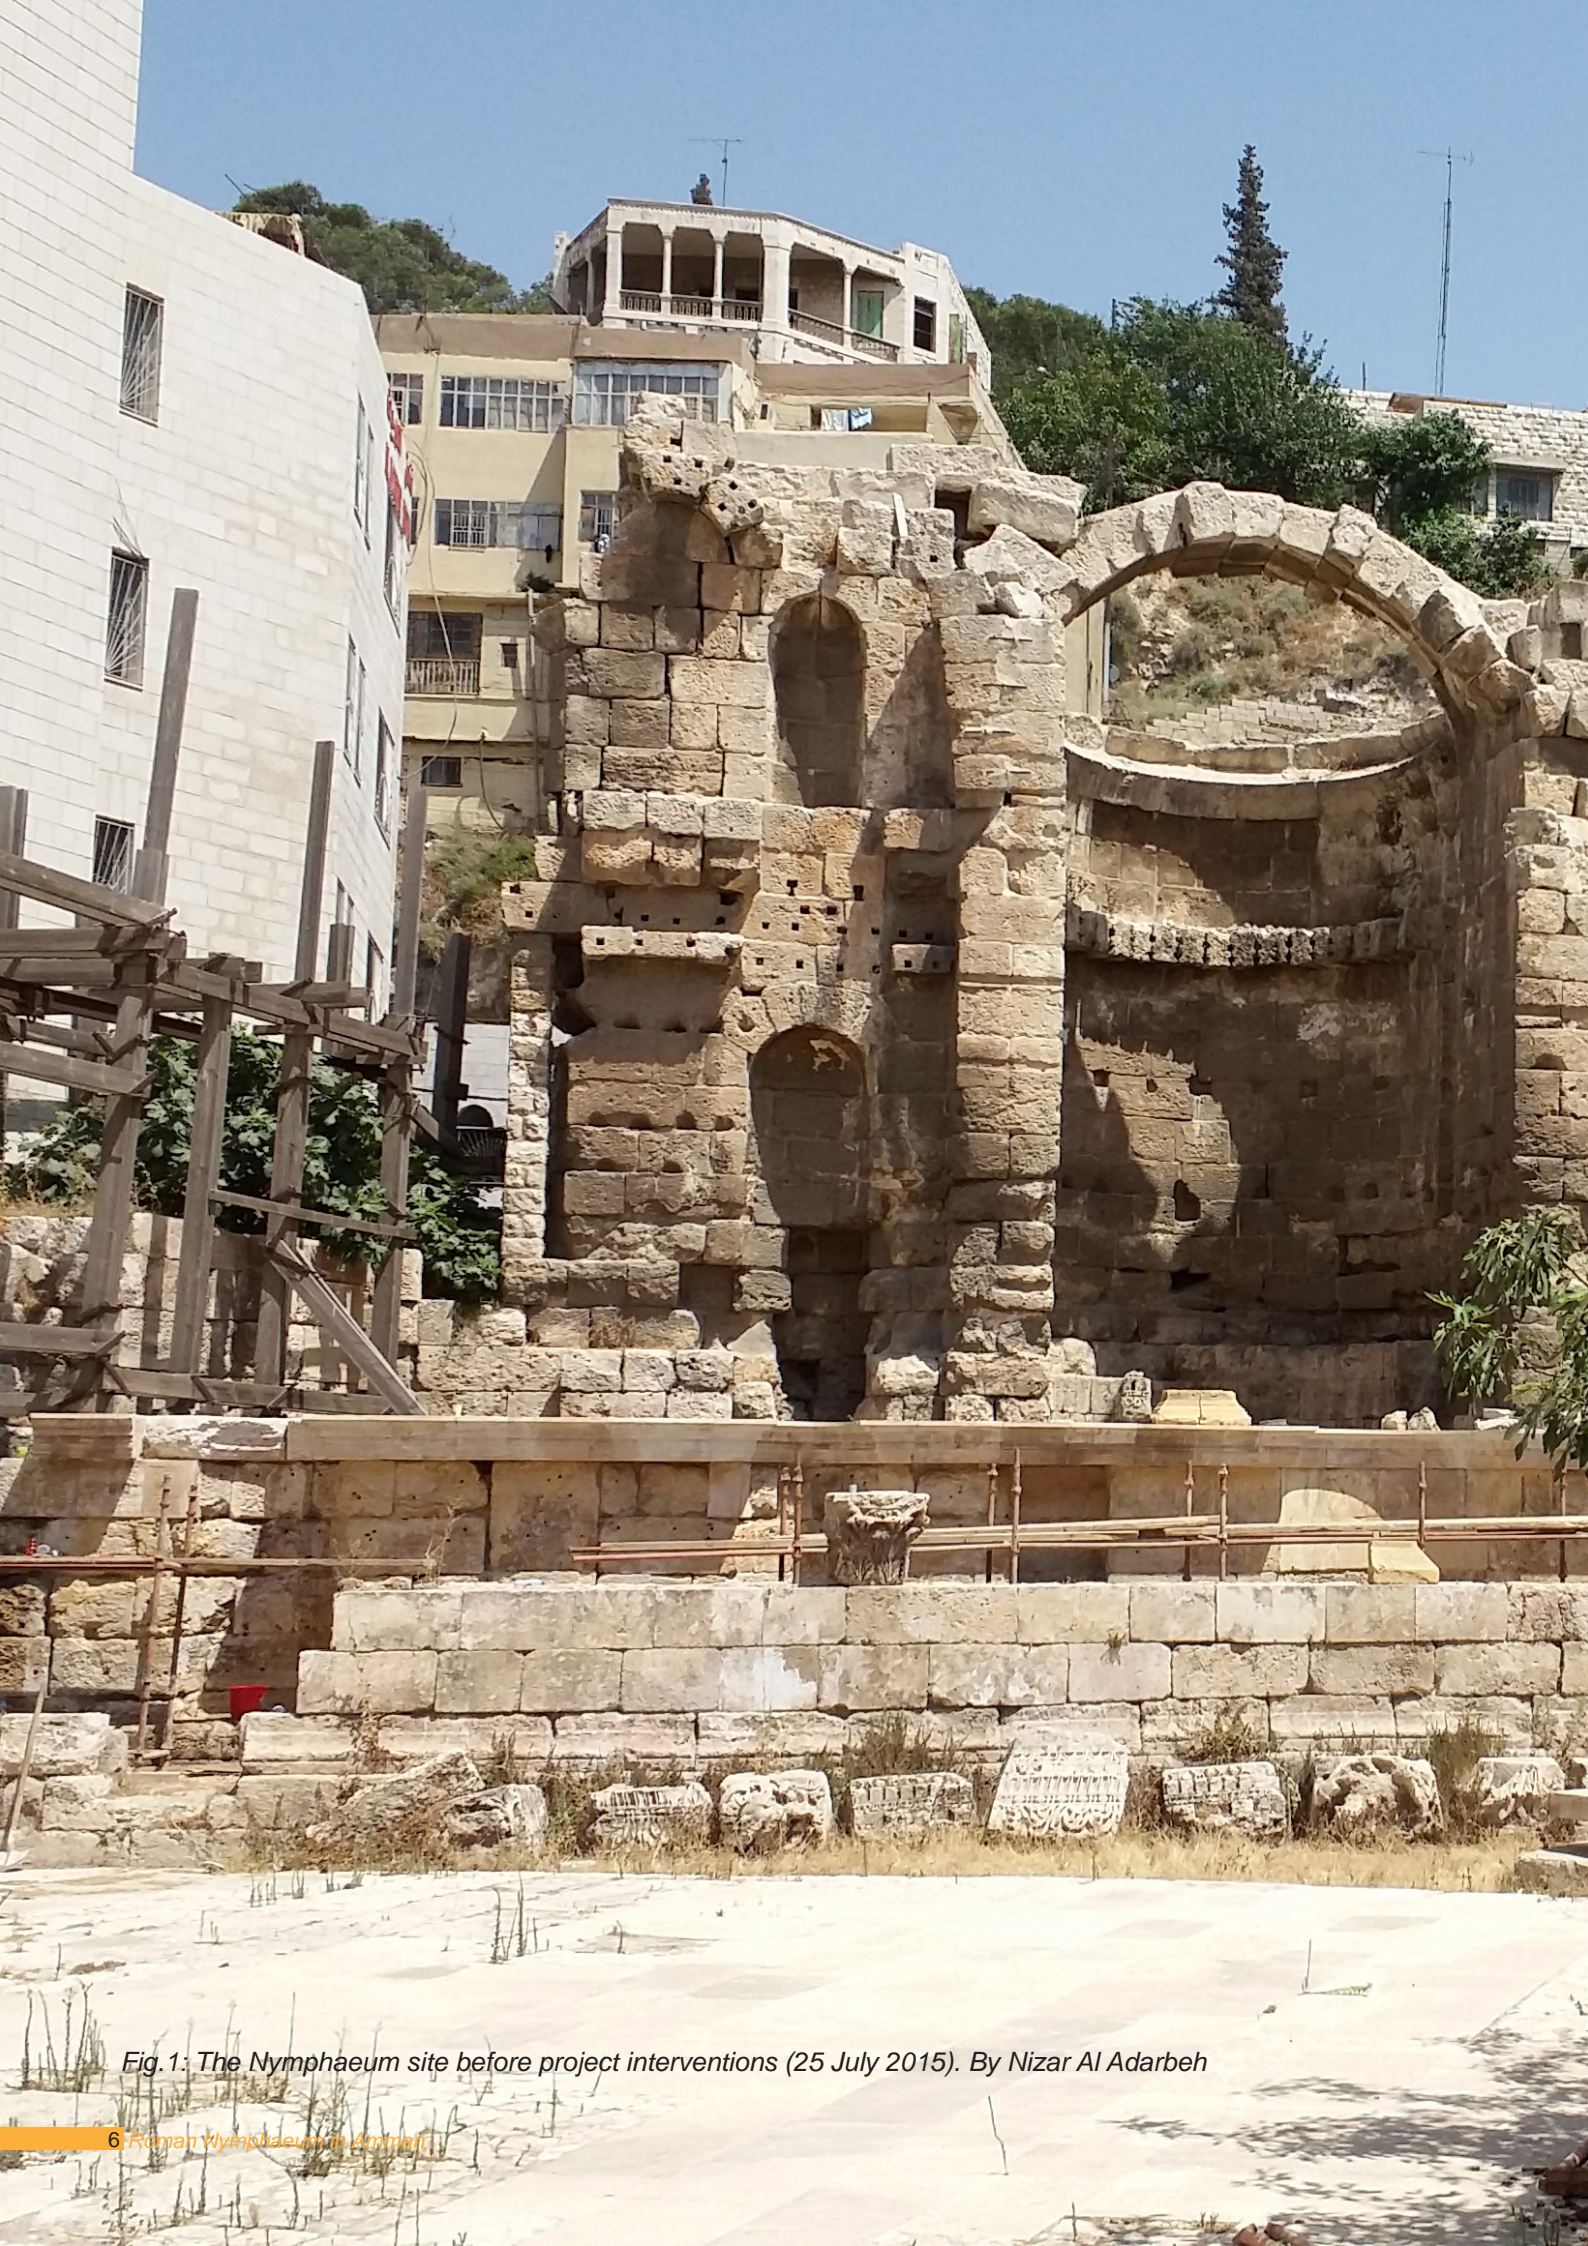
*Fig. 1: The Nymphaeum site before project interventions (25 July 2015). By Nizar Al Adarbeh*

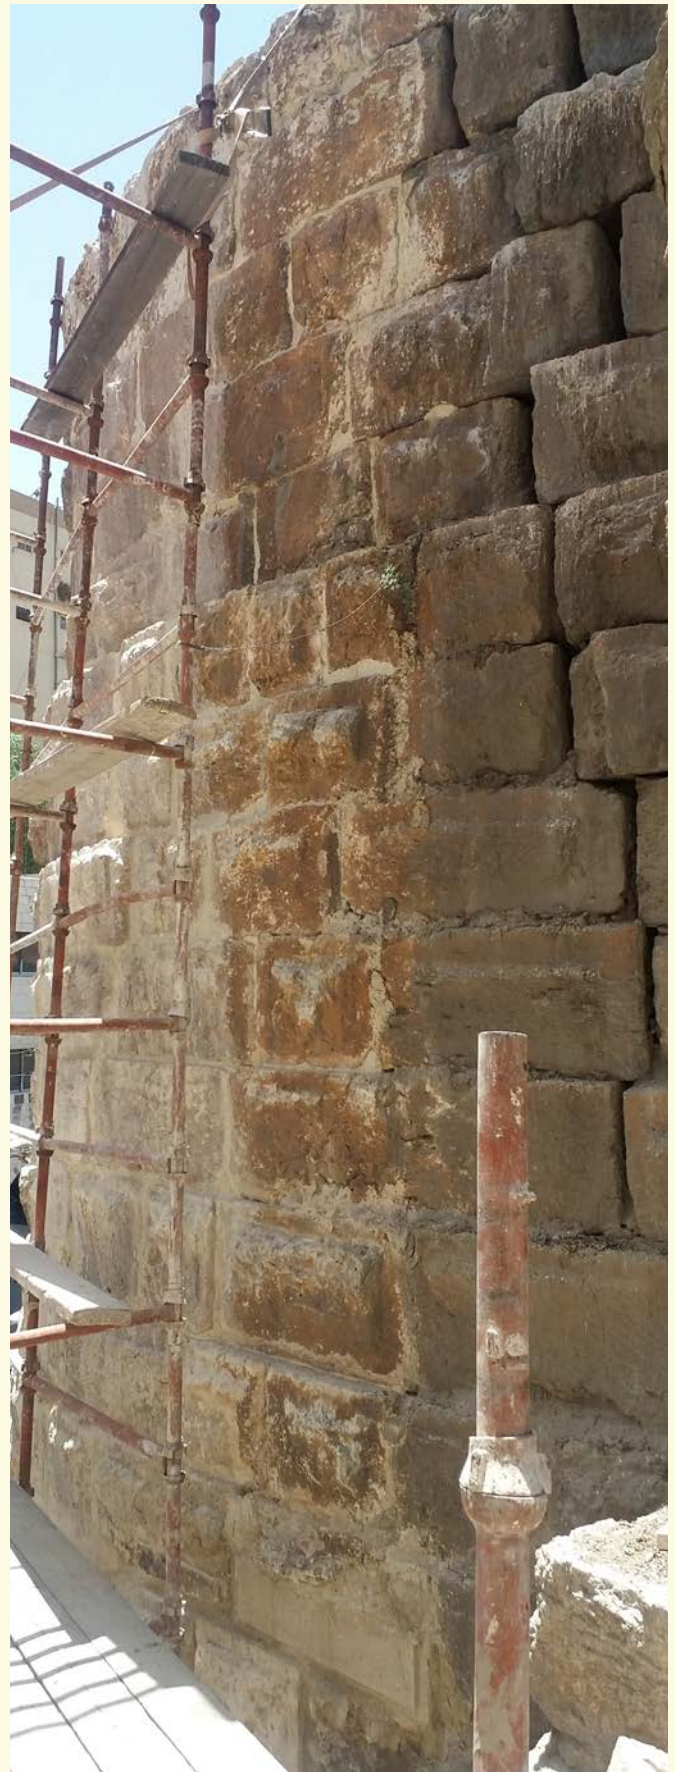
*Fig. 13: During the cleaning stage of the site with a clear view of a major crack.*

- The cleaning was conducted first to the front façade of the monument and then to the rear façade through different mechanical techniques.
- Water pumps with low pressure were used to remove all the dirt and rust accumulated on the façade from the air pollutions; this was a mandatory procedure to start the conservation intervention.
- Use of different small tools including small brushes to clean the surface of the stone blocks including removing crusts and external crystalized salts, as well as removing any plants and fungi on the surface.
- Limited chemical cleaning technique by using wet bandages for some parts of the monument.

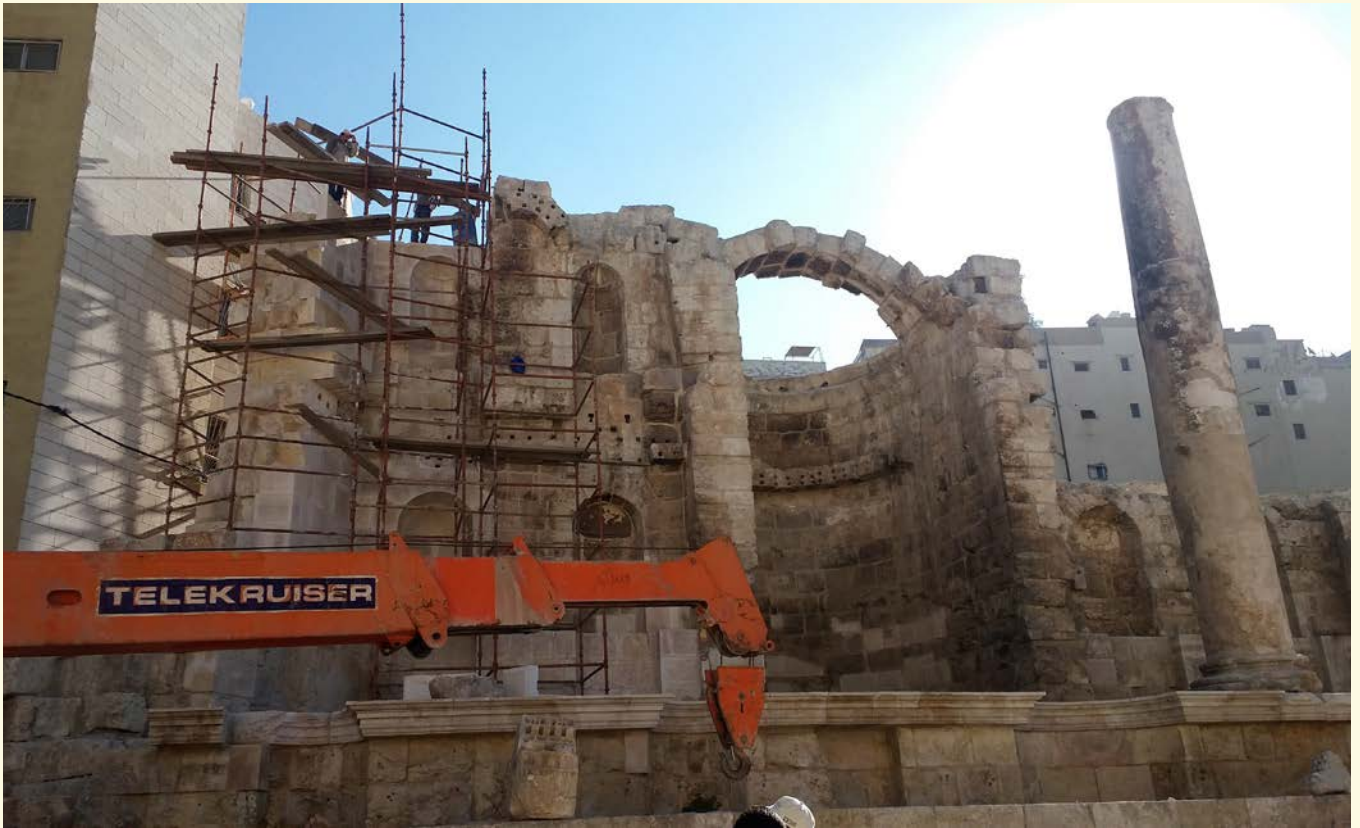
*Figure 27: Close-up photo of butress construction using scaffolding system and crane*

- The main reconstructing work focussed on building a buttress to support the vulnerable parts of the monument (figs. 21 & 22).

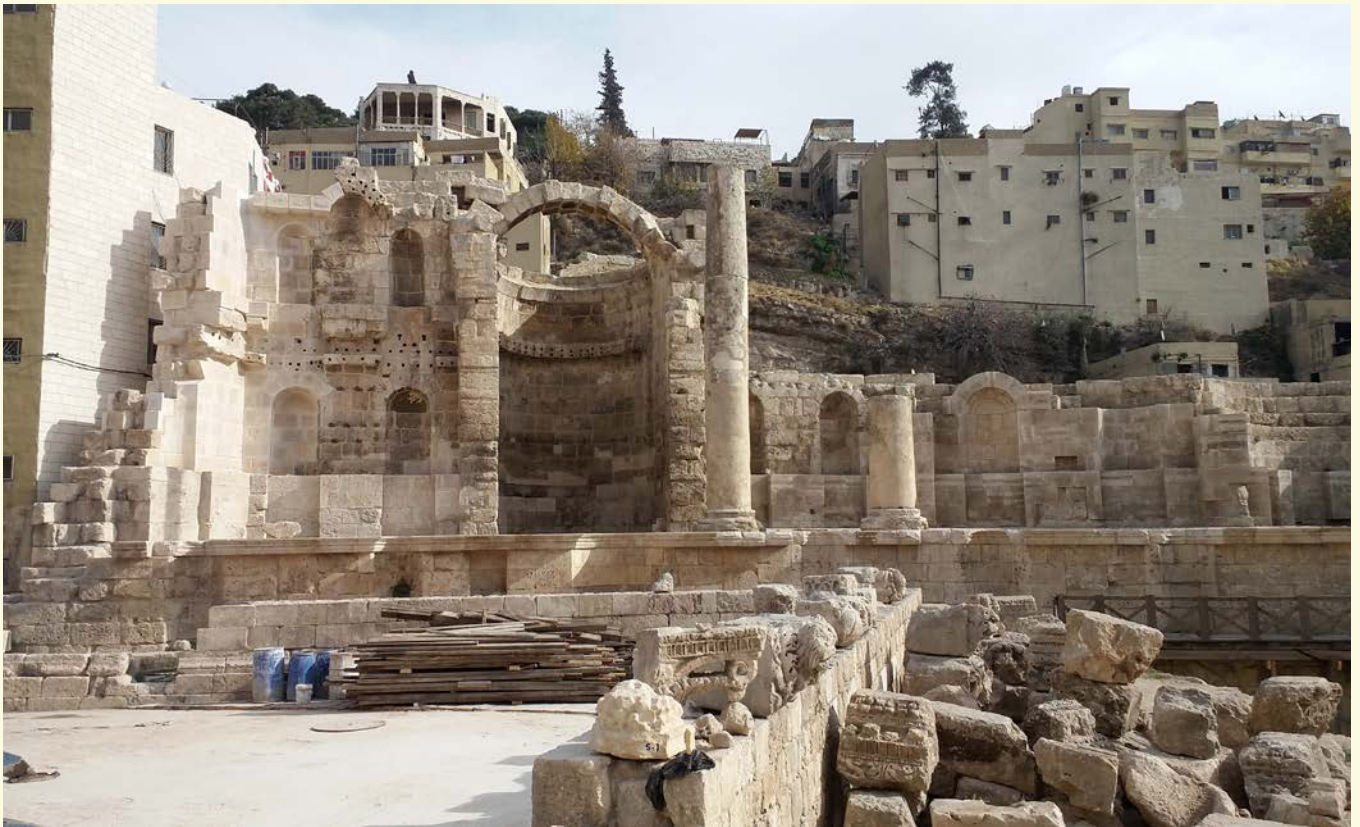
*Figure 28: Buttress after finishing the construction work which highlight the success of the intervention as it enhanced the architectural interpretation of the monument and enhanced the stability of the structure.*

The project had fully achieved the consolidation of all vulnerable parts of the monument and mainly accomplished the stabilization of the eastern part of the building through constructing the buttress. The construction intervention was taken for the very critical parts of the monument which was an important measure to stabilize the very risky parts and to ensure better structure stability. This action also strengthened the vulnerable and exposed parts suffered from different deterioration features. The following is a detailed progress narrative of the interventions during the project implementation:

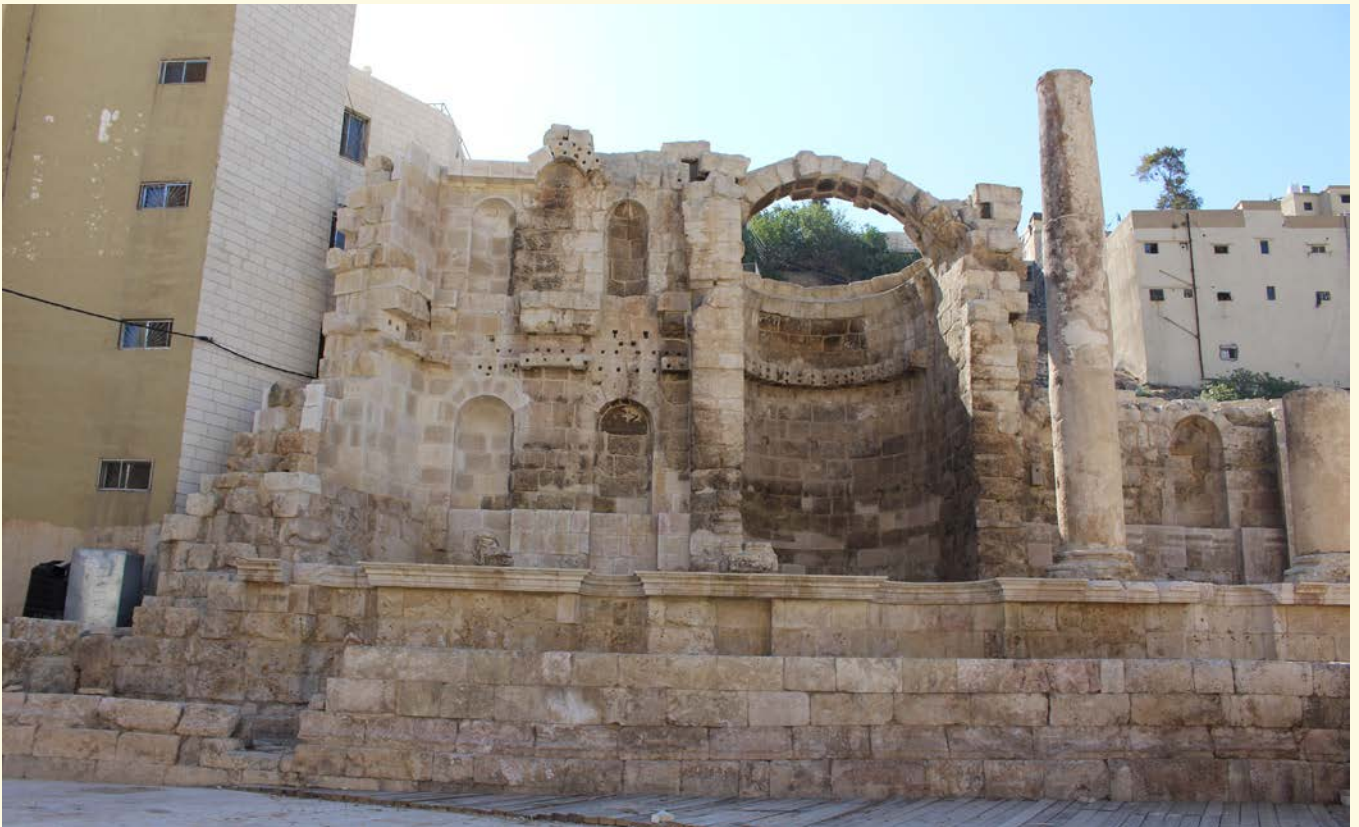
*Figure 30: Eastern part after finishing the buttress construction*

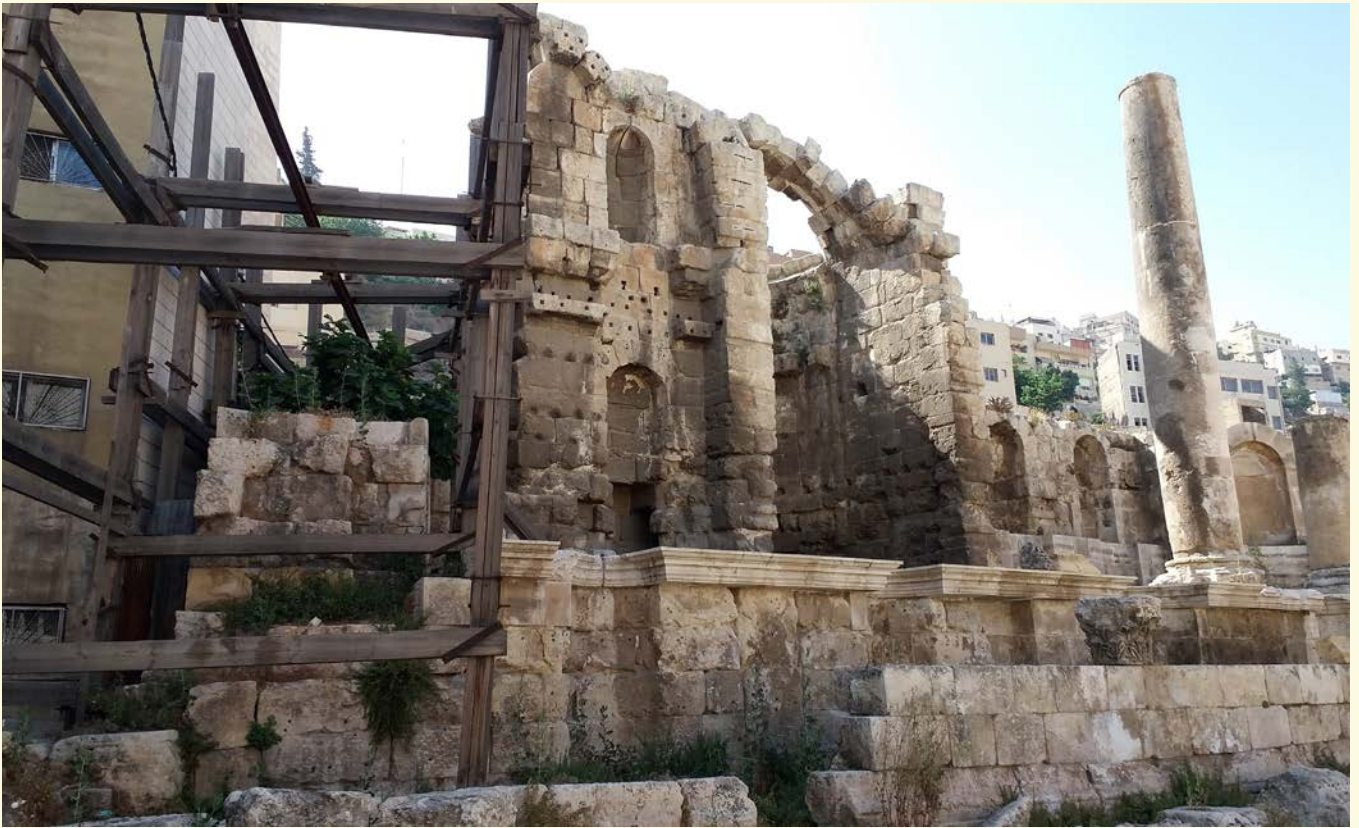
*Figure 31: Eastern part before buttress construction*

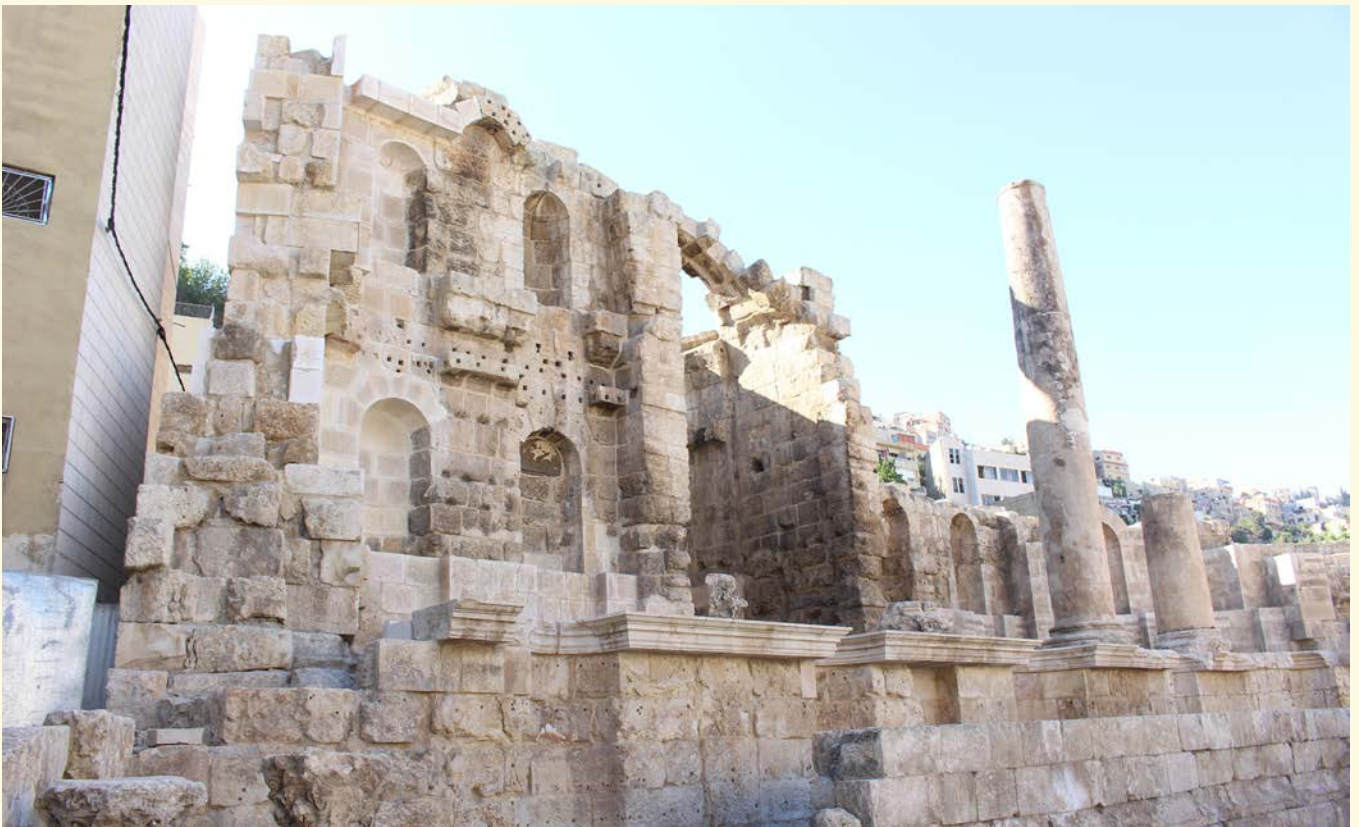
*Figure 32: Eastern part after finishing the buttress construction*

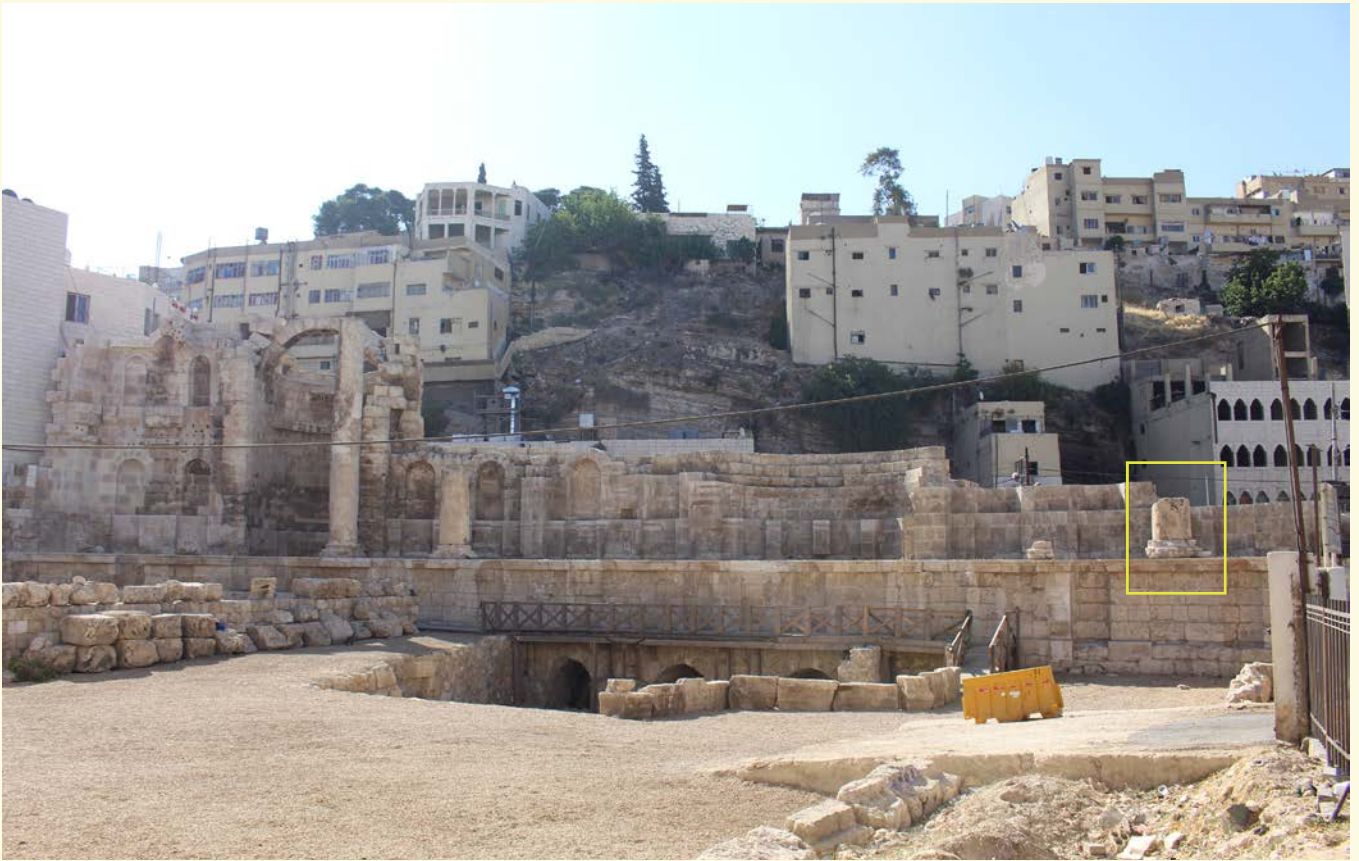
*Figure 42: Reinstalling one of the columns into its proper location in the monument*

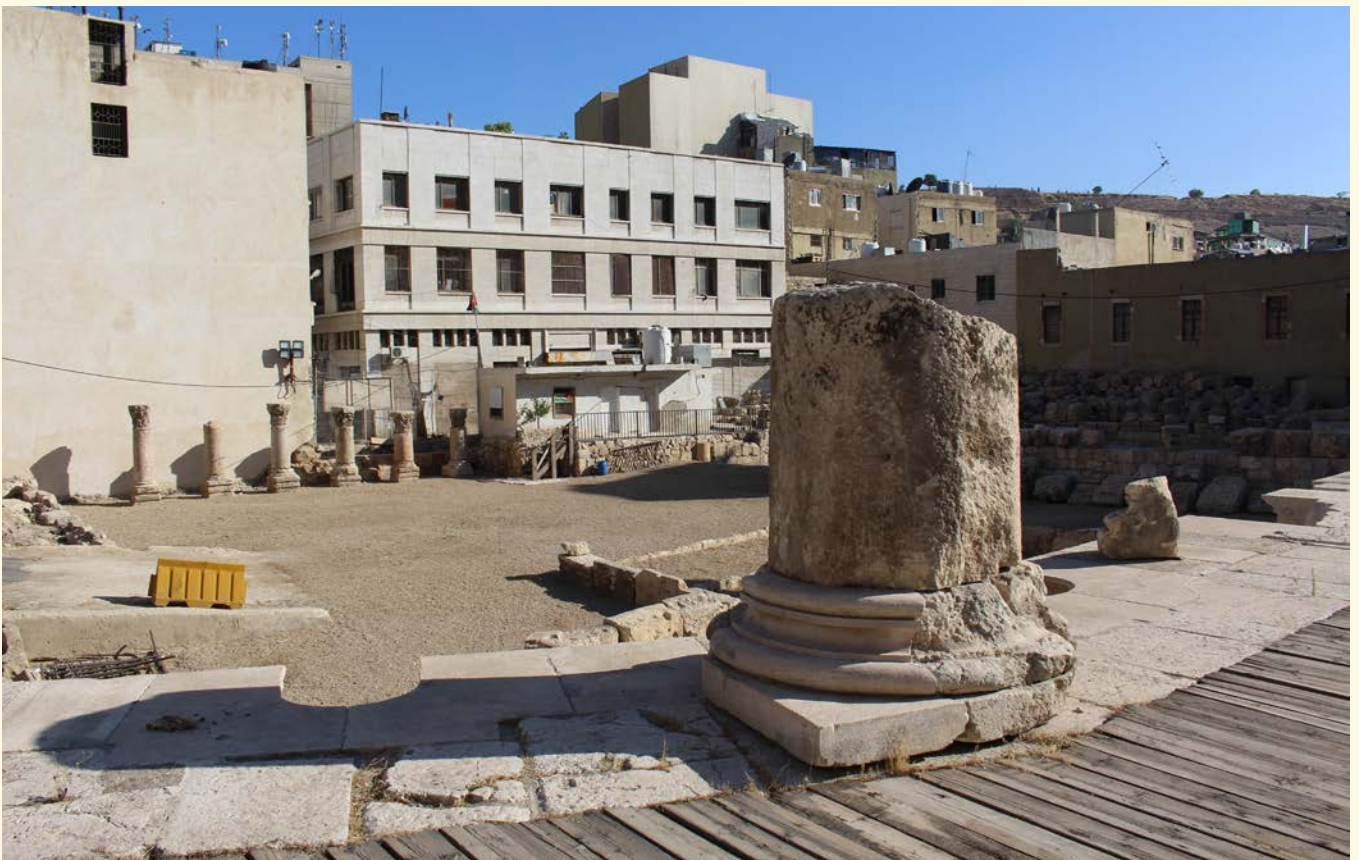
*Figure 43: Reinstalling one of the columns into its proper location in the monument*

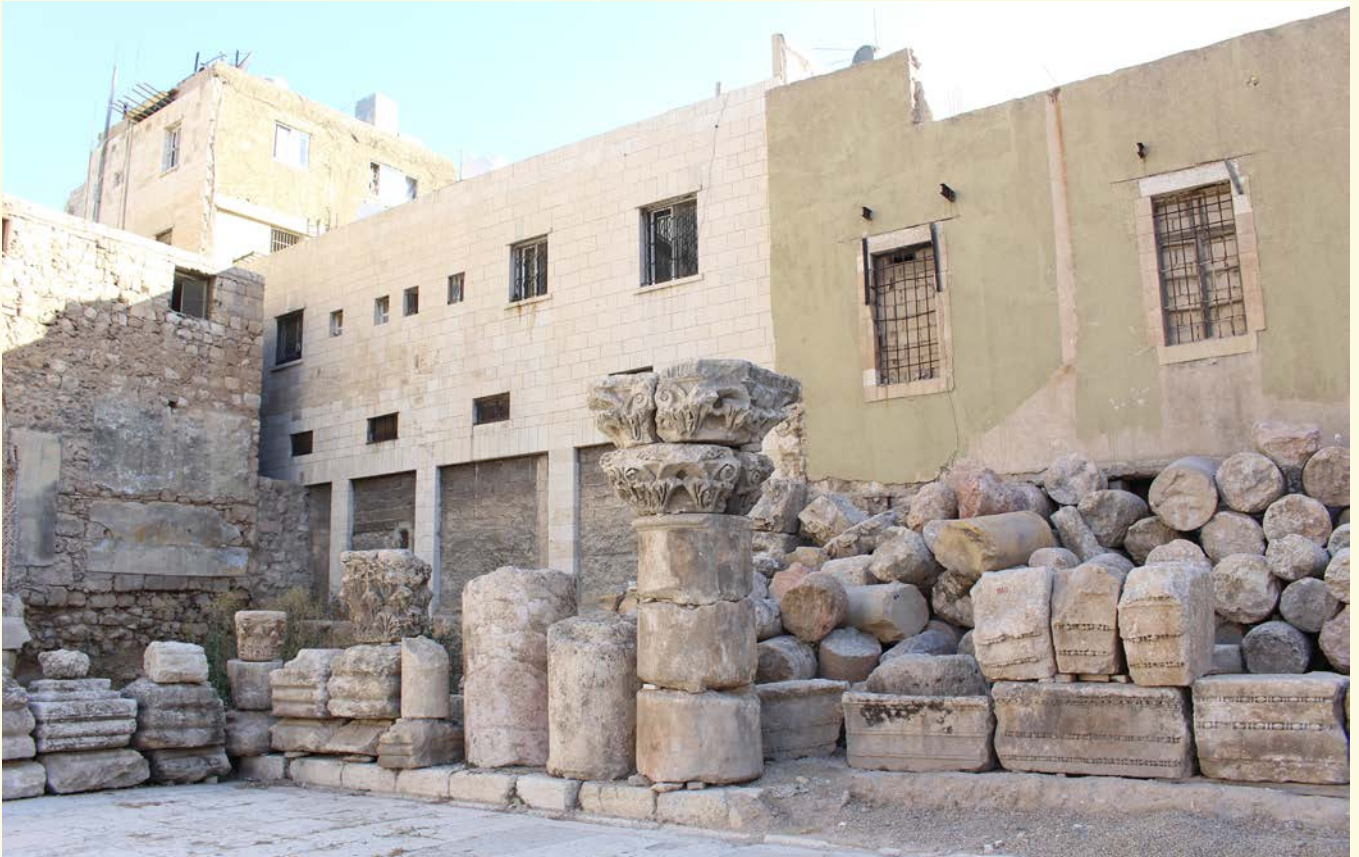
Figure 44: Anastylosis of a column at the site to present how the capital capped the top of the drums

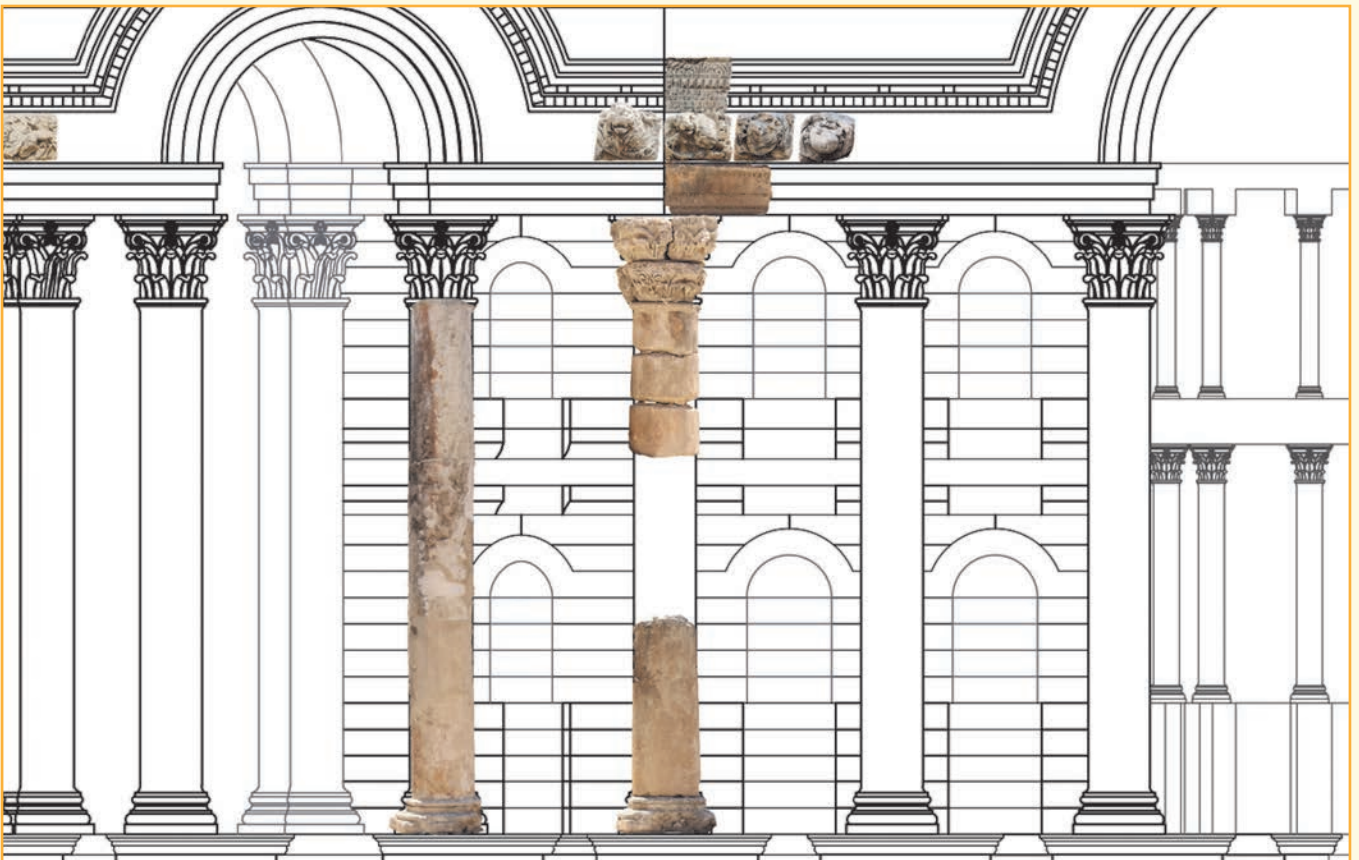
Figure 45: A computer generated drawing showing the location of the previous column with anastylosis. This drawing was used in one of the signs at the site

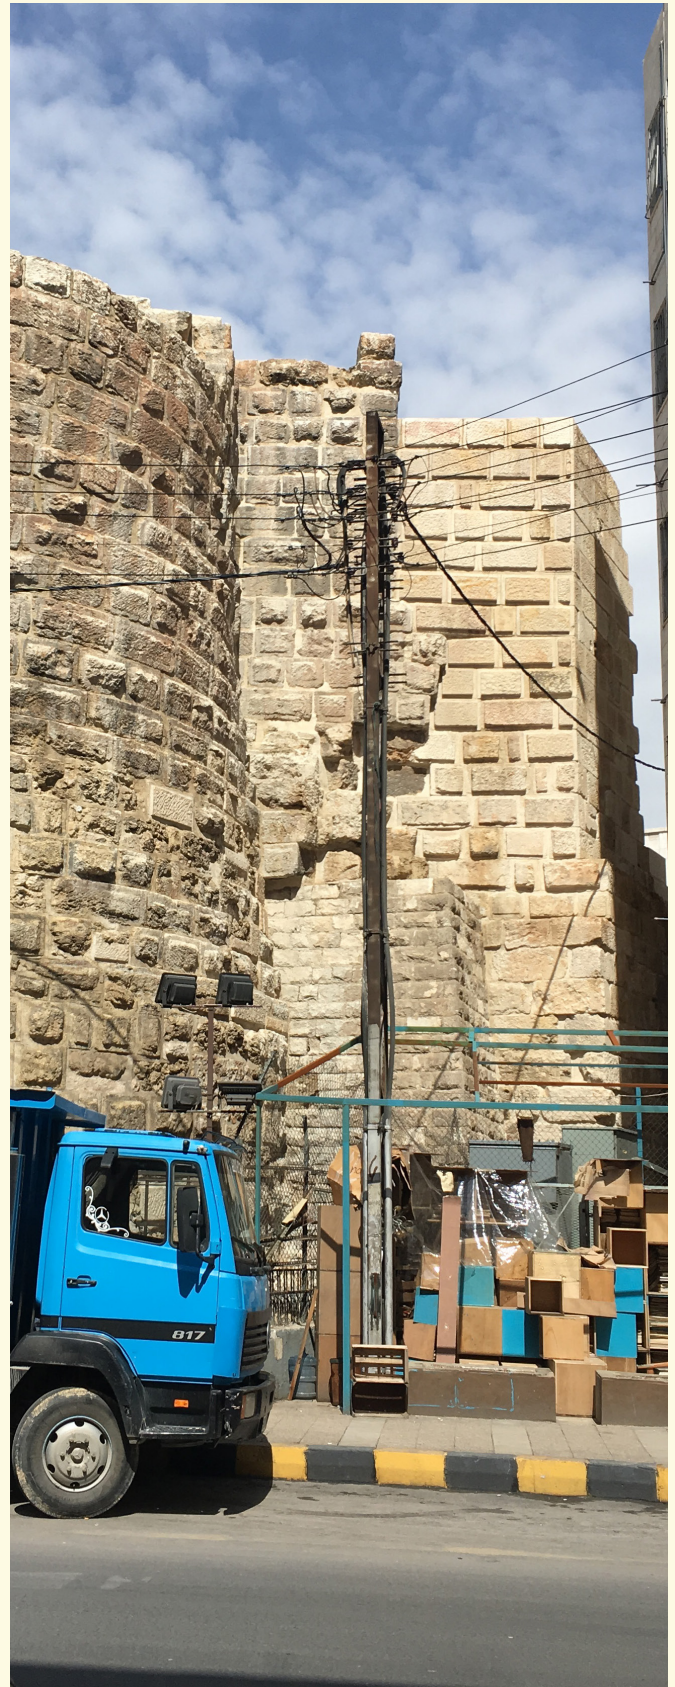
*Figure 46: The rear façade after conclusion of cleaning and consolidation process and the full construction of the buttress from the back side*

- The cleaning process continued for the rear façade of the Nymphaeum using different mechanical techniques (fig. 47)
- Water pumps with low pressure were used to remove all the dirt and rusts accumulated on the façade from the air pollution. This was a mandatory procedure to start the conservation intervention
- Use of different small tools including small brushes to clean the surface of the stone blocks including removing crusts and external crystalized salts, as well as removing any plants and fungi on the surface (figs. 51-53)
- Filling the joints of the stone blocks with compatible mortar
- The project accomplished full clearance, consolidation and stabilization of the rear façade with the buttress fully constructed (fig. 46)

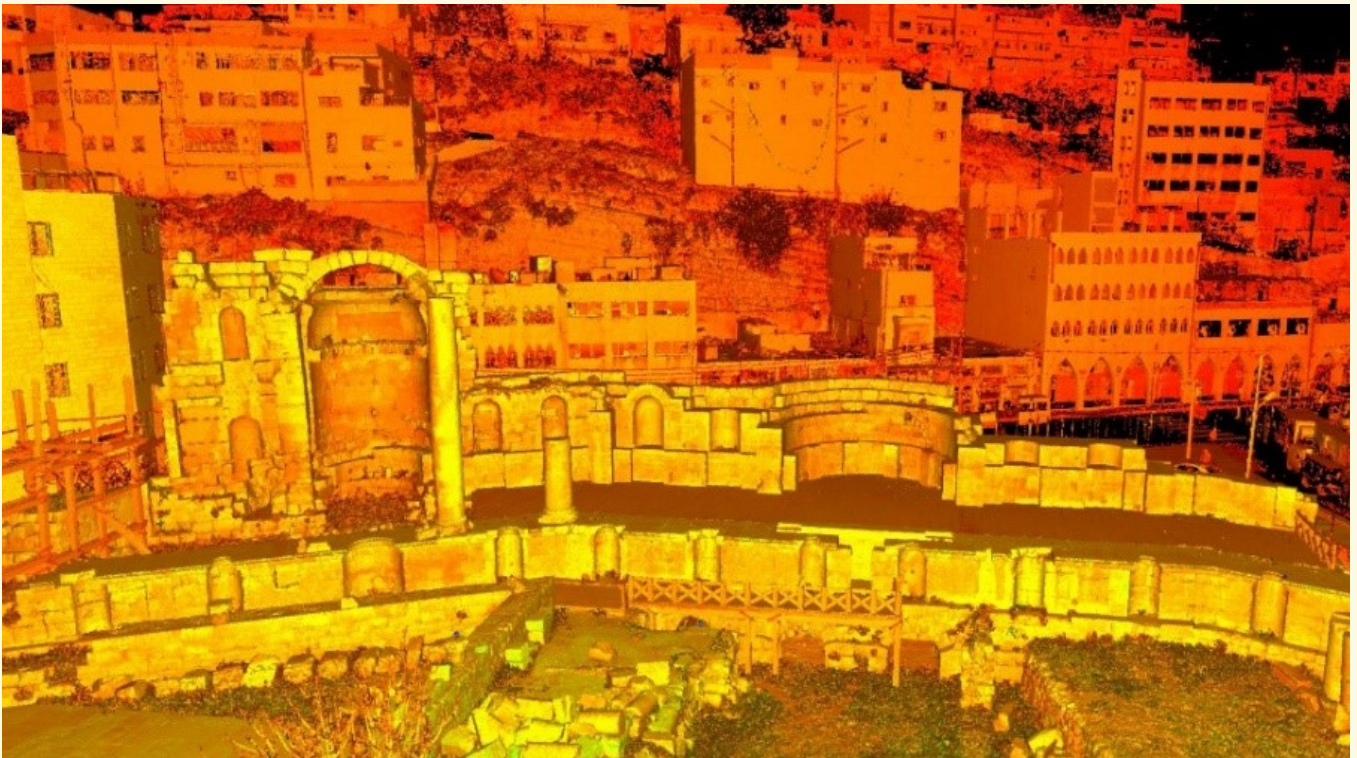
*Figs. 64: A view of a point cloud image for the main façade from the 3D scanning of the Nymphaeum*

From the previous accomplished 3D Laser scanning and advanced documentation conducted in cooperation with the Department of Antiquities (DOA). The collected data were processed by the responsible project team members and several sections and illustrations were developed for the conservation efforts and for the site management plan. More details of conservation interventions and deterioration features are added to the illustrations. The illustrations will be used for interpretation and presentation purposes.

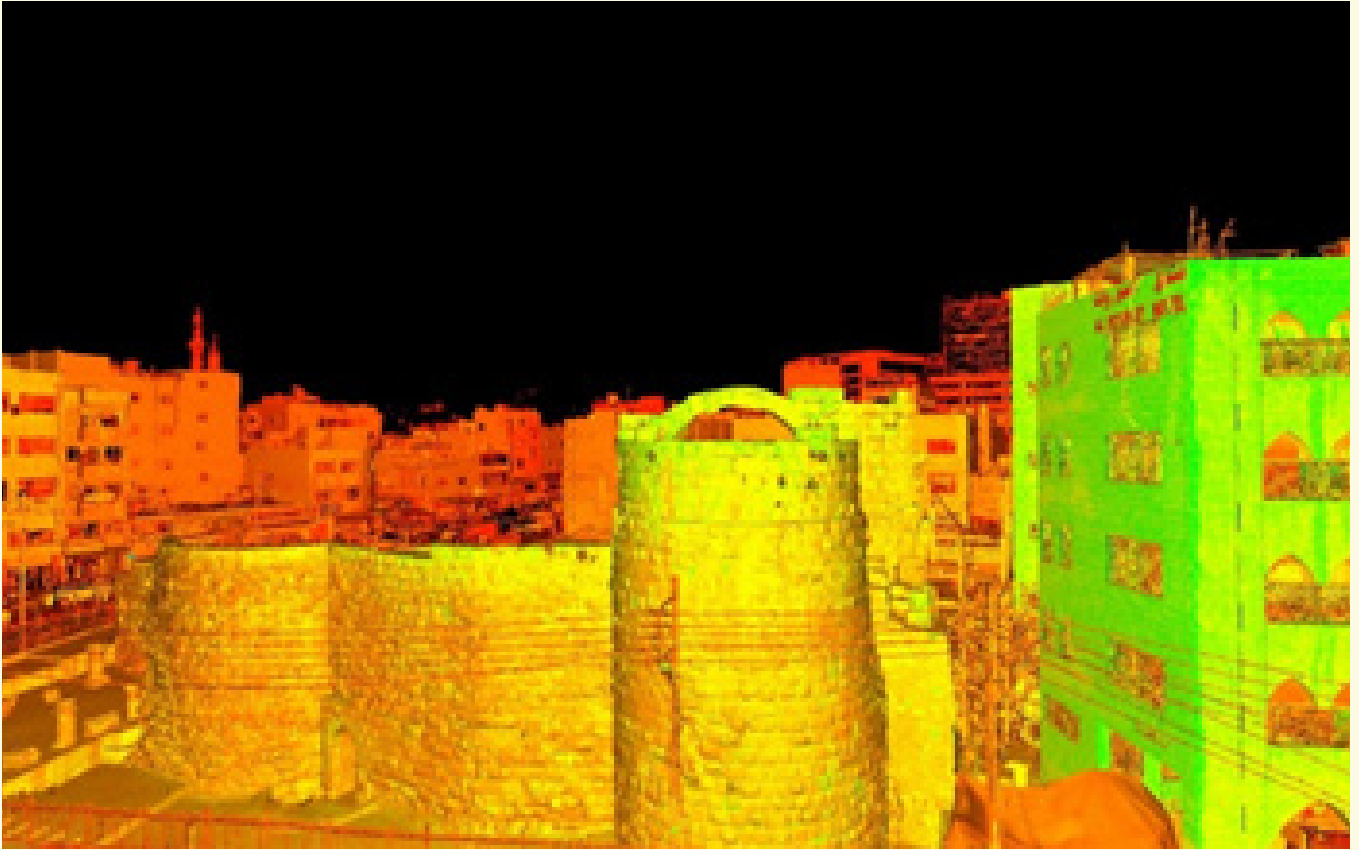
*Figs. 65: A view of a point cloud image for the rear façade from the 3D scanning of the Nymphaeum*

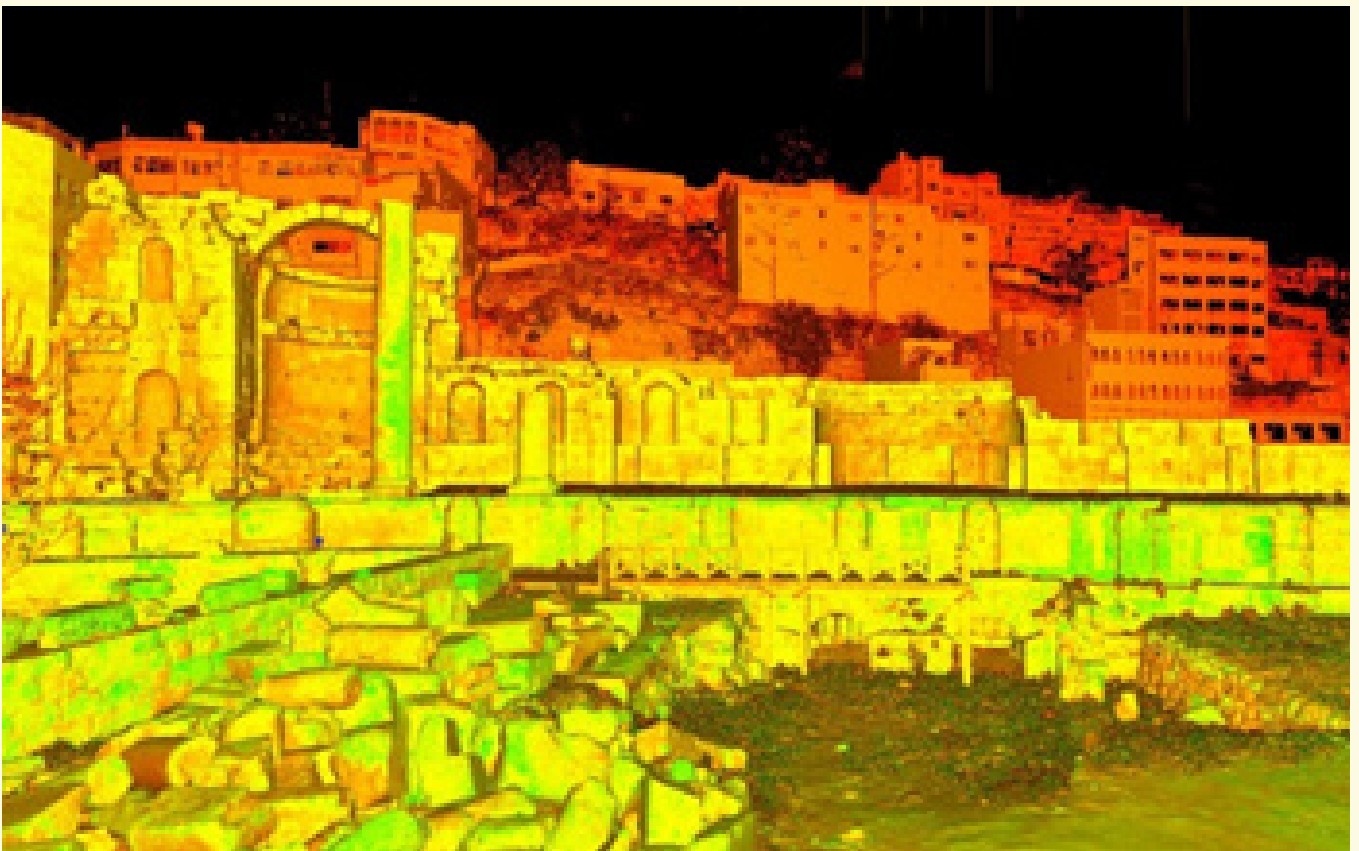
*Figs. 66: A view of a point cloud image for the main façade from the 3D scanning of the Nymphaeum*

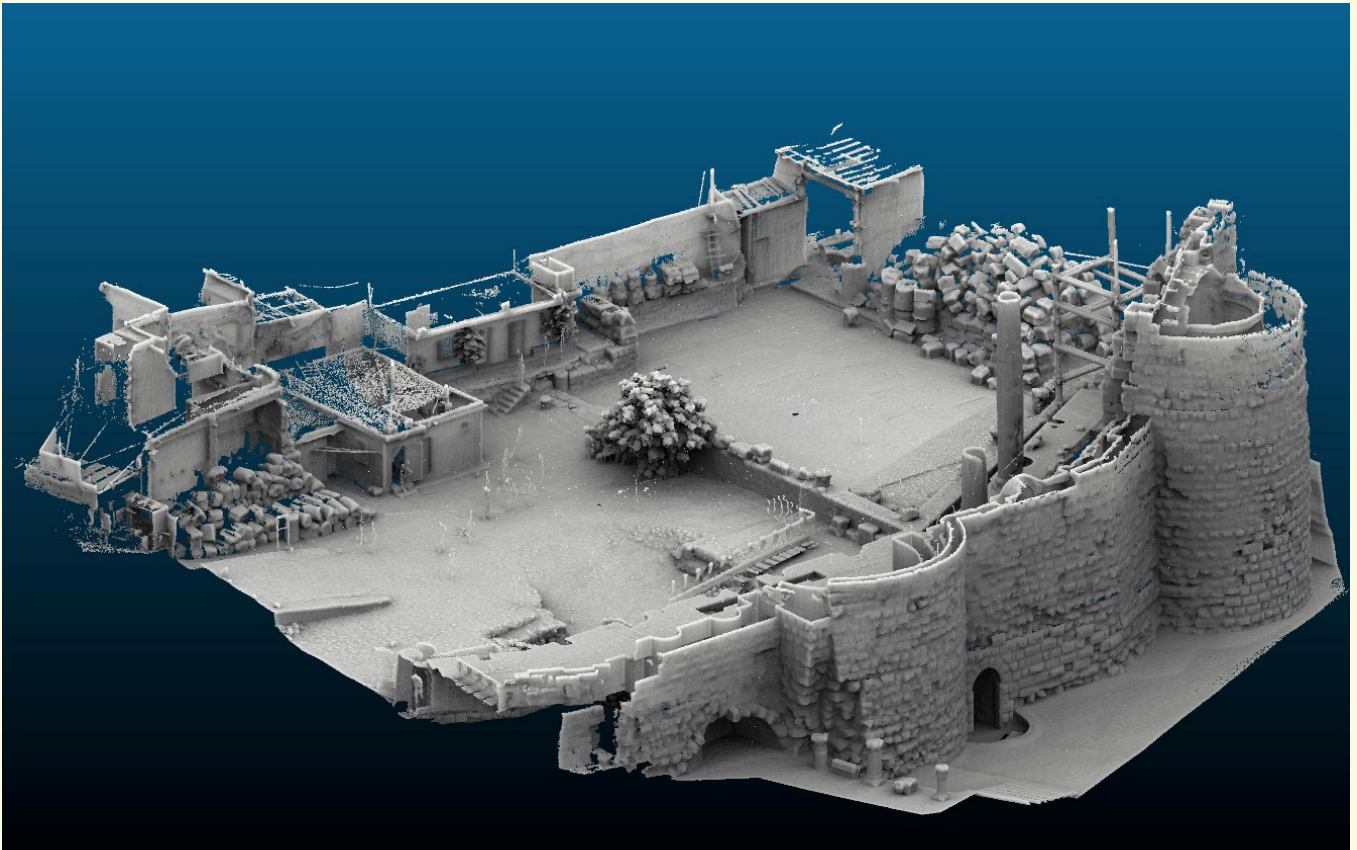
*Figs. 67: A 3D model point cloud for the Nymphaeum*
