# Roman Nymphaeum in Amman Restoration and Rehabilitation

## **Restoration and Rehabilitation**

The Roman period Nymphaeum in Amman, considered to be the largest monument of its kind in ancient Provincia Arabia, had suffered from different deterioration factors that affected its state of conservation.

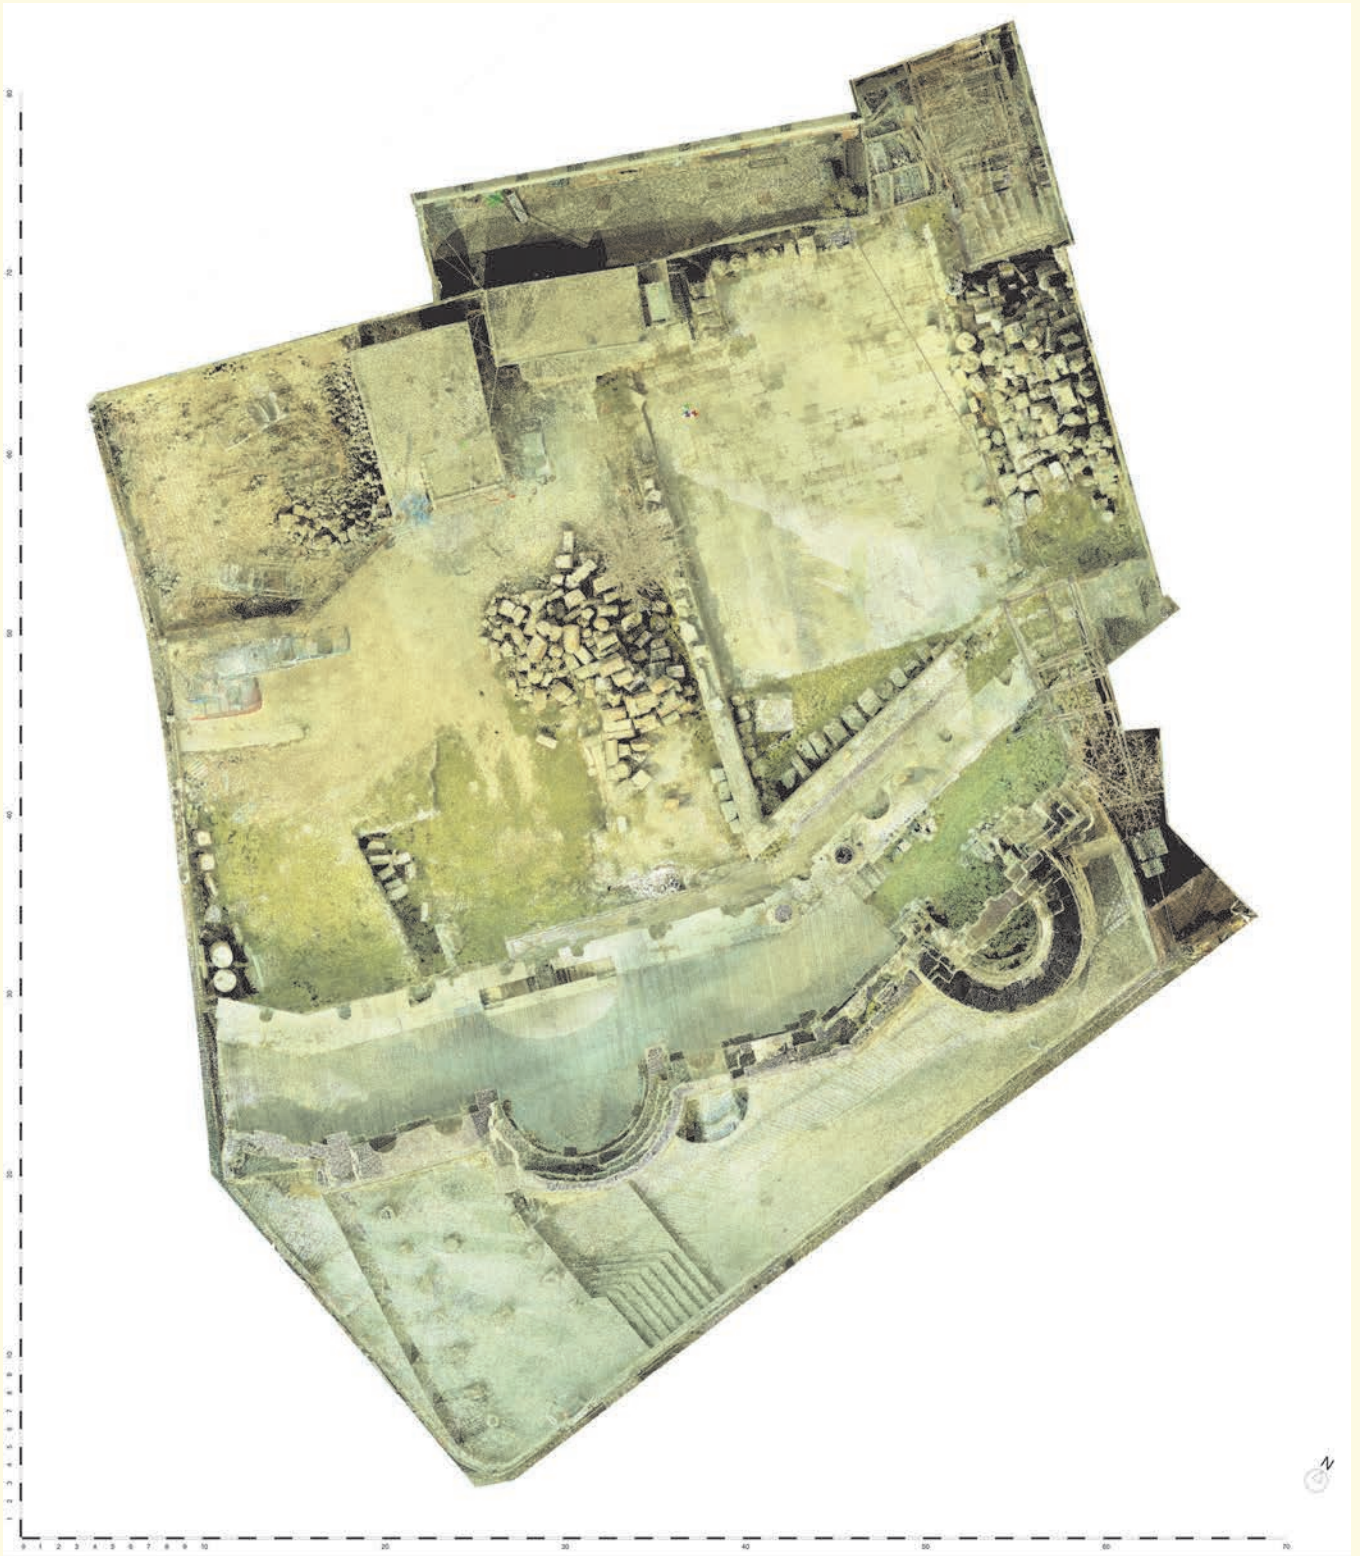
Fig. 68: 2D Geometric Model, RGB texturized Giga photo of the General Plan View, scale 1:50

New plans and sections were developed in partnership with La Sapienza University of Rome. The documentation work was carried out by an international team made of Jordan and Italian researchers. The relevance of this experience, quite apart from the application of the 3D capturing technologies, must be found in two different but complementary aspects:

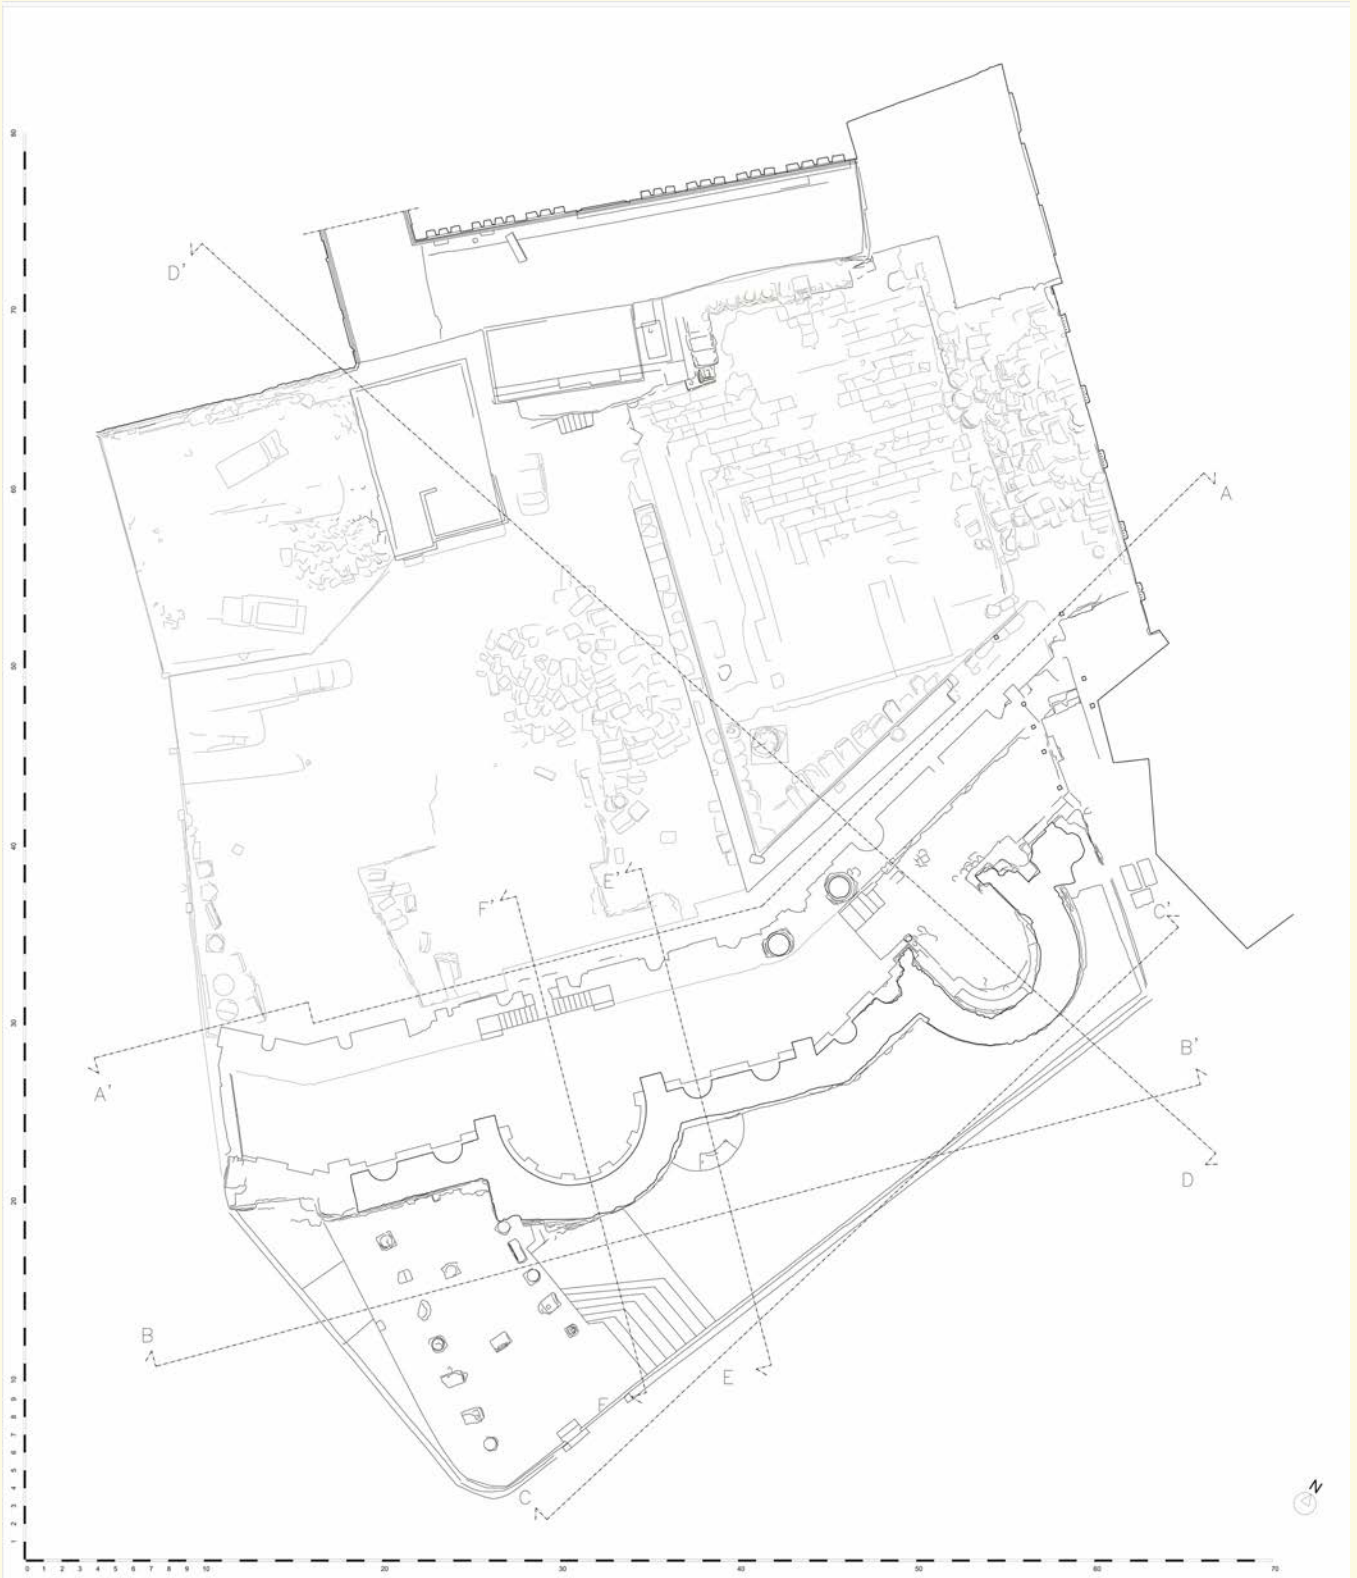
Fig. 69: 2D Architectural Model, Plan View, upper level, line drawing scale 1:50

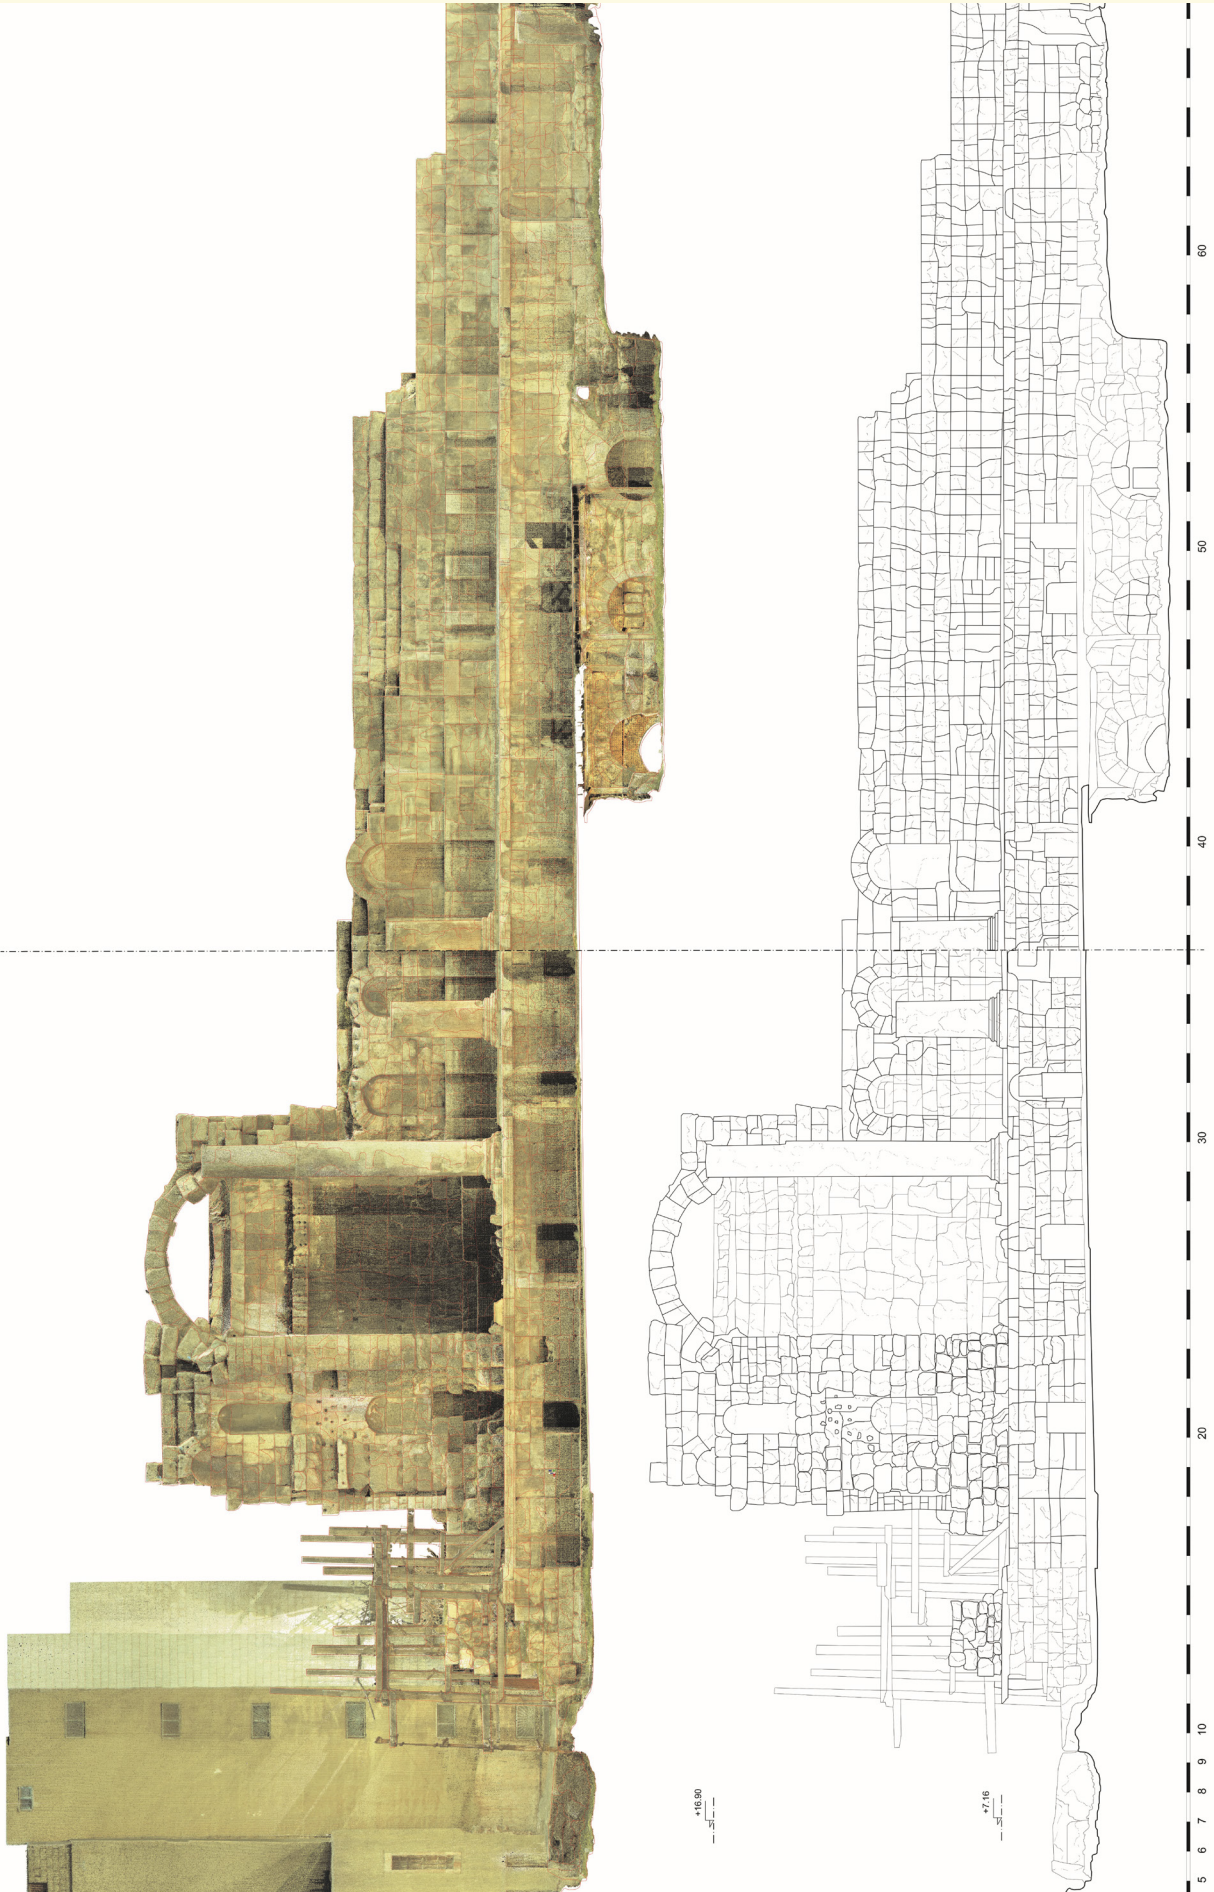
*Figs. 72-73: 2D Geometric Model, Elevation AA', internal main façade, RGB texturized Giga photo with overlay of the line drawing scale 1:50; 2D Architectural Model, Elevation, internal main façade, line drawing scale 1:50*

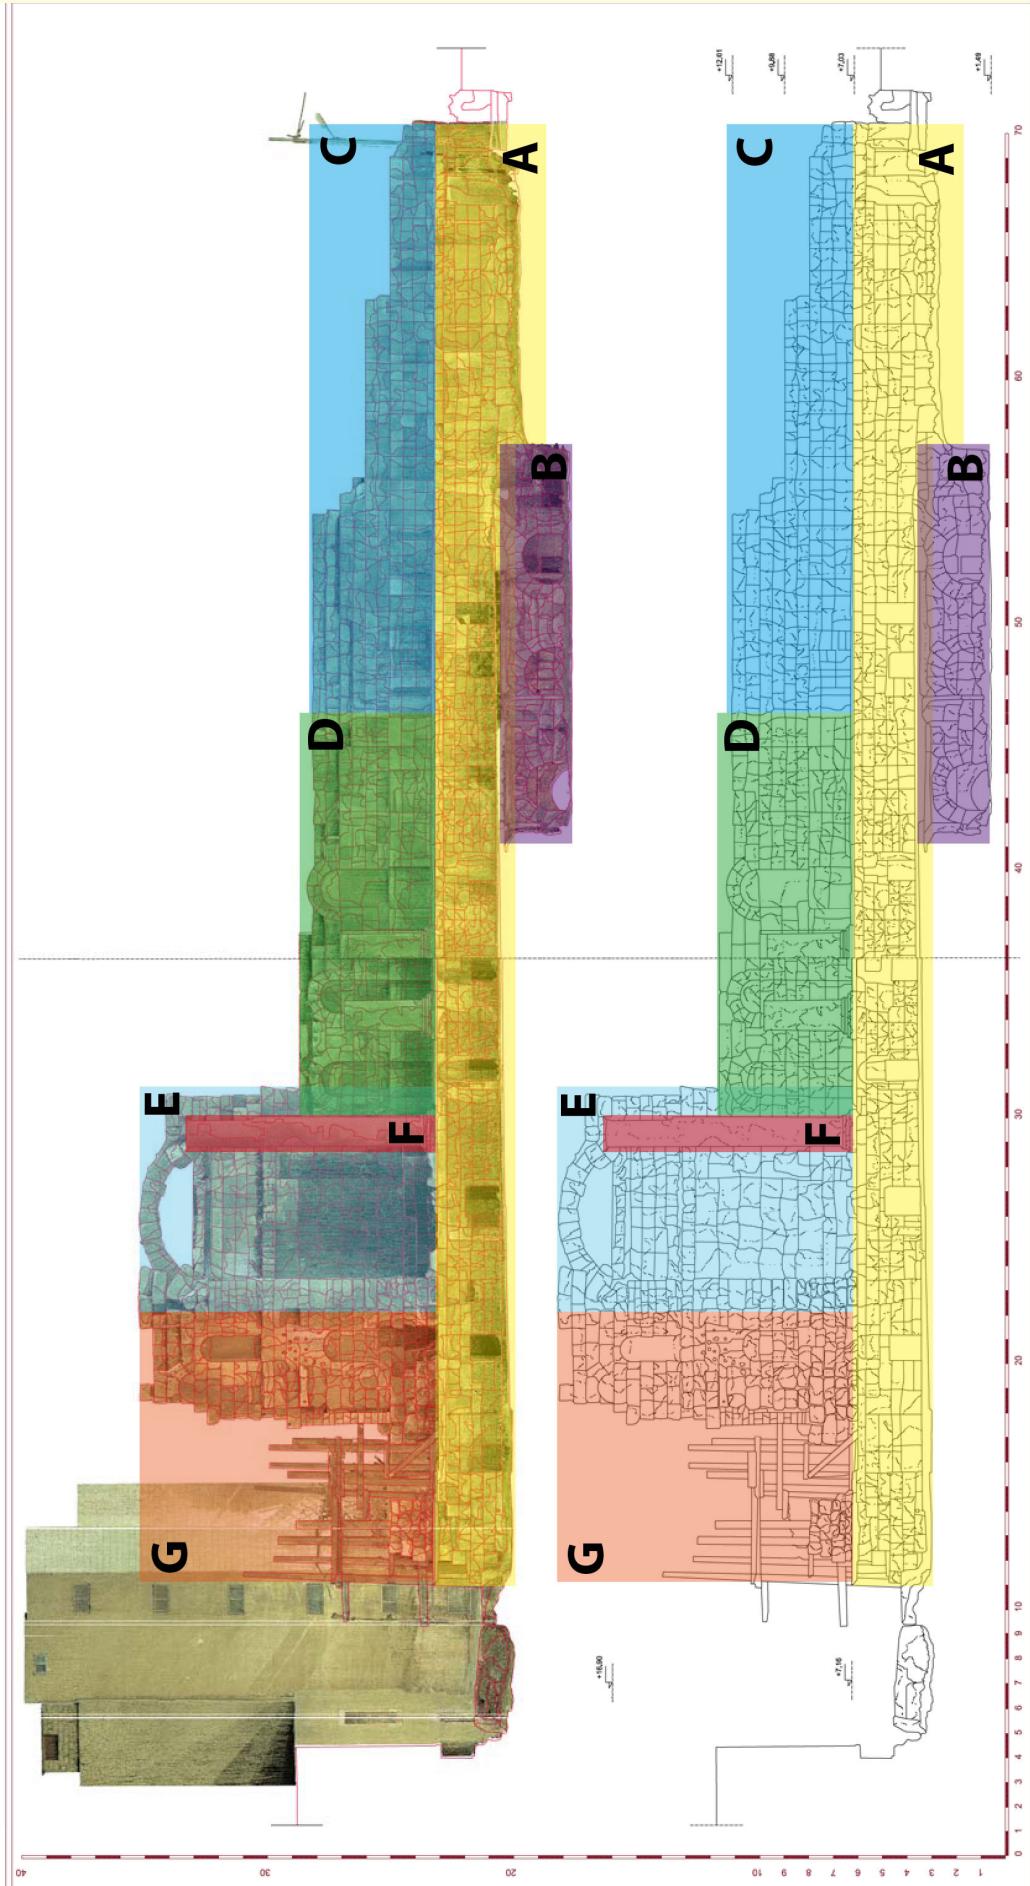
Figs. 74-75: Conservation intervention classification areas using the 2D Geometric Model, Elevation

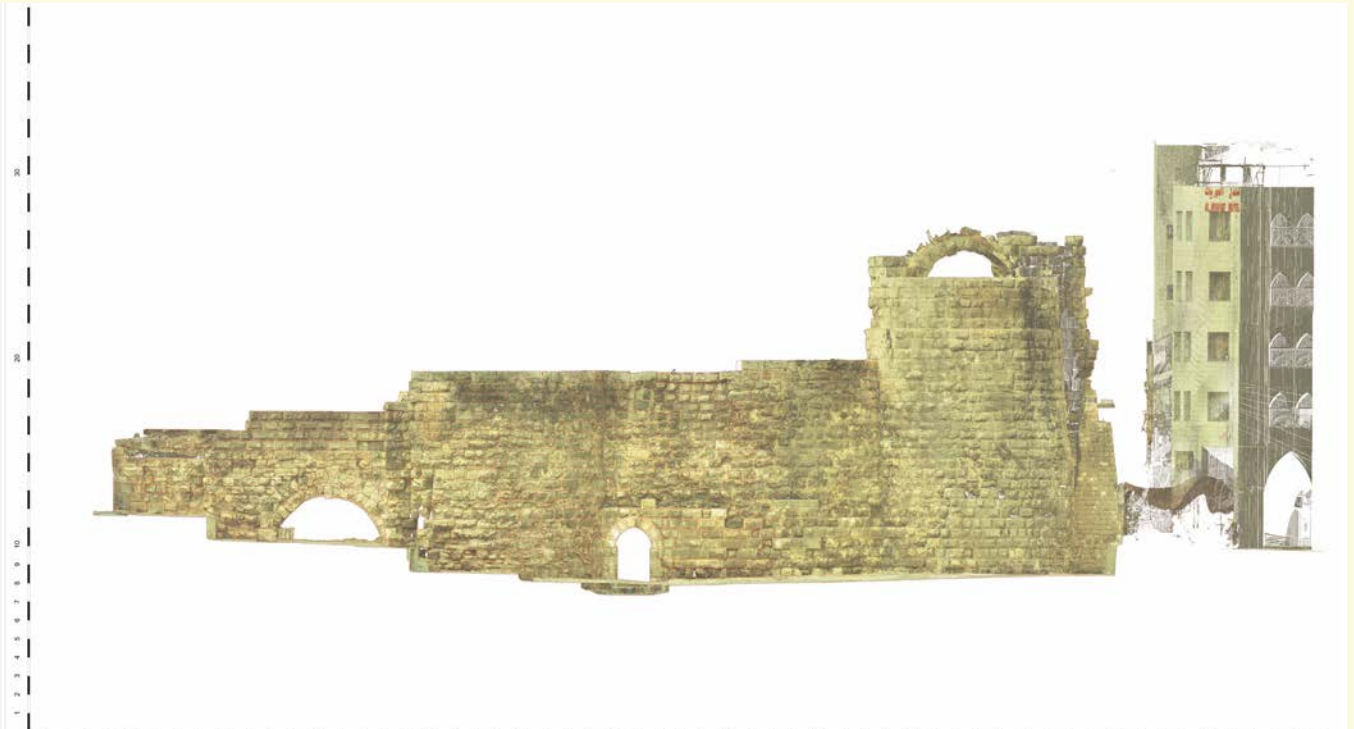
*Fig. 76: 2D Geometric Model, Elevation BB', external main façade - left portion, RGB texturized Giga photo with overlay of the line drawing scale 1:50. Due to the deformation caused by the inclined position of the right portion of the façade, the redrawing limited in this table only to the left part. The Giga photo on the right is thus added only to provide a complete reference and NOT for measuring purposes.*

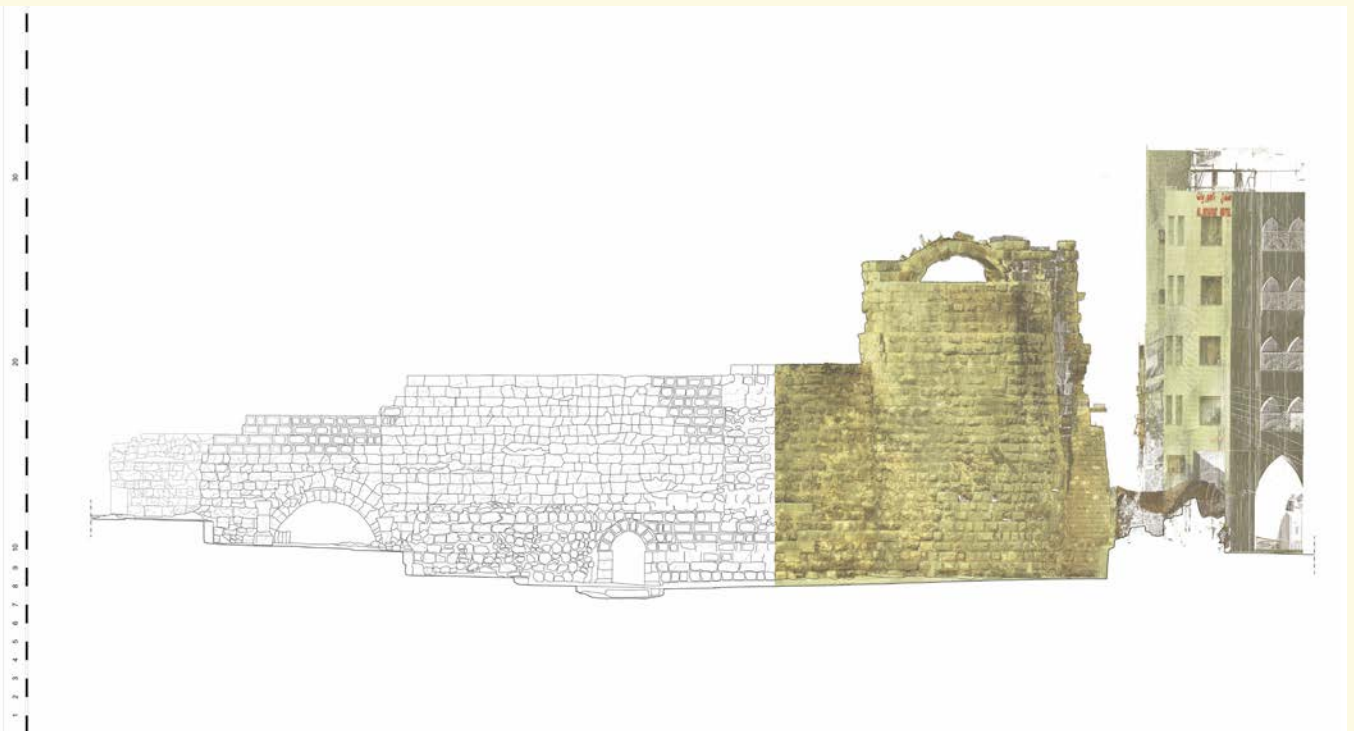
*Fig. 77: 2D Architectural Model, Elevation BB', external main façade - left portion, line drawing scale 1:50. Due to the deformation caused by the inclined position of the right portion of the façade, the redrawing limited in this table only to the left part. The Giga photo on the right is thus added only to provide a complete reference and NOT for measuring purposes.*

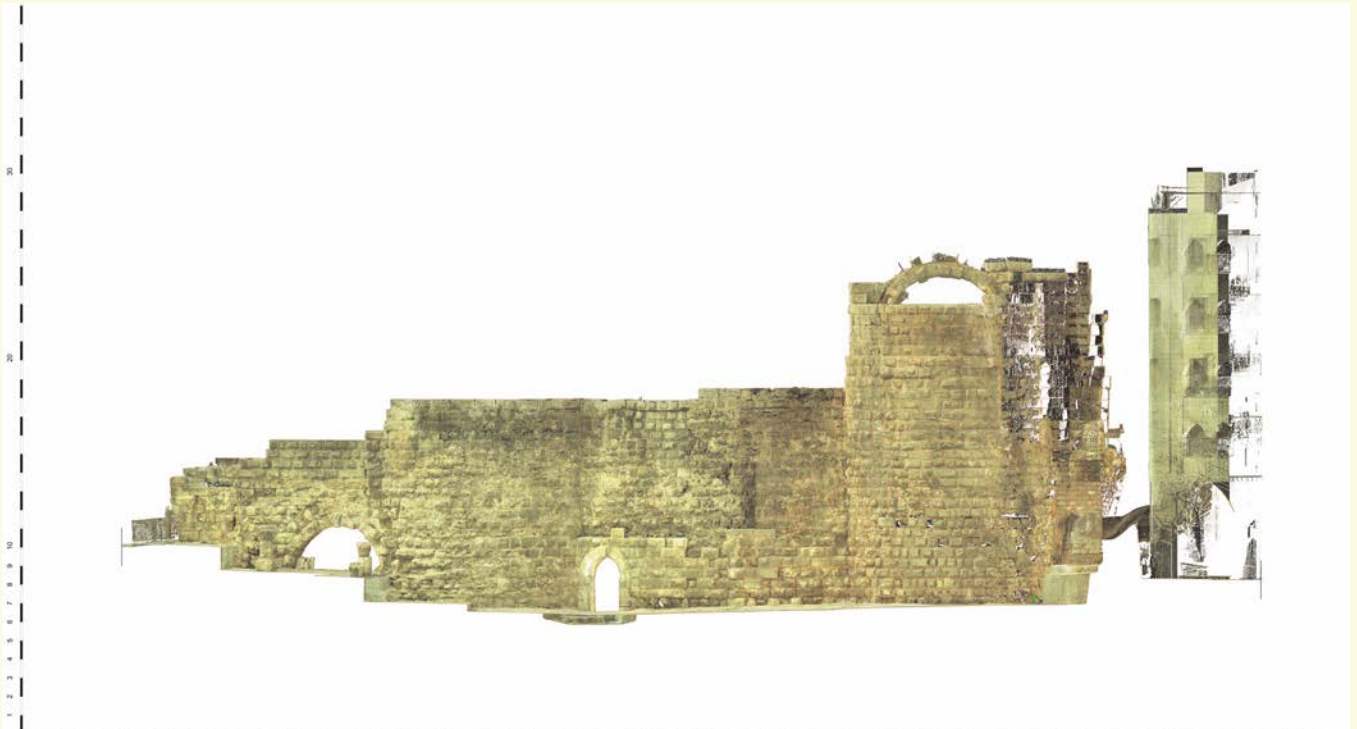
*Fig. 78: 2D Geometric Model, Elevation CC', external main façade - right portion, RGB texturized Giga photo with overlay of the line drawing scale 1:50. Due to the deformation caused by the inclined position of the left portion of the façade, the redrawing limited in this table only to the right part. The Giga photo on the left is thus added only to provide a complete reference and NOT for measuring purposes.*

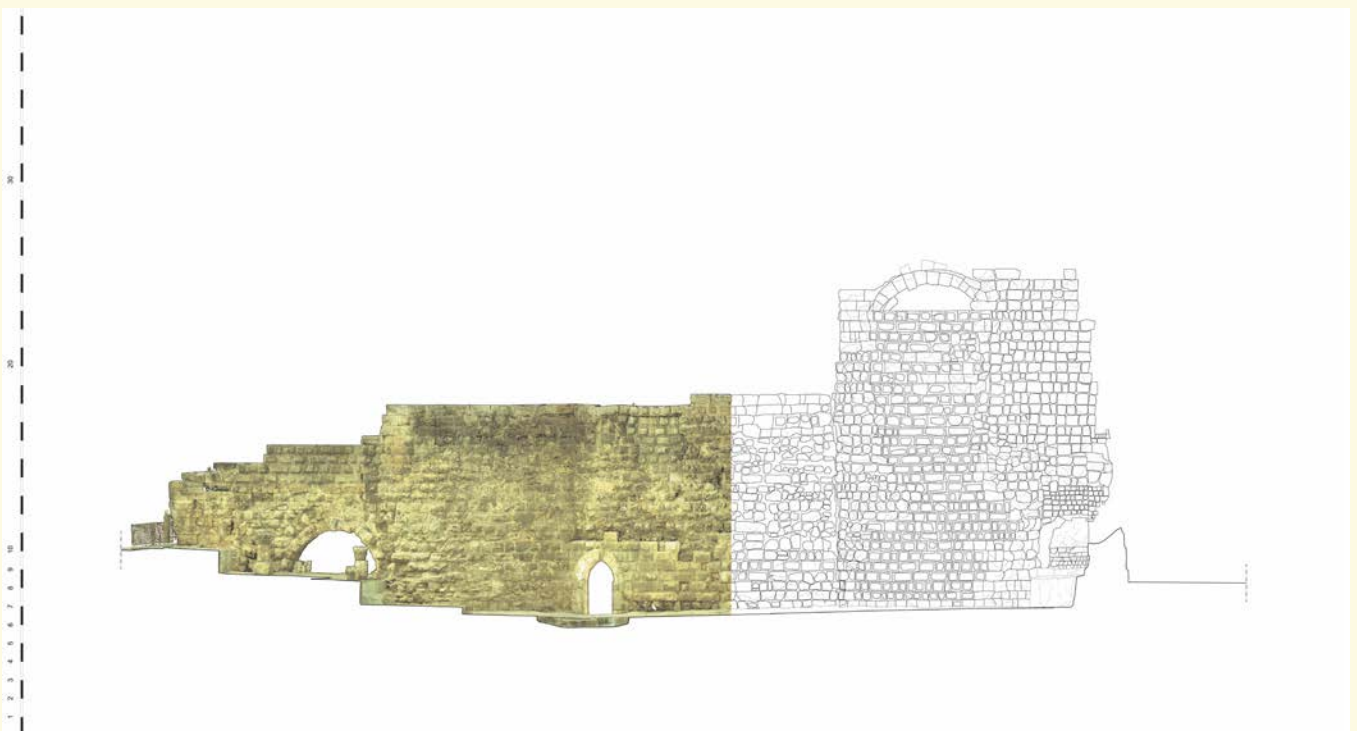
*Fig. 79: 2D Architectural Model, Elevation, external main façade - right portion, line drawing scale 1:50. Due to the deformation caused by the inclined position of the left portion of the façade, the redrawing limited in this table only to the right part. The Giga photo on the left is thus added only to provide a complete reference and NOT for measuring purposes.*

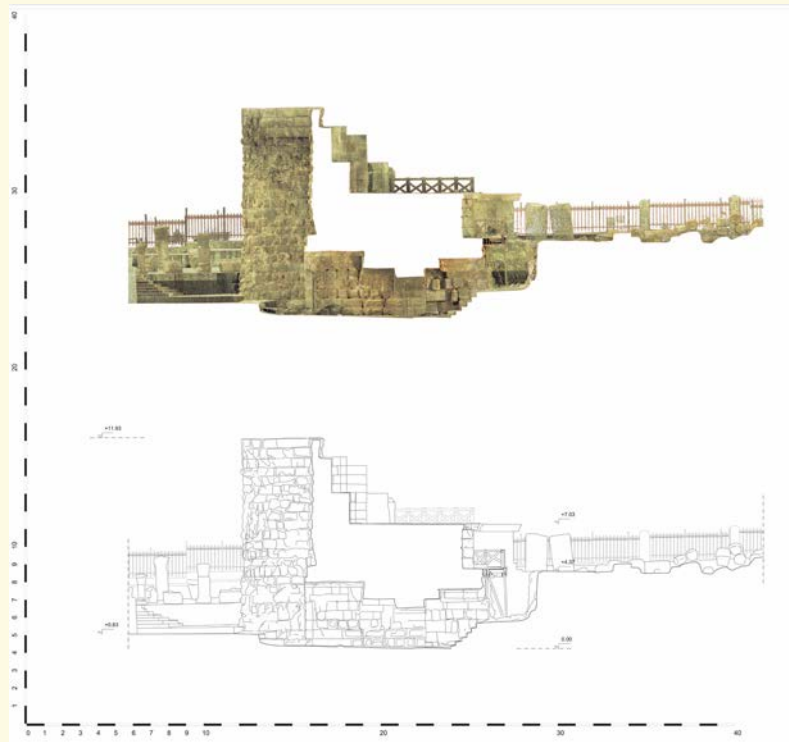
Fig. 81: 2D Geometric Model, Transversal Section EE' on the wall between the towers, RGB texturized Giga photo with overlay of the line drawing scale 1:50. 2D Architectural Model, line drawing scale 1:50.

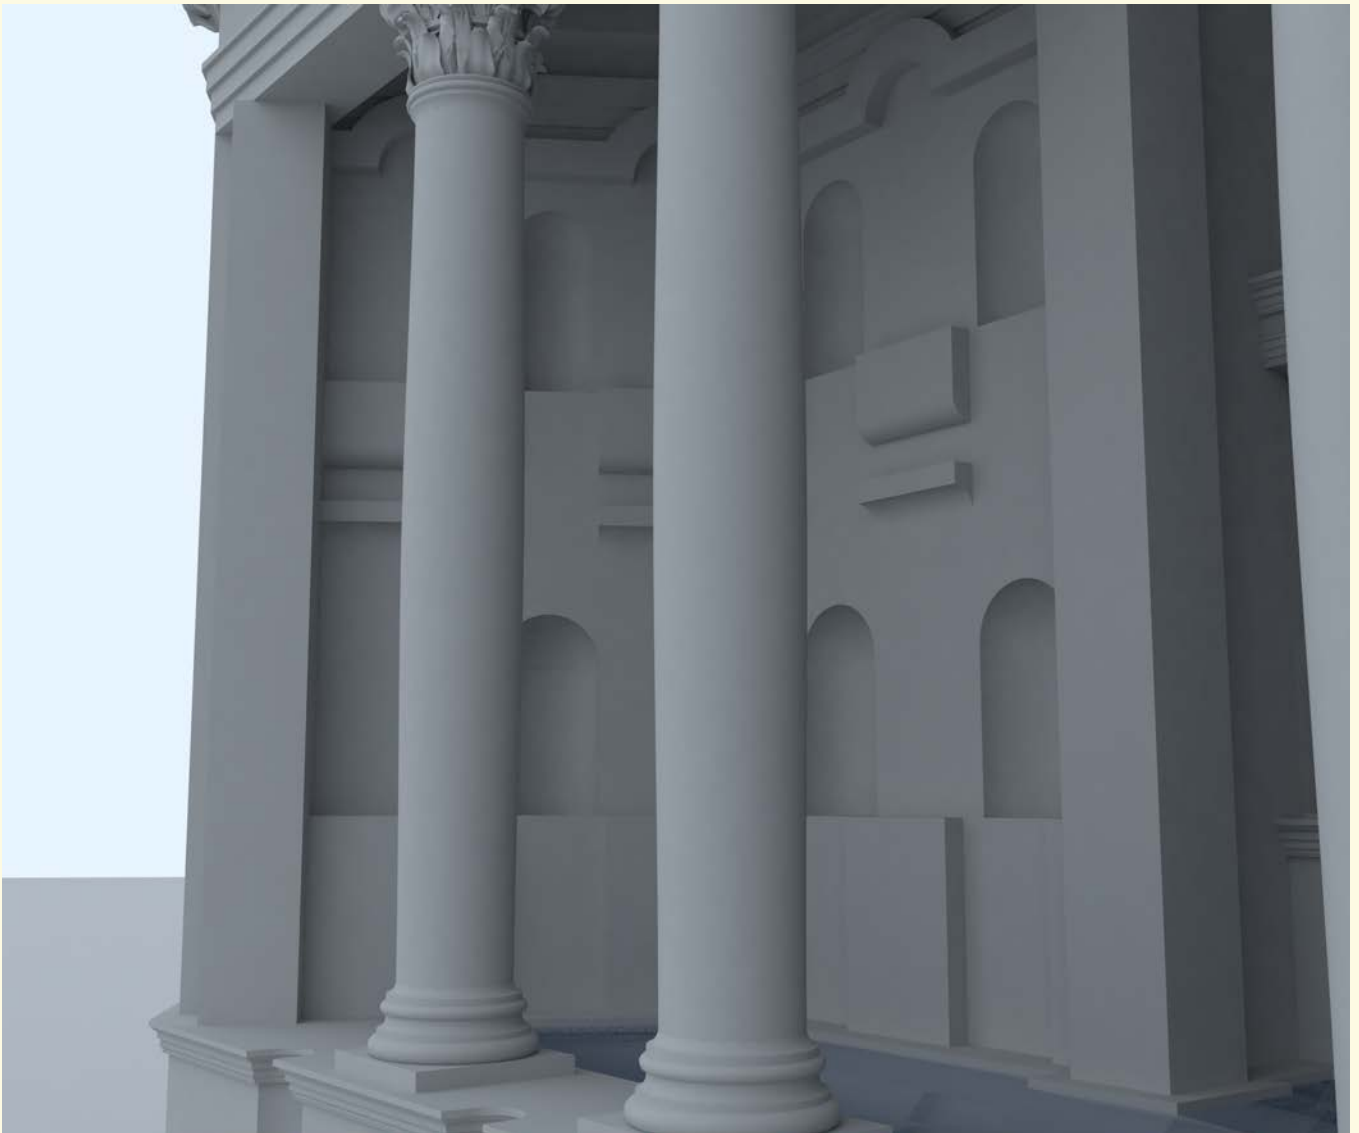
*Fig. 91: The 3D rendered model for the Nymphaeum showing the interior of the area of the constructed buttress in the eastern part of the monument*

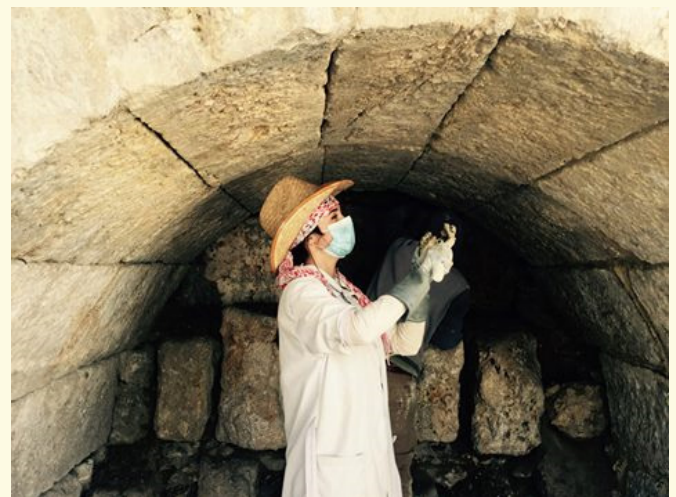
Fig. 99: One of the team members working on consolidation at a subterranean vault at the site

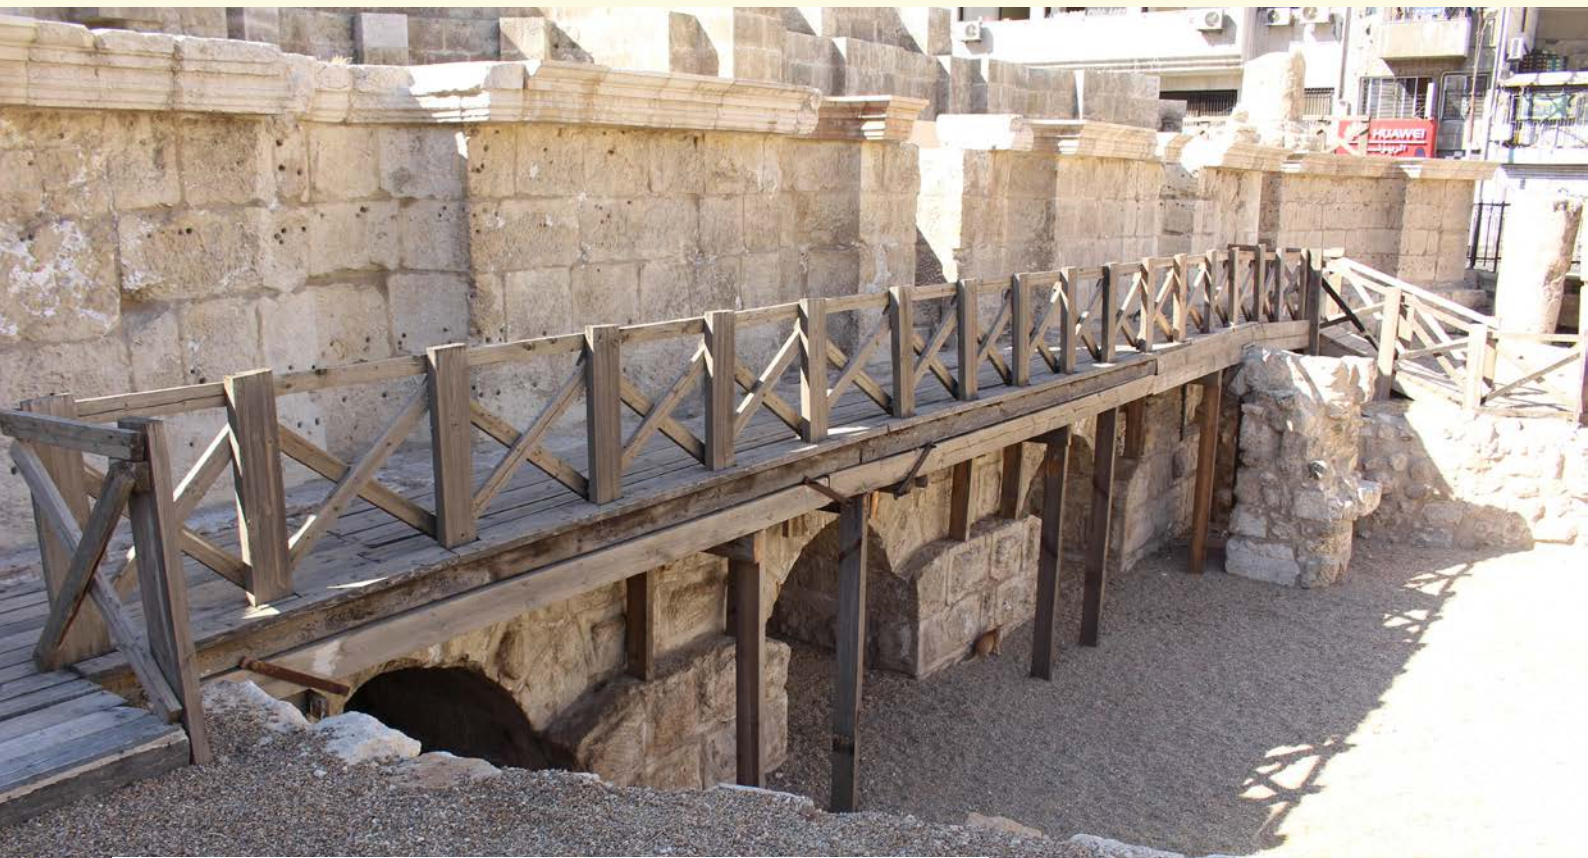
*Fig. 105: A view of the wooden bridge after being repaired and extended*

Other important intervention at the site is the fixing and replacement of the wooden bridge, platforms, and stairs. This intervention involved replacing damaged wooden beams and fixing the whole platform area on top of the basin to ensure safety, in addition to installing a platform and wooden stairs (figs. 130-132).

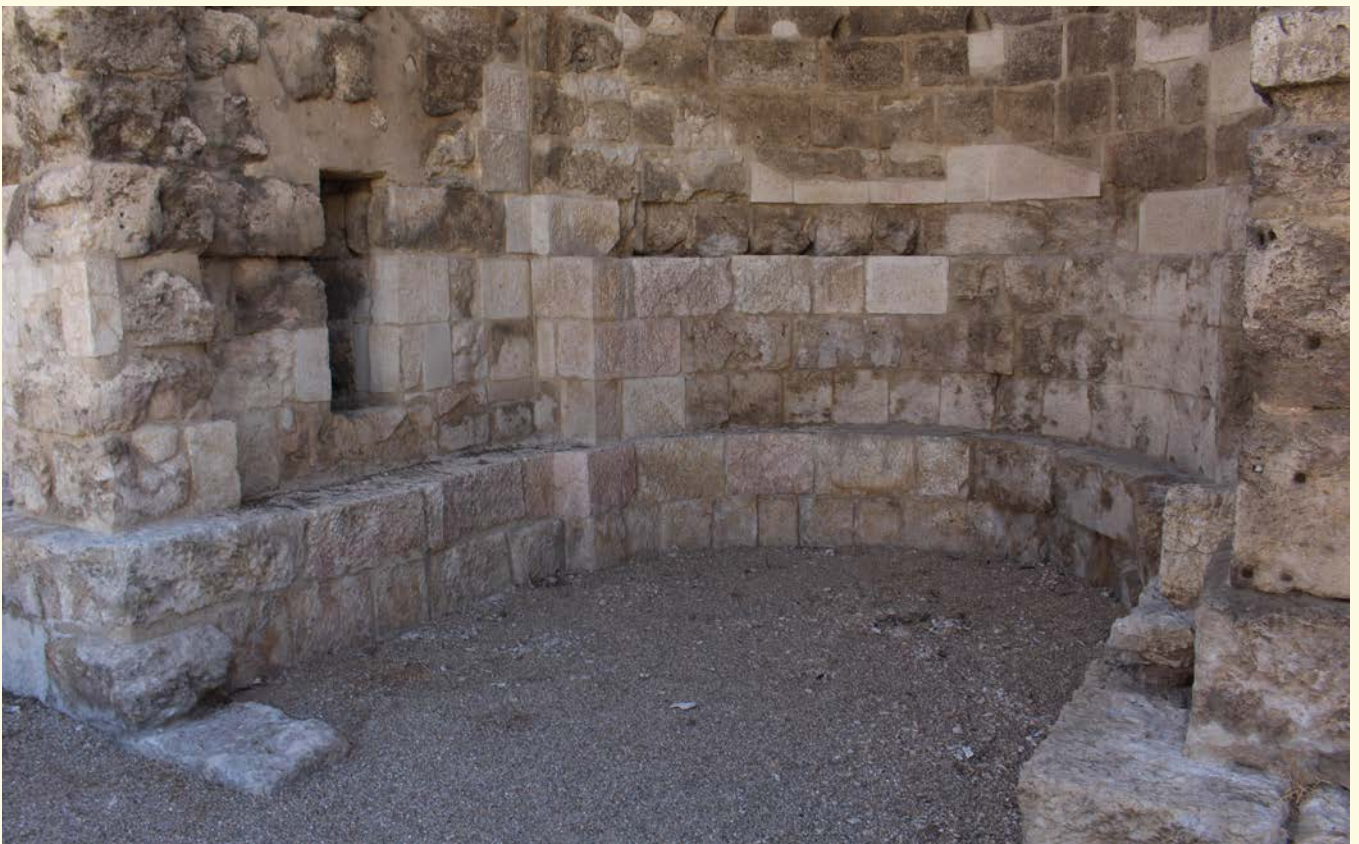
*Fig. 114: Basin after end of project restoration and conservation and the basin covered with gravel*

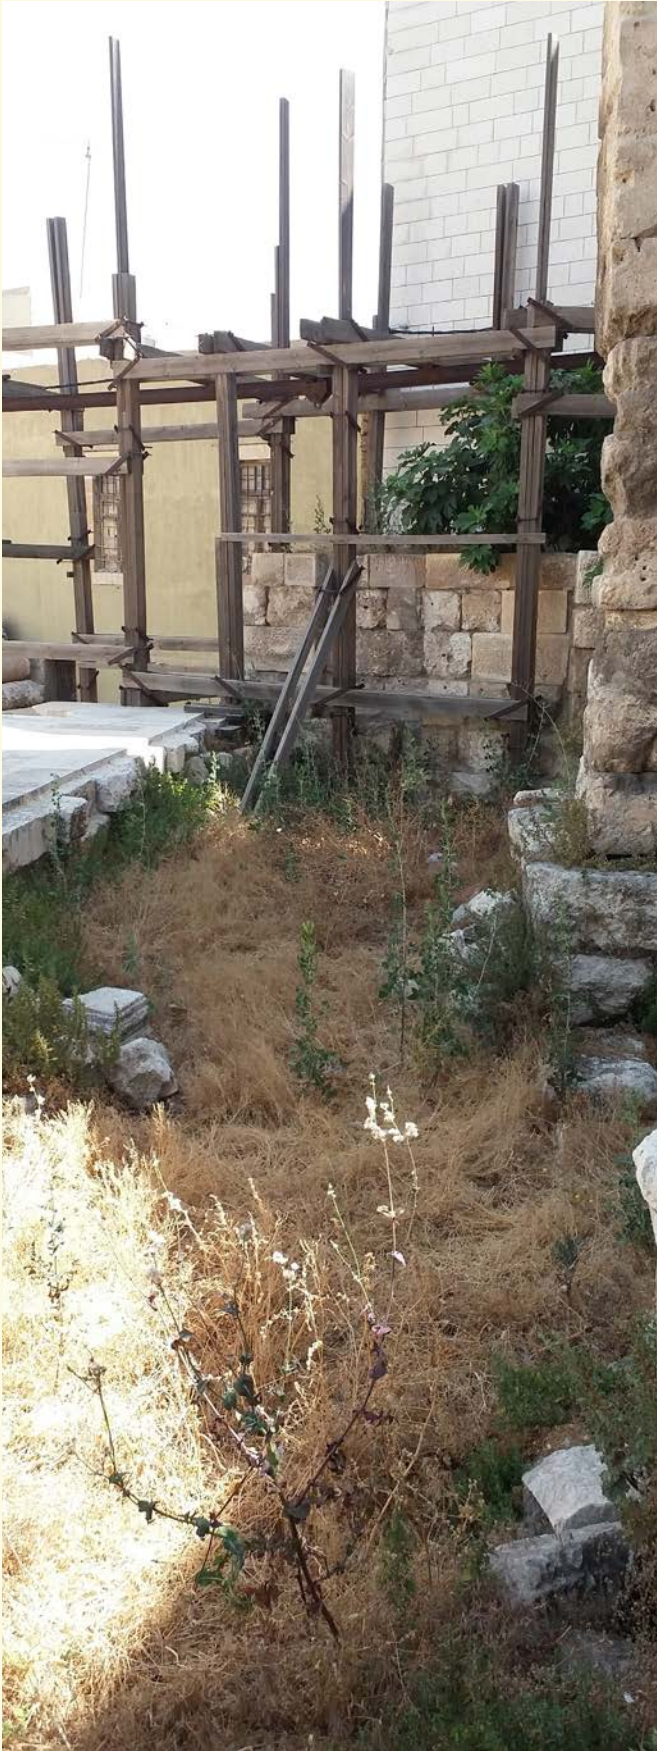
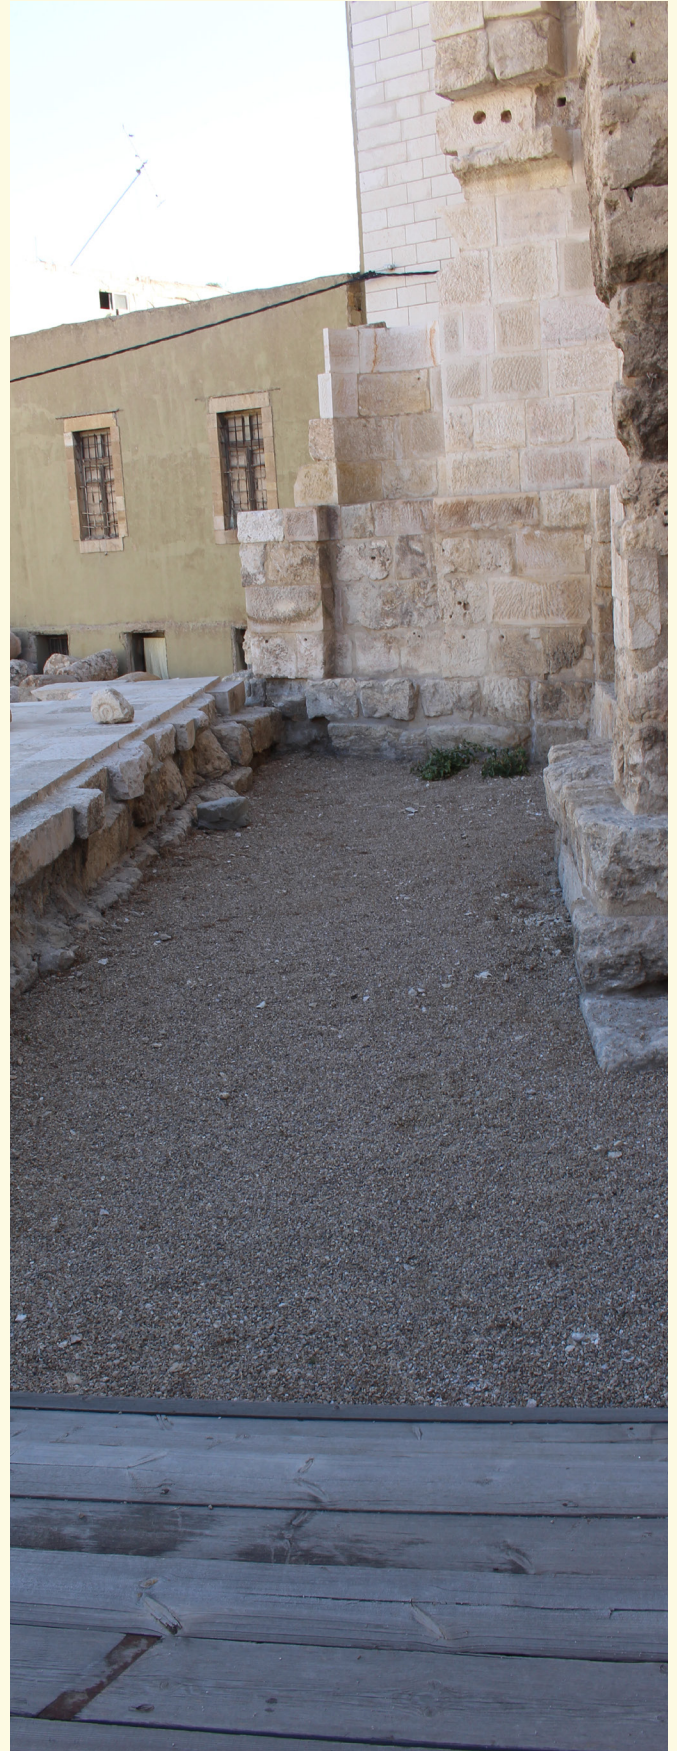
*Figs. 115-116: Basin before starting the project interventions (left) and after (right) end of project with all restoration and conservation interventions and the basin covered with gravel*

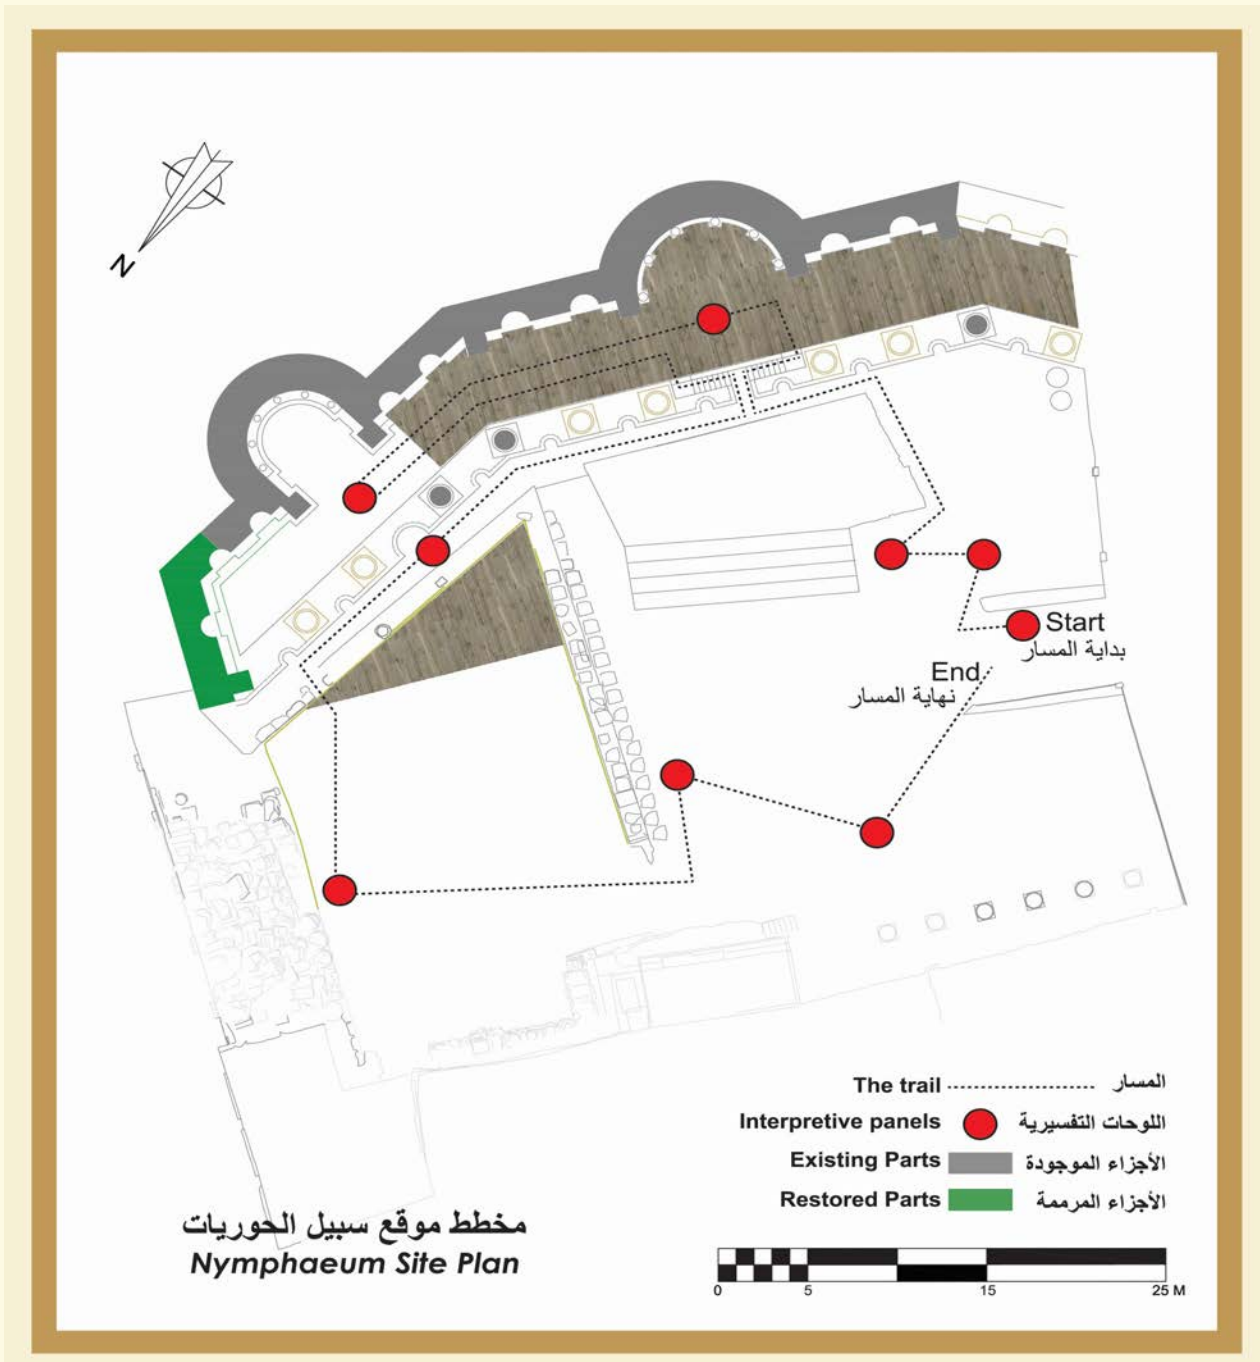
Fig. 128: Nymphaeum Site Plan with visitor circulation
