# Roman Nymphaeum in Amman Restoration and Rehabilitation

## **Restoration and Rehabilitation**

The Roman period Nymphaeum in Amman, considered to be the largest monument of its kind in ancient Provincia Arabia, had suffered from different deterioration factors that affected its state of conservation.

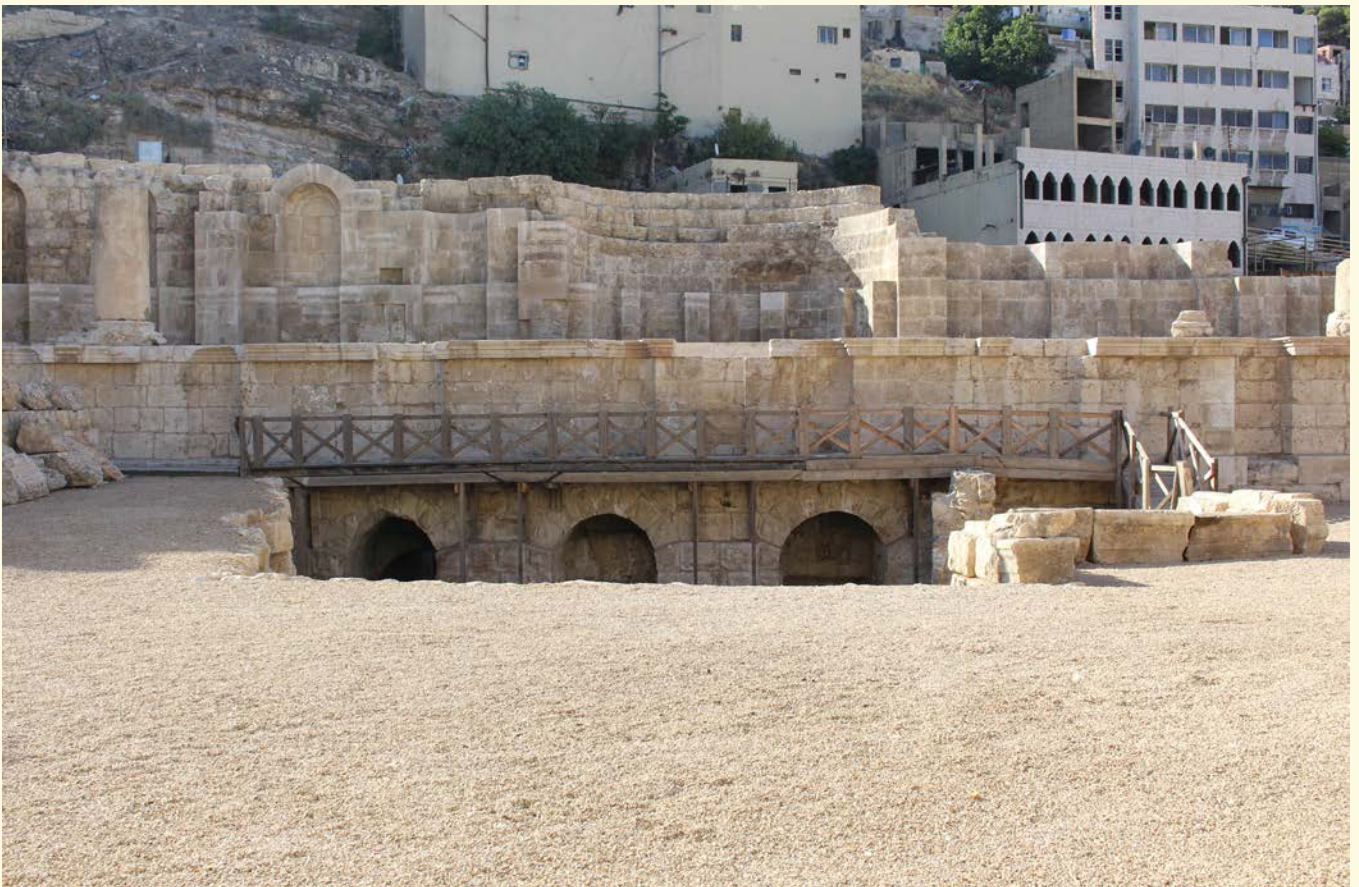
*Fig. 132: Front façade with the new bridge extension at the end of the project with all restoration and conservation works concluded and the site ground covered with gravel*

Other important intervention at the site is the fixing and replacement of the wooden bridge, platforms, and stairs. This intervention involved replacing damaged wooden beams and fixing the whole platform area on top of the basin to ensure safety, in addition to installing a platform and wooden stairs (figs. 130-132).
