An interdisciplinary approach to a knowledge-based restoration: the dark alteration on Matera Cathedral (Italy)

An interdisciplinary analytical campaign was carried out on the exterior walls of the Santa Maria della Bruna and Sant'Eustachio Cathedral in Matera. Large areas of these walls have become darkened and the main objective was to evaluate the state of conservation of the stone material (a very porous, organogenic limestone called "Pietra di Matera"), and to suggest the best strategy for the current restoration. Several techniques were used in situ and ex situ in laboratory analyses: X-ray diffraction, infrared spectroscopy, ion chromatography, pyrolysis/gas chromatography coupled with mass spectrometry, colour change measurements, laser-induced fluorescence together with biological techniques. Ex-situ and in situ cleaning tests were also carried out on the stone surface.

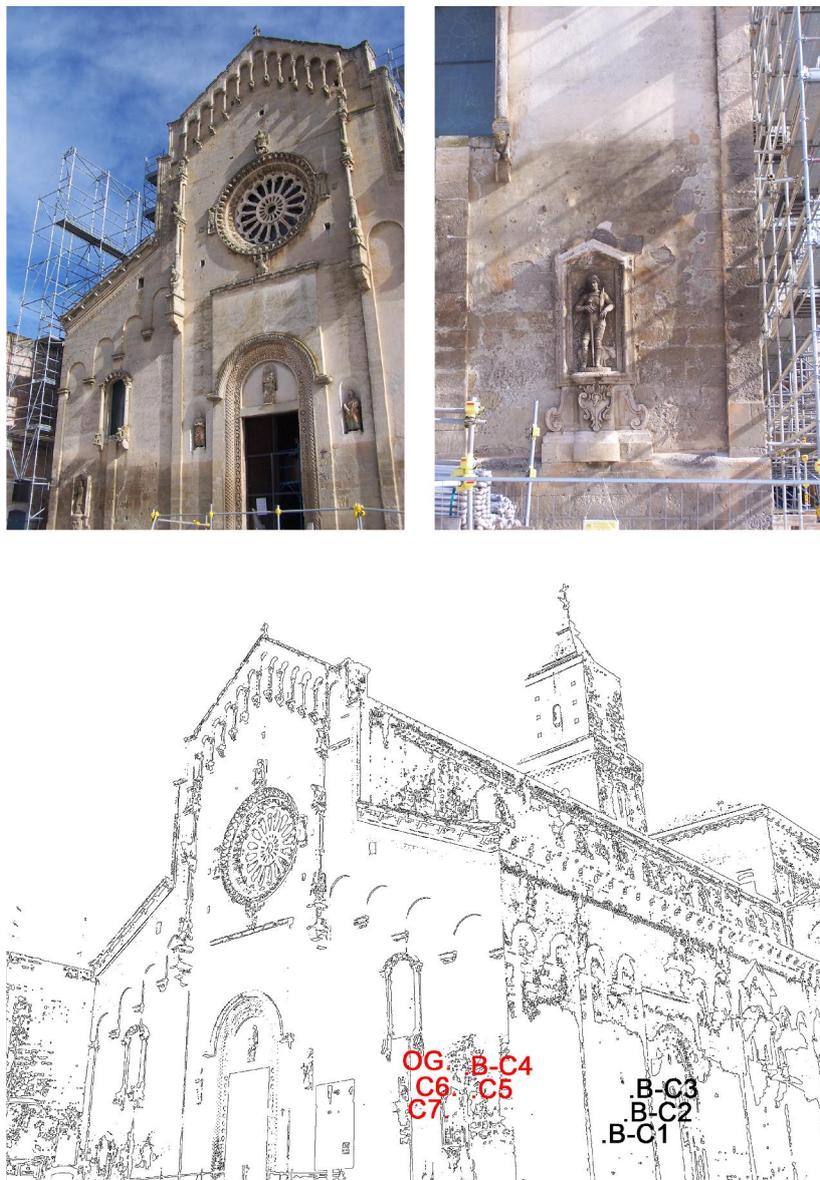
Fig. 1. Facade of Matera Cathedral (Matera, Italy) with the dark alteration in the lower part of the structure (up to 6–8 m) and details of the niche with St. Eustache statue (above). The provenance of the samples (bottom).

The exterior walls of the cathedral are made from the local organogenic limestone. The lower part of the walls (up to 6-8 meters) have become darkened since at least the beginning of the 20th century (Figure 1). This is of major concern because of the serious aesthetic damage to one of the most important landmarks in Matera. No historical information could explain the alteration, for example whether it originated from past surface protection treatments or to unknown phenomena affecting the stone inside.

Eight samples (C1-C7, OG) of “Pietra di Matera” and mortar (C4 sample) were taken from the stone surfaces of the southern wall and from the façade, both as powder and fragments scraped off the surface using a scalpel (Table 2). Selective sampling of C4 and C6 sample was carried out by a micro-lancet under an optical microscope, in order to analyse the three and two layers of the stratigraphy, respectively. The samples of powders for the biological analyses (B1-B4) were scraped off the surface with a sterile chisel (Table 2). Figure 1 shows the sampling points.

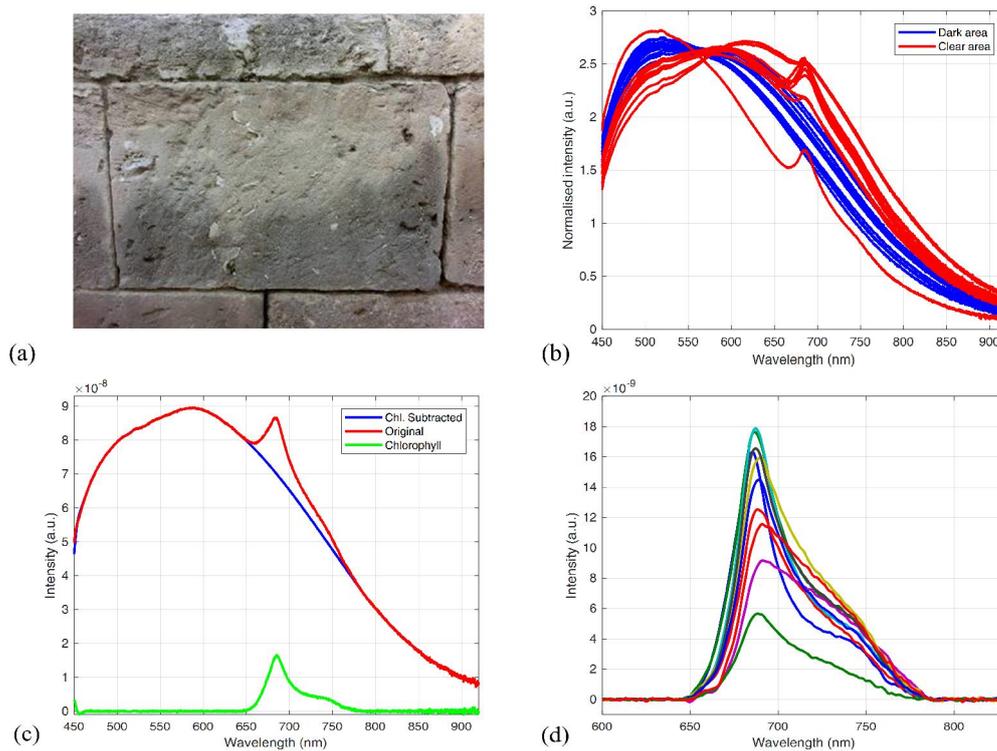
Fig. 2. LIF analysis of the ashlar of the southern wall: (a) Photographic image of one of the examined ashlar featuring the characteristic dark patina. (b) LIF spectra acquired in various spots of the ashlar, both in the upper and clear part of the ashlar (red lines) and in the lower and dark part of the ashlar (blue lines). (c) Procedure applied to the acquired LIF spectra (red line) in order to separate the fluorescence contribution of chlorophyll (green line) from that of the stone substrate (blue line). (d) Fluorescence of chlorophyll retrieved from the LIF spectra acquired in various spots of the dark area. All the LIF spectra were normalised in intensity to their standard deviation. (For interpretation of the references to colour in this figure legend, the reader is referred to the web version of this article.)

The LIF spectra were mainly acquired on selected ashlar of the southern wall and of the façade of the cathedral, focusing on those characterised by dark and clear areas. As an example, one of the examined ashlar is shown in Figure 2a.

For each ashlar, several LIF spectra were acquired in various spots of both the upper (clear) and lower (dark) part of the ashlar (Figure 2a). The spectra acquired on the dark part of the ashlar (blue-line spectra in Figure 2b) showed two main fluorescence contributions centred at about 510 nm and 610 nm. The spectra measured on the clear part of the ashlar (red-line spectra in Figure 2b) showed a similar spectral distribution to the one detected in the dark part (broad bands at about 510 nm and 610 nm), along with the typical fluorescence peak of chlorophyll at about 685 nm. In order to separate the fluorescence contribution of chlorophyll from the one due to the stone substrate, all the spectra were processed by interpolating the spectrum in the 640 nm - 800 nm spectral range (Figure 2c): the interpolated spectrum (blue line) was subtracted from the original one (red line) in order to determine the chlorophyll fluorescence spectrum (green line), which shows the typical main peak at about 685 nm and a shoulder at about 740 nm.

While most of the spectra acquired in different spots of the clear part of the ashlar showed a typical chlorophyll fluorescence peak, none of the spectra measured on the dark part of the ashlar showed any fluorescence contribution that could be attributed to chlorophyll. All the spectra measured in the clear part of the ashlar were processed by

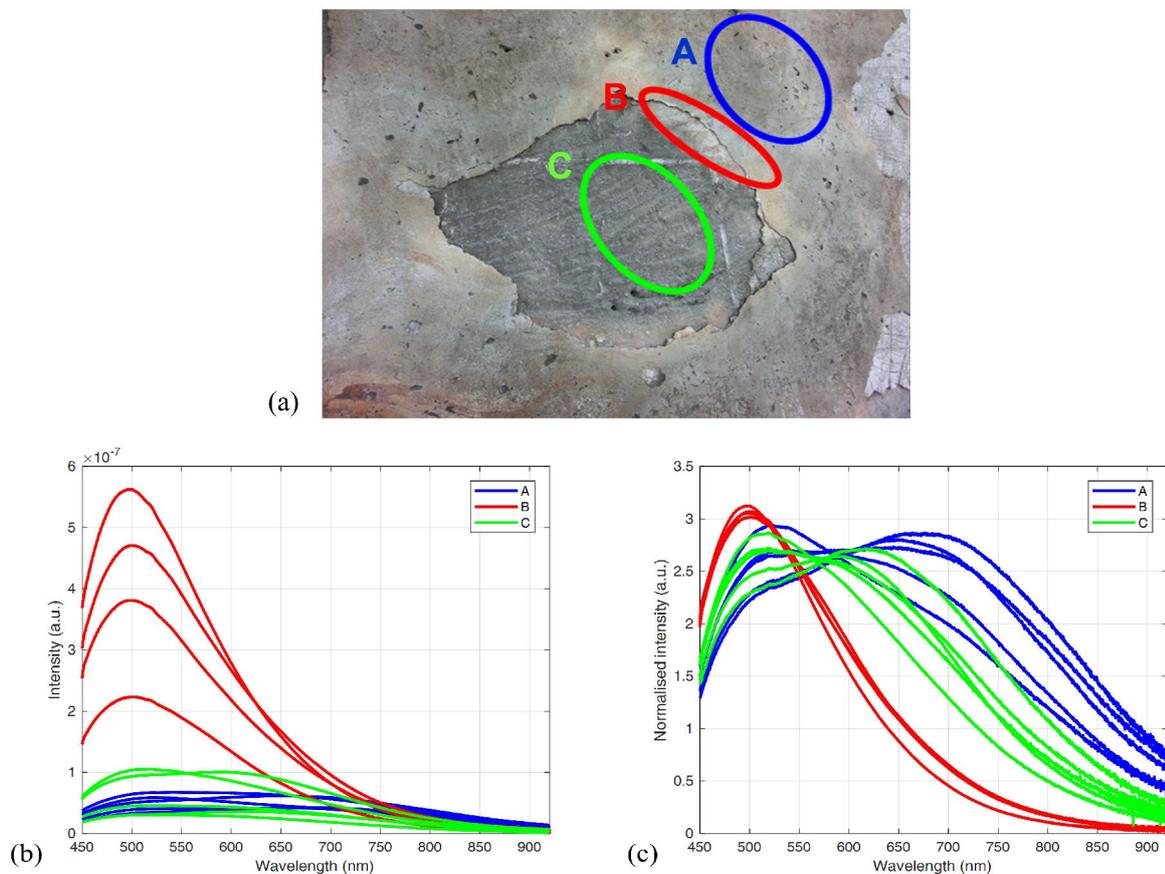
Fig. 3. LIF measurements on a plastered area of the cathedral's façade. (a) Photographic image of the examined area: three areas are highlighted in the photo: a plastered area (Area A), an area where the plaster was deliberately detached mechanically (Area B), and an area corresponding to a former gap in the plaster (Area C). (b) LIF spectra measured in the three different areas. (c) LIF spectra measured in the three different areas and normalised in intensity to the relative standard deviation.

The LIF technique was also used to study a plastered portion of the façade (Figure 3). The surveyed area included a plastered surface (Area A in Figure 3a), an area of stone ashlar from which the plaster was mechanically detached immediately before the measurements (Area B in Figure 3a), and an area with a large gap due to a previous plaster detachment (Area C in Figure 3a).

Figure 3b shows the LIF spectra acquired in the three different areas, while Figure 3c shows the same spectra normalised in intensity to the corresponding standard deviation in order to highlight their spectral distribution. Figure 3b shows that Area B (plaster removed before the measurement) has a high fluorescence efficiency, significantly greater than in the other two areas. Figure 3c shows that Area C has a very similar spectral distribution to that observed on the dark areas of other ashlar (Figure 3b, blue spectra), with two main fluorescence contributions at about 500-510 nm and 600-610 nm.

The spectra acquired in Area B are remarkably similar to the spectra that were acquired on a stone specimen obtained from an ashlar quarried out of an external wall of the cathedral (spectrum not shown in this paper). This suggests that the layer of plaster had in some way protected the stone from external agents, natural and/or artificial, which caused the darkening of large areas of the outer surface of the cathedral.

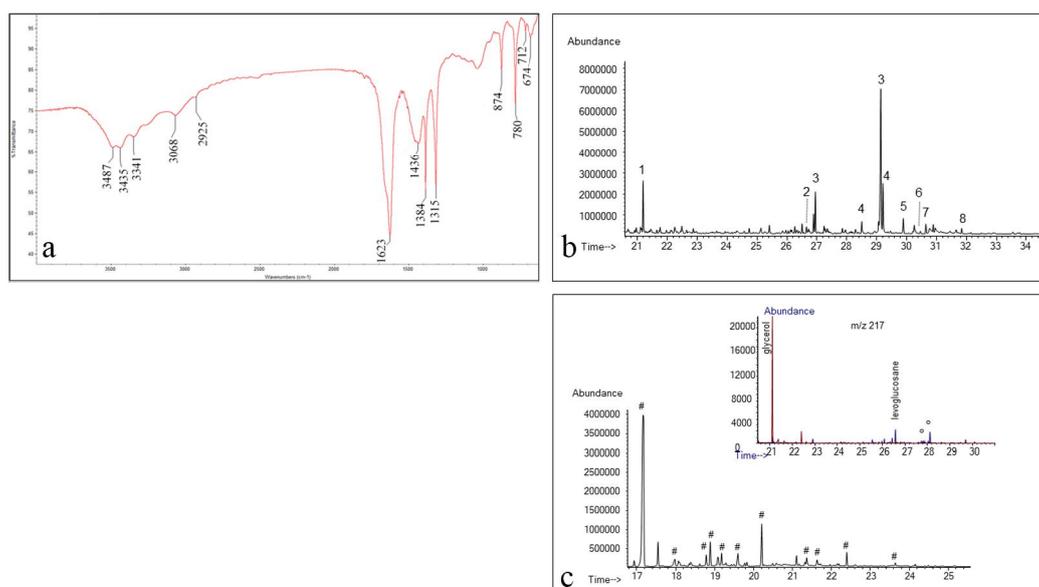
Fig. 4. (a) Transmission FT-IR spectrum of the external layer of sample C4, showing the presence of whewellite (3487, 3435, 3341, 3068, 1623, 1315, 780, and 674 cm^{-1}), calcite (1436, 874, and 712 cm^{-1}), alkalin nitrates (1384 cm^{-1}), traces of organic substances (2870–2980 cm^{-1}); (b) pyrogram of sample C3, with the most significant compounds identified: 1: glycerol, 2: levoglucosane, 3: arabinitol, 4: ribitol, 5: hexadecanenitrile, 6: mannitol, 7: palmitic acid, 8: octadecanenitrile, 9: inositol; (c) pyrogram of sample OG with the siloxane compounds marked (#) and in the upper part, the extract ion m/z 217, highlighting the markers of a saccharide source (glycerol, levoglucosane and other minors labelled with ‘°’).

The three layers that formed sample C4 showed signals of calcite and traces of organic matter. The features determined in the spectra of the external layer suggested the mineralogical phase of calcium oxalate monohydrate, which is whewellite ($\text{CaC}_2\text{O}_4 \cdot \text{H}_2\text{O}$) (Figure 4a). This identification was due to the presence of very specific bands at 3487, 3435, 3341 and 3068 (O-H stretching bands), 1623 and 1315 (C=O stretching vibration), 780 and 674 cm^{-1} (O-C-O bending vibrations) [29]. The intermediate layer contained gypsum, as shown by the typical peaks, which have already been discussed. The same absorbance signals of whewellite were recognized in the spectra of samples C5 and C7. The external layer of sample C6 was composed of gypsum, whewellite and organic compounds, whose peak pattern suggests a proteinaceous substance (2962, 2928, 2873, 1508, 1243 cm^{-1}).

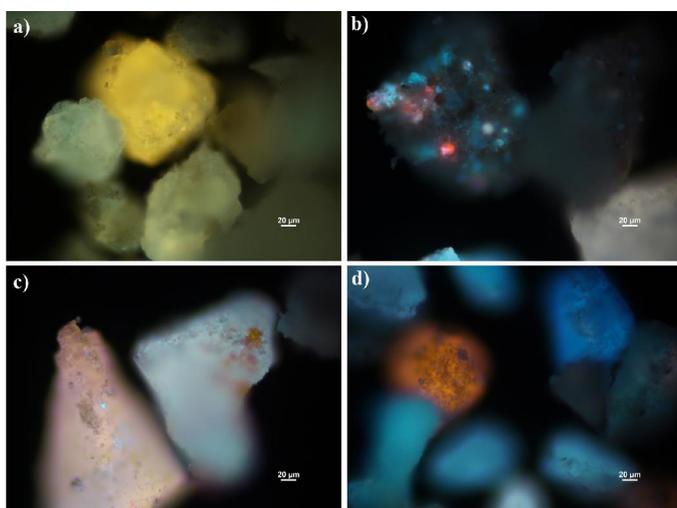
Fig. 5. Autofluorescence examples of the powder samples B1 (above, left), B2 (above, right), B3 (bottom, left) and B4 (bottom, right).

The powders of four samples, collected from the south wall (B1, B2, B3) and the façade (B4), were observed in epifluorescence with an optical microscope. They showed a red fluorescence due to the chlorophyll of photoautotrophs, and a yellow, orange or blue fluorescence ascribable to the presence of other unidentified organic products (Figure 5). Sample B4 had a lower microbial contamination than the other samples characterised by a greater biodiversity, especially compared to sample B3 (Table 5). The fungal strain *Alternaria* sp. was present in almost all the samples, except B4.

In the nutrient media BG₁₁M used for the development of phototrophic microorganisms, the coccoid cyanobacteria of the family of *Xenococcaceae*, with spherical mucilaginous colonies were dominant in all the samples, except for sample B4 where the presence of phototrophs was insignificant. Light and deep pink pigmented bacteria (cocci and rod-shaped) were observed, above all in samples B1, B2 and B3 in the heterotrophic nutrient media (PCA). Some of these bacterial colonies showed a pink (B1 sample) or yellow (B2 sample) autofluorescence.

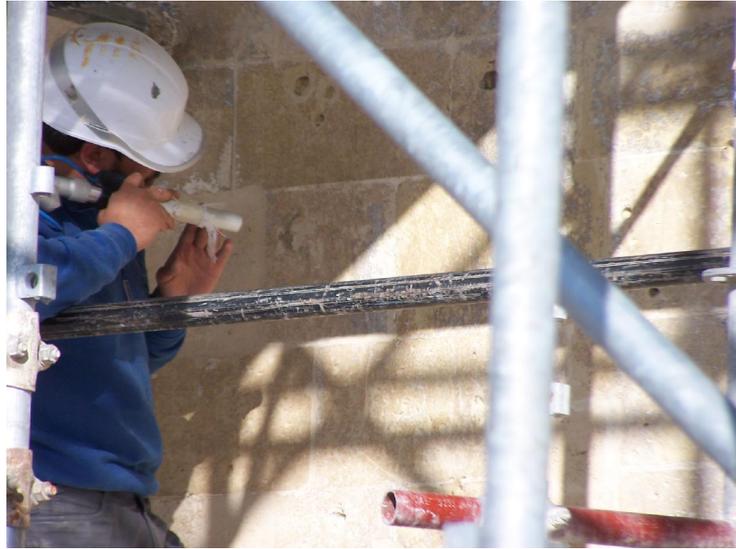
Fig. 6. Laser cleaning of a limited area on the tufa stone surface of the Matera Cathedral.

Laser technology was used on a limited area of the carved surface of the cathedral that had been altered by hard layers of dark films that were still present even after the previous cleaning treatments cited above (Figure 6). The laser cleaning proved to be: i) selective, the laser radiation was absorbed by the superficial dirt without affecting the substrata; ii) adjustable, the beam power, frequency and laser spot diameter could be selected according to the operator's needs; iii) highly effective without the need to pre-consolidate the stone.

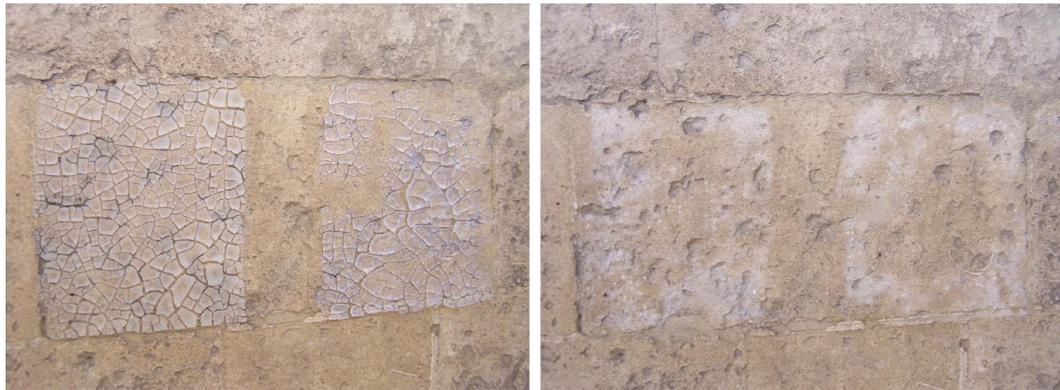
Fig. 7. In situ biocleaning test performed on the lateral wall of Matera cathedral; laponite biogel bacteria, after 48 h of bioapplication, before (left) and after (right) the soft biogel removal.

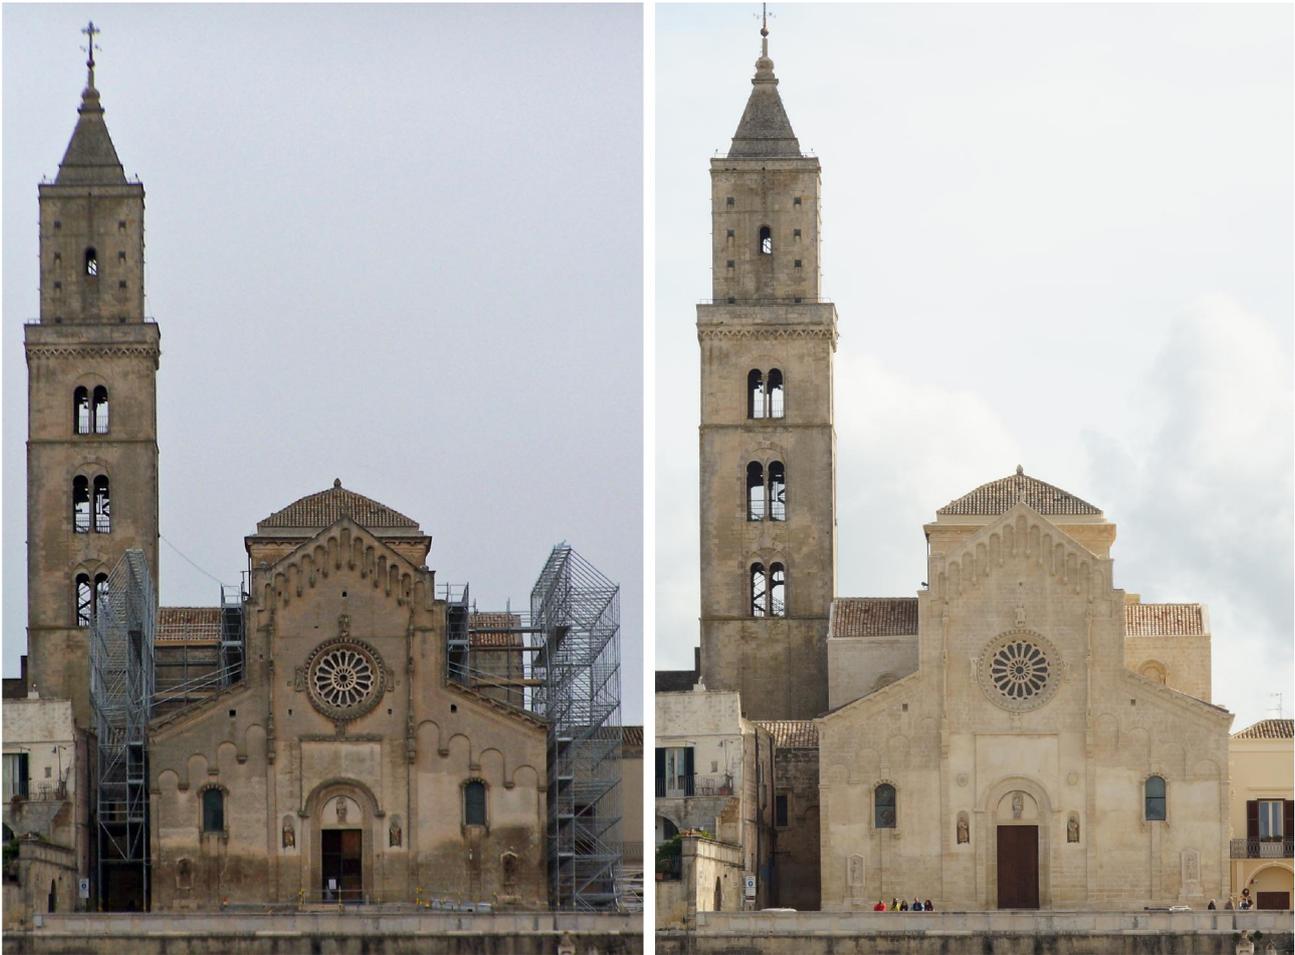
Fig. 8. Matera Cathedral before (left) and after (right) the conservation work reported here.
