**Proceedings of the  
Inter-ISC'18**

**Anti-Seismic Vernacular  
Heritage of Anatolia and  
Beyond**

**Proceedings of the Inter-ISC'18  
ICOMOS Inter-ISC Meeting & Colloquium  
July 10-13, 2018 Kastamonu, Turkey**

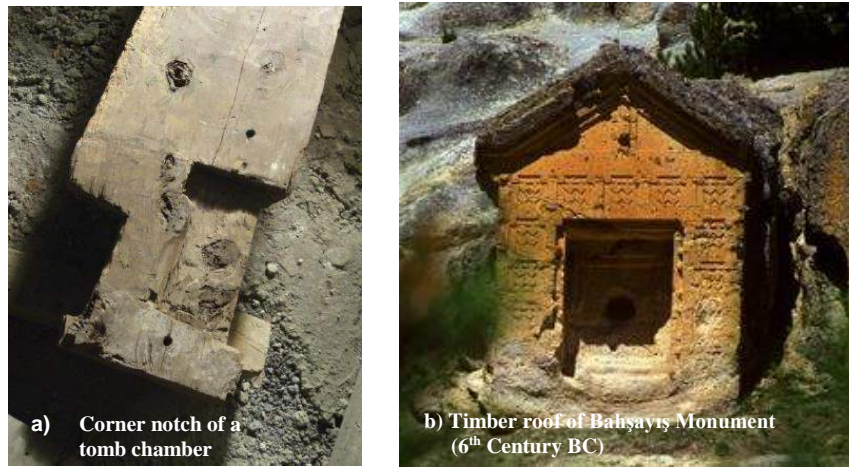
**Figure 1** Ancient timber construction

Wood is one of the earliest building materials used in many parts of the world. The rock reliefs, drawings, traces of timbers on stone masonry, and written sources show that timber construction was also highly appreciated in ancient Anatolia. The technical implementation of timber construction, especially in the densely wooded regions as Paphlagonia in north, Phrygia in middle and Lycia in west of Anatolia, were from the Bronze Age in all fields of structures [1]. Archaeological excavation reports of Gordion, the former capital of Phrygia, mentions that tomb chambers from 9th to 6th century BC were constructed like log houses (Fig. 1a) [2]. Traces on the stone walls show that roofs of large town halls spanning more than 15 meters, temples spanning 10 meters were of timber trusses of cedar. And tombs were spanned by simple timber purlins (Fig. 1b) [3].

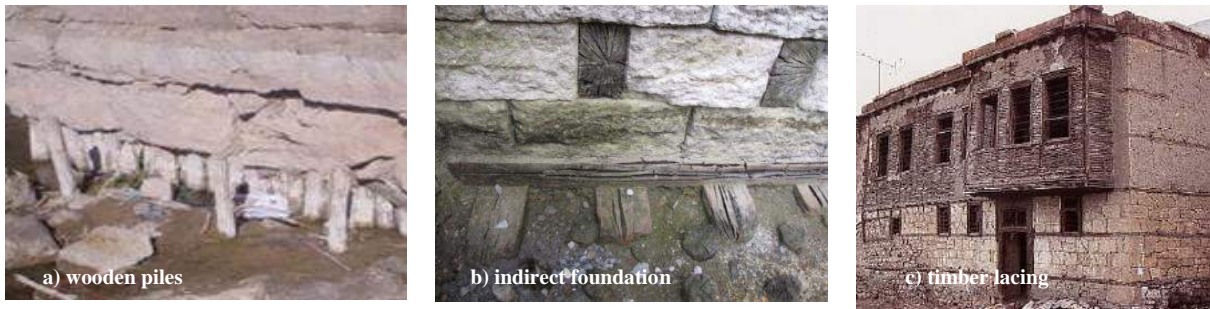
**Figure 2** Use of wood in masonry construction

Besides forming the walls, floors and roofs of timber buildings, wood has been traditionally used in the construction as piles for ground consolidation (Fig. 2a), as indirect foundations in case of poor soil conditions (Fig. 2b) and as horizontal timber lacing to tie two faces of load bearing masonry walls (Fig. 2c).

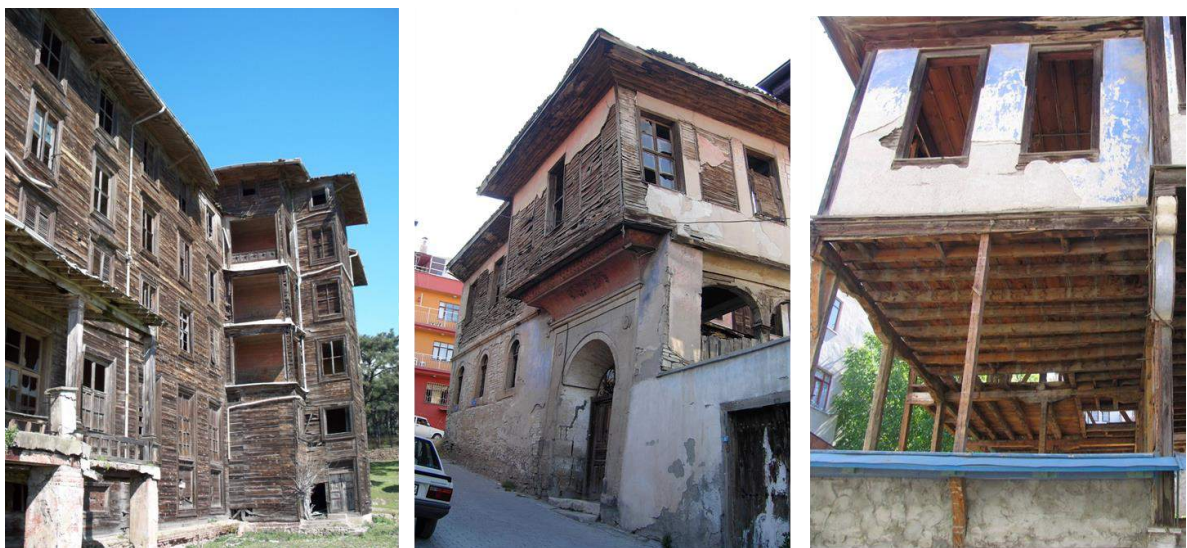
**Figure 3** Timber houses rise on foundation wall, on masonry wall and on columns

The timber walls of one or more stories in height were supported on the foundation walls, on timber laced masonry walls of the ground floor or raised on cripple studs or post and beam supports (Fig. 3). In the first two cases, the masonry wall top is first covered with a layer of lime and timber sill beam forming a level set for the timber wall. The foundations of timber walls were of masonry, later of concrete. The footings of the timber columns are either anchored in concrete or masonry foundations or placed on a big footing stone.

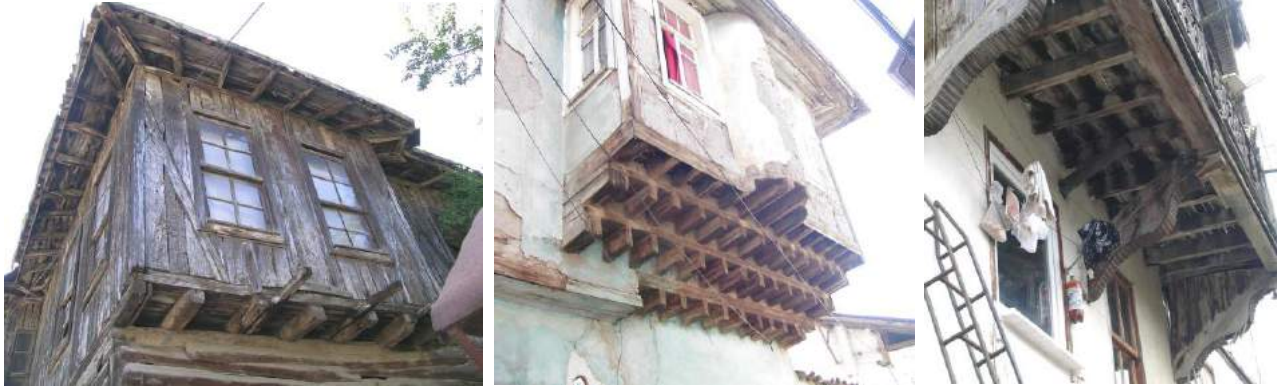
**Figure 10** Cantilevering joists

The walls having cantilevering joists projecting out about 60 cm help to give additional strength to the wall below against lateral forces. Longer cantilevering joists are supported in various ways. The upper story's wall rises from the end of the cantilever because the walls are light enough to be supported on the cantilevered timbers (Fig. 10).

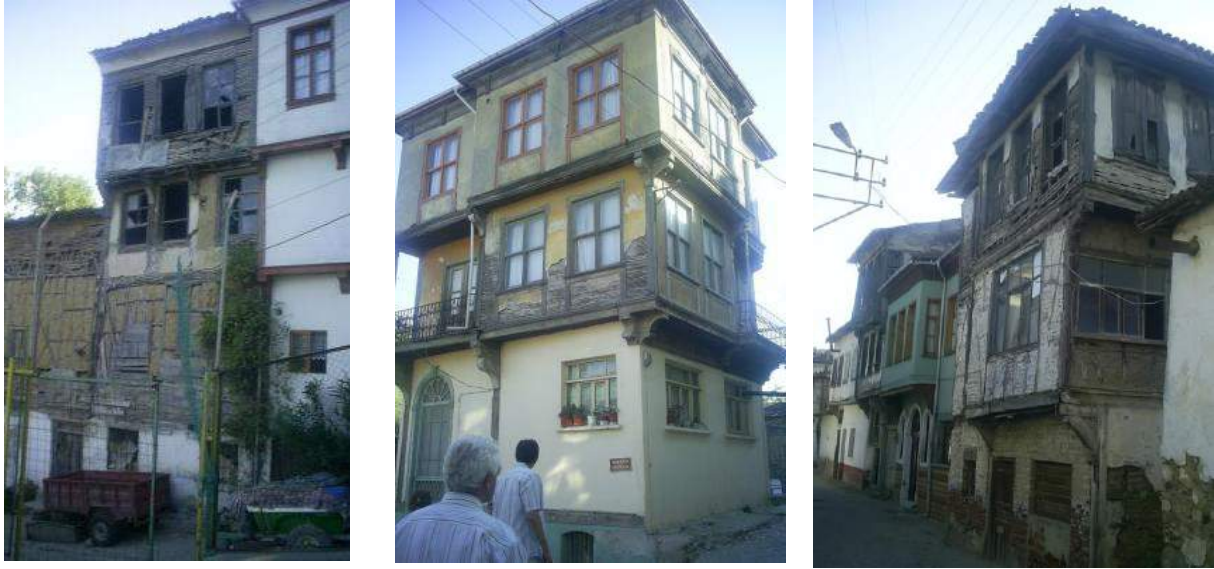
**Figure 11** Timber buildings getting progressively lighter

The traditional multi-storey dwellings in seismic areas are constructed getting progressively lighter both with construction material and the thickness of the wall. These are constructed with a heavy wall as stone masonry at ground floor; timber frame filled with brick or adobe masonry solid then with cavity brick walls at intermediate level and wattle or lathed wall construction at upper floors (Fig. 11). The building getting lighter at upper floors make the timber frame at top more ductile and therefore more able to meet the higher seismic demands that occur at upper levels.

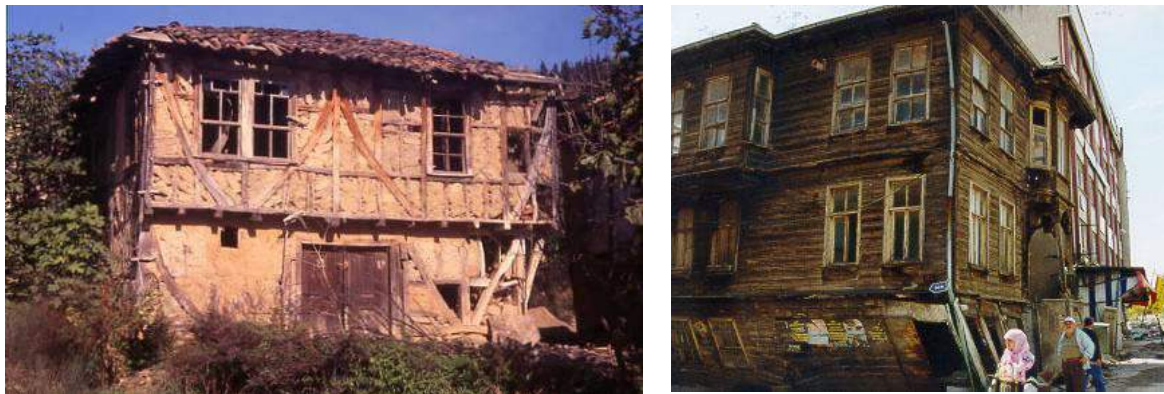
**Figure 12** Earthquake damages

Traditional timber constructions with monotonous repetition of wooden joists, studs and rafters have numerous load paths and are considered structurally redundant in providing level of safety in earthquakes without loss of their integrity. Thus, this redundancy of elements with a high level of energy-dissipating capacity leads to the good performance during earthquakes. Masonry infill falling out of the frame and cracks in the plaster are considered a nonstructural damage that dissipates a lot of earthquake induced energy (Fig. 12a).

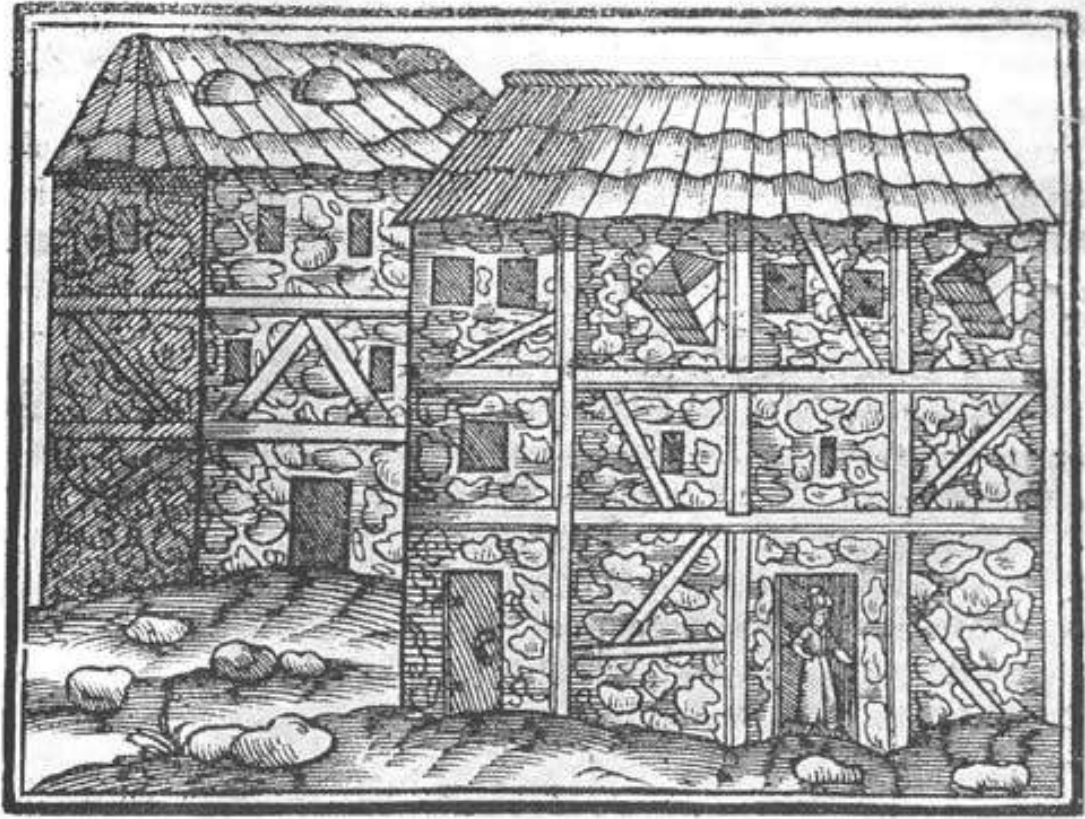
**Figure 2:** 17<sup>th</sup> century *hımış* Istanbul house depicted in the Salomon Schweigger's travel book. [3]

Istanbul houses were depicted in travel accounts as timber framed buildings with adobe or brick infill since the very beginning of the 17<sup>th</sup> century (**Fig. 2**) [3]. Local sources from the 17<sup>th</sup> century, such as Ottoman judicial records or cost estimates use the term **infilled wall** (*dolma duvar*) or only the word **infill** (*dolma*) in order to describe the construction technique of a timber framed building [4, 5]. The word **framework** (*çatma*) was another term used in the 17<sup>th</sup> century pious foundations' records, to specify the infilled timber frame construction technique of a one or two storey Istanbul houses [6]. Very few of the *himiş* Istanbul houses have survived today. Most of those are in ruinous state with many inappropriate additions. (**Fig. 3**) Sedad Hakkı Eldem had a chance to record the structural features of 18<sup>th</sup> century *himiş* houses in Istanbul or in nearby towns during the first half of 1900s. Köçeoğlu mansion and Yasinci mansion built on the Bosphorus in the 18<sup>th</sup> century were two of the masonry infilled timber framed buildings recorded by Eldem. (**Fig. 4 and 5**) Masonry infilled timber frame was not applied only in the constructions of grandiose mansions, the timber framed buildings constructed in poor neighbourhoods of the city prior to mid-19<sup>th</sup> century were also built with masonry (stone or adobe) infilled timber frame. (**Fig. 3 and 6**)

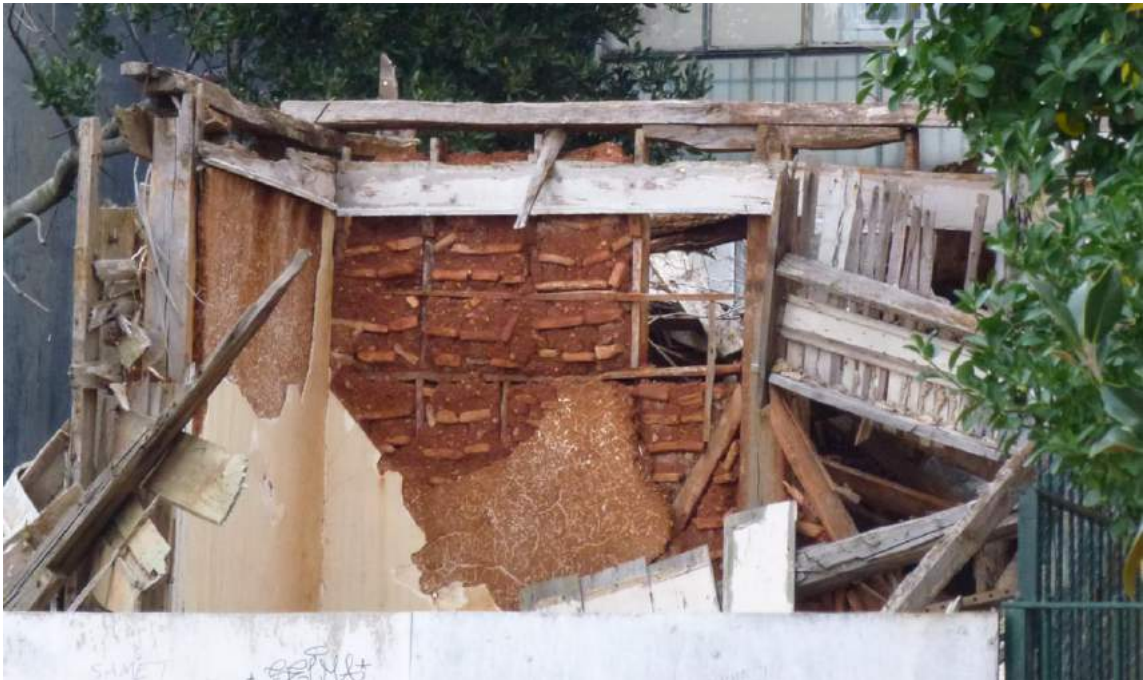
**Figure 3:** Timber frame with brick infill from the beginning of the 19<sup>th</sup> century in a demolished house in Prinkipo Island/Istanbul (2014) (Photo: D.Acar).

*Himiş* houses constructed in poor neighbourhoods used adobe (*kerpiç*) or rubble stone built with earthen mortar as an infill, whereas in more prosperous houses the infill was built with brick and lime mortar (*horasan*). Brick was a relatively expensive material and mostly the mortar joints were done wider than the brick layer. (**Fig. 3 and 4**)

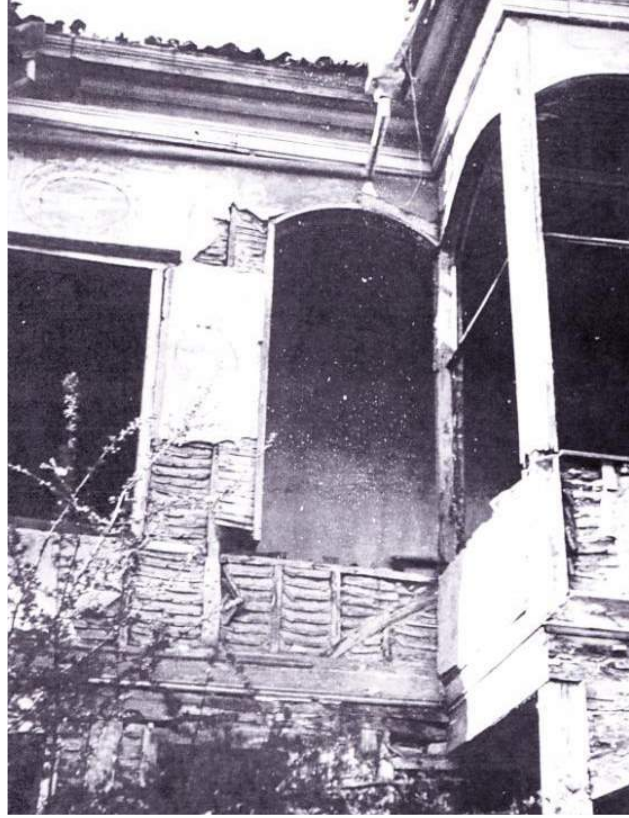
**Figure 4:** Masonry (brick) infilled timber frame of Köçeoğlu mansion built in the 18<sup>th</sup> century in Bebek/Istanbul and pulled down in 1941 (Photo: Sedad Hakkı Eldem) [7]

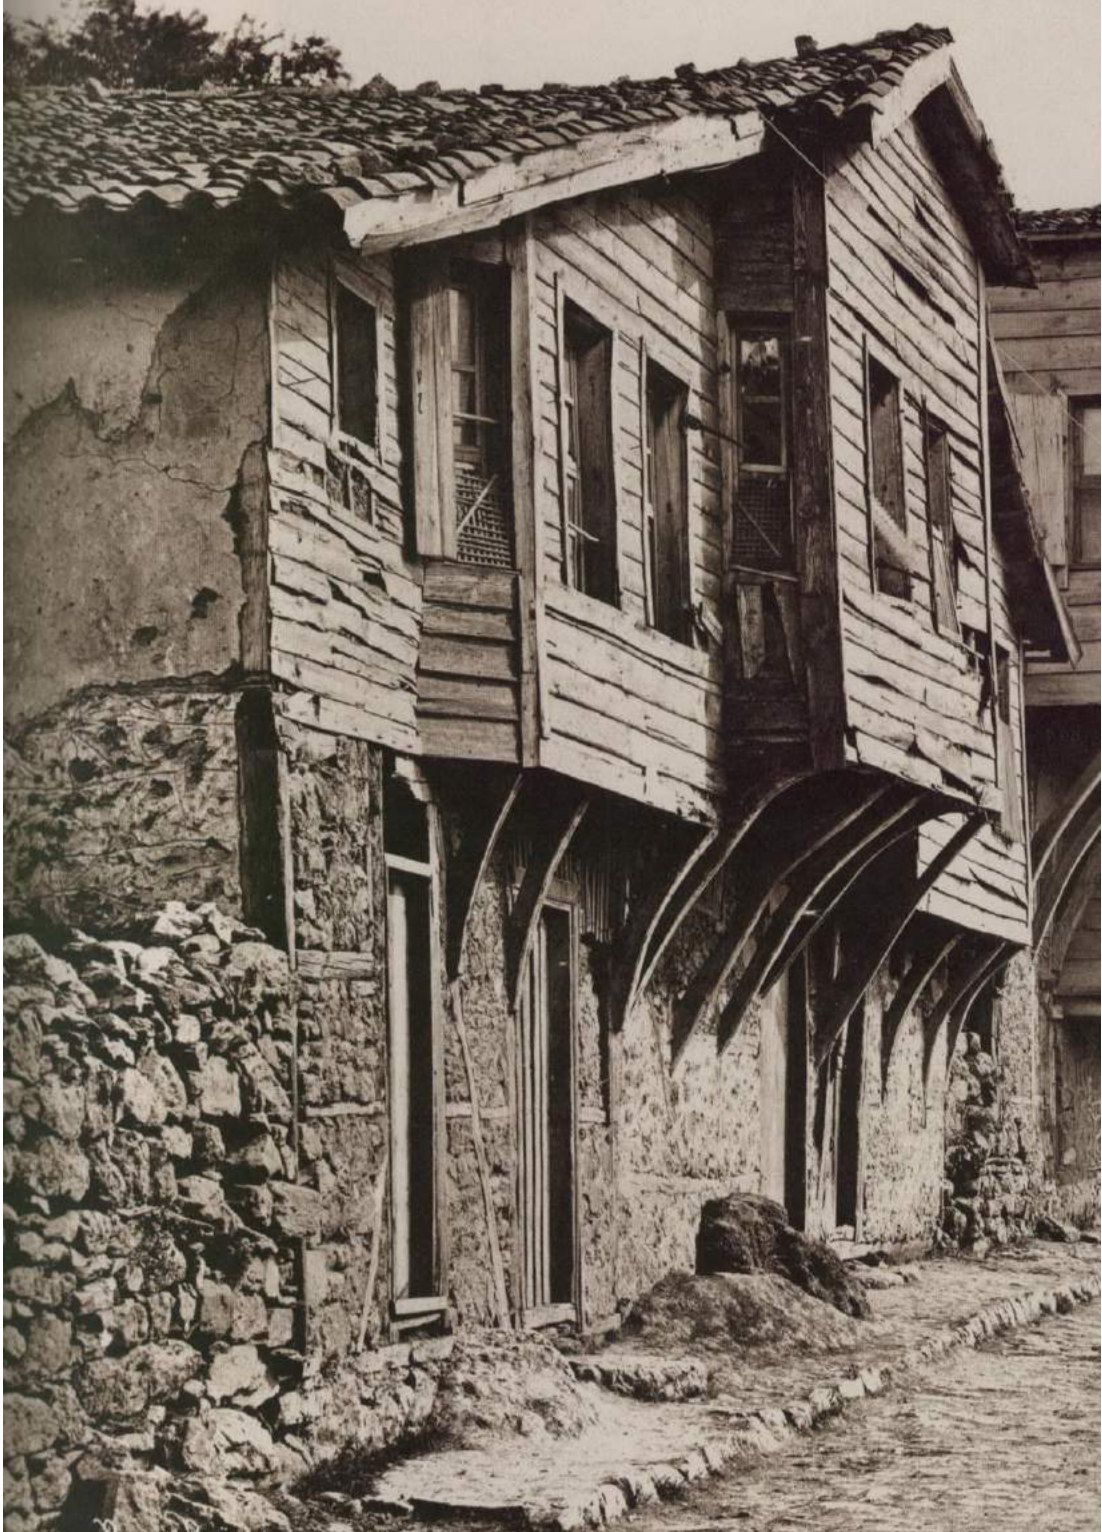
**Figure 6:** Masonry (stone and adobe) infilled timber frame of a house in Beykoz/Istanbul built in the first half of the 19<sup>th</sup> century (Photo:Pascal Sebah, 1865-70) [9]

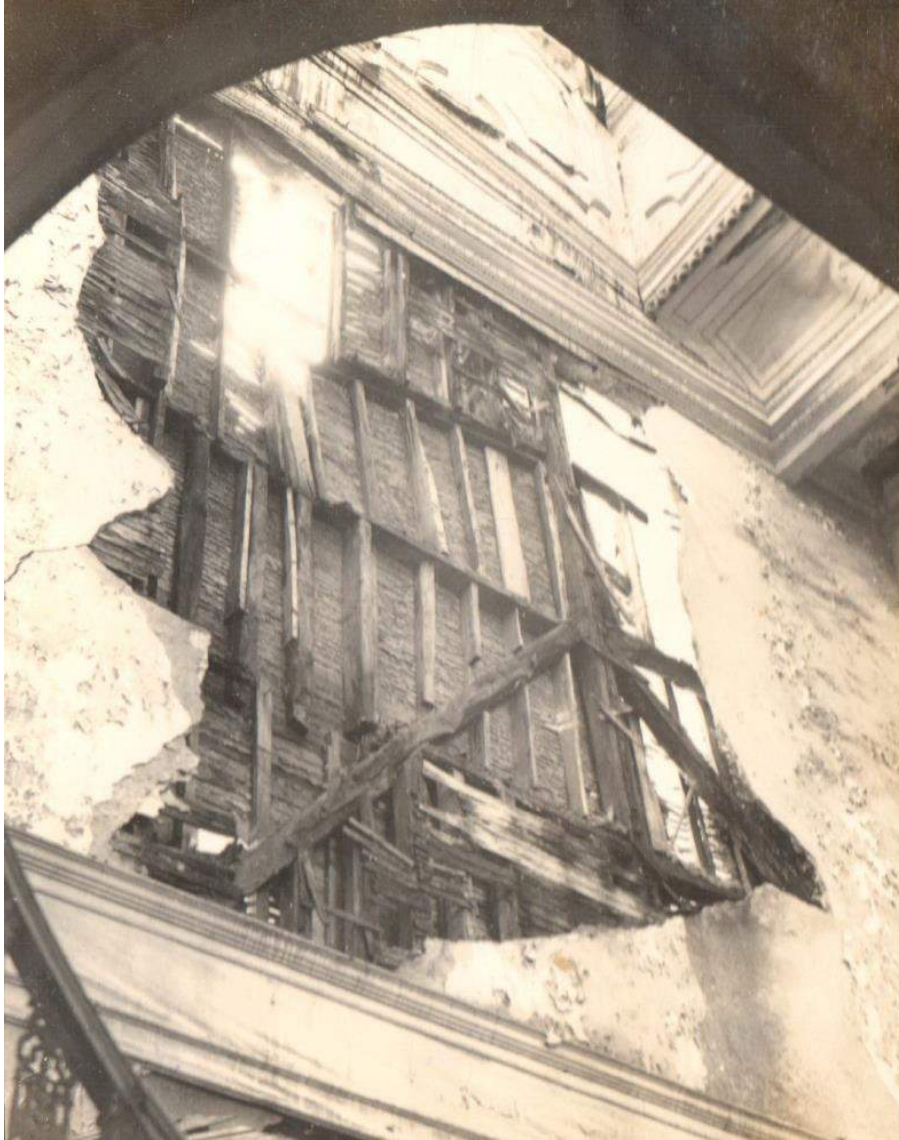
**Figure 9:** Çaglayan Palace staircase hall timber frame, 1940 (Photo: Istanbul Protection Board Encümen Archive)

Ottoman engineers educated in Imperial Naval Engineering School put into practice their knowledge on timber frame design during the construction of Çaglayan palace in 1862-63. Çaglayan Palace is one of the first buildings built with vertically braced timber frame without infill. (**Fig. 8**) The cost estimate of the building reveals that all sills, principal studs and diagonal braces of the timber frame were sawn at the Imperial Dockyard (*Tersane-i Hümayun*) [11]. The sills, principal studs and diagonal braces were cut into square cross-section rafters (25 x 25 cm for the ground floor and 22 x 22 cm for the upper floor) from oak logs. (**Fig. 9**) At that time Imperial Dockyard and Imperial Arsenal (*Tophane-i Amire*) were the only places in Istanbul which had steam powered parallel blade saw in their carpentry shops. However, the capacity of the steam powered saw in the Imperial Dockyard was not adequate and the thin vertical braces, which were considered of secondary importance, were roughly hand shaped on site. (**Fig. 9**) Moreover, the habit of placing horizontal timber laths in adobe/brick filled timber frame could be clearly observed in Çaglayan Palace structure. (**Fig. 9**) Instead of placing the monolithic vertical braces, which shall transfer and distribute the loads through the wall, horizontal braces were placed uninterrupted. Vertical braces were used only to support horizontal laths, a practice typical of *hımış* structures. The vertical braces unable to transmit the loads caused an out of plane failure and breaking occurred along the horizontal braces. (**Fig. 9**)

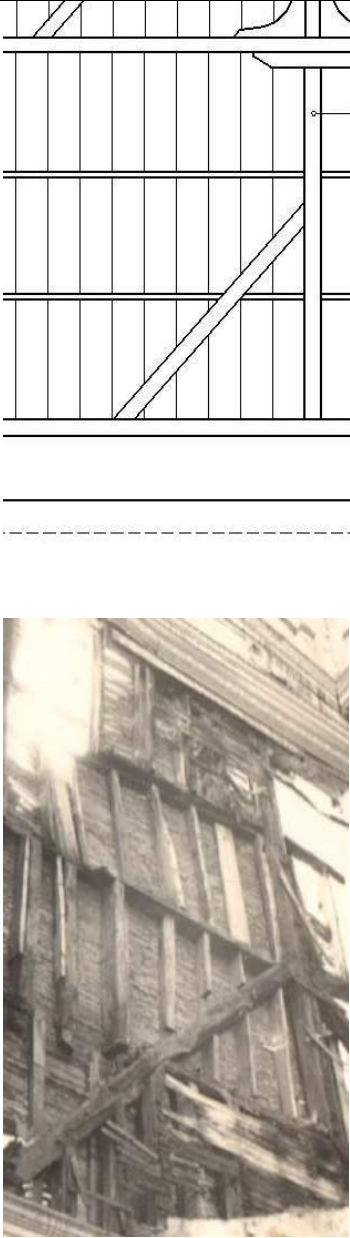
<b>A:</b> <b>TIMBER FRAME</b> <b>WITH ADOBE/BRICK</b> <b>INFILL</b>	<b>B:</b> <b>TIMBER FRAME</b> <b>WITHOUT INFILL</b> <b>WITH HORIZONTAL</b> <b>BRACES</b>	<b>C:</b> <b>TIMBER FRAME</b> <b>WITH HAND CUT</b> <b>VERTICAL BRACES</b>

<p>Wall thickness: 20-26 cm</p>	<p>Wall thickness: 22-25 cm</p>	<p>Wall thickness: 10-18 cm</p>

**Figure 10:** The evolution of timber frame in Istanbul before the industrialization of timber sector. [1]

The timber frame of Çaglayan Palace was lightened by the elimination of infill in the structure; (**Fig. 10/ B**) however the design principles of the timber frame with closely placed thin vertical braces were violated. The timber frame was constructed as if a masonry wall would be built as an infill. Moreover, the mechanization of the woodworking sector in Istanbul was not at a level to meet a large-scale demand for standard structural timber members for the market, even for the construction of Imperial buildings. However, the building technique with vertically braced timber frame quickly spread to neighborhoods of the city due to its low cost and ease of construction. The constant migration from the Balkans to Istanbul, especially after the Russian-Turkish War (1878) caused a huge demand for new housing, for which the new technique offered significant advantages. However, hand shaped (with axe or frame saw) principal studs and carelessly placed thin vertical braces caused the uneven distribution of load through the frame and the emergence of a “loose and unstable” in Bachmann’s terms, timber frame [1, 12]. (**Fig. 10/C**) Additionally, the usage of non-standard wrought iron nails in the vertical braces’ connections caused cracks in thin vertical braces, which weakened the joints. Thus, those structures needed frequent maintenance without which they could not survive for a long time.

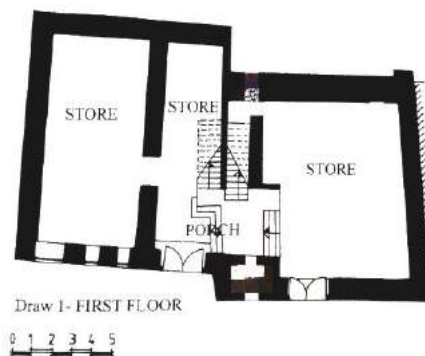
**Figure 10:** Floor plans of the Robevci house (split belly type)

The house had its ground floor typically encroached by the streets and the lot (Figure 10). The vertical distribution of the space was made through stairs positioned in the ground floor that lead to the upper floors onto a space called *chardak* (*sofa*, *hayat*, hall). This was the space from where other rooms were accessed. This hall allowed different distribution of the space around it with adjunctions of spaces creating different plan typologies (Figure 11).

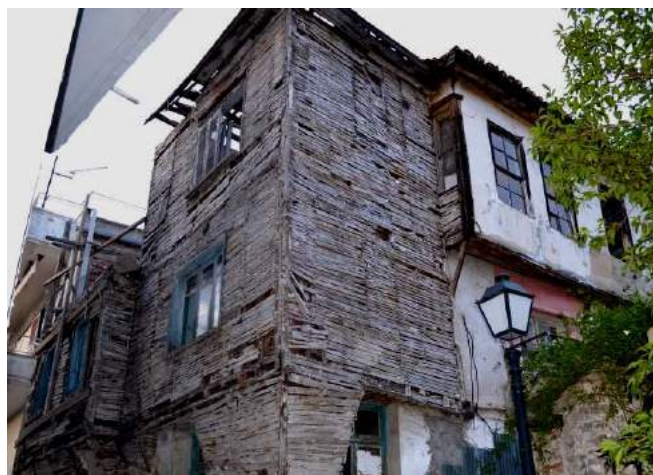
**Figure 14:** Wooden lattices applied over the wooden frame in the houses in Kavala (Ivkovska, 2014)

Plaster was applied to the exterior surfaces of the wooden (*bondruk*) wall frame that was covered with wooden lattices as a surface for applying the plaster (Figure 14). This plaster was made of different materials: hydrated lime or dry pulverized lime, river sand, and a small amount of a material with pozzolanic features (ground volcanic stone, powder dust from clay tiles or pozzolanic earth) [37]. Glass was used for closing the windows after this material be-came commonly used in the Balkans during the 19th and at the beginning of 20th century.

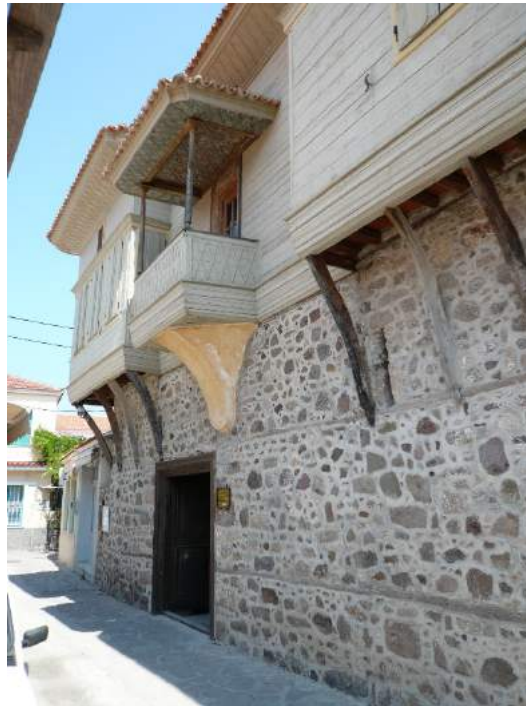
**Figure 1:** The Varelzidena house in Petra, Lesvos is a fine example of Ottoman-era architecture constructed in the first half of the 18<sup>th</sup> century exemplifying the use of *sachnisi*. Note also the exposed sanages.

The upper stories of townhouses frequently have cantilevered bays (*çikma*, *σαχνισια* - sachnisia) supported on diagonal braces (Figure 1). The bays are often lightweight, construct-

wood to dry when wetted and permitting any rot that occurs to be readily seen (refer to Figure 1).

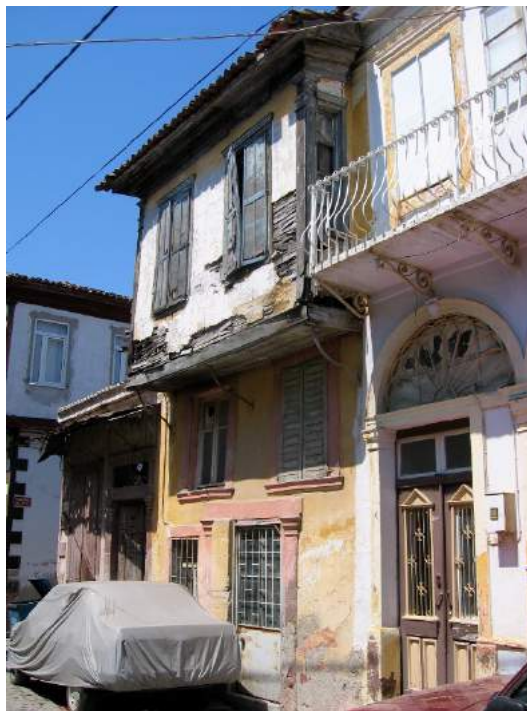
**Figure 2:** Typical baghdhati construction in Ayvalik, Turkey.

ed with lath and plaster (*bagdadi siva*, μπαγδατη - baghdhati) or finished with wood siding [13], and the jetties help restrain the lower masonry wall [6] (Figure 2).

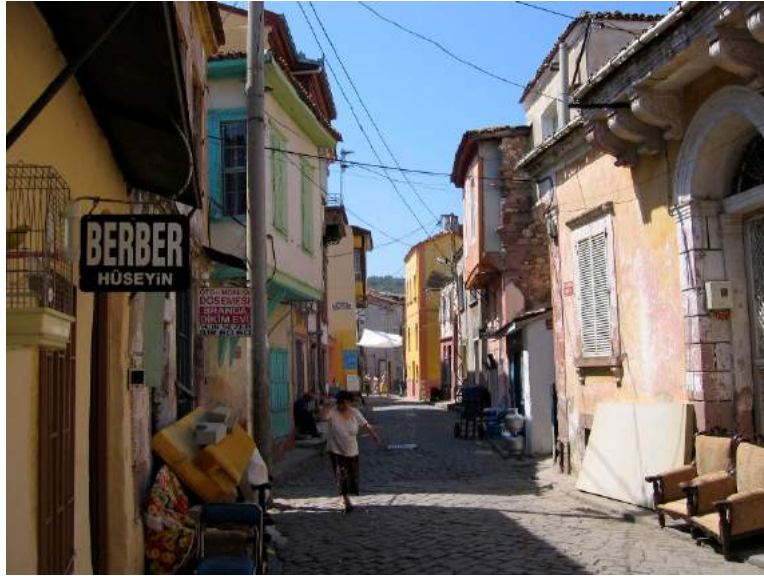
**Figure 3:** Townhouses along a narrow street in Ayvalik.

Townhouses are often stuccoed, considered superior weather protection for the façades (refer to Figures 3 and 4). This was traditionally a lime stucco but is more likely to be composed of a lime-cement stucco in current times. When stonework is left exposed, it is pointed with lime-based mortar that has pozzolans added. These can be volcanic ash (*volkanik küller*, *θηραϊκή γη* – thiraïki ghi) or ceramic dust (*horasan*, *κουρασάνι* – kourasani). Pozzolanic mortars are considered soft and have large pores, permitting evaporation of trapped moisture. The same applies for lime-based stuccos [15].

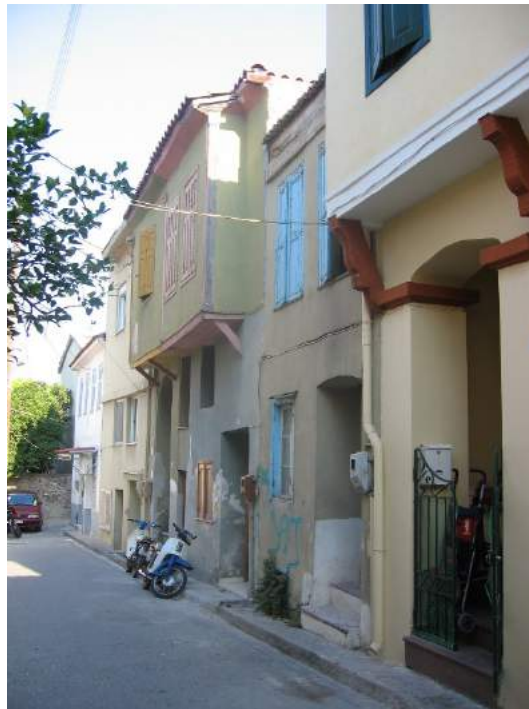
**Figure 4:** Townhouses along a narrow street in Mytilene.

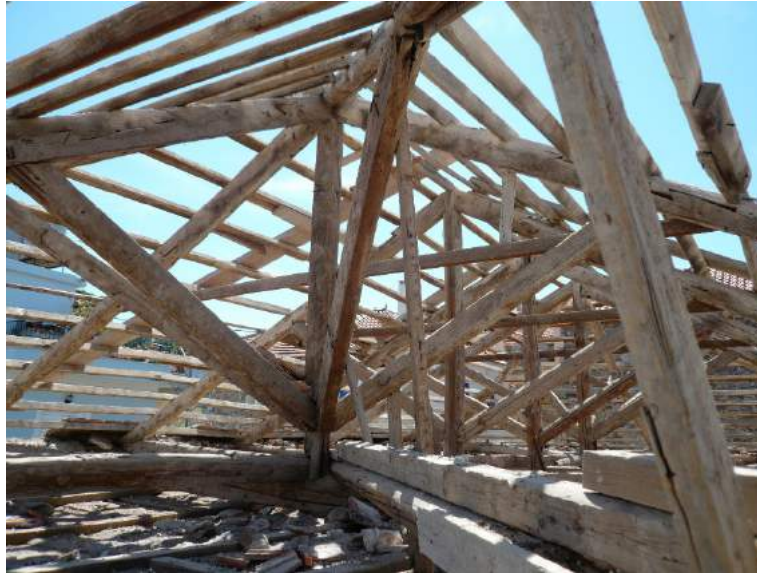
**Figure 5:** Typical roof framing of a Mytilene house before the *plywood*, *καπλαμαδες* – kaplamades (planks) are installed that will support the terra-cotta tiles.

Townhouses sometimes also have doors leading to small balconies that project from the front façade. Typically, there is only one, sometimes centrally located in a reflection of Neo-classical aesthetic. Roofs are hip-style with terra-cotta tiles. The attic space between the wood-paneled ceiling and the roof tiles, also serves to regulate interior climate (Figure 5).

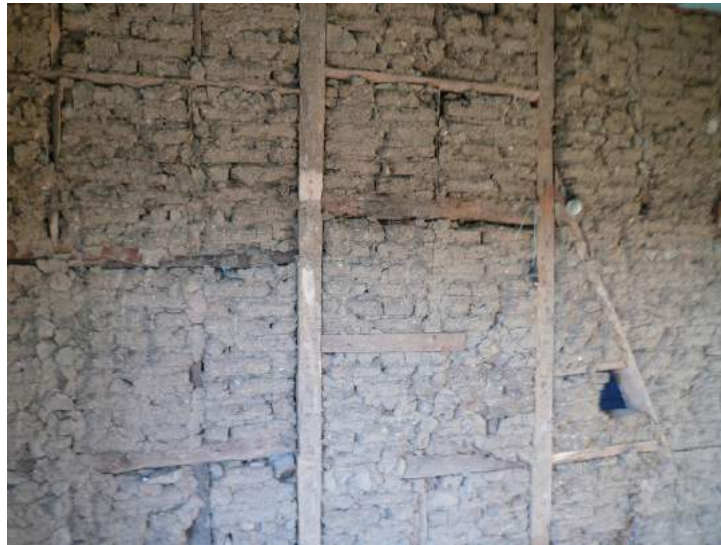
**Figure 6:** Wood framework of an interior partition in an abandoned house on Lesbos. Interior partitions are load bearing and anti-seismic in design.

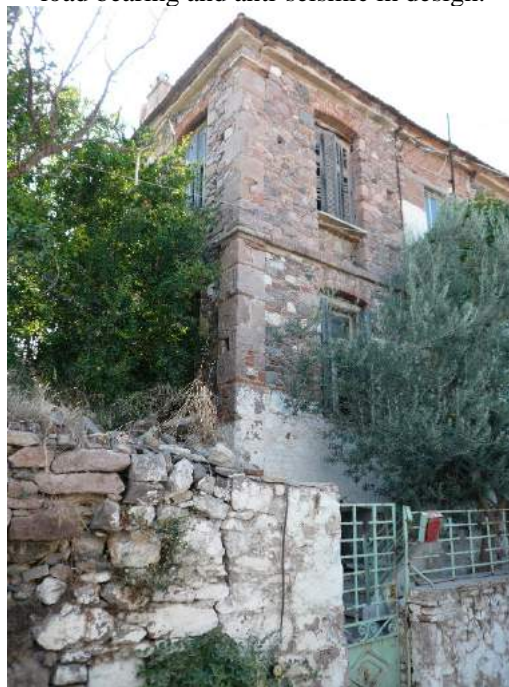
**Figure 7:** Townhouse in Mytilene with stonework exposed showing the corner quoins which knit the exterior walls together.

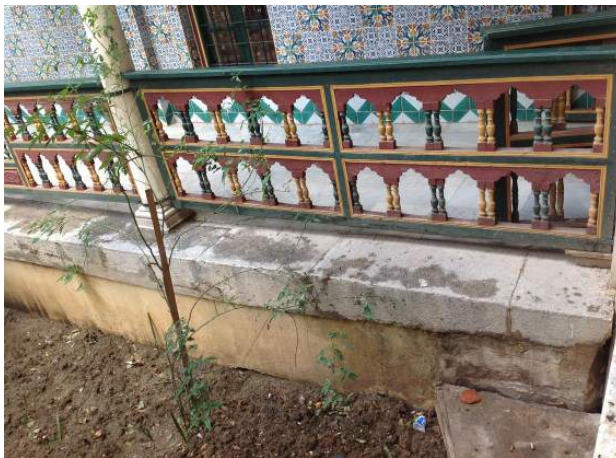
**Figure 7:** ancient stone blocs as a base, bey's palace of Constantine.

From the constructive view point, the whole monument is distributed on three levels. On the ground the building rests on the large cut stone blocks recovered from the Roman sites (see figure 7), without forgetting that in large part it is superimposed on other visible vestiges in the basements, which gives an exceptional archaeological stratification. The structure was based on a mixed carried system, the first using marble monolithic columns to support the porticoes (see figure 3), to create a set of single and double in arcature galleries. Maintained by horizontal wooden tie-rods where arcades are executed in solid brick (see figure 8). In addition, there was a second type of structure, supported by the load bearing walls (see figure 10), which apparatus was founded on a stone base, and executed in rubble intertwined with a solid brick, than covered with a mortar of sand and lime (see figure 11). These two described bearing systems ensure the function of carrying the floors (see figure 9), which in turn, rely on a system of wooden beams (see figure 12). The roofs taking a slight slope, it rest on wooden frames, and the whole is covered with tiles.

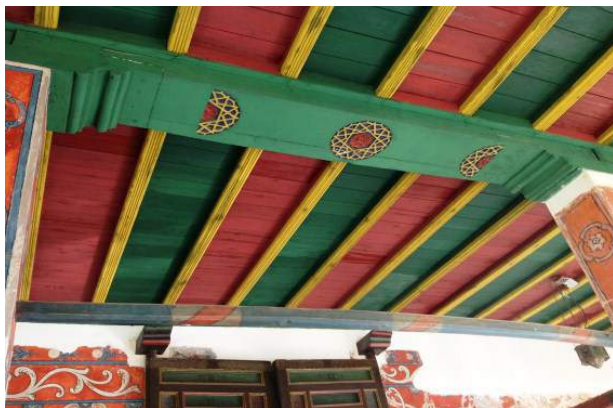
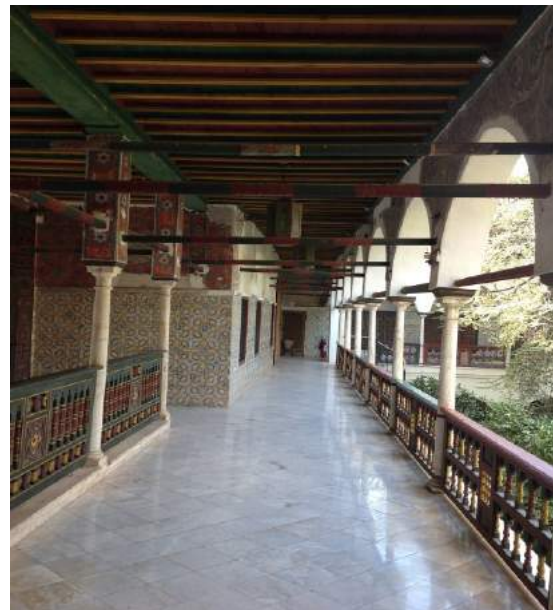
**Figure 8:** the use of wooden tie between the arcs.

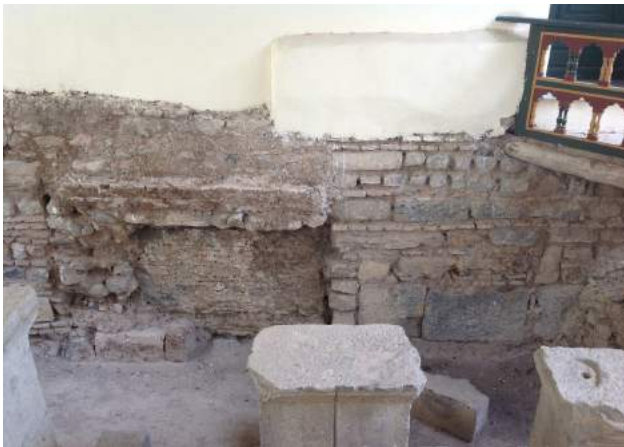
**Figure 10:** apparent composition of a mixed bearing wall, bey's palace of Constantine Source: BOUNOUIOUA Ferial, 2016.

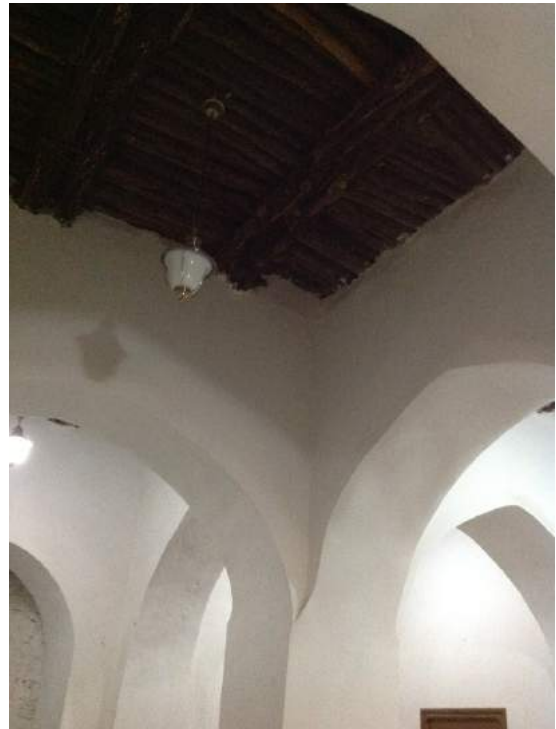
**Figure 11:** bearing walls relieved by arches, Bey's palace of Constantine. Source: BOUNOUIOUA Ferial, 2016.

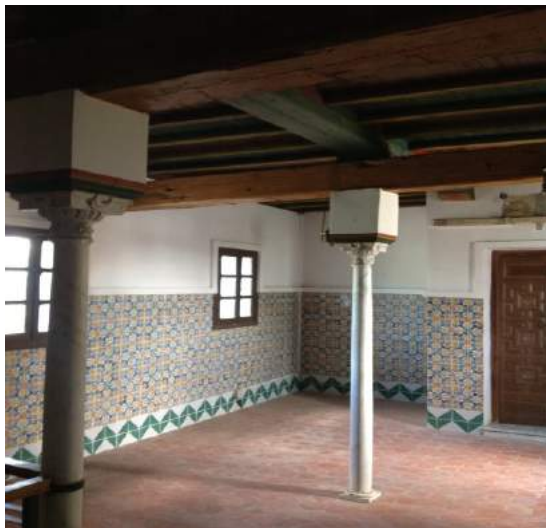
**Figure 12:** wooden beams support.  
Source: BOUNOUIOUA Ferial, 2016.

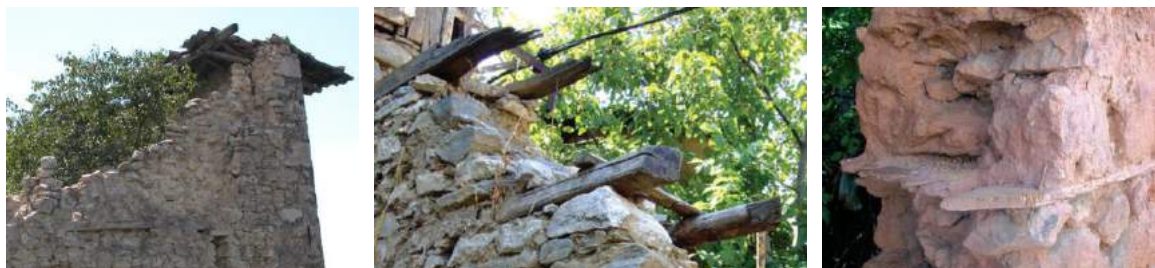
- A massive timber log embedded into the wall and connected to metallic anchors in façade;
- Ladder-like timber bands inserted at regular spacing;
- Several planks or logs placed next to each other on the whole wall section.

**Figure 2: a) massive timber logs embedded in a partially collapsed masonry wall at Poggio Picenze (Italy); b) ladder-like timber bands inserted at regular spacing in Cumalikizik (Turkey) and c) planks insertion in a masonry wall in Kastamonu (Turkey) (Credit: Hofmann)**

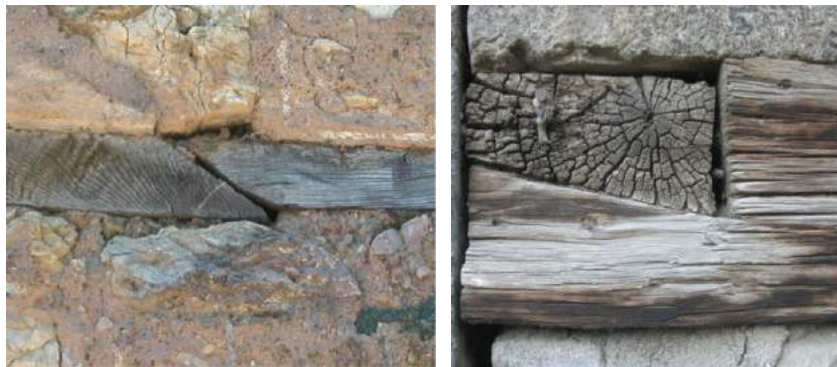
Moreover, connections between elements are very interesting to compare. Planks are usually connected by overlapping and basic nailing, while in case of ladder-like insertions, connections are more sophisticated: halved or chamfered joints, and in case of recent high seismic activity, dovetail joints were more likely to be observed.

**Figure 3: a) a chamfered joint in Vevçani (Macedonia) and b) a dovetail joint in Erzurum (Turkey) (Credit: Hofmann)**

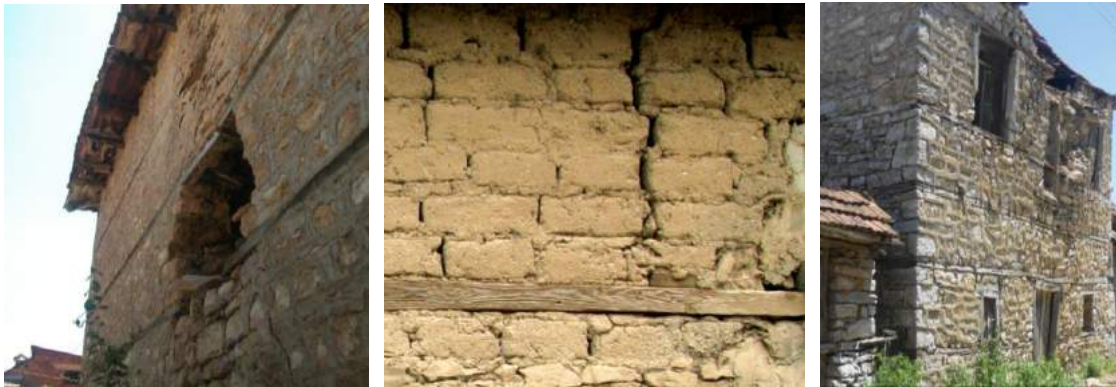
**Figure 4: a) ladder-like insertions acting as lintels when partial collapse of a masonry wall occurred; b) preventing cracks propagation and c) restricting bending deflection (Credit: Hofmann)**

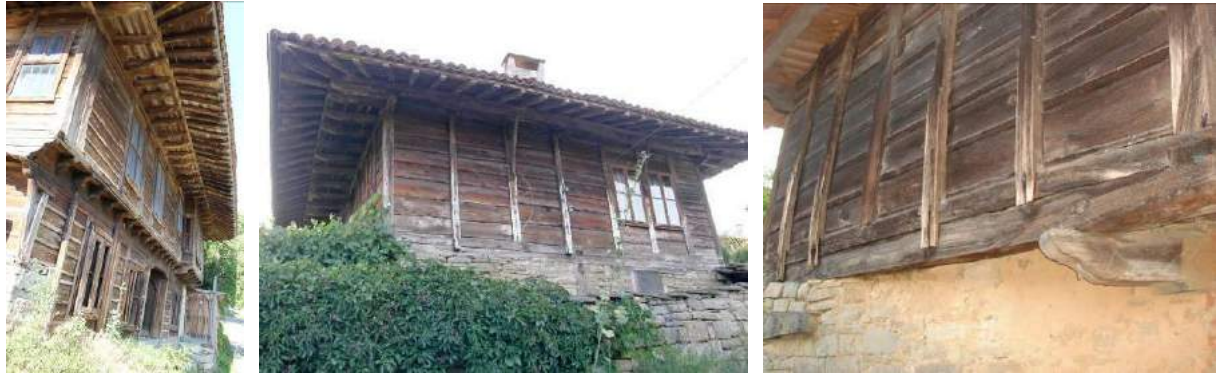
timber. Oak and beech wood is mostly used in this region. Figure 1 shows typical houses from the villages of Zheravna and Katunishte. The three main parts of the timber walls can be clearly distinguished. They are horizontal beams, vertical posts, and horizontal planks. The horizontal beams and the vertical posts form a frame filled with planks. The main elements are connected through carpentry joints without the use of metal connectors.

**Figure 1:** General view of houses with post-and-plank walls in the Kotel region

The posts have tenons on both ends which are connected to the beam mortises. There are grooves along the length of the vertical elements for the planks (Figure 2). The planks are driven into the grooves one above another without any specific joint in the contact zone in the longitudinal direction. Considering the hand tools used during this period, the contacting faces of the planks are not perfectly smooth and plane, thus in some cases a gap is formed between them. Sometimes the gap is covered by nailed laths (Figure 1, left and right).

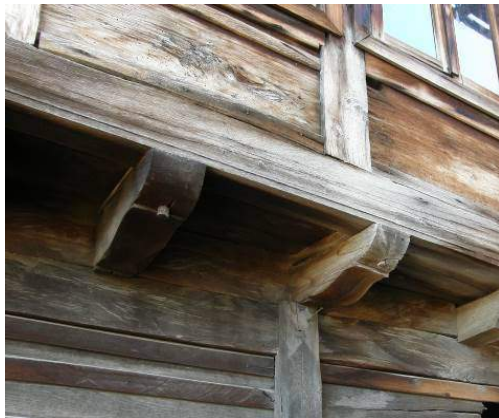
**Figure 4:** Wooden pegs connecting the floor joists with the lower beam of the post-and-plank wall

The post-and-plank walls are connected with the floor/ceiling joists that are crossing the upper and lower beams. The connections are realized through notched joints, wooden pegs, or iron nails. Figure 4 shows wooden pegs between floor joists and lower beam.

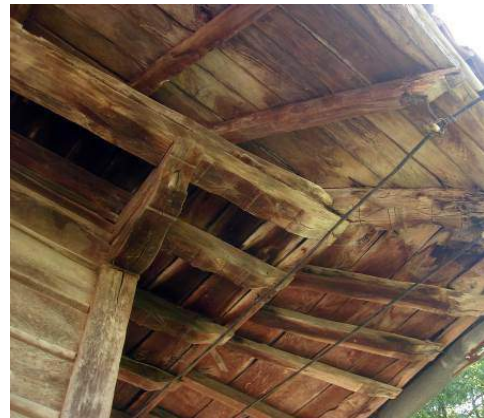
**Figure 5:** Overhanging upper beam supporting the external purlin. A wooden peg is added to fix the two elements

Since the eaves of these houses are very wide, in many cases the upper beams overhang the walls and act as a support of the external purlins. Sometimes secondary horizontal elements are added under the upper beams to distribute the concentrated loads (Figure 5).

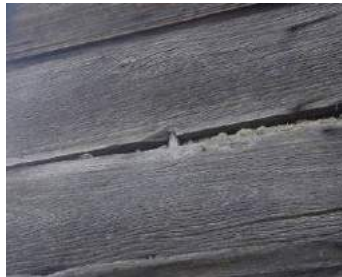
**Figure 6:** Additional pegs connecting the planks in a longitudinal direction

cm in depth. As the planks are not connected in another way one above another, these pegs contribute to the shear capacity of the wall.

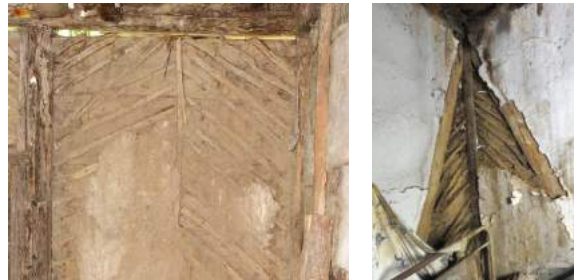
**Figure 7:** Laths (left and right) and diagonal boards (right) nailed on the inner side of the planks when the walls are plastered

The wooden laths nailed to the planks on the inner side of the walls also have an impact on the overall behavior of the wall structures. One of the functions of the laths is to provide a rough surface for the clay plaster. Nailed in a diagonal direction, they restrain the planks against displacements in different directions (Figure 7). Sometimes there are even inclined planks nailed to the planks also contributing to the overall behavior of the walls.

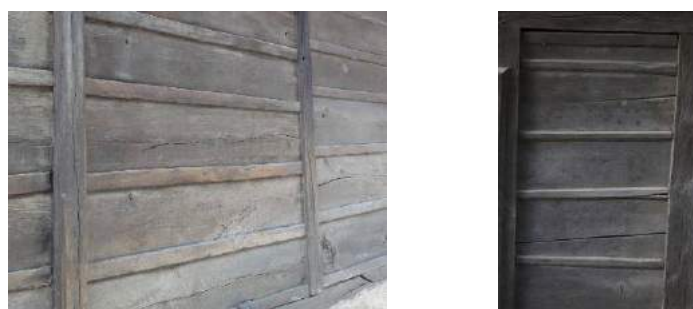
One problem that decreases the horizontal load-bearing capacity of the walls is the out-of-plane deformation of the planks. Cracks are sometimes present in the middle line along the length of the planks where the deflection is the greatest (Figure 8). In those cases, shear due to lateral loading can cause the planks to split into two parts.

**Figure 8:** Deformations of the planks causing cracks and splits

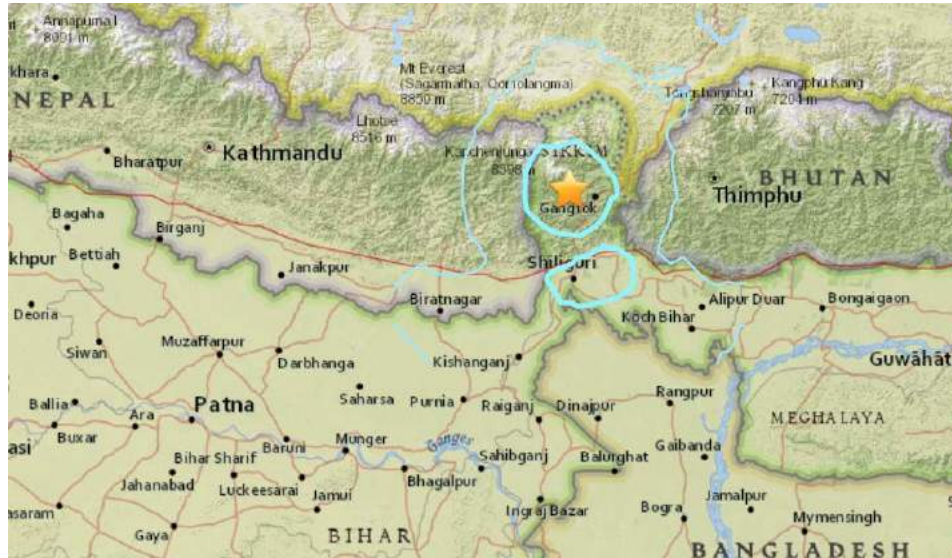
**Figure 4:** Seismic impact of 2006 Earthquake – Source: <https://earthquake.usgs.gov/earthquakes/eventpage/usp000ea1q/map>

The February 2006 Sikkim earthquake was a moderate earthquake ( $M_w$  5.3). The detailed reports about this moderate earthquake ( $M_w$  5.3), its characteristics and its impacts on the Sikkim region were reported by Kaushik, et. al, [1, 2]. The location of the epicenter and the shaking intensity felt in the Sikkim region is presented in the map shown in Figure 4 and Figure 5 [1]. These shaking intensity maps can help provide a rational basis of understanding the

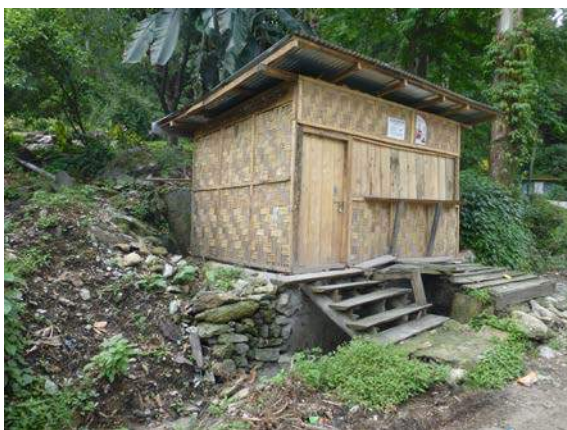
**Figure 8:** Ekra House Annex – Woven Bamboo Matting – Exterior Walls – Photo Credit: S. Rihal

The general details of the Ekra houses in Sikkim has been presented by Murty, et. al., [4]. The Ekra houses generally consist of wood-framed walls with an infill of cross-woven bamboo matting or wooden plank construction, which is called 'Shee Khim'; plastered on both sides typically with mud, or cement mortar in recent times. For a flat site, the wood-framed walls rest on a short masonry plinth consisting of stone masonry with mud mortar, around the building perimeter. An Ekra type of construction for a house annex, observed in Sikkim is presented in Figure 8

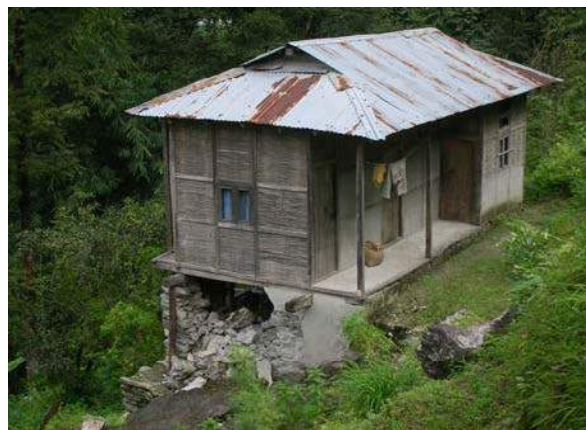
**Figure 9:** Performance of Traditional Ekra Houses – Photo Credit: Murty, et. al., Ref. [4]

According to the findings of the reconnaissance teams this type of vernacular housing typology was found to have performed extremely well, as compared to the URM constructions, and the more recent building typologies e.g. non-engineered RC frame buildings with URM infills, under the varying levels of shaking intensities they experienced across the Sikkim region. The observed performance of traditional Ekra houses is presented in Figures 9-11 below, [4, 6]. The observed seismic performance of heritage buildings e.g. the Enchey Monastery in Gangtok is presented in Figure 12 [3].
