**Proceedings of the  
Inter-ISC'18**

**Anti-Seismic Vernacular  
Heritage of Anatolia and  
Beyond**

**Proceedings of the Inter-ISC'18  
ICOMOS Inter-ISC Meeting & Colloquium  
July 10-13, 2018 Kastamonu, Turkey**

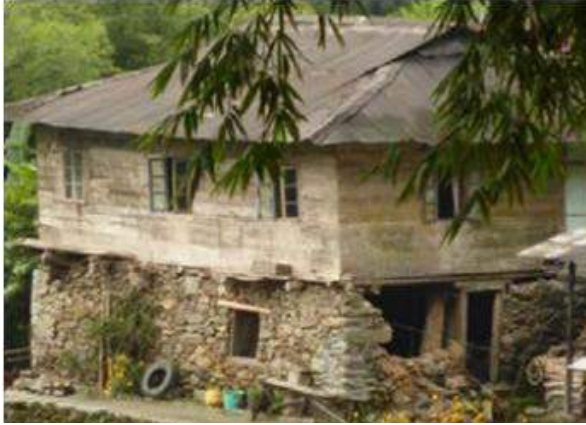
**Figure 10:** Ekra House - Partial Collapse of RR Support Wall – Source: Ref. [6]

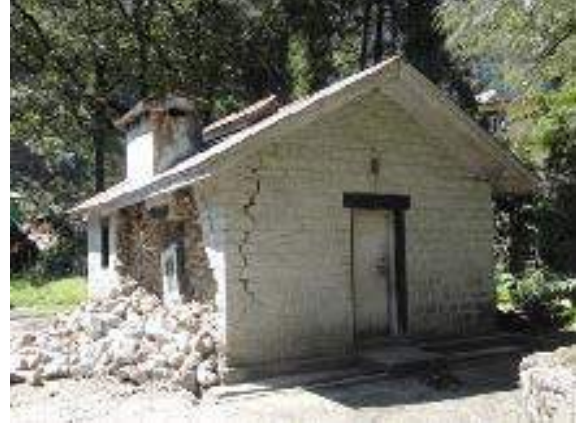
**Figure 11:** Unreinforced Masonry House – Photo Credit: Murty, et. al., Ref. [4]

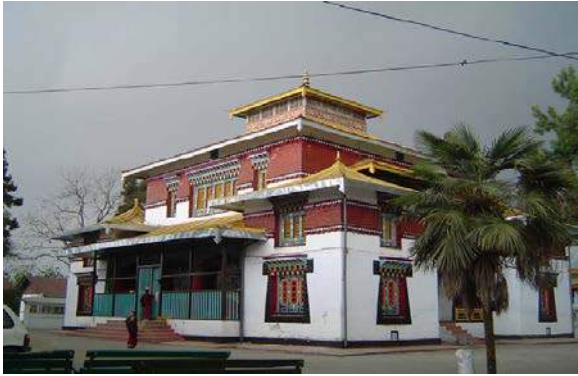
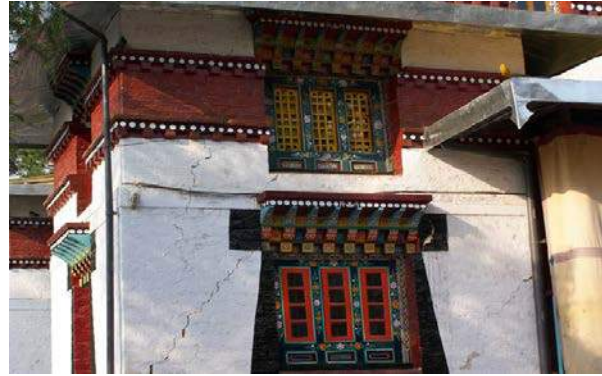
**Figure 12:** Enchey Monastery in Gangtok – Heritage Landmark, Shear Cracks in URM Walls – Source: Ref. [3]

According to the findings of the reconnaissance teams this type of vernacular housing typology was found to have performed extremely well, as compared to the URM constructions, and the more recent building typologies e.g. non-engineered RC frame buildings with URM infills, under the varying levels of shaking intensities they experienced across the Sikkim region. The observed performance of traditional Ekra houses is presented in Figures 9-11 below, [4, 6]. The observed seismic performance of heritage buildings e.g. the Enchey Monastery in Gangtok is presented in Figure 12 [3].

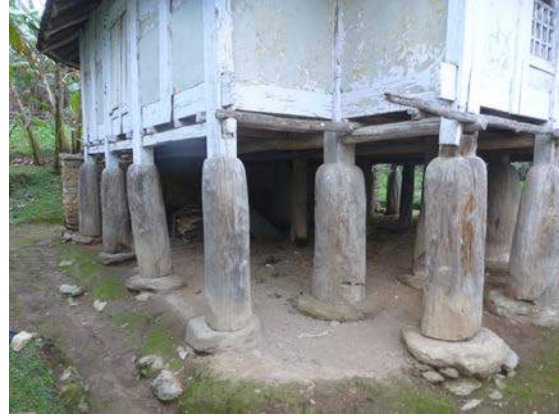
**Figure 19:** Timber Posts seated on a stone  
base: Ground Floor – Photo Credit: S. Rihal

The view of the timber posts seated on a stone pedestal, underneath the Lepcha house, is presented in Figure 19. A closer view of joinery connecting the posts and floor framing is presented in Figure 20.

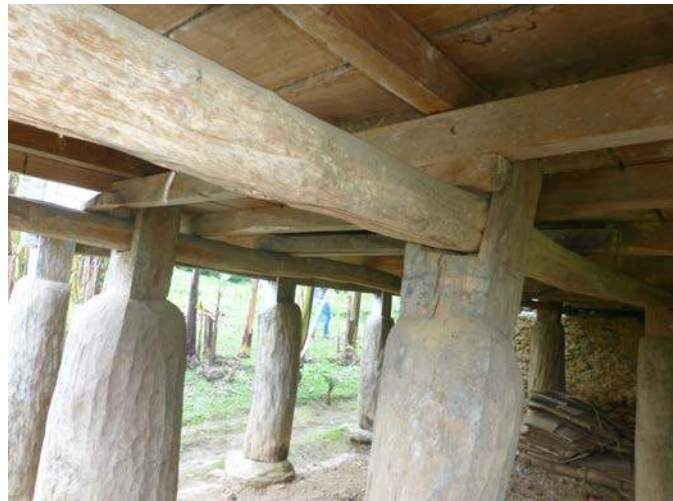
**Figure 20:** Connection details – Wood posts and floor framing – Photo Credit: S. Rihal

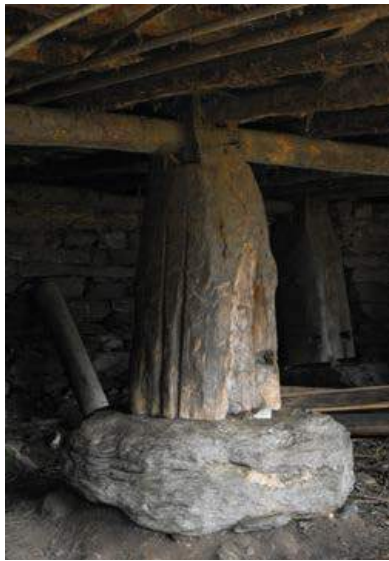
**Figure 21:** Wood Post seated on a Stone Base – Source: Ref. [11]

During our field study trip to Sikkim, it was suggested that one of the possible reasons for survival of the Lepcha houses was the innovative detail at the base of the round timber posts under the house, as shown in Figure 21 [9]. It appears that the nine round wooden posts, seat-

ed under the house on a slightly rounded stone bases, worked like an isolation system to help the Lepcha houses ride out the earthquake without damage and collapse of the overall structure during the 2006 and 2011 Sikkim earthquakes.

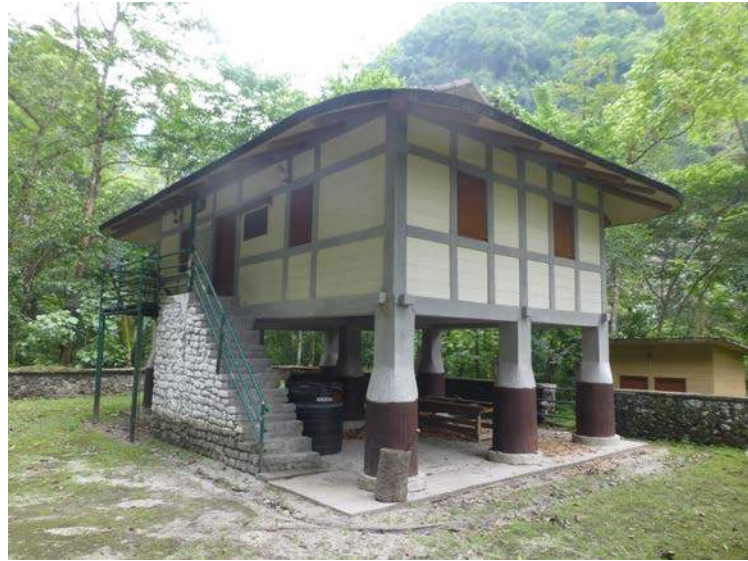
**Figure 22:** New Demo Structure using Vernacular Techniques – Photo Credit: S. Rihal

Therefore, the cultural heritage of traditional vernacular houses in Sikkim, that has evolved over centuries of cultural development and wisdom, should be improved upon and actively preserved for future generations. There is a lot that can be learned from the wisdom of the traditional materials and methods of construction of the vernacular houses in Sikkim for ensuring safety of vernacular houses, during future earthquakes in the region. During our field study trip to Sikkim in 2014, a proposed new demonstration earthquake resistant house structure was observed as presented in Figure 22.

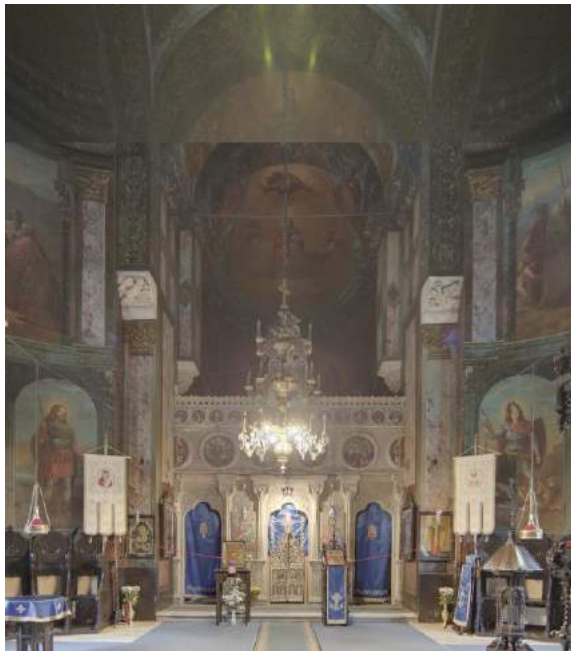
**Fig.01** – Current photography – original stone iconostasis refitted in initial positions

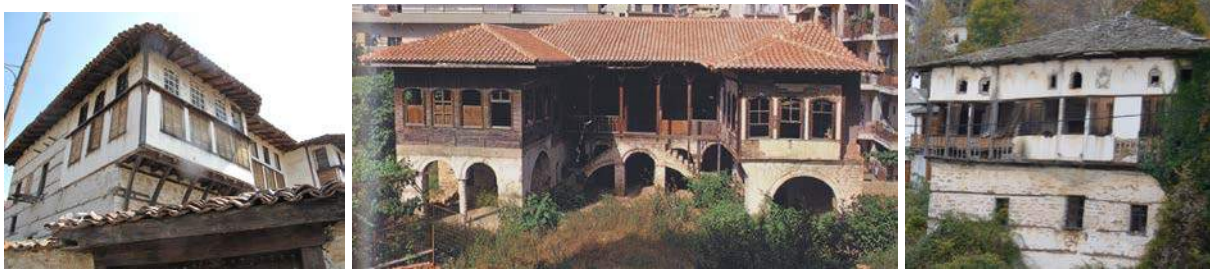
**Figure 1:** Post-byzantine buildings in Greece, in a) Macedonia, b) Epirus, c) Thessaly.

Buildings of two or three-stories, with similar architectural and structural characteristics, were very common during the Ottoman period in several countries in Balkan and Minor Asia area. In Greece, structures of this type are found in many areas of the central and northern part, in Thessaly, Macedonia, Thrace. The majority of them have been built before 19<sup>th</sup> century and although there is substantial variation in size, configuration and regional techniques, the main construction principles are similar. The ground and mezzanine floors are usually built using thick rubble walls reinforced with timber lacings (see below, 2.5), while the last floor consist of both rubble masonry and timber-framed walls (Figure 1).

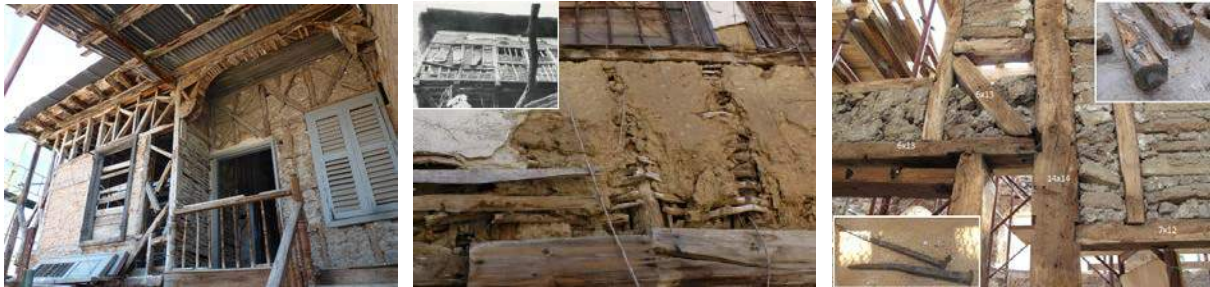
**Figure 2:** Different types of infill. a) stone, b) raw earth on timber branches and c) solid bricks. Round timber mortises and “gypsy” nails of rectangular section were used for the timber-to-timber connections.

Timber-framed walls are composed by vertical, horizontal and diagonal elements, with different types of infill (stone, adobe or solid bricks, canes or small diameter flexible timber branches plastered with raw earth (Figure 2). The mortar is either lime based, or raw earth. In several cases the plaster is reinforced with straw or animal hair.

The width of the wall depends mainly on the dimensions of the timber posts which is usually 10-16cm, without the plaster. In most cases the main load bearing system of the frame is composed by vertical timbers placed every 70-160 cm over and under horizontal beams (beddings), at the level of the floor and at the level of the roof (Figure 3). The connection of the vertical posts to these horizontal timbers was accomplished in several cases by round tenon and mortise joints (Figure 2 c)). The other vertical, horizontal and diagonal timbers have usually smaller dimensions and their connection to each other and to the vertical posts, was made either with 1 or 2 mild steel “gypsy” nails, or by shallow grooves and a nail (Figure 2, c)) [1].

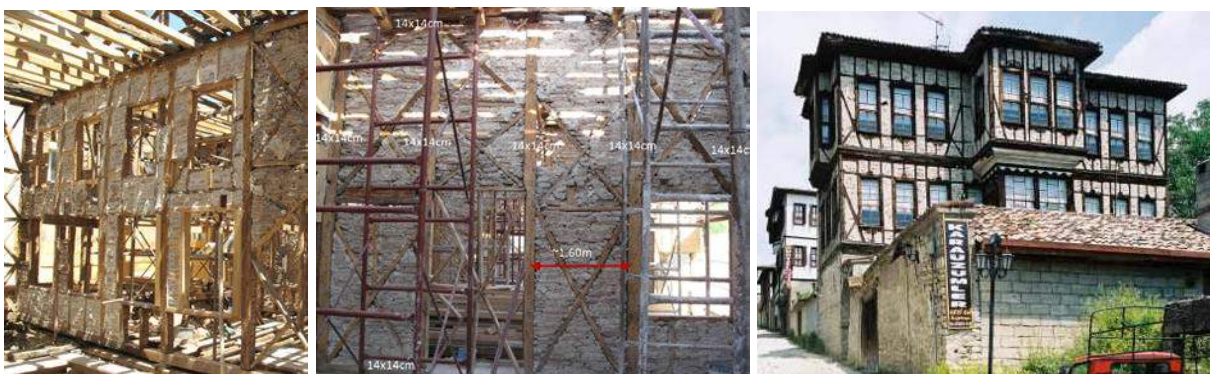
**Figure 3:** Concerning architectural and structural characteristics, two types of timber-framed walls are met in Greece. a) The one with a lot of openings which has none or few diagonal elements, and b) the one without or few openings that has several diagonal bracing elements [1]. c) A 3-story house in *hımsı* construction, with many openings in Safranbolu, Turkey [2].

The use in most cases of diagonal timbers that work as bracings improves a lot the rigidity of the frames. There are cases that diagonal timbers are few or do not exist (timber-framed walls with many openings) (Figure 3 a), c)). In these cases the capacity of the filling is even more important for their lateral resistance. In Greece, most of timber-framed walls are plastered.

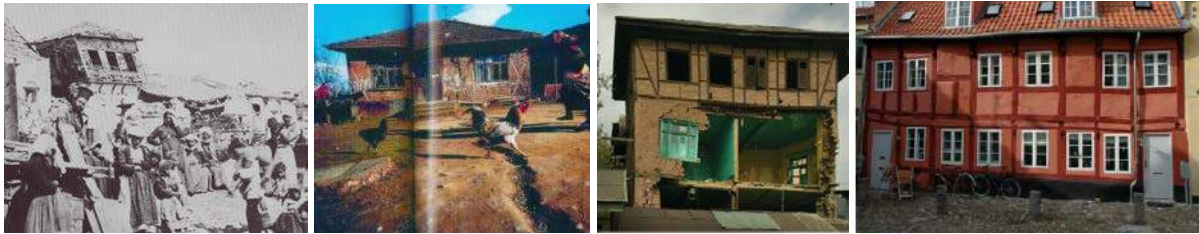
**Figure 4:** Timber-framed structures that presented excellent ductile behavior. a) Earthquake in April 1881, Chios, Greece (after Fasoulakis, Bouras 1983), b) Earthquake in 1999, Turkey (photo by Nat. Geographic). The seismic fault is passing through the house. c) Earthquake in 2005, Kashmir. Half-timber structure severely damaged but still standing [2]. d) A house in Scandinavia, though deformed, is still in use (after Copani 2007).

Though this type of construction technique was probably not born as a result of a conscious design for an anti-seismic system<sup>2</sup>, it was soon widely appreciated for its beneficial features against earthquakes<sup>3</sup> (Figure 4) [2,3,5]. Recent research on this topic through numerical analysis and laboratory testing has proven too their good performance in earthquake events. It was observed that the many in number nailed timber-to-timber connections, the slip along timber-masonry interfaces and the cracking of the infill during an earthquake, work as dissipative mechanisms, providing damping [3].

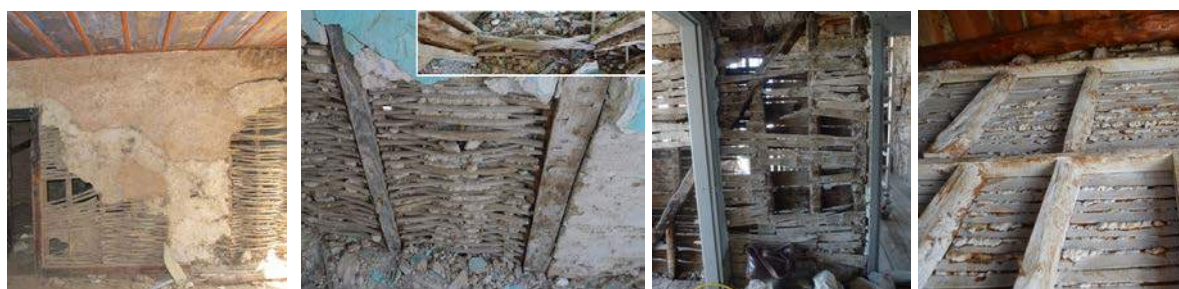
**Figure 5:** Non-load bearing partition walls: a), b) with curved branches and c), d) with *bağdadi* system.

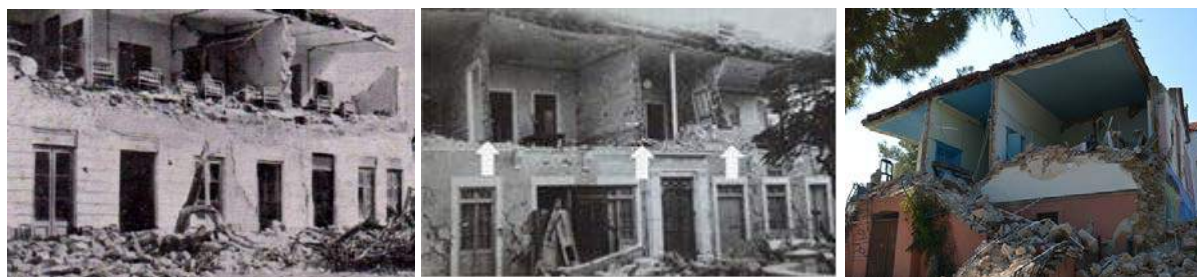
**Figure 6:** Partition non-load bearing timber walls supporting the roofs after the collapse of the external walls, in Korinthos earthquake (1928, web photo), in Cephalonia (1953) and in Vrisa in Lesbos island (2017).

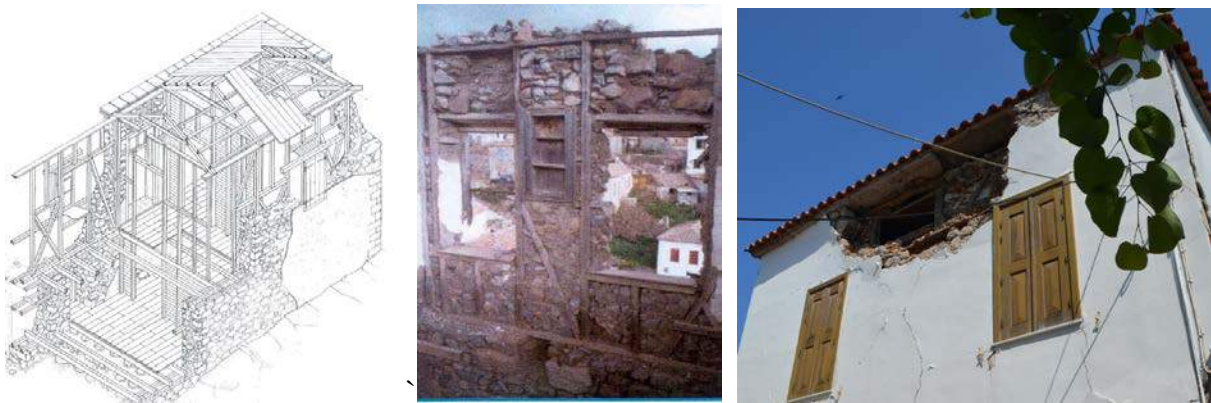
**Figure 13:** a), b) The Eressos system [11]. c) An external part of the masonry collapsed. The embedded timber frame, at the inner face of the wall is supporting the roof of this building of Vrisa in Lesvos. A big part of this village was destroyed during the recent earthquake in 2017. The Eressos system was used only in few buildings.

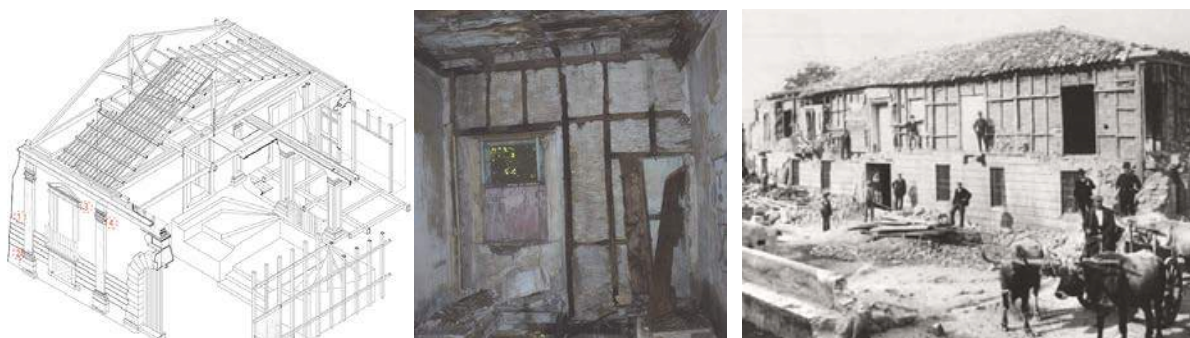
**Figure 14:** Bishop's Palace of Mileto, Italy a) Axonometric drawing by Stellacci and b) photo, showing the timber frame at the inner face of the external thick masonry wall. c) Messina, Italy. A baraccato building. The external masonry leaf fall outside after the 1908 earthquake. The embedded timber frame at the inner face of the wall prevented the collapse of the building [10].

In this version of *Casa Baraccata* system, a timber frame is incorporated only at the internal face of the thick masonry wall [10].

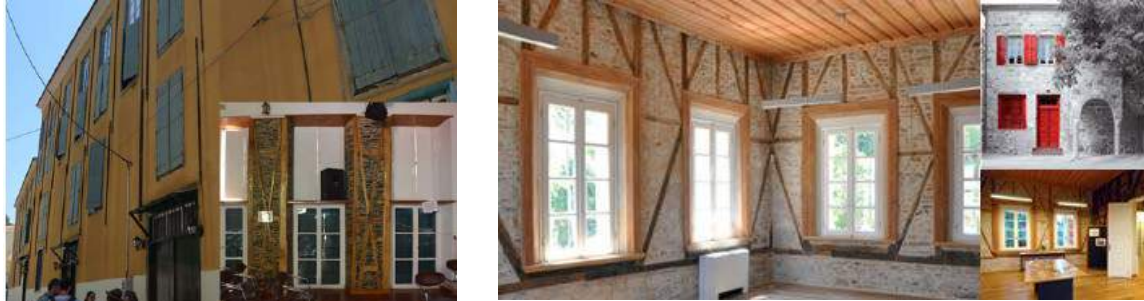
**Figure 15:** a) Plomari, Lesvos island. An industrial building. b) Chios island. The building of Ephorate of Antiquities [12]. It is noteworthy that after the restoration projects, in both cases, the timber frames were decided to remain visible, an excellent choice for didactic reasons too.

Eressos system was first located and studied at traditional buildings of the settlements of Eressos, in the island of Lesvos, in Greece (Figure 13). The timber-frames were used only at the upper floor of 2-story buildings. Their absence at the ground floor is a weakness of the system. The same system was found in Bergama too, in the western coast of Turkey [11], and recently it was located in two other settlements of Lesvos (Plomari and Vrisa (Figure 13 c), 15 a)) and in few buildings in the island of Chios (Figure 15 b) [12].

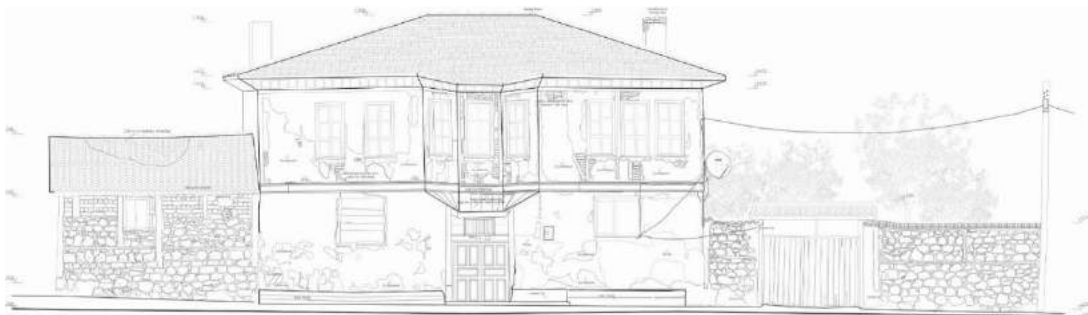
**Figure 8:** Southern façade of the house (B. Arslan, 2017)

Each façade layout take shape according to the interior organization. The southern façade, facing Doğdu Street, has the entrance in the middle and one window on its either sides at the ground floor level (Fig. 8). There is a chamfered bay over the entrance. Due to privacy, two windows at the ground level are smaller and in different proportion comparing the sash windows at the upper level. As a consequence of that the eastern and northern façades are facing the garden, the lower windows are also sash windows at the ground level. Yet, some them has been changed or closed. Moreover, there are more windows at the upper level. On the northern façade, another projection is located in the middle of the upper level. The western façade which is mostly covered with hayloft adjacent to the house on this side has only one window at the first floor level (Fig 9). There is also a wooden projection which represents the washbasin of the toilette.

All the façades were plastered in original, except main vertical and horizontal wooden bearing elements, and timber doors and windows. The eaves are covered with timber. However, the plasters have been detached, and wooden materials are deteriorated due to the lack of maintenance. Moreover, the deformations at some parts of the façades indicate structural problems on the house.

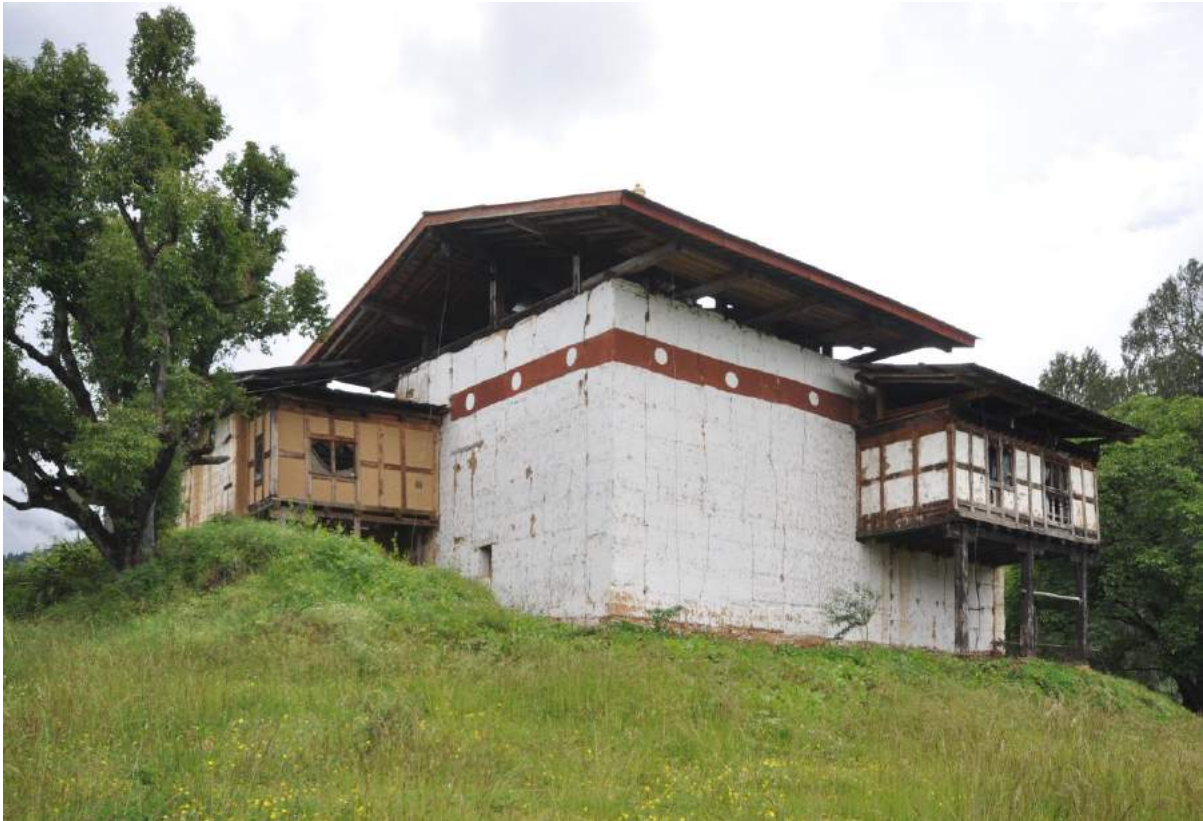
Figure 1: Exterior view of the Tseto Goenpa. The Lhakhang is the large structure in the foreground (June 2014).

To the north of Paro valley, facing the cliff that supports the internationally recognized Paro Taktshang (Tiger Nest) stands an equally significant a monument, Tseto Goenpa (Figures 1 and 2). It is positioned on a hilltop that appears like a tip of a vajra, a ritual three-bladed knife that contains spiritual power. About two hours walk from Lango village, the temple is at a vantage point that serves spectacular view of Paro valley.

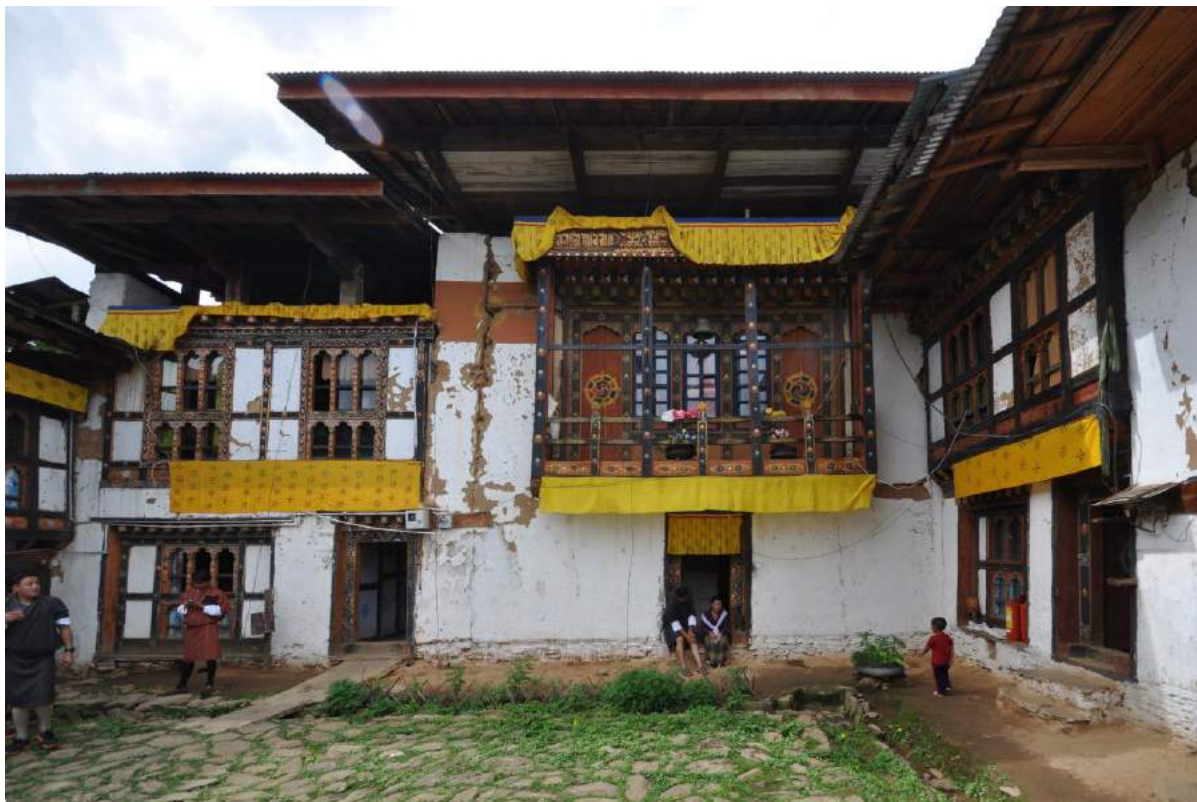
Figure 2: View looking northward in the courtyard. The Lhakhang is in the center of photograph. Note the large vertical cracks on the corner of the Lhakhang (June 2014).

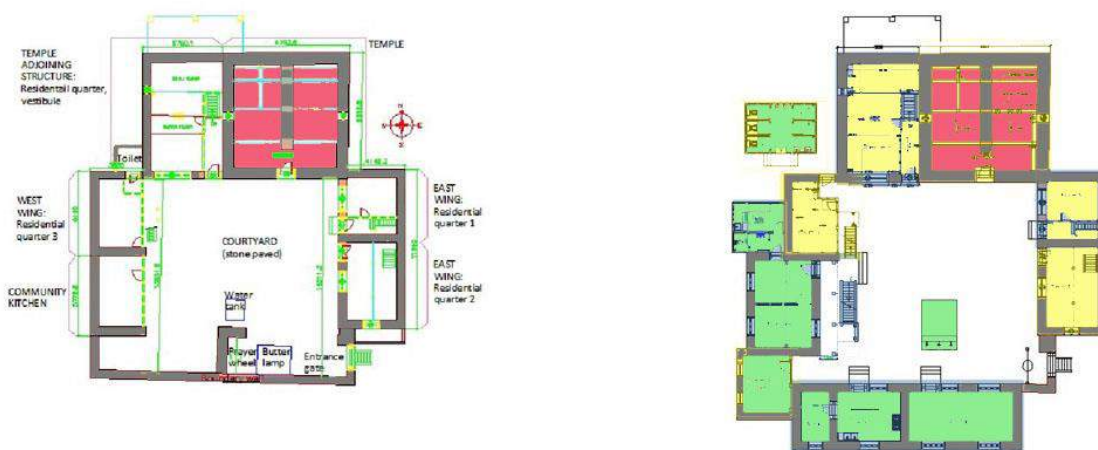
Figure 3: The plan on the left is the goenpa prior to work and on the right, after work is completed. The Lhakhang is shown in red. Areas shown in yellow have been rehabilitated, and those shown in green are new construction.

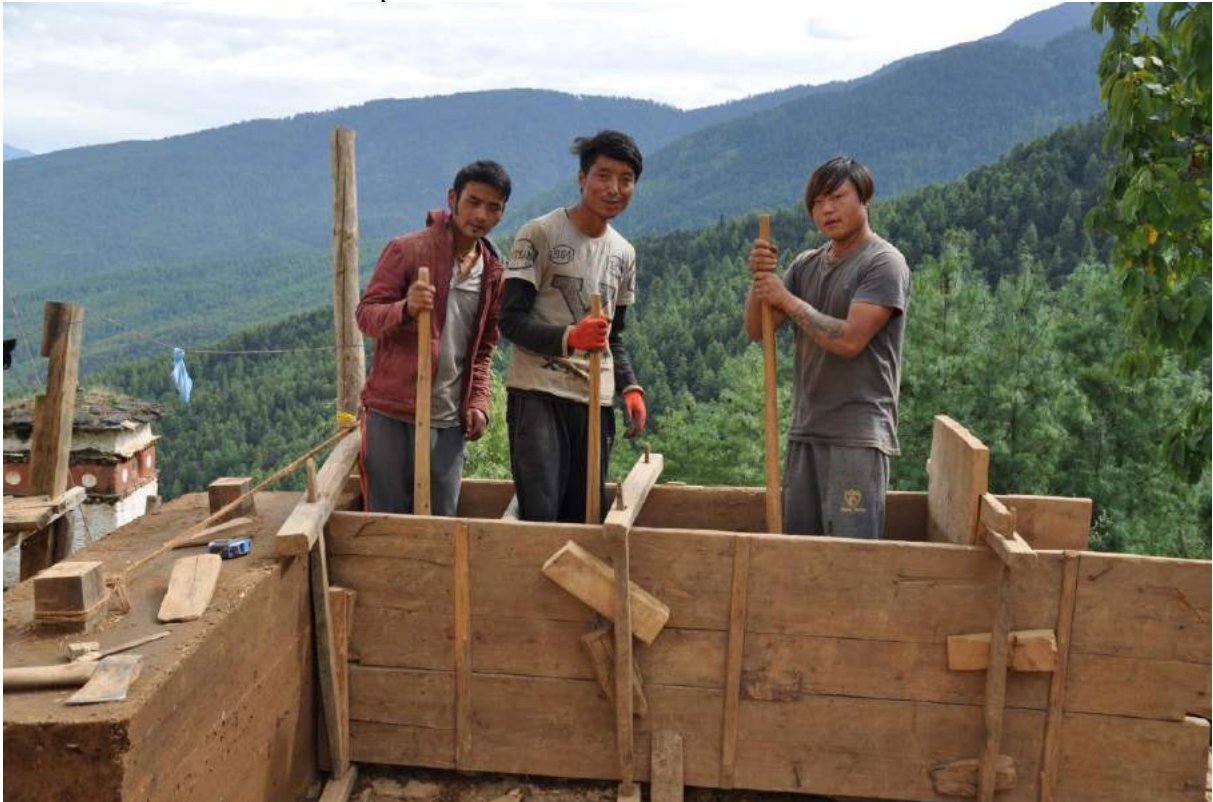
Figure 4: Workers ramming dampened clay into the formwork. On the left is a rammed earth wall where the formwork was recently stripped away.

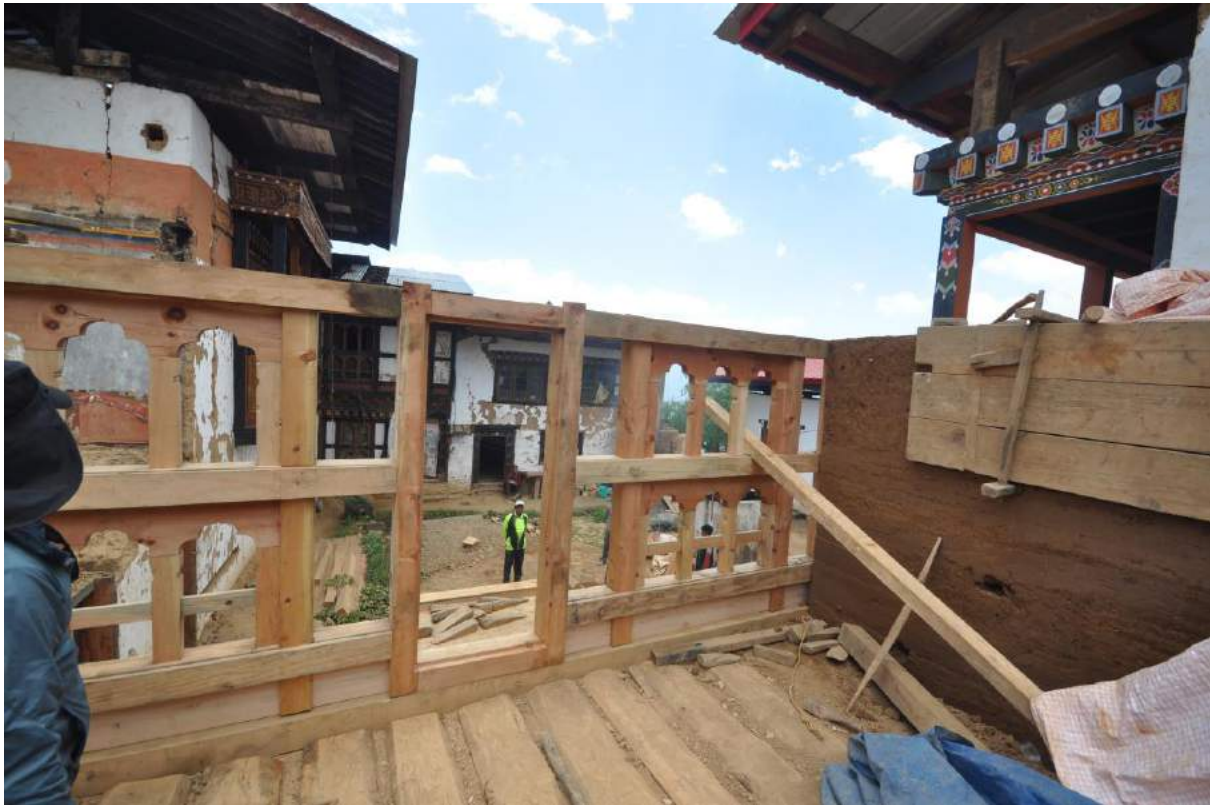
Figure 5: Eckra walls being installed.

Framed wood walls are found facing into the courtyard are more prevalent on the first floor and are also used for small post supported rooms that extend beyond the rammed earth walls. These frames are constructed of rectangular cut timber members that are mortised into place in a grid (Figure 5). The openings are either filled with *horzhing* windows (trefoil shaped) or *eckra* panels (woven bamboo panels that are plastered on both sides with clay plaster).

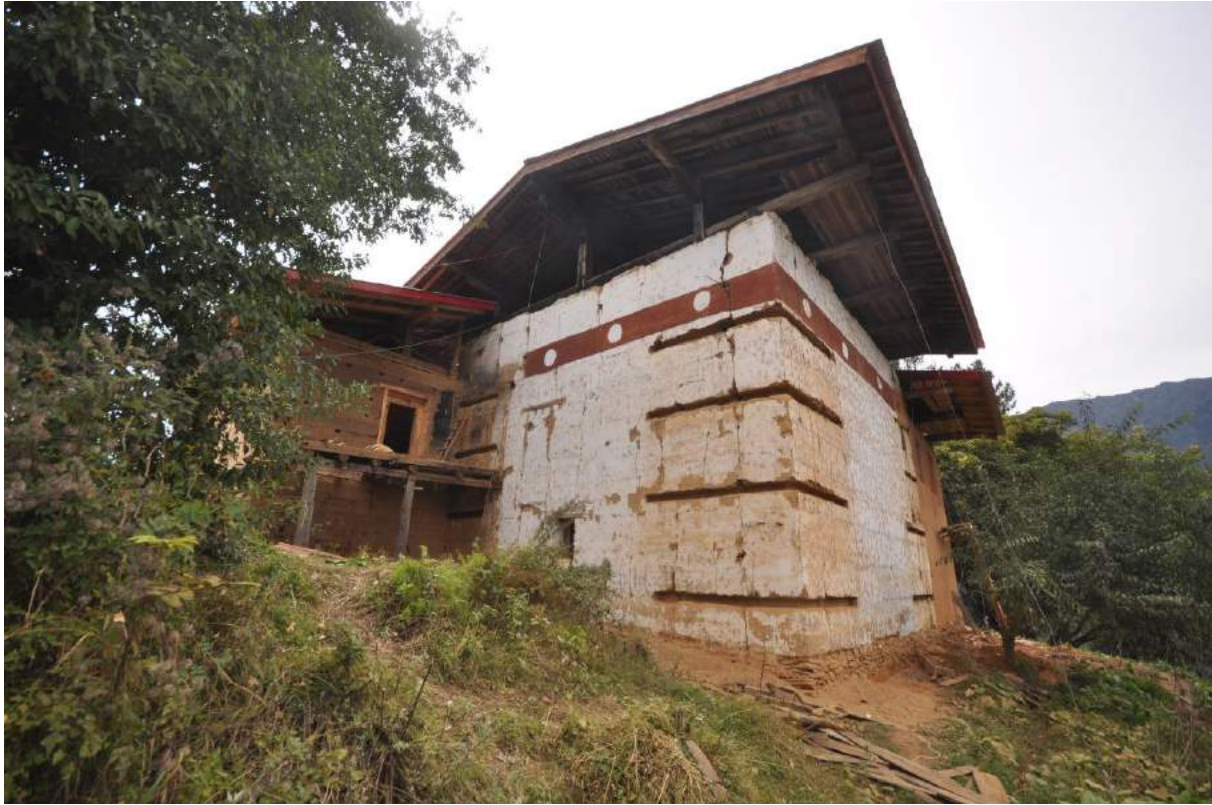
Figure 9: the northeast corner of the Le Kang with the corner keys installed.

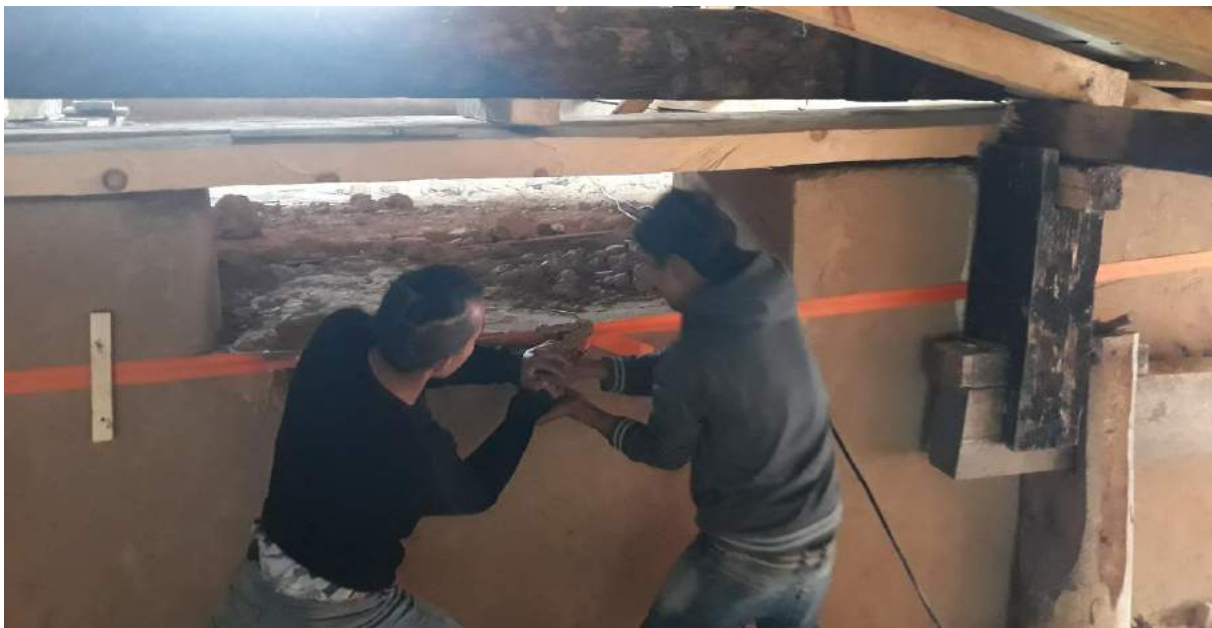
Figure 10: polypropylene seismic straps being installed at the top of the Lhakhang.

The entire envelope of the building was then wrapped with the structural strap. The strap was installed in three places: at the first-floor level; at the first-floor ceiling level; and just below the roof (Figures 10 and 11). The straps were tensioned after they were put in place

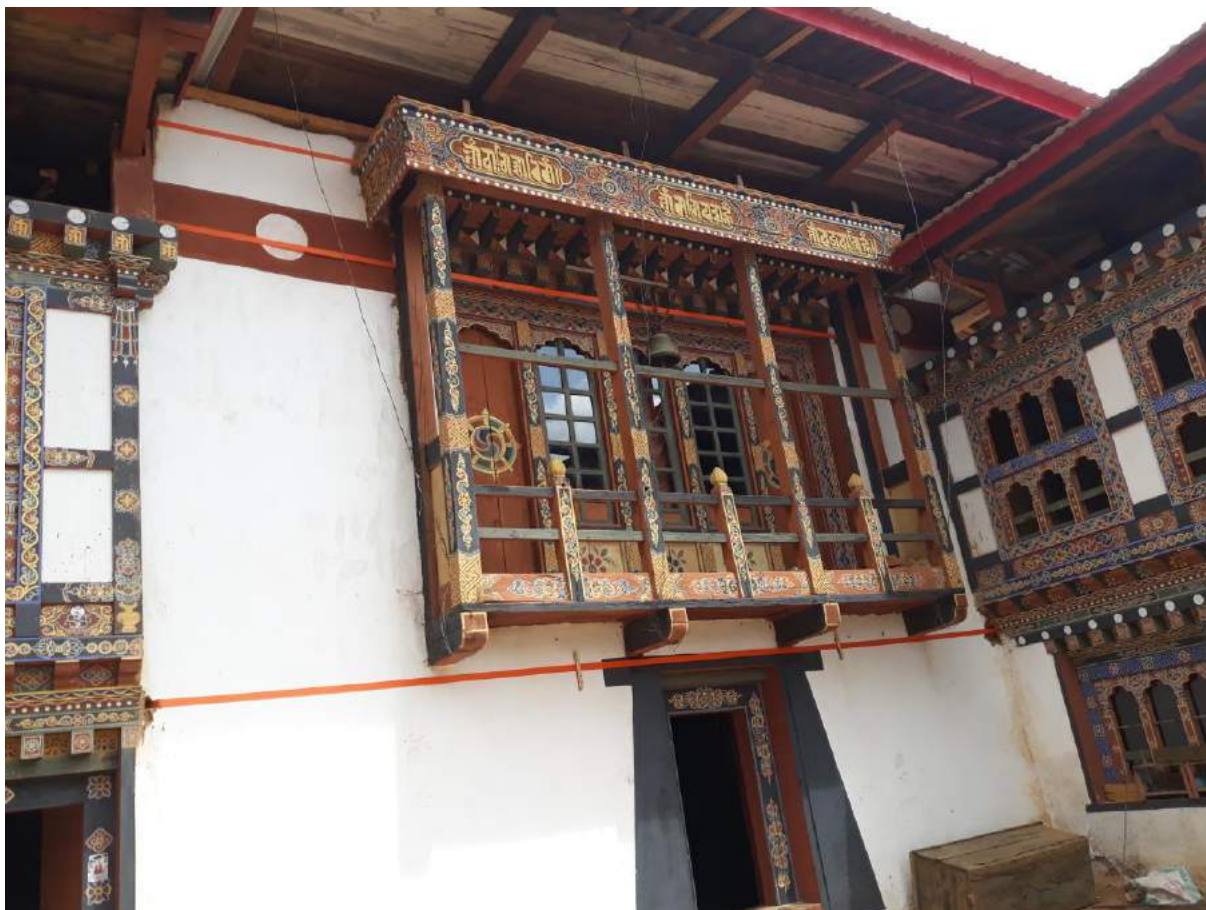
Figure 11: polypropylene seismic straps in place at the first floor level, second floor level, and below the roof.

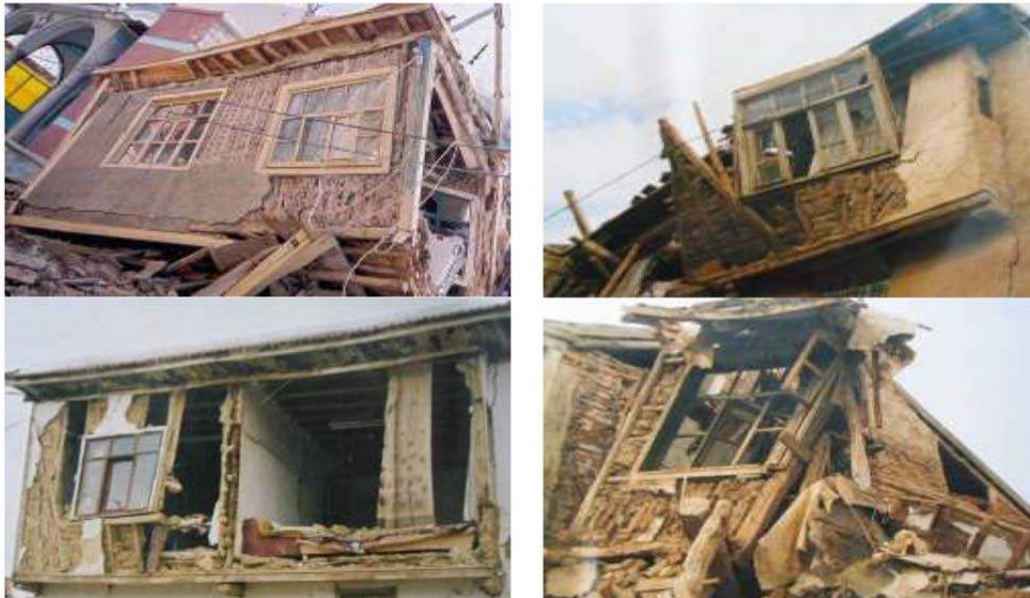
**Figure 13:** Failure and damage of *himis* building [39]

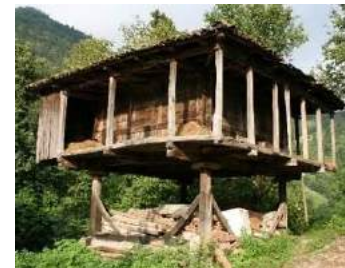
**Figure 7.** "Seren" in Artvin/Borçka/ Aralık Village [30]

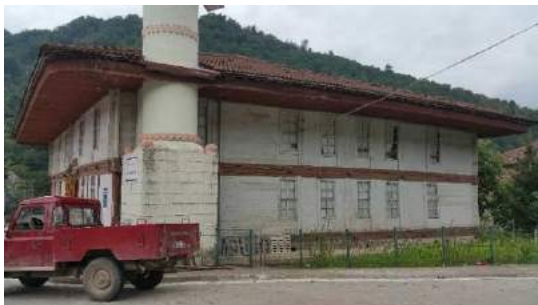
**Figure 21.** The western façade, masonry minaret, tile covered roof and roof [30]

The facade characteristics of the mosque are constituted by the walls built in the log timber technique, sash windows, 2 m wide fringes and the minaret. Body of the minaret made of cut stone is square, its body is cylindrical, and the cone is conical. There are three rings in the body of the single-balcony minaret and a three-ring base under the balcony. Minaret body is plastered (Fig.21).

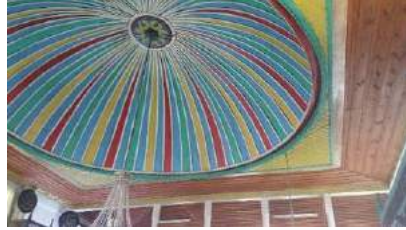
**Figure 26.** Wooden dome and ornaments [30]

The ceiling of the lodge (mahfil) floor is a flat beaded ceiling. Top of the sanctuary (harem) of the mosque which is two-storey high is covered with a wooden dome. There are 10 wooden posts in the ground floor supporting the lodge (mahfil) floor. On the lodge (mahfil) floor, there are 17 woodenpost supporting the dome [17]. The wooden dome is arranged on the hipped roof and is not externally visible (Figs.25-26).

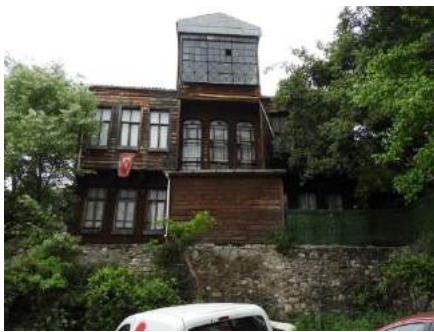
**Figure 12-** Mansion from the west, 2018.

The mansion is a building that is three-stories and in addition has a “cihannüma” floor on the roof. Because of the slope of the land it is perceived as three stories or as two stories (Fig.12, 13). The building's entrance floor has been settled on a level on which the sloping road in ramp form rose from the “Kadiri” Yokuşu (Fig.14). From this level one enters the mansion's entry floor and below this floor is the basement floor that opens on the harem garden while above is the first floor which is used as the main living floor and part of the attic floor. In the southwest corner of the mansion is the masonry “tevhid-hane” and in the southeast corner is the two-story wooden-framed şeyh's house; on the north is the one-story masonry “hamam” and cistern, and on the west is the harem garden with a pool. Between the mansion and the tevhid-hane there are passageways on the ground floor and first floor level and between the mansion and the first şeyh's house at the ground and basement floor levels there are passageways. Likewise a tie exists between the tevhid- hane's ground floor and the first floor of the şeyh's house. From the basement floor of the mansion a passage way is provided to the hamam and an exit to the harem garden.

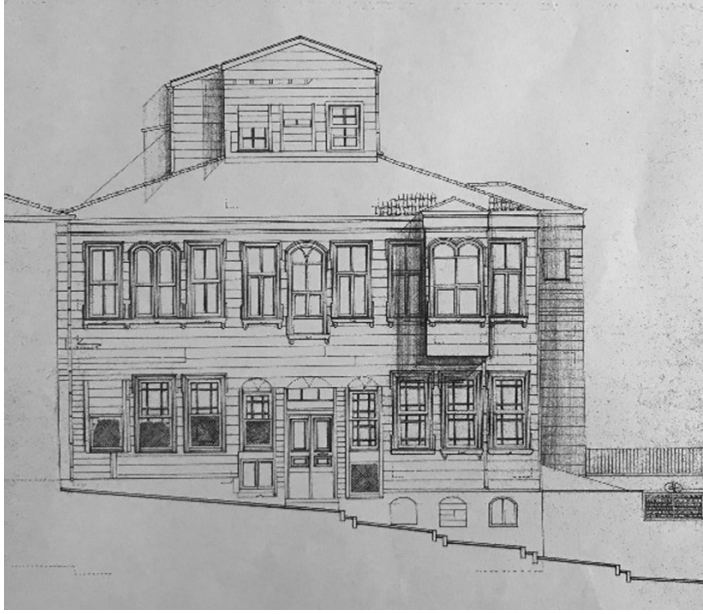
**Figure 25:** Survey of the entrance (eastern) façade, 1980.

On the eastern (entrance) facade at the level of the main living floor, the room on the right side carries to the road with a bay window that has been placed right in the middle (Fig.25-26). On the facade where the threesome and rectangular window organization dominated, at the main living floor level the windows in the middle of the threesome group are double arched in the rooms that were different from the others and in the hall it is arched. On the ground floor too it is seen that with the entrance door in the centre of the facade the windows on the two sides of the door are arched. It is understood that the original window woodwork was sliding (hung) wing and every wing with the help of the half-batten in different dimensions were separated into nine sections. It is thought that the wooden lattices that exist in the building’s ground floor windows were on all the windows in the past.

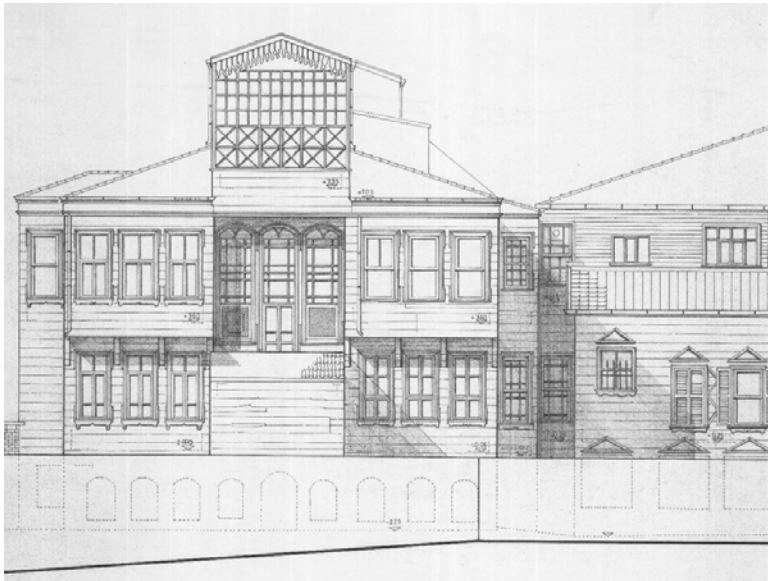
**Figure 27-** Survey of the western facade of the mansion (1980).

The western facade is pointed towards the harem garden and Tombaz St (Fig.25, 26). It is seen that the rooms on both sides of this facade has projections at the main living floor level and the projections are supported by wooden cantilevers. The room windows are rectangular and the “eyvan” windows are both arched and made higher than the room windows. The attic floor’s enclosed balcony appears in the forefront with wooden eave decorations in the art nouveau style and with a glass facade.

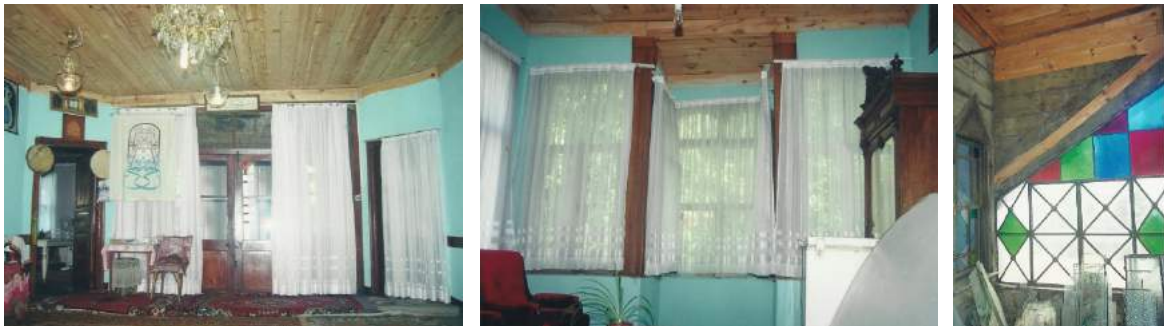
**Figure 29, 30, 31** - Central hall and northeast room of the main floor and "cihannüma" after the 1997 repair.

In 1997 in the fire that broke out because of electric contact in the wooden "selamlık" section that wrapped a portion of the "tevhid-hane", the wooden parts of the "tevhid-hane" and the "cihannüma" (mansion's attic) floor completely and the ceilings of main living floor partially were destroyed. Because it was winter time the "Şeyh of Tekke" had emergency repairs carried out through his own initiative. During this repair that was done without the approval of the Preservation Council and the Foundations Directorate, the elements that were destroyed because of the fire were not made in their original form (Fig.29-31). Separately characteristics that still existed in spite of the fire were changed. For example on the facades the covering board used was narrower, the roof that didn't have eaves was built with eaves and the mouldings which was a little below the level of the eaves was destroyed.

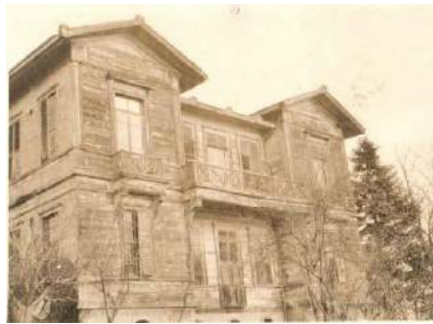
**Figure 2:** Prefabricated timber house Stcherbakoff in Çengelköy (Istanbul), 1955 [6]

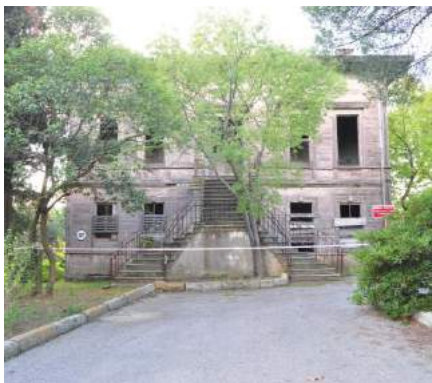
Figure 7: East facade

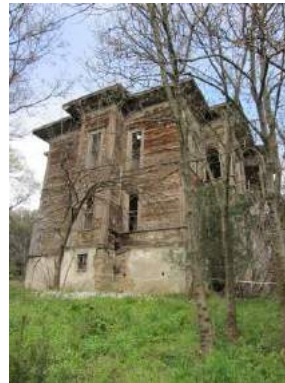
Figure 8: West facade

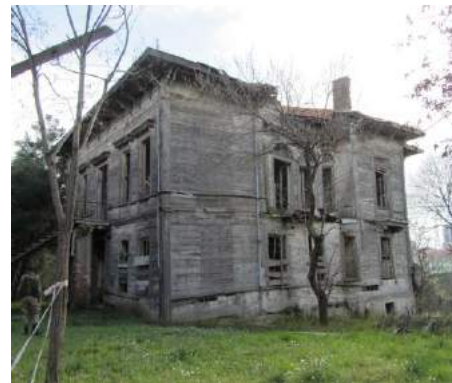
Figure 9: North facade

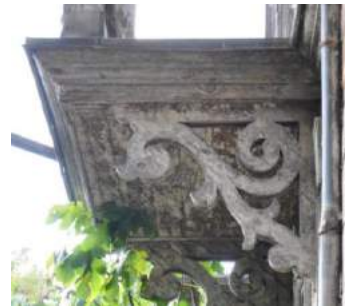
Figure 11: Timber bracket of Ahmet Celaledin Pasha Mansion

The balcony on the northern facade of the building which was carried by decorated wooden brackets seen in the photographs of 1988 (Figure 20), was destroyed at an unknown date. Ali Talat expresses decorated timber brackets (Figure 10, 11) are not carriers and should only be used as ornaments [8]. In this example, interventions and faulty workmanship were found to damage the construction system of the structure in addition to the effect of earthquakes. As a result of the abandonment of the building, the chimneys and floors were destroyed due to lack of maintenance.

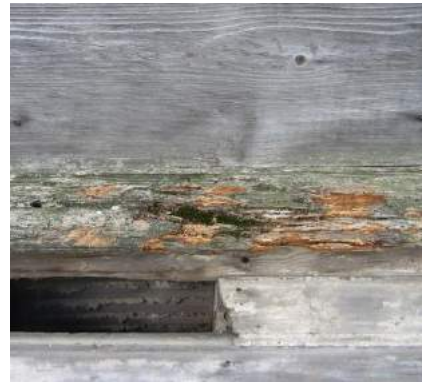
**Figure 13:** Biological deterioration

Ahmed Celaleddin Pasha Mansion has a qualified construction technique as one of the few timber-frame mansions of 19<sup>th</sup> century in the Acibadem district. It was officially registered as a cultural asset in 1987 and it survived until today. However, there has not been any architectural documentation effort and no preventive or provisional application has been implemented for its preservation. According to archival researches, in 1955, while it was under the military administration the roof was repaired and the outer facade was painted. At that time, it is known that there was plumbing and electrical wiring in the mansion installed at an unknown date prior to 1955. It has been observed that deterioration due to the interventions is not at a level that would destroy the architectural integrity of the mansion, however, over time, external factors such as atmospheric conditions and biological deterioration have caused serious deterioration in the load-bearing system and materials (Figure 13).

The 25 m<sup>2</sup> of the roof in the western part of the structure is collapsed also the balcony and the eave located at the symmetry axis of the north facade. When the roof collapsed, the basement was destroyed and the deviations occurred on the vertical and horizontal load-bearing system. Due to the floor problem in the northern part of the eastern front, there was maximum deflection on the facade. The lack of sill on rubble stone basement walls caused the quick deterioration of the timber principal posts and vertical braces. The internal staircase that provides access to the floors has begun to lose its carrier character due to the weakening structure system. Wood stems and trunks of the plants on the outer surface of masonry walls in the basement to the west and south facades have caused structural cracks in the walls (Figure 12). Ground water in the basement floor and the water coming from the collapsed roof lead to salinization in masonry material and biological deterioration in timber material.

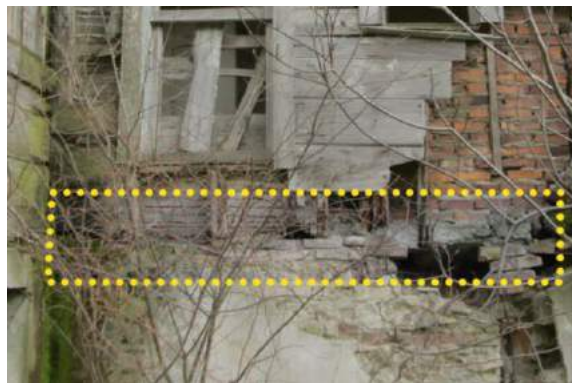
**Figure 16:** Faulty workmanship 2

In Figure 15 shows that the alternate wall construction with two or three courses of brick in alternation with stone courses is not supported by timber runner beams, but in Figure 16 it is seen that the principal posts and vertical braces sit directly on the masonry wall since there is no timber sill. This situation brings the risk of timber-framed structure slipping from the supports when a sudden load comes at the moment of the earthquake.
