**Proceedings of the  
Inter-ISC'18**

**Anti-Seismic Vernacular  
Heritage of Anatolia and  
Beyond**

**Proceedings of the Inter-ISC'18  
ICOMOS Inter-ISC Meeting & Colloquium  
July 10-13, 2018 Kastamonu, Turkey**

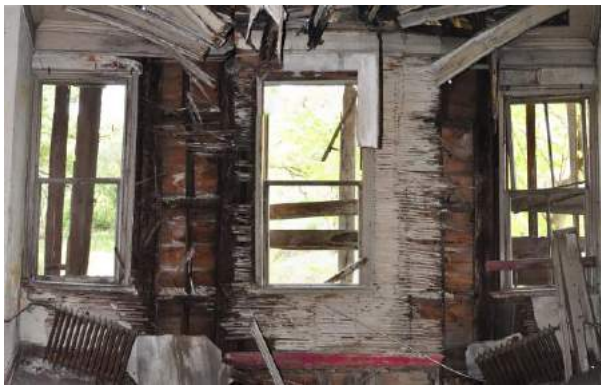
**Figure 18:** Space ZK-07, timber structure

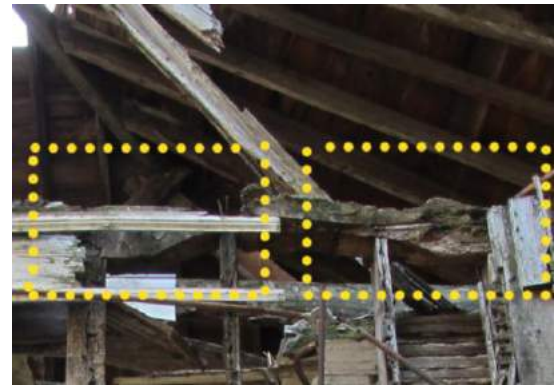
**Figure 19:** Space 1K-05, timber headings

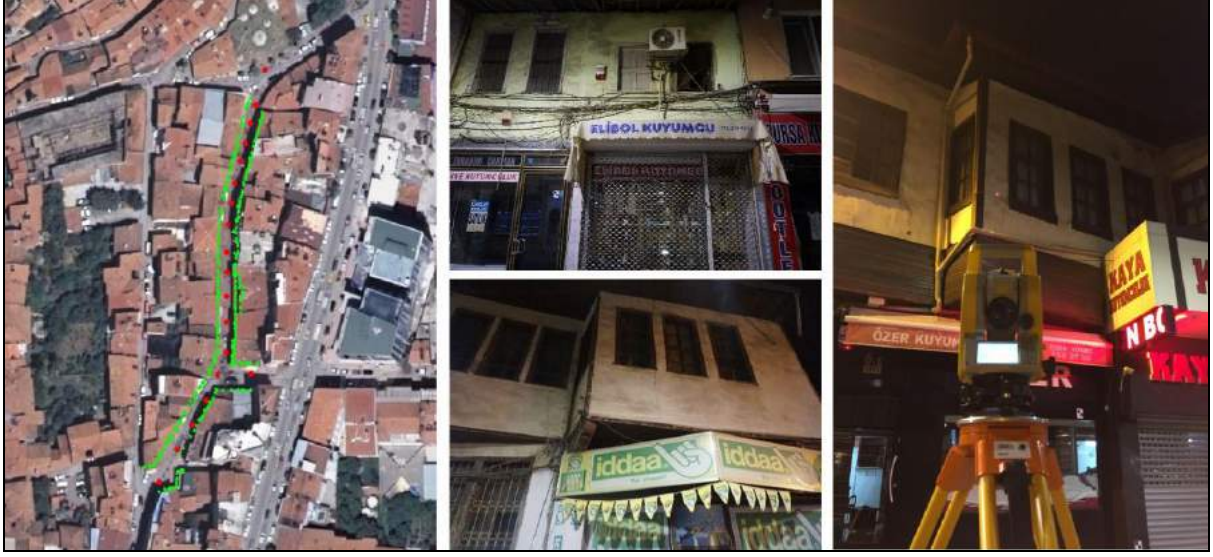
**Figure 3:** (left) Traverse points (red) along the street and measured control points (green) and (right) some images for field study

the street. As in geodetic measurement, movement between two photography depending on the base distance was made considering the topography of the street and the locations of the buildings. General view of traverse points, measured control points, some photographs taken for façades and geodetic measurement are indicated in Figure 3.

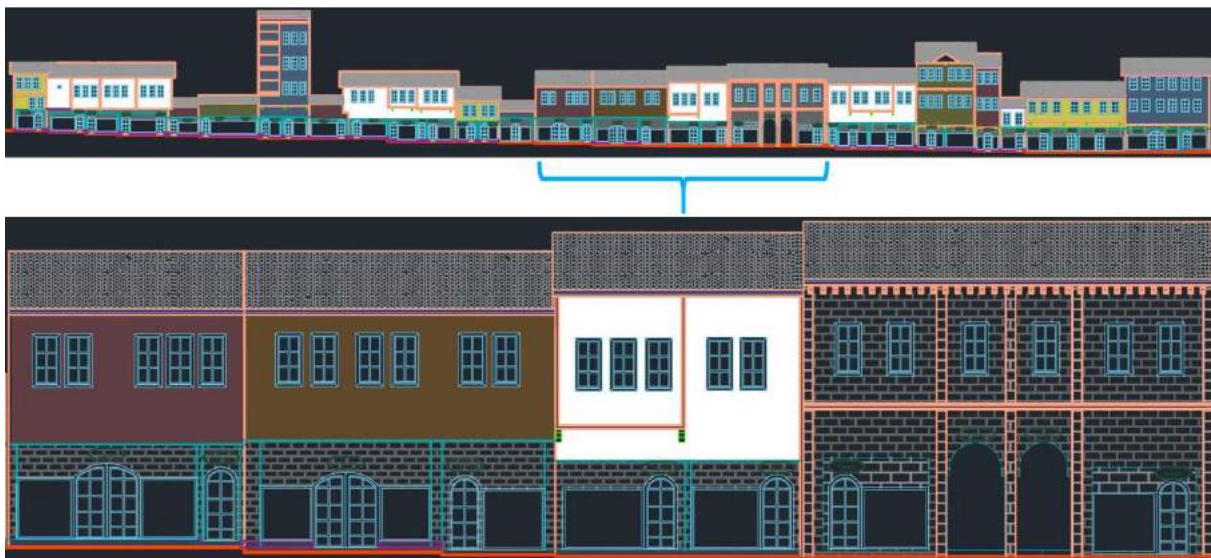
**Figure 5:** (upper) Planned situation of right side of the street and (bottom) a zoomed view of a small part

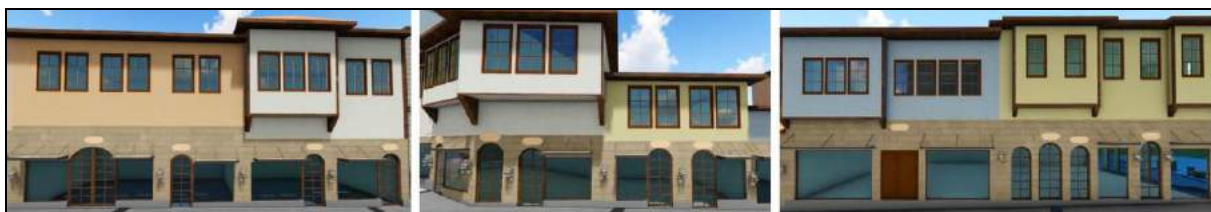
**Figure 6:** Some views from 3D animation

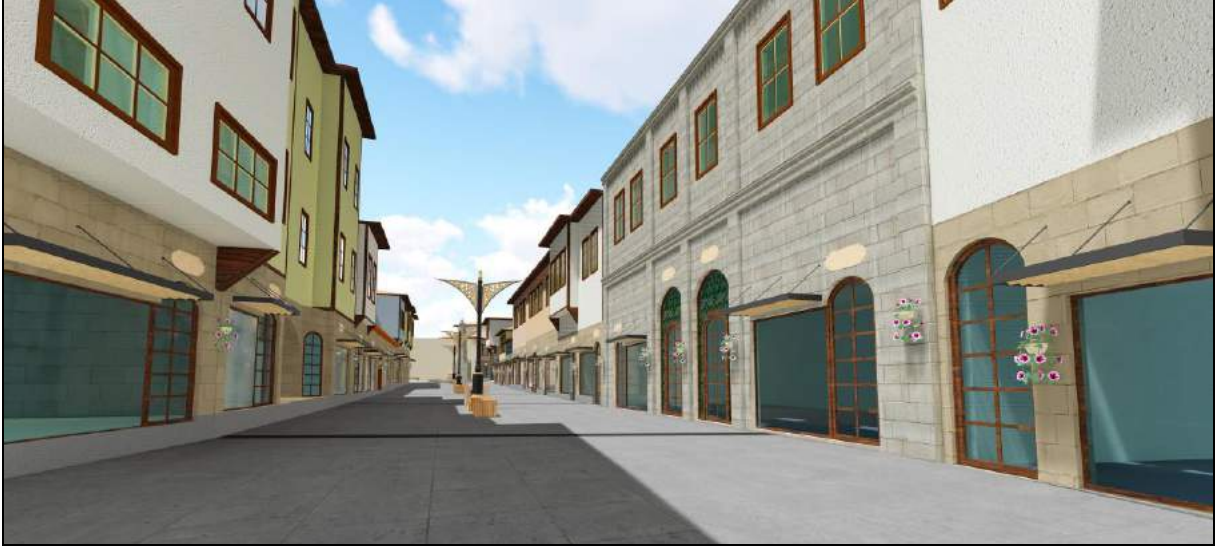
**Figure 7:** A part of the general view of the street in 3D animation

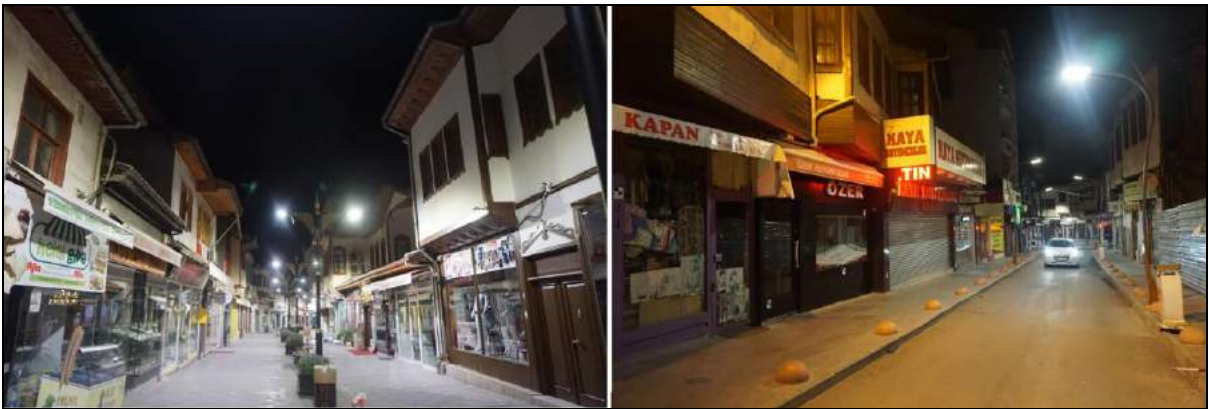
**Figure 8:** The time and conditions under which the taking of the photographs performed

In order to achieve the desired accuracy in terms of both quantity and quality, some conditions must be appropriate for the CRP study. The fact that the photographs of the surface cannot be taken from the suitable distance due to the narrowness of the street affects the accuracy negatively. Additionally, if there is an obstructive object in front of the façade, it is difficult to obtain photographs, and this can cause a mistake in the drawing because the façade could not be reflected as it should be. Moreover, the lack of adequate lighting reduces the quality of the photographs [10]. As indicated in Figure 8, all these factors are available in this study.

There was no possibility to take photographs during daylight hours because of the people crowd on the street during the day. Therefore, photography was carried out at midnight after the shops closed. It was benefited from the light to the extent that the lighting poles located in the middle of the street allow. Sitting benches and sometimes lighting poles were obstructive objects for overlapped photographs. In the photographs belonging the upper parts of the higher buildings, the lighting lamp can be included in the framing. Similarly, sitting benches, dustbins and flowerpots fixed on the floor may be included in the lower parts of the surfaces. Since the street is not wide enough, the required distance was not met in some regions.

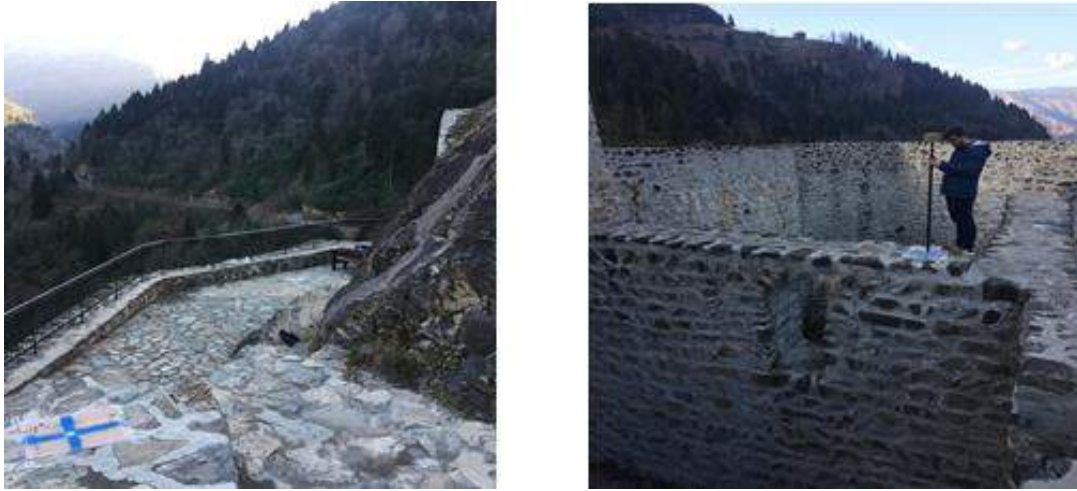
**Figure 3:** Ground Control Point Sample

In this study, 5 ground control points (GCP) were placed on the castle walls cover the working area for interior and exterior orientation of photographs taken by UAV. GCPs were designed to be 50 cm x 50 cm in size so they can be displayed clearly during the photogrammetric evaluation phase. In Figure 3, sample of GCP was presented. The GCP zone selection is designed to provide a homogeneous distribution where the view is clear, distant from any object that may cause multipath, and can best be characterized by the characteristics

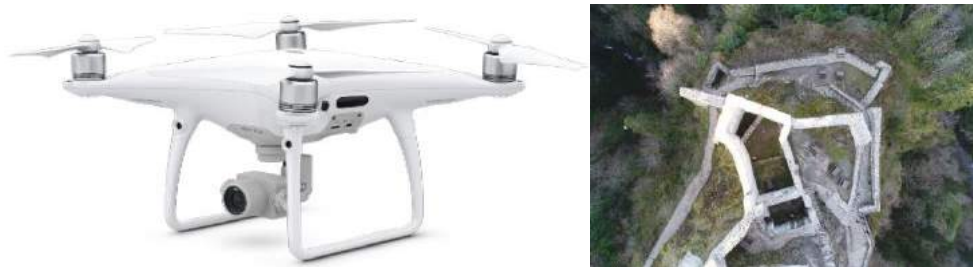
**Figure 4:** Used UAV and example of photograph taken by

DJI PHANTOM 4 pro was used as UAV which can perform automatic and semi-automatic flight. PHANTOM 4 is integrated with the GoPro camera for image recording. Used UAV in the study and one of the photographs taken by same UAV have been presented in Figure 4.

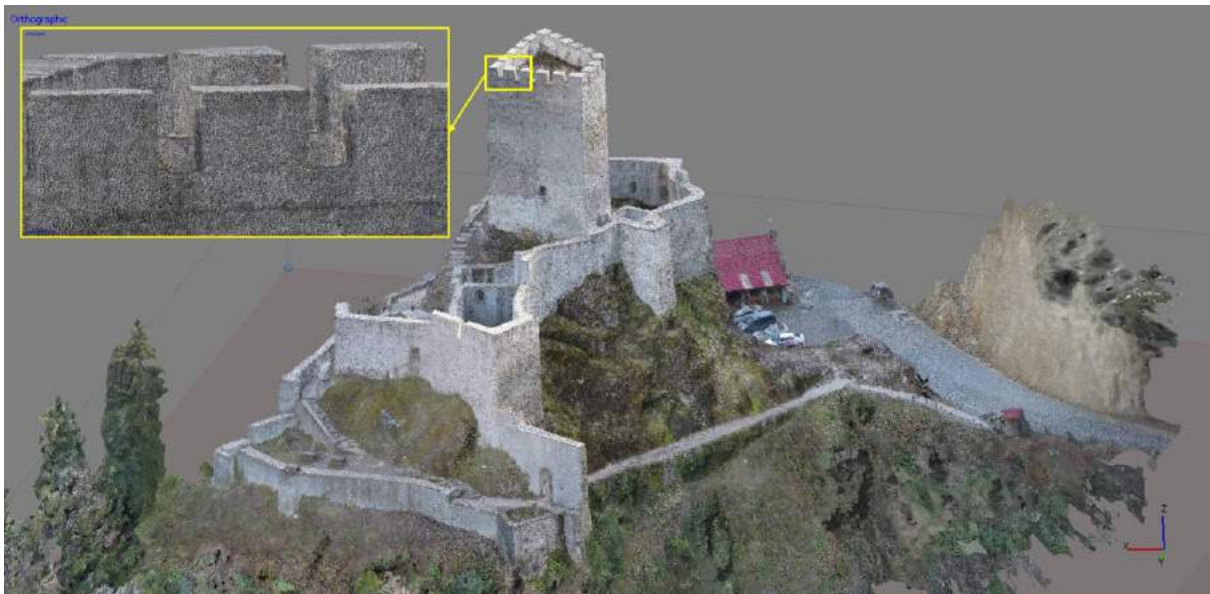
**Figure 6:** Dense point cloud and details part of the castle

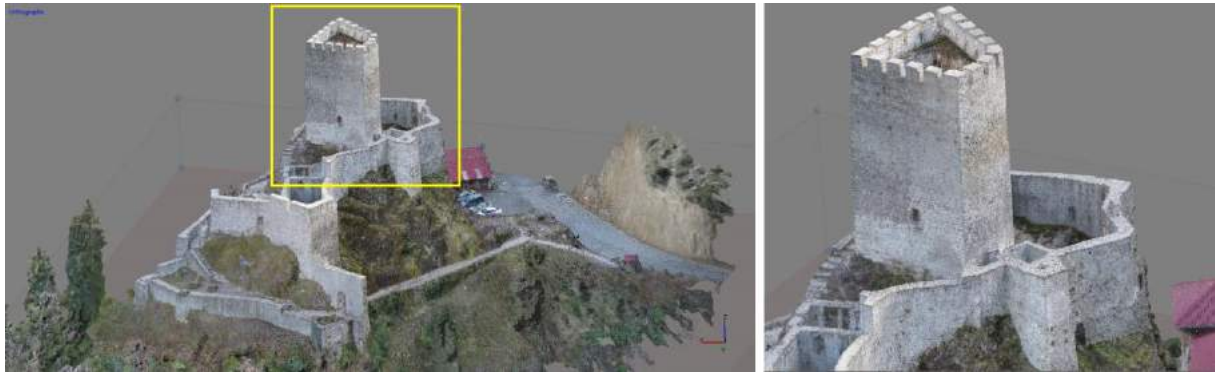
**Figure 7:** Textured model of the study area

Applying image processing techniques on dense point cloud textured model was produced. In this model 125 015 faces and 62570 vertices were produced. Draping images on this model tiled model of the historical castle was produced. Produced tiled model is presented in Figure 7.

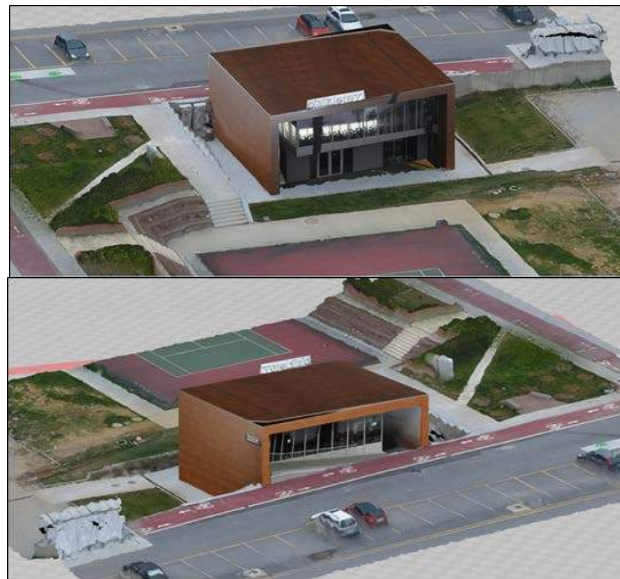
**Figure 8:** Combined 3D model

This project consists of a combination of two different 3D models. First model is the digital surface model (DSM) created in Agisoft PhotoScan software with UAV images and the second 3D model is the ITU Bicycle House created in Photomodeler Scanner with close-range photogrammetry techniques. The aim of this study is to combine these two separate models. The models have been combined in Microsoft Windows 3D Builder software that allows the user to view, capture and personalize 3D models. For combining the models, the DSM model and the building model have been exported as “.obj” files and these files have been imported to the 3D Builder software. The models have been adjusted to their exact position in real topography (Figure 8).
