An Evaluation of Shelter Coating as a Preventive Conservation Method for Earthen Sites

AN EVALUATION OF SHELTER COATING AS A PREVENTIVE
CONSERVATION METHOD FOR EARTHEN SITES

A THESIS

MASTER OF SCIENCE IN HISTORIC PRESERVATION

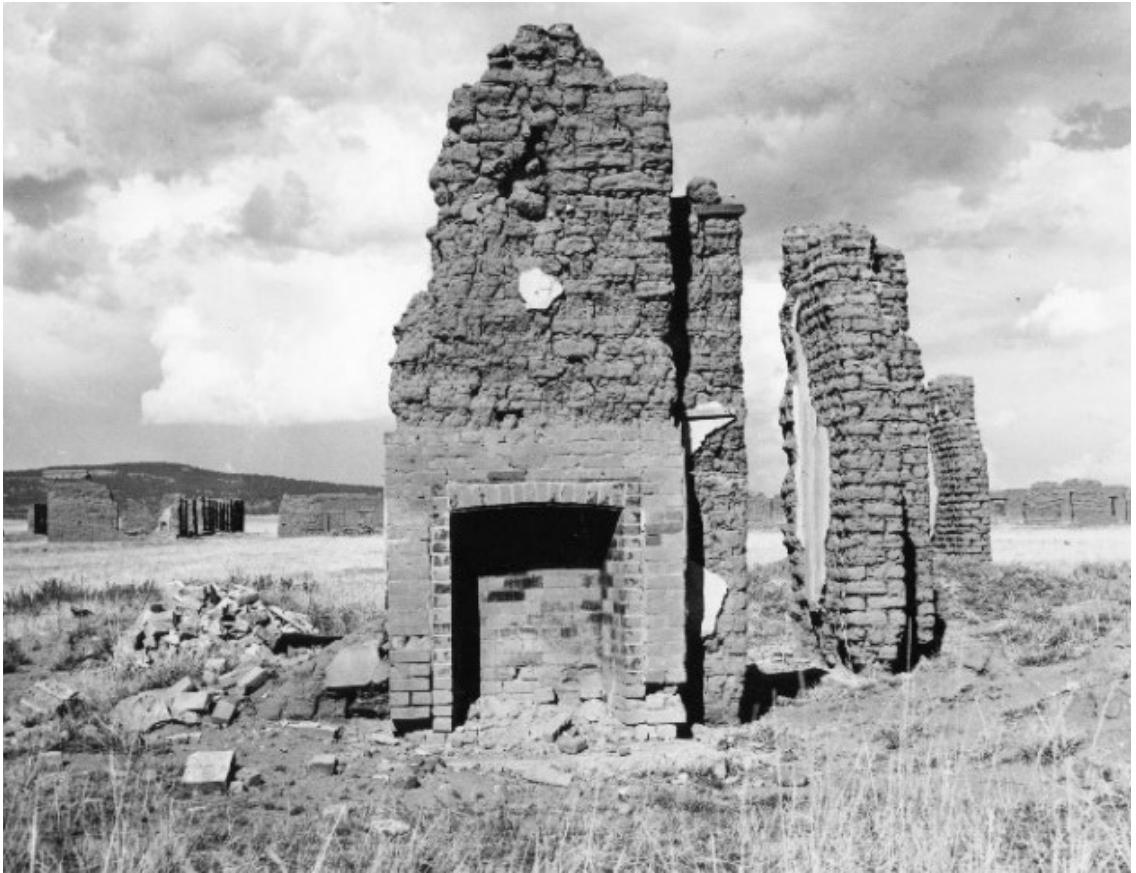
Figure 1: Exposed Adobe at FOUN 1954 (Wilson).²²

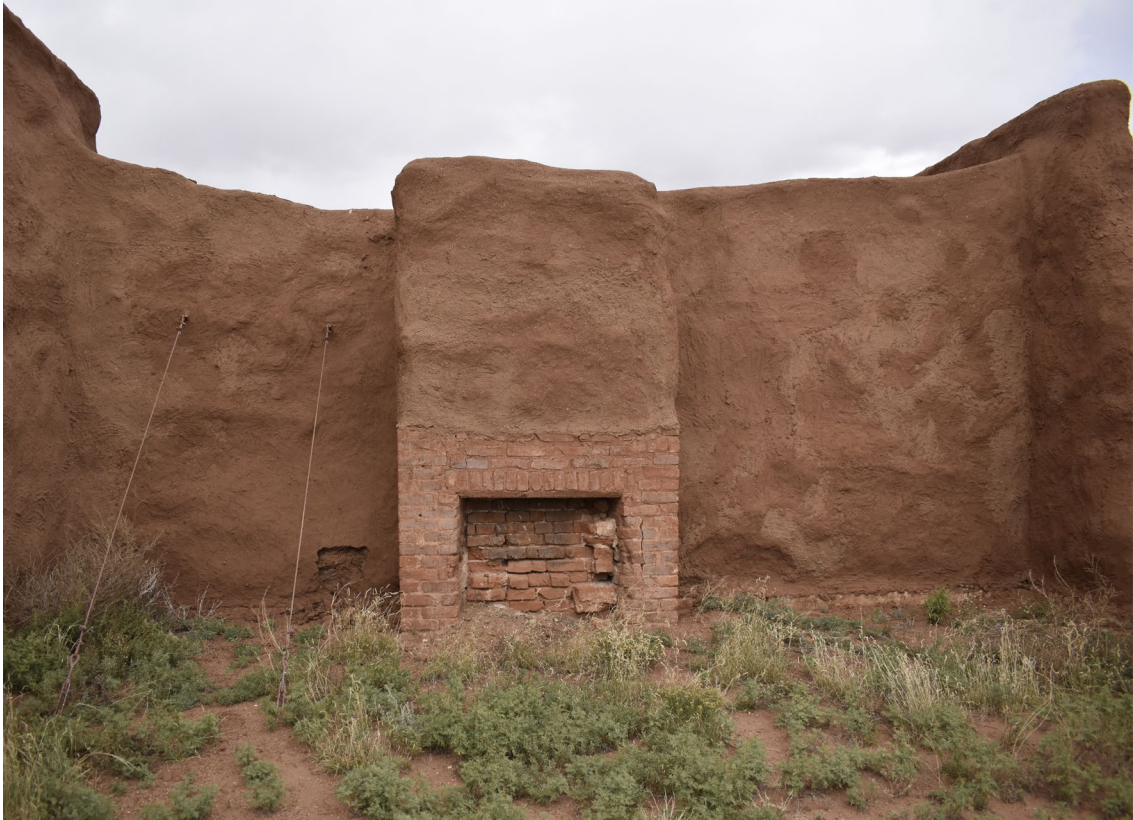
Figure 2: Shelter Coated Adobe at FOUN 2021 (Photo by author).

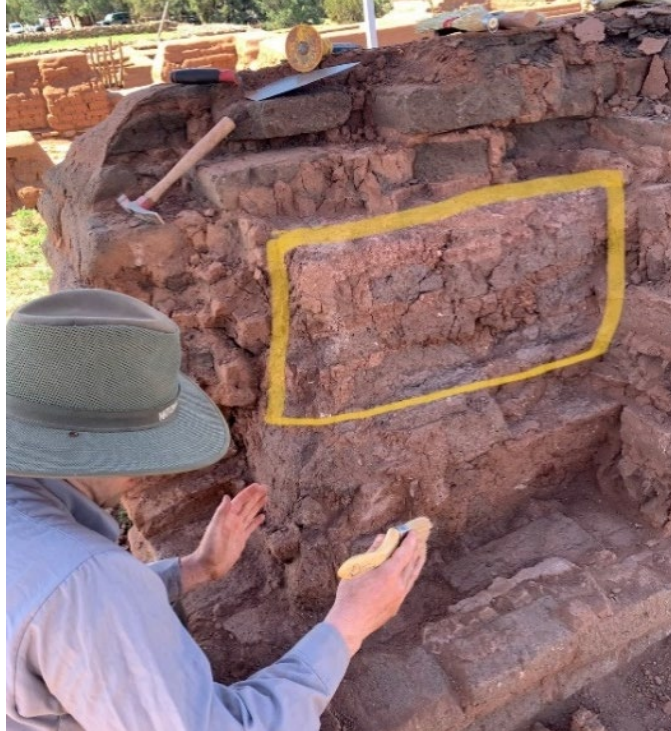
Figure 12: Encapsulation: Excavation of encapsulated adobe (original adobe protected by encapsulation is outlined in yellow) at Pecos National Historical Park 2021 (Photo by author).

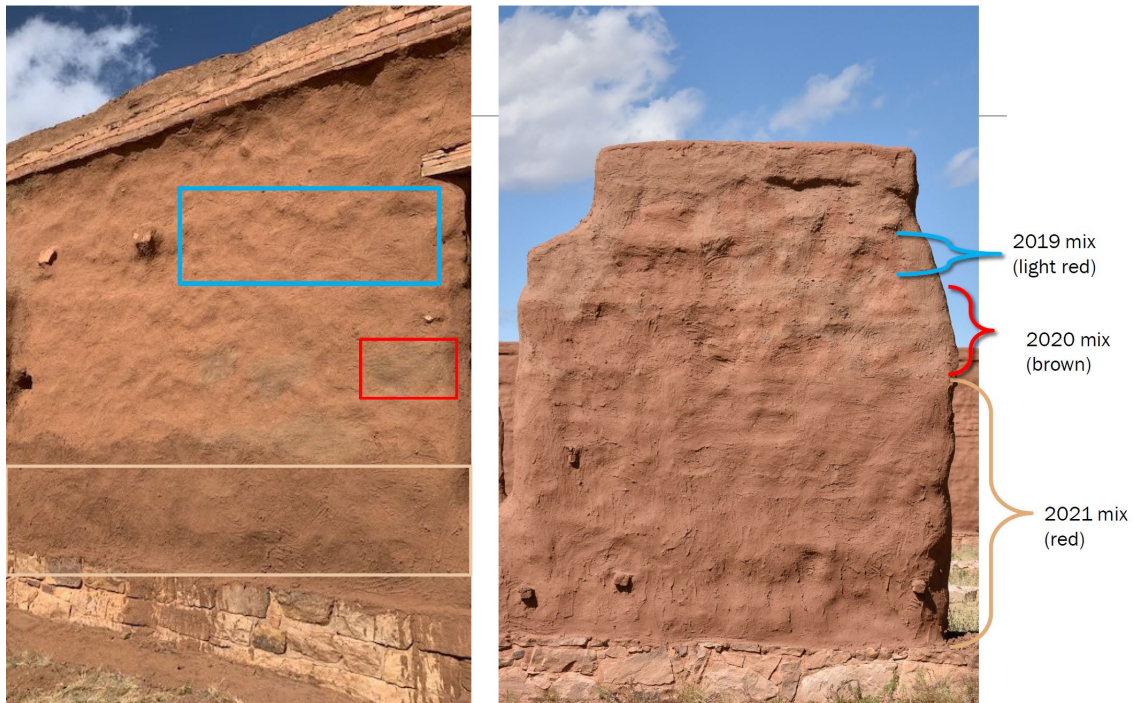
Figure 16: Different soils used for shelter coating at Fort Union (Photos by author).

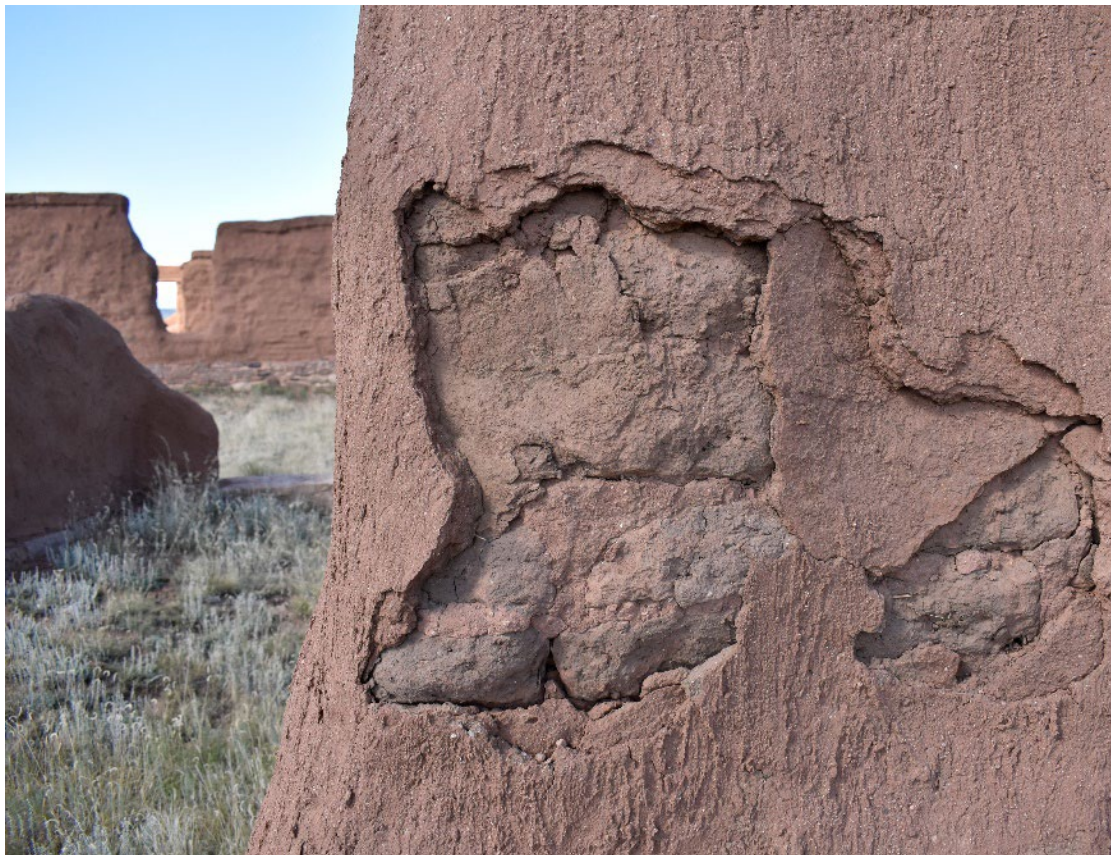
Figure 17: Spalled shelter coat at FOUN exposing multiple layers of shelter coating and underlying adobe (Photo by author).

Significant weather events crack the shelter coat and many of these areas display spalling or incipient spalling (partial detachment). At present, shelter coat cracks and spalls are repaired by patching the shelter coat rather than removing the entire coating from the wall and replacing it with a fresh one.

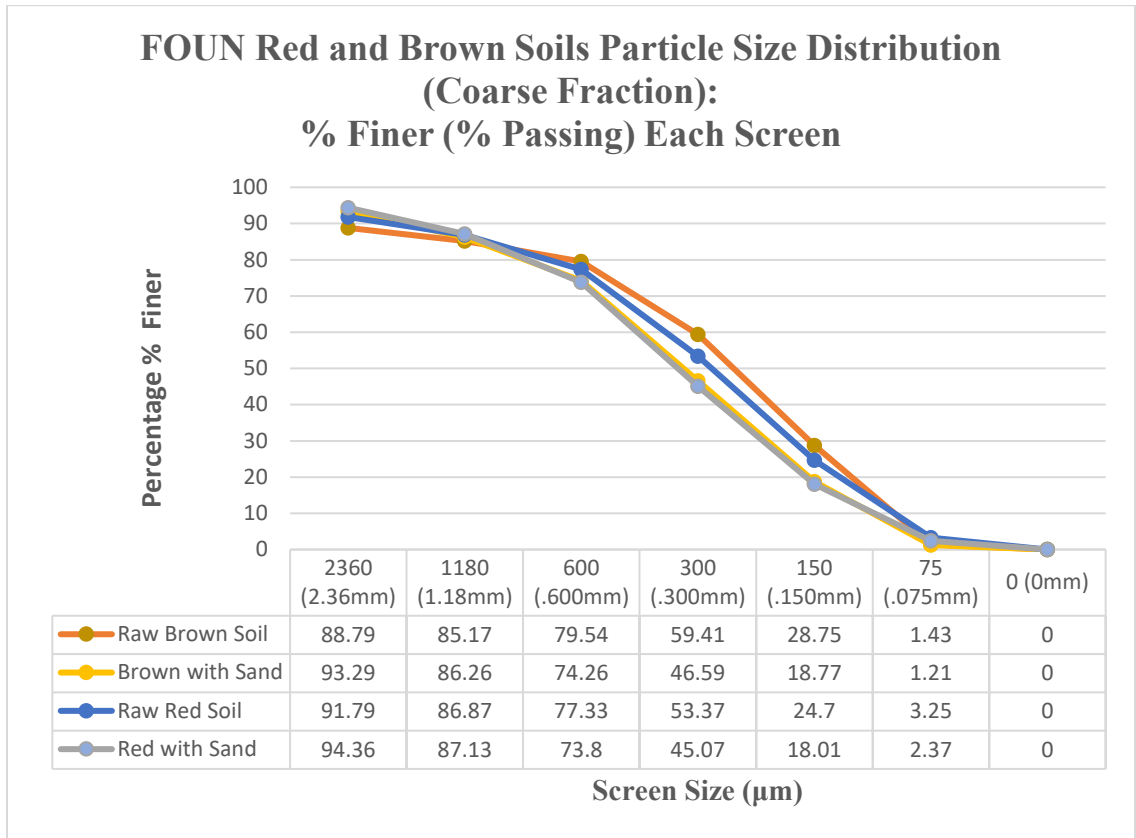
Graph 1: Raw Grain Size Curves (Coarse Fraction Only).

the grain size distribution of both soils, as is indicated by the grain distribution curves (Graph 1).

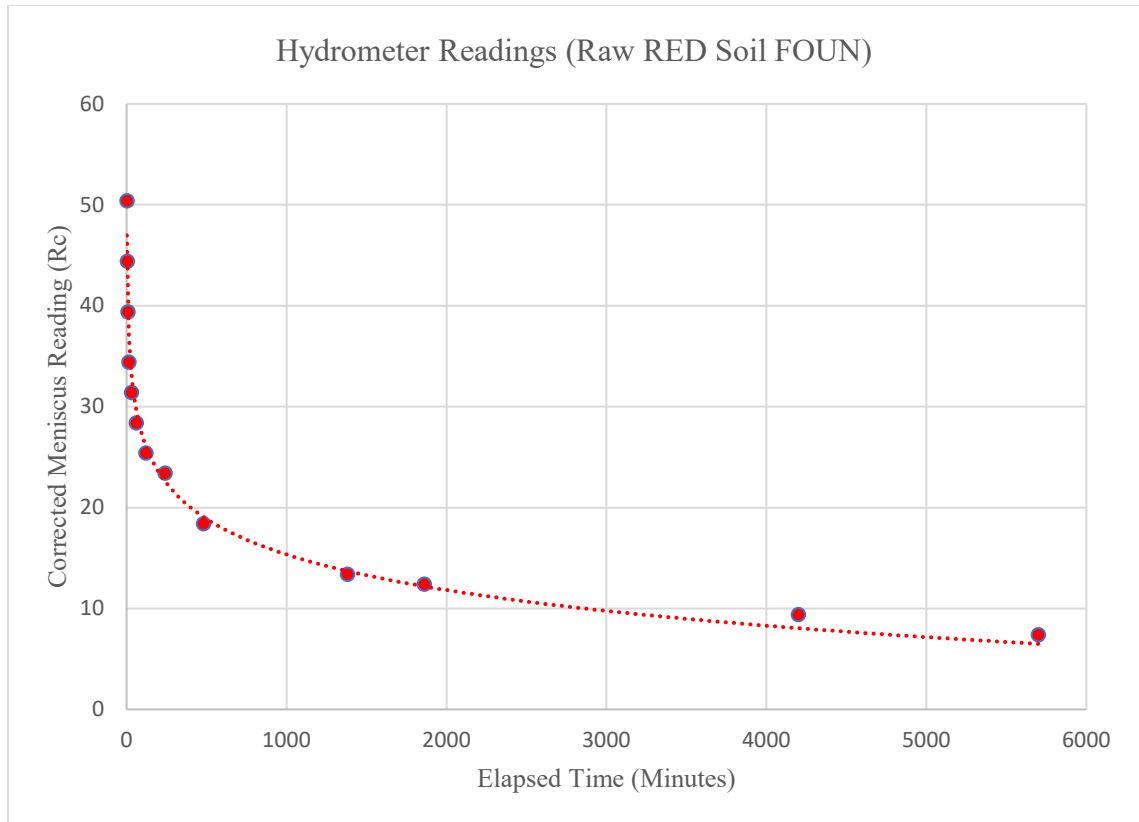
Graph 2: Hydrometer Readings Red Soil.

The hydrometer readings from the red soil indicate that the fine fraction contained approximately 36% silt, and 18% clay. The hydrometer reading remained above 60 for less than two minutes of testing, indicating a lower number of fines than the brown soil (Graph 2).

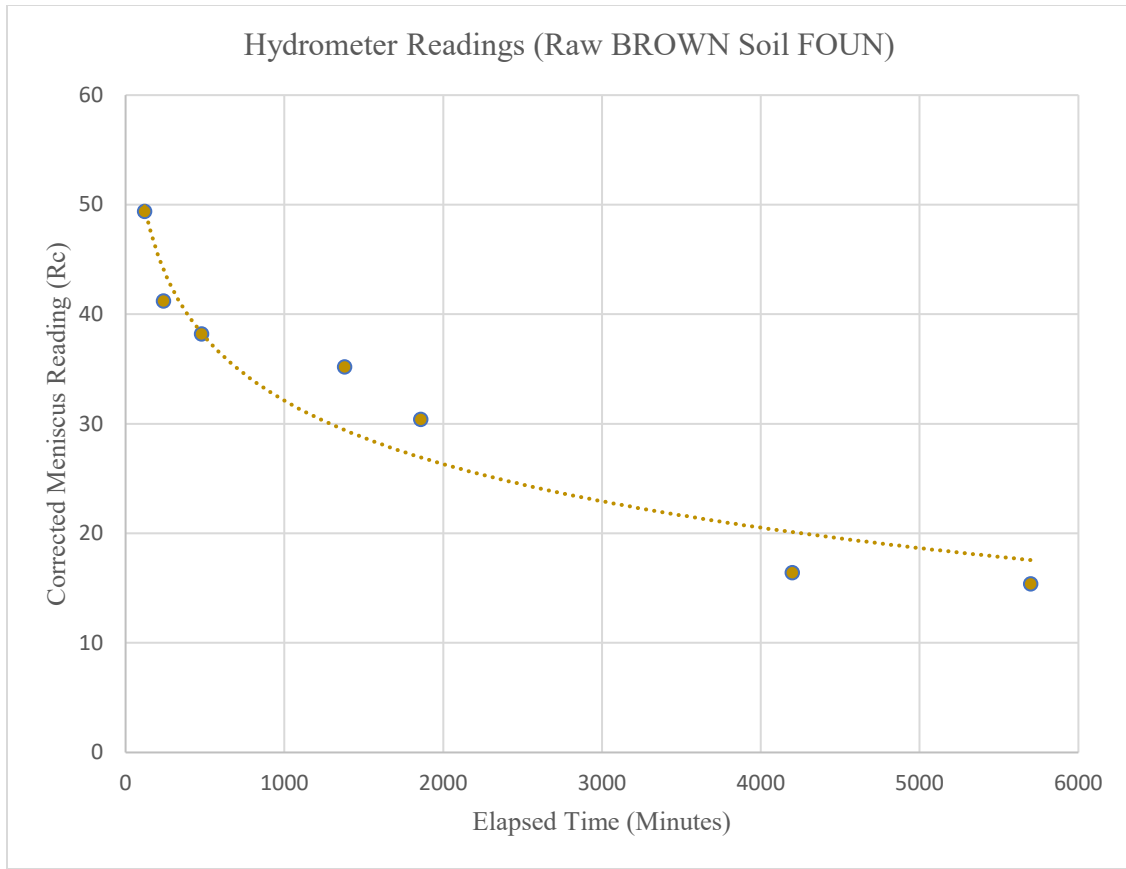
Graph 3: Hydrometer Readings Brown Soil.

The hydrometer readings for the brown soil indicated a highly clayey soil, with no measurable amount of silt. The number of fines in the brown soil was so high that the hydrometer reading remained greater than 60 for at least the first hour of testing. It was only possible to take the first hydrometer reading after two hours (120 minutes) of testing (Graph 3). The hydrometer readings indicated that the fine fraction of the brown soil contained over 27% clay (see Appendix D for the full sedimentation analysis and calculations).

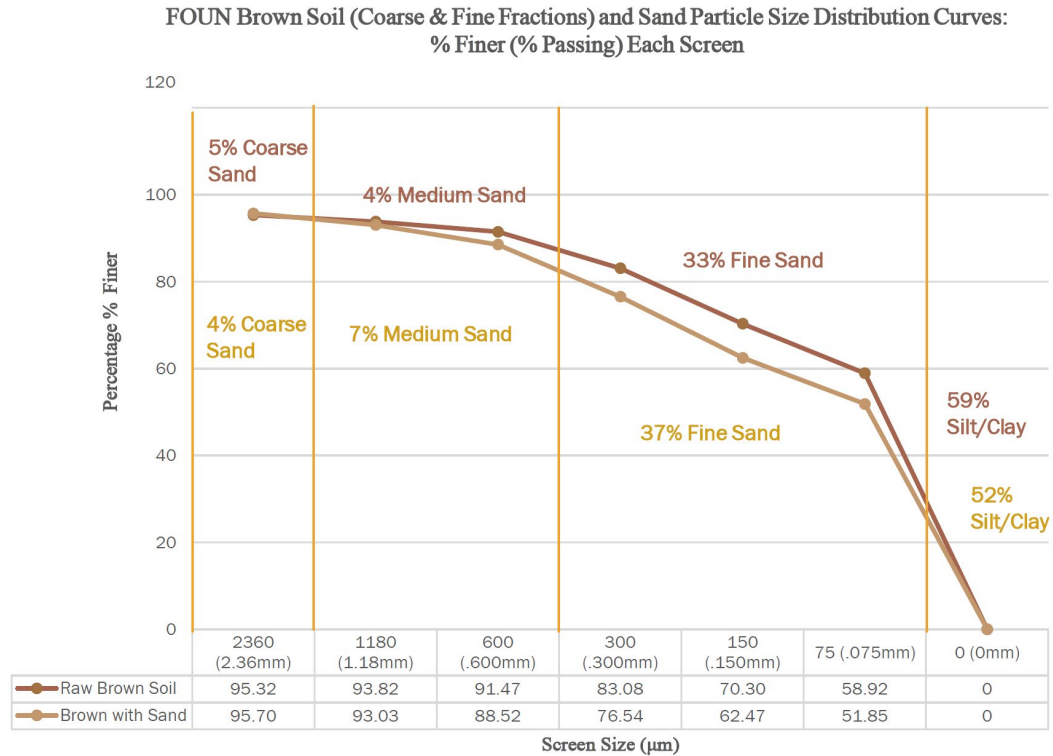
Graph 4: Brown soil coarse and fine fractions particle size distribution curve.

The addition of sand to the brown soil resulted in a more even distribution of particles to provide optimal consistency and to help with shrinkage upon drying (Graph 4). The addition of sand to the brown soil lowered the percentage of course sand increased the percentage of medium sand, while the percentage of fine sand increased, and the percentage of silt/clay decreased. Given that the hydrometer analysis revealed a significant amount of clay in the brown soil, the addition of sand will also increase the strength of the brown soil and decrease its propensity to shrinkage.

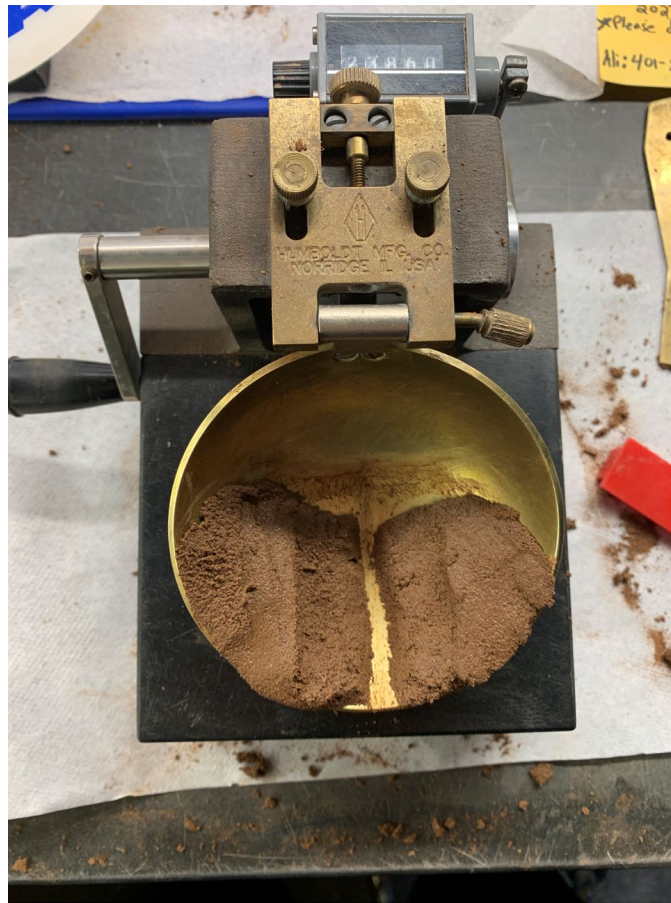
Figure 19: Casagrande device, used to measure liquid limit, with the center groove.

plastic limits, and the plasticity index of soils.¹⁶¹ The liquid limit test is a measure of the water content at which a soil begins to behave as a liquid. Liquid limit testing is conducted by smoothing the soil into a Casagrande device which is turned to measure the number of drops it takes for the groove in the soil to close (Figures 19-20). The test begins with the soil in a drier state, a higher number of drops required, to a wetter state, requiring a lower number of drops.

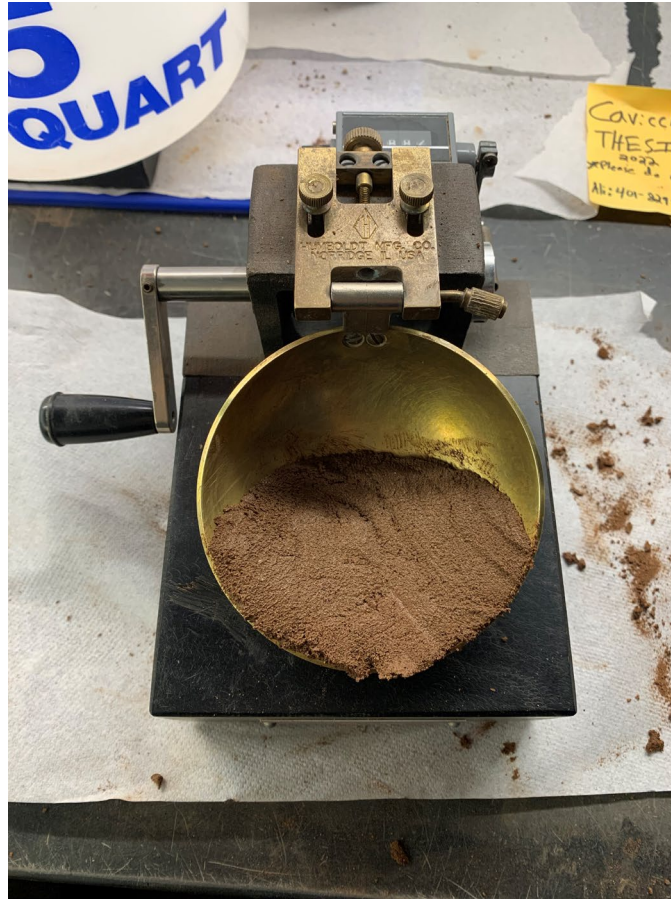
Figure 20: Casagrande device, used to measure liquid limit, without the center groove.

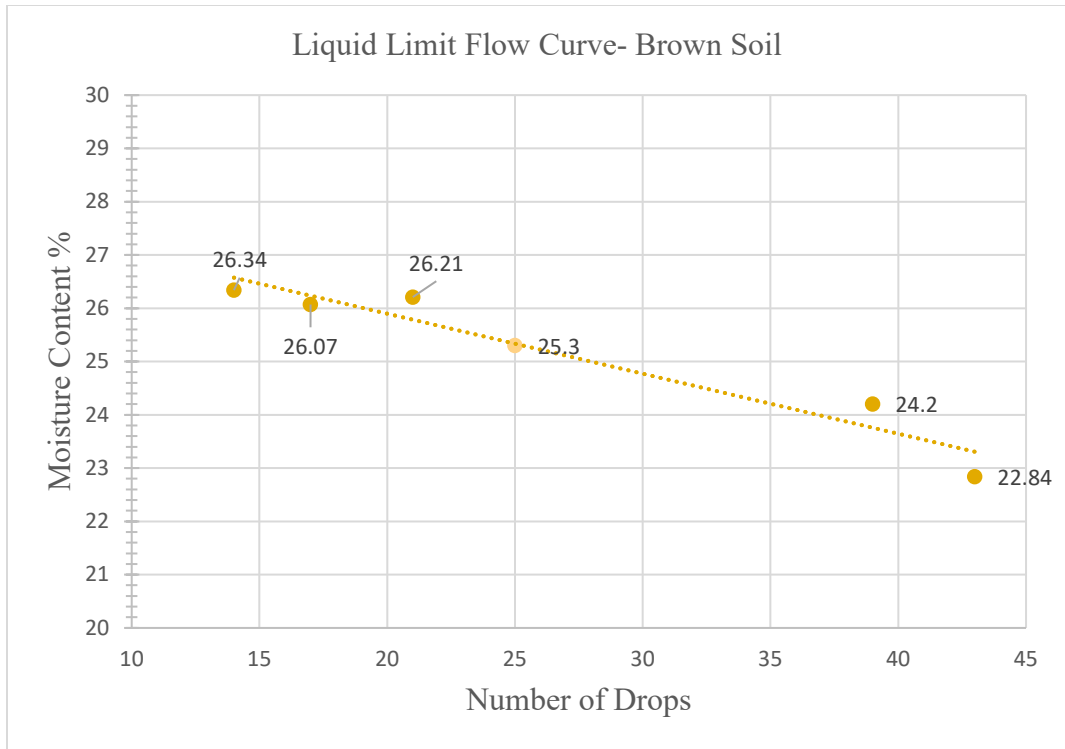
Graph 5: Brown Soil Flow Curve with a Liquid Limit of 25.

The raw brown soil had a high liquid limit of 25 (Graph 5) indicating that it was able to absorb a high amount of water before turning to its liquid state. The raw red soil was non plastic (Graph 6) – even at its driest state the soil performed poorly, meaning the liquid limit could not be determined.

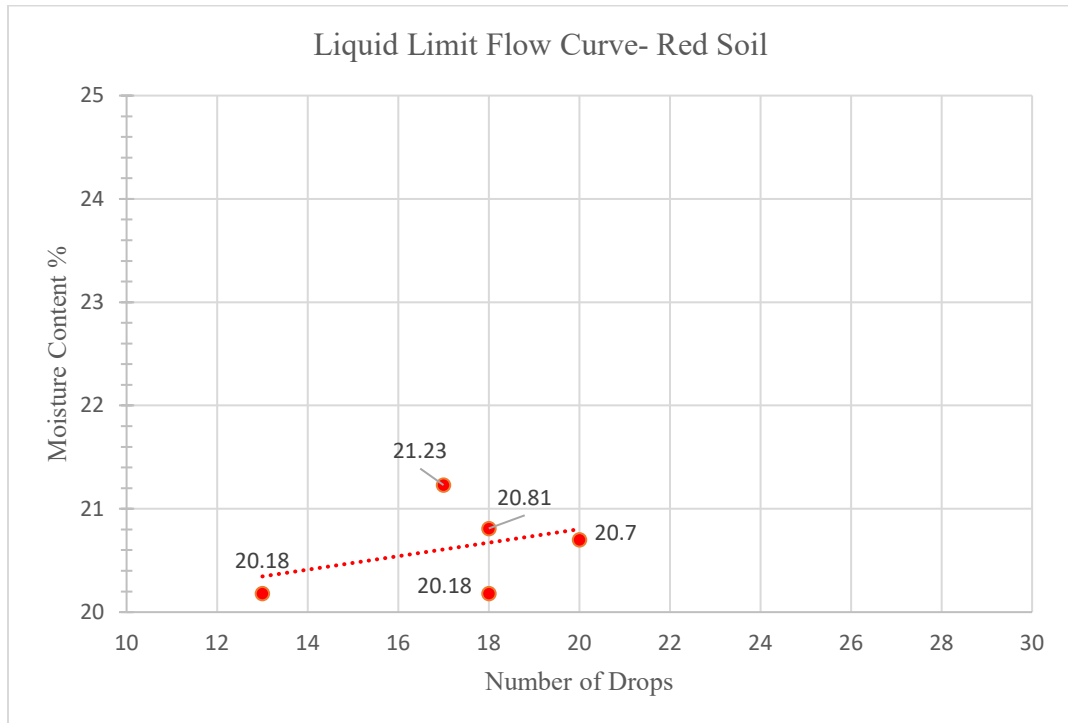
Graph 6: Red Soil Flow Curve, Liquid Limit could not be determined.

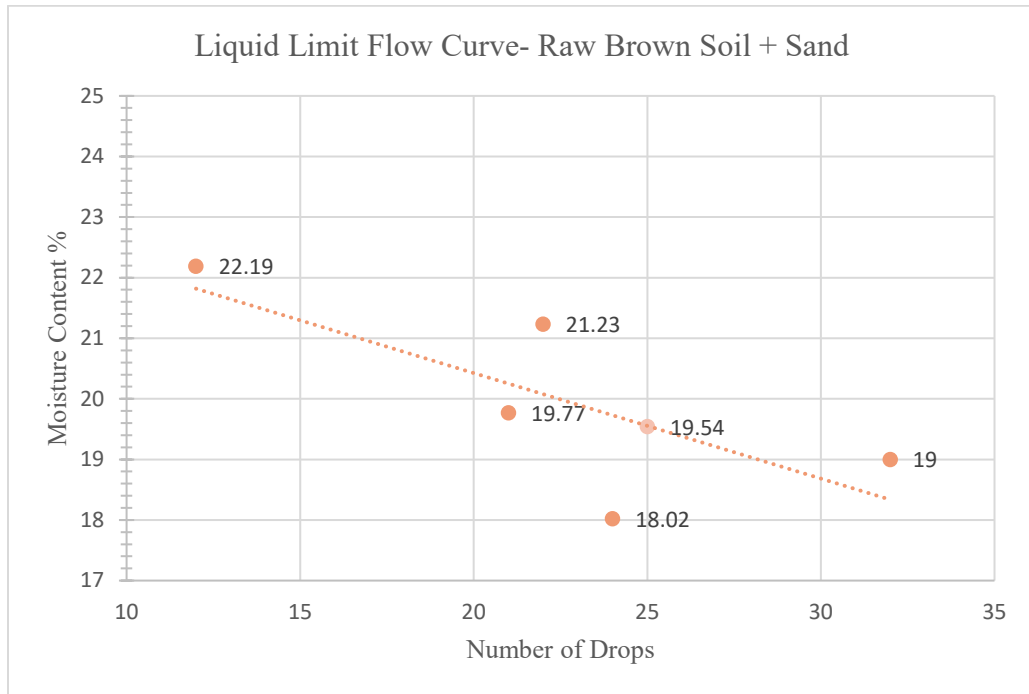
Graph 7: Brown Soil and Sand Flow Curve with a Liquid Limit of 20.

With the addition of sand, the brown soil had a slightly lower liquid limit of 20 (Graph 7), while the red soil's liquid limit could not be determined meaning that the soil is non-plastic (Graph 8).

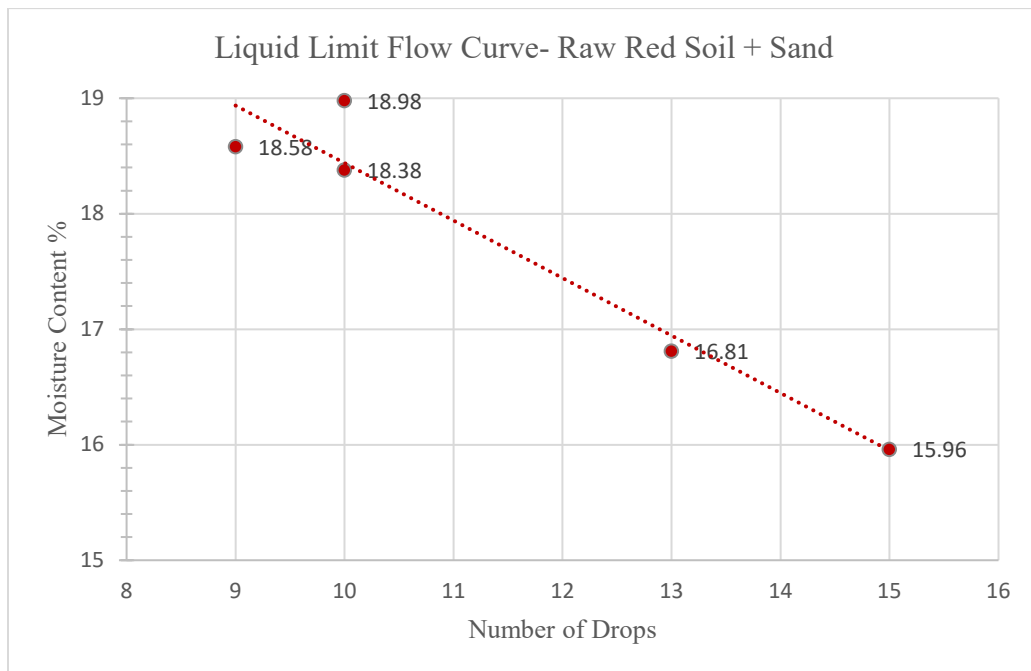
Graph 8: Red Soil and Sand Flow Curve, Liquid Limit could not be determined.

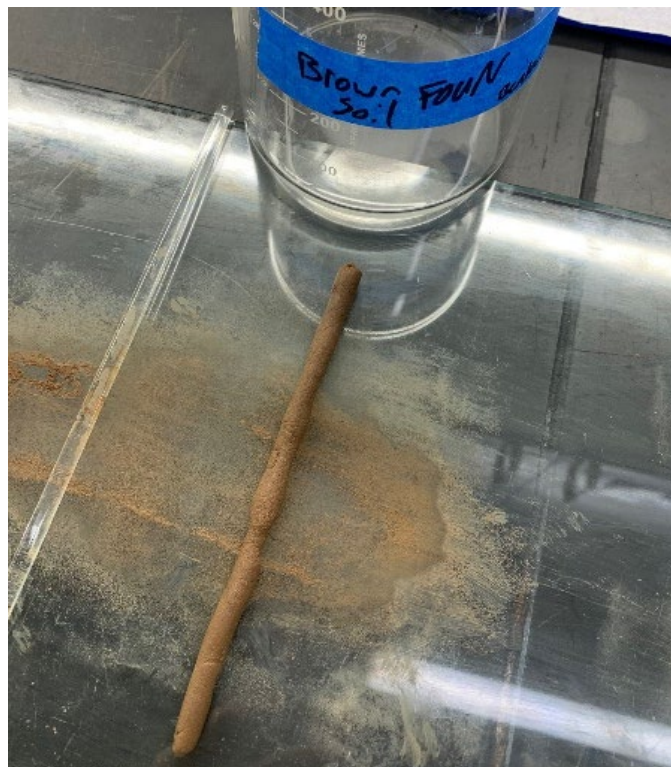
Figure 21: Plastic limit of raw brown soil.

The raw brown soil had a workable consistency with a plastic limit of 15 and a plasticity index of 10. The addition of sand increased the brown soil's plastic limit to 18 and lowered the plasticity index to 2. Yet, the soil was still able to perform plastically, and the addition of the sand assists with overall shrinkage upon drying. The addition of concentrations of Rhoplex™ E-330 was also tested on the brown soil given its later selection for the performance tests. The differences between the plastic limits of the 7% and 14% Rhoplex™ were negligible; 18 and 17, respectively. The liquid limits for the 7% and 14% Rhoplex™ E-330 formulations were equal, both at approximately 22 (Graphs 9 and 10). This resulted in the 7% formulation having a plasticity index of 4, and the 14% formulation with a plasticity index of 5.

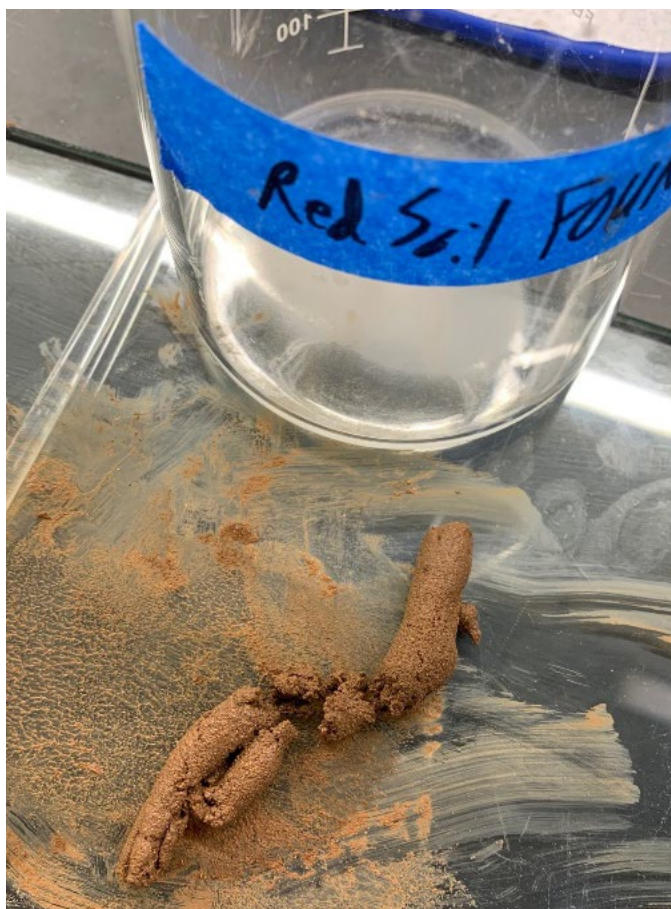
Figure 22: Plastic limit of raw red soil.

The raw red soil ultimately proved to have limited plasticity and poor workability. Despite having a very high plastic limit at 107, the inability to determine the liquid limit meant that the soil was non-plastic or not cohesive. The red soil and sand had a lower plastic limit of 19, yet was also non-plastic given the inability to determine its liquid limit.

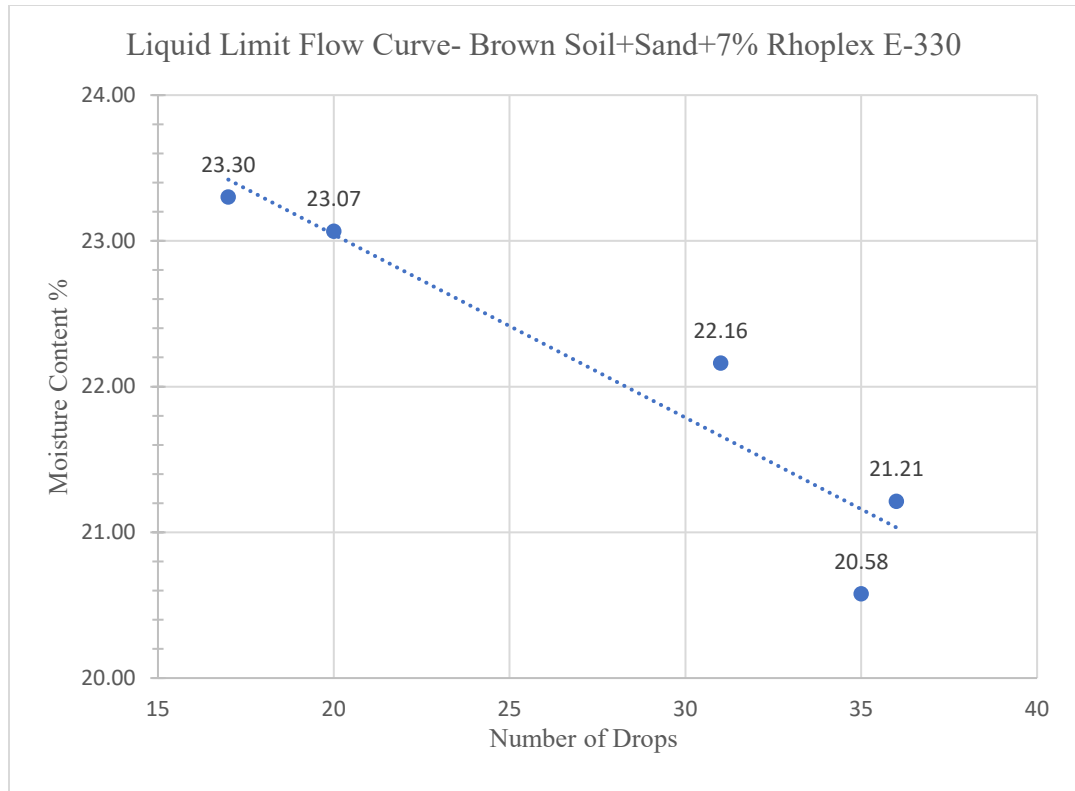
Graph 9: Liquid limit of soil with a 7% Rhoplex™ amendment.

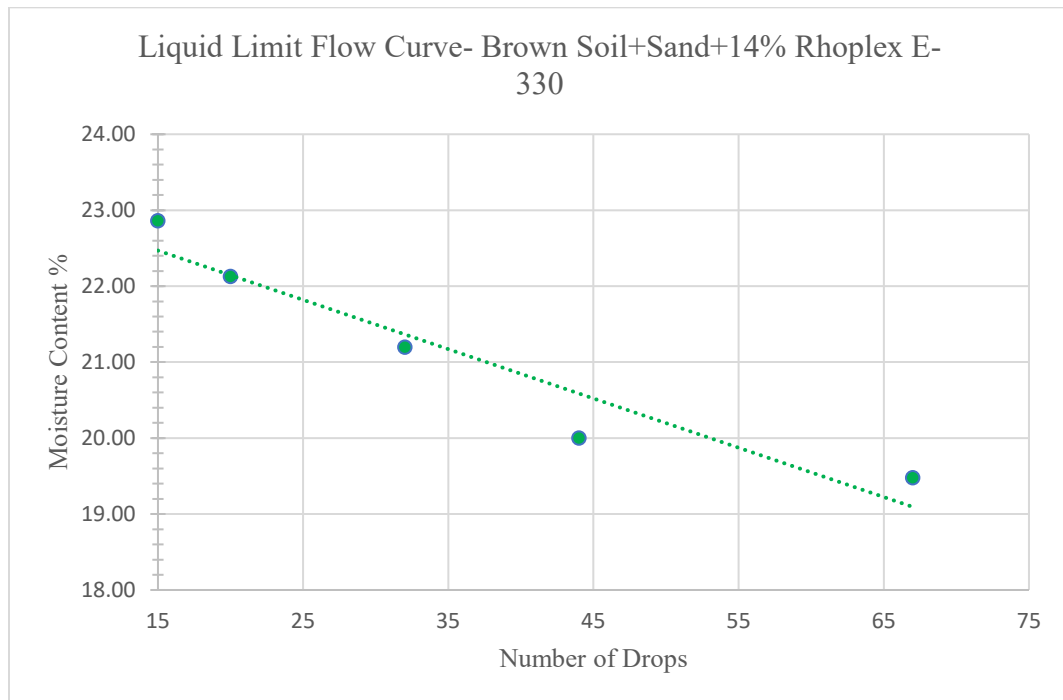
Graph 10: Liquid limit of soil with a 14% Rhoplex™ amendment.

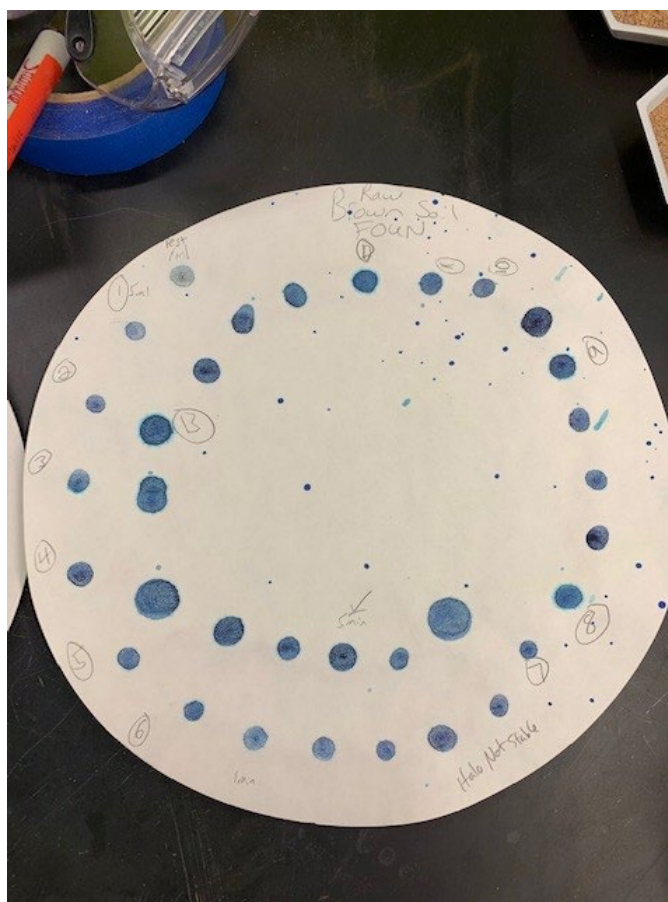
Figure 23: Methylene Blue Test Brown Soil.

If the surface area value (SA) is within the range of 20 m²/g to 800 m²/g it indicates clay minerals may be present, and if the value ranges between 1 m²/g to 4m²/g it suggests the presence of inert materials.¹⁷³ The brown soil's surface area value (SA) was 25.68 m²/g, while the red soil's SA value was 16.14 m²/g.

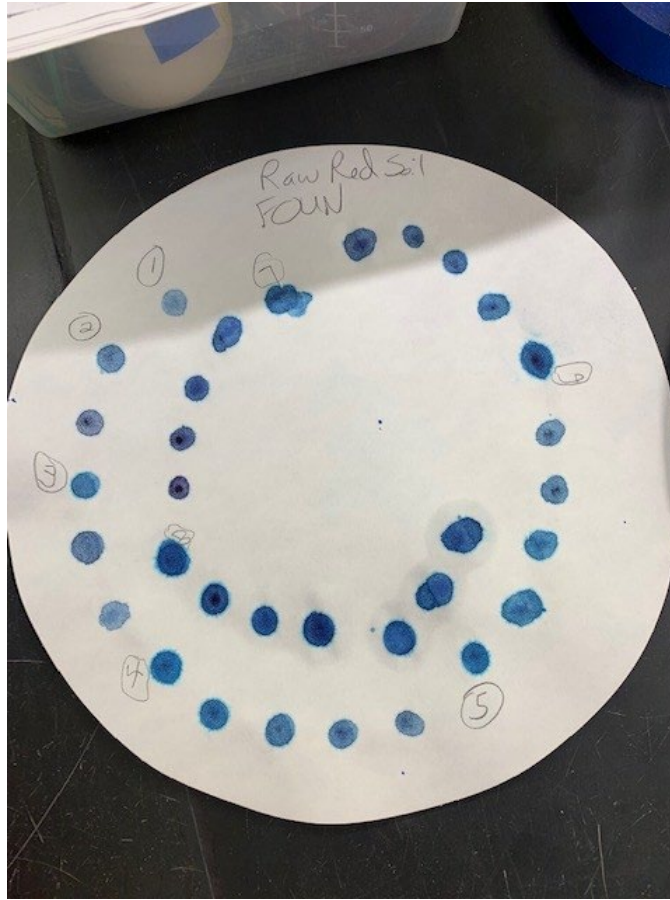
Figure 24: Methylene Blue Test Red Soil.

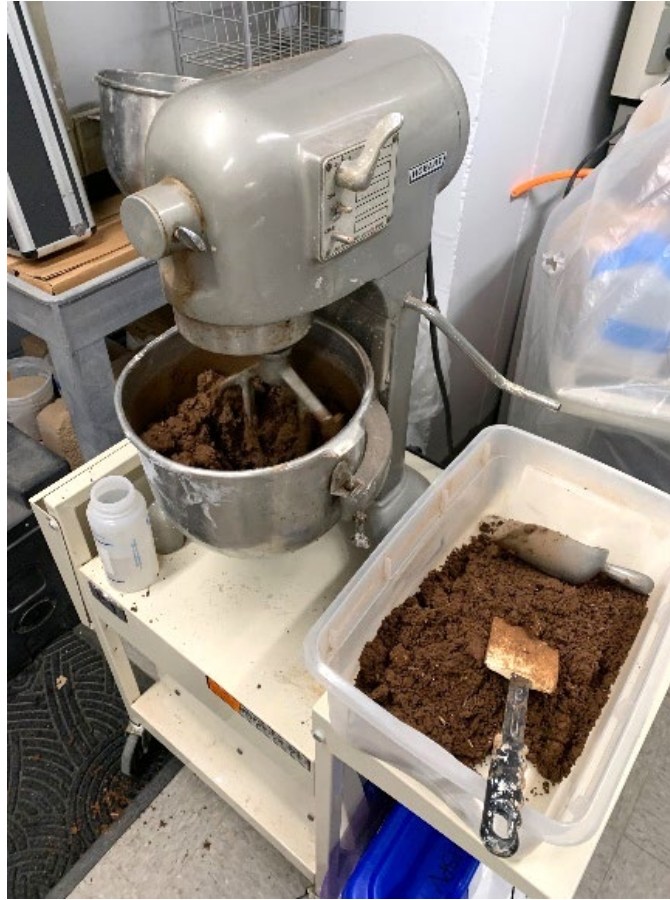
Figure 27: Hobart c-100 mixer used to mix adobe bricks, and shelter coat formulations.

Similarly, shelter coat formulations were mixed using the Hobart C-100 mixer. Prior to mixing, the raw brown soil was sieved through a $\frac{3}{4}$ " sieve to remove the largest particles as is the practice on site at FOUN. Sand was then added to the soil in a 1:3 ratio of sand to soil (by volume), also replicating the same process carried out on site (Table 1). Three shelter coat formulations were then mixed based on current site practices: 1) unamended soil, using only water to reach the desired consistency, 2) soil with a 14% Rhoplex™ E-330 solution, and 3) soil with a 7% Rhoplex™ E-330 solution. The desired consistency for shelter coats based on the ratios of materials provided by FOUN (Table 1) can be described as a mud that maintains its shape when dropped or thrown onto a wall yet is easily spreadable and more wet than the adobe paste. It can be easily smoothed

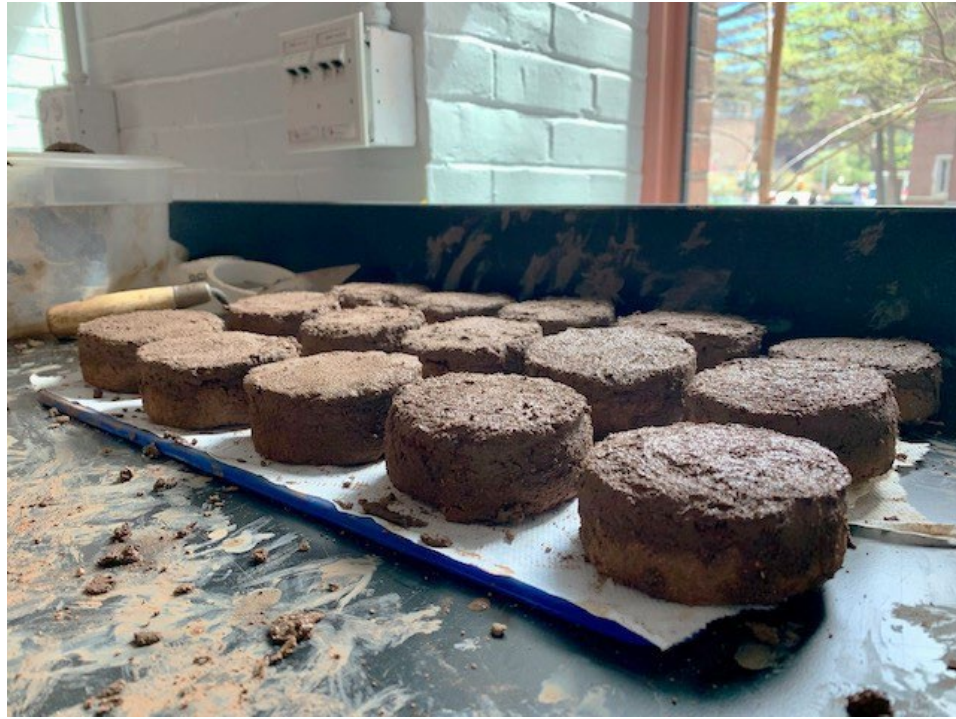
Figure 28: Adobe disks shelter coated with formulations at ¼" thick.

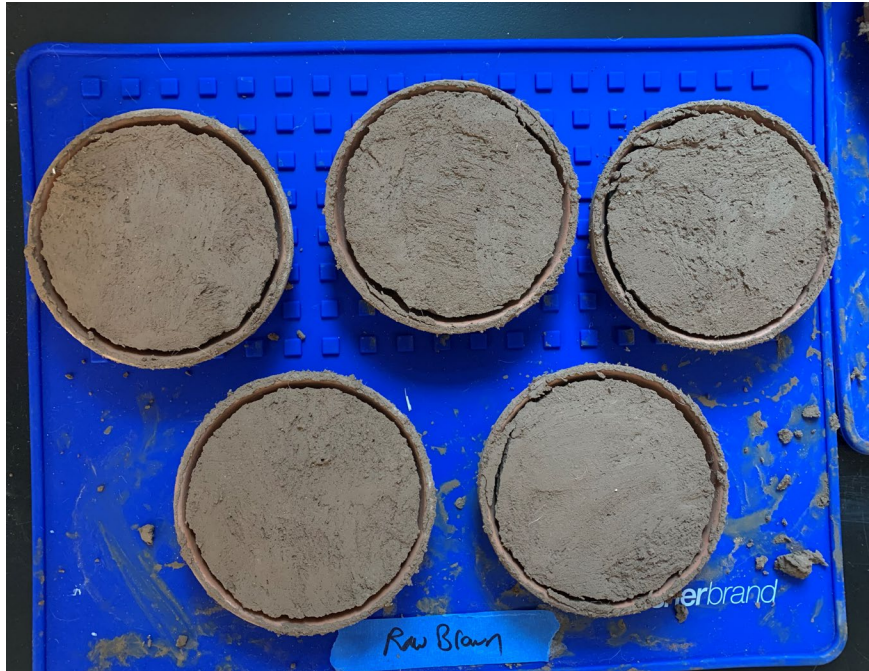
Figure 29: Raw brown soil displayed greater shrinkage in the saucers.

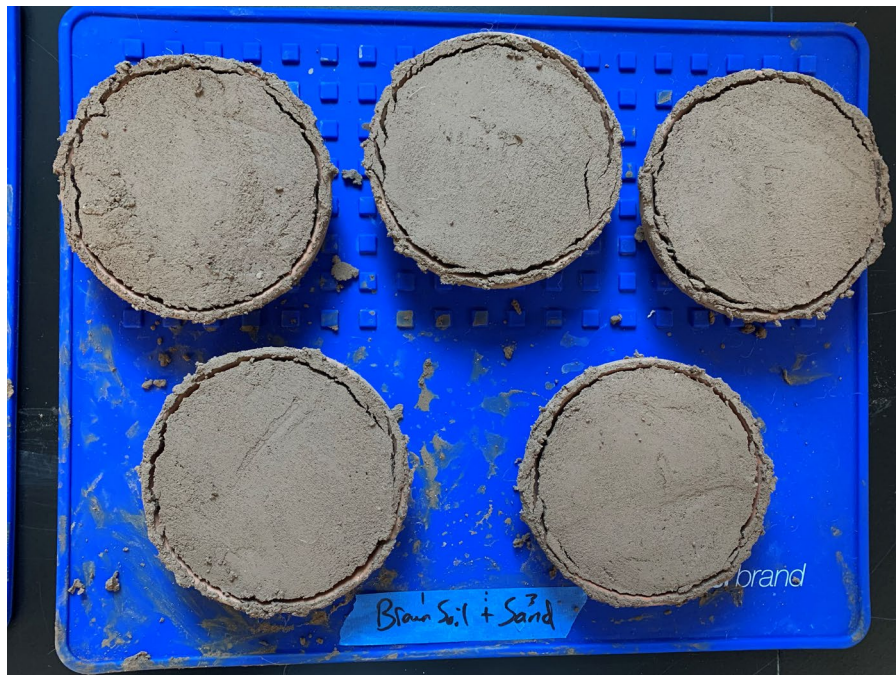
Figure 30: Brown soil plus sand displayed less shrinkage in the saucers.

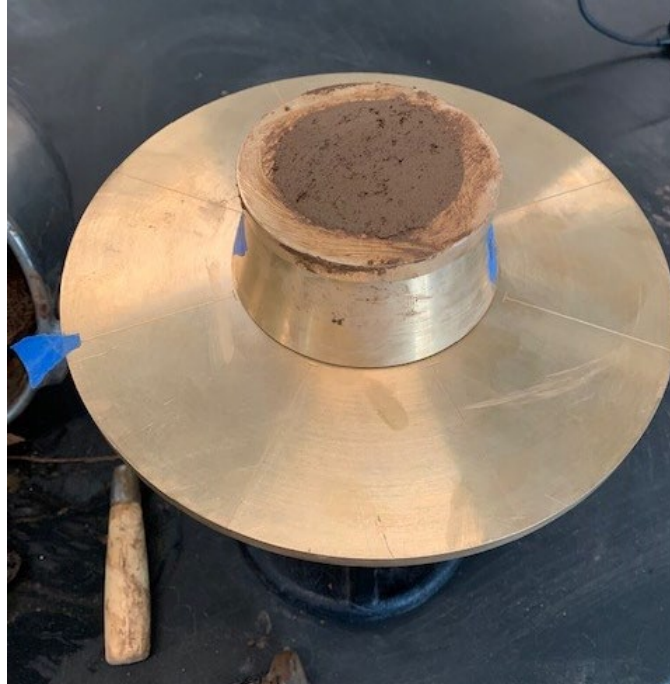
Figure 31: Formulation in mold on flow table.

The consistency (flow) is “the resulting increase in average base diameter of the mortar mass, expressed as a percentage of the original base diameter.”¹⁸³ Original base diameter of the flow was 100mm. The flow is calculated by dividing “A” by the original inside base diameter in millimeters and multiplying by 100. “A” is the average of the four readings in millimeters, minus the original inside the base diameter in millimeters.

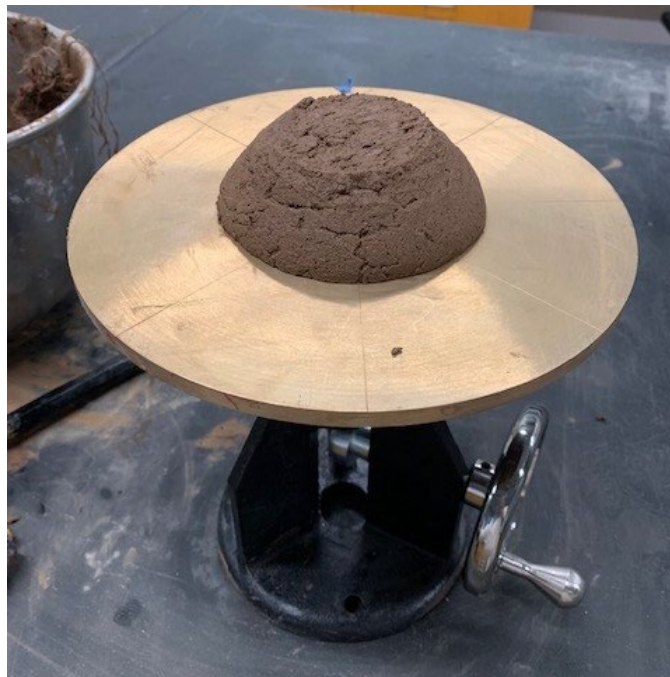
Figure 32: 14% formulation with the mold removed.

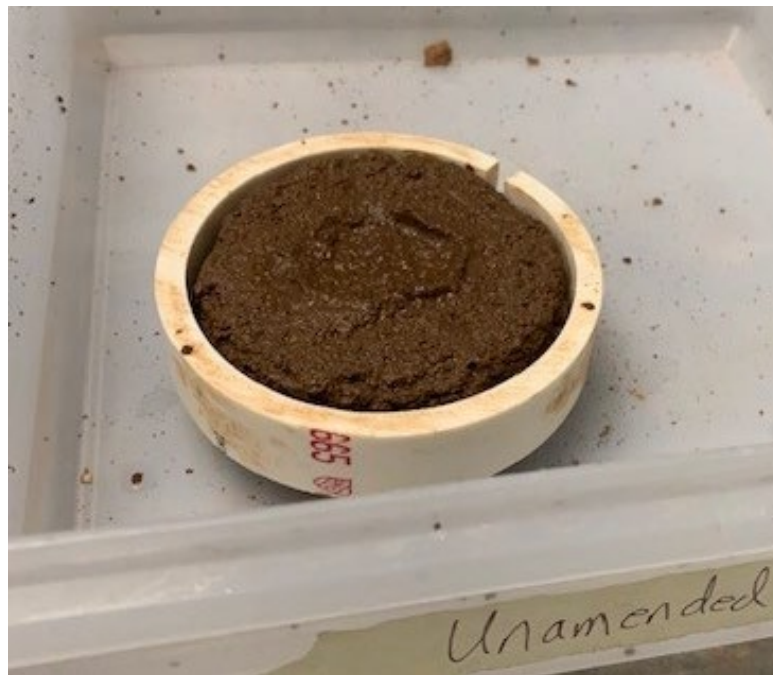
Figure 33: Unamended shelter coat after only one minute of testing, fitted with a circular mold.
