An Evaluation of Shelter Coating as a Preventive Conservation Method for Earthen Sites

AN EVALUATION OF SHELTER COATING AS A PREVENTIVE
CONSERVATION METHOD FOR EARTHEN SITES

A THESIS

MASTER OF SCIENCE IN HISTORIC PRESERVATION

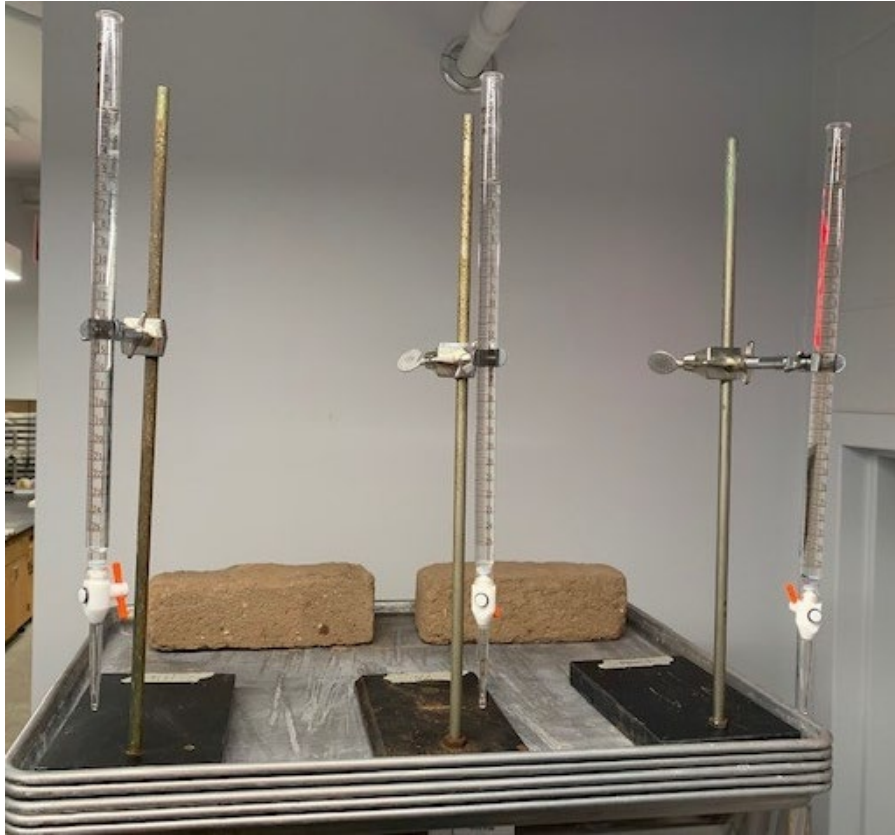
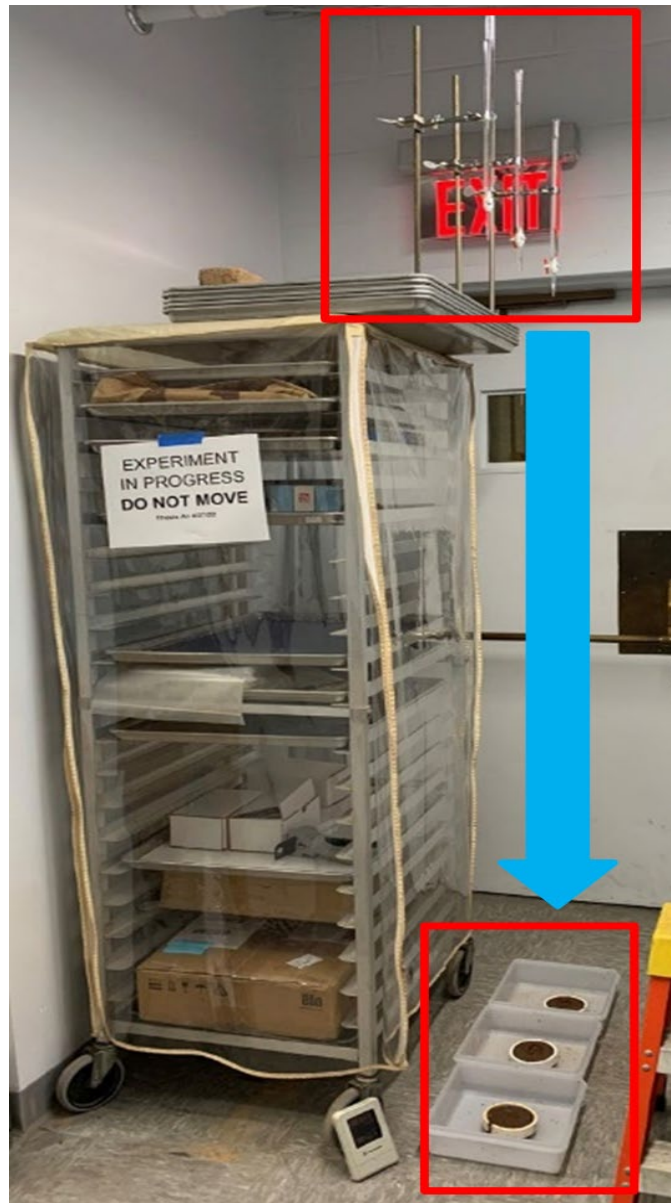
Figure 34: Water drop erosion burettes set up.

Figure 35: Water drop erosion full set up.

The water drop erosion test is not a published standard, it was developed by CRAterre to determine the mechanical action of falling water on earthen surfaces. Previous laboratory theses describe the procedure in detail.¹⁸⁴ The test measures the depth of erosion on a sample when exposed to the direct impact of falling water. Each shelter coated adobe sample, including unamended, 7% and 14% Rhoplex™ E-330, was dried in the oven for twenty-four hours prior to testing. Each sample was then fitted with a circular PVC mold to protect the shelter coat from being dislodged during the test (Figure 33). Burets were filled with deionized water and were set to disburse one drop of water every second for one hour, falling from a height of approximately 2.6 meters (Figures 34-35).

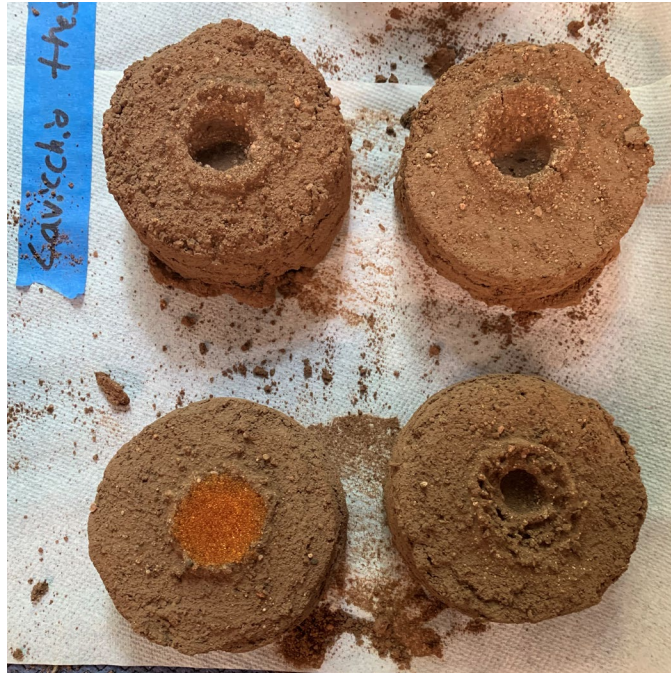
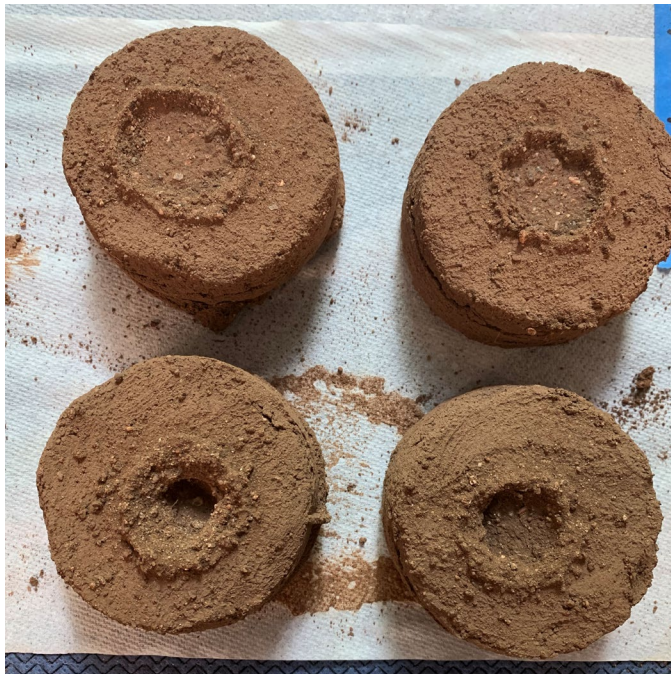
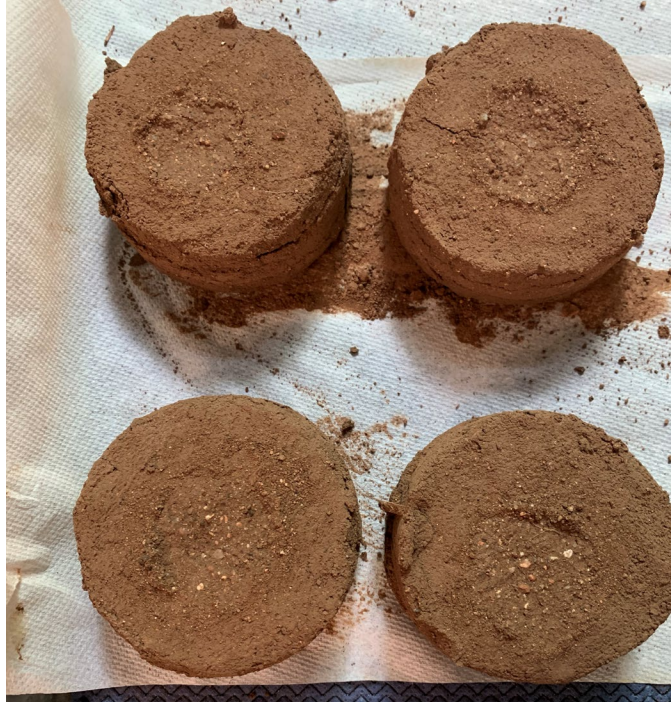
Figures 36-37: Water drop erosion results on 1) unamended soils (upper), 2) 7% shelter coats (lower).

Figure 38: Water drop erosion results on 14% shelter coats.

The unamended samples were thoroughly eroded through to the adobe disk, while the 7% amended samples performed slightly better in terms of erosion resistance. The 14% amended samples saw almost no erosion; the imperceptible holes in these samples were not measurable (Figure 36-38). The average depth of erosion on the unamended samples was 3.5 cubic cm (standard deviation: 0.69 cubic cm), and 2.6 cubic cm (standard deviation: 0.49 cubic cm) on the 7% amended samples (Tables 6-7) suggesting a reduction in erosion of nearly 26%. The depth of erosion in cubic centimeters for the unamended and 7% samples was compared through an f-test and a t-test (Table 6-7). The f-value of 0.58 and t-value of 0.04 indicate that there were no significant outliers and the difference in variances between the samples is not statistically significant.

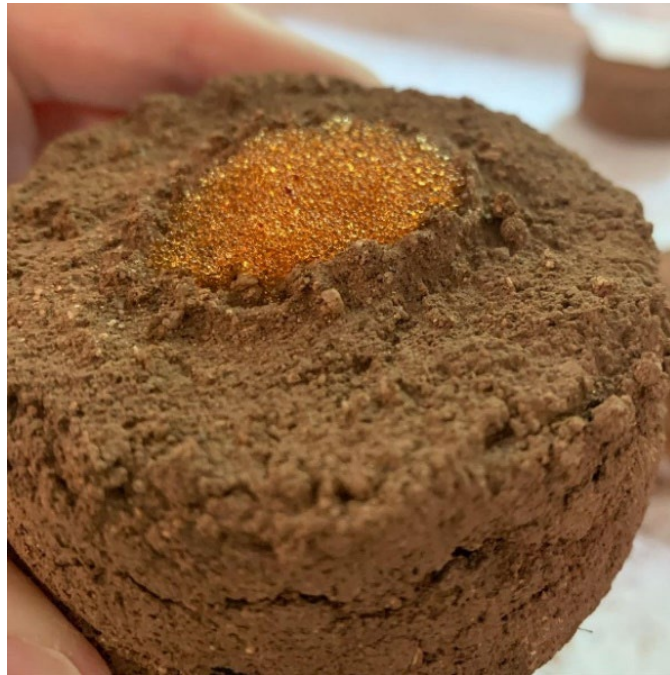
Figure 39: Glass microbeads filling the hole on an eroded unamended shelter coat.

Following the test, samples were left to dry in the plastic containers given that they were too fragile to move. After the samples were thoroughly air dried, they were treated in the oven for twenty-four hours. To measure the precise depth of erosion, an approach was adopted using glass microbeads. The hole formed by the falling water was

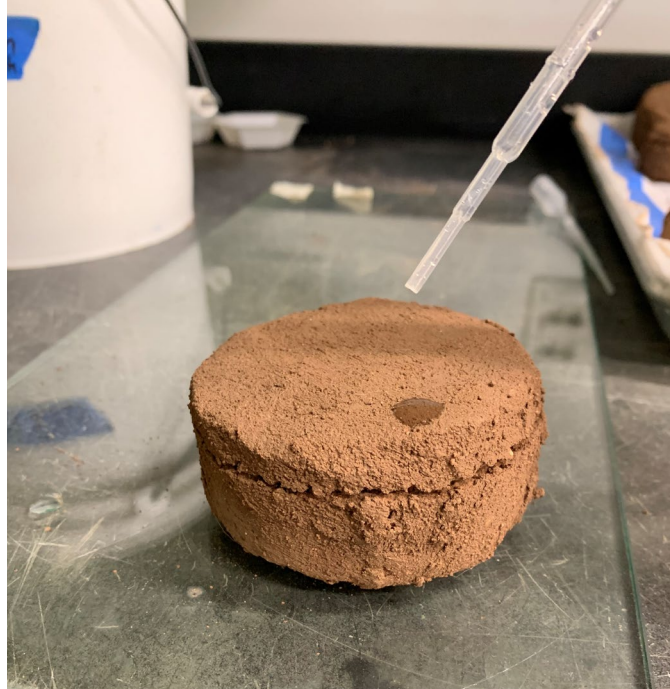
Figure 40: 1ml pipette used to drop one droplet of water onto the shelter coat.
