DYNAMIC LANDSCAPE SETTING : RIVERBANK EROSION AND EFFECT OF GLOBAL WARMING ON PERMAFROST THREATEN YORK FACTORY NATIONAL HISTORIC SITE OF CANADA

Lunn, Kevin / Canada

Fontaine ,Lyne / Canada

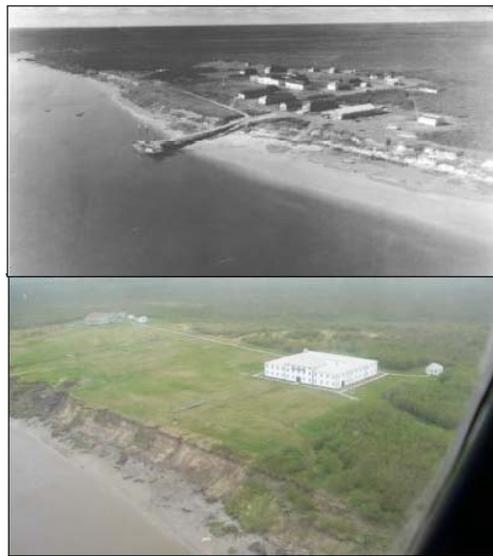
Figure 2. York Factory in 1923 (top) and in 2005. The Depot (centre of bottom photograph) and library (to right) are the only historic buildings left. Only part of the historic site, with more than seventy archaeological features, is kept clear of willows (Photos from National Archives of Canada, K.Skaffeld)

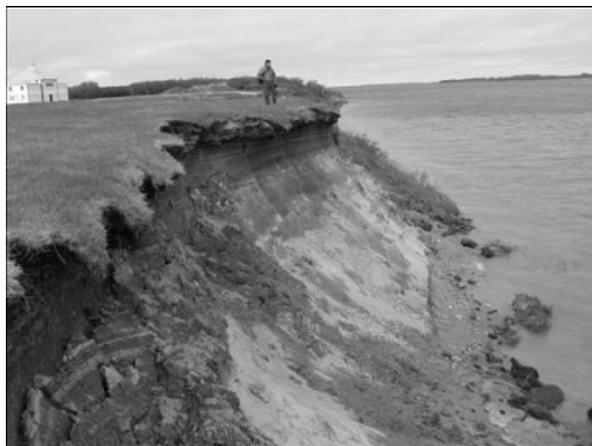
Figure 3. Bank slump, Hayes River at high tide.(photo from K.Skaffeld)

Riverbank erosion along the Hayes River has been happening at York Factory since its beginnings. York Factory I (1684 to 1715) and York Factory II (1715 to 1788) were lost as long ago as 1900. Today, we estimate that York Factory III that dates from 1788 to 1957 may be lost within 100 years (Figure 3).

- Hydrology studies indicated that wave action is mainly responsible for riverbank erosion. Wave action washes away the toe of the slope, exposes permafrost to the sun and warm air, eventually promoting fresh slope failures. Channel migration, surface and groundwater drainage, ice scour and seasonal flooding can also contribute to the erosion.
- Any engineering works designed to stabilize the riverbank, including extensive use of riprap or rock mounds are best regarded as “holding actions” only and, with proper maintenance, would extend the life of the site by 25 to 100 years.

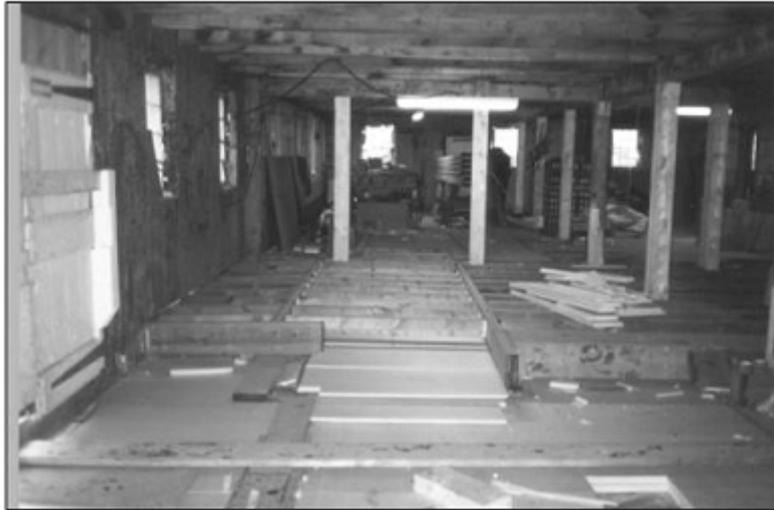
Figure 4. Conservation work on the Depot in the 1990s. Elements of the foundation were repaired and replaced, insulation was placed beneath the floor to stabilize the permafrost, and drainage was improved. (photo from Parks Canada)

The Depot is a case in point. The Depot was built in 1832-38 as the center of supply operations at York Factory. It is both architecturally and historically significant and is designated a Classified Federal Heritage Building. The original construction used shallow wooden foundations. It had a complex drainage system. It featured adjustable beam/column connections that permitted adjustment to deal with seasonal frost heaving or permafrost active layer movement, an important building engineering innovation for the time. However, by the 1980s the heavy wood frame resting on a sleeper foundation had decayed considerably, particularly in the lower level in contact with the soil, and to a lesser extent the superstructure. The building suffered significant differential movements over the years. Some of the columns had punched through the ground floor. The lack of connection between the sills, and the wall structure resulted in the exterior walls moving outward, off the sills.

In the early 1990's a major stabilization project was undertaken to reduce movement in the foundation, improve strength of the wall structure, create a new insulated floor, and protect the numerous artefacts and an earlier building located under building. Insulation was used around the building as well to reduce the active layer in the permafrost, i.e., stabilize the year-round permafrost layer (Figure 4). A

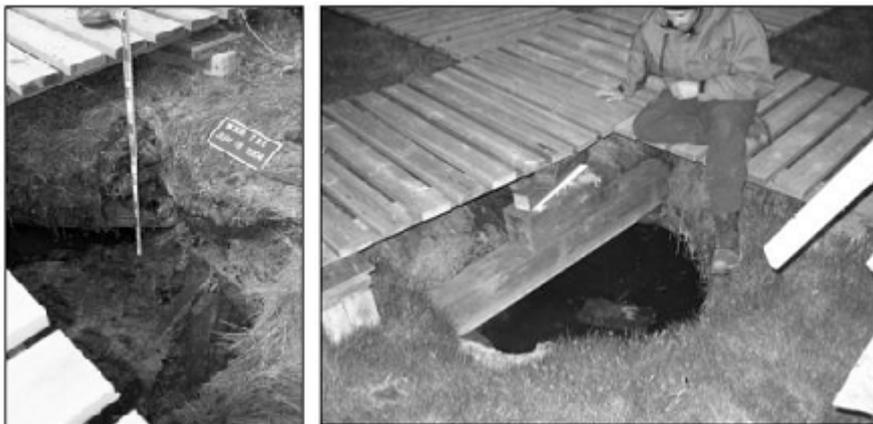
Figure 5. Sinkhole that has formed in the last couple of years within the courtyard of the Depot. The hole fills with groundwater that is warmed by exposure to surface air and then warms surrounding frozen ground. Drainage appears to be the issue. (Photos from Parks Canada and K. Skaffeld)

temperature monitoring program was set up to evaluate the rate at where the active layer stabilized above and below the insulation. Additional work was carried out on the building envelope, windows and roof, and on the drainage in the courtyard and around the building. A system of sump pits and drains were incorporated into the work on the foundation and landscaping. Within the last two years a sinkhole has appeared in the courtyard of the Depot that may be signalling a problem in the drain system (Figure 5). Water is filling the hole, warming it and accelerating soil loss around the hole.

Readings from monitoring equipment and inspections of the Depot indicate that while there is some significant heaving in the building's main level floors and there are drainage problems, notably evident by the start of the large sink hole in the courtyard, overall indications are that the superstructure is in good condition. Monitoring air temperature beneath the Depot and the water table will continue along with routine maintenance and repair of sump pits, drainage and eaves troughs.
