CONSERVATION OF THE GROTTOS AND EARTHEN ARCHITECTURES ON THE SILK ROAD IN CHINA

Deputy director and professor of Dunhuang Academy

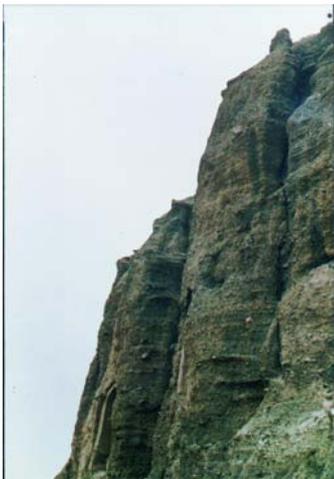
Fig.16

Generally, the grottoes are cut at banks of river valley. There are many relief crack in the side slope(Fig.16), whose obliquity is close to 90° and which incline extroversion. The side slope is incised by the tensile crack, construct crack, weather crack , crack among the layers, fracture surface or shear band , weak intermediate layer ,etc, which make up slipping moving , collapse and straggly separation body potential. So the slope exist hidden dangers. This kind of damages generally exist in all grottoes. The most typical one is Mogao Grottoes of Dunhuang , Yulin Grottoes of Anxi, the Maijishan Grotto and Binglin temple Grotto in Gansu Province.

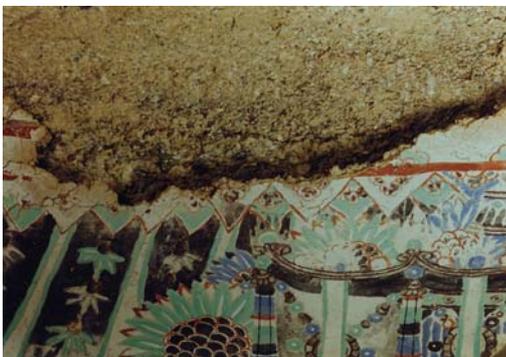
Fig.18

A Detached wall-paintings are divided into two types: (1) Partly loss of the wall-painting; (2) Wall-paintings plaster detaches from the rock but remained. The cracked and detached wall-painting are the main damages of wall-painting. (Fig18).

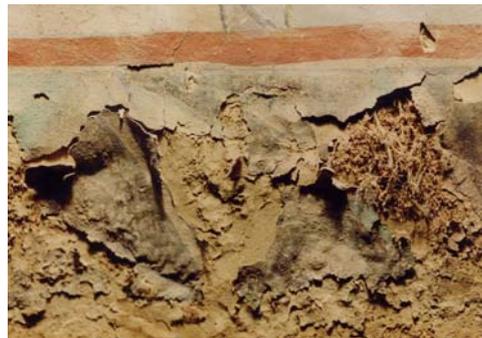
Fig.19

B Moving of Salts and water causes the structural

damage of plaster layer even lose(Fig19) and another kind of damage, the blister wall-painting.C because of the material and techniques of wall-painting and changing of environment, the flaking of painting layer wall-paintings almost distributes in every caves(Fig20).

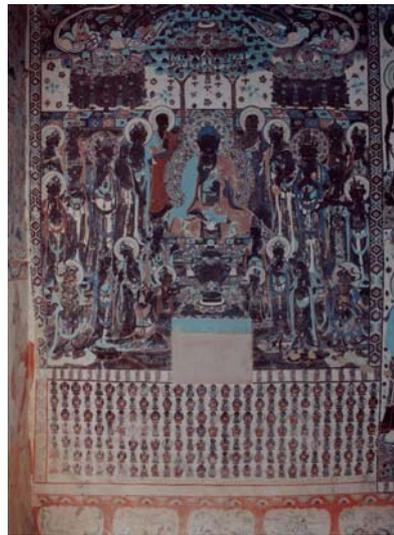
Fig.21

D Sunlight and higher humidity and other factors cause the color change(Fig21)

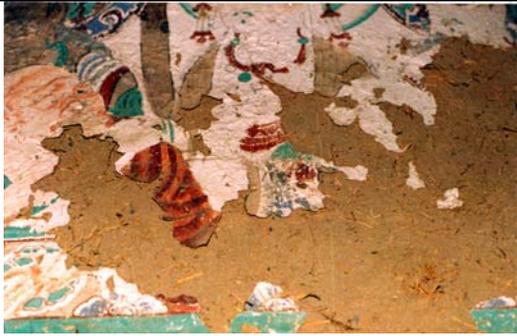
Fig.22

E the particle of pigments gradually lose and make the painting layer to be faintness(Fig.22).

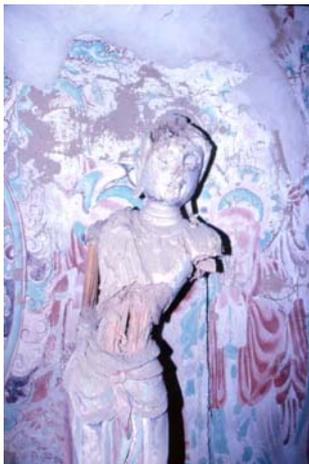
Fig.24

G The changing of the structure of the painted sculptures causes its damage even collapse(Fig.24).

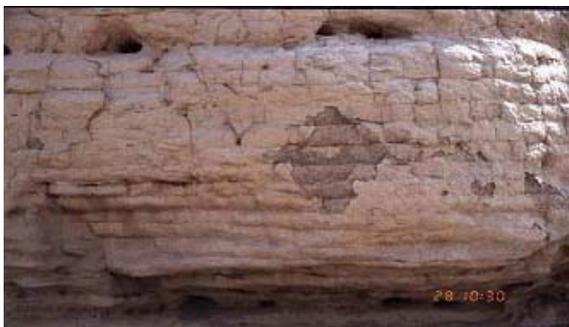
Fig.26

It is a kind of issues that generally exists in earthen sites (Fig.26). The dominating destroying agency is wind, rain, abrupt change of humidity and temperature, transporting moving and capillarity of salts, the plant root system grows and destroys. The main type is as follows, ①exfoliate; ② Cracking; ③Massiveness peeling off; ④Salts action; ⑤ Biological weathering; ⑥ Rain erosion.

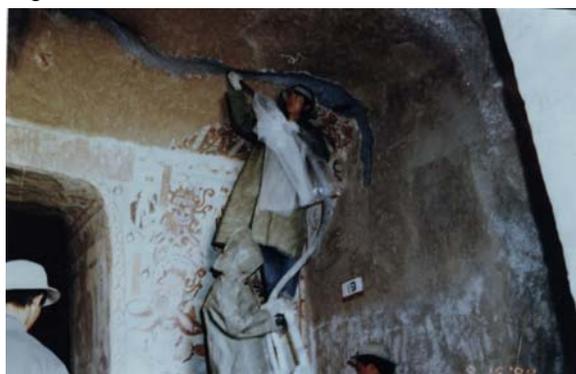
Fig.31

The crack grouting may not only prevent the atmospheric precipitation destroy the wall painting, but also coordinates with the anchor cable project, strengthen effectively the rock body’s own anti- destructive capability. Regarding the low intensity and argillaceous cemented or half cemented condition conglomeration of the grotto on the Silk Road. The PS-F serosity has good fluidity, does not come into being eduction, the PS-F concretion has favourable contractibility and stability, cold resistance and slake durability and acid and alkali resistant. The PS-F serosity intensity can be controlled approaches with the rock body intensity. The construction technics is briefness and the cost of PS-F is vile(Fig.31).

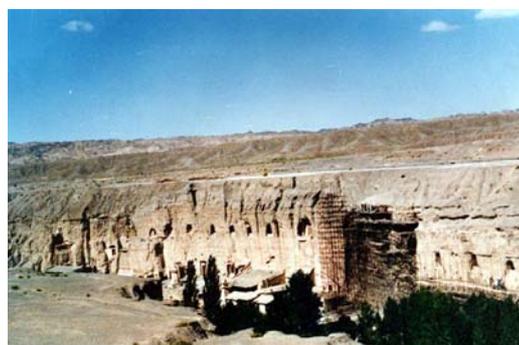
Fig.32

Under the serious weathering, the top of the grotto goes thinly, endangers the grottoes' preservation. Along with the PS material prevented the sandstone weathering develops successfully^[3], the cliff surface reinforcement against weathering uses it. The room tests, the wind tunnel simulation test and the scene effect observation indicated that, after the PS material reinforcement, weathering quality of the sandstone is enhanced approximately 200~300%, and the erosion resistance has been increased. meanwhile the cliff surface has not changed its original condition (Fig.32).

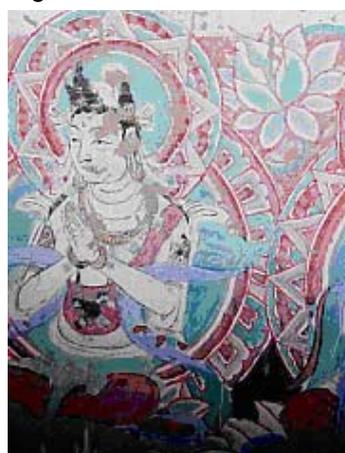
Fig.34

We used to adopt polyvinyl acetate and Polyvinyl alcohol to restore the flaking wall-paintings. After dozens of years of practice, we have explored a set of complete repairing techniques. At present, the gelatin is used to replace polyvinyl acetate and Polyvinyl and has a good effect. It possesses the main characteristics of having the identical properties with the material of the wall-paintings, the excellent compatibility as well as the multiple permeability of the other restorative materials. Surely it takes time to test the consolidating effect of this material^[9].(Fig.34)

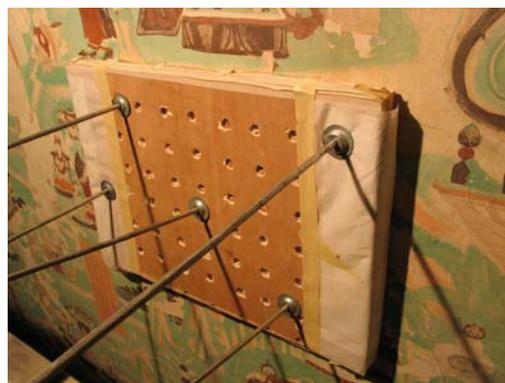
Fig.36

The disease of salt-damaged is so called cancer for the protection of the wall-paintings and for a long time we had no effectual treatment toward it. The wall-paintings which had been restored in the 1970s arose the same problems in the 1980s , moreover after the reinforcement in the 1980s they experienced the same in the 1990s. Therefore, Dunhuang Academy and GCI ,USA sifted the materials and techniques for this disease, particularly we have achieved inspiring accomplishments in the technique of desalination of the wall-paintings^[10] (Fig.36).

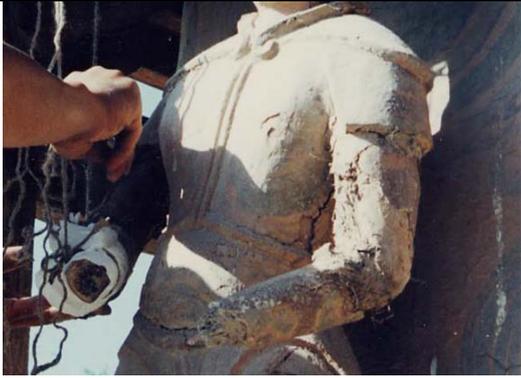
Fig.37

We adopt the methods of “remould oneself” and consolidation plus strengthening to restore and reinforce those sculptures with decayed frames which tend topple with the effort not to alter their present protecting form^[11]. They are not replenished and restored in case the requirements of maintaining stability. Employing these methods the sculptures in force have been restored. (Fig.37)

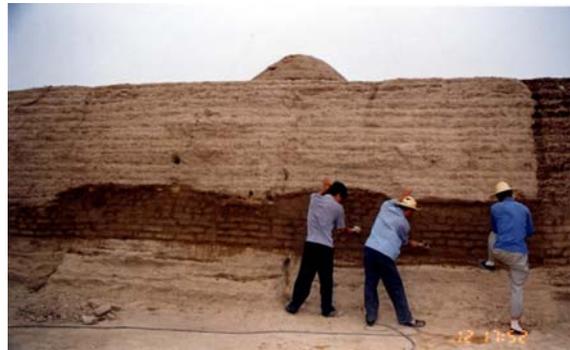
Fig.41

Remedy is a traditional reinforcement measure and is used in early conservating work. This technique is propitious to conservating earthen site shortcoming and caving zone by using the soil-made brick. The increased part should be close contact with the site. The soil-made brick is made up of silt that has the same quality to the soil of the site, and the silt salinity is less than 0.50%, the the water content is less than 3.0%, the density is more than 1.70g/cm³. In order to enhance the wholeness, the wooden anchor is used to joint the site and the increased part(Fig.41).
