THE USE OF CLIMATE CHAMBER SIMULATIONS AS AN PROTECTION ANALYSING TOOL AGAINST MOISTURE AND SALT DETERIORATION PROCESSES IN MONUMENTAL BRICK CONSTRUCTIONS

Svebor Heruc*, Caspar Groot & Thoborg von Konow

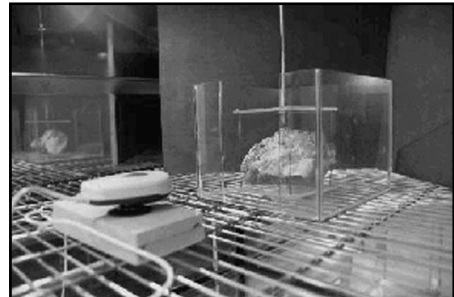
Fig. 2 The sample and the camera inside the Climatic Cabinet.

Original samples from the fortification were used in the testing programme. The monitoring of the test specimens during testing was done through continuous observation with: computer camera, microscope and an continuous weighting system. At the end of the testing programme some X-ray diffraction tests were carried out under relevant climatic conditions as applied in the cabinet.
