A CHANGING TOWNSCAPE: *Røros throughout a century of heritage management*

METTE BYE

Abstract

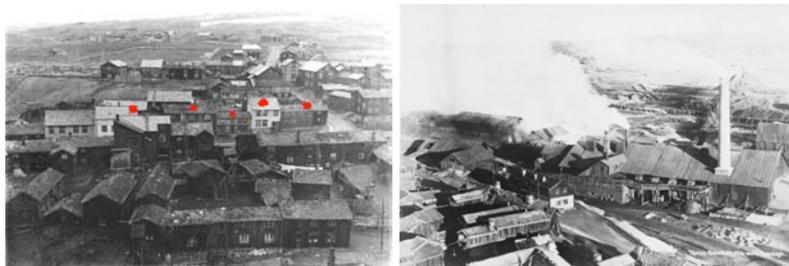
Figure 3. Røros at the time the Sohlberg Square (red dots) buildings were listed. Note the town farm courtyard structure. Photograph by Johan Skjervagen 1925, reproduction courtesy of the Røros Museum.

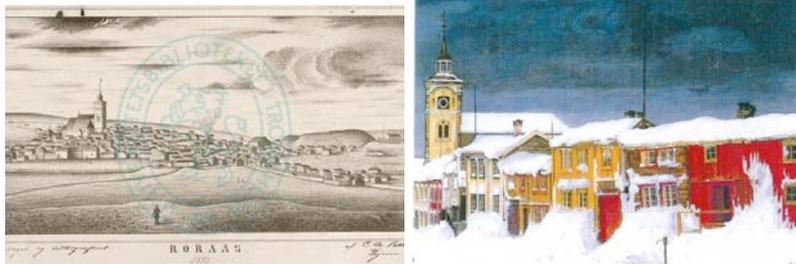
Figure 3. “Røraas 1853. Lithographed by C.M. Schult, T.hjem” NTNU library

Figure 4. The buildings on Sohlberg Square: ”After the snowstorm” painted by Harald Sohlberg (1869-1935) in 1904. National Gallery

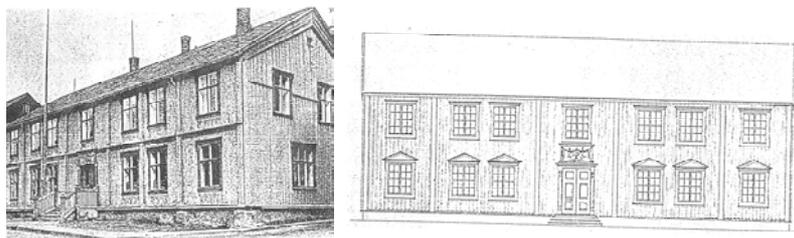
Figures 4 and 5. The monumental “Bergskrivergården”, stylistically restored back to its neoclassical origins after a design by the architect Tycho Castberg. Photograph to the left shows the building “done up” in the popular Swiss Style; plan for the façade restoration to the right.
In reprint from Vreims 1944 article.

The era of antiquarian and aesthetic cultivation of Røros was initiated during World War 2 with a generous grant from the German-instated Prime Minister Vidkun Quisling, a fact which is known to few (Lidén 1991). Among the early planned restorations was the former home of the director of the Røros Copper Mine, “Bergskrivergården”, a grand 18th century building which was stylistically restored away from its “Swiss style” facade back to its neoclassical origins, a model plan which set the standard for later restorations of street facades in Røros (Vreim 1944).

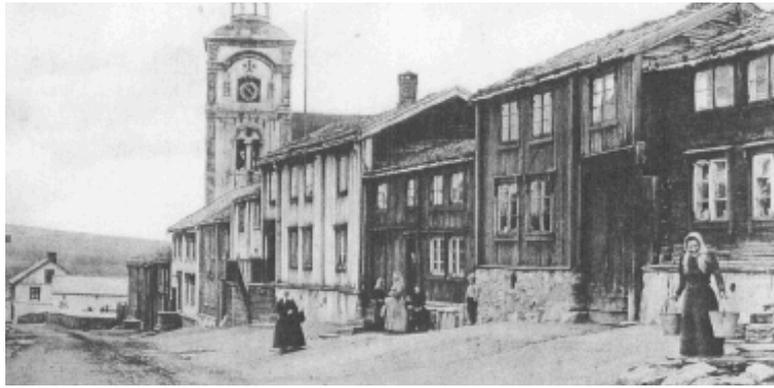
Figure 6. Sohlberg Square around 1913.
Postcard reproduced courtesy of Amneus Bookstore, Røros

By the time of the listing in 1923, Sohlbergs painted version of the street scene in Sohlberg Square was already gone. Number 60, the red house on the corner, had by that time acquired a Swiss style façade makeover, as so many of the town's buildings. In his 1944 article, Vreim described this particular building in the following terms: "Poisonous and murky colours, splintery side-boarding and shabby mouldings." and recommended the following treatment: "... different panelling, mouldings and colours and the house will again fall into the true image of Røros." Ten years later the house was demolished and replaced with a new structure twice the size. This was not what Vreim advised, but at least architectural features were improved according to his recommendations. The fact that these buildings were listed as a "scene" and not as individual buildings is likely to have contributed to the compromise. The result has been described as an early example of *adaptive* or *harmonizing* architecture (Eide 1990).

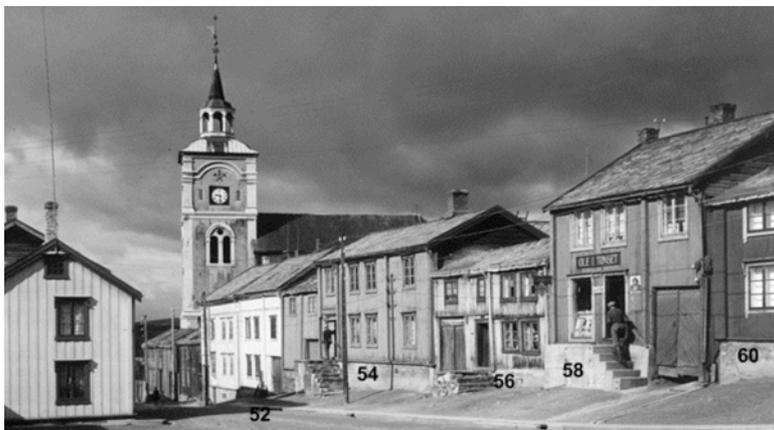
Figure 7. Sohlberg Square circa 1950. # 56 is painted, 58 is converted to a store with a new façade and the sod roof replaced by cement tiles. The dark log wall in 60 now has panelling and the windows are fitted with new mouldings.
Photograph: Mittet, NTNU library

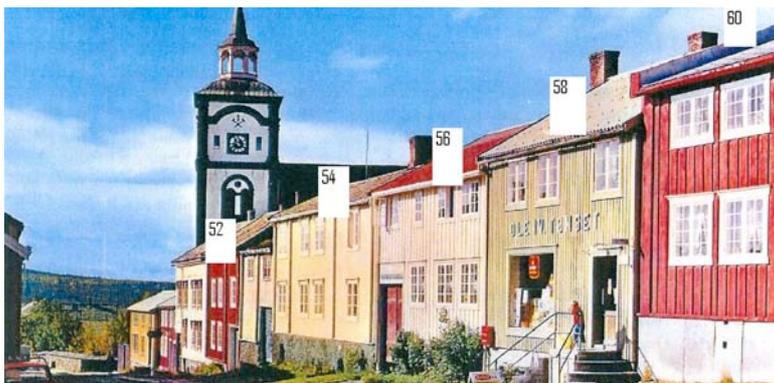
Figure 8. Postcard from the late 1960s. The front door and stairs in # 54 are removed. 56 is completely altered, its eaves now levelling with its neighbours, the façade without stairs or a front. The store in 58 has enlarged its premises into the gateway area, moved the front door and stairs and fitted a new shop window. In # 60 a new house has replaced the old one.
Photograph Normann Kunstforlag.

In Sohlberg Square, antiquarian Vreim was involved as an advisor and not a restoration architect, as was employed for more monumental buildings like Bergskrivergården. It is difficult to derive principles from Vreims priorities. He was for example strongly opposed to the removal of the stairs in number 54, while commenting only subtly on the demolitions of 56 and 60, projects he even grudgingly granted subsidies from the meagre fund for listed buildings. Number 54 was rather large and well fitted for its time, and with a façade Vreim found valuable. An explanation might therefore be that Vreim fought his battle over an aesthetic dilemma and gave in to alter the smaller and poorer houses, thus declining to argue against the recommendation from the municipal engineer that the owner of 56 be allowed “to repair his tiny, fragile and derelict house, wherein five people lived, one seriously ill”, even when the “repairs” involved demolition of the entire historical structure.
