2020 ICOMOS 6 ISCs Joint Meeting Proceedings

2020 ICOMOS 6 ISCs Joint Meeting Proceedings
Advancing Risk Management for the Shared Future

17 October 2020

Presented by 6 ICOMOS-ISCs
ICORP, ISCARSAH, ISCEAH, ICTC, ISCES+CC and CIPA

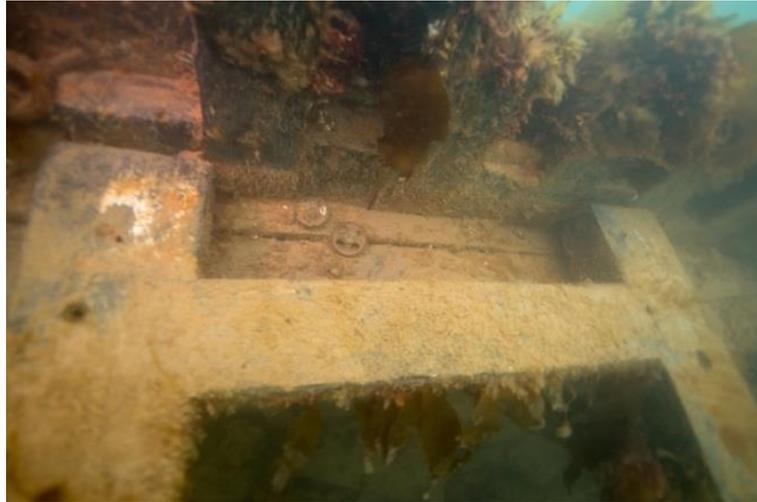
Figure 1

HMS Erebus, 2018. Part of the upper deck along the starboard side of the hull showing where a section of deck planking had been forcibly dislocated from the deck beams due to presumed storm-induced water movement. Note the relative absence of vegetation on the newly exposed upper surfaces of the deck beams and beam shelf, and the movement of the two pulley sheaves into the newly exposed zone.⁵

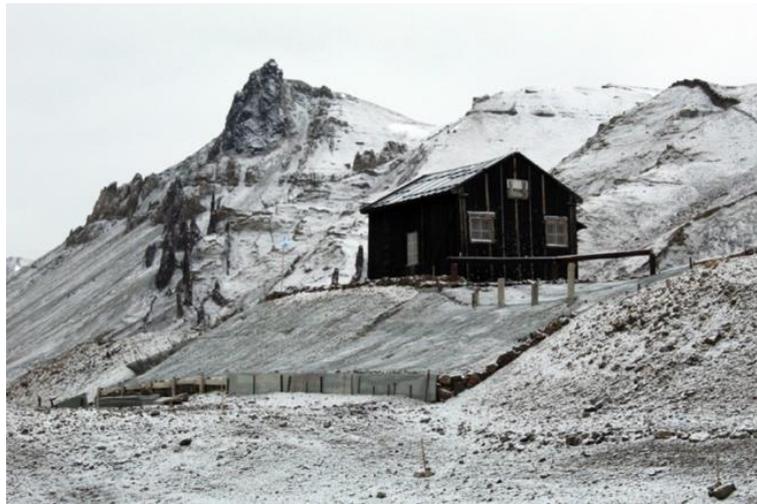
Figure 2. Physical interventions have been attempted to stabilise the moraine on which the hut is built.

Dr Otto Nordenskjöld's Swedish Antarctic Expedition, 1901–03, established an overwintering science base hut (figures 2&3) on Snow Hill Island. Their support ship, Antarctic, was unable to reach them the following spring due to impassable sea ice, then was crushed and sunk. The Argentine ship Uruguay rescued the expedition survivors (Headland 2009, 233).

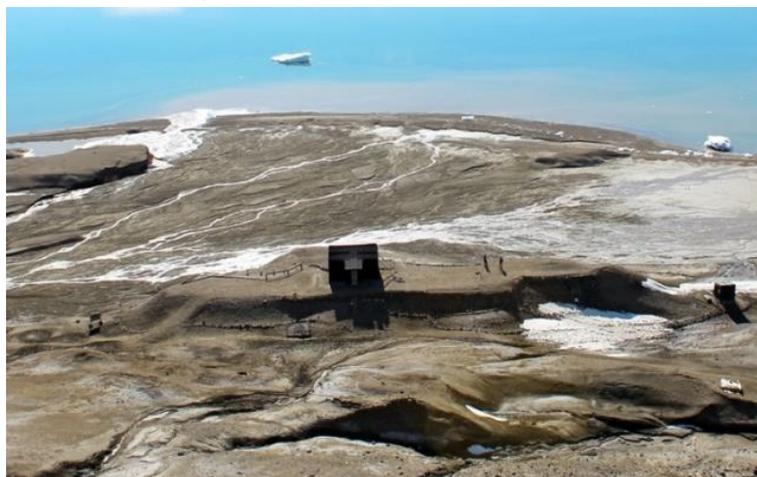
Figure 3. Snow Hill Island during summer, showing the collapse of the moraine from

The hut is located in a rapidly warming area of Antarctica. To inform future decision making, Swedish and Argentine heritage experts, logistically supported by Argentina, have commenced a comprehensive recording and monitoring programme that included: photogrammetric and Lidar surveys, installation of an automatic weather station (AWS) and temperature and humidity sensors in the huts.

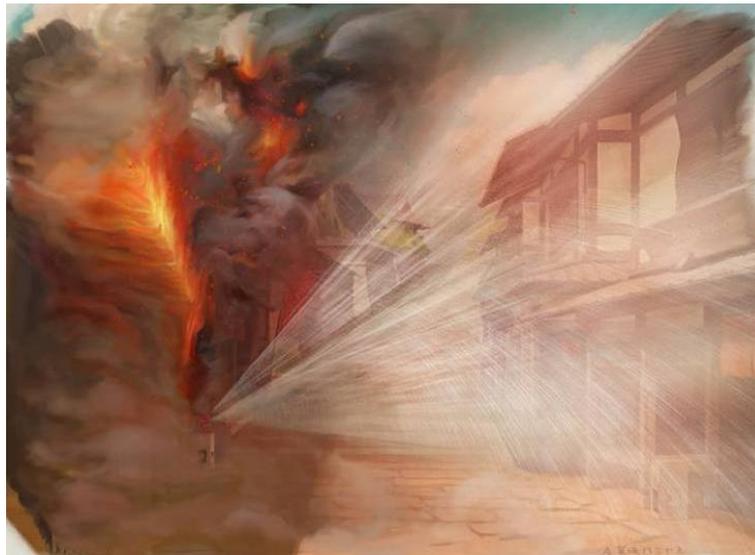
Figure. 1 Image showing WSS startup

Previous experimental research conducted by Okubo et al.¹⁾ proves that fire can be resisted temporarily by sprinkling a certain amount of water on wooden surfaces of buildings. On this basis, the Water Shield System (WSS) has been designed to prevent fire from spreading in highly dense areas of wooden cultural cities (Refer to Figs. 1 and 2). In an experiment, Horiuchi et al. used the water sprinkler system to prevent the fire from spreading²⁾. Since this system sprinkles water from the bottom to the back of the eaves, it does not cover the entire wall surface. The present research offers a system that sprinkles water from a water spray nozzle to the entire surface of wooden walls on the other side of the fire. In this way, the performance of the proposed system is similar to that of a fire-proof wall as it suppresses the spread of the fire on the other side. It can be effective in suppressing the fire spread across the blocks with limited water since it can operate in narrow roads commonly found in historic towns even under hot conditions that are too harsh for the firefighting team.

Until now, we have conducted a study on water spray nozzle that suits WSS to achieve the practical use of WSS in our prior research³⁾. When water spray was experimented using conventional nozzles and their combinations, it became evident that no existing nozzle can widely and effectively sprinkle water on the wall surface as required for fire spread control. However, no study has not been conducted for water spray on uneven wall surfaces also in the space under eaves which are vulnerable to fire. Thus, demonstrating its effectiveness for fire control in a realistic environment is cited as a major issue.

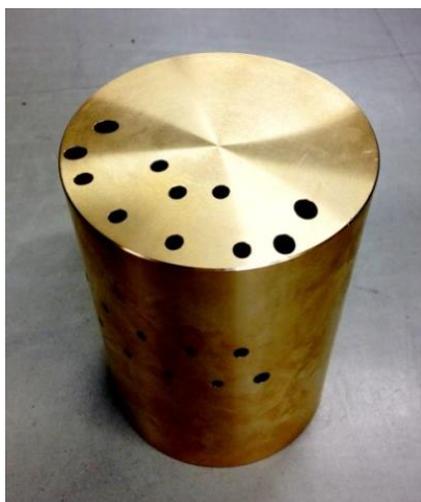
Figure. 4 Special nozzle developed

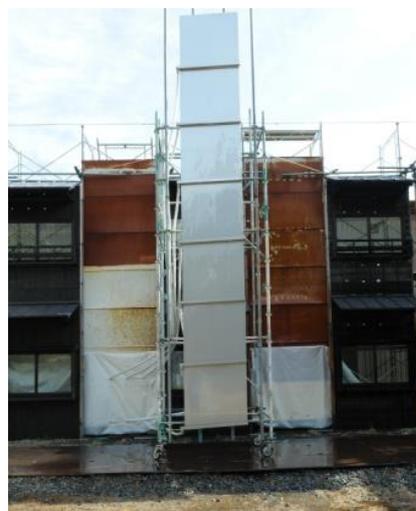
Figure. 5 Seven water collecting panels for measuring the amount (Arrow direction)

In the case of measurement of the amount of sprinkling water on the surface, we arranged 7 water collecting panels of 1 m × 1 m in perpendicular direction as shown in Figure 5 and developed the equipment that can separately collect the water on each panel that runs down along the gutter. As for the test conditions, we set installation level at 0 m above the ground. The nozzle distance from the water collecting panel was set at 5 m and water discharge pressure at 0.25 MPa in order to meet the installation requirements of the nozzle. Measurement time was set at 1 minute. Further, since the spray width with one nozzle is assumed as 10 m, we used 2 nozzles and fixed the intervals between the nozzles at 10 m in order to have accurate data on the water spray condition between the adjacent nozzles. Based on the result of the preliminary experiment, the quantity of water discharged from the nozzle was reduced to 460 l/minute per nozzle. At the time of measurement, we fixed the position of the water

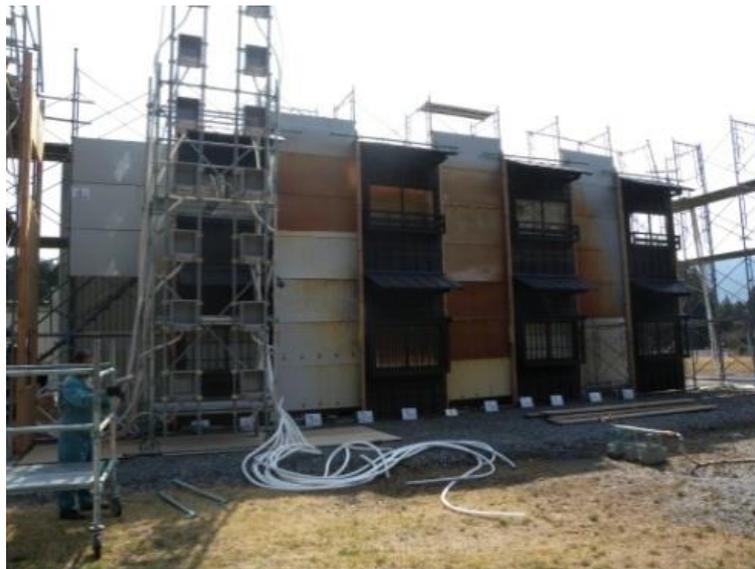
Figure. 8 Experimental equipment on the whole

While heating the models of traditional wooden townhouses approx. at a width of 1.8 m and the height of the actual houses in the assumed fire spread environment, water will be sprinkled thereon from the nozzle simultaneously so as to confirm the effectiveness for fire spread control in real scale. Then, in order to evaluate the effectiveness, we will carry out visual check and also install thermocouples on the outer wall surface of the wooden structure to record the changes in temperature at each part due to temporal changes.

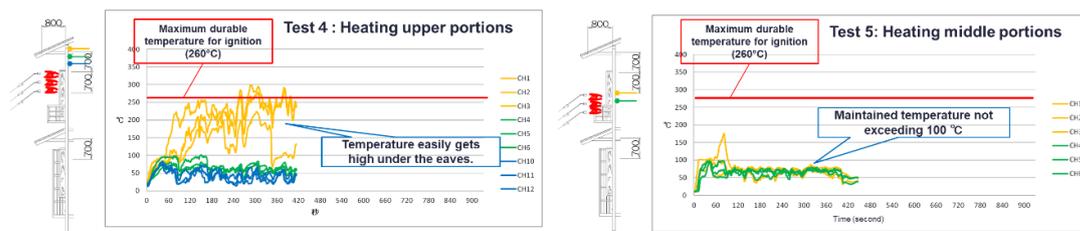
Figure. 12 Comparison based on the difference in heating position under water spray

Lastly, we will compare temperature changes at each part depending on the heating position (Figure. 12: Refer to Test 1 in Figure. 10 and 11 for lower section).

If the heating position is in the middle section (Test 5), there is no such area under the eaves which is prone to high temperature. Hence, it becomes stable almost at a value that does not exceed 100°C during water spray. In Test 5, no temperature of an observation point for the lower row (blue) is recorded. It is because the position of this observation point overlaps with that of a supporting scaffold at the backside of the model, and thus, in reality, no observation point as such could be secured. On the other hand, when it comes to the upper section (Test 4) and the lower section (Test 1), the space under the eaves partially tends to attain higher temperature when compared to other observation points, and we observed that the temperature exceeded 260°C at some

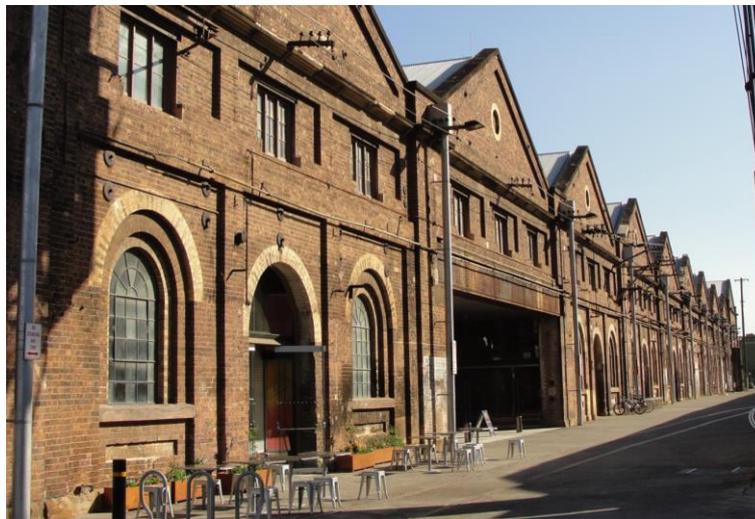
Figure.2 Eveleigh Carriage Workshops in Sydney have been adaptively reused as a contemporary performing arts centre called Carriageworks. The masonry exterior and steel roof have been retained and new structures inserted within. Source: Authors

An example of the loss of embodied energy is the removal of the internal structure from historic warehouse buildings and the replacement with a concrete structure. Many of the substantial masonry warehouses erected in Sydney, New South Wales, from the 1860s onwards were demolished in the 1960s, following the lifting of height restrictions. The warehouses that have survived have substantial hardwood post and beam structures designed to remain standing in the event of a fire, Australian hardwood proving more effective in resisting fire than steel. Timber floors can be upgraded to a required level of fire rating rather than needing replacement by a concrete slab. Hardwood timber posts can also be retained, thus allowing for the overall warehouse character and volumes to be retained and the new uses such as offices inserted within.

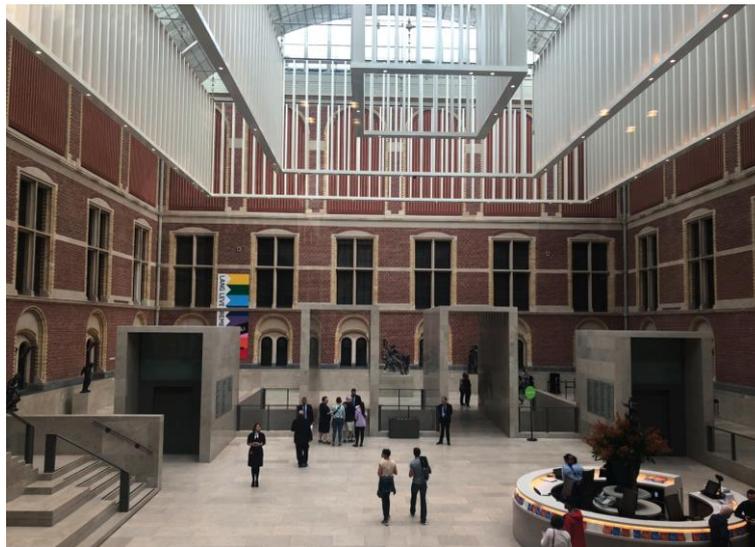
Figure.4 At the Rijksmuseum in Amsterdam a new entry was inserted into former courtyards with a large central climate-controlled atrium retaining the original and inserting new windows opening into the space and natural light. Source: Authors

Public chambers such as nineteenth century courthouses and parliamentary chambers were designed with operable ventilation that could be adjusted depending on the temperature. Sealing these chambers so that they permanently need air conditioning, rather than allowing for operable windows and occasional supplementation in hot or cold weather, is not cost effective as the running costs increased considerably. More recent retrofitting projects have included a balance, retaining operable windows to give the occupants a degree of flexibility and choice regarding airflow from the exterior.

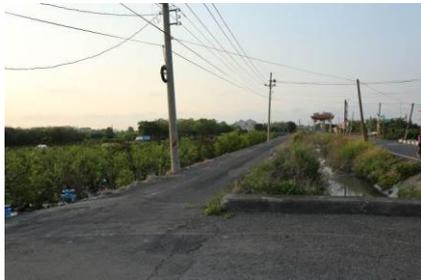
I. Low-lying site

The original low-lying site and high ground water content pose threats to the stability of the estate and causes severe deteriorations.

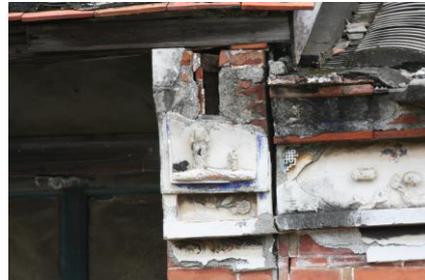
II. Ground settling:

Some walls and ridges were torn due to foundation subsidence caused by ground settling. The over pumping of groundwater in the Changhua area also intensifies the ground settling.

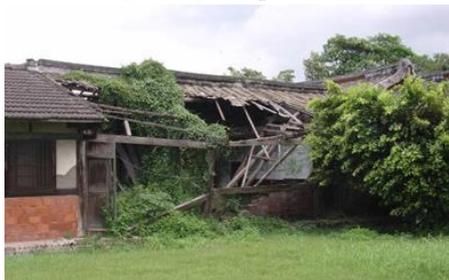
III. Earthquake:

Many structures were seriously damaged after the 9/21 earthquake in 1999: The left outer wing collapsed and the roof of the right wing collapsed.

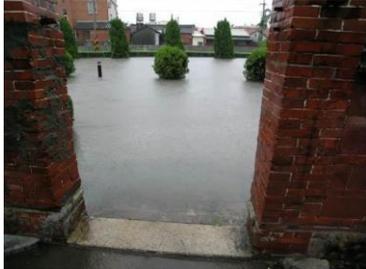
V. Extreme weather conditions—heavy rain or flood:

The low-lying site and more and more frequent torrential rains have brought floods to the estate. E.g. The flood at the courtyard of the Cheng Mei Ancestral Hall after Typhoon Kalmaegi in 2008:

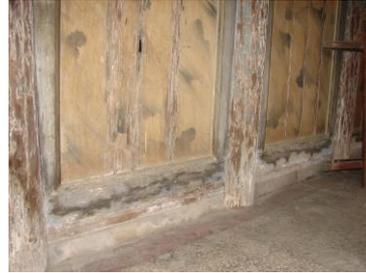
VI. Moisture fluctuation and ground dampness:

Many deteriorations caused by moisture fluctuation and ground dampness occurred: Distortion, salt efflorescence, flaking paint layers on wooden structures. E.g. Salt efflorescence on timber structure:

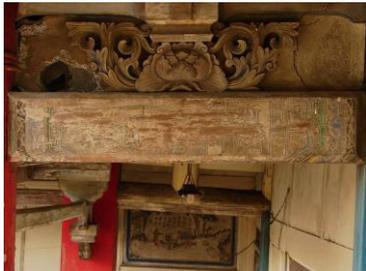
VII. Direct sunlight:

Long term exposure to direct sunlight has caused deteriorations such as flaking, stained, cleavage, paint loss or discoloration on polychrome wood or mural paintings.

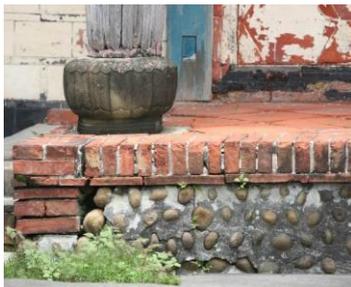
I. Insufficient foundation:

The original foundation was only filled with earth that is insufficient for supporting. The foundation subsidence is evident around heavy loaded columns and walls.

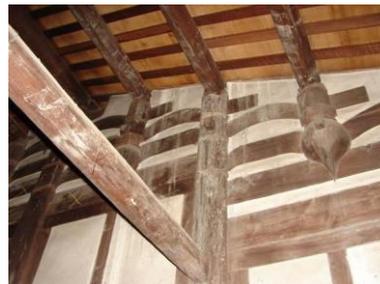
II. Roof leakage:

Large amount of water damage of the timber structure caused by roof leakage:

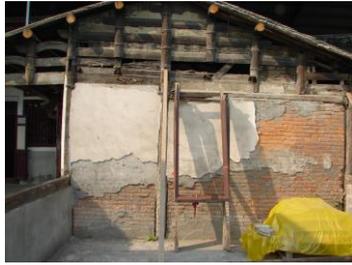
III. Material deterioration—deformation of wooden truss:
There are often cracks and insufficient bonding between the brick wall and the timber system.

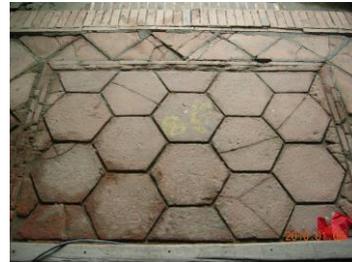
IV. Material deterioration—Salt migration:
Salt efflorescence, and leaching of materials have occurred on flooring tiles.

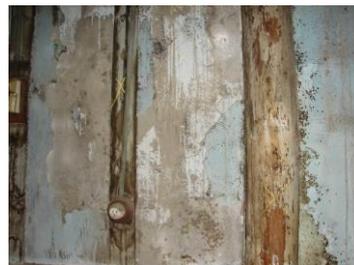
II. Fungal infestation:
The high temperatures and dampness have caused fungal infestation on wooden structures and painted surfaces.

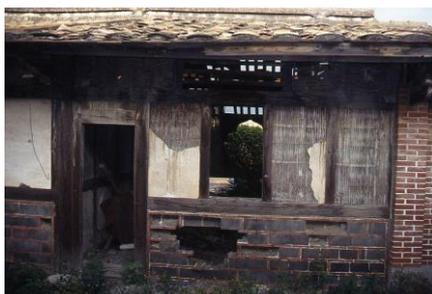
I. Negligence or lack of maintenance:
Before the conservation, most family members had moved out overtime, and there was only one household living in the compound for 19 years. Hence it is hard to maintain unoccupied buildings.

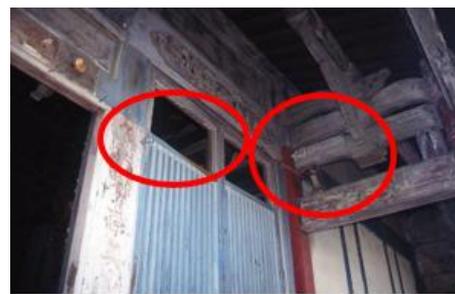
III. Improper alteration—roofing tile replacement:
The roofing tiles were replaced with red Japanese style roofing tiles.

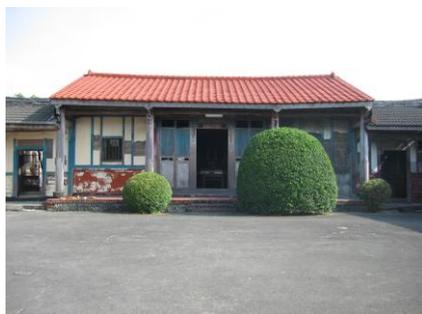
IV. Improper alteration—using cement replacing original materials:
The cement was often used for repairing original materials. E.g. The original stone plinth was repaired with cement filling.

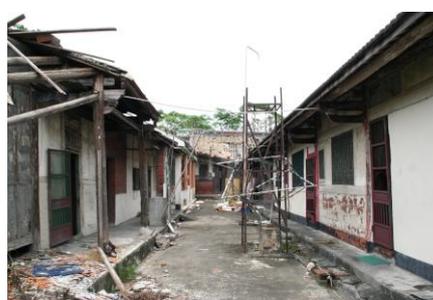
VI. Ownership issues:
The scattered landholdings have caused the lack of management for most of the property, especially the unoccupied buildings.

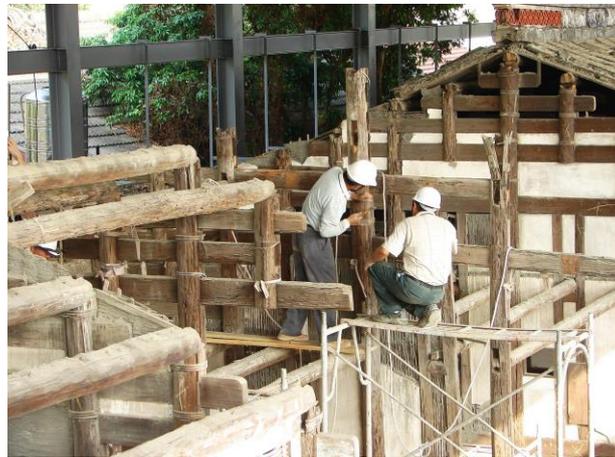
Figure.2 The structure was first disassembled during conservation. Source: Tinghsin Hote Foundation

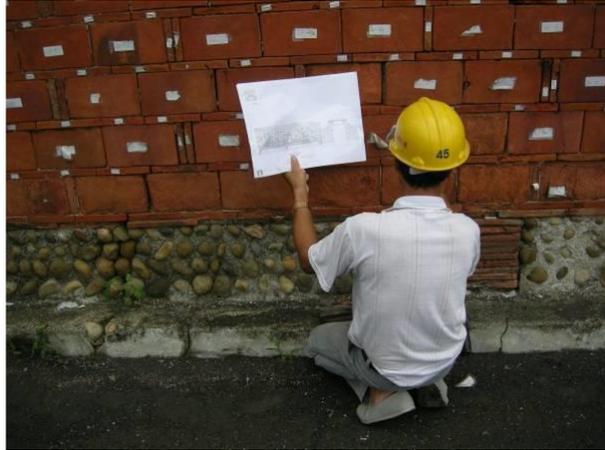
Figure.3 The original materials were carefully labeled and recorded before disassembled, and then stored accordingly before reuse. Source: Tinghsin Hote Foundation

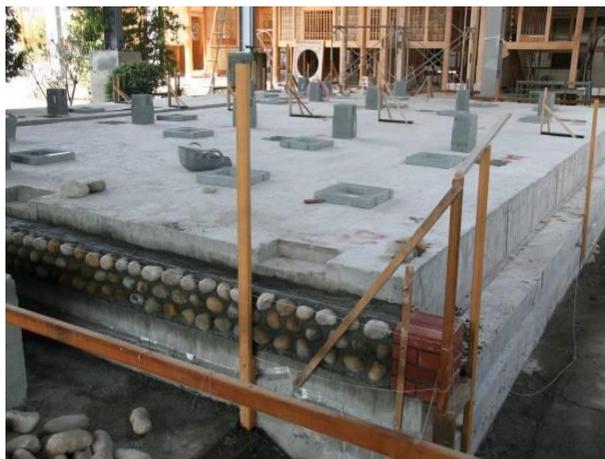
Figure.5 The new raised foundation reserves space for future piping/electricity system. Source: Tinghsin Hote Foundation

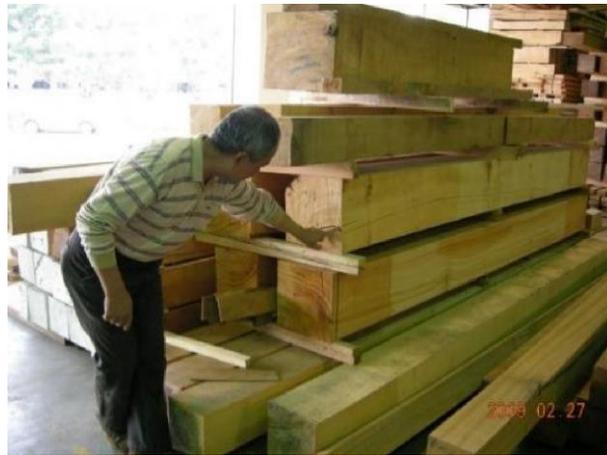
Figure. 7 The carpentry master was in charge of material quality control and all timbers were prepared in traditional method and naturally dried for 2 years in advance in order to assure the moisture content under 20% that would minimize the termite infestation probability. Source: Tingsin Hote Foundation

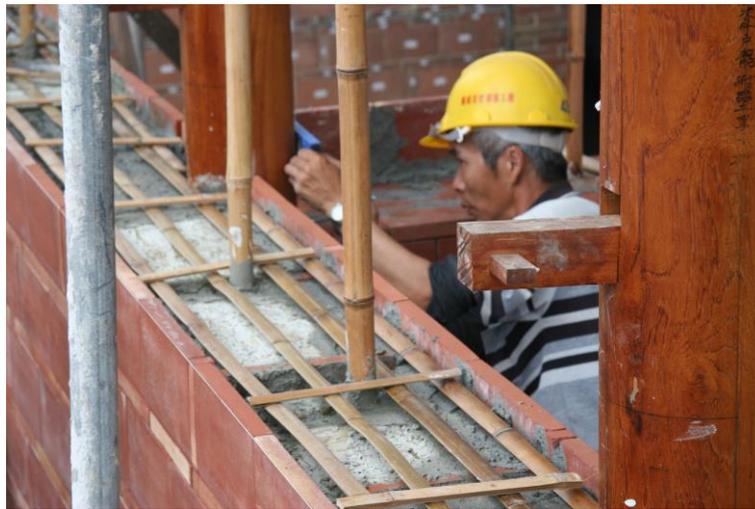
Figure.8 The long bamboo frame and bamboo braid mesh are inserted into cavity walls for better attachment between timber frameworks and walls. Source: Tinghsin Hote Foundation

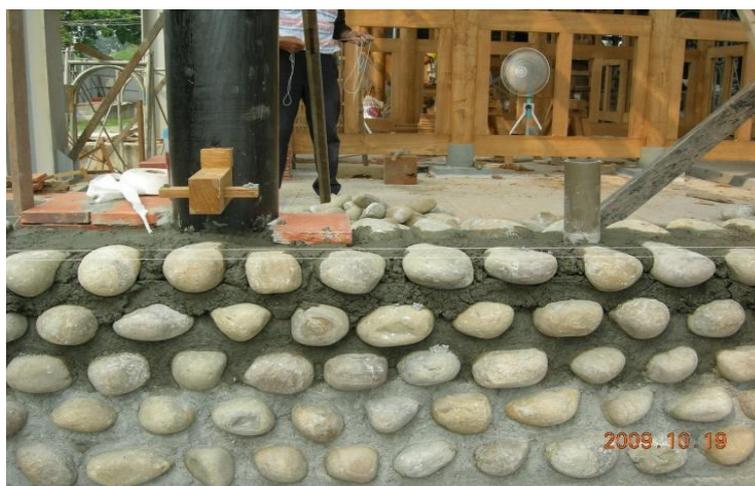
Figure. 9 A shear mechanism between the wood column and masonry wall for reinforcement. Source: Tinghsin Hote Foundation

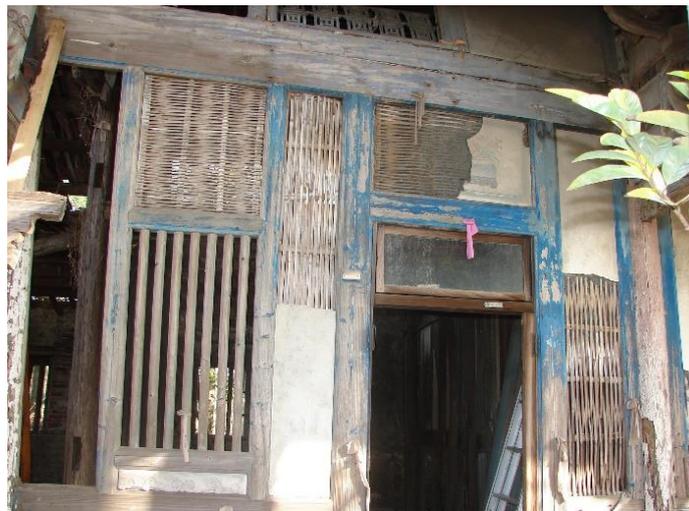
Figure. 10 The original bamboo wattle and daub wall that is degrading. Source: Tinghsin Hote Foundation

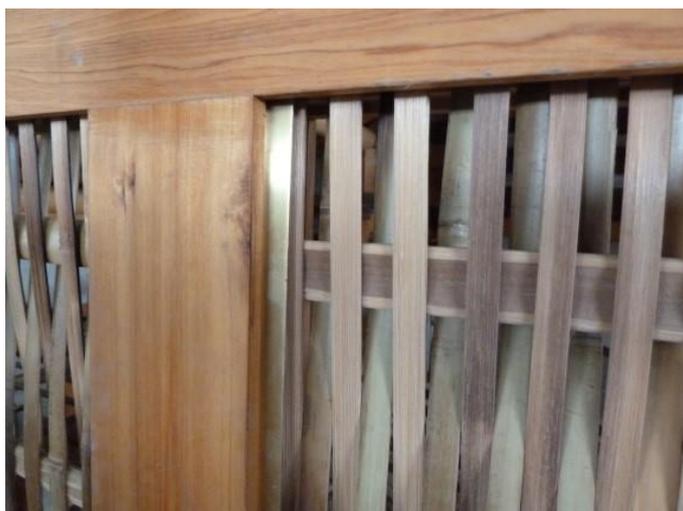
Figure. 11 The new water insulation mechanism installed during conservation.
 Source: Tinghsin Hote Foundation

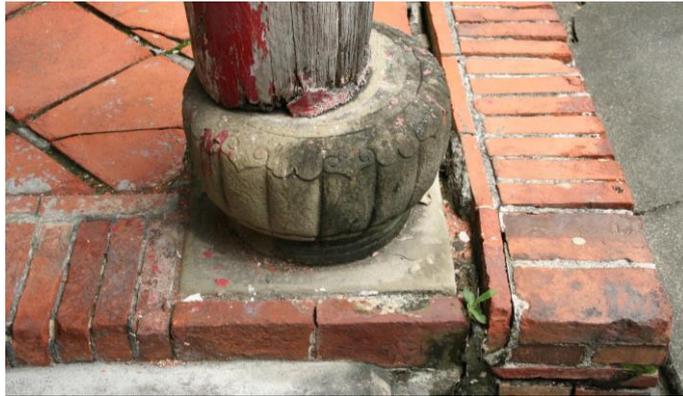
Figure. 13 Before conservation: Timber column misplaced on the stone plinth and the cracking of the stylobate are due to distortion caused by moisture fluctuation. Source: Tingsin Hote Foundation

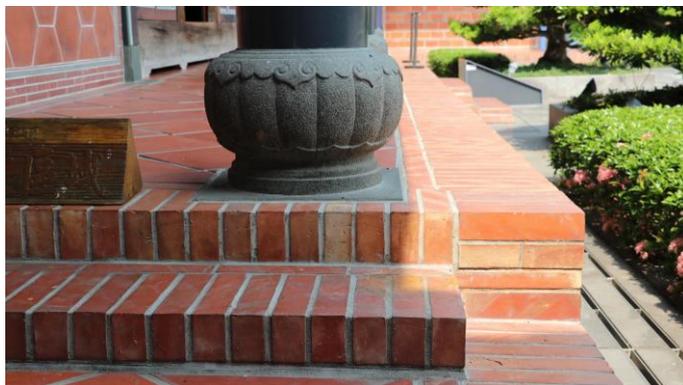
Figure. 14 After conservation: the improved wooden column–stone plinth–stone stylobate structure. Source: Tingsin Hote Foundation

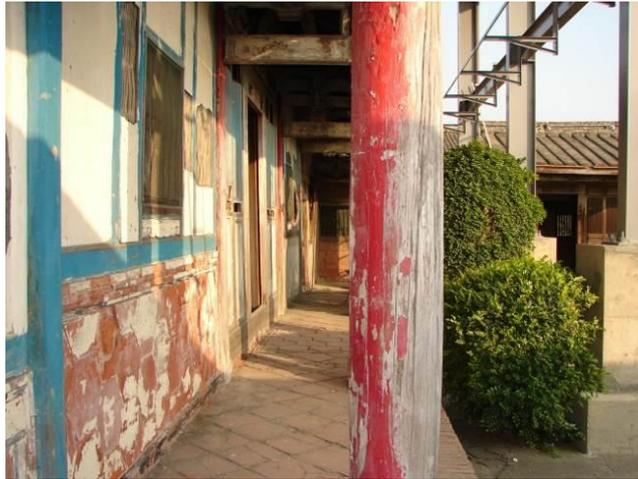
Figure.46 The main tone of painted finishes is red and blue: red for outdoors and blue for indoors. Source: Tinghsin Hote Foundation

During the conservation, detailed color information of each ornament or painted structure is recorded carefully using the Pantone color chart for future reconstruction (Figure. 16). Before setting up the tone for the whole compound, the basic tone of the original wooden surface was first measured and simulated on the computer. Besides color reconstruction, all decorative ornaments were reconstructed digitally for adjustments beforehand, and Sol-silicate mineral paints from KEIM and LIVOS, Germany were selected due to their stability and durability.

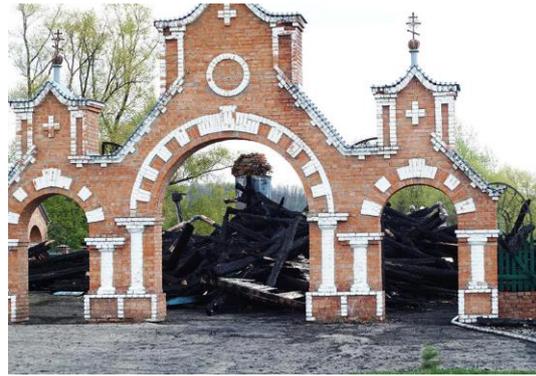
Figure. 7 Burnt church in Prislönikha, Source: simbirsk. city¹

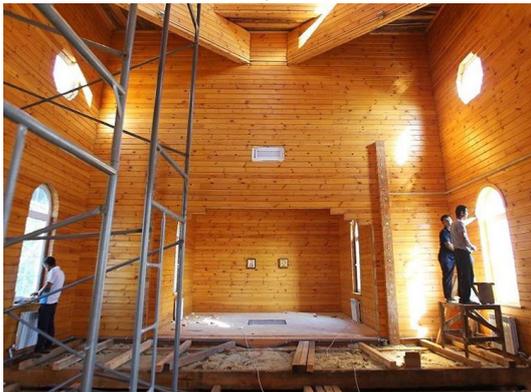
Figure.8 Restoration work in the Epiphany Church in Prislönikha. August 21, 2017, Source: 1ul.ru²

Over 12 million rubles were spent on the restoration of the church. Also, the domes cost about 3 million. The painting and interior decoration, iconostasis, Church utensils, and so on took about 8 million rubles. Most of this was given by the Simbirsk Metropolia. The wood of the restored church has been treated with fire-resistant materials. The frame was made of glued beams. And this was a truly popular construction site. In the temple of the Epiphany of the Lord, the interior decoration was restored, the bells that survived the fire were returned. At the expense of Nikolai Plastov, the grandson of the people's artist A.A. Plastov, the large and small iconostases were restored, samples of icons for them were provided from the collection of the State Tretyakov Gallery. The first icons, collected by the staff of the Ulyanovsk Regional Art Museum throughout the region, marked the beginning of the collection of the Museum of Simbirsk icon painters. Four ancient wooden icons of the 19th century were donated to the temple by a resident of the Sursk region. Also, the restored icon of the Epiphany of the Lord, lost in the fire, took its former place in the Church, the author – Alexander Stepanovich Gordeev, an icon painter, a resident of the Sursky district presented the icon as a gift to the newly restored Church.

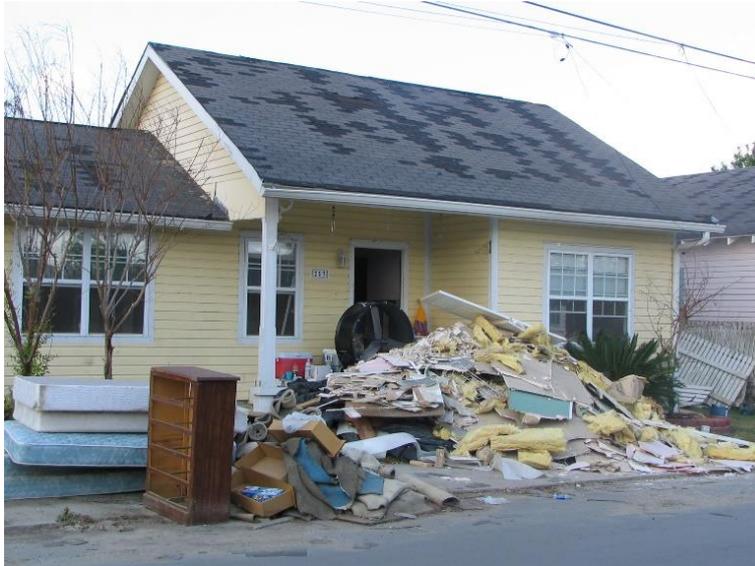
Figure 2 – Historic cottage in Bay St. Louis, Mississippi following Hurricane Katrina. Like an almost drowned human, the heritage structure regurgitates contemporary materials – drywall, carpeting, particle board and insulation – leaving the original wood plank floors and wood slat walls and ceilings in place and reusable.

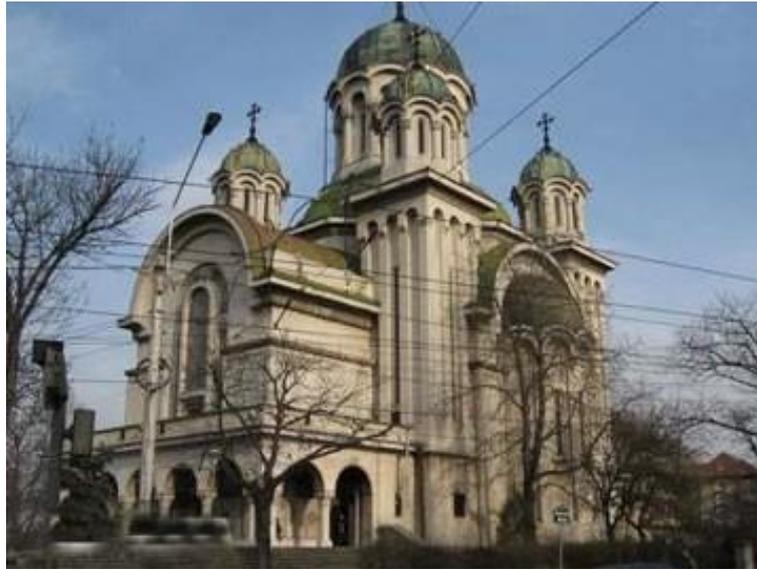
Figure.2 Casin church located in Bucharest. Source: Sofronie R., 2015

The Orthodox church Casin located in Bucharest was erected in less than seven months, between 1937-1938. The golden ratios were respected during design process. The structural system consists of a spatial frame of RC that supports the main steeple, and also the other 4 small steeples. The church was closed with thick walls of solid brick and pure lime mortar. Anyway, the state of the structure was not perfect. There were an important number of cracks caused by the foundation system. Each column is founded using an independent foundation, with no connection to the others, and also with different foundation elevations. (Sofronie R., Feodorov V., 2015)

Five measures were proposed as follows: 1) Putting the floor under safety by temporarily construction in basement a supporting metallic structure for limiting the damages in case of a brittle collapse. 2) Reinforcing the soil around the church body with polymer geogrids and water proofing the surrounded pavement. 3) Remove the existing canalization on a more distant location. 4) Permanently monitoring the church by controlling the 27 marks installed in the basement by technical expert. 5) According to the Code P100-3/2008 the building was classified on the second class of seismic risk. Consequently, by a written advertisement, displayed at the entrance, the believers should be prevented that visiting the church could be dangerous. These measures were carried out in order to repair the damages caused by the foundation. (Sofronie R., Feodorov V., 2015) No measure made sense if the structural system had no resilience reserves. Repairing the damages caused by the foundation system will lead to a minimum seismic resilience of 65%.

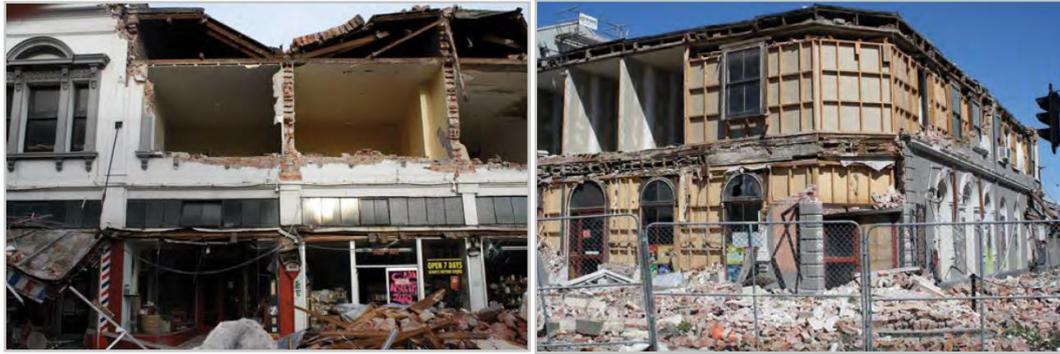
Figure 1. Examples of buildings where unreinforced brick masonry parapets and facades collapsed onto the pavement during the Christchurch Earthquake in February 2011.

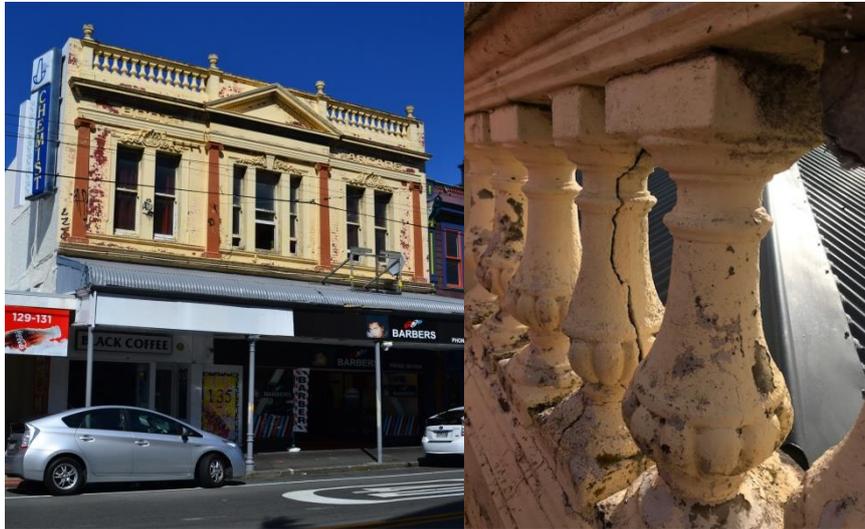
Figure.2 Typical solution, before and after

Before – Typical commercial building in the Newtown Shopping Centre Heritage Area

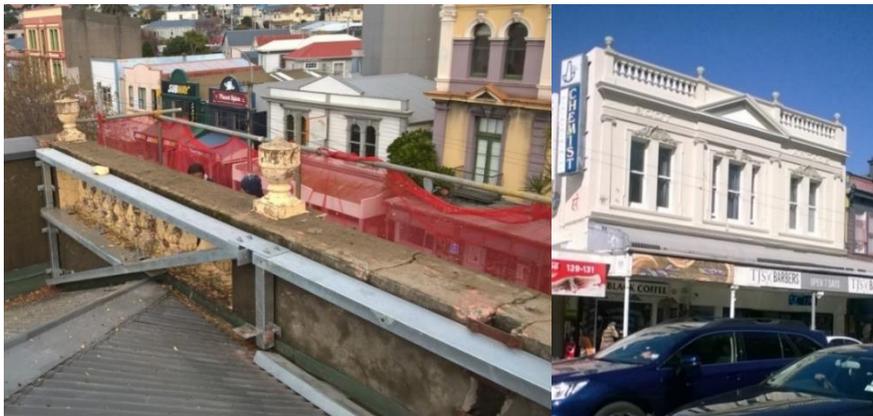
After – Parapet has been secured to a new steel frame

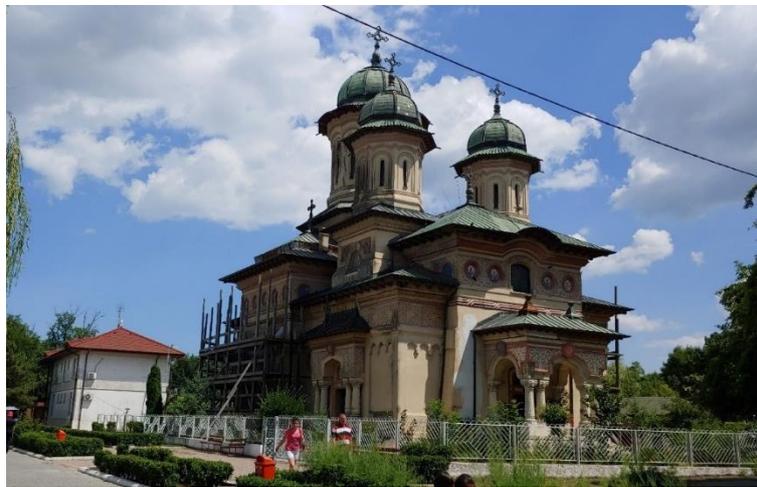
Figure 4. Orthodox Cathedral "St. Nicolae and Alexandru "
Original Image: by the author

The author started a study to investigate the modal parameters, such as mode shapes, modal frequencies, of a masonry type historical Orthodox Cathedral by performing numerical and experimental analyses. The structural system of the Cathedral consists of a shallow foundation of weak concrete and slender masonry brick walls. The roof has a wooden structure and supports a dome in the traditional ecclesiastical style. Over the years, the seismic protection codes were upgraded and the Cathedral location was enclosed in the seismic zone with a higher PGA of 0.20g. There were made careful investigations in order to establish the seismic risk of the building. The investigations include visual inspections, historical study, material tests, numerical 3D modelling, in-situ measurements, photos and visual inspection, technical expertise.

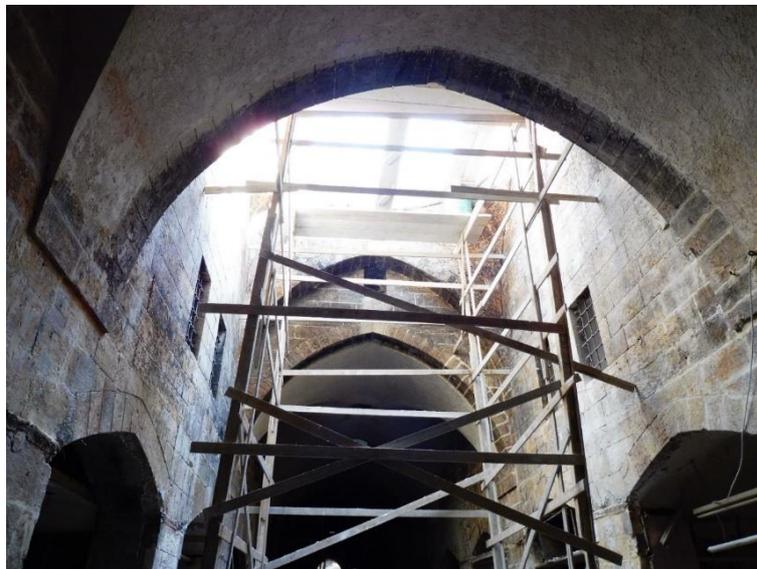
Figure. 4 – Aleppo: Souk al Saqatiya during restoration, January 2019 – Photo s. abdulac

The project involved a complete restoration of the damaged covering and structures, the construction of new and modern technical installation (water, electricity, communication, etc.) and the design of appropriate functional and decorative elements (wooden portals for the shops, artistic lighting of spaces, etc.) in harmony with the historic character of the souk.

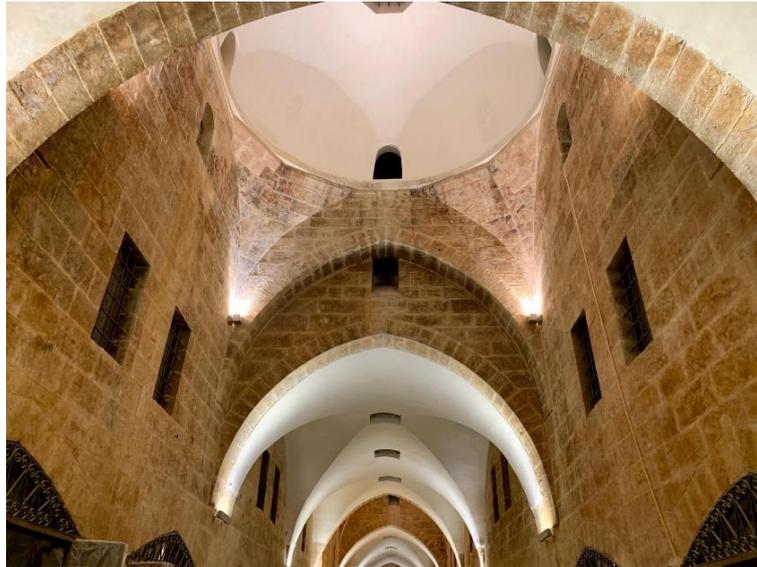
Figure. 5 – Aleppo: Souk al Saqatiya after restoration, September 2019 – Photo dgam

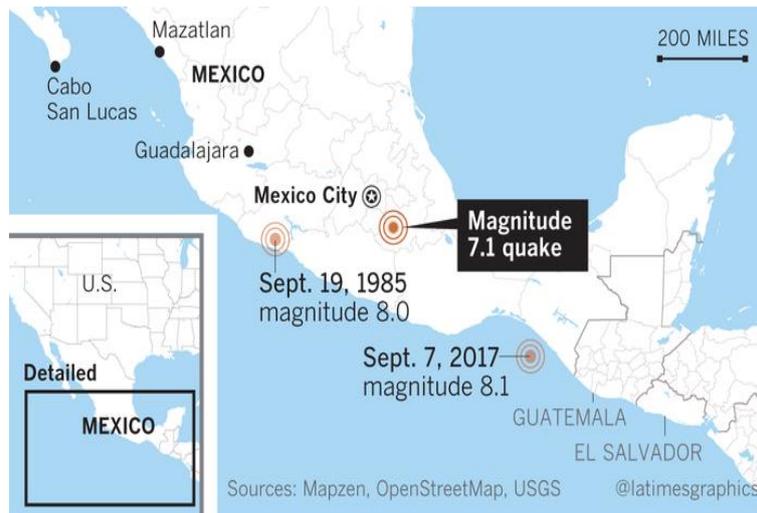
Epicentral Locations of Mexico Historic Earthquakes

The epicentral locations of the catastrophic 1985 Michoacán earthquake, Sept. 19, 2017 Puebla earthquake, and the Sept. 7, 2017 Chiapas earthquake are shown in Figure 1 (left). The earthquake shaking intensity experienced during the Sept. 19, 2017 earthquake is shown in Figure 1 (right)

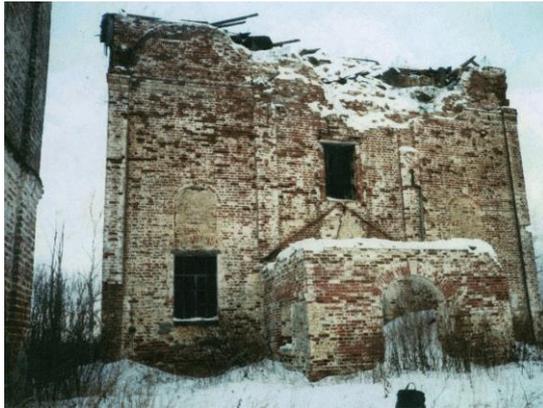
Figure 1. View of the church after the collapse of the completion – drum and dome.

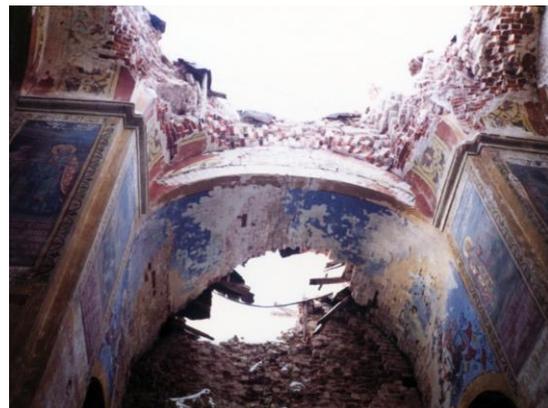
Figure 2. View to the ruined bearing arches from the interior.

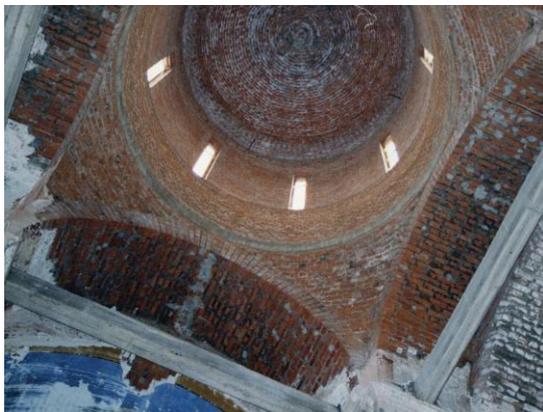
Figure 3. Restored drum, bearing arches and reinforced concrete air bonds from in the same place and dimensions as original wooden ones.
