FURNACES OF SALAMANCA: VERNACULAR BUILDING TECHNIQUES APPLIED TO SEMI-INDUSTRIAL TOBACCO PRODUCTION IN CHILE BETWEEN 1960 AND 1990

C. Gómez Maestro¹*, A. Rivera², I. Olivares Miranda³

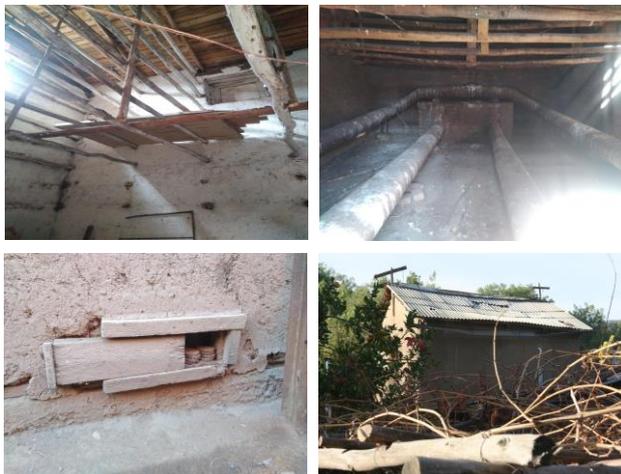
Figure 2. Mechanical features designed to enhance tobacco drying. a. Poplar logs were used to hang tobacco leaves b. Iron tubes conducted hot air through the furnace c. Wooden portholes controlled air intake in the furnaces d. Ridges could be lifted mechanically to allow for better ventilation.

Green tobacco leaves were threaded and hung on canes, which were laid between poplar logs which covered the inner width of the furnaces. Once the tobacco plants were hung, furnaces were heated with ovens, which were always located outside them. Hot air was conducted from these ovens through iron pipes, which toured inside the furnaces and finally ventilated through a chimney on the outside. Both ovens and the wall segment through which these pipes entered and exited the furnace were built with burnt bricks. During the years in which tobacco furnaces operated, different fuels - gas, paraffin or firewood - were used to heat them up. Fuel choice influenced on production times, costs and processes, but not on the architectural or building distribution of furnaces.

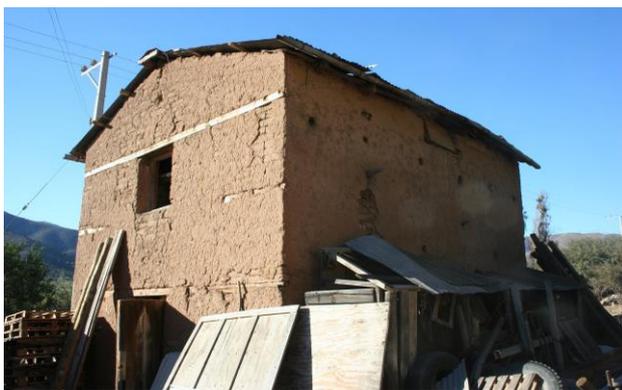
Figure 3. Adobe furnace in Chuchiñf, in which both continuous and corner horizontal wooden reinforcements can be identified.

Nevertheless, these cases recurrently incorporated horizontal wooden elements. These elements are set between adobe layers at different heights, either wrapping the whole perimeter of the construction, or just reinforcing corners. They are materialised differently in each of the studied locations - mostly through a different amount of reinforcements per furnace and different wood sizes and joints in each element - and would help to counteract large slenderness ratios, therefore contributing to the better seismic performance of these buildings. Damage due to biotic or anthropic factors in these wooden reinforcements is found to be related to the general conservation of furnaces and to severe damage in adobe walls (Figure 8). In parallel, poplar logs used to hang tobacco leaves were frequently anchored directly into adobe walls (Figure 2a). This thick concentration of horizontal links between parallel planes of furnaces would have also mitigated the effect of high slenderness ratios.

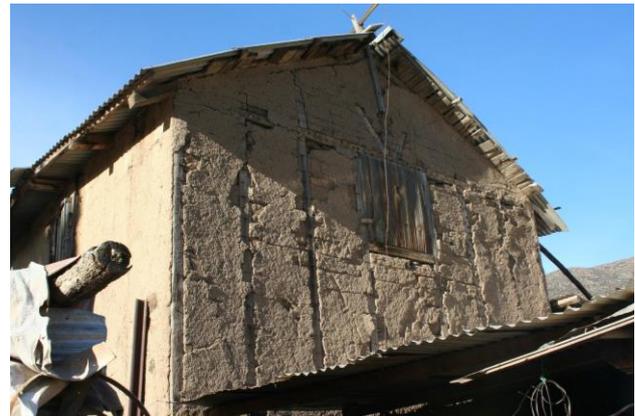
Figure 4. 'Tabique' furnace in El Queñe with one horizontal block between the sawn wooden elements and horizontal wires.

confined with metal wires. These are nailed to the main wooden structure on their outside and inside to keep adobes from falling from the wall's axis. Wooden structures present variations within the studied cases, both in the geometry of the wood and in its section and structural logic. In the particular case of El Boldo, for example, two furnaces belonging to a same ensemble are built using different techniques. The first of them was built with unsawn wood, which shows natural irregularities in a pile and beam system and in which acacia pillars were directly buried into the ground. The second example is erected with sawn upper, lower and diagonal hearths of poplar (Ventura, p.c., 2019)- following an adapted balloon frame system with concrete foundations. This system is found more commonly than the first throughout the studied areas (Figure 4).

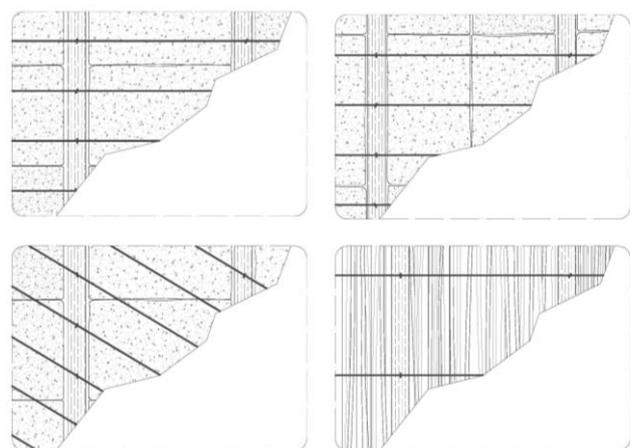
Figure 5. Schemes showing variations in tabique and quincha infills. a. 'Tabique' with single horizontal adobe and horizontal wiring b. 'Tabique' with double vertical adobes and horizontal wiring c. 'Tabique' with single horizontal adobe and diagonal wiring d. 'Quincha' with vertical tobacco branches confined with horizontal wiring.

On the other hand, differences were also observed in the way of arranging adobe blocks which infill wooden structures. Spaces between wooden pillars can be filled either with one single horizontal block or with several of them, set vertically. A last difference lays in the distribution of metal wires confining the adobes, which were found to be arranged horizontally or diagonally in different cases. Vertical adobe arrangements and horizontal wiring distribution were shown to be more vulnerable to emptying due to dynamic forces of earthquakes (Figures 5a, 5b and 5c).

3.2.3 ‘Quincha’: A third technique found in the area is the branch-filled ‘quincha’. This is another hybrid wood-earth technique, in which the bearing structure is made of wood. Variations within these structures are similar to those found in furnaces built with ‘tabique de adobe en pandereta’; with the difference that ‘quincha’ walls are not filled with adobes but with a combination of medium-sized vegetable fibers and earthen plasters. This technique was only observed in the upper level of one of the studied furnaces (Figure 8) and in minor elements such as gables in other studied cases. In the first, fibers correspond to tobacco branches, which are confined externally with horizontal metal wires and then covered with earthen and wheat straw plasters (Figure 5d).

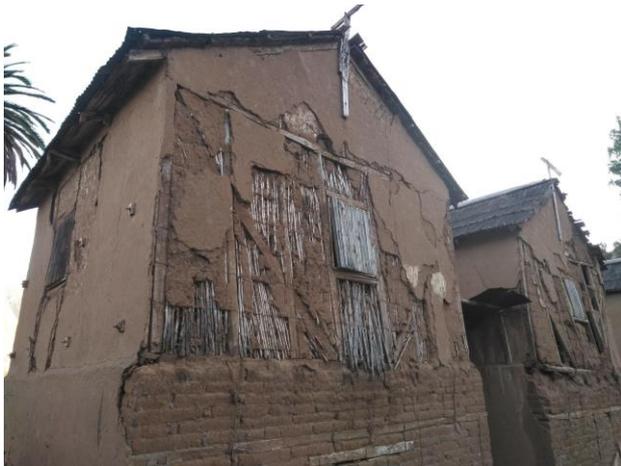
Figure 6. A singular case of ‘quincha’ in Chalinga. The lower area is built with adobe.

Only one of the studied ensembles is currently incorporated as a cultural and touristic asset. In spite of their poor state of conservation, the furnaces of Chalinga (Figure 6) stand near a neo-colonial house which is currently used as a modest museum and community meeting centre. This ensemble is managed by the owner’s family and relies only on payment coming from visitors for its maintenance.

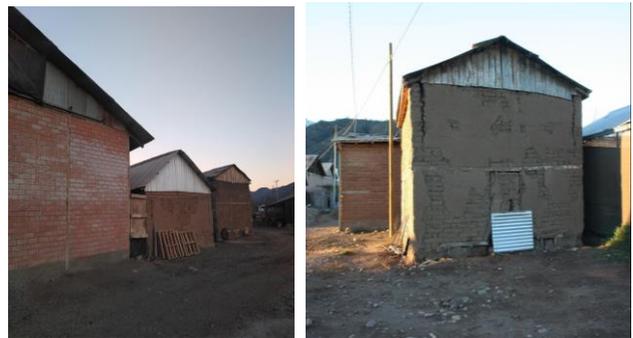
In the first case, this change in use has implied the extraction of the antique heating system, which was placed in the lower area of the furnaces, making storage difficult. Some furnaces which are now used as storage have been lowered, in order to ease cleaning tasks and to reduce their slenderness; thus supposedly increasing their structural capacity. This transformation has nevertheless not always been successful, since the extraction of continuous wooden reinforcement on the upper area of walls is associated to the appearance of new, deep cracks in these constructions (Figure 7).

Figure 7. Lowered furnaces in Chuchiñi.

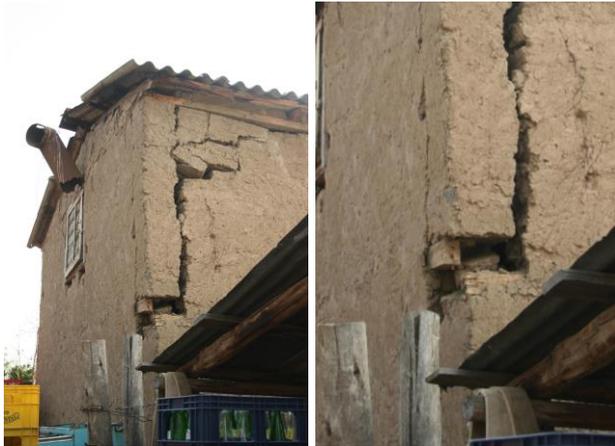
4.2.1 Cracks: Those which compromise the structural capacity of furnaces appear mostly on adobe walls. Severe in-plane cracking of the walls was observed in some cases, particularly in those where horizontal wooden reinforcements were not present or deficiently designed - with poor link between the wood elements and insufficiently distributed in their total height (Figure 8). Cracks appear most commonly in corners and in higher parts of furnaces, particularly in adobe gables.

Figure 8. Crack in a furnace in Panguessillo, associated to poor links within its horizontal wooden reinforcement.

Another recurrent issue detected in the deterioration of wooden structures is the poor choice of wooden joints in some specific cases, which lead to major deformation of walls (Figures 8 and 10).

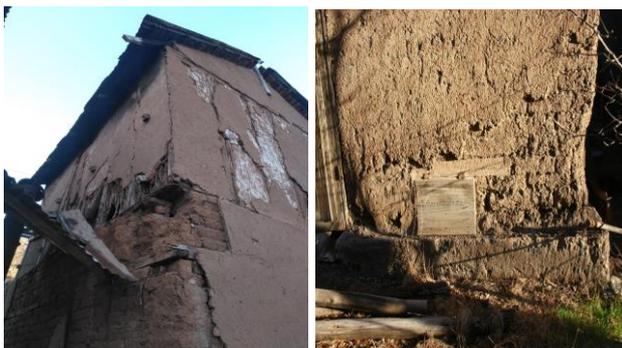
4.2.2 Material loss: Material loss is a general classification of three particular damages: plaster loss, erosion and voids. While the first is common to all studied furnaces -triggered either by environmental or mechanical factors affecting adherence to different surfaces such as adobe blocks or wooden structural elements - erosion affects mostly adobe structures in their lower or upper areas and it is due to water infiltration or splatter. This damage rarely compromises structural stability of studied cases.

Figure 9a. Erosion in a. upper area of an adobe wall in Chalinga b. lower area of an adobe wall in Chuchiñi.

On-site assessment detected major damage in wooden structures in the area, ranging from deformation of roofs, with the consequent risk of water infiltration - even if Salamanca is a mainly dry region - and deterioration of reinforcements within adobe walls. Much of this damage is associated to the large presence of xylophagous insects in the area and becomes especially severe in cases where wood is exposed to water (Figure 9a).

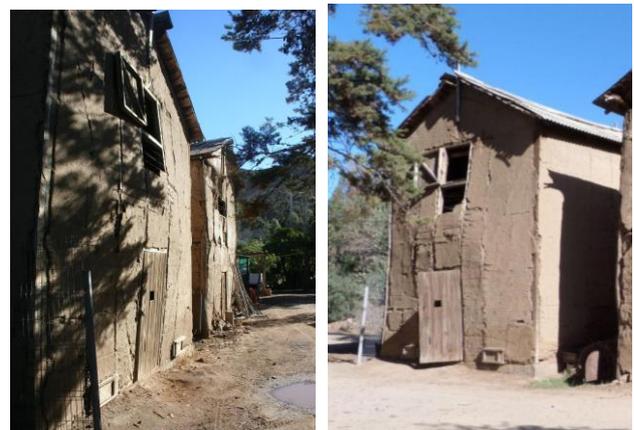
Figure 10. Severe deformation of a tabique wall associated with an inappropriate choice of wooden joints in pillars - Furnace in El Boldo.
