SAN PAWL MILQI , BURMARRAD , MALTA – PRESENTATION OF A MULTI-CULTURAL SITE IN A CHANGING LANDSCAPE

Faculty of Architecture and Civil Engineering, University of Malta

Institute for Masonry and Construction Research, University of Malta

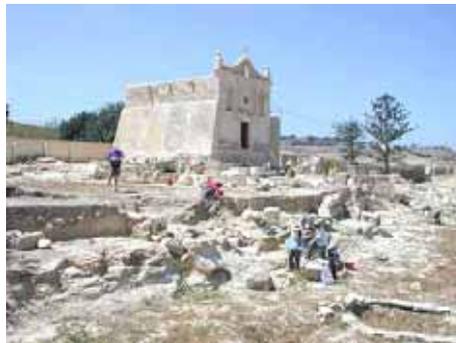
Figure 2 View of the Baroque church and its relationship to the archaeological site.

In such a landscape, San Pawl Milqi is to be found in a position of control, situated on a wide natural terrace that breaks the North-Eastern slope of Gebel Ghawzara. The Baroque church that dominates the archaeological site (Figure 2) stands as a real landmark, visible from all over the area – from the North, South, East and West, and above all for all who approached the coast from North to East. In this dominating position, the archaeological area is exposed to often strong winds from the North East and from the North West which often batter the church and the archaeological remains.

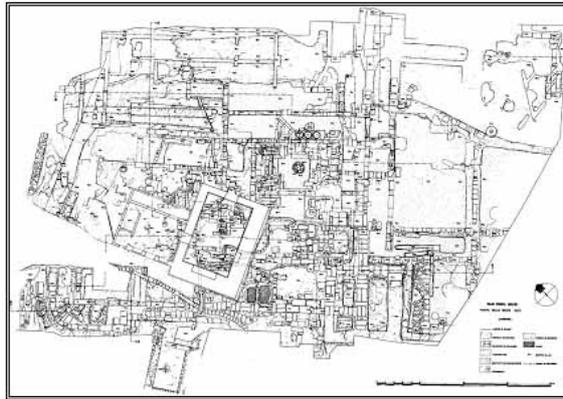
Figure 3 Plan of the multi-cultural site showing also the superimposition of the church on the archaeological remains.

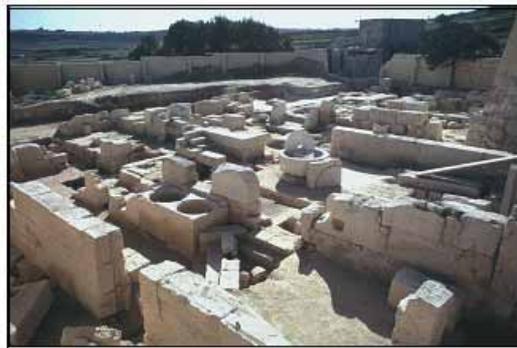
Figure 4 View of part of the site showing the boundary wall which surrounds only part of the remaining archaeological structures.

During the 1960s, a boundary wall was built which incorporates an area of approximately 4000 m² (Figure 4). Unfortunately the boundary wall does not include all the archaeological structures: some of these are found behind the church, on the other side of a small country-road that deeply cuts the rock in the North-West part of the archaeological area, exposing the soft yellowish layers of Globigerina Limestone and even cutting through some of the archaeological features.

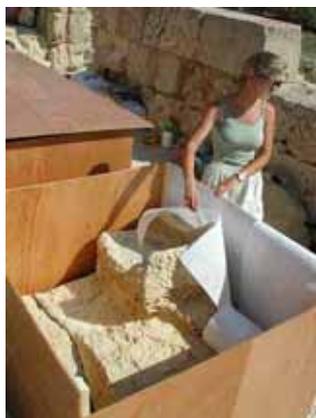
Figure 5 Measures being taken to protect one of the friable oil vat found on site.

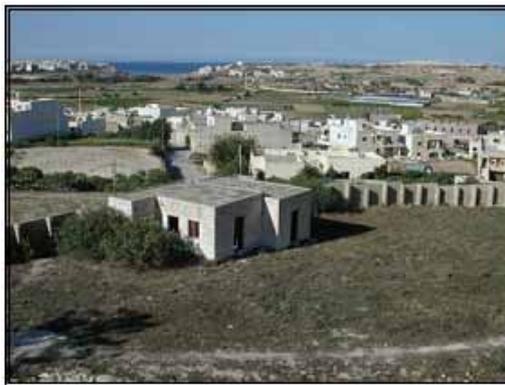
Figure 6 Store rooms built during the 1960s and the encroaching village of Burmarrad.

Situated on the plateau, above the location just mentioned for the visitors' center, there exist rooms built during the 1960s as store rooms (Figure 6). These rooms are not in a good state of repair and hence it would be ideal to demolish them so as to eliminate the negative impact on the skyline

due to their proximity to the archaeological site and the church. The concrete flooring of these rooms, which would create a scar on the landscape were it removed, could be retained and refurbished to house information panels explaining the archaeological site.

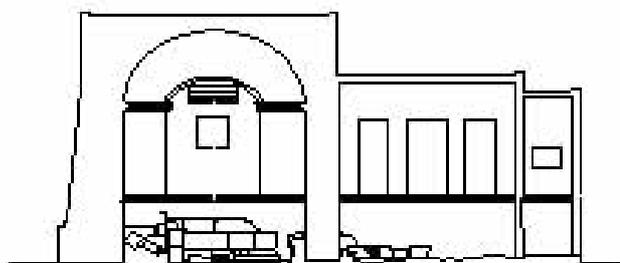
Figure 7 Proposed Section A-A'

Figure 7 Section through church and sacristy showing the archaeological remains located underneath.

flooring of the church was removed. After the excavations were concluded, wooden planks and iron beams replaced the original flooring. A trap door within the wooden flooring in the church allows access to the archaeological finds beneath (Figure 7).
