## **HAMINA AREA AS AN EXAMPLE OF THE POSSIBILITIES OF RESTORATIVE RENOVATION**

Architect, Dr.Tech. ANU SOIKKELI  
Architect ANITA YLI-SUUTALA  
University of Oulu, Department of Architecture,  
POB 4100, FI-90014 Oulun yliopisto, Finland  
anu.soikkeli@oulu.fi

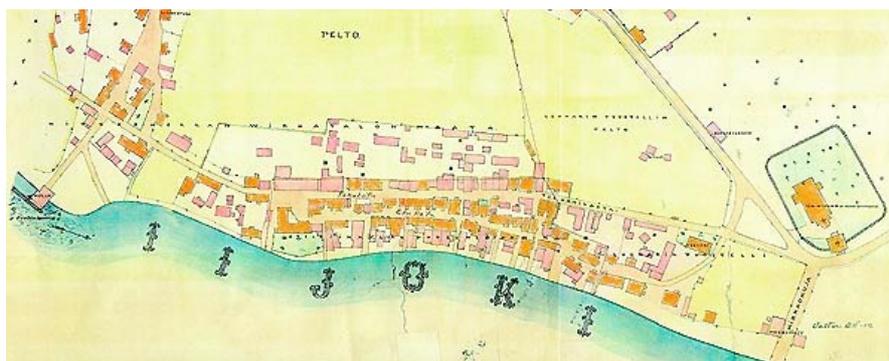
*Figure 2.* Old map of Hamina, 1901. The houses were grouped in a ladder formation along two meandering streets. (Kononow 1901)

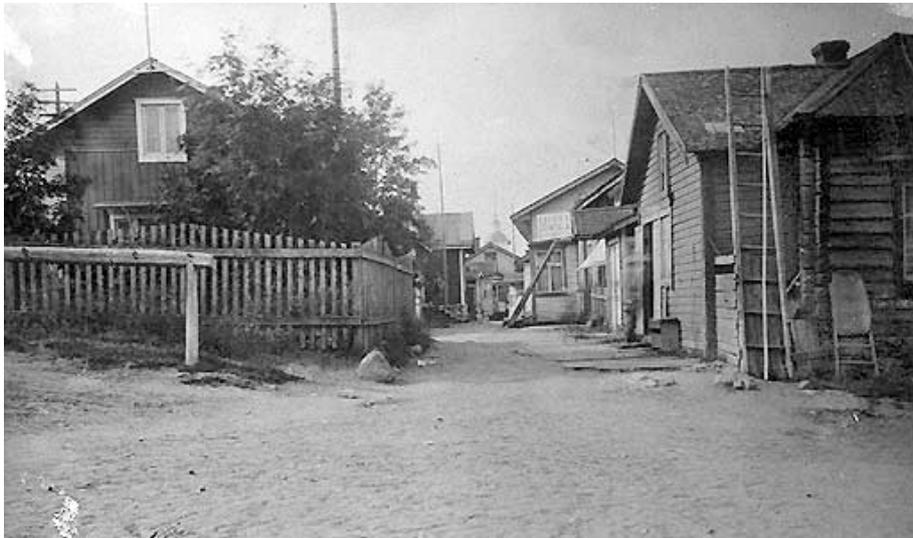
*Figure 3.* Crossing of the streets Takakatu and Etukatu, 1931. On the background a coffee house. The street is very dense. (Kalle Backman's private archive)

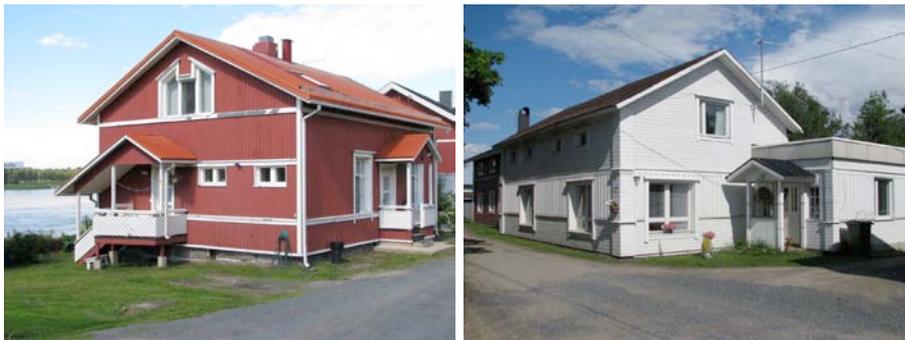
*Figure 5 and 6.* Typical buildings after alterations: windows have been enlarged, a thick layer of insulation has been added outside the building and the original, simple type of boarding has been changed. (Photos A. Soikkeli)

Typically, a thick layer of additional exterior insulation has been added to the buildings. As a result the eaves are narrower, the windows and foundation are left deep in the facade and the building

has a bloated appearance. The windows and doors have been replaced with modern ones. The old thick, wide facing boards have been replaced with thin, narrow, commercially produced paneling with poor long-term durability. Traditional paints have made way for commercially produced plastic paints. The buildings have lost their original proportions and their original layout of openings, and they have become clumsy caricatures of their appearance at the time when they were built. Unused outbuildings have either been destroyed or left to decay.

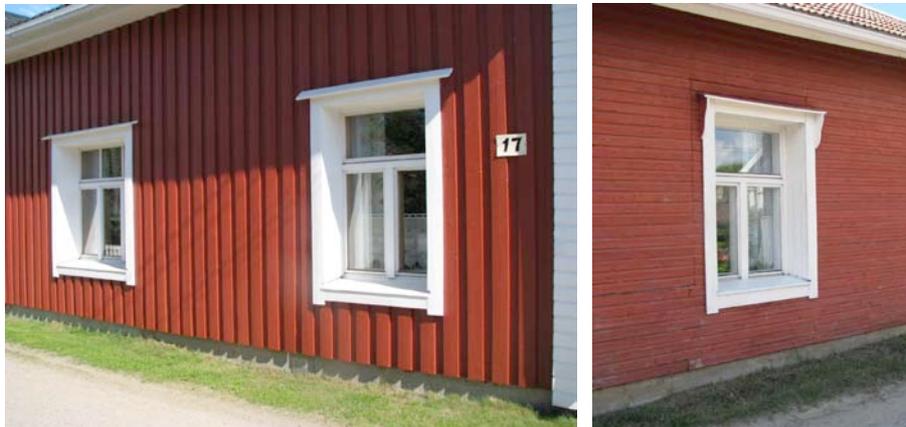
*Figure 7 and 8.* As an result of exterior insulation the eaves are narrower and the windows are left deep in the façade. The building has a bloated appearance. (Photos A. Soikkeli)

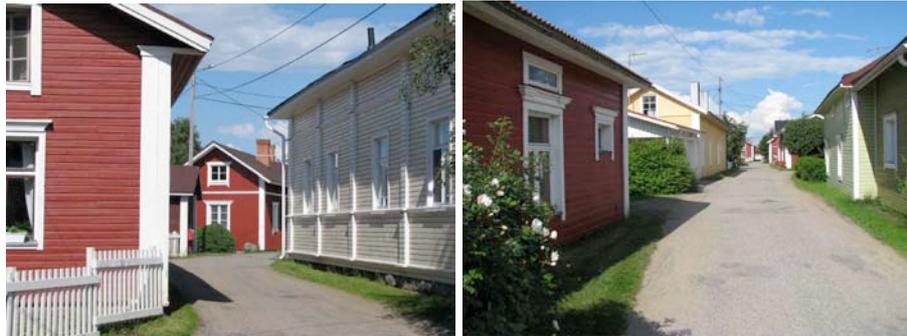
*Figure 9 and 10.* Regardless of all the modifications of buildings, the area's cultural and historical value is still significant and the milieu is unique.  
(Photos A. Soikkeli)

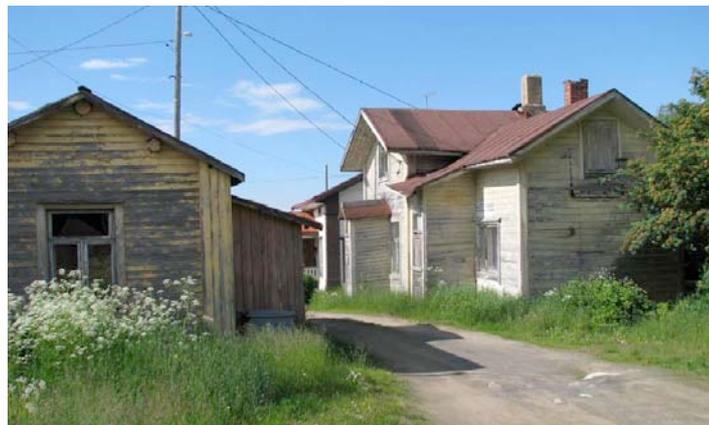
*Figure 11.* One of the last original buildings in Hamina area. (Photo A. Soikkeli)
