THE INTEGRITY OF STRUCTURE: SHOULD WHAT IS HIDDEN INSIDE THE WALL BE CONSIDERED A PART OF A HISTORIC BUILDING'S CULTURAL VALUE?

Randolph Langenbach

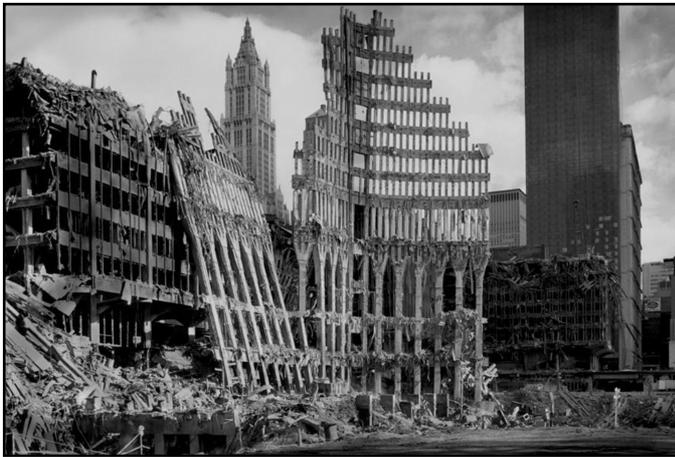
Ruins of North Tower Façade with the Woolworth Building Constructed in 1913, behind.(photo 1)

The collapse of the World Trade Center towers has irrevocably changed our perceptions of buildings, at least for a generation. Even now, a year after the event, we struggle to make sense of an event that, until it occurred, was beyond our imagination. Bridges, radio towers, or other structures can fall down, but, absent an earthquake, major modern engineered buildings are simply not known to do so. They seem so solid, so permanent. Or course, intellectually the collapse made sense. How could any building stand up to the fiery crash of a large fully loaded commercial airplane? But in fact they withstood that force – only to suddenly collapse an hour later into an indefinable pile of debris – except for the evocative Gothic ruin of the broken facade of each tower. (Photo 1)

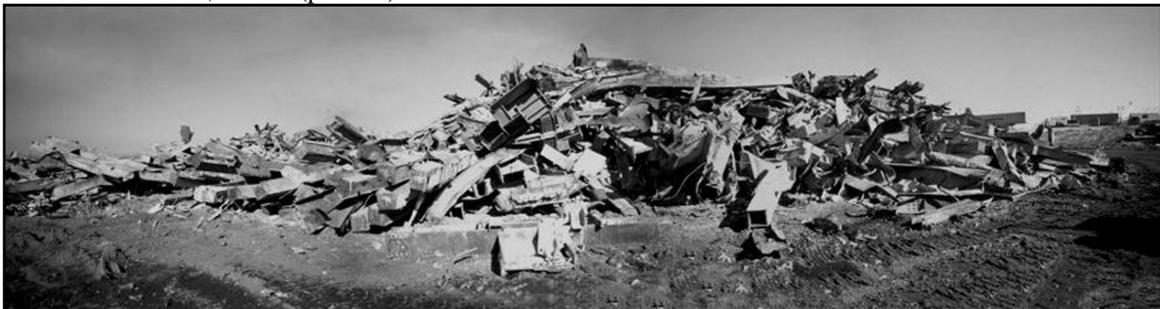
Steel from the World Trade Towers stacked for scrap at Fresh Kills Landfil (photo w (photo 2)

These buildings have passed into history while they were still young –wiped completely from the face of the earth except for a few select pieces stacked in New Jersey scrap yards and at the ironically named “Fresh Kills”¹ landfill site on Staten Island (Photo 2). In addition, in the penumbra of their collapse, the other buildings of the World Trade Center complex were set on fire from the falling debris and destroyed as well. One of them, WTC #7, became the world's first steel-frame high-rise building to collapse solely because of fire, when it collapsed about six hours after Towers 1 and 2 came down. All of the other buildings in the complex remained standing, with gaping holes and missing sections that were squashed by the cascade of debris, but their structures were twisted and warped by the uncontrolled fires that raged in them for hours.

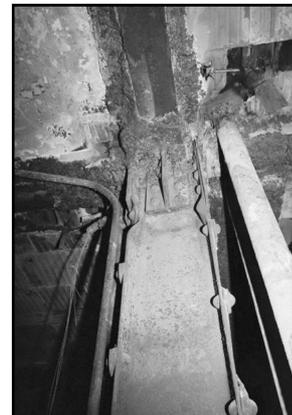
Photo 4

A year after the collapse of the towers, the interior of 90 West Street is a burned out ruin. Almost every floor suffered extensive fire damage, and some became sufficiently hot (Photo 4) to soften the steel columns. This building stands as evidence of how far the burning debris was catapulted into the surrounding area. However, unlike all of the other burned out buildings, not only did it not collapse, as did the 50 story World Trade Center #7, *its structural system was only slightly damaged*. That system, which consists of hollow clay tile and riveted steel, proved to be more durable and capable of avoiding the destructive warping of the steel joists and columns that occurred in the massive group of 1960's seven-story buildings that surrounded the towers. Only a few columns were slightly buckled, (photo 5) a testament to the fact that even though the fires were hot, the onset of collapse was arrested (most probably by the rivets) just as it had been for many similarly constructed high-rise buildings which were thoroughly burned out in the San Francisco Earthquake and Fire of 1906 almost a century earlier.

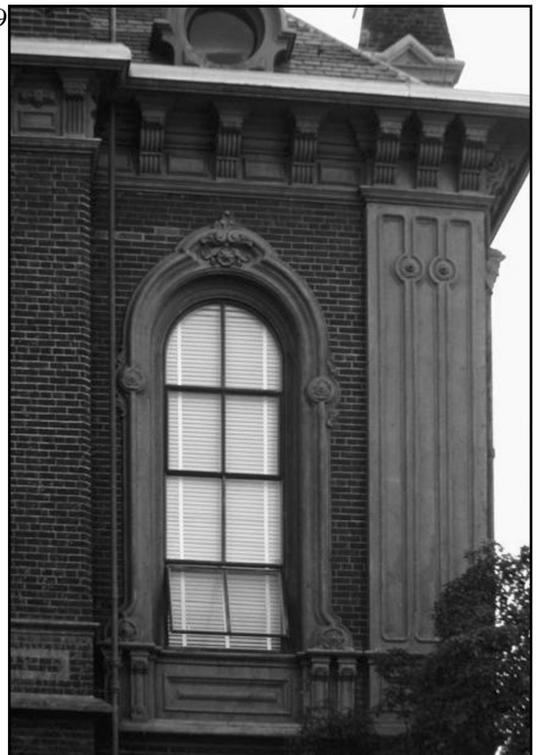
Photo 9

masonry had been constructed with “bond iron” – a system of wrought iron bars – that tied the building together above and below the windows on every level. (Photo 9) In addition, the beams and joists were anchored to the walls with iron ties that were imbedded into the walls so that they would be hidden on the exterior. (Photo 10) What was visible on the exterior, and what should have provided a clue to what was inside, were large cast iron ornamental plates with large bosses attached to the corners of the building. The bosses were in fact the nuts that held the ends of the bond iron straps that ran from corner to corner through the length of every wall. Ironically, there was historical evidence in the University’s own records of the existence of this reinforcing, but historical research was not included as part of the design phase of the project.
