OLD AND GREEN

Environmental performance of traditional Chinese housing

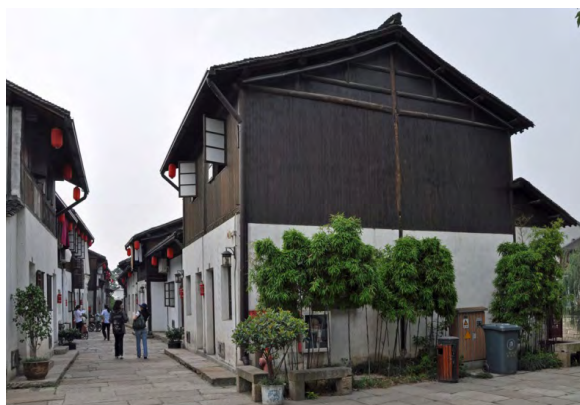
Figure 2. Typical construction of houses in Xiao He Zhi Jie (Peter Phillips)

The style of the buildings is typical of the late Qing dynasty and reflects the living environment of relatively poor people (Figure 2). Most of the buildings were one or two storeys high, combined in terraces or around courtyards. The buildings originally had no

bathrooms or kitchens, and little acoustic or thermal insulation. The spaces between the houses were very narrow and contained little or no landscaping. Masonry (usually brickwork) coated with a weak stucco was used mainly for ground floor walls, although some common walls were built in masonry to two storeys. The main structure consisted of framing poles (often built into the masonry) with horizontal poles as beams. Many upper floor external walls were timber framed and boarded, even between adjoining houses, with the pole framing partly exposed.

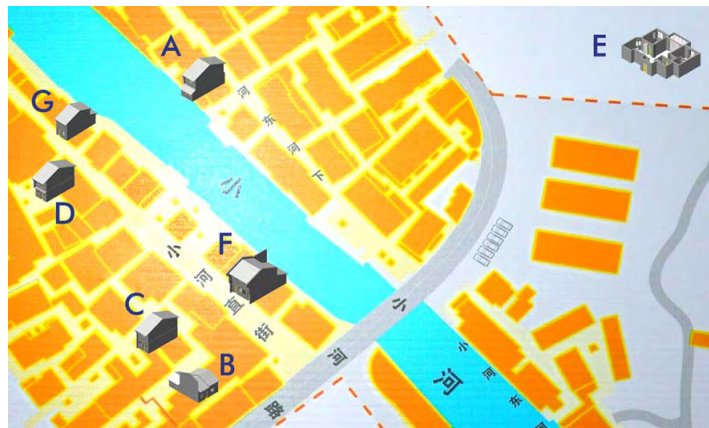
Figure 4. Location of the seven sample buildings within Xiao He Zhi Jie (base map adapted from original by Hangzhou municipal government)

buildings are shown in Figure 4, and details of each dwelling are given in Table 1.

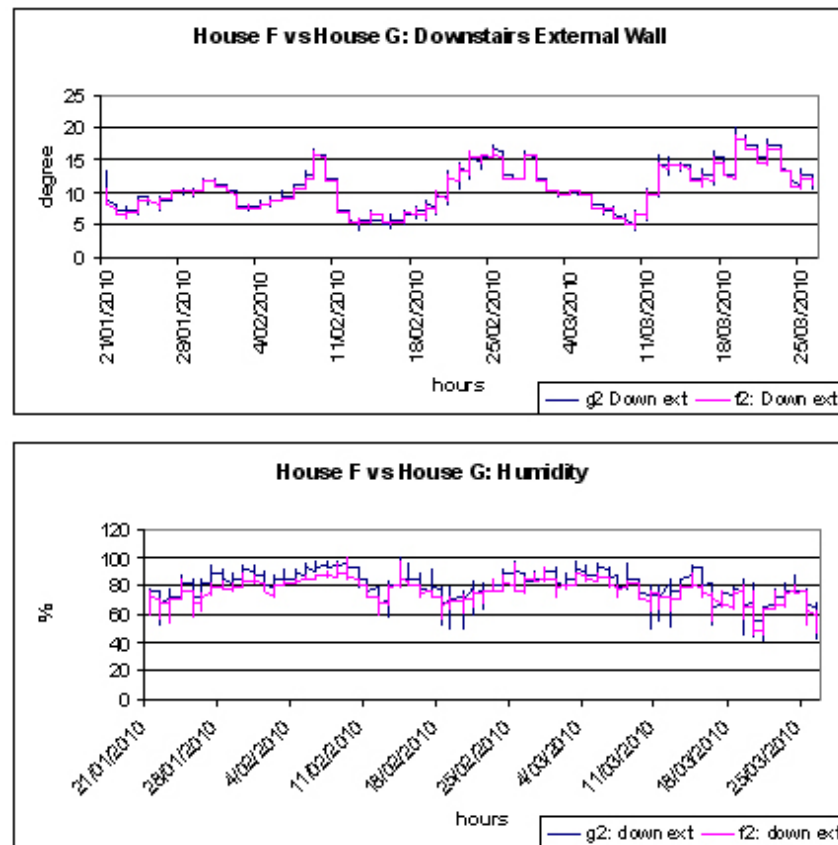
Figure 6. Graphs comparing temperature (above) and humidity (below) readings from monitors located on the inside of external ground floor walls in Buildings F and G (Janet Ge)

When data from different houses is compared, the research has shown surprisingly little difference between the temperature and humidity readings in the conserved old buildings and those in the houses that have been rebuilt using modern materials (Figure 6). These findings were reasonably consistent for all of the buildings in the study. This indicates that, at least for the construction types encountered in the study, buildings of conventional modern construction may perform little better than historic buildings.
