Rendre compatible les techniques traditionnelles et les modernes  
Compatibilizar técnicas tradicionales y modernas  
Combining traditional and modern techniques

## The 'Svevo' Village of Termoli. The traditional constructive techniques of Molise

## The Swabian Village of Termoli. The vault system: techniques and recovery

## Building and Rebuilding with earth. Earthen architecture in Cyprus and the problem of its conservation

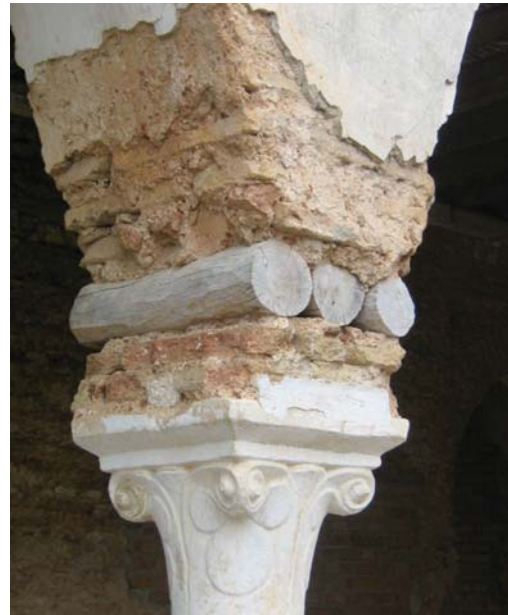
Détail articulation colonne - arc

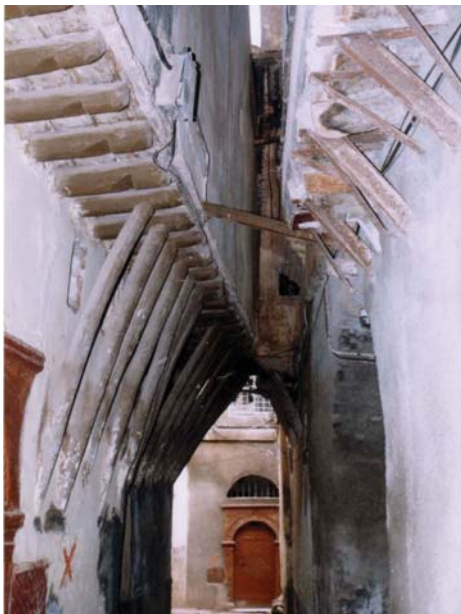
Encorbellement à Alger

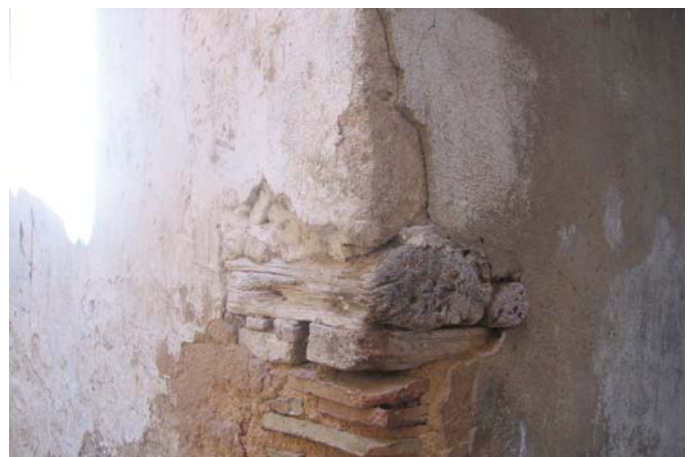
Bois inséré dans la maçonnerie à Fès

A Fès, il semblerait que cette technique soit semblable à celle observée dans les deux autres médinas. Cette technique a été décrite lors des travaux de restauration de *Da r'Adyal*<sup>11</sup>. Il est dit que des plaques de bois sont intégrées tous les 50 cm aux sections des piliers assurant ainsi la connexion entre les piliers octogonaux des rez de chaussée et les piliers rectangulaires de l'étage. Ces éléments en bois, disent-ils, ont pour fonction d'absorber les éventuels désordres générés soit par les séismes soit par les tassements différentiels du sol de fondation.

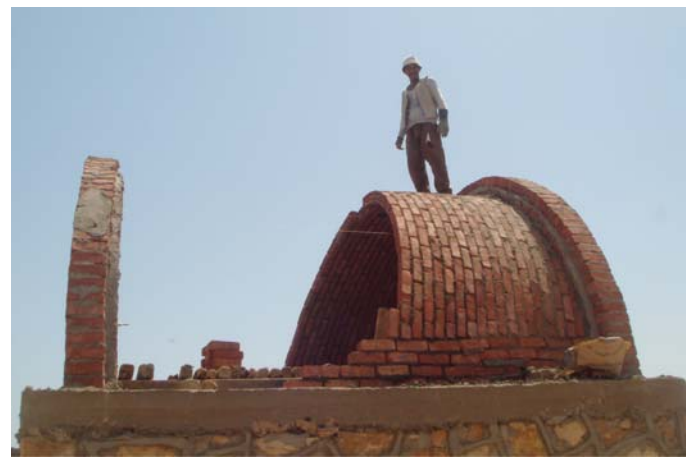
Fig(4) brick vaults users in project.
