Tangible Risks, Intangible Opportunities: Long-term Risk Preparedness and Responses for Threats to Cultural Heritage

Proceedings of the
ICOMOS Scientific Symposium

31 October 2012
Beijing, China

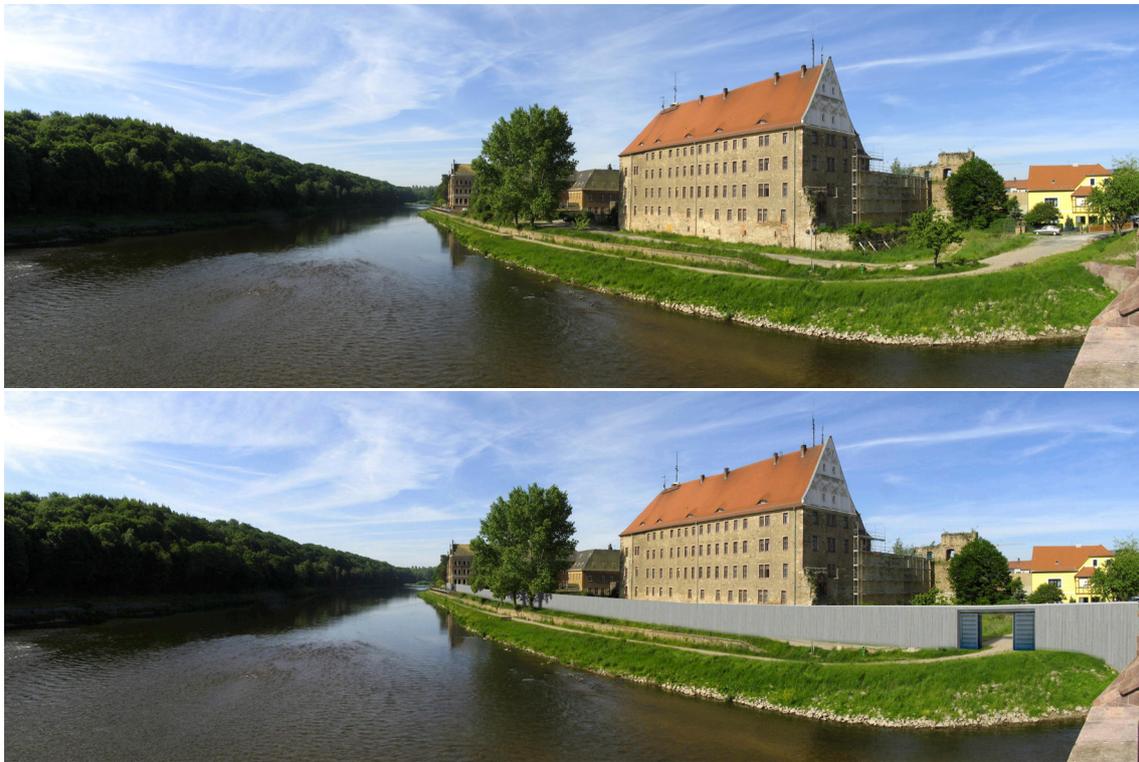
Figure 1. Grimma, Mulde River (Saxony): the former palace as seen from the baroque bridge. Status quo (top) and rejected preliminary flood protection proposal (bottom).

It was obvious that realization of this scheme would involve severe and lasting damages not only to the waterfront aspect, but also to the cultural heritage and to functional and aesthetic qualities of the city. Heated discussions led to the agreement that for a place such as Grimma, with its valuable stock of historic buildings, flood control planning based solely on hydraulic and monetary parameters is insufficient. It may even prove counterproductive, since it is likely to screen off, damage or even destroy those elements and features that (in addition to its foremost task of safeguarding the population) it is supposed to protect.

At that point, our team of conservation and landscape architects from the Technical University in Dresden was called in for consultation (Will 2008). Since then we have been involved in Grimma as planning advisors to assist in integrating the concerns of flood protection and heritage conservation along the historic urban waterfront.

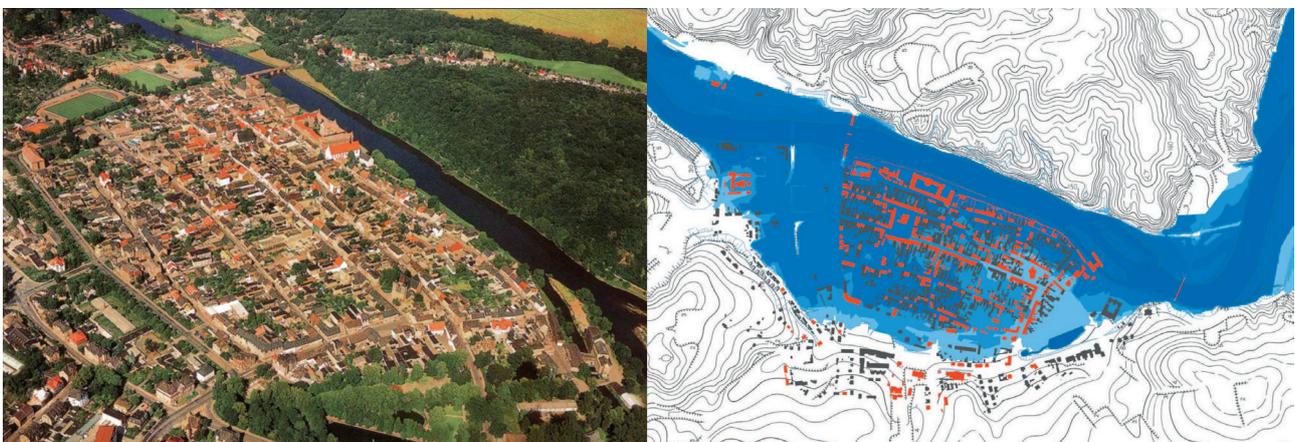
Figure 3. Grimma: aerial view and area flooded in 2002, listed historic buildings in red.

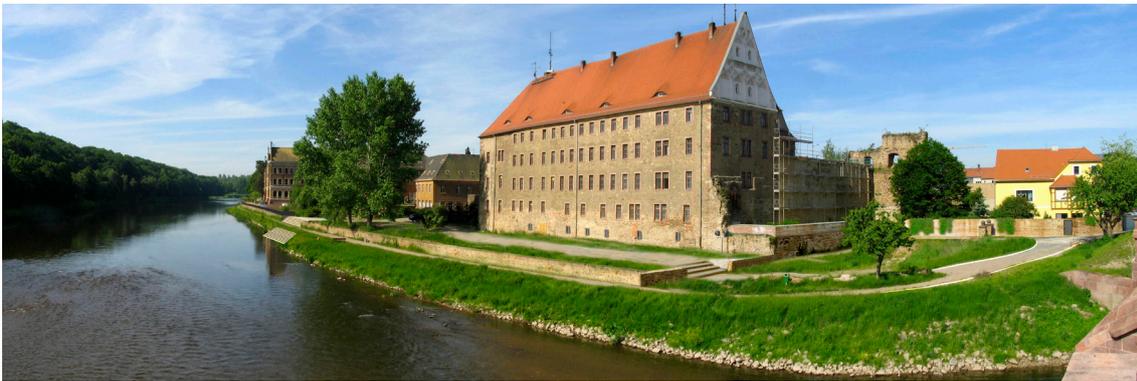
Figure 5. Grimma: the former palace as seen from the baroque bridge. Integrated flood protection proposal (Photomontage)

The arched bridge by the famous Baroque architect M. D. Pöppelmann marks the main entrance to the town, adjacent to the former palace. It was partially destroyed by the water in 2002. Because of the damming effects caused by its original piers during floods, the bridge has been rebuilt in a modified version in order to avoid the need for even higher flood walls (an independent decision by the city not favoured by the conservation office). A continuous concrete wall right along the riverbank, as suggested initially, would have severely and irreversibly damaged the view toward the city, its historic buildings and the river landscape. [FIGURE 1] Our studies showed that the riverside wall of the former palace could be treated to integrate flood protection into the building, so that it nearly disappears from sight. They also suggested moving the alignment away from the river, following the remnants of a wall along the former moat, and thereby allowing for a much lower protective structure. [FIGURE 5]

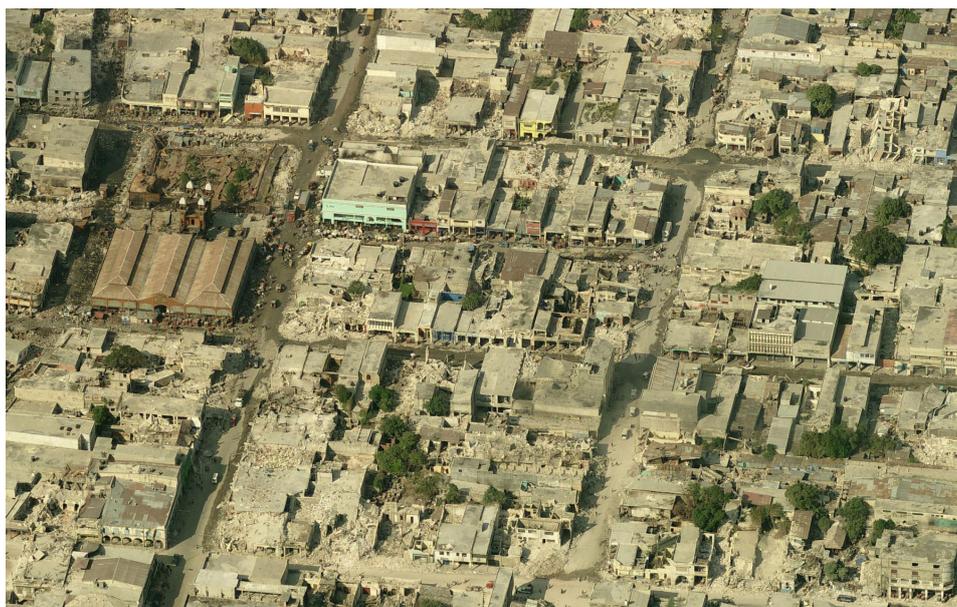
Figure 3. A detail from a Pictometry oblique aerial view of central Port-au-Prince one week after the earthquake. The collapsed unfinished building in Figure 1 is visible in the upper left
(© Pictometry International Corp.)

My recent research on Haiti stems from access to an unusual source of data – the oblique aerial photography of the damage district in and around Port-au-Prince, generated in the weeks following the 2010 earthquake by Pictometry International Corp.. For the first time, it was possible to survey the damage patterns over a much larger area than would be possible to do from the ground, and with greater clarity than is possible from satellite imagery.

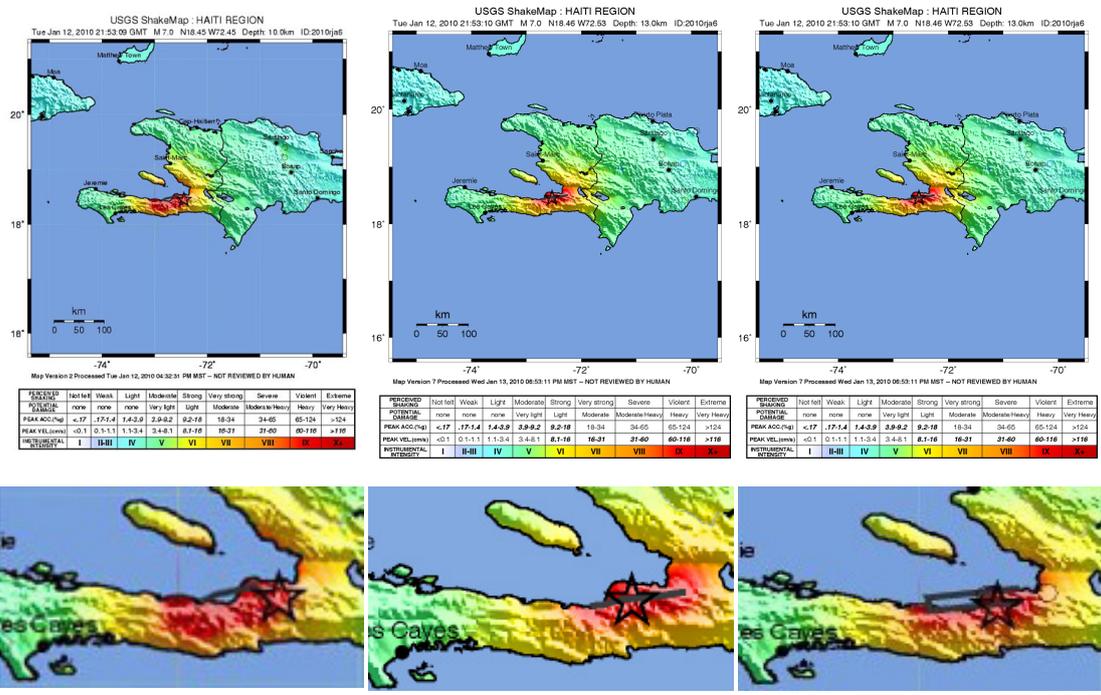
Figure 5. USGS Shakemaps with details of each map. Left: Version 2 (January 12-Day of earthquake); middle: Version 7 (January 13); right: Version 10 (March 4)

The version 7 shakemap shows the city of Port-au-Prince as having been subjected to a shaking equivalent to an Modified Mercalli Scale (MMI) IX, while version 10 shows a reduction in shaking to an MMI-VII or VIII. The transition from the yellow for VII, to orange for VIII extends over part of the area. An undated UN/European Commission shakemap classifies all of Port-au-Prince as having a value of VII. Interestingly, USGS versions 2 and 3, published on the day of the earthquake also show Port-au-Prince having been subjected to a MMI-VI to MMI-VII, considerably lower than version 7 a day later, but not much different from the latest and final map version 10 of March 4.⁷

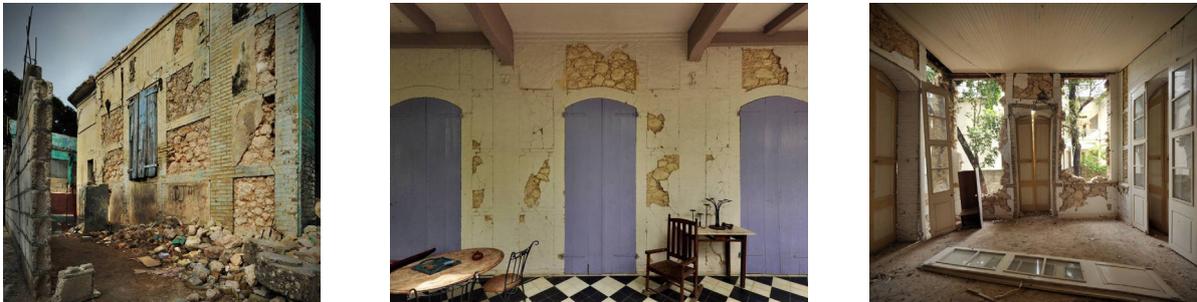
Figure 10. Brick and empaneled rubble stone construction, as is typically found in many of the Port-au-Prince ‘Gingerbread’ Houses from the late 19th century, showing different levels of damage from onset, to collapse of the rubble panels. Surprisingly few houses with this construction collapsed overall, despite the weakness and vulnerability to earthquake shaking of this construction – a further verification that the intensity did not exceed MMI-VII at these Port-au-Prince sites.

The other historic masonry buildings were most often constructed with a mixture of brick with round-rock rubble stone set in clay or lime mortar – many of which had been poorly maintained during the decades leading up to the earthquake. The damage to these ranged from medium [FIGURE 10, left and middle], to heavy [FIGURE 10, right]. However, very few suffered collapse, except for the falling out of some of the empaneled rubble stone. This is also consistent with the MMI-VII classification. All the affected buildings were within the central Port-au-Prince damage district, making it difficult to explain these phenomena as only a consequence of extreme differences in local site effects.¹⁰

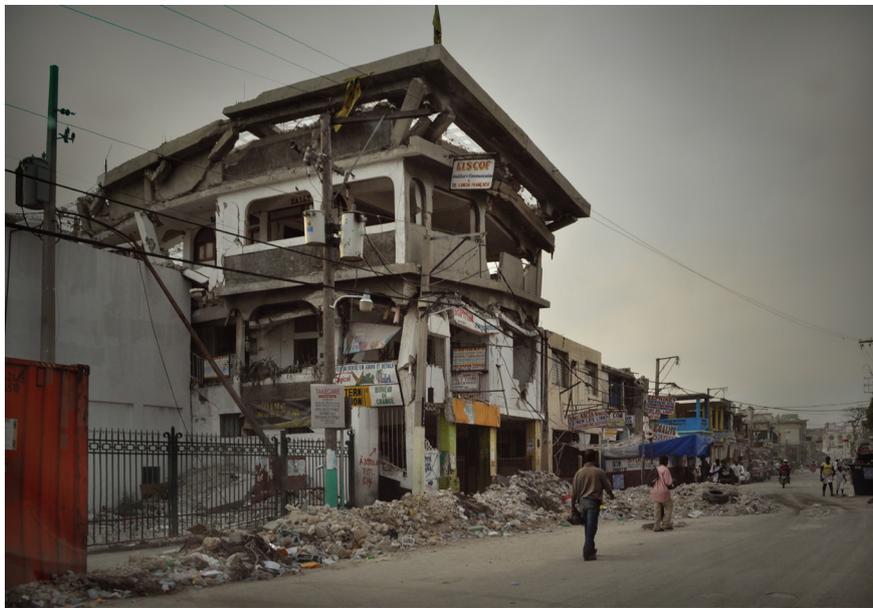
Figure 11. A downtown commercial building in a near state of collapse, illustrating the brittle vulnerable nature of many of the formal, contractor-built reinforced concrete buildings in Port-au-Prince. Many buildings of this type did pancake collapse, but as demonstrated by the buildings on either side that are still intact, everything did not fall down. Approximately 40% of the buildings in the central city were partially or totally collapsed; but of the remaining 60%, many suffered little damage¹³

Unlike most recent earthquakes that have stricken developing countries where the affected buildings are largely rural, this one struck a capital city. The RMS report expected that the preponderance of the fatalities would be in the 'bidonvilles' because of their belief that the owner-built houses mostly of cement block masonry and concrete slabs would be most vulnerable. However, the Pictometry images have revealed that the majority of the building collapses were not, as anticipated by RMS, in the 'bidonvilles', but in the formal, contractor-built multistory reinforced concrete buildings in and around the city center [FIGURES 1,3 and 11].

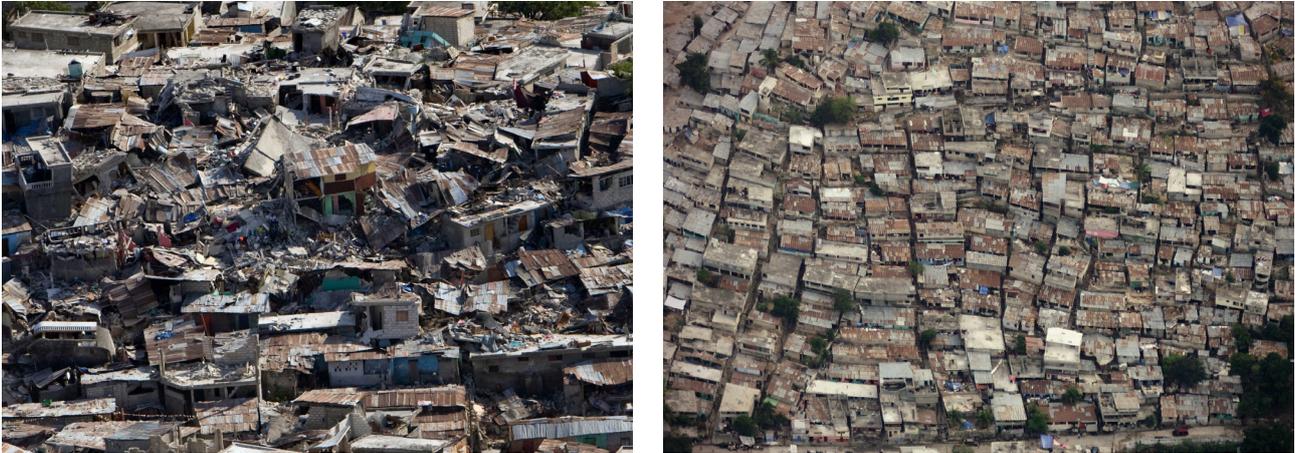
Figure 12. Views of a bidonville near central Port-au-Prince showing (left) a view of an area with extensive collapses, and (right) an area with very few collapses. A careful review of the Pictometry of the Port-au-Prince damaged district as a whole has shown that the number of areas with minimal evidence of collapsed buildings, were higher than those with greater damage. (Left: Source: UNDP Global from RMS Report; right © Pictometry)

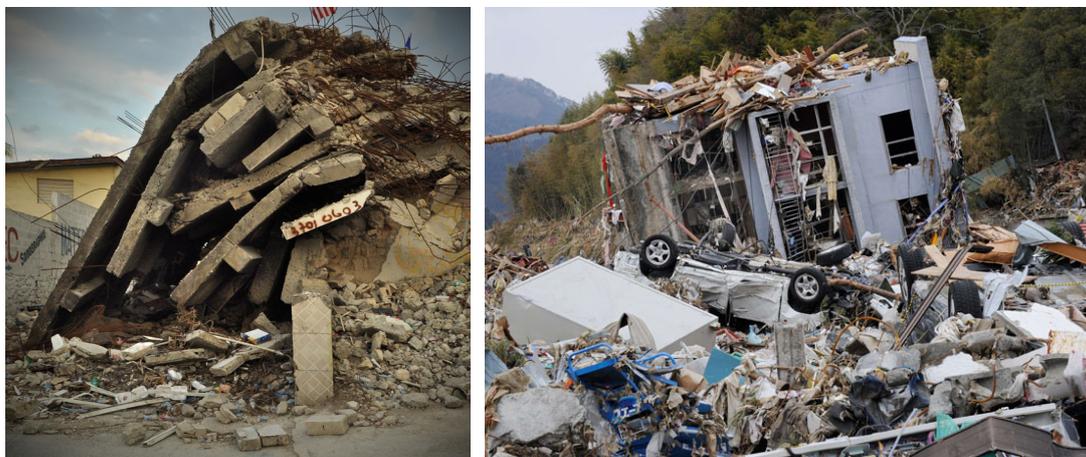
Figure 13. Left: Pancake collapse of a reinforced concrete building on the East side of Port-au-Prince. Pancake collapses of the heavy floors of multi-story RC buildings are particularly lethal and make it hard to extract the survivors. Right: A reinforced concrete building in Rikuzentakata Japan, swept onto its side and carried upstream by the March 10, 2011 earthquake and tsunami (Source: AFP/Getty)

This situation in Haiti contrasts sharply with the outcomes which followed Chile, and a year later Japan. It was only the buildings of reinforced concrete and steel that remained standing after the remarkable onslaught of the Tsunami in Japan. Some smaller RC buildings were even found on their side with their superstructures intact, having been turned by the tidal wave and carried away from their original location by the great wave [FIGURE 13, right]. In Haiti, which is frequently subjected to hurricanes, the resistance from weight of concrete buildings makes that system more favorable over wood and lighter materials.

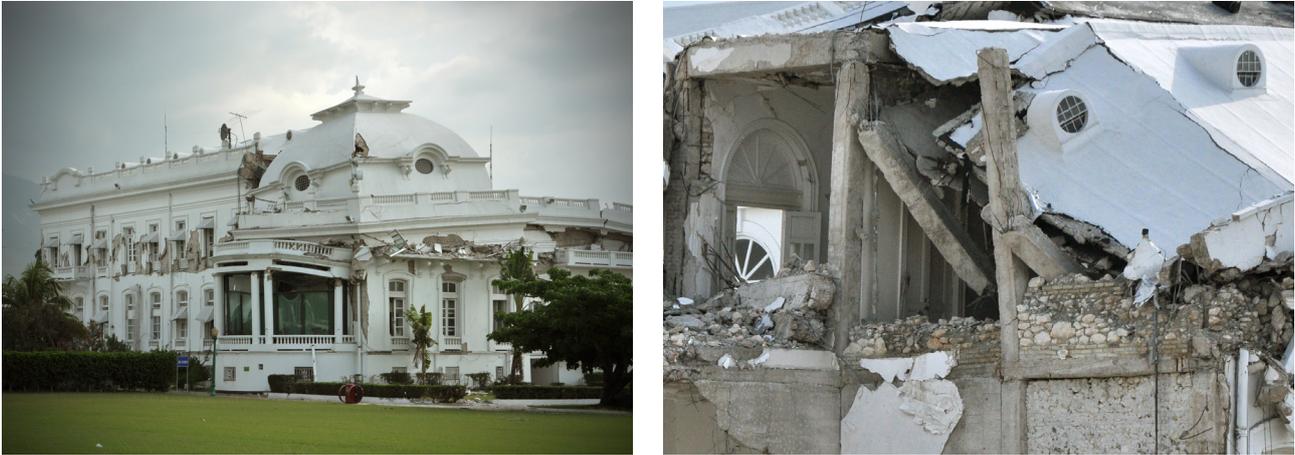
Figure 14. The 90-year-old National Palace in Port-au-Prince after the earthquake and partial demolition, revealing the reinforced concrete frame infilled with rubble stone. The steel reinforcing bars in the exterior portions of the frame and poured concrete walls (visible on left side of left photo) were heavily corroded in this over 90 year old structure.

the world in news reports after the earthquake [FIGURE 14]. This building, dating from 1916-18, is reported to have been finished by the U.S. Navy when the United States occupied Haiti.¹⁴ It has a reinforced concrete frame infilled with masonry composed mostly of rubble stone. The Catholic Cathedral was also reinforced concrete except for its steel truss roof. The upper level walls and towers collapsed, bringing down the roof. The steel reinforcing, which was minimal to begin with, had corroded over the century of exposure to the tropical elements. Many of the other churches in Port-au-Prince had collapsed for the same reason.

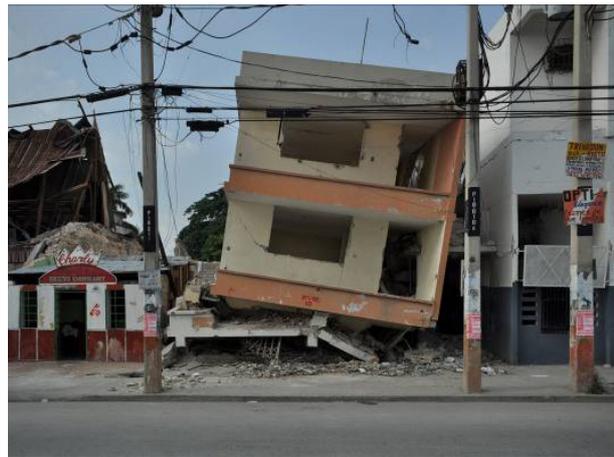
Figure 26. A formerly four story building in Port-au-Prince showing weak story collapse

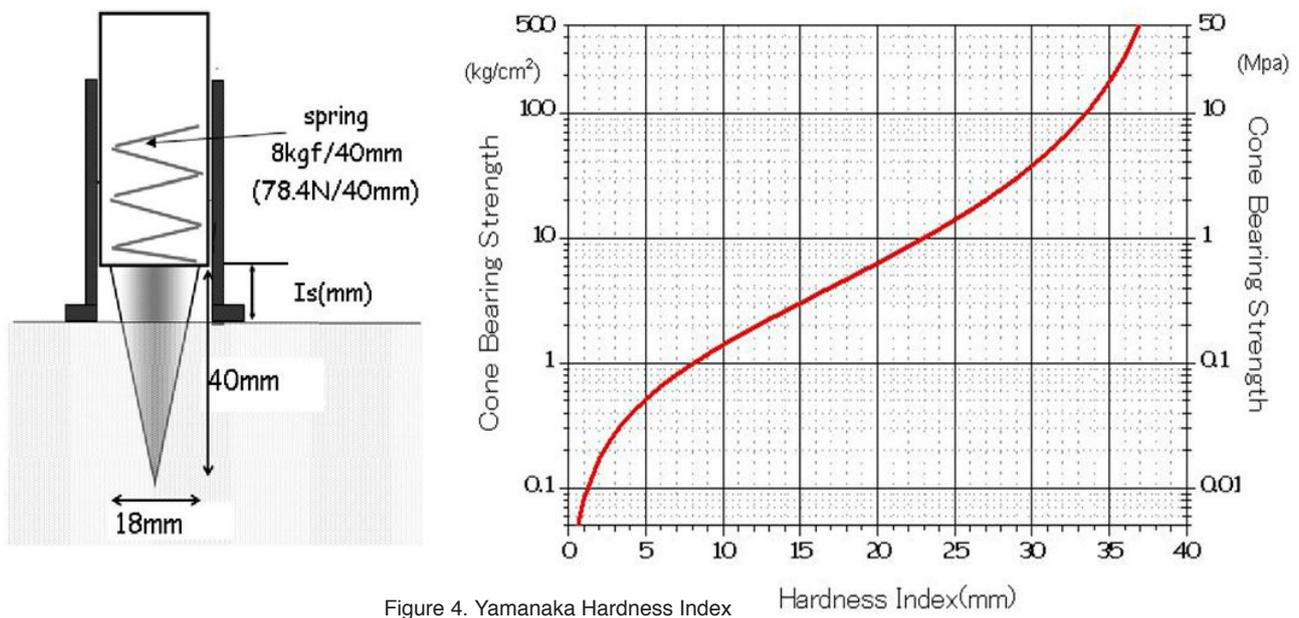
Figure 4. Yamanaka Hardness Index

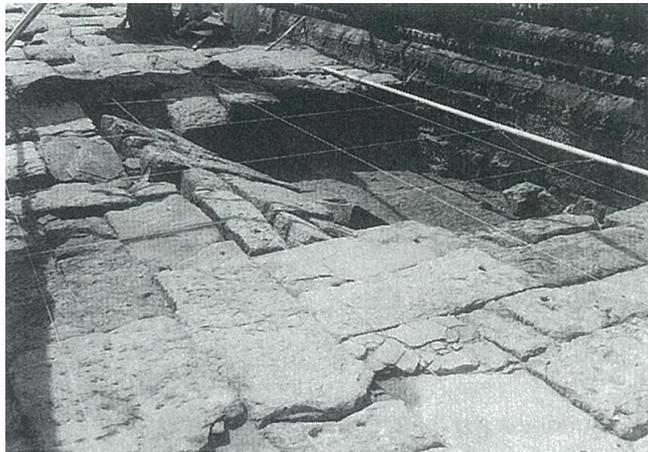
Figure 5. Damaged Pavement 60 years after archaeological excavation/backfilling (Source: JSA 2001)

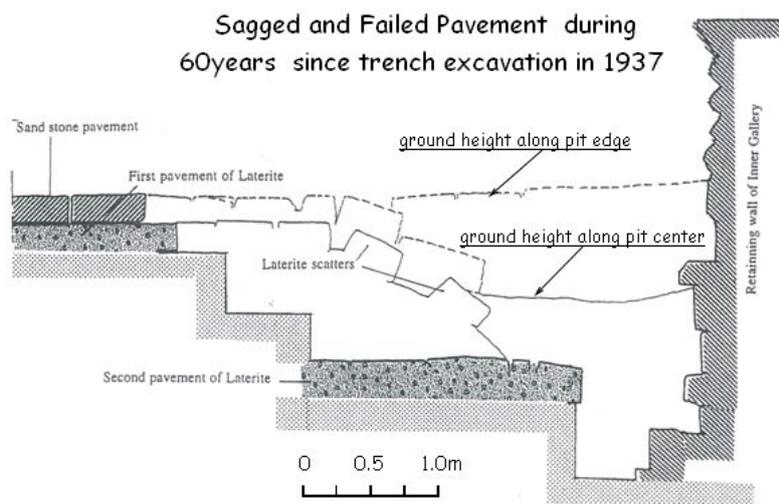
Figure 6. Vertical section of stone pavement with ground surface lines (Source: JSA 2001)

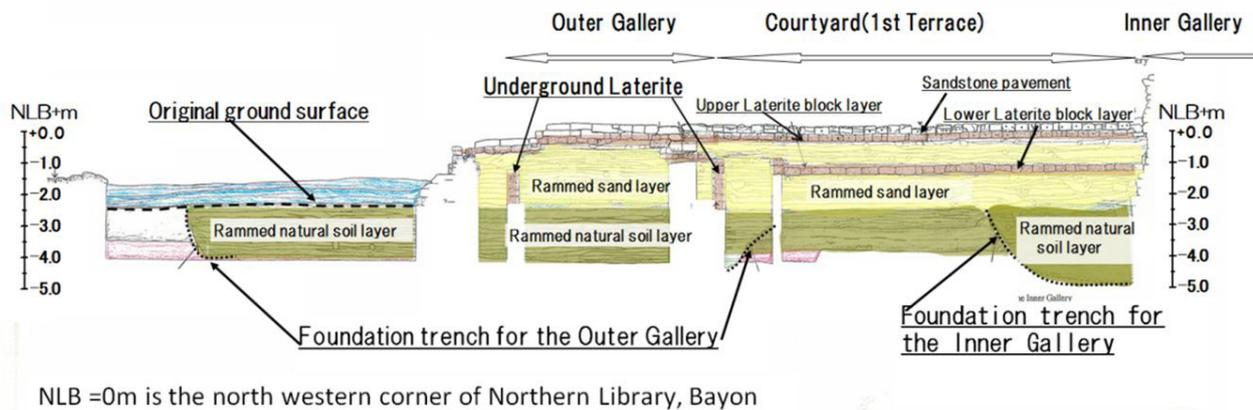
Figure 8. South section of the archaeological long trench to the north of the Inner Gallery (modified color Fig.1. Source: JSA 2000)

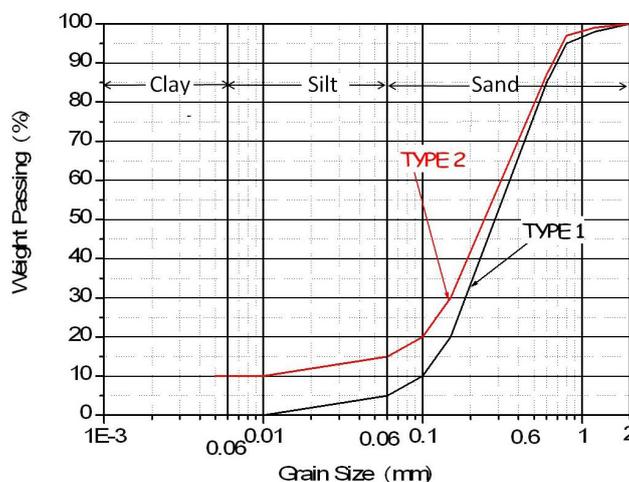
Figure 9. Grain size Distribution for Type I and Type II sands

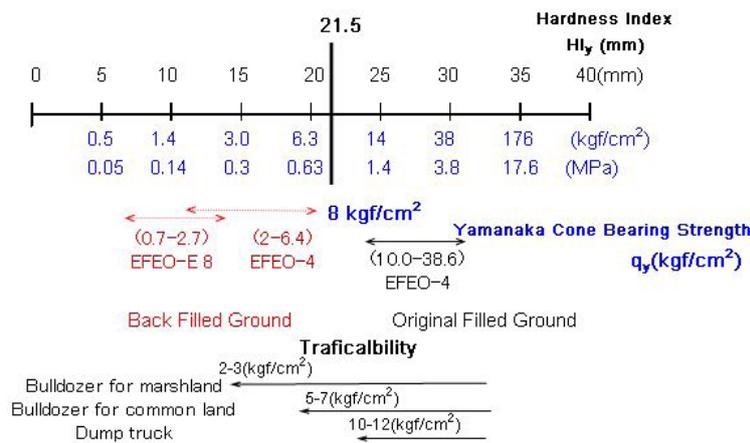
Figure 10. Controlling Compaction by Yamanaka Index

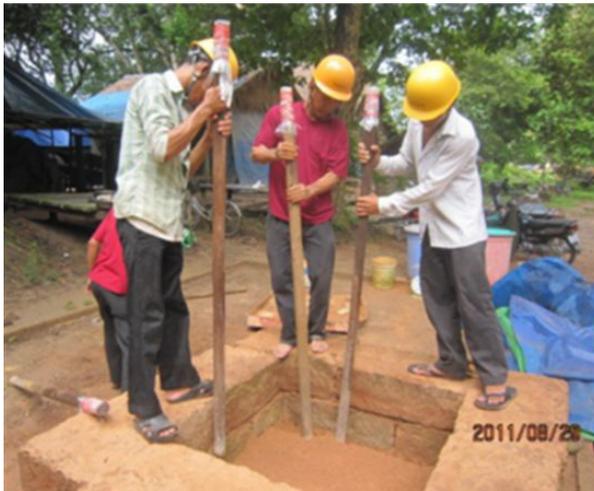
Figure 11. Rod compaction

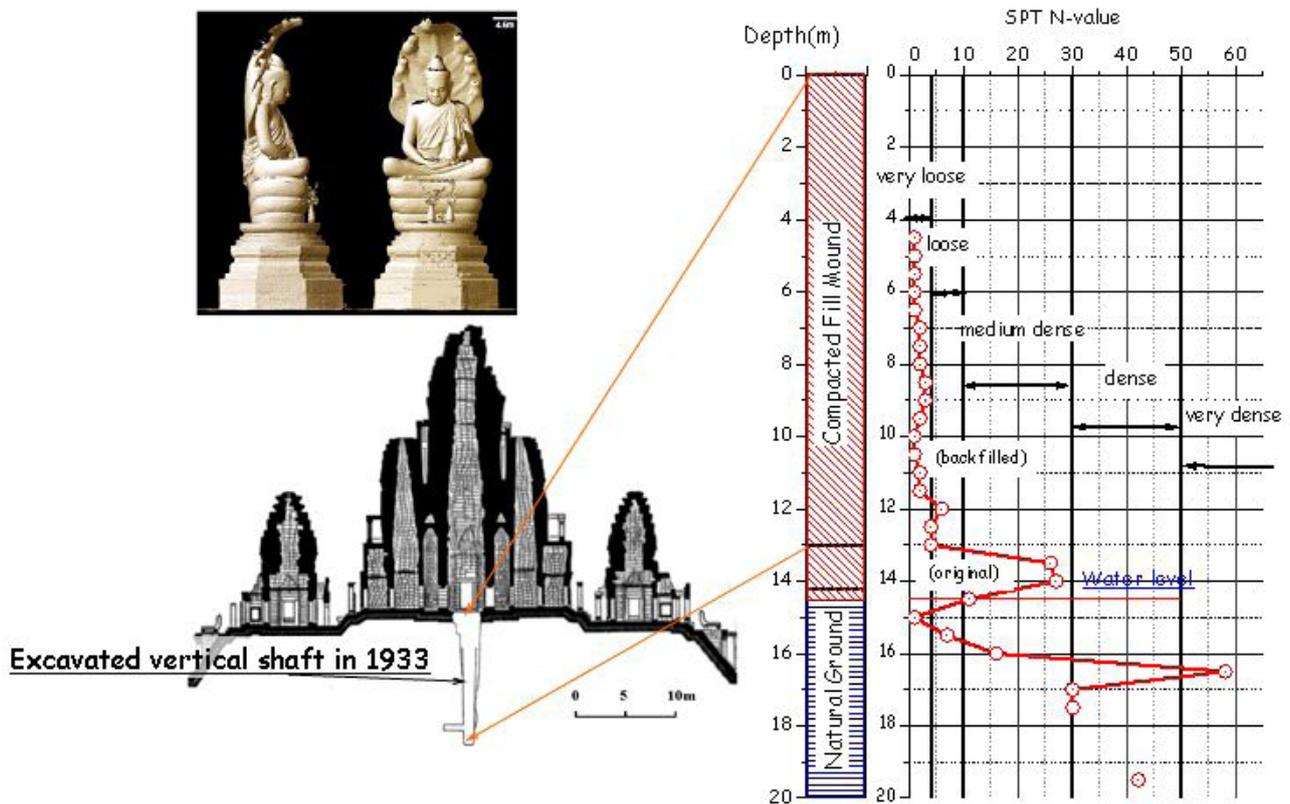
Figure 13. Underground shaft at the Central Tower, Bayon (Source: Iwasaki 2009)
(Reconstituted Buddha statue and boring log from the floor of the central chamber)

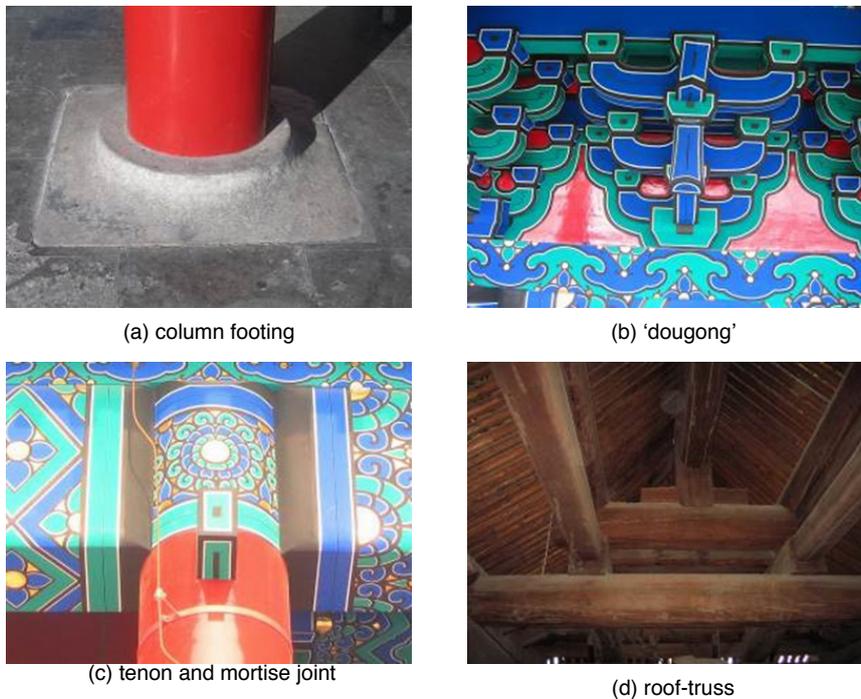
Figure 1. Earthquake resistant structural elements in ancient Chinese wooden buildings

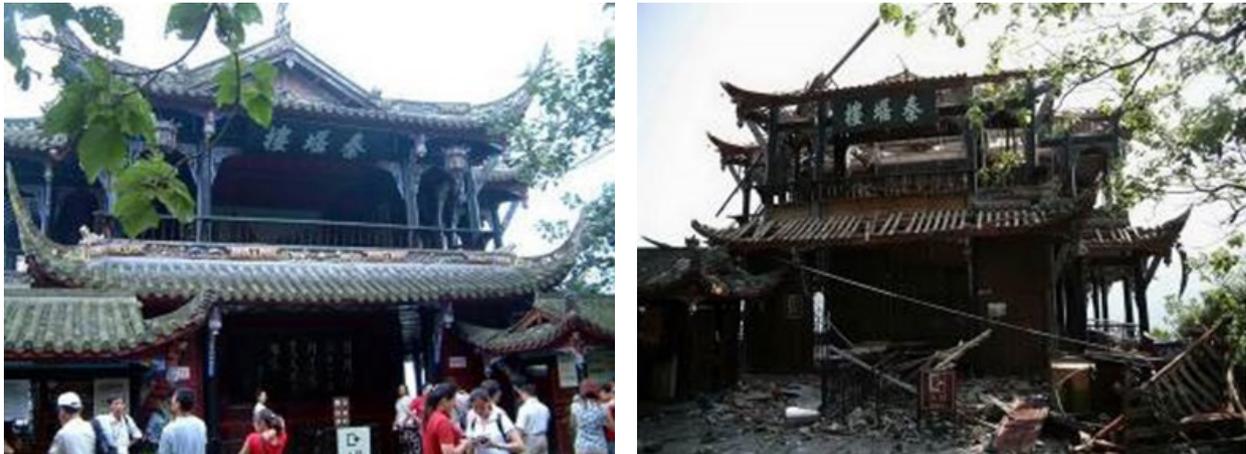
Figure 2. An ancient building before and after Wenchuan earthquake

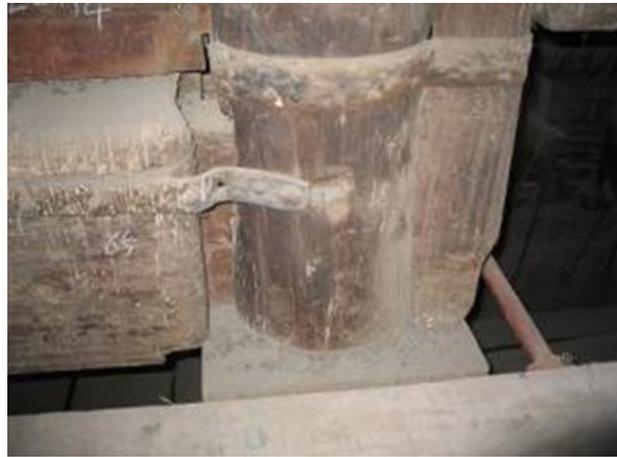
Figure 6. Connection method

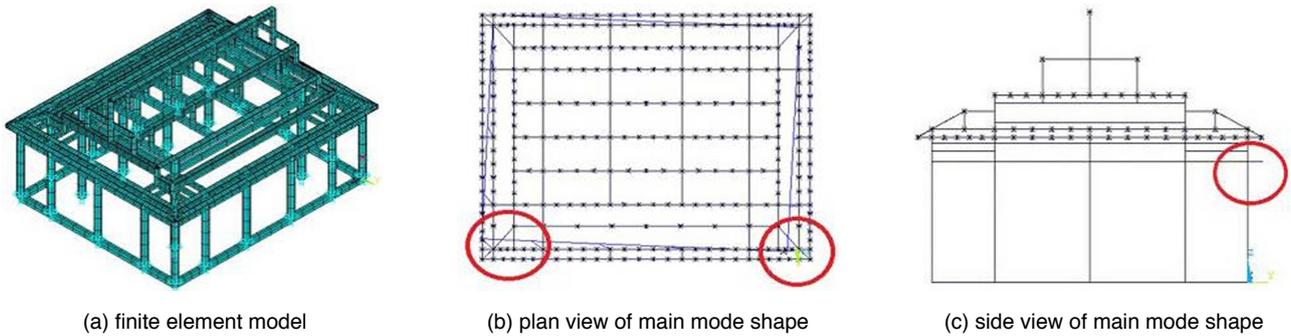
Figure 8. Finite element analysis on Da-Xiong Palace

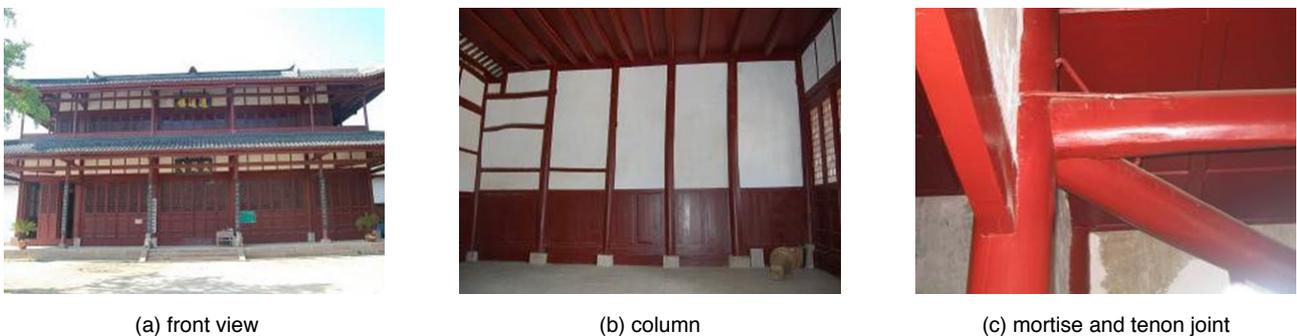
Figure 9. Photos of Xiao-Yao Palace post-earthquake

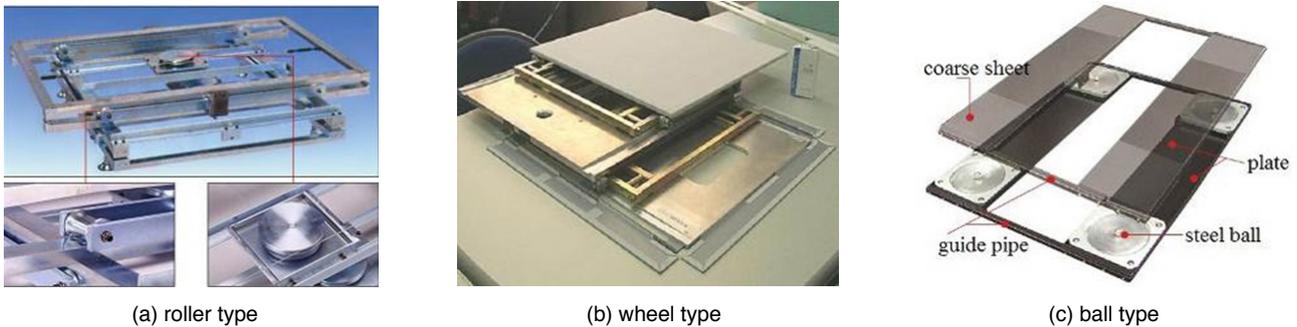
Figure 4. Horizontal isolation devices

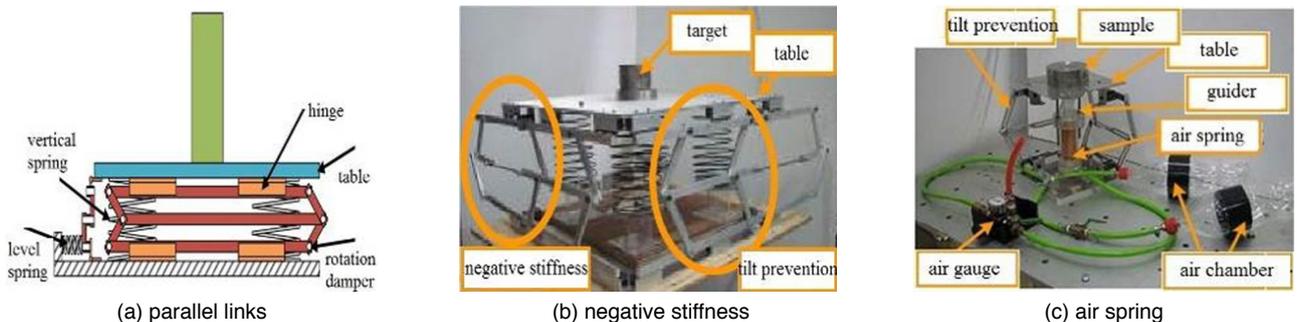
Figure 5. Vertical isolation devices

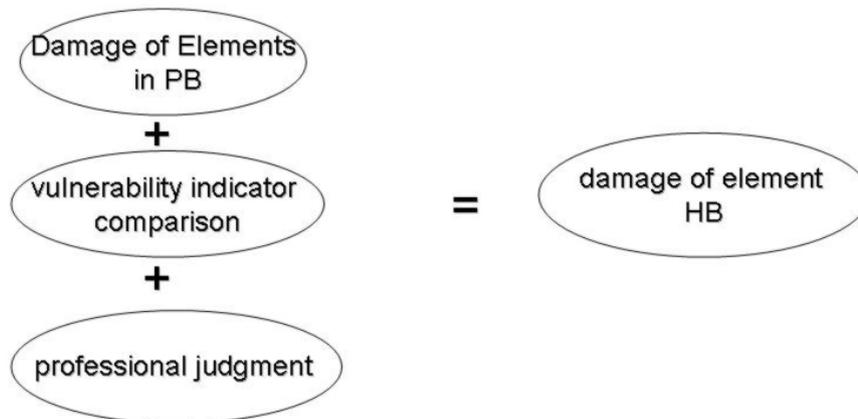
Figure 3. Damage judgement of major building elements (PB=prototype building, HB=historic building)

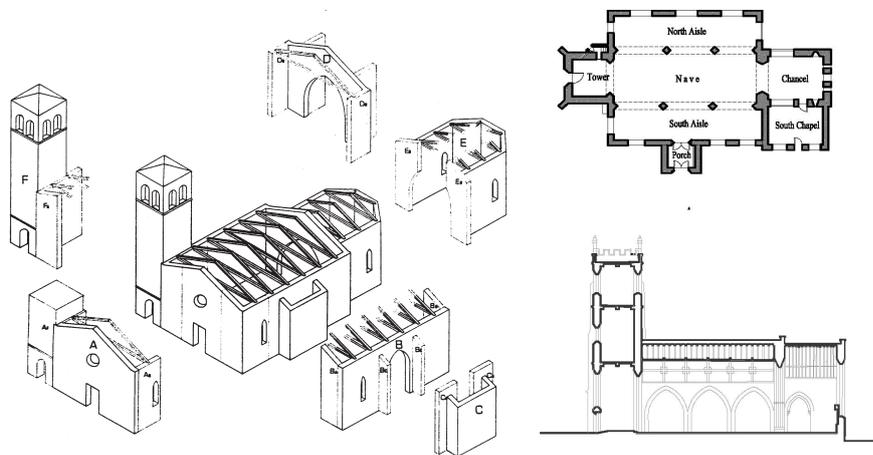
Figure 4. Configurations and macro-element of a typical Italian church (left, after Doglioni et al. 1994); plan and cross-section of the English church (right)

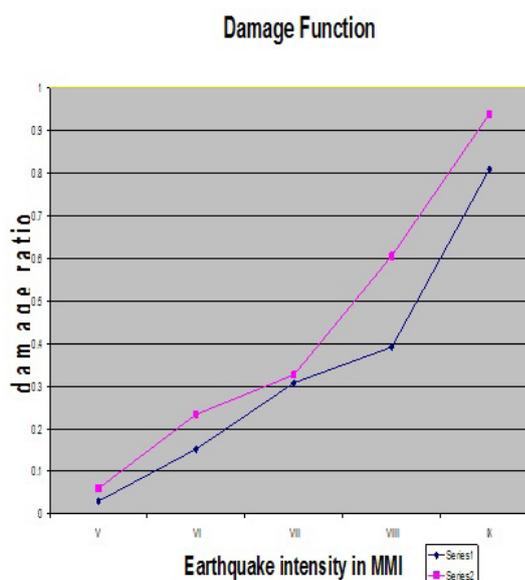
Figure 5. Chancel façade of the examined church (left) and damage function of the similar element in the prototype building (D'Ayala 2000) (right)

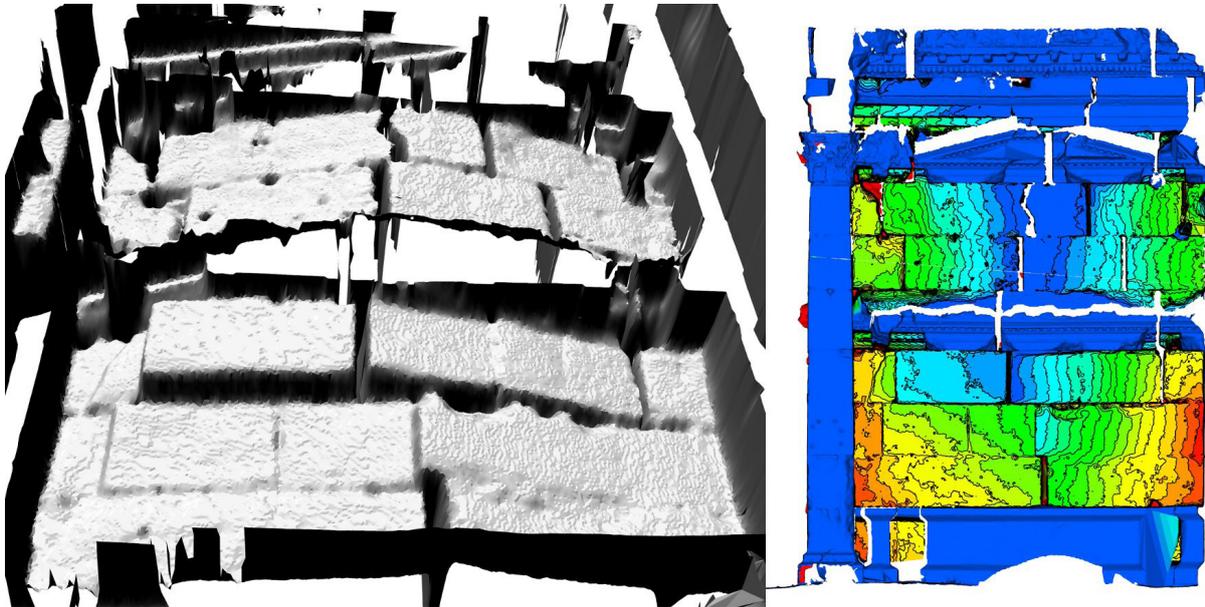
Figure 5. Eastern Wall of the northwestern semi-circular chamber of the Great Court. Left: exaggerated (10x) deformations of the wall. Right: elevation where colours indicate the distance to a vertical reference plane. The two figures were created with Points&Forces software using the data of the laser scanning documentation of the site

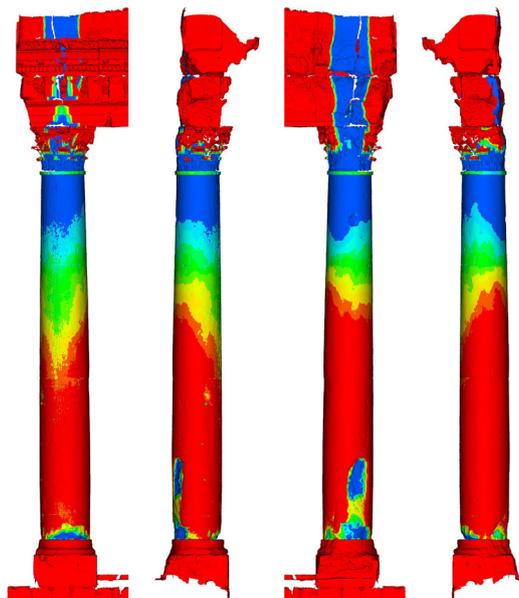
Figure 6. Analysis of the deformations on column of the Temple of Jupiter. Colours indicate the distance between the surface of the column and a vertical reference cylinder

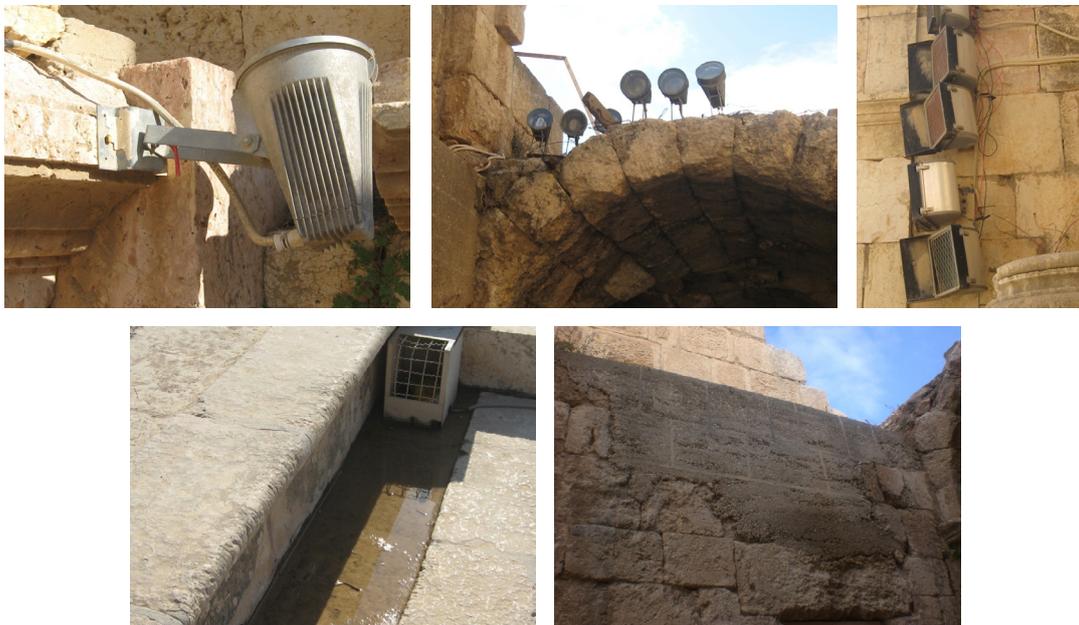
Figure 3. Examples of risks of lighting systems that caused damages from due to the fitting of modern theatrical equipment during the festival events, in addition deterioration due to previous wrong restorations in the southern theatre in Jerash in Jordan.

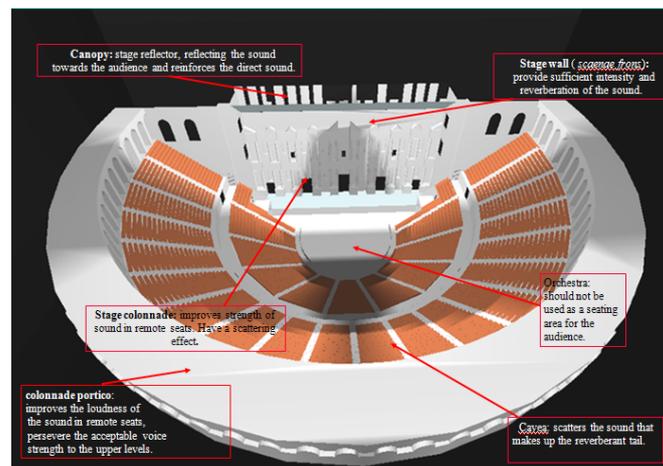
Figure 4. The main architectural and acoustical elements of a typical open-air Roman theatre.
