돌, 나무, 흙 건축의 구조 특성과 안전관리 방안 국제워크숍 결과보고서

International Workshop Report
on the scope of the material
and techniques Stone, Wood and Earth

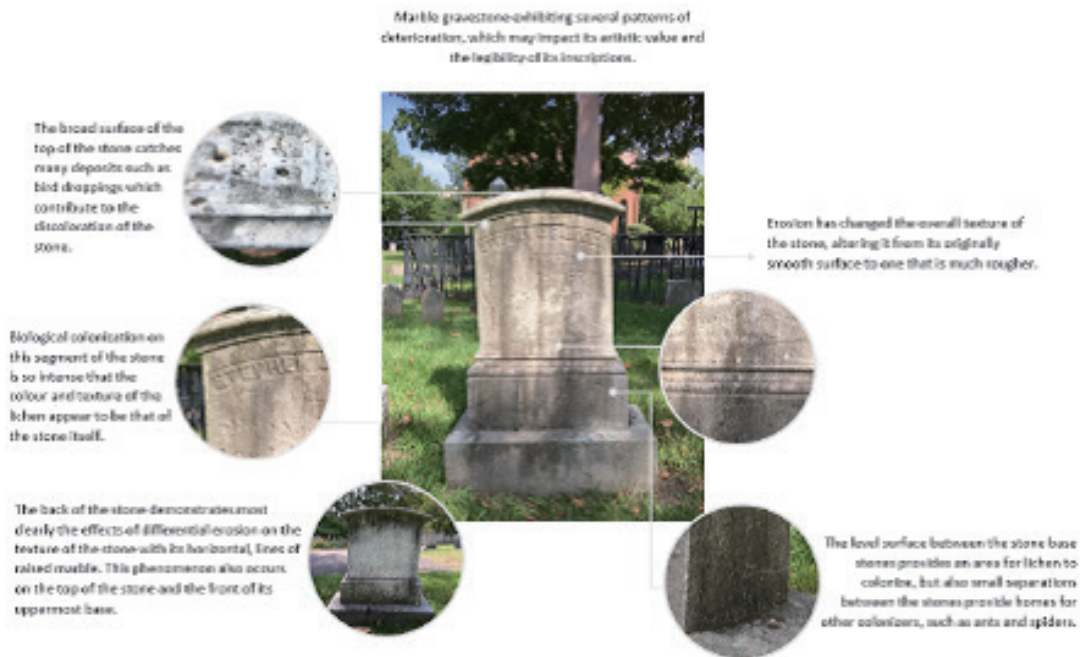
시각적 풍화패턴 매핑은 이러한 패턴의 유형, 범위 및 분포를 기록하고자 첫번째 진단도구로 사용되었는데 이는 부식의 원인과 메커니즘을 이해하기 위한 첫단계였다. 또한 추가 진단연구와 보존개입 계획에 사용되는 방법을 결정하는데 중요한 역할을 한다. “ICOMOS ISCS 석재 부식패턴에 관한 삽화용어사전”¹⁾은 지도의 공간을 이루는 다양한 풍화형태에 대한 분류 체계를 제공해 준다. 문헌조사 후, 학생들은 선택된 기념비석의 사진들에서 보여지는 시각적 풍화패턴을 매핑했다 (그림 1).

The mapping of visual weathering patterns was used as a first diagnostic tool with the aim to register the type, extent and distribution of these patterns as the first step to understand the causes and mechanisms of decay. It has also a key role in determining the methods used for further diagnostic studies and the planning of the conservation interventions. The "ICOMOS ISCS Illustrated glossary on stone deterioration patterns"¹⁾ provides a classification scheme for a broad variety of weathering forms, which forms the backbone of the mapping. Following the literature review, the students mapped the visual weathering patterns on the photos of the selected stone memorials (Figure 1).

그림 1 대리석 비석에 있는 시각적 풍화형태 매핑

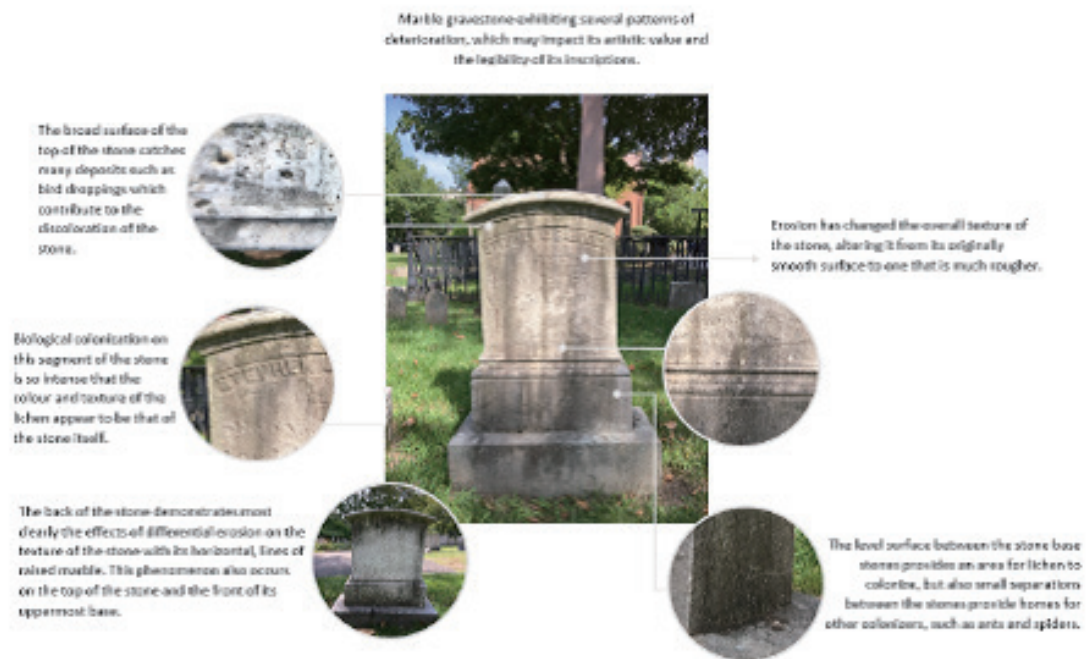
Figure 1 Mapping of visual weathering forms on a marble tombstone

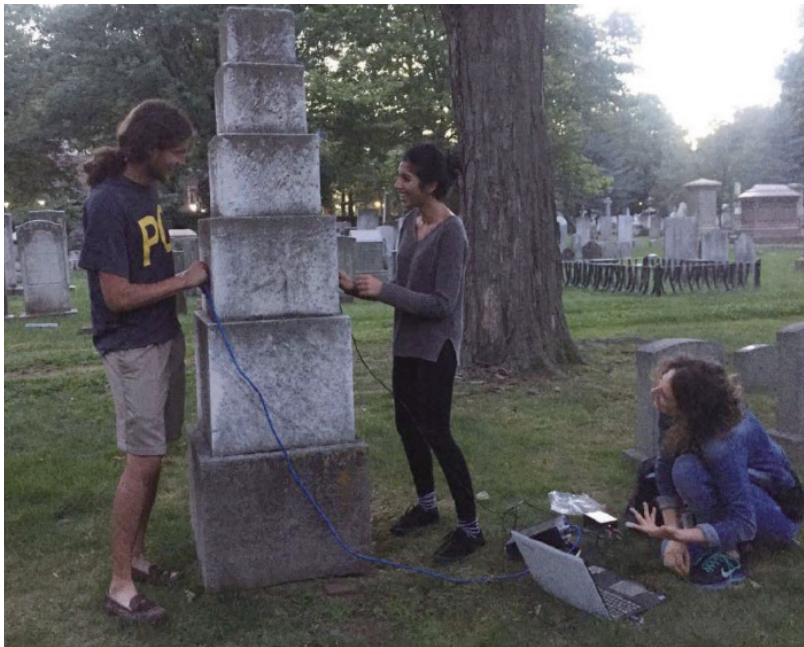
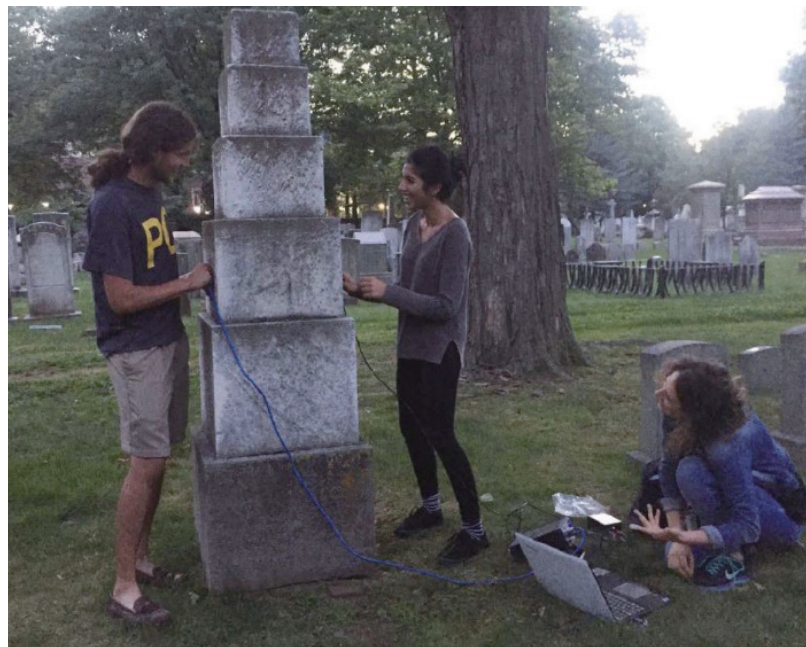
그림 4 GSC에 있는 기념비의 초음파 속도 실험

Figure 4 Ultrasonic velocity testing of memorials on GSC

돌의 초음파 속도는 물질을 통과하는 고주파 초음파로 측정을 한다. 속도 측정값은 더 강하고 단단한 돌의 경우 더 높고, 더 약하고 손상된 돌의 경우 더 낮다는 점에서 돌의 상태에 대한 정보를 제공할 수 있다. 더 강한 돌(또는 더 “온전한” 돌)은 더 손상된 돌보다 더 작은 미세 구조, 더 낮은 다공성, 그리고 더 높은 밀도를 가지고 있고, 이러한 특성으로 인해 초음파가 돌을 통해 이동하는 속도는 증가하며, 더 높은 기계적 강도를 나타낸다.

Ultrasonic velocity measurements for stone are made using high frequency ultrasonic sound waves that travel through the material. The velocity measurements can give information about the condition of the stone in that the values will be higher for stronger and more solid stone and lower for weaker and more damaged stone. Stronger stone (or more “intact” stone) has a more compact microstructure, lower porosity, and higher density than more damaged stone, and with these properties the speed with which the ultrasonic wave travels through the stone increases, reflecting a higher mechanical strength.

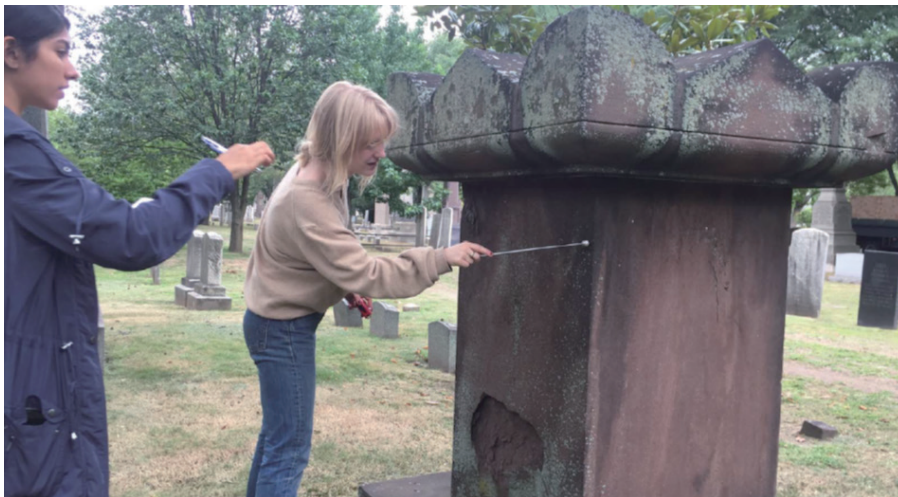
공명탐지는 간단하지만, 놀랍도록 강력한 기술로 공명주파수를 사용하여 스케일, 확장 및 깊이를 감지한다. 이 도구는 게르하르트 리에비에르거 (TU-München, Lehrstuhl für Ingenieurgeologie)에 의해 개발되었으며, 비석 표면을 부드럽게 가로지르는 얇은 막대에 부착된 무게있는 금속공으로 구성된다 (그림 6). 표면 아래 빈 공간에 의해 발생하여 들리는 공명주파수의 변화를 주목하여, 그에 따라 그릴 수 있는 스케일링 또는 박리 영역을 식별할 수 있다 (그림 7).

그림 6 공명탐지 측정

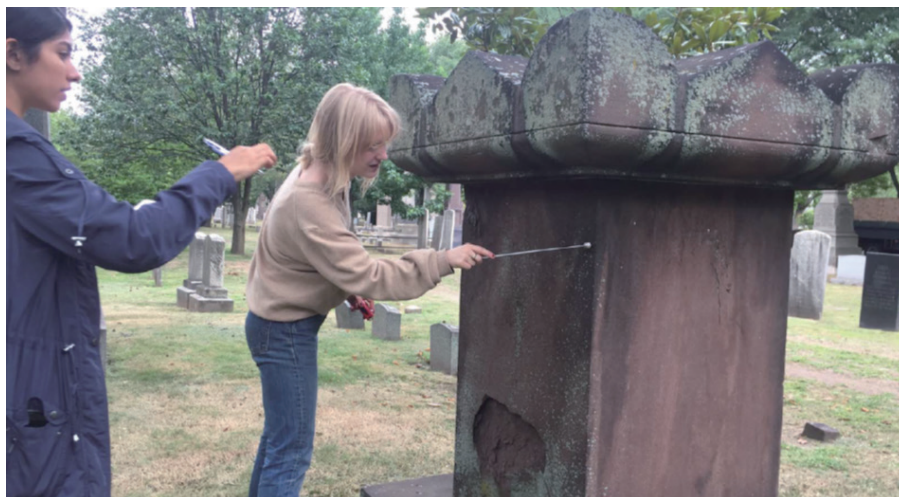
Figure 6 Resonance detection measurements

Resonance detection is a simple, but astonishingly powerful technique which relies on the use of resonance frequency to detect scales, their extension and depth. The tool has been developed by Gerhard Lehrberger (TU-München, Lehrstuhl für Ingenieurgeologie) and consists of a weighted metal ball attached to a thin rod, which is passed gently across the stone surface (Figure 6). Noting variations on audible resonance frequency created by hollow spaces below the surface, it is possible to identify areas of scaling or delamination, which can be mapped accordingly (Figure 7)

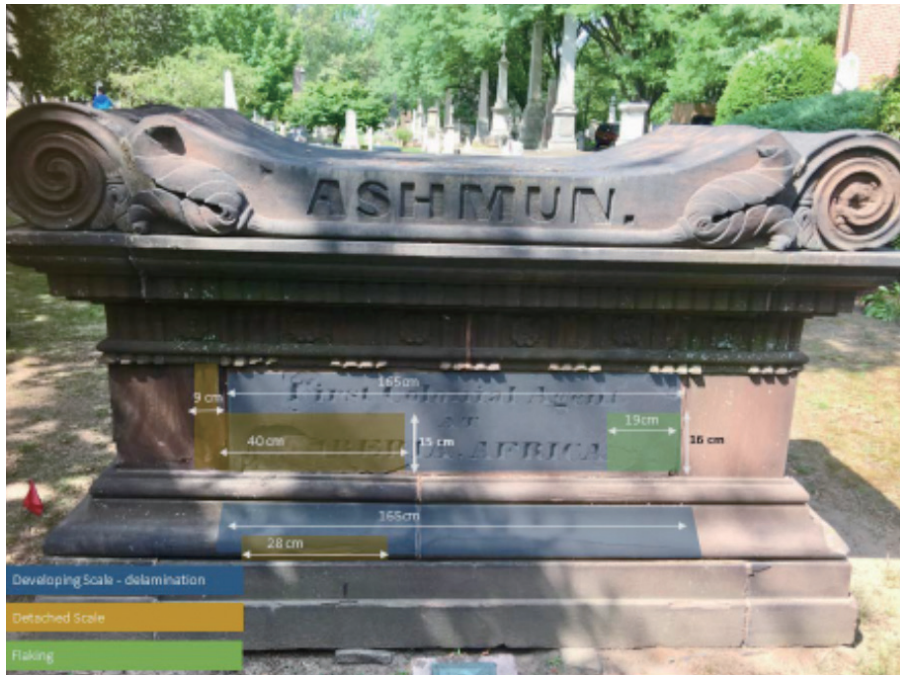
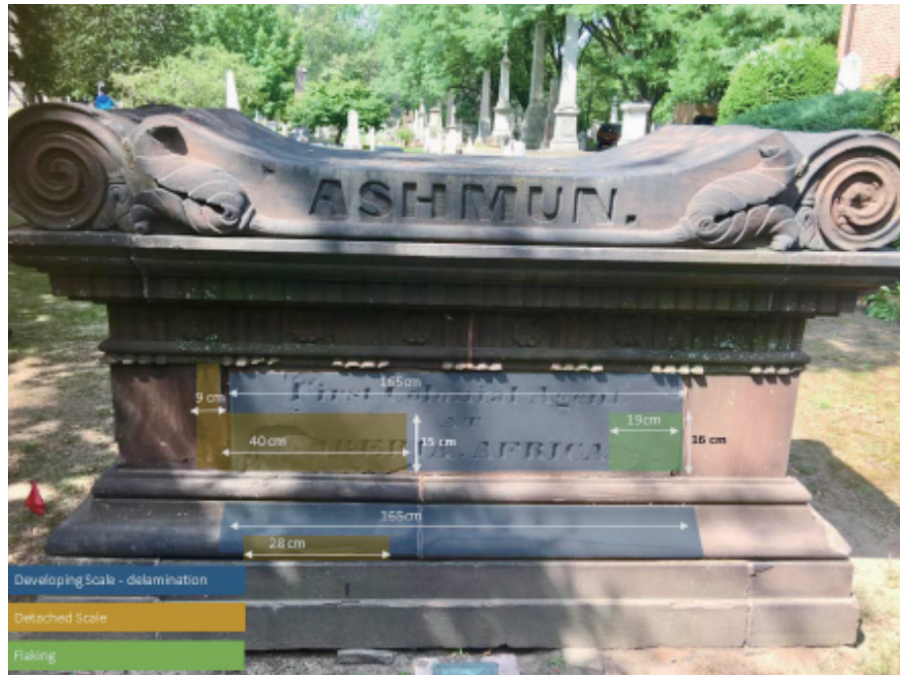
그림 7 애쉬먼 기념비의 공명탐지 매핑

Figure 7 Resonance detection mapping on Ashmun Memorial.

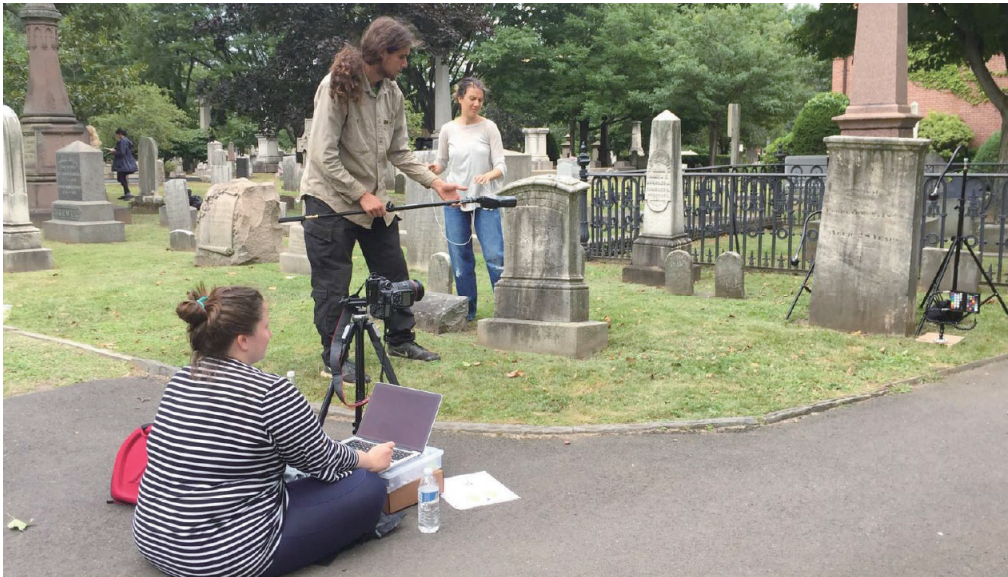
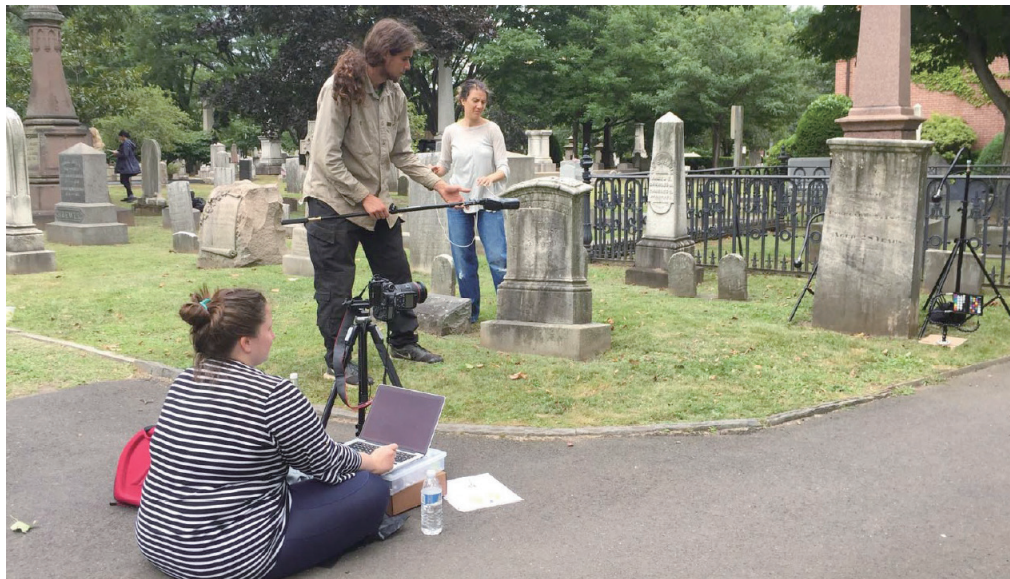
그림 8 RTI 데이터 수집

Figure 8 RTI data collection.

하이라이트 기반 방법은 특별한 장비 없이, 물체의 크기에 상관없이, 실외에서 데이터를 수집할 수 있으므로 하이라이트 이미지 캡처에 대한 안내서⁶⁾에서 설명한 절차에 따라 적용되었다. 이 데이터 처리 방법론은 민호 대학이 2009년 문화유산 이미징(CHI)과 공동으로 개발한 RTI 빌더 소프트웨어를 사용한다. 결과 RTI 파일들은 RTI 뷰어(ISTI-CNR/CHI RTI뷰어)⁷⁾와 같은 특수 소프트웨어를 통해 볼 수 있으며, 이를 통하면 다른 렌더링 모드를 이용하여 조명 위치의 상호 작용을 조작할 수 있고 최종 결과도 향상시킬 수 있다. 기본 설정과는 별도로, 보기용 소프트웨어는 RTI 이미지의 수학적 향상을 가능하게 하는 다른 렌더링 모드를 제공한다. 경면 향상은 가장 빈번하게 사용되는데, 그것은 이용가능한 두 가지 보기용 소프트웨어의 예시에서도 제공되고 또한 RTI 빌더(Builder)의 최신 출시에도 포함되어 있기 때문이다. 이것의 주요 장점은 표면 모양 인식 기능이 향상되었다는 점이다.

The Highlight-based method was applied, following the procedure described in the Guide to Highlight Image capture⁶⁾ since it is able to capture data outdoors, regardless of the size of the objects, without any special instrumentation. The data processing methodology uses the RTI builder software, developed by the University of Minho in collaboration with Cultural Heritage Imaging (CHI) in 2009. The resulting RTI files can be viewed via specialized software such as the RTI viewer (ISTI-CNR/CHI RTIViewer)⁷⁾, which enables interactive manipulation of the lighting position and enhancement of the final outcomes through different rendering modes. Apart from the default the viewing software provide different rendering modes, which enable mathematical enhancement of the RTI image. The specular enhancement is the most frequently used, as it is provided by both available examples of viewing software and is also included in the latest release of the RTI Builder. Its main advantage is the improved perception of the surface shape.

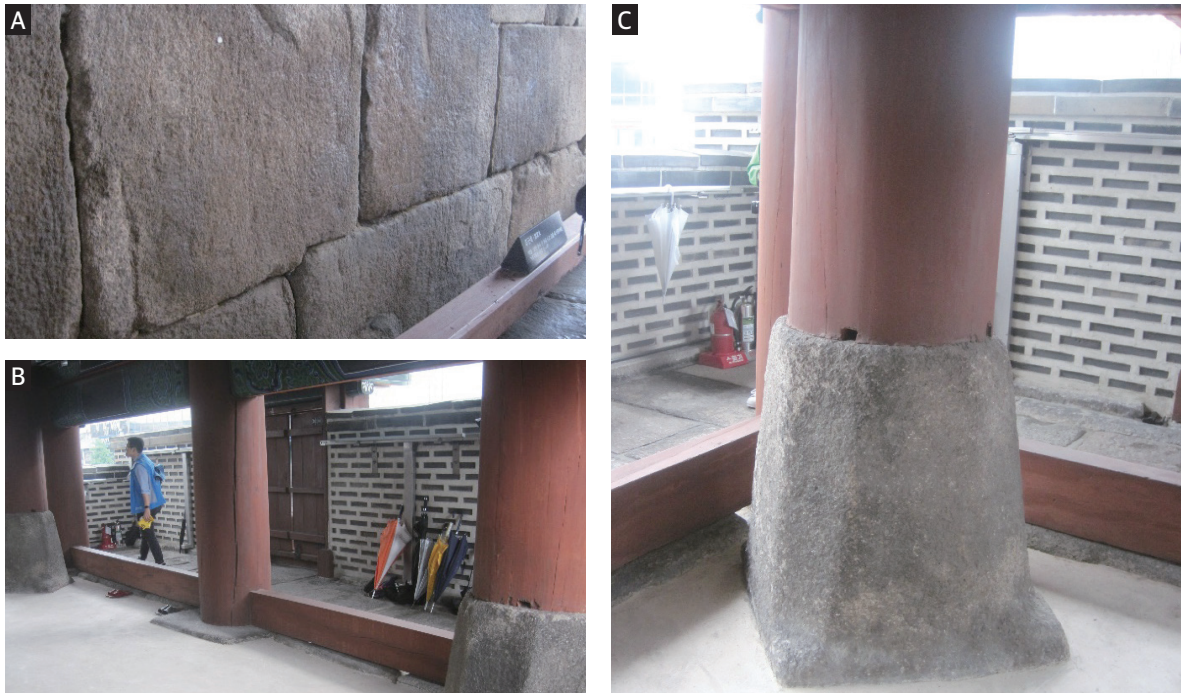
The same deteriorations were also observed by the author when visited the building in June 07, 2017. In the ground floor, the weathering of the Stones was not only by rain or surface water but also from the underground water. The Stones around the arched entrance were wet (Figure2 A). And the stone base of the 1st floor's two south columns were wet (Figure2 B). As a Korean colleague explained, the southeast column base was made deeper during the last restoration. The wetness of that column base might be that the column passed underground water level (Figure2 C).

그림 2 송례문 석조의 습기

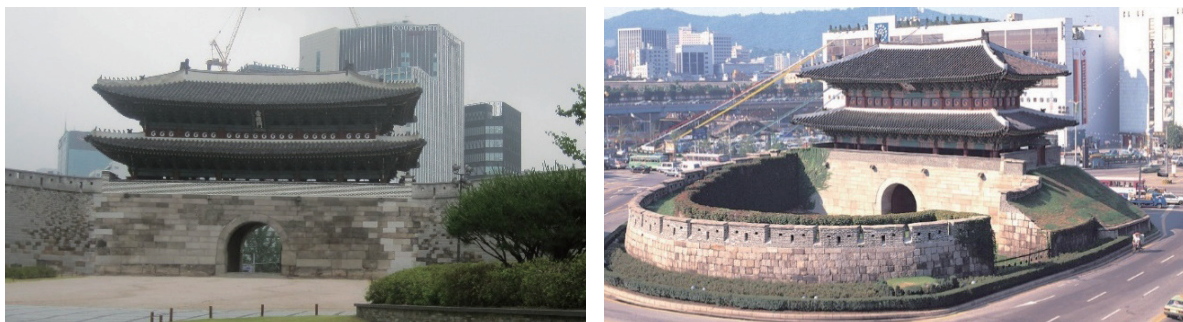
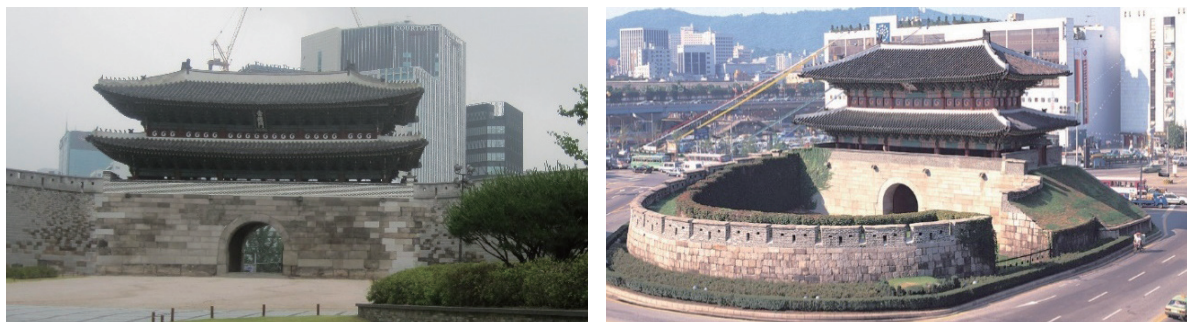
그림 3 흥인지문

Figure 3 Heunginjimun Gate

흥인지문은 도성 동쪽에 위치하고 있으며, 아래는 아치형 입구가 있는 석조로 되어 있으며, 그 위에 두 개 층의 목조를 쌓아 올린 구조이다(그림 3). 이 문은 1398년에 축조되었으며, 1453년, 1869년에 수 차례에 걸쳐 복원되었다. 기둥 사이에 배치된 공포가 지붕의 처마를 지지한다. 흥인지문에는 방어와 공격을 목적으로 한 반원형의 망루가 갖추어져 있다(그림 3) [1].

The Heunginjimun gate situated on the east of the Capital Wall is constructed of two storey wooden floors raising on stone floor with arched entrance (Figure 3). The gate was built in 1398. It passed several restorations in 1453, 1869. The eaves of the roof are supported by a bracket system, placed on and between the pillars. Heunginjimun Gate have a semi-circular barbican built both for defensive and offensive purposes (Figure 3) [1].

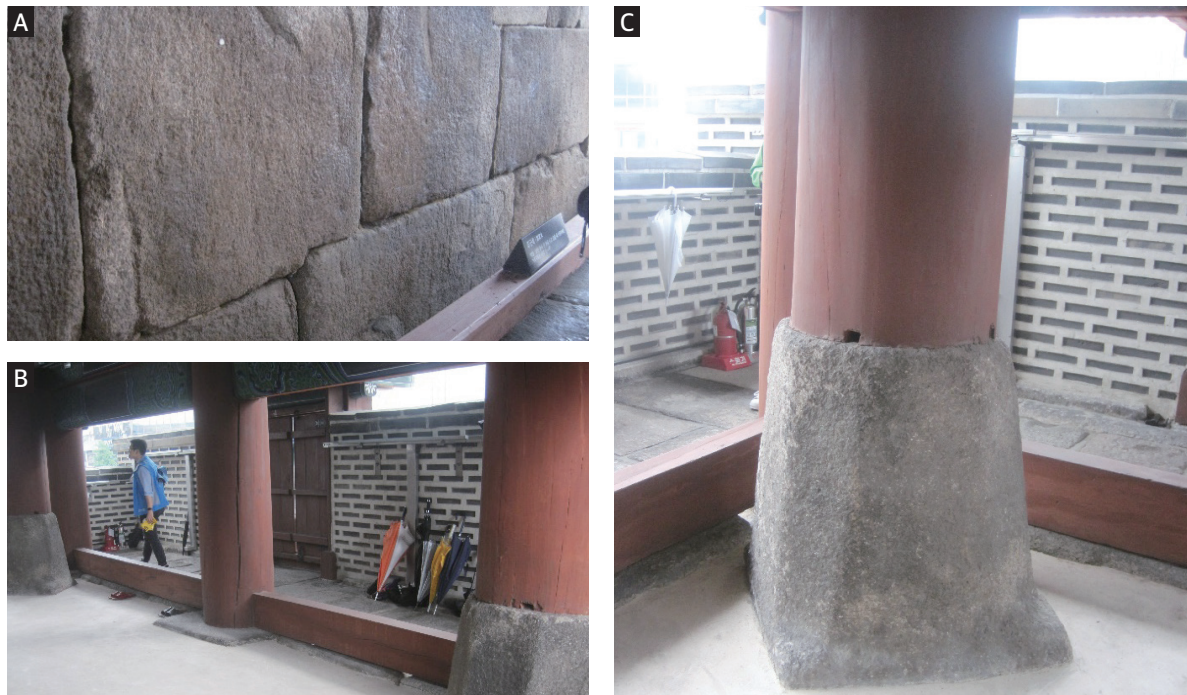
Figure 2 Wetness of Sungnyemun gate's stones

- (A) wetness of the arched entrance (B) wetness of the 2 column bases on 1st floor
(C) wetness of the southeast column base on 1st floor

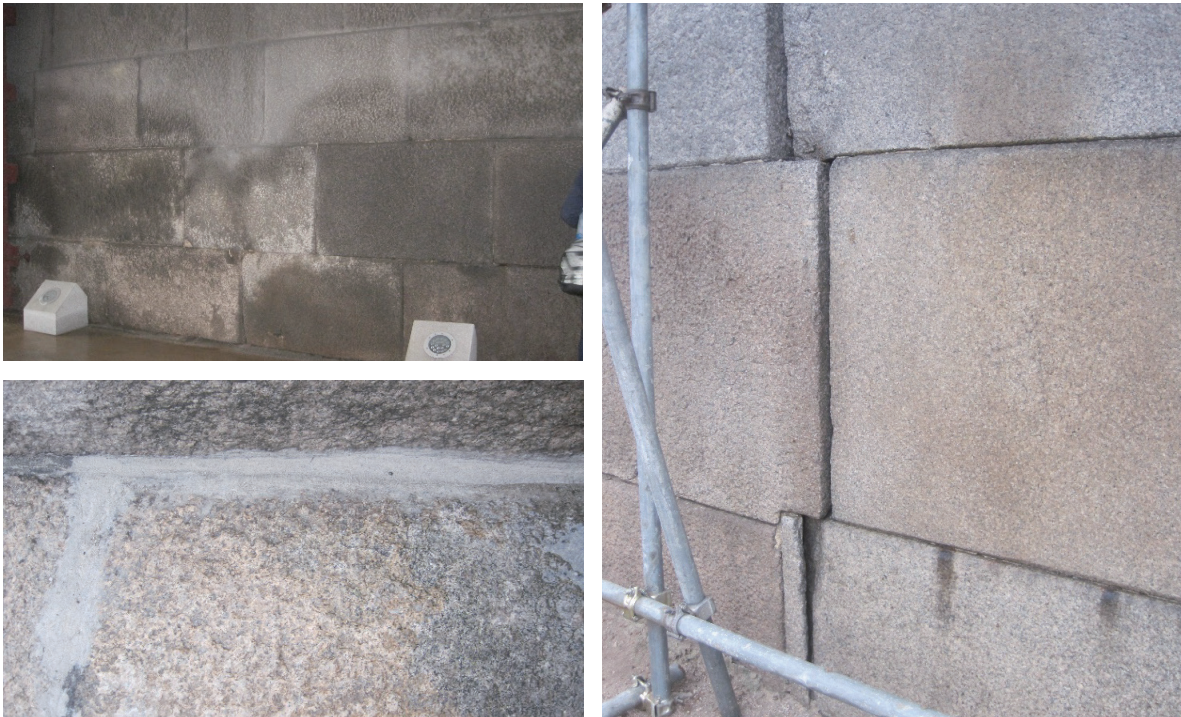
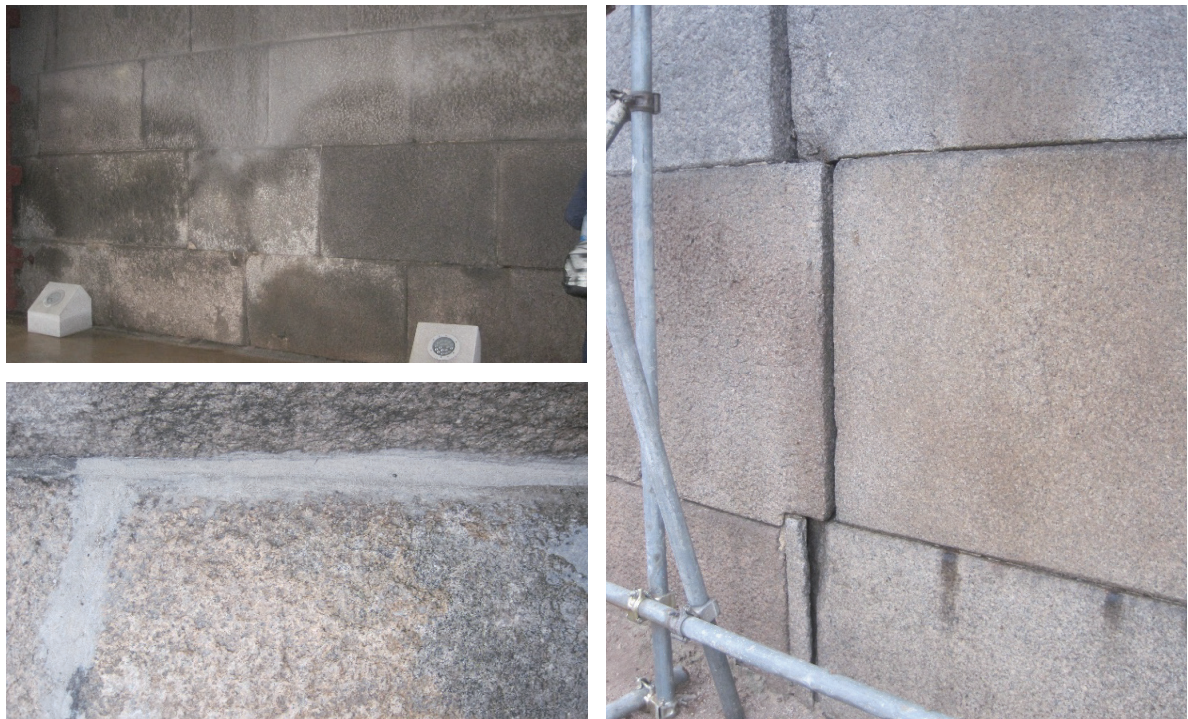
저자가 2017년 6월 7일 이 건축물을 방문했을 때도 동일한 질적 악화 현상이 관찰되었다. 1층 석조부재의 풍화작용은 비, 지표수뿐만 아니라 지하수에 의해서도 발생하였다. 아치형 입구의 석조에서 습기가 발견되었으며, 일부 석조부재들은 제 위치에서 벗어나 있었으며 시멘트 기반의 콘크리트로 수리되어 있었다(그림 4).

그림 4 흥인지문 석조 상의 결함

The same deteriorations were also observed by the author when visited the building in June 07, 2017. In the ground floor, the weathering of the Stones was not only by rain or surface water but also from the underground water. The stones around the arched entrance were wet, some stones were dislocated and there were repairs with cement-based concrete (Figure 4).

Figure 4 Defects on Heunginjimun gate's stones

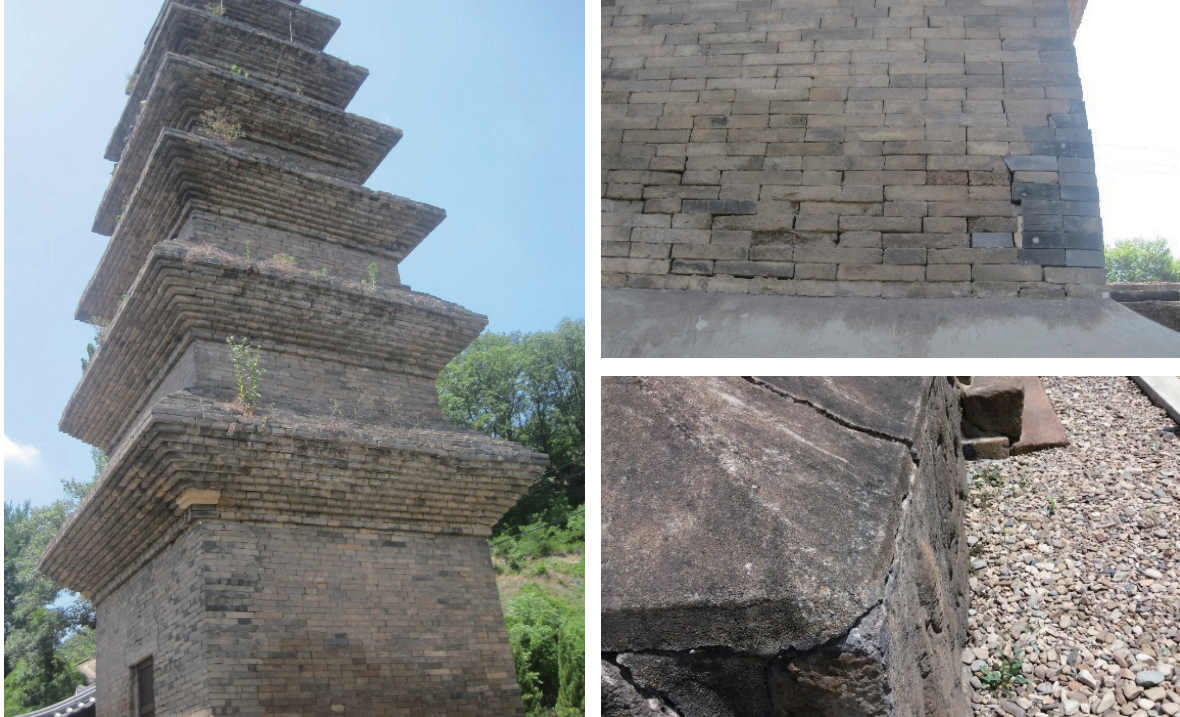
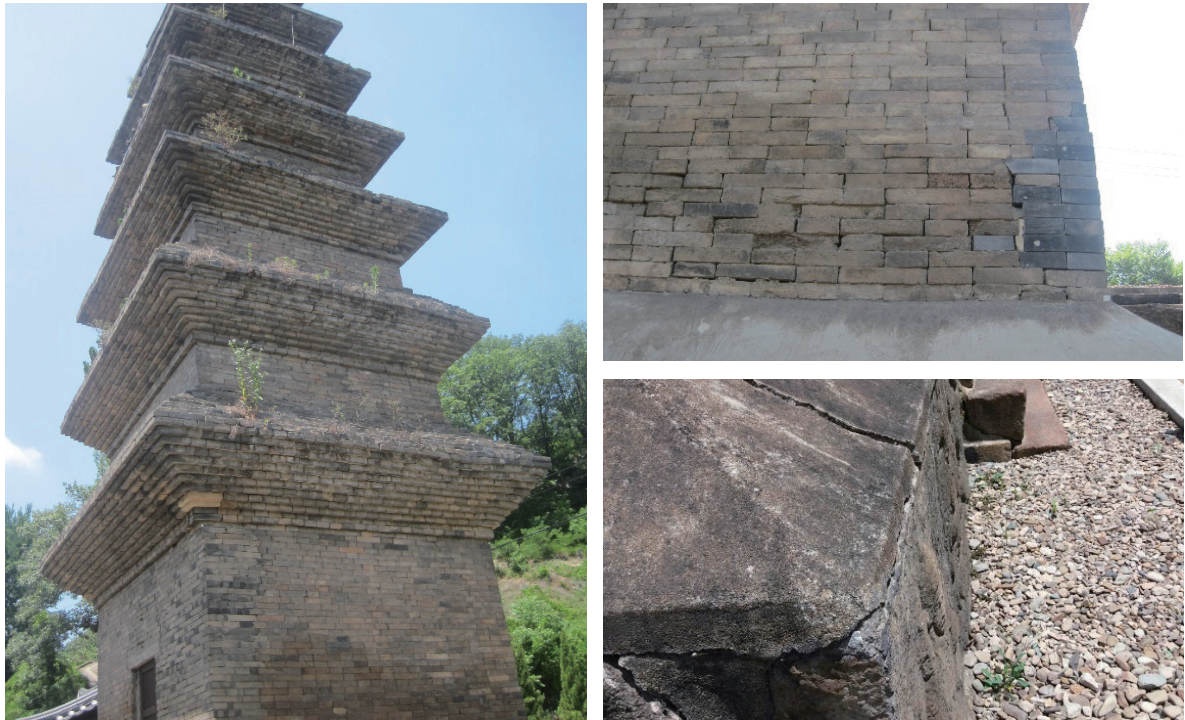
그림 5 탑 1층에 뿌리내린 식물과 습기

Figure 5 Vegetation and wetness of the first floor of the Pagoda

The same deteriorations were also observed by the author when visited the Pagoda in June 08, 2017. When the platform on the ground level and the bricks of the first floor was touched, it was easy to feel the wetness. Besides, the change of the color on the bricks also proved the presence of water at the foundations (Figure 5). The wet soil due to water abstraction combined with the dynamic influences of train vibrations could have accelerated the deteriorations on the Pagoda.

1998년 이후 1년에 두 차례씩 실시된 현지 당국의 모니터링 결과, 균열, 처짐, 부재 간 이격, 풍화의 흔적 등이 발견되었다. 탑 위에 뿌리내린 식물들로 인해 벽돌들이 떨어져 나가고 있다. 열차의 진동을 모니터링한 결과 관련 기준을 초과하는 것으로 판명되었다. 하지만 구조적 성능의 질적 악화, 균열 및 구조적 거동이 진행된 양상은 확인되지 않았다[1].

According to the monitoring made by local authorities two times a year since 1998, crack, sagging, separation between bricks and weathering were identified. The vegetation on the pagoda brought separation between bricks. The monitoring of the train vibration was found to be more than related reference. But no progressing pattern on the degradation, cracks and structural behavior of the structural performance was not identified [1].

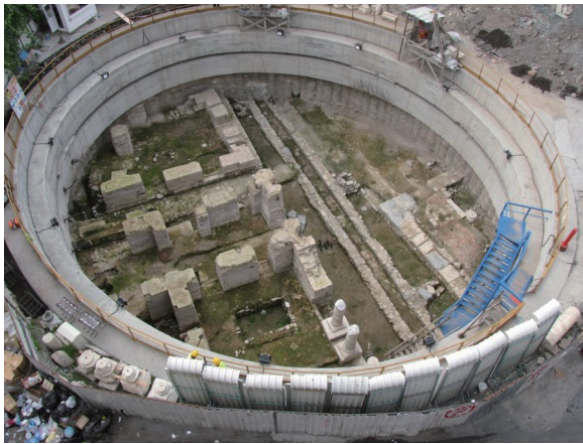
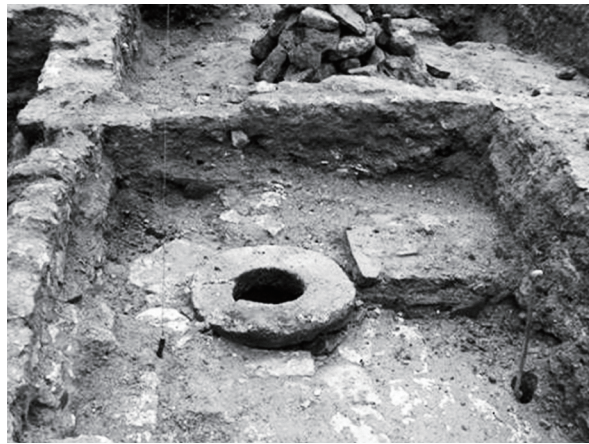
그림 6 건축물의 우물, 출입문, 수로

또는 수로는 우물끼리 서로 연결하거나 건물에서 물을 내보내는 역할을 하였으며, 건물의 필요에 따라 그 크기와 길이가 30~40cm에서부터 1.0~2.5m까지 다양했다. 이러한 회랑이나 수로는 주로 석재 또는 벽돌로 만들어졌다[2]. 이 수로들 덕분에 표층수와 지하수로부터 발생하는 습기를 제거할 수 있었으며, 구조물을 겨울에 따뜻하고 여름에는 시원하게 유지할 수 있었다. 그리고 지진이 일어나는 동안, 수로들은 상승하는 지하수를 토양의 액상화를 피하는 동시에 배출하는 역할을 하였다.

chimneys ventilated the water (Figure 6). The size and length of the galleries or channels connecting wells to each other or discharging water away from the building varied from 30-40cm to 1.0-2.5m depending on the size and need of the building. These are generally constructed of stones or bricks with mortar binding [2]. These channels removed the moisture from surface and underground water, served to keep the structure warm in the winter and cold in the summer. And during earthquake, they discharged the raising underground water avoiding soil liquefaction.

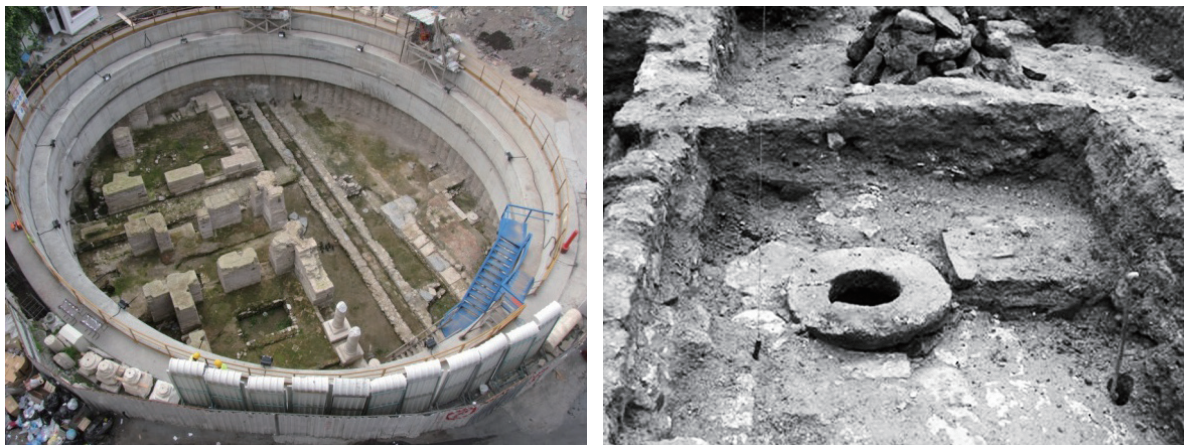
건물 내부 지표면의 물을 배출하기 위한 배수시설로는 지하에 있는 우물이나 저수조 등이 포함된다. 회랑이나 수로는 건물 밖으로 물을 내보내는 역할을 하고, 굴뚝 모양의 관문은 물을 순환시키는 역할을 하였다(그림 6). 회랑

Figure 6 Wells, gates, channels in the building

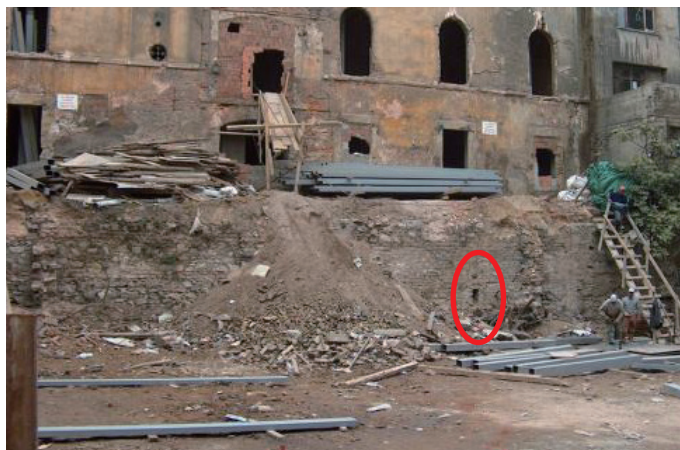
그림 8 신축공사중에 파손된 배수로

Figure 8 Broken drainage channel during a new construction

이러한 방법은 완전히 잊혀졌기 때문에, 이를 더 이상 필요하지 않다고 여기고 건물 내 우물을 메우거나 건축물 유산 주변에 새로운 건물을 세워 배수시설을 파괴하는 것은 현 시대에 있어서 흔하게 일어나는 현상이다(그림 8). 지하수 관리시설이 막히거나 파손될 경우, 지하수가 건물 쪽으로 올라가고 토양이 연화되어 건물에 습기가 차기 시작하며 건물의 기초가 침하하기 시작한다. 건물의 파괴를 진단하는 과정 중에 이러한 지식을 무시한다면 젖은 땅을 강화한다고 해서 이러한 문제를 해결할 수는 없을 것이다.

Because this practice is completely forgotten, either filling the wells in the building with concrete thinking that these are not necessary in this era or the new constructions around the heritage structure demolishing the drainage system is a frequently met phenomenon (Figure 8). Such blocking or demolishing of the subsurface water control system causes water to rise to the building so that the building suffers moisture and soften the soil which leads to the building settlement. During diagnosis of the failures of the building, if this knowledge is ignored consolidation of the wet soil will not solve the problem.

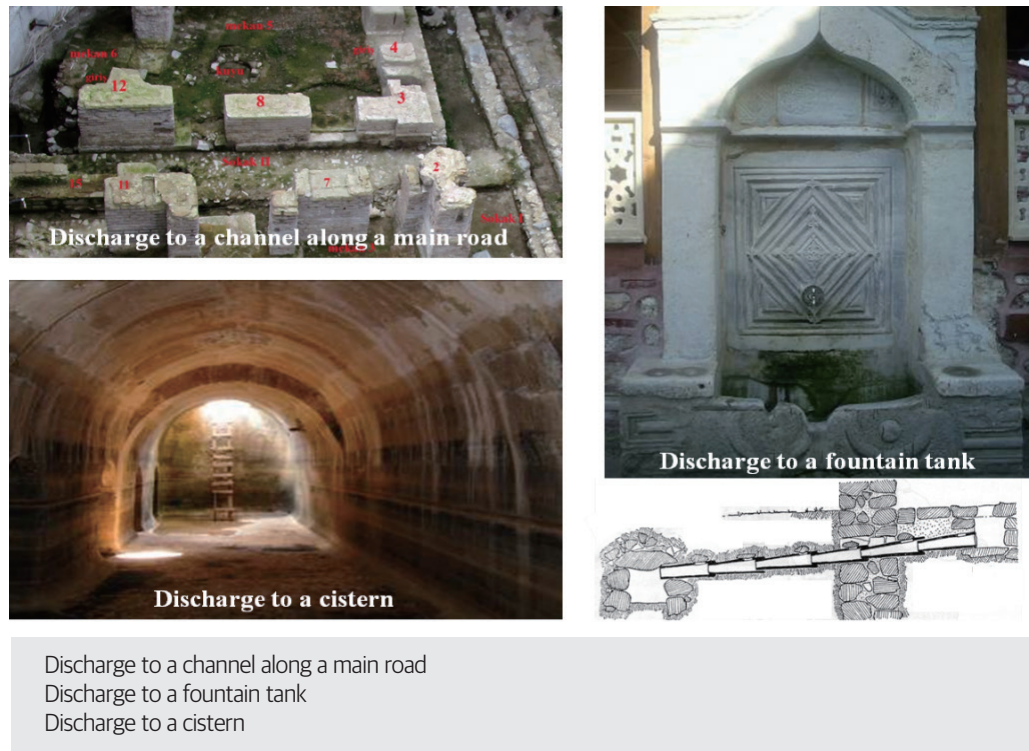
Discharge to a channel along a main road: 주도로를 따라 조성된 배수시설을 따라 배수
Discharge to a fountain tank: 분수조로 배수
Discharge to a cistern: 저수조로 배수

Figure 7 Discharge of underground water

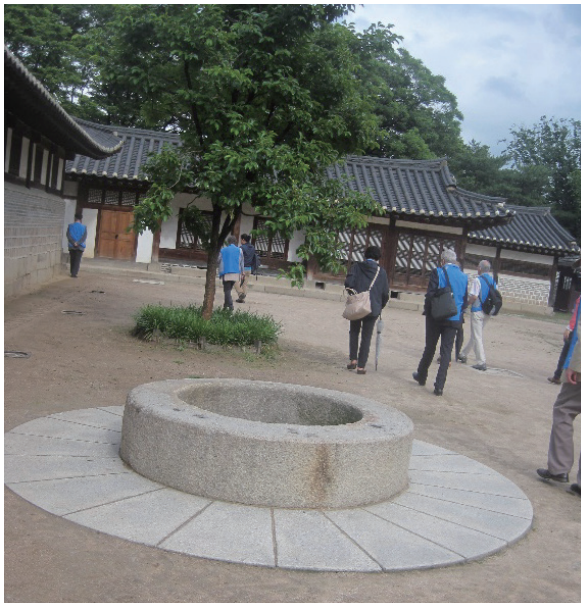
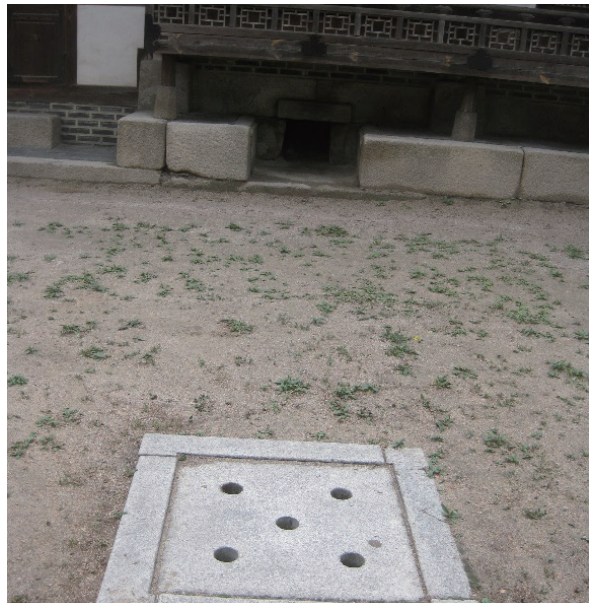
그림 9 한국의 배수시설

저자는 워크숍 방문 동안 기념물의 정원에서 일부 집수시설 및 배수시설을 접할 수 있었다(그림 9). 현지의 고고학 자들과 건축 역사가들은 한국의 전통적인 지하수 배수시설에 대한 정보를 제공할 수 있다. 지하 시설을 이해하는 데 있어서 레이더 검사(비파괴 검사)가 유용하게 이용될 수 있다.

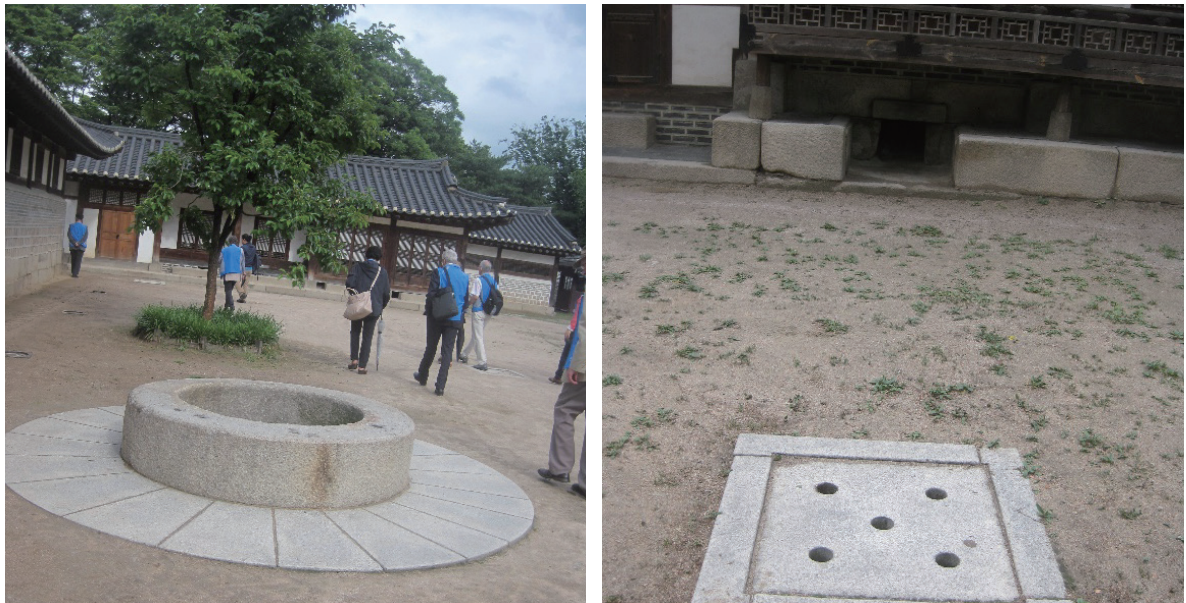
Figure 9 Drainage system in Korea

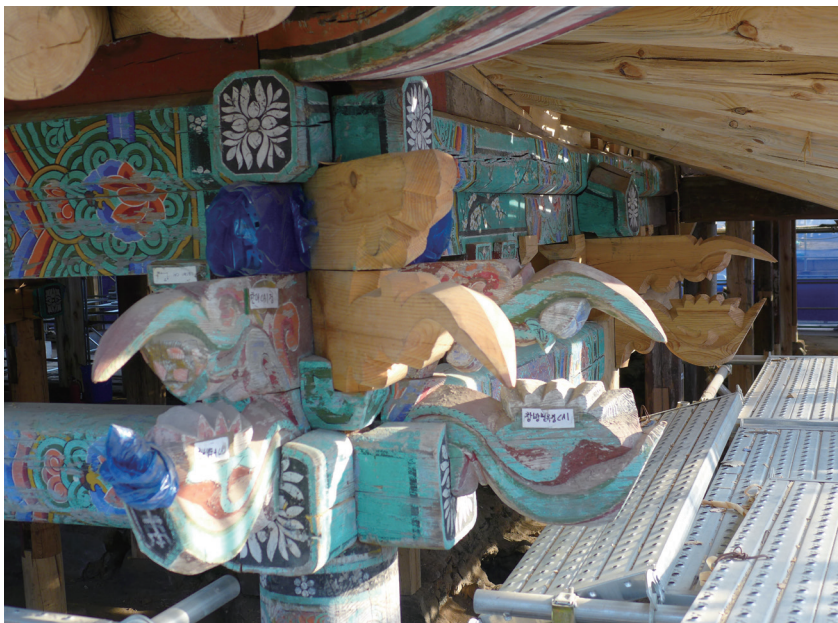
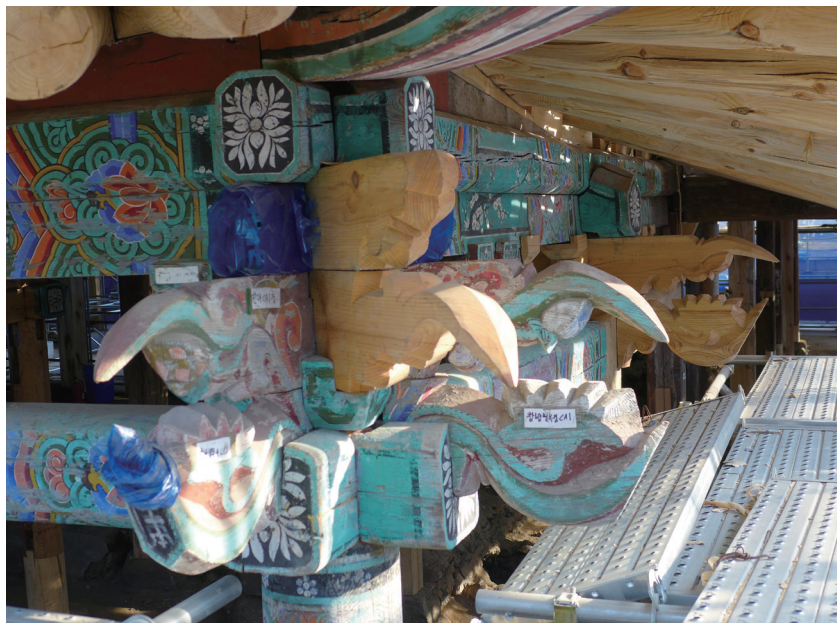
사진 1 서울의 한 역사가 있는 건물에서 복원기술을 사용하여 같은 모양, 같은 기술로 잃어버린 원형을 재현하는 작업이 진행되고 있다.

Figure 1 Replacement of missing elements with others that reproduce exactly the same shapes, with the same techniques, in an historic building in Seoul, undergoing restoration.

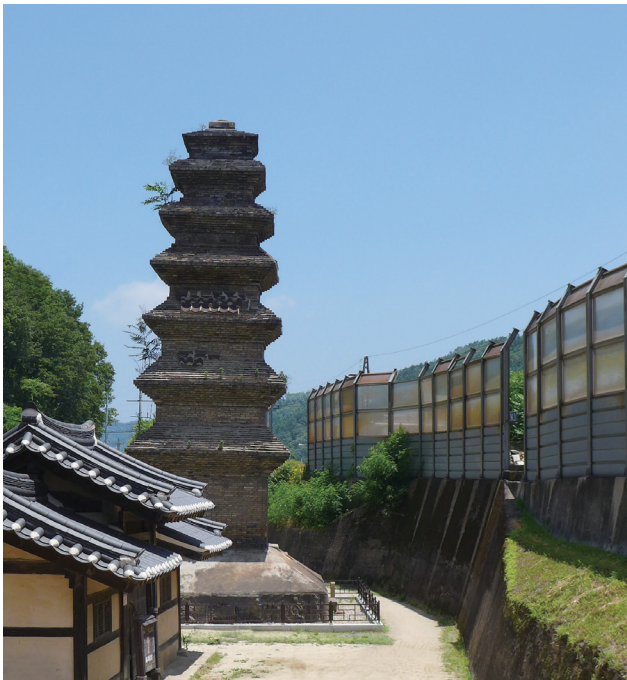
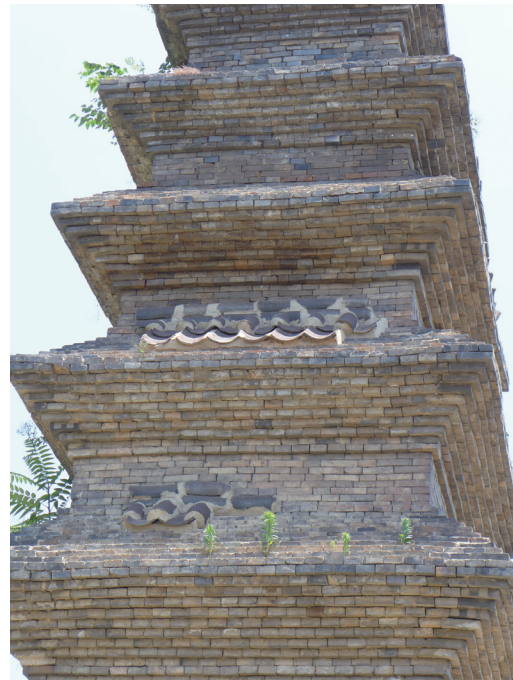
사진 4 법흥사지칠층전탑

사진 5 법흥사지칠층전탑

법흥사지 칠층전탑은 비록 방문했던 모든 유적들 중에서도 특히 최근 들어 가장 무시당한 채 방치된 것으로 보이지만 매우 흥미로운 사례이다. 사실, 주기적인 유지보수 노력이 부족하였다는 것을 여실히 보여주고 있는데 그로 인해 벽돌 사이의 틈새와 그것을 구성하는 다른 층들의 위쪽 부분에서 식물이 자랄 수 있게 되었다. 게다가, 고속도로와 철도 노선과 같은 기반시설이 가까운 곳에 설치됨으로 인해 그 주변을 근본적으로 변화시켰기 때문에 이 기반시설들은 법흥사지 칠층전탑을 부정적으로 인식되게 만드는 가장 큰 두 가지 영향요인이다.

매우 큰 장벽이 하나 세워졌는데 이는 법흥사지 칠층전탑의 가치를 고려할 때 완전히 부적절할 수밖에 없으며, 오늘날에는 시각적으로 탑을 왜곡하고 있다. 예전에는 강물에 탑이 비춰지고 아름답고도 거대한 자연 경관으로 둘러싸여 있었다. 지면은 차량과 철도로 인해 지속적으로 그리고 상당히 심하게 진동하고 있으며, 이로 인해 장기적으로 건물의 구조에 부정적인 영향을 미쳤다. 안타깝게도, 당분간은 이러한 기반시설이 존재할 수 밖에 없으며, 그로 인한 되돌릴 수 없는 변화가 수반되는 것은 어쩔 수 없는 것이 현실이다. 단기적으로는 철도에 대한 시각적 영향을 완화하기 위한 조치를 제안할 수 있을 뿐이며, 장기적으로는 철로의 이전 계획을 세우는 것이 바람직하다.

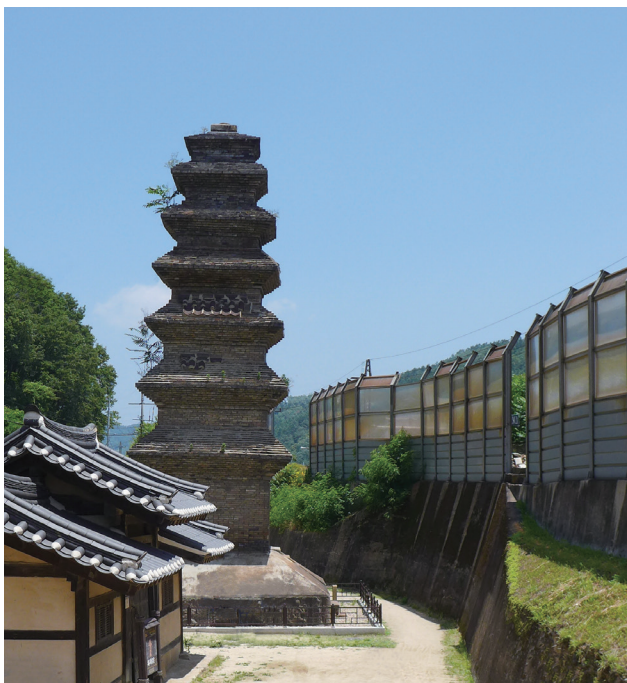
Figure 4 Seven-story Brick Pagoda at Beopheungsa

As for the pagoda itself, it is possible to discern the existence of some cracks in the joints between the bricks. In all probability, they are due to the effects of these vibrations, aggravated by the aging of the mortars with which the bricks are laid. It would therefore be advisable to seal the joints with traditional mortars in order to prevent water from infiltrating the structure and, most importantly, to avoid the growth of vegetation, the roots of which would just contribute to increase the problem. On one side of the pagoda, some remains of tiles can be seen, the dating of which was not possible. If they belong to the original structure, it would be advisable to complete them, as they would provide an adequate protection from rainwater filtering from the top.

A very tall barrier, that is completely incompatible with the value of the monument, nowadays visually distorts the pagoda, which in other times was mirrored on the river and was framed by a natural landscape of great beauty. The ground vibrates continuously and significantly due to vehicular and railway, and this, in the long run, has had negative effects on the structure of the building. Unfortunately, for the time being the presence of these infrastructures entails an irreversible transformation, and it is only possible, in the short term, to propose an intervention aimed at mitigating their visual impact on the building, while in the long term it would be desirable to make plans to divert the railroad track away from the monument.

탑 자체는 벽돌 사이의 접합부에 균열이 존재함을 확인할 수 있다. 모든 정황을 고려해 볼 때, 벽돌을 쌓은 모르타르의 노화와 이러한 진동의 영향 때문일 것으로 추정된다. 그러므로 빗물이 구조물에 침투하는 것을 방지하기 위해, 보다 중요하게는 문제를 악화시키는 근본원인인 식물의 성장을 막기 위해, 전통적인 모르타르로 접합부를 봉인하는 것이 가장 중요하다. 탑의 한쪽 면에는, 타일의 잔해를 볼 수 있는데, 그것의 연대를 추정하는 것은 불가능했다. 그 타일들이 원래 구조물 내부에 붙어 있었다면, 위로부터 흘러내리는 빗물을 여과하여 빗물로부터 탑을 적절히 보호할 수 있기 때문에 그에 대한 보수를 완료하는 것이 바람직할 것이다.

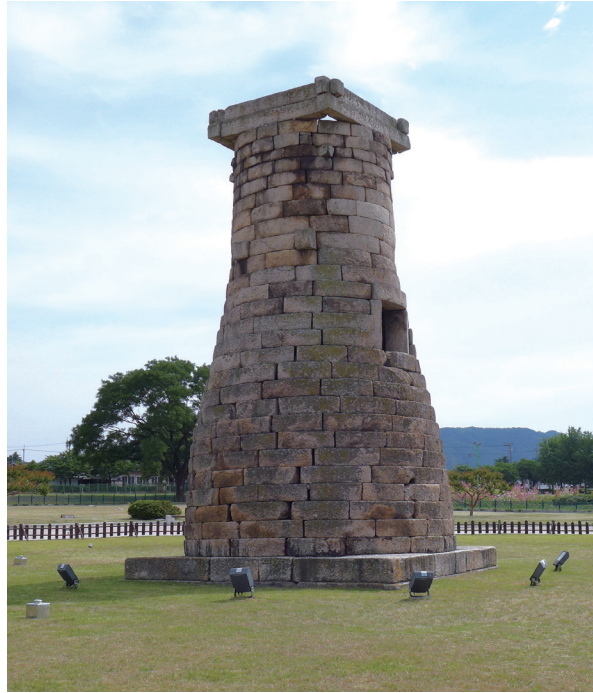
사진 6 경주 첨성대

그것은 시적일 뿐만 아니라, 그것은 또한 건축 과학의 교훈이기도 하다. 왜냐하면 그것은 지진 사건 앞에서 벽의 붕괴와 그들의 거동을 보여주기 때문이다. 만약 그 건물이 복원되었다면, 그러한 흔적들은 모두 지워졌을 것이고 아무도 그것들을 연구하거나 해석할 수 없었을 것이다. 따라서 첨성대는 현재 상태를 유지할 수 있으며, 정적인 거동의 진정한 모델이 될 수 있다.

경주 첨성대는 신비로운 자태, 그 기능, 고풍스러움, 그리고 그 맥락으로 볼 때, 특별한 유산으로서 기념비적인 가치를 지니고 있다. 네모난 석조 블록으로 된 벽은 거칠어 보이지만 안정성에 있어서 위험한 수준은 아니다. 이 건축물은 수세기 동안 이 땅에서 살아 숨쉬고 있었으며 아마도 지진으로 인한 균열(한국은 전통적으로 지진 위험이 높지 않은 국가로 분류된다고 하더라도)은 건물의 노화의 징후이고 수세기가 넘게 지나왔던 사건들의 흔적이다.

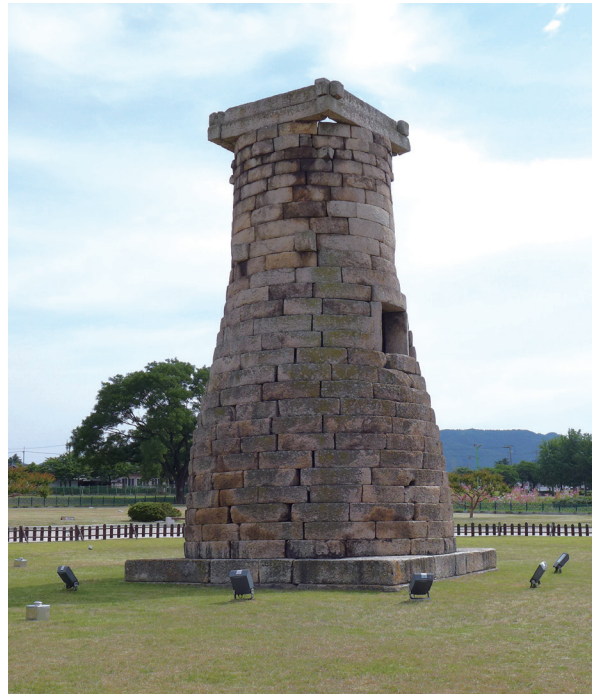
Figure 6 Cheomseongdae Observatory in Gyeongju

It is not only poetic; it is also a lesson in construction science because it shows the mechanisms of collapse of the walls, their behaviour in the face of a seismic event. If its buildings had been restored, those traces would have been erased and no one could study them and interpret them. Thus, the Cheomseongdae observatory can continue to remain in its current state and constitute a real model of static behaviour.

The mysterious observatory of Cheomseongdae in Gyeongju is an exceptional heritage asset, given its function, its antiquity, and the context in which it stands, which is of extraordinary landscape and monumental value. Although its walls in square stone blocks appear rough, its stability does not seem to be in danger. The building has lived in this state for many centuries and the cracks, probably due to earthquakes (even if Korea has not been traditionally considered a country with a high seismic risk), are the signs of the building's age, of the events that have marked it over the centuries.

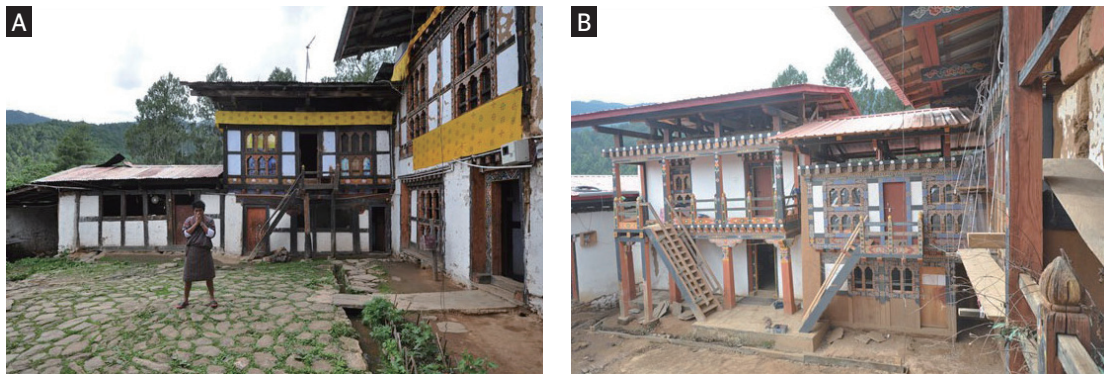
체토 고엔파(Tseto Goenpa)는 2011년 발생한 히말라야 지진으로 피해를 입었다. 부탄에는 아직 흙을 다지는 기술이 남아있기 때문에, 우리가 주도하는 재건축 기간 동안 이 기술이 사용될 것이다. 이 프로젝트의 또 다른 측면은 수도승 인원을 두 배 이상 늘리면서 그들에게 비교적 현대적인 편의시설을 제공하려는 현 라마의 계획이었다. 이 프로젝트에는 사원을 복원하고 내진 설계를 보강할 예정이었지만, 많은 주변 구조물들은 재활용된 토양을 이용하여 분해하고 다시 재활용해 원래의 토대 위에 세워졌다. 새 목재를 현장에서 채집 가공하였다(그림 2). 기존의 안마당을 더욱 존중하면서도 더욱 명확히 정의할 수 있도록 새로운 구조물을 추가하였다.

그림 2 체토 구엔파 수도원 마당에서 서쪽으로 보이는 모습
(A) 2014년 (B) 2017년(저자 사진)
