돌, 나무, 흙 건축의 구조 특성과 안전관리 방안 국제워크숍 결과보고서

International Workshop Report
on the scope of the material
and techniques Stone, Wood and Earth

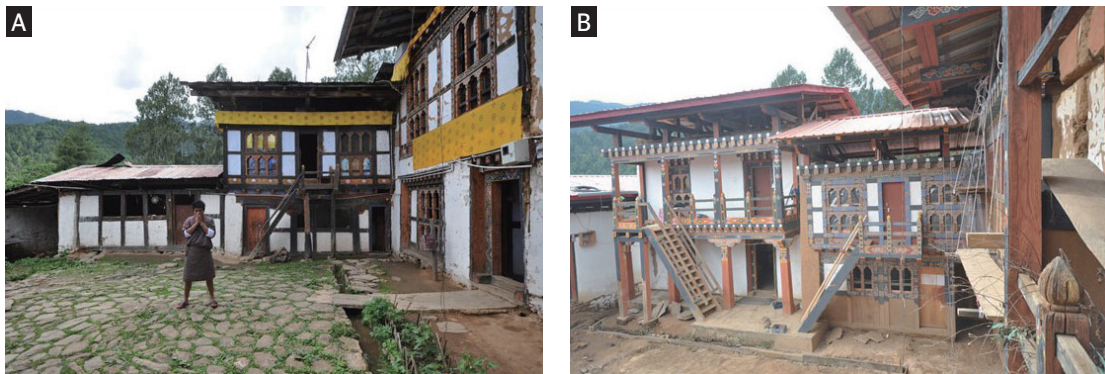
The Tseto Goenpa was damaged by the 2011 Himalayan Earthquake. Since the rammed earth technique is still alive in Bhutan its use would come into play during the rehabilitation which we would lead. Another aspect of the project was the present lama's plan to more than double the monk population and provide relatively modern conveniences. The project would include restoration and seismic strengthening of the temple, but many of the surrounding structures were disassembled and renewed using the recycled earth and set on the original foundations. New wood that was harvested and milled on site (Figure 2). New structures were added that respected yet further defined the existing courtyard.

Figure 2 View looking west in the Tseto Goenpa monastery courtyard
(A) in 2014 (B) in 2017. (Photos by the author)

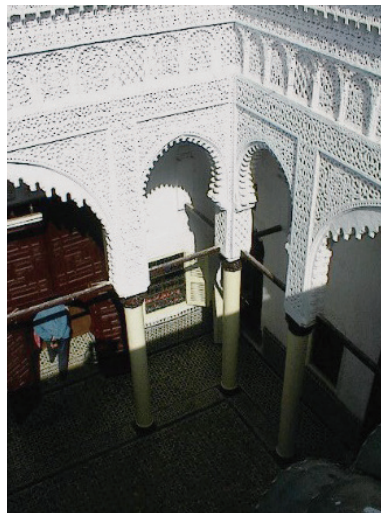
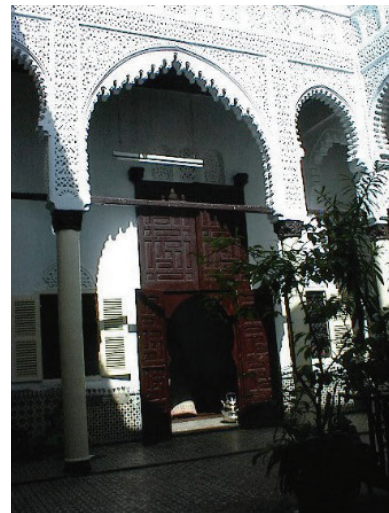
그림 10 전통적인 중정형 주택

전통 가옥은 입구, 중앙 뜰 또는 파티오, 그리고 그 주위를 둘러싸고 있는 방들로 이루어져 있다(그림 9). 이러한 요소들을 가지고 내부 공간의 구성요소를 설명할 수 있다(그림 10).

개방된 부분은 실내 기후를 개선하고 자연적인 환기가 이루어지도록 하기 때문에 중요하다. 또한 개방된 부분은 태양과 바람으로부터 보호해주는 역할을 하며, 벽은 태양 광선으로부터 보호하기에 충분히 높으며, 햇빛은 보통 오후까지 안뜰에 든다. 그리고 따뜻한 공기는 상승하면서 대류가 일어나 방의 환기가 이루어진다. 그러나 일부 연구에 의하면 내부 안뜰의 지붕이 개방된 경우, 특히 고온다습한 기후에서는 부정적인 요인으로 작용할 수 있다는 보고가 있었다.

The traditional house can be defined by the following elements: the entrance, the central yard or patio and its surrounding rooms (Fig. 9). These elements make it possible to describe the components of the domestic spaces (Fig. 10):

The opening is important because it modifies the indoor climate and contributes to natural ventilation. It also works as a protection from sun and wind, walls are high enough to protect from the sun rays, that usually reach the courtyard until the afternoon. Then the warm air rises, and convection is created, ventilating the rooms. However, some studies have shown that the roof opening in the inner courtyard can be negative, especially in hot and humid climates. In hot humid climates, the temperature in the courtyard can be higher than outdoors because there is little wind and it can become stuffy inside the house.

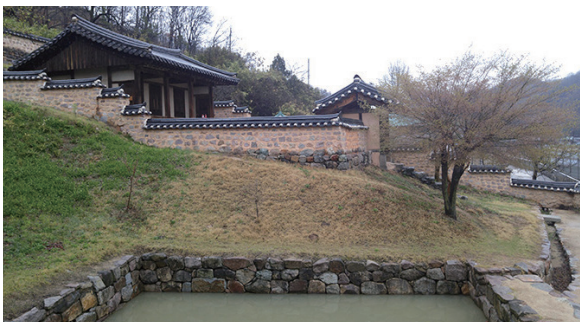
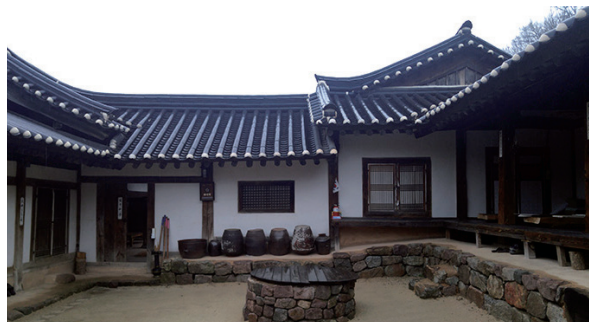
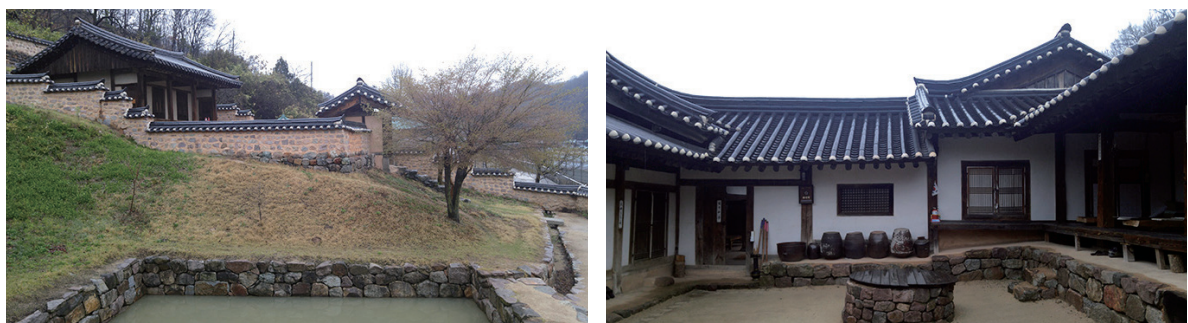
그림 13 임청각 건물 [11]

임청각의 각 건물은 영남산의 각기 다른 높이의 지대에 지어졌기 때문에 각 방에 햇볕이 잘 드는 구조를 갖추고 있다.

Each of the buildings of Imcheonggak is built at a slightly different elevation on Yeongnamsan Mountain, providing each room with plenty of sunlight.

Figure 13 Imcheonggak buildings [11]

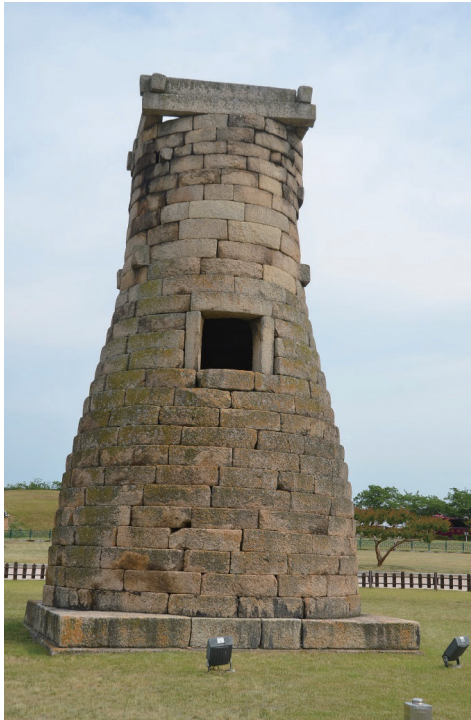
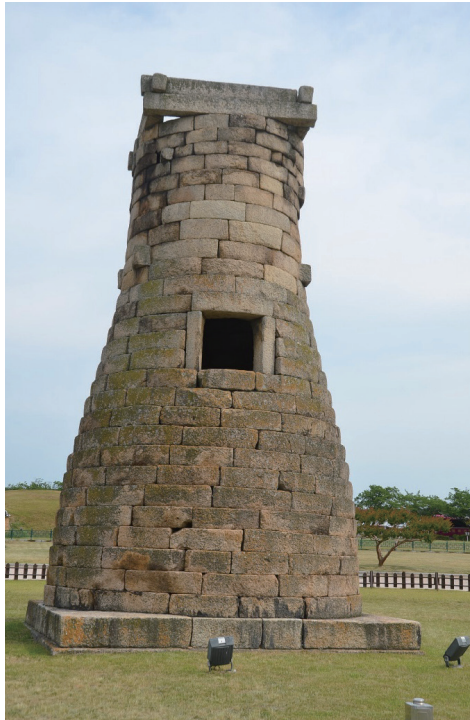
그림 1 남측 외관

건축물은 천연석으로 된 총 27개의 층으로 구성되어 있고, 층의 높이는 약 30cm이다. 천연석은 케이크 조각 형태이며 모서리의 길이는 약 1.0 ~ 1.2m, 깊이는 약 1.3m이다. 천연석은 대접(bed joint)과 맞댐이음(butt joint)에 모르타르 없이 이동된 것으로 보인다. 창문 아래의 빈 공간은 완전히 서형 석자재로 채워져 있다.

Figure 1 Ansicht von Süden

Das Bauwerk besteht aus insgesamt 27 Schichten aus Natursteinen mit einer Schichthöhe von ca. 30cm. Die Natursteine sind tortenstückförmig mit Kantenlängen von ca. 1.0 ~ 1.2m und einer Tiefe von ca. 1.3m ausgeführt. Die Natursteine sind sowohl an den Lager-, als auch den Stoßfugen ohne Mörtel nur an Kontaktstoß versetzt worden. Der Hohlraum unterhalb des Fensters ist vollständig mit kleinerem Steinmaterial aufgefüllt.

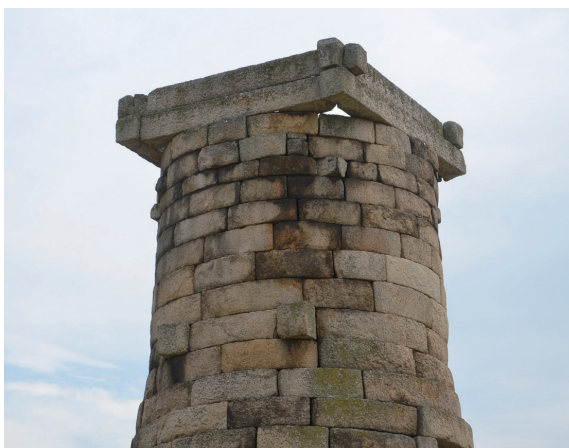
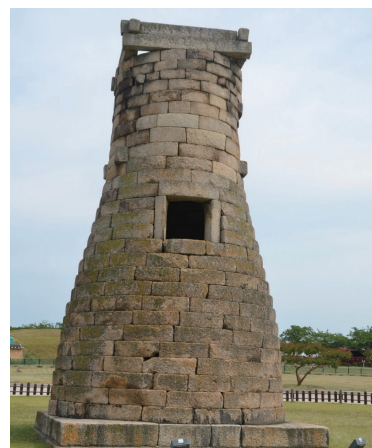
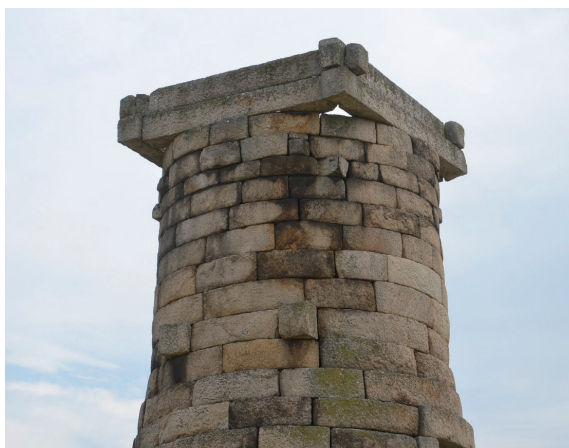
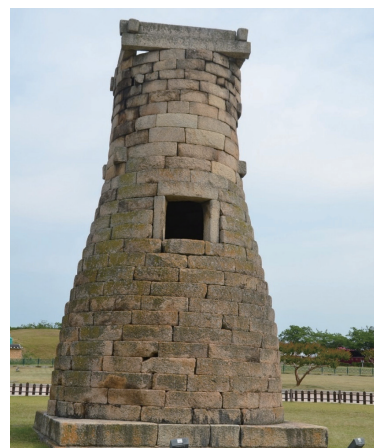
그림 3

건축물의 상부는 두 개의 정사각형 모양으로 배열된 석층을 외고리뒹 형태로 결합하고 있다. 약 3.2m 길이의 30 x 30cm 천연석은 끝 부분에 갈고리 모양으로 배치되어 최상단의 석층을 결합시킨다. 석층 19, 25, 26번에도 동일하게 정사각형의 가로배치로 되어 있으며, 건축물을 인장에서부터 견고히 결합할 수 있다.

Den Kopf des Bauwerks halten zwei quadratisch angeordnete Steinlagen ringankerförmig zusammen. Die ca. 3.2m langen, 30 × 30cm starken Natursteine sind an den Enden hakenförmig ausgeführt und halten die obersten Steinschichten auf Zug zusammen. In den Steinschichten Nr. 19, 25 und 26 sind ebenfalls quadratische Querlagen eingebaut, welche das Bauwerk auf Zug zusammenhalten.

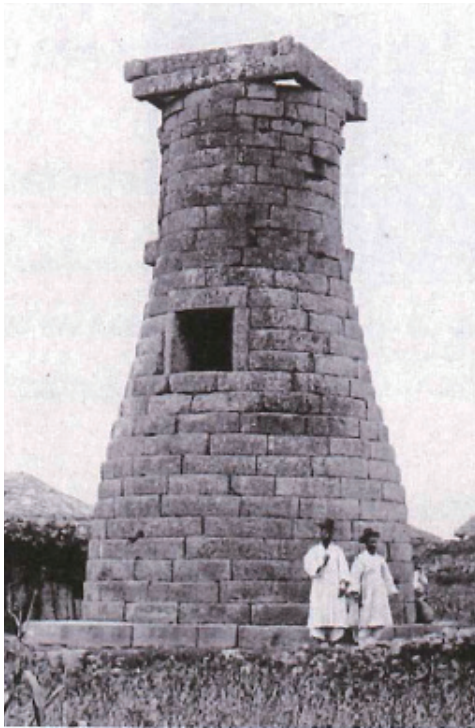
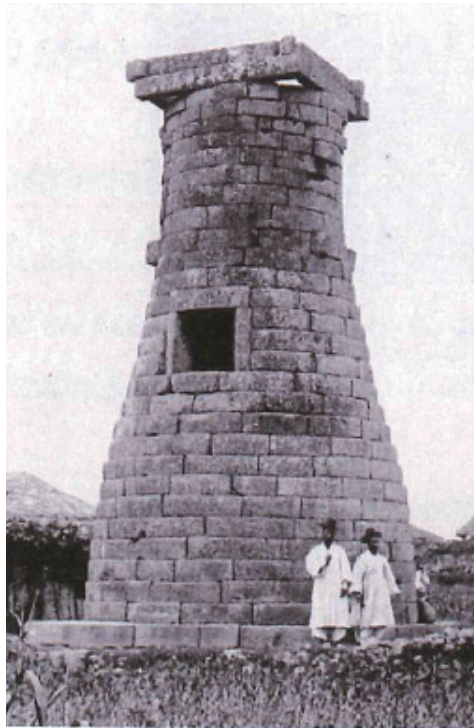
그림 4 1916년

27개의 석층은 정사각형 형태의 5.3 x 5.3m 받침대 위에 세워져 있다. 본 받침대는 총 9개의 정사각형에 가까운 크기 1.8 x 1.8m, 높이 약 40cm인 개별 판으로 구성된다. 받침대 아래의 토대는 약 5 ~ 10cm 위에 있고 대형 천연석판으로 제작되었다. 그 강도와 구성은 알려지지 않았다. 다만, 1976년도의 사진을 통해 이것과 연결되는 지대가 약 10cm 더 낮아 토대가 지면보다 위에 있음을 확인할 수 있다(역사 사진 참조).

Die 27 Steinschichten ruhen auf einem quadratischen Sockel $5.3 \times 5.3\text{m}$, welcher aus insgesamt 9 nahezu quadratischen Einzelplatten ca. $1.8 \times 1.8\text{m}$ und einer Höhe von ca. 40cm besteht. Das Fundament unterhalb des Sockels steht ca. 5 ~ 10cm über und ist ebenfalls aus großen Natursteinplatten gefertigt. Deren Stärke und auch Ausbildung sind nicht bekannt. Lediglich auf einem Foto aus dem Jahr 1976 ist das anschließende Gelände um ca. 10cm tiefer, sodass das Fundament aus dem Erdreich schaut (siehe historisches Foto).

Figure 4 In 1916

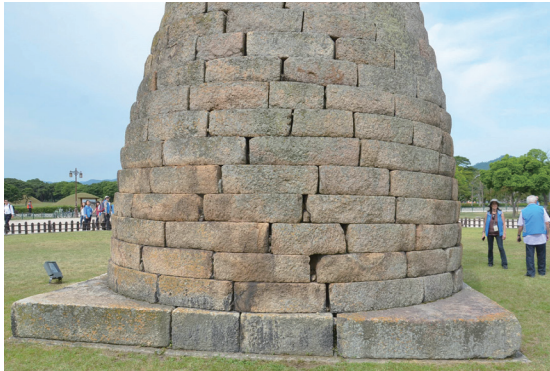
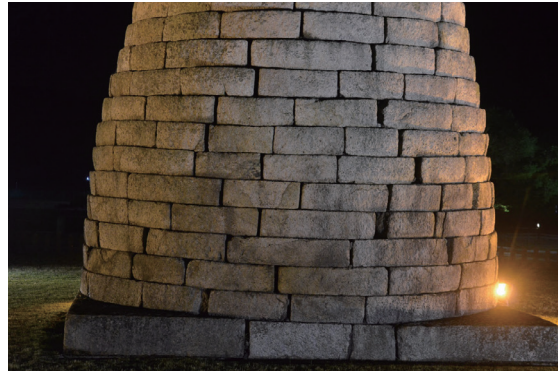
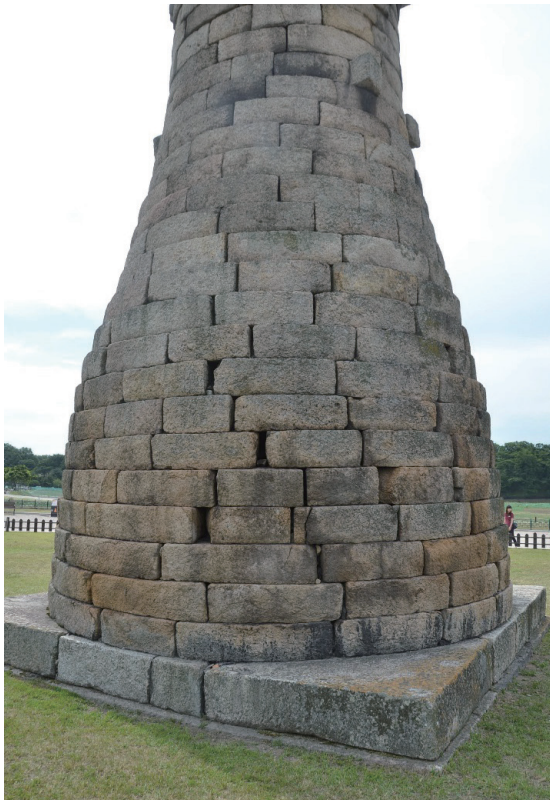
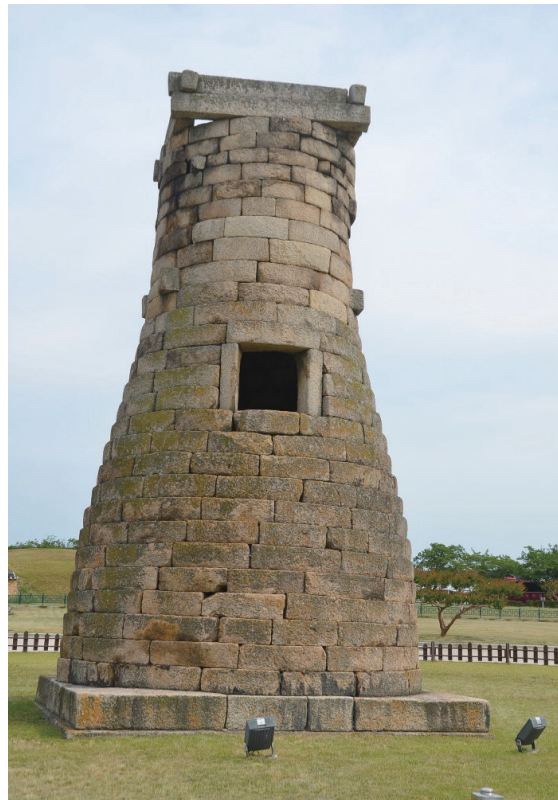
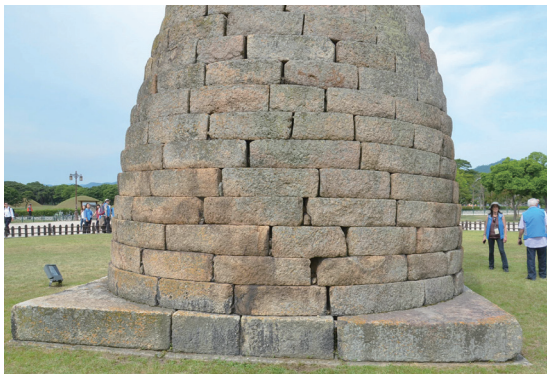
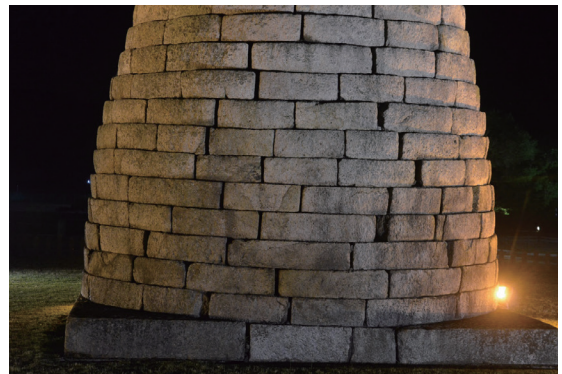
그림 6

- 받침대와 토대의 마름돌 구성으로 인해 중심이 4개의 정사각 모서리판의 내부에 형성된다. 모서리판은 내부에서 부하의 증가로 안쪽으로 모여져 4개의 받침대 모서리가 위로 향하게 되었다.
- 판의 중심에 대한 부하의 증가와 변형으로 중심에 위치한 양 받침대 판이 북측과 남쪽으로 부러진 상태이다.

- Aufgrund der Ausbildung des Sockels und der Fundamentquader steht das Hauptgewicht auf den Innenseiten der 4 quadratischen Eckplatten auf. Diese haben sich auf der Innenseite aufgrund der höheren Auflast nach innen gesetzt, sodass die 4 Sockelecken nach oben gegangen sind.
- Aufgrund der höheren Auflast und der Verformungen in der Mitte der Platten sind die beiden mittleren Sockelplatten auf der Nord-und Südseite gebrochen.

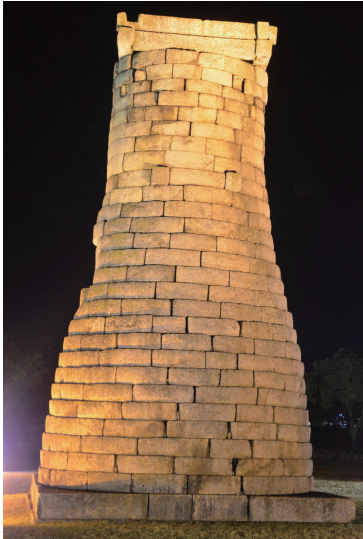
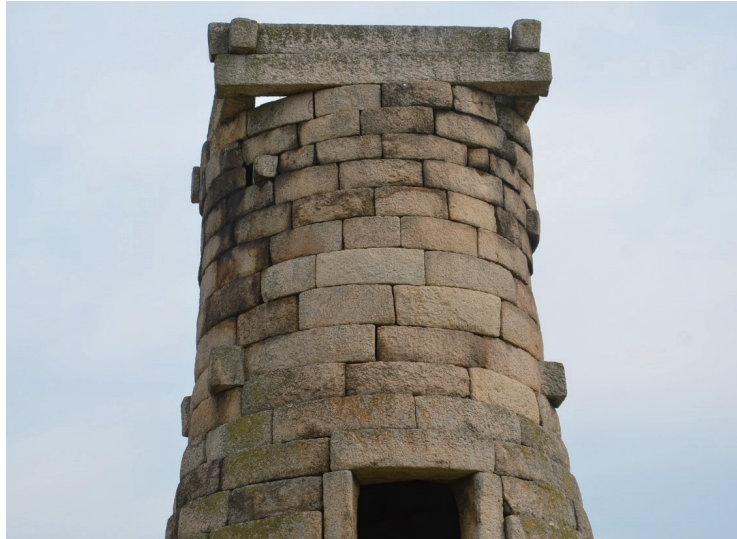
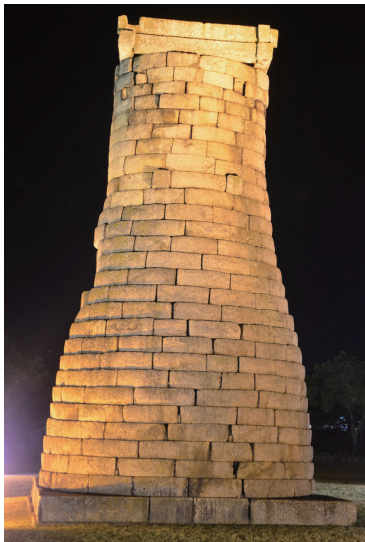
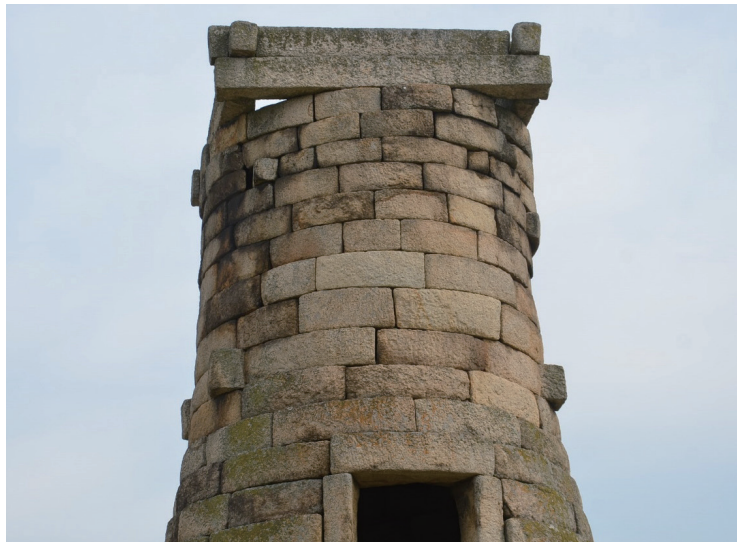
그림 7

- 건축물 상부 3분의 1 부분에는 2016년의 지진으로 인한 주요 손상이 관찰된다(강도 5.8). 이로 인해 건축물 상부를 에워싸는 양 연결 부분의 부러짐과 위에서 4번째까지의 석층 맞댐이음에 대한 수직 위치 이동이 발생하였을 것으로 보인다. 동측에는 수직 바깥쪽을 향하는 돌의 이동이 나타났다.

- Im oberen Drittel des Bauwerks sind im Wesentlichen Schäden aus dem Erdbeben aus dem Jahr 2016 zu beobachten (Stärke 5.8). Hierauf sind die Brüche an den beiden umlaufenden Zugverbindungen am Kopf des Bauwerkes und die horizontalen Verschiebungen an den Stoßfugen der 4 obersten Steinschichten zurückzuführen sein. Hier haben sich an der Ostseite auch Steinverschiebungen horizontal nach außen ergeben.

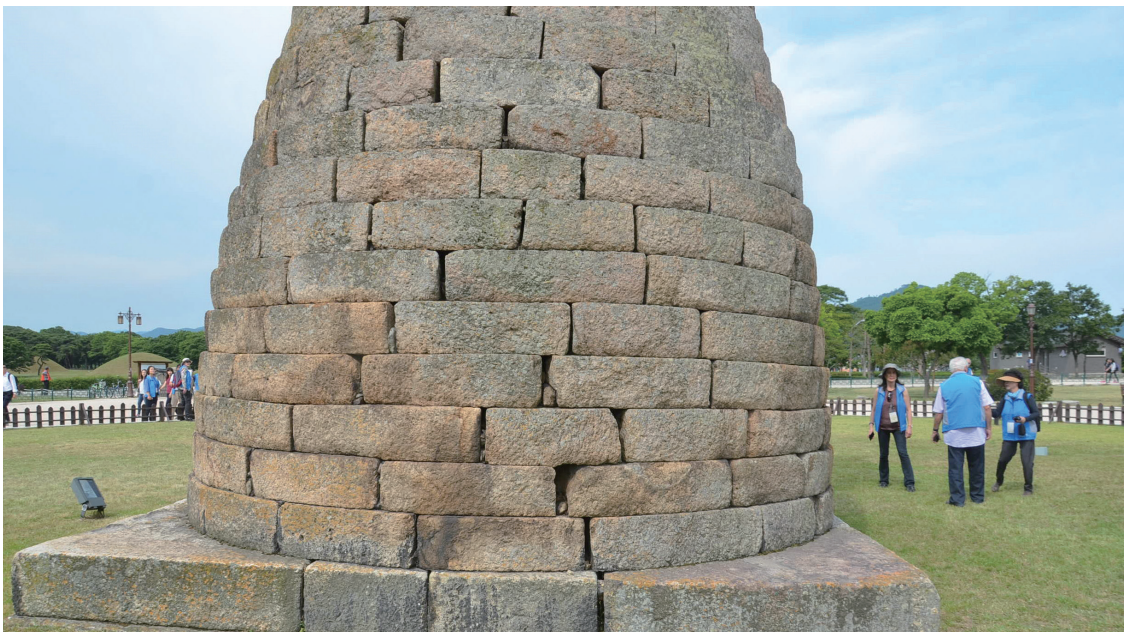
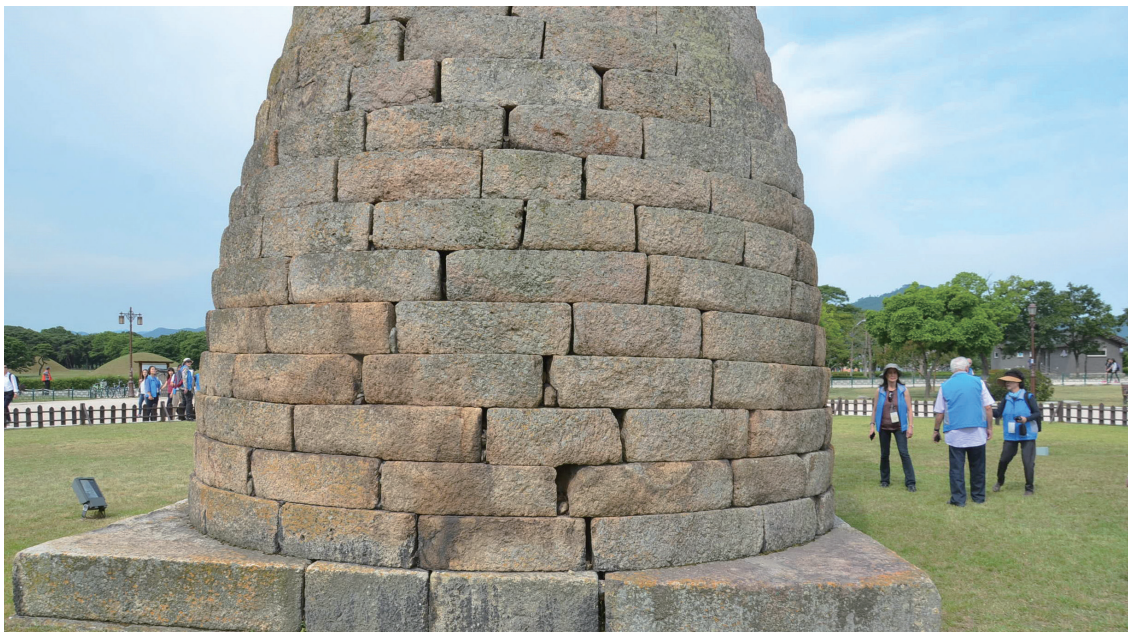
그림 8

- 몇몇 지점에는 맞댐이음 부조화와 이와 관련된 벽층의 맞물림이 북측의 침강 증가에 기여하였다.

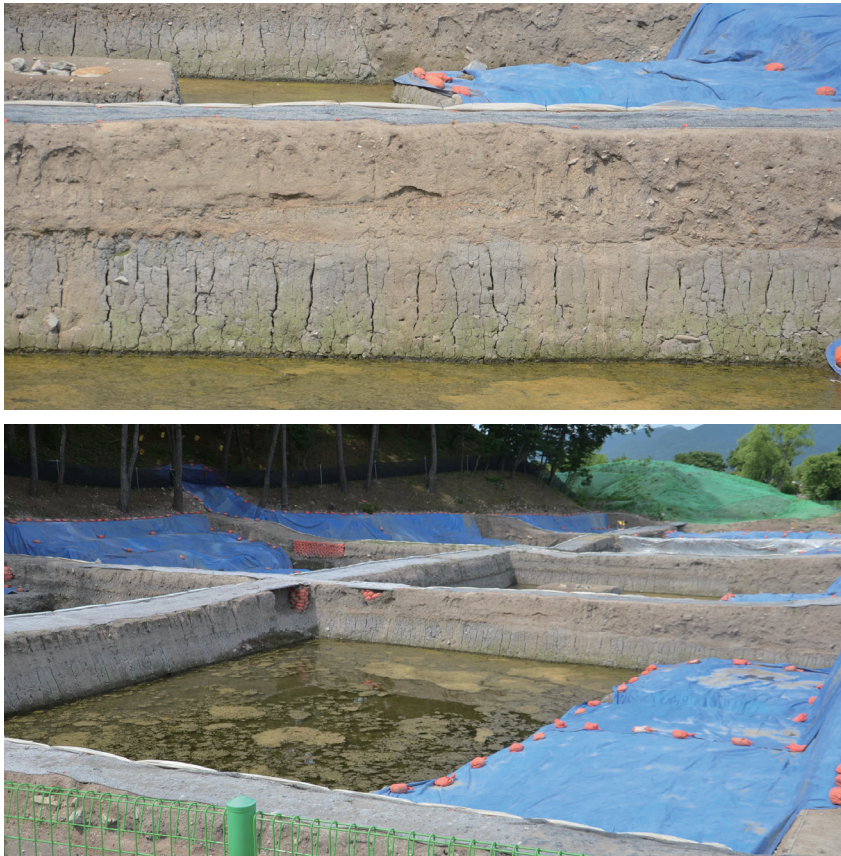
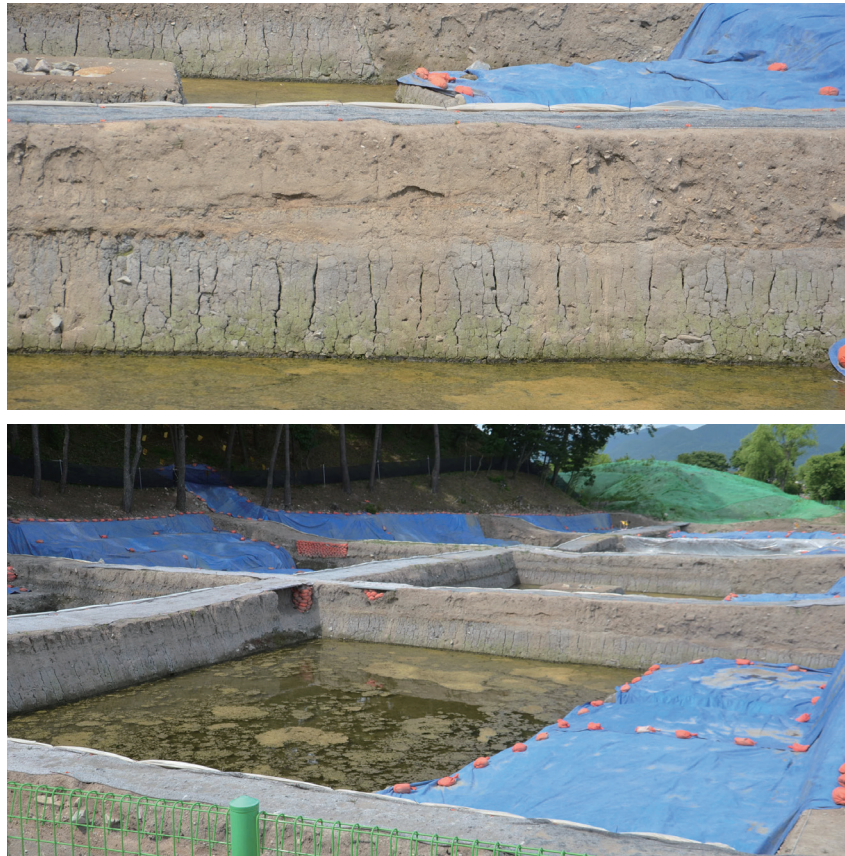
그림 9

- 관측소와 직접적인 거리에 고고학 발굴장소가 위치한다. 그곳의 지하수 수위는 매우 높다(부지 아래 약 1.5m). 인접하는 바닥은 모래와 점토로 구성된다. 점토는 지하수 위쪽으로 건조로 인한 수직 수축균열을 보인다.

- In unmittelbarer Nähe des Observatoriums befindet sich das archäologische Grabungsfeld. Dort ist ein sehr hoher Grundwasserstand (ca. 1.5m unter Geländeoberkante) vorhanden. Der anstehende Boden ist aufgefüllt aus Sand und Lehm. Der Lehm hat überall des Grundwassers vertikale Schrumpfrisse aufgrund der Austrocknung

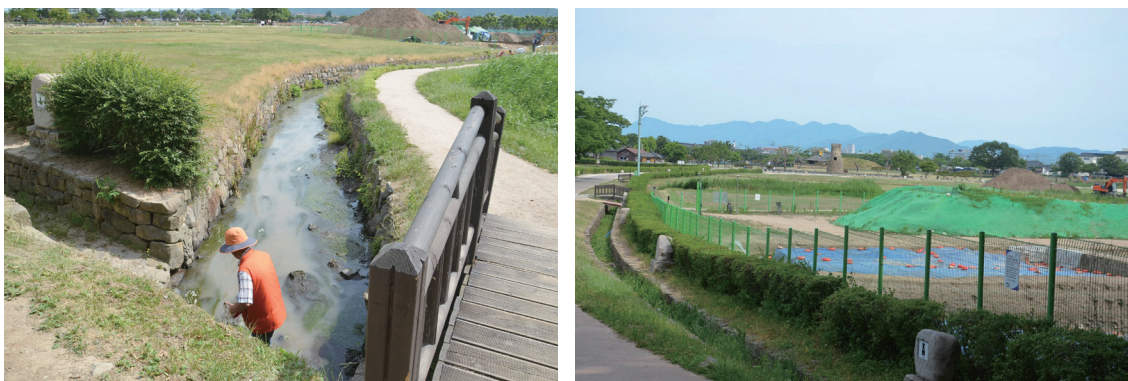
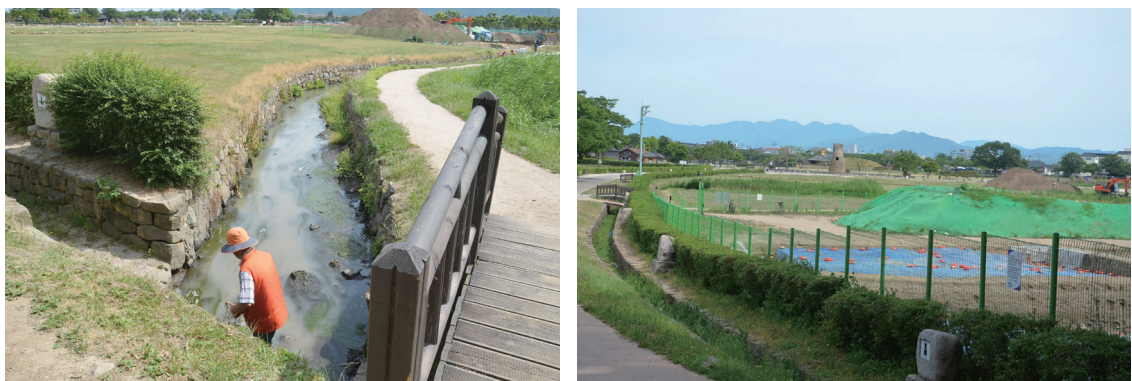
그림 10

- 발굴 부지 주위로 배수시설을 설치하여 개별 발굴장소를 배수하거나 지하수 수위를 낮춘 것으로 보인다. 어쩌면 본 조치들도 건축물의 침강에 부정적인 영향을 미쳤을 수 있다.

- Offensichtlich sind um das Grabungsgelände Entwässerungskanäle angelegt, um die einzelnen Grabungsfelder zu entwässern bzw. den Grundwasserspiegel abzusenken. Möglicherweise haben diese Maßnahmen auch einen negativen Einfluss auf die Setzungen des Bauwerks gehabt.

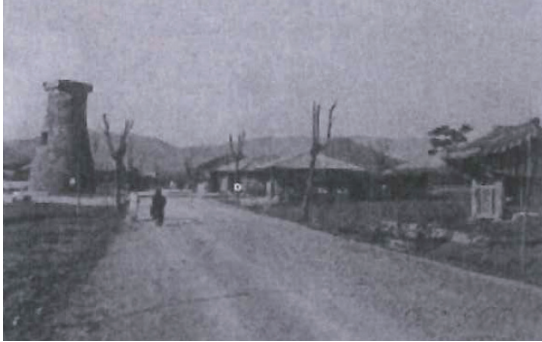
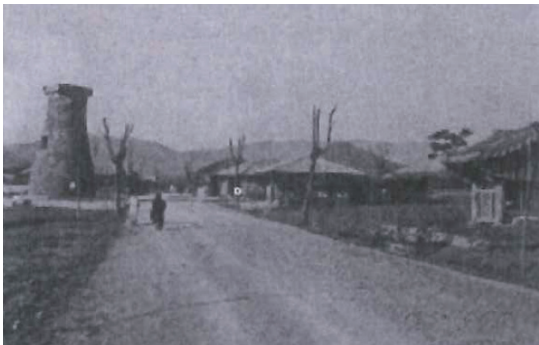
그림 11 1950년

- 1916년의 사진에는 건축물의 상태가 현재에 비해 현저히 나은 수준에 있다. 1950년의 사진에는 북측에 도로가 인접함을 확인할 수 있다. 한국 참가자의 설명에 따르면 그곳에 한국전쟁 중 무거운 미국 전차들이 지나 다녔다고 한다. 이는 상태가 좋지 않은 건축 부지와 관련하여 13cm에 이르는 북측 침강의 주요 원인일 것이다.

- Auf den Fotos von 1916 ist das Bauwerk in einem wesentlich besseren Zustand zu sehen als heute. In dem Foto von 1950 ist zu sehen, dass unmittelbar auf der Nordseite eine Straße vorbeiführte. Nach Auskunft der koreanischen Teilnehmer sind dort im Korea-Krieg die schweren amerikanischen Panzer entlang gefahren. Dies dürfte wohl in Verbindung mit einem schlechten, tragfähigen Baugrund die Hauptursach für die Setzungen auf der Nordseite in Höhe von 13cm sein.

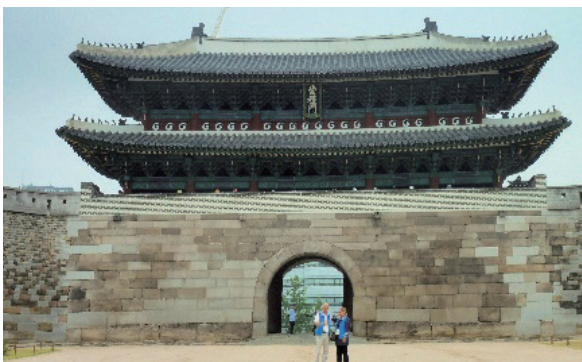
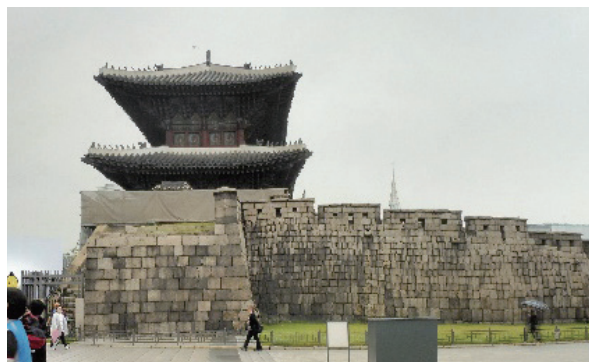
그림 1 송례문, 흥인지문 서울

서울의 송례문(1398/1447)은 이 두 가지 가치 모두를 보여준다. 2008년 화재로 인해 파괴된 상부구조의 진정성이 상실되었을 때 택한 방법은 재건축이었다. 다음 세대를 위해 이 중요한 기념비를 물리적인 방법으로 복원하였으며, 복원하는데 필요한 문서 및 기술 개발은 소중한 자원이 되었다.

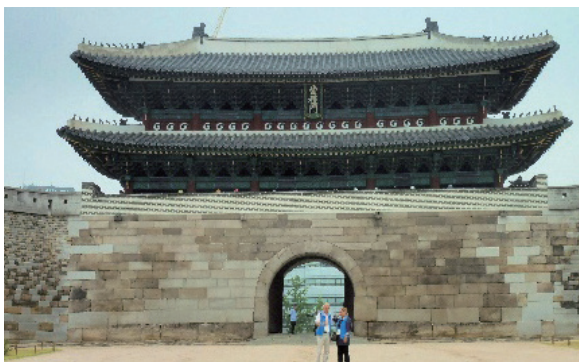
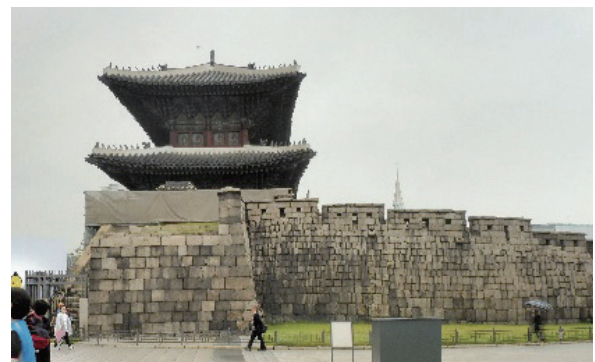
Figure 1 Sungnyemun Gate, Heunginjimun gate seoul

The Sungnyemun Gate in Seoul (1398/1447) demonstrates both of these values. When the authenticity of the superstructure destroyed by fire was lost in 2008, the choice was made to rebuild. The memory of this important monument was physically restored for future generations and the documentation and skills development required to make the restoration possible has become a valuable resource.

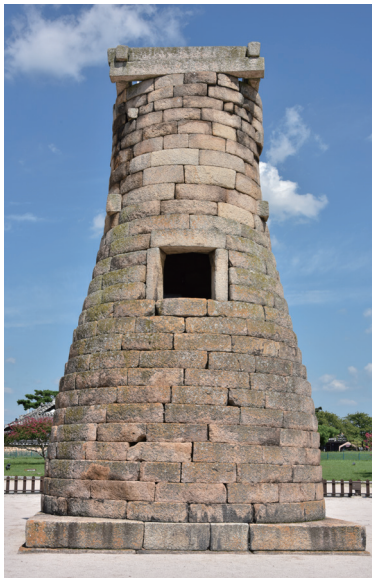
그림 3 첨성대

2. 경주의 첨성대(632-647)는 석조 건축물이다. 첨성대는 최근에 발생한 지진으로 인해 0.1도 가량 더 기울어져 북쪽으로 약 1도 가량 기울어져 있다. 탑 근처에서는 굴착 및 시험을 허용하지 않기 때문에 지하의 기초 상태 또는 깊이를 명확히 알 수 없었다. 지상의 수분 상태는 계절에 따라 지하수면과 함께 변할 수 있다. 커다란 개방된 접합부가 있는 석조 사이에는 모르타르가 없는 것으로 보인다. 석조 내부의 양상, 깊이 및 토대는 명확히 알 수는 없었다. 탑의 상부에는 꼭대기로부터 1.4m 떨어진 곳에 석조로 된 가로보를 대어 보강할 수 있으며, 탑 상부에 겹치는 모서리가 있고 한쪽 모서리가 부서진 것으로 보이는 직사각형 모양의 기둥 구조가 있다. 중심부는 부분적으로 반 정도만 채워져 있으며, 충전재가 무엇인지는 제대로 파악할 수 없었다.

이 탑은 1300년 동안 변함없이 버텨 왔으며 매우 견고하게 지어진 것으로 보인다. 첨성대가 안정적인 이유 중의 하나는 그 구조가 피라미드 구조를 하고 있기 때문일 수 있다. 현재의 주요 문제는 탑의 기울어짐, 석재의 침식 및 변위, 그리고 비를 막을 수 있는 수단이 없다는 것이다.

모르타르가 사용됐는지 여부에 대한 증거는 제한적이거나 아예 없었다. 석조 내부의 양상 및 각 층의 깊이와 토대는 명확히 알 수는 없었다. 석조의 토대는 중력에 의존하는 것으로 보이며 지지를 위한 중심부 충전재에 의존하고 있을 수도 있다. 개방된 접합부로 중심부의 배수가 일어나 벽면의 수분으로 인한 손상을 감소시킬 수 있을까?

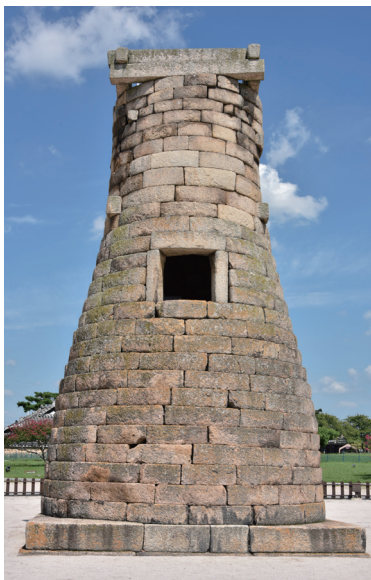
Figure 3 The Cheomseongdae Observatory

The tower has survived, apparently unchanged, for 1,300 years and appears to be very solidly built. The pyramidal shape may be one reason for the stability of the structure. Currently the main concerns are the tilt of the tower, erosion and displacement of the stones and no protection from rain.

The tower foundation appears to be nine large, flat stone slabs arranged in a square and extending clear of the tower base. These slabs have settled towards the north resulting in a tower lean of about 1 degree. After so many years the base has not sunk into the ground or become partially buried unless there has been some excavation for a wide area around the tower. This suggests stable subsoil conditions.

There is limited or no evidence of mortar. The interior profile of the stones and depth and bedding of each layer of stones is not clear. The bedding of the stones seems to depend on gravity and may also depend on the core fill materials for support. Do the open joints permit drainage of the core and reduce moisture damage to the walls?

In review, it is possible that the wide, open joints of the walls and the partially open core allow precipitation to be rapidly drained so that the structure can dry out. In addition, the loose construction may be allowing the structure to be flexible during an earthquake. Potential failure could occur due to the loose stones at the top of the structure or dislocation of the stones in the bulging areas.

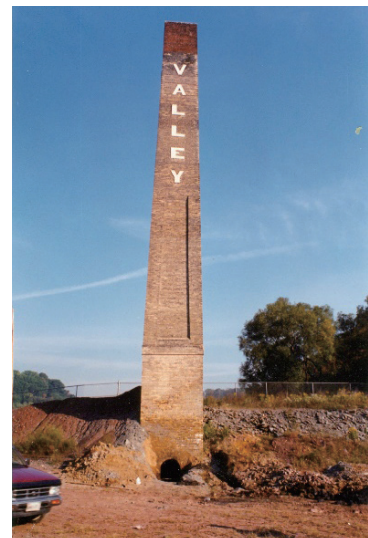
그림 4 돈 밸리 브릭웍스 밸리 침니

굴뚝은 현지에서 제작된 가마에서 석회 모르타르로 만들어졌으며 도면상 직사각형 모양을 하고 있다. 이 직사각형 형태는 전체 높이에 걸쳐 유지되고 있지만 약간 뒤틀어져 있다. 연통 또는 중심부는 24m의 내부 계단과 29m의 또 다른 계단까지 직선으로 이루어져 있다. 원래 굴뚝에는 나팔 모양의 지붕이 있었는데, 그 꼭대기는 29m에서 현재의 32m 사이 부분에 재건축되었다. 재건축된 이 부분은 상태가 좋지 않았다. 굴뚝은 2도 가량 기울어져 있다.

조사 초기과정에서는 이전 보수의 범위와 날짜를 결정하고 굴뚝 기울어짐이 증가하는지 여부를 결정하기 위해 역사적인 사진을 광범위하게 분석하였다. 1948년 굴뚝 꼭대기를 교체한 역사적인 사진들이 있었으며, 그 보수 과정의 흥미로운 특징은 굴뚝이 기울어져 있지만, 새로운 벽돌은 똑바르고 수직적이었다는 것이다. 이것은 그 이후로 굴뚝의 움직임이 거의 없거나 또는 전혀 없었다는 것을 확인시켜 주었다.

DVBW 밸리 굴뚝은 현지의 가마에서 구운 벽돌로 만들었으며, 일부 벽돌은 광택 면이 있었다. 벽돌로 지은 석조물은 원래 석회 모르타르로 만들어졌지만 1948년에 이루어진 보수 과정에서는 석회를 접합하였다. 굴뚝의 안정성을 위해, 수직 벽에 테이퍼를 주었다. 각 면의 중심에는 하방 균열의 패턴이 있다. 특히 가마가 작동 중일 때의 가변적인 온도와 같은 힘, 노출 및 풍하중 등 기타 요인 등이 기존에 발견된 손상의 원인으로 생각되었다. 휨 모멘트로 인한 균열 가능성 또한 고려하였다. 또한 보수를 위해 촘촘한 모르타르를 사용한 구역 및 그 주변에도 손상이 발생하고 있었다.

각 면에 있는 커다란 수직 균열이 있는 광범위한 균열 패턴은 굴뚝의 기울어진 부분 때문에 보이지 않았다. 역사적으로 볼 때 그 원인은 용광로의 열, 고밀도 모르타르 보수에 대한 동결/융해 작용 및 풍하중의 영향일 수 있다. 철도 교량이 위쪽으로 통과하기는 하지만, 진동이 잠재적 원인인 것으로 확인되지는 않았다.

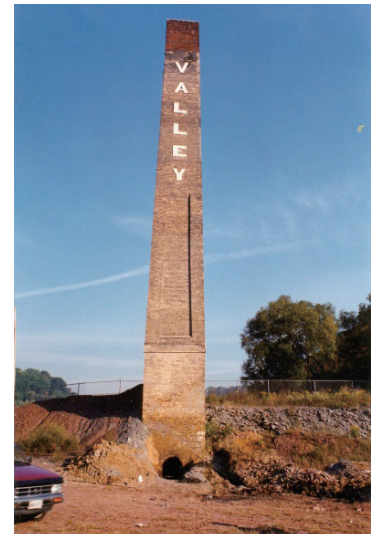
Figure 4 The Don Valley Brickworks Valley Chimney

The chimney was constructed with locally made kiln fired brick set in lime mortar and is rectangular in plan. This rectangular form is continuous throughout its height but there is a slight twist. The flu or core was a straight shaft up to an interior step at 24m and another step at 29m. Originally the chimney had a belled top which was removed and the top was rebuilt between 29m and the current 32m. This rebuilt section was in poor condition. The chimney has a 2 degree lean.

The initial investigation used extensive analysis of historic photographs to determine the extent and dates of previous repairs and to determine if the tilt of the chimney was increasing. There were historic photographs of the 1948 replacement of the top of the chimney and the interesting feature of those repairs was that, although the chimney was leaning, the new brickwork was plumb and vertical. This confirmed that there was little or no further movement of the chimney after that date.

The DVBW Valley chimney was constructed of locally made kiln fired brick and some brick had a glazed face. The brick masonry units were originally set in lime mortar but not the repairs made in 1948 which were cement with the addition of lime. The chimney has vertical walls with a taper which can be considered adding some additional stability. There is a pattern of cracks down the centre of each face. Forces such as variable temperatures, especially when the kilns were operating, exposure and wind loads and other factors were considered as causes for the damage found. The possibility of cracking due to bending moments was also considered. Damage was also occurring in and around areas where dense mortars had been used for repairs.

The extensive pattern of cracking with a major vertical crack on each face did not appear to be due to the lean of the chimney. The historic causes would have been the heat of the furnace, freeze/thaw action around dense mortar repairs, and the possible effect of wind loads. Vibration was not identified as a potential cause although there is a railway bridge passing overhead not far away.

Minimal intervention was recommended as the most practical and honest approach to the conservation of the chimney on the basis of historical and interpretive integrity, structural equilibrium and architectural compatibility. It was decided to stitch the chimney together with a pattern of intersecting Cintek anchors into the core of each of the four walls. The chimney was repointed where mortar was failing and wherever possible, dense mortars were replaced with more flexible lime mortars. The faulty 1948 reconstruction was removed and partially rebuilt following the original lines of the chimney although the original belled top was not reconstructed.

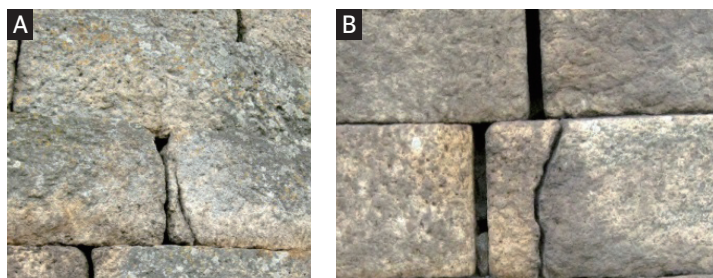
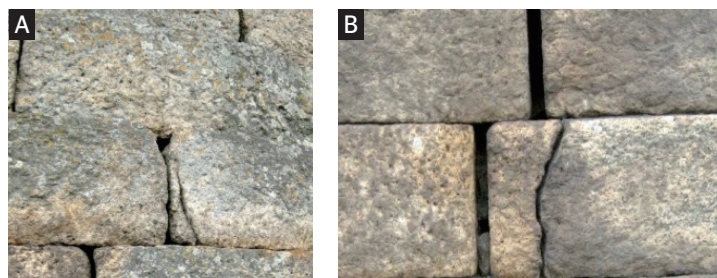
그림 4 (A)와 (B) - 서로 대칭인 면이 있는 좁은 균열

Figure 4 (A) and (B) - Narrow cracks with faces mirroring each other.

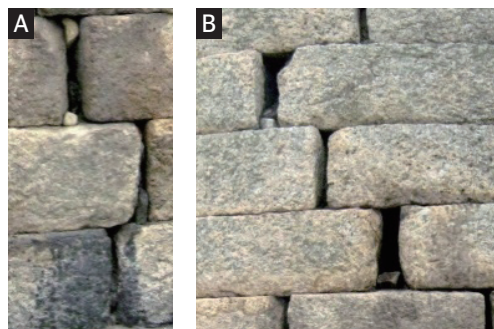
Phase 6 : as a consequence small stone pieces, pebbles and sand move down inside the widened slit between blocks until they look as inserted from the outside (Figure 7 A, B)

Figure 7 (A) and (B) - Stones and pebbles fall down the slits

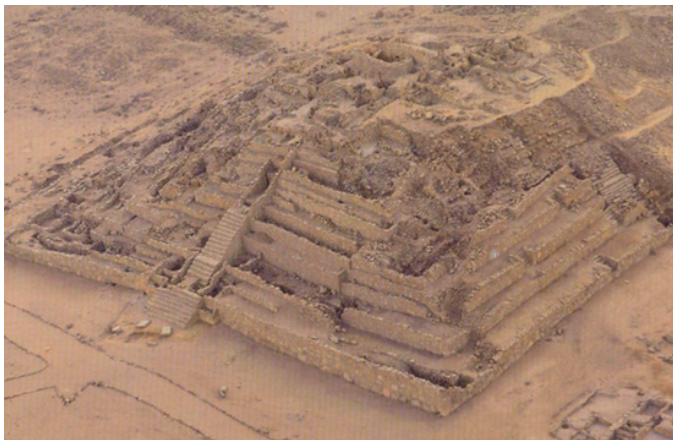
카랄 문명은 50세기 전(기원전 3000년 경)에 만들어졌으며 아메리카에서 가장 오래된 문화이다. 이 문화는 자연 재해에 맞선 가치 있는 건축학적 지식을 드러내었다. 가장 대표적인 피라미드 중 하나의 연구에 따르면 건축가들은 땅, 돌, 유기물들로 이루어진 조합을 개발했으며, 이러한 조합은 재난에서 제대로 기능하였다. (그림 1 참조)

그림 1 갤러리 피라미드 카랄(기원전 3000). 제공 : Christopher Kleihege

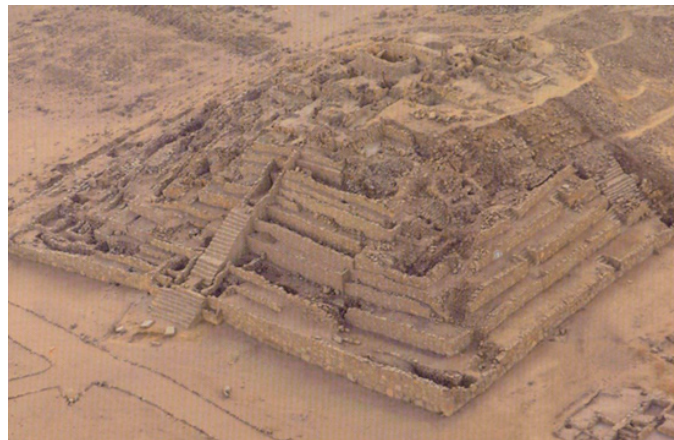
It was created 50 centuries ago (3 000 B.C.) and is the most ancient culture in America. This culture reveals valuable constructive knowledge that faced natural disasters. Studies in one of the most representative pyramids showed that constructors developed combinations made of earth, stone and organic materials that performed properly under disasters (Vargas J. et al 2011). (See Figure 1)

Figure 1 Galery Pyramid, Caral (3000 B.C.). Credit: Christopher Kleihege

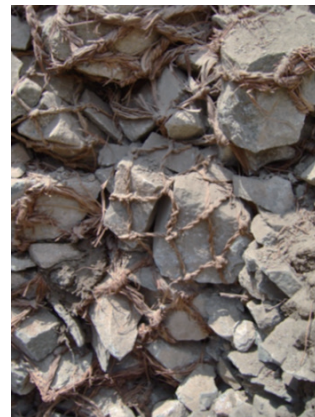
이 마지막 해법에서 건축가들은 진흙을 대신해서 튼튼한 식물로 꼬아 만든 밧줄을 이용하여 돌을 붙였다. 첨단 공학 기술로 간주되는 이 해결책은 현재 널리 보급된 개비온(gabion) 기술의 시초가 되었다. 피라미드의 중심부는 과거에 입증한 바와 같이 정적이며 동적으로도 안정적이다. 그림 2는 자외선 노출을 견딜 수 있는 해결책을 보여주고 있다. 2012년에 H. Fukuyama 등이 언급한 바와 같이, 진동대를 사용한 일본의 연구는 높이가 0.1~0.5m인 석재 층이 시공 시 지진 에너지를 막고 분산시킬 수 있는 기능을 할 수 있음을 입증하였다.

그림 2 천연 밧줄을 주머니에 넣은 각진 채석 석조를 느슨하게 하여 만든 안정적인 피라미드의 중심.
갤러리 피라미드, 카탈 제공 : J. Vargas-Neumann, C. Iwaki 및 A.Rubiños.

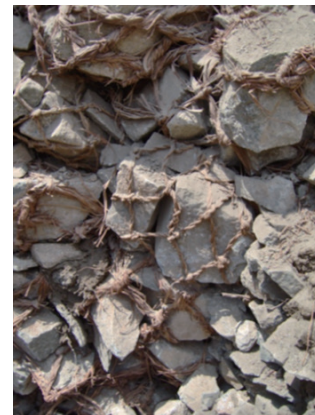
In this last solution, constructors replaced clay mud to attach stones by strong plant braided ropes used as bags (brought from the high of the Andes). This solution, which is considered as an advanced engineering technique, became a precursor the current disseminated gabions. The cores of the pyramids are static and dynamically stable as it has been proven in the past. Figure 2 shows this solution that has withstood UV rays exposure. As it is stated in H. Fukuyama et al, 2012, studies in Japan using shaking tables evidenced that the layers of stone bags whose height varies from 0.1 m to 0.5 m are able to perform as seismic energy isolators and dissipators, when placed underneath a construction.

Figure 2 Core of stable pyramids made of loosen angular quarry stones pocketed with natural ropes.
Galery pyramid, Caral. Credit: J. Vargas-Neumann, C. Iwaki y A.Rubiños.

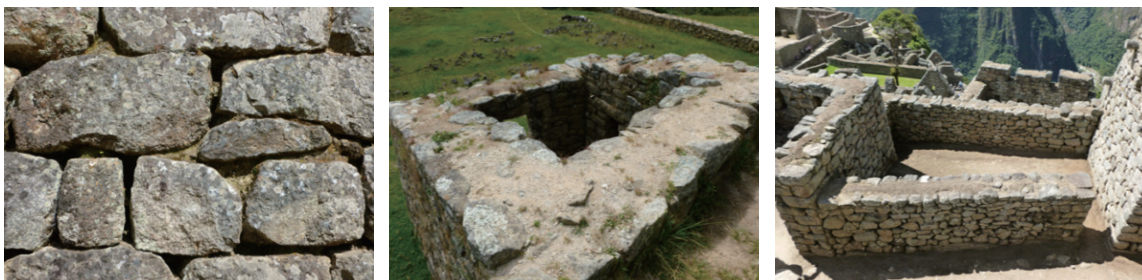
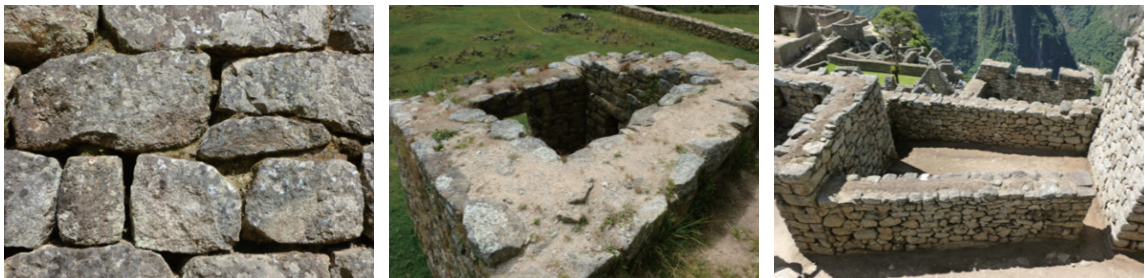
그림 3 중심부와 잘 보이는 흙으로 된 접합부가 있고 돌로 덮여 있는 벽.
제공 J. Vargas-Neumann

Figure 3 Walls with cores and visible earthen joints, covered with stones.
Credit J. Vargas-Neumann

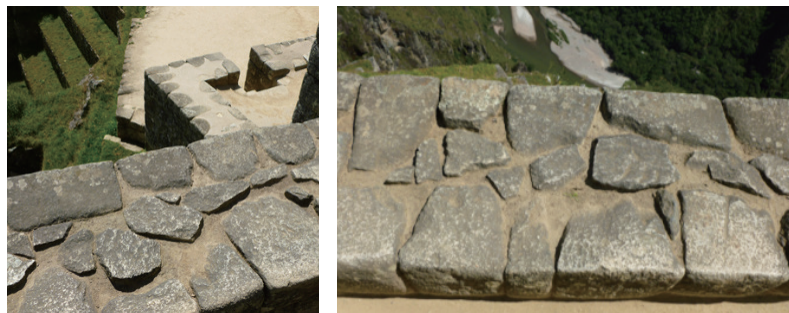
- 3) 흙으로 된 접합부가 있는 석조 석축기술. 흙으로 된 접합부가 보이지 않는 외관정면(그림 5 참조)

그림 5 내부의 흙이 노출된 돌담
제공 : J. Vargas-Neumann

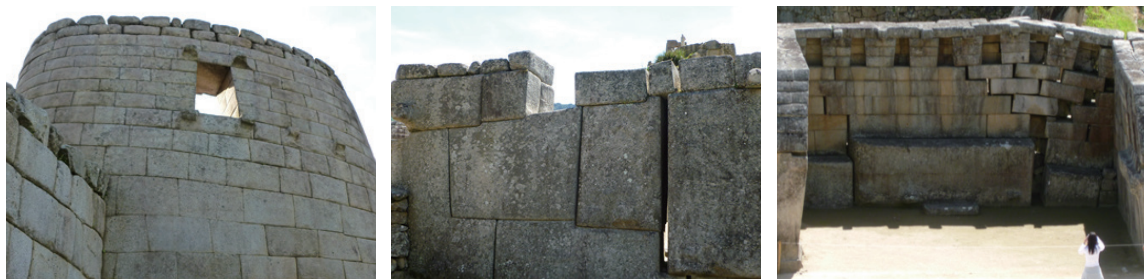
- 4) 흙이 없는 건조 접합부를 가진 석조 석축기술(그림 6 참조)

그림 6 비밀 장소에서만 사용되는 정교하게 조각된 석조 벽면. 지진이 일어나는 동안 지어진 벽은 덜 안정적이다.
제공 : J. Vargas-Neumann

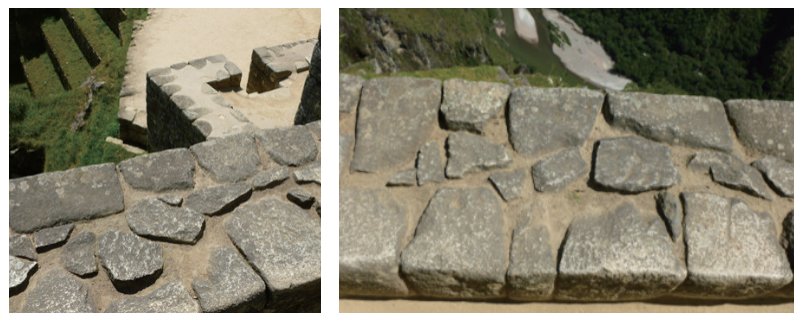
3) Stone masonry with earthen joints. Façades without showing earthen joints (see Figure 5).

Figure 5 Stone walls with exposing earth from the inside.
Credit: J. Vargas-Neumann

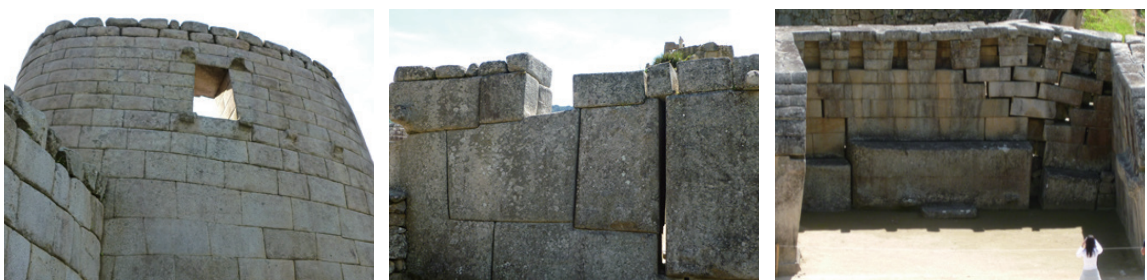
4) Stone masonry with dry joints without soil (see Figure 6).

Figure 6 Stone walls finely craved used only in sacret places. Less stable walls were built during the occurrence of earthquakes. Credit: J. Vargas-Neumann

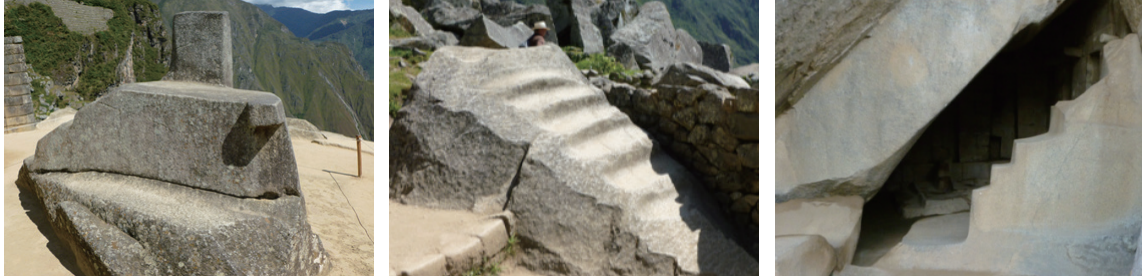
5) 접합부가 없는 일체형 구조물(그림 7 참조).

그림 7 단일 조각의 석조 구조물. 제공 : J. Vargas-Neumann

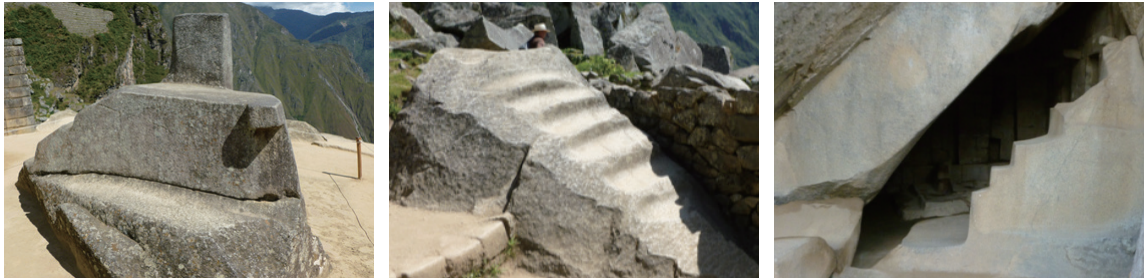
5) Monolithic structures without joints (see Figure 7).

Figure 7 Monolithic sculpted stone structures. Credit: J. Vargas-Neumann
