# PRINCIPIOS PARA LA CONSERVACIÓN DE LA MADERA EN ESTRUCTURAS HISTÓRICAS : EL DEBATE Symposium and Discussion of the Updating of the PRINCIPLES FOR THE PRESERVATION OF HISTORIC TIMBER STRUCTURES (1999)

**PRINCIPIOS PARA LA CONSERVACIÓN  
DE LA MADERA EN ESTRUCTURAS HISTÓRICAS : EL DEBATE**

Symposium and Discussion of the Updating of the  
**PRINCIPLES FOR THE PRESERVATION  
OF HISTORIC TIMBER STRUCTURES (1999)**

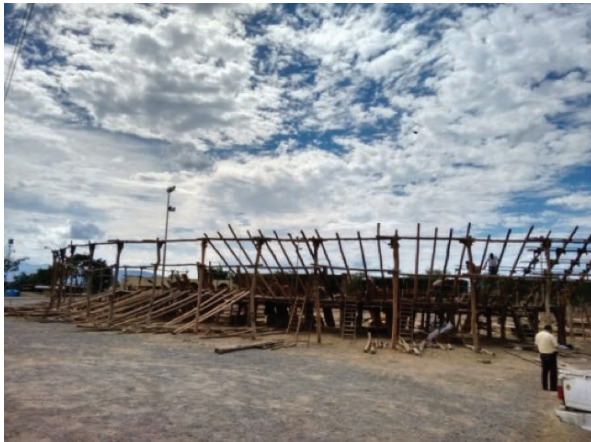
Fig. 2 Process of assembly of the parts and constructive elements of La Petatera

This structural system is joined together with ixtle cords and ropes. The work begins once the center of the land is located and the circle that defines to the ring is traced, which has a sixty meter-diameter and the built surface near three thousand square meters. The tier area, also built in wood, has an area of two thousand m<sup>2</sup>, what allows a capacity of approximately five thousand spectators. These tiers are divided in 70

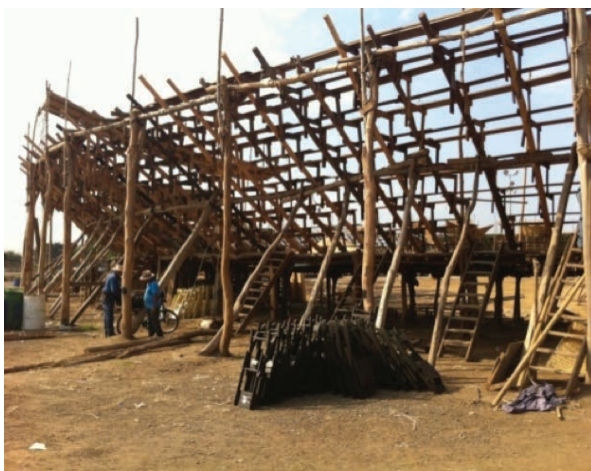
Fig. 3 Here can be observed the magnificent vertical support beams that bear the highest part of the construction and the cans or containers that will support the planks where the public in general sits.

It is an intelligent architectural work, endowed with a flexible, ingenious and efficient structure for the seismic area. The structure is an interwoven skeleton tied in perfect harmony and provided with great structural stability which is viable with a low recurrent cost of construction. It is formed structurally by a lattice of several types of woods found in the region and according to the characteristics of the system, either to absorb traction efforts through beams and main beams, as to transmit the compression forces to the land by means of horcones (supports).

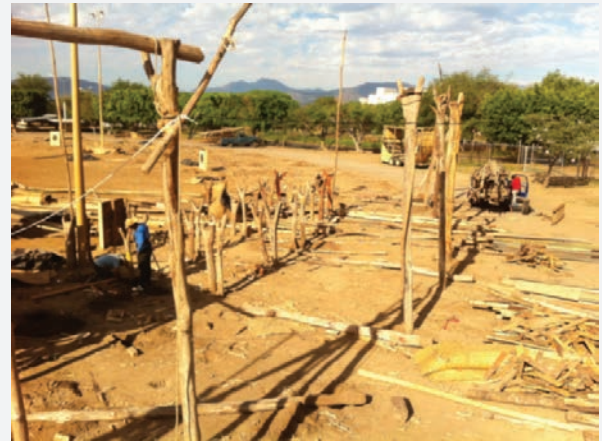
Fig. 4 Forks of initial support.

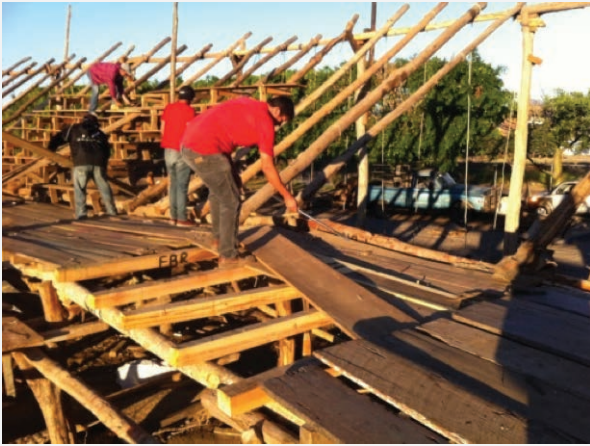
Fig. 6 Construction of the circulation Corridor of the whole ring.

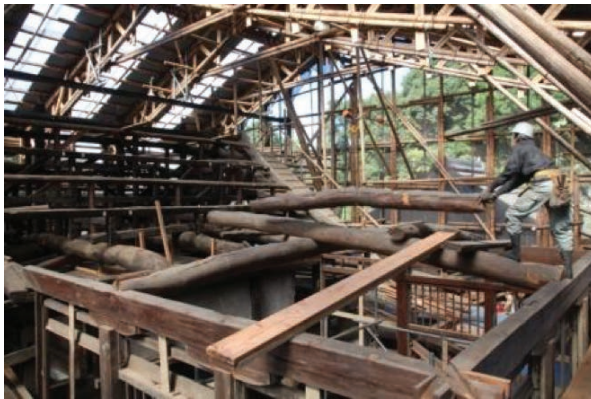
Fig. 8 Dismantling-conservation of the Hiari private palace in Kyoto

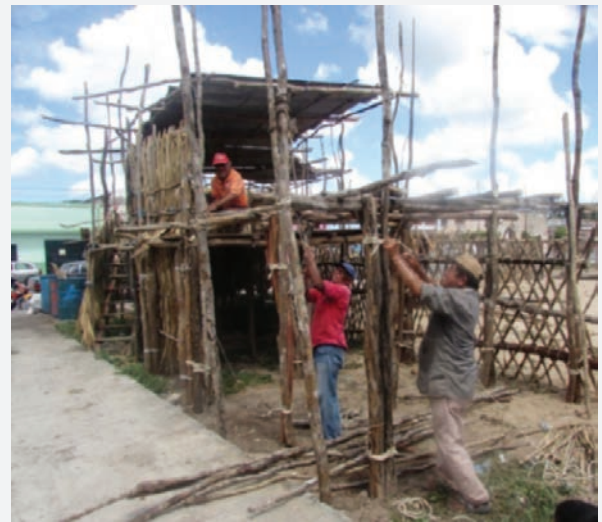
Fig. 10 Reformulation-conservation of the stands of Tizimin, Yucatán

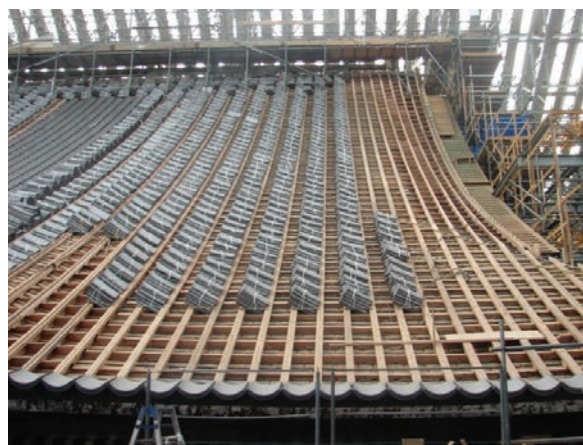
Fig. 12 Removal of materials and dismantling of the Himeji-jo Palace in Himeji Japan

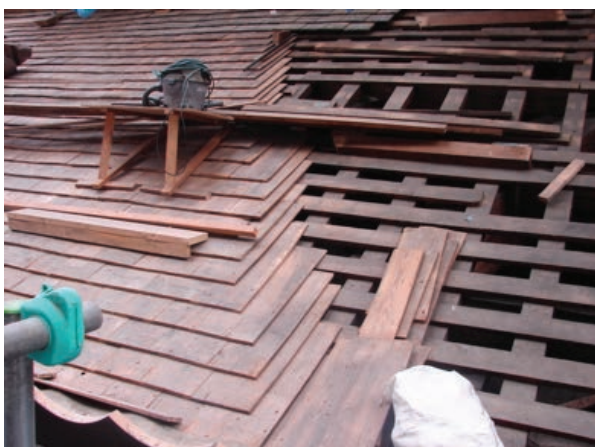
Fig. 13 Process of replacing missing members in the reassembling of elements on the palace's roof

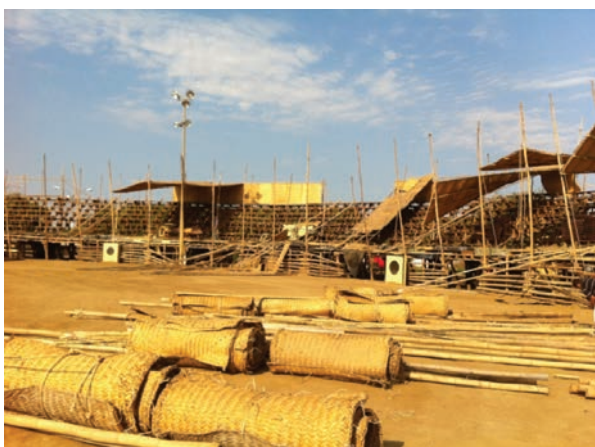
Fig. 14 Process of dismantling of La Petatera at the end of the festivities.

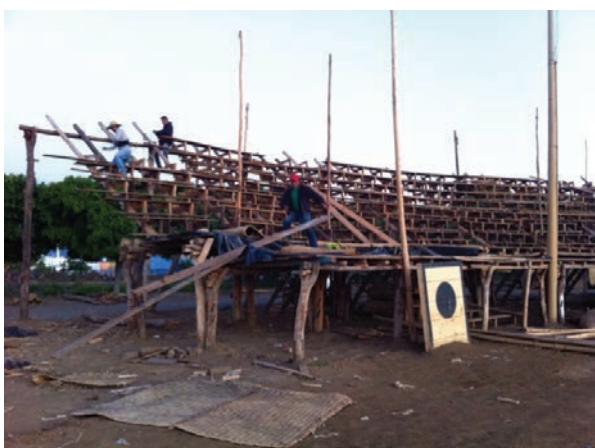
Fig. 15 Removal of materials and dismantling of La Petatera.

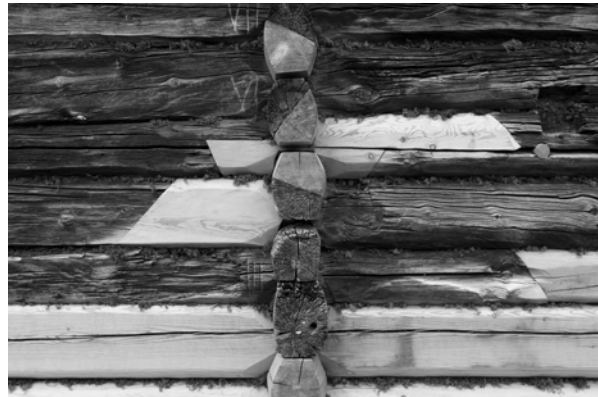
Norway-Old Kleppe farm.repair of logs with grafts

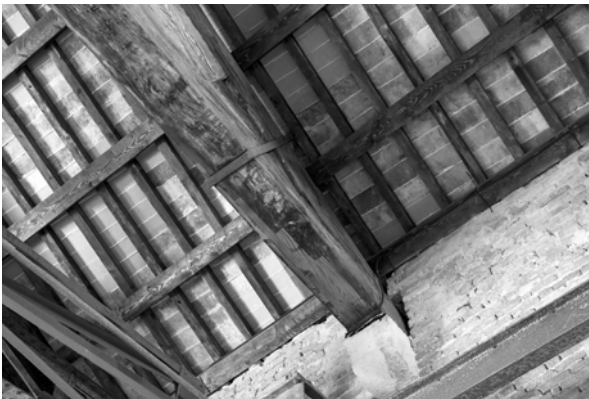
Italy. Venezia. L'Arsenale. Repair of a tie beam with a graft

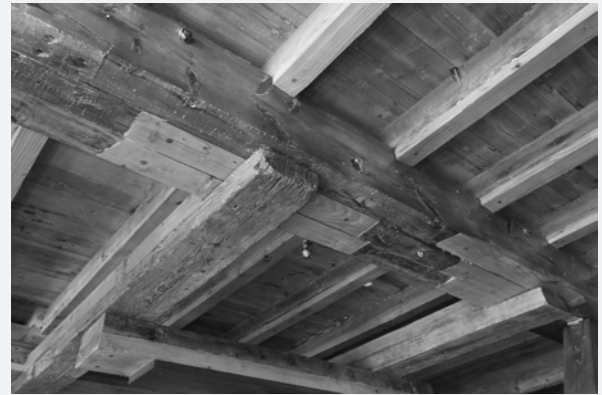
Spain. Aviles-Palacio Valdes theater. Repair of mobile structure. Grafts

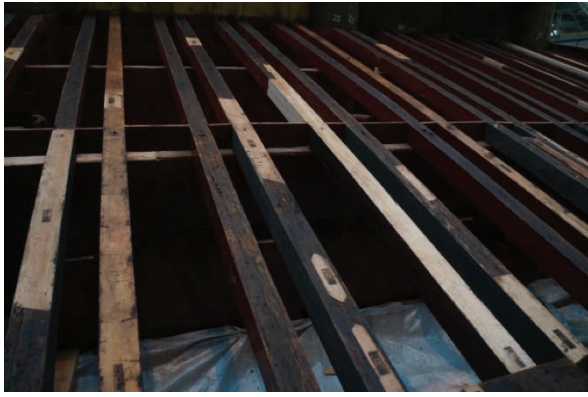
Fig.4 Different kinds of repairs of rafters made by splicing damaged timber with new wood, Rin'oji Temple, 2015. The date of the repair is burnt into the new.

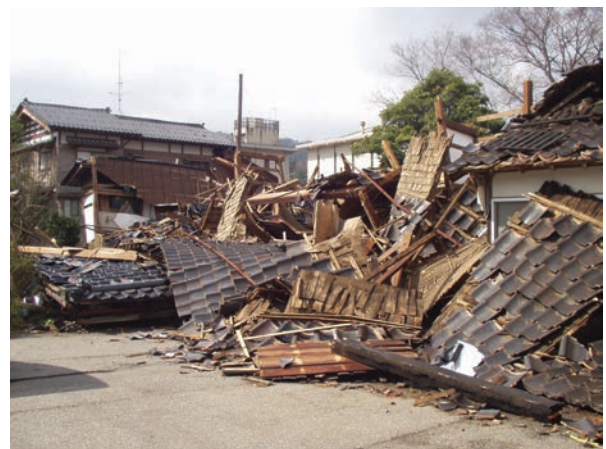
Fig3. Completely destroyed houses by the earthquake

Noto Peninsula Earthquake happened April 25th 2007. It recorded Magnitudes 6.9 and brought region one death and several hundreds of casualties. Also number of completely destroyed houses was 684 houses (Fig3), and partially destroyed houses counted around 30,000 houses.

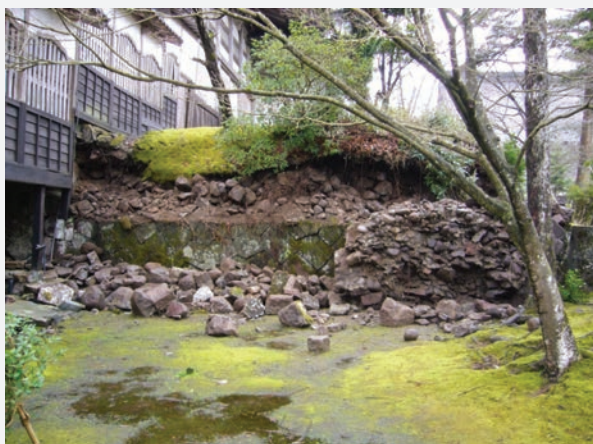
Fig4. Stone wall fell off

Front part of the ground for the building slid 15cm forwards and sank 16cm downwards. And stone wall fell off (Fig4). As a result of movement of the ground, plaster wall fell off, showing the bamboo frames. Not only walls were damaged, but also pillars were tilted that joints of thresholds for sliding doors loosened (Figs). The tilted pillars caused floor to sink, and it was dangerous to have ceremonies. For post-and-beam structure, the loosened joints and deformation of structure are critical damage for safety.

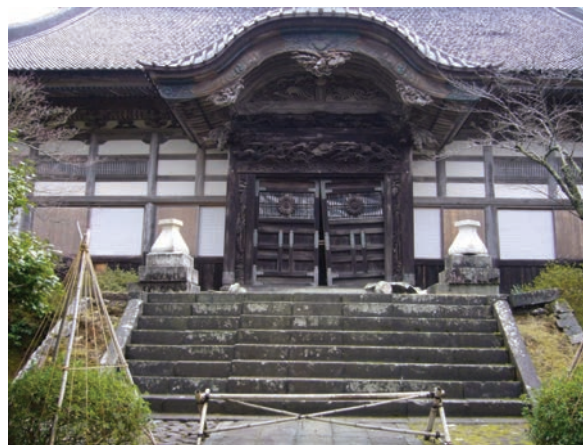
Fig5. Stone torches broken, main doors are damaged

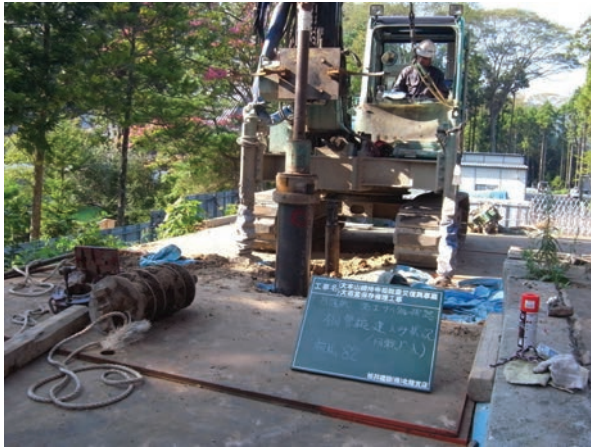
Fig6. Piling steel pile

One of the reasons that caused the ground slid was that front part of the ground was artificial and not stable. Prior to conservation project, we ran entire ground survey to decide which method shall be suitable for the building and the ground. As a result, we could see that there is solid layer about 7 meters beneath of the building. So steel piles were piled to the ground to prevent the artificial ground from further slide.

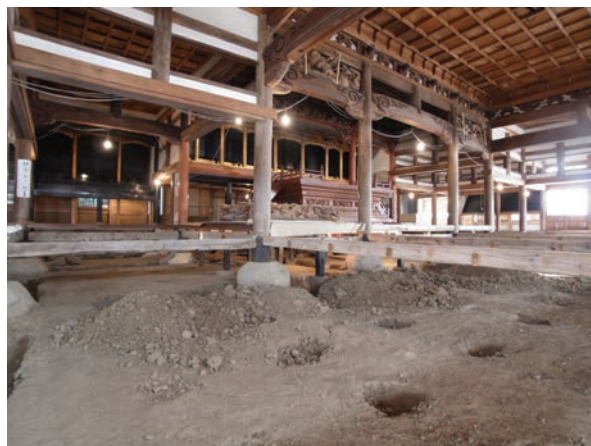
Fig7. Dismantling floors

### 3) Dismantle the floor and make preparation for jacked-up (Fig7).

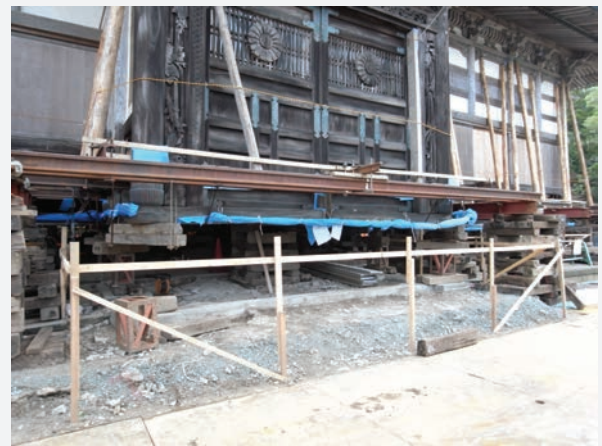
Fig8. Jacked up

It took almost a year from Jacked-up to Jacked-down.

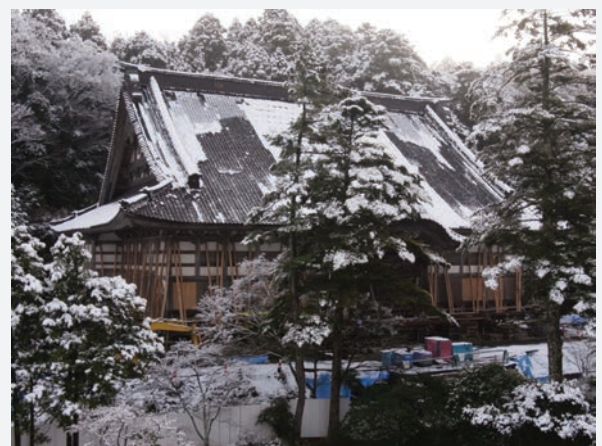
Fig9. Entire building is jacked-up

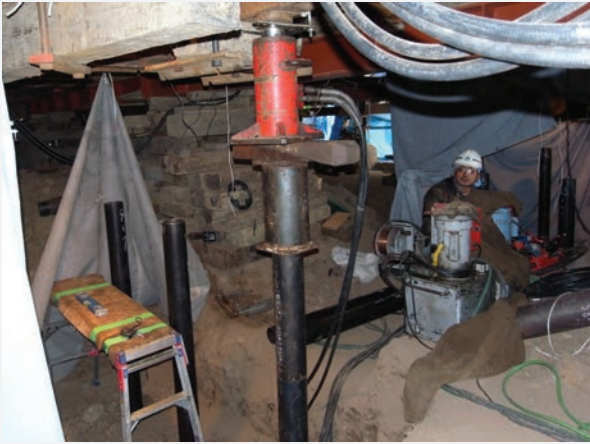
Fig10. Piling steel pile

**2) Install steel piles to support the ground and prevent further slide (Fig6).**

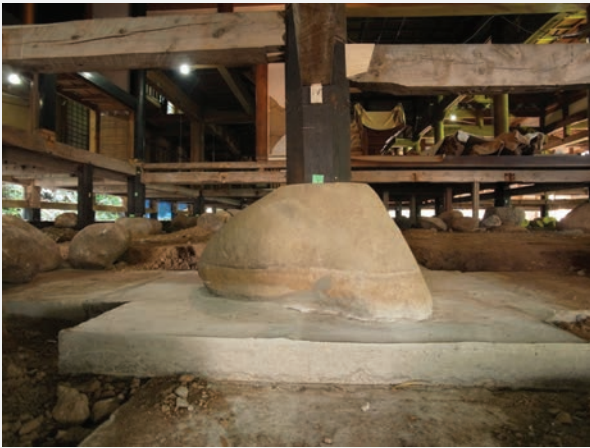
Fig11. Underground beam and base stone

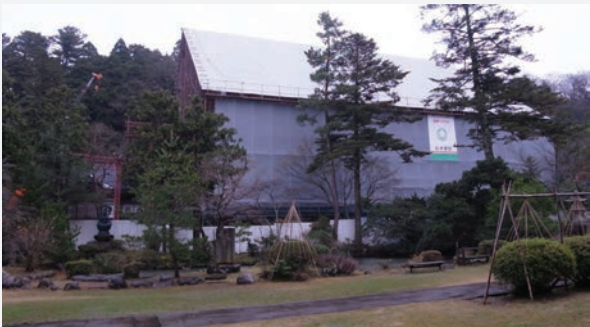
Fig12. The temporal structure to cover the building

#### 5) Construct temporal structure to cover.(Fig12)

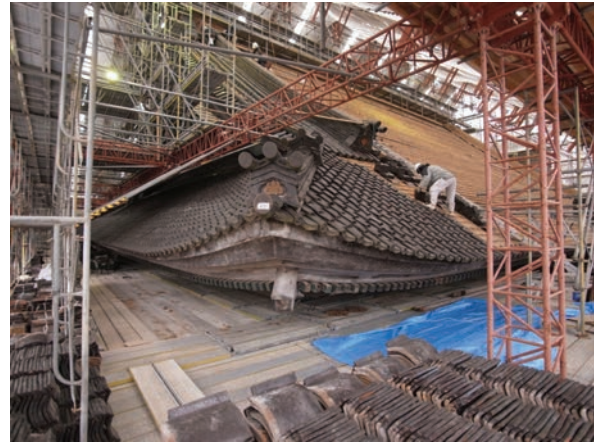
Fig13. Dismantling the roof tiles

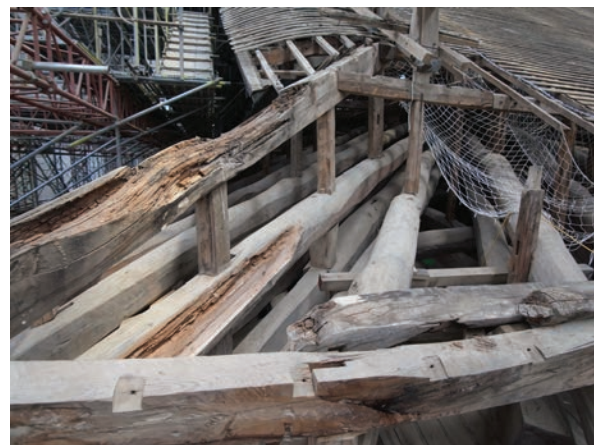
Fig14. The North West corner decay

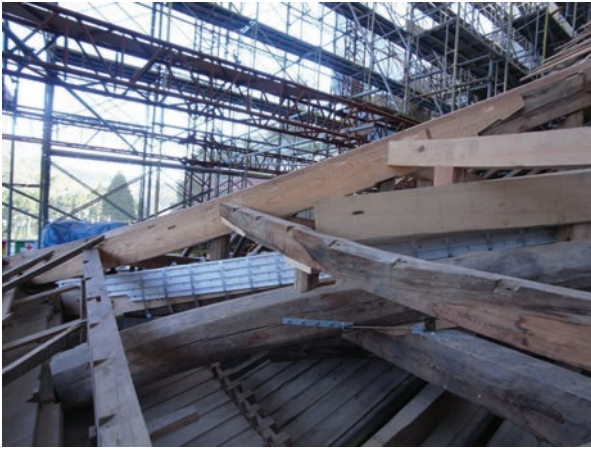
Fig15. The North West corner steel reinforcement

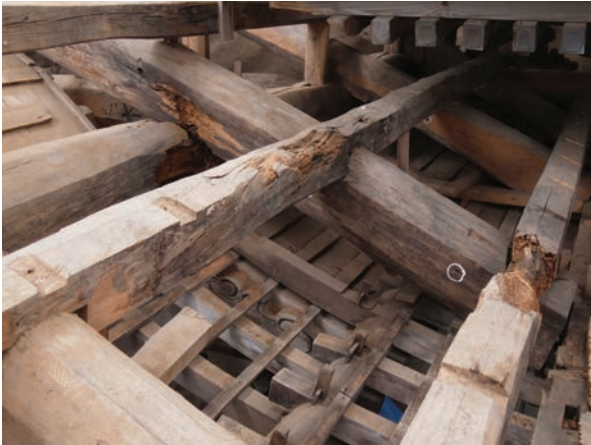
Fig16. Decayed projecting roof structure

The projecting roof was seriously damaged. Important structural timber decayed so that they are structurally useless. So those timbers needed to be replaced (Fig16-17).

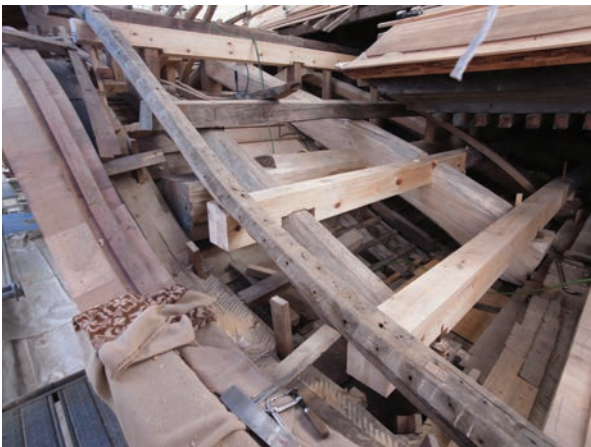
Fig17. Repaired projecting roof structure

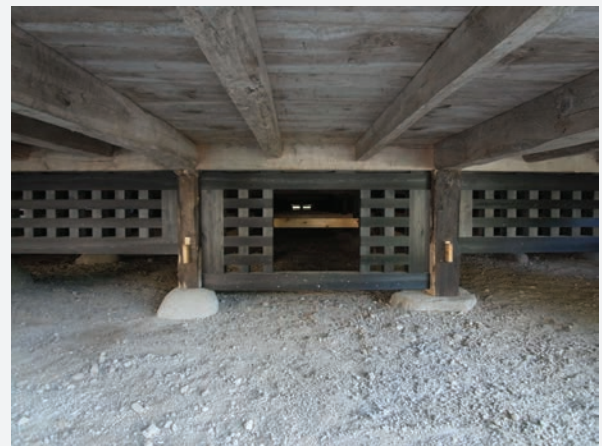
Fig18. Under floor reinforcement

To increase the seismic resistance and support the post-and-beam structure, we put solid grid and penetrating tie beam under the floor (Fig18). Floors, attached facilities were reassembled. We renewed fire alerts.

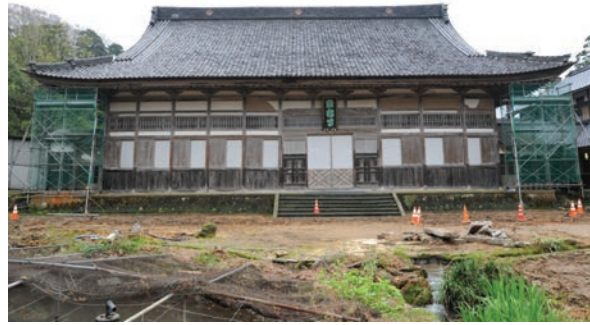
Fig20. Butsuden Scaffolds are for supporting roof

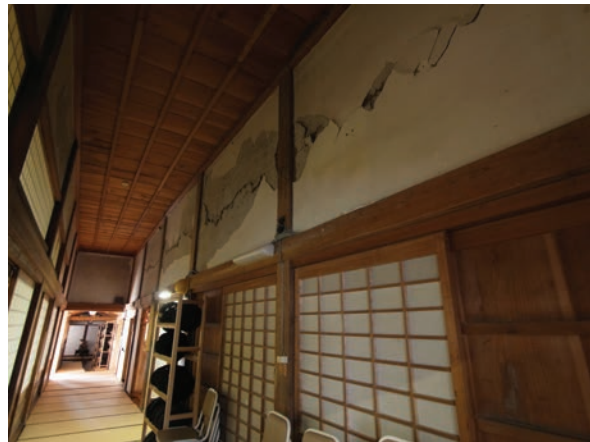
Fig21. Plaster wall fell off and cracked

As Daisodo, plaster wall fell off (Fig21), corridor tilted (Fig22). Also, roof structure was loosened by the deadly shake from the earthquake. Butsuden is the place for worship, but sometimes it is used as visitors' facility for staying overnights. So it requires severe safety for public. Not only from the earthquake, but also from critical water leak, they caused the damage to the building. It is known that Noto peninsula is area of heavy rain, snow and humidity. However the style of the roof was not considered for this harsh climate. So heavy rain and snow stacked on the roof for a while and thawed water leaked into the roof structure. This leads to the decay of the timber and caused the roof structure being unstable. Decay and fragile roof structure resulted dislocation of timber by the earthquake (Fig 23).

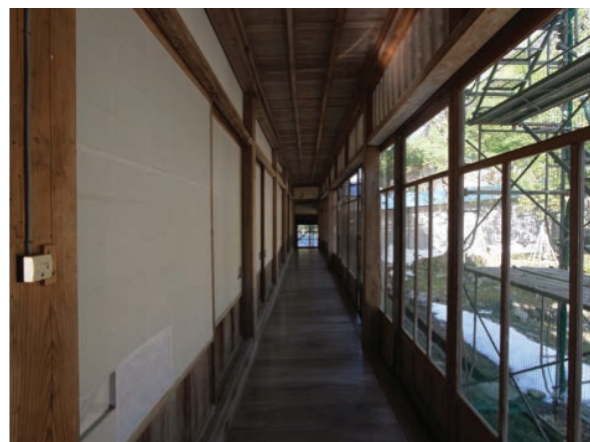
Fig22. Corridor tilted, floor sank 3.5cm in 1m (3.5%)

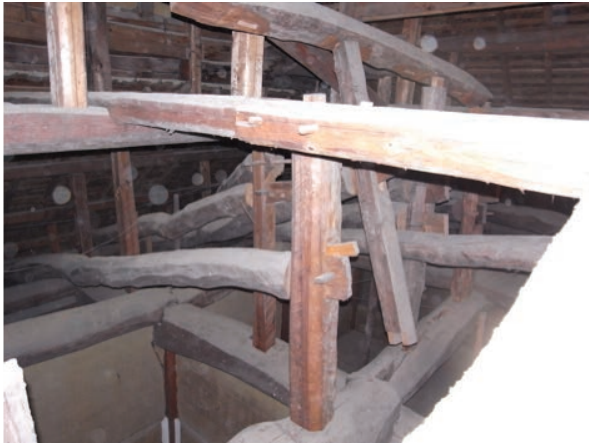
Fig23. Roof structure dislocated

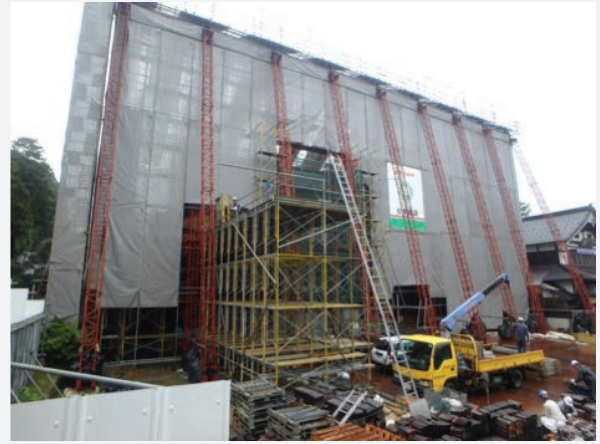
Fig24. Temporal structure to cover

#### 1) Dismantle attached buildings and construct temporal structure to cover. (Fig24)

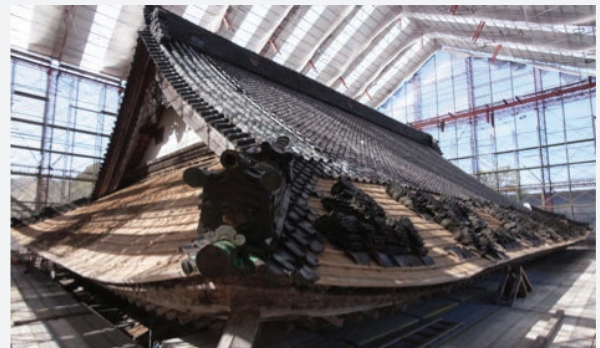
Fig25. Dismantling rooftiles

Full-dismantling method begins from inspection. Before dismantling roof tiles, we recorded styles of roof tiles, their condition, and materials and estimated the percentage of reusable roof tiles. Concerning dismantling the structural timber, first we took record of the shape, joints and measurements. During dismantling, each timbers were carefully removed from each other. Before storage, each timbers were again inspected for planning repairs (Fig 25-31).

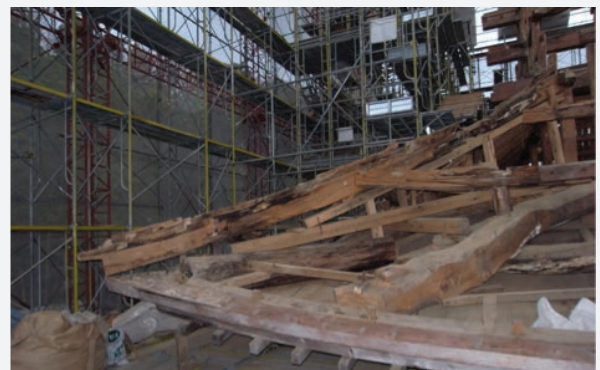
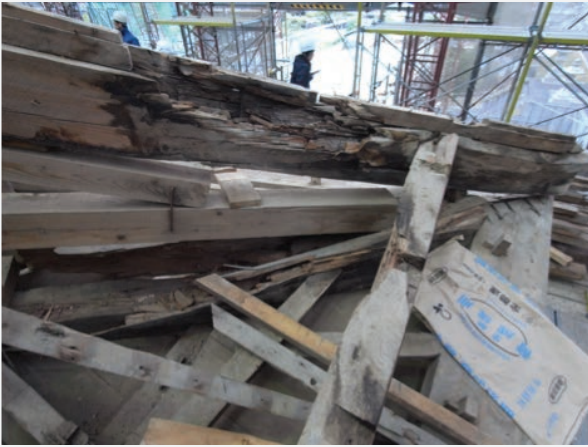
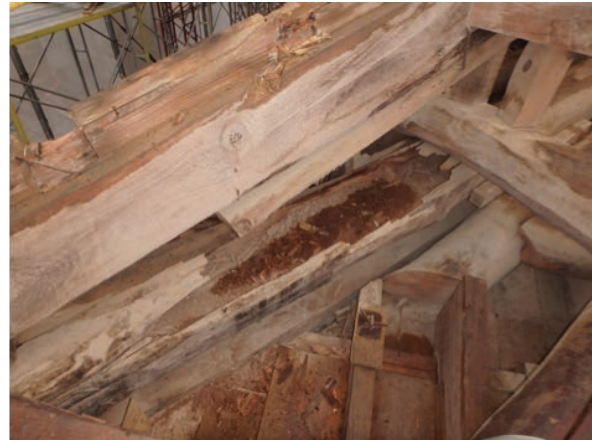
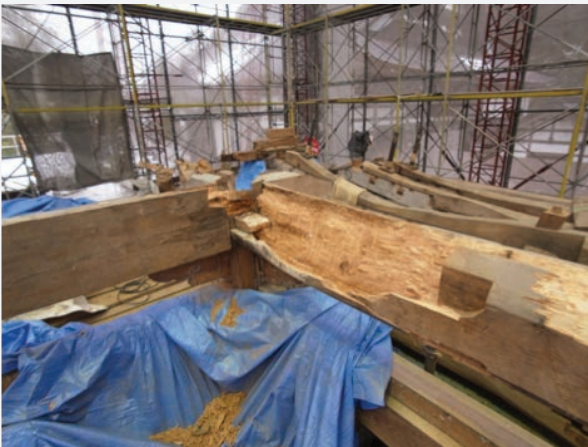
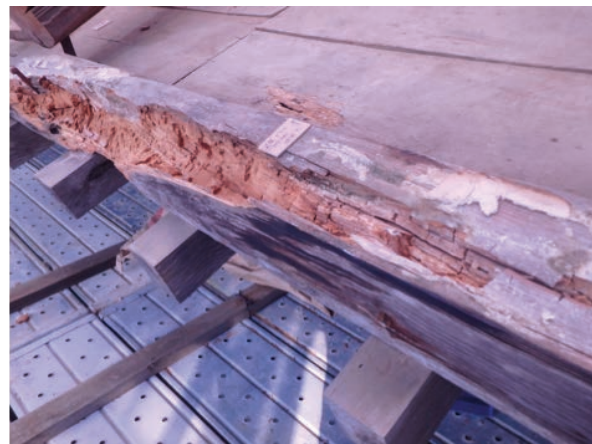
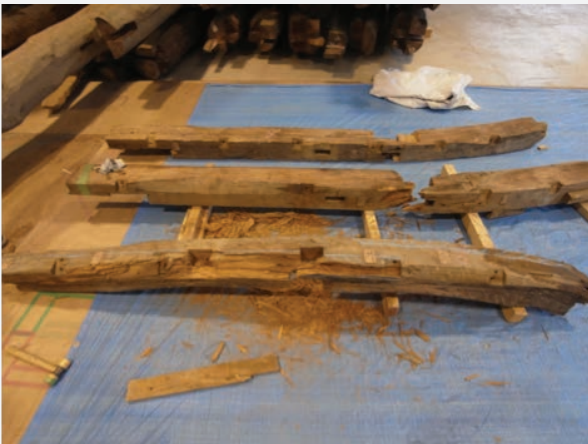
Fig26. Decayed structural timber

Fig27. Decayed structural timber

Fig30. Decayed structural timber

Fig28. Decayed structural timber

Fig31. Decayed structural timber

Fig29. Decayed structural timber

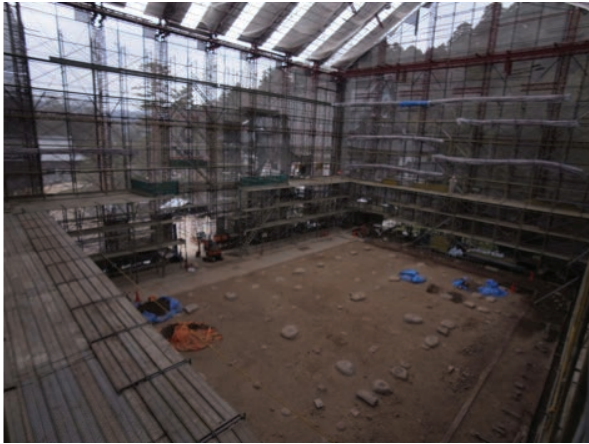
Fig32. Dismantling completed

On the end of February, we have completed dismantling the entire structure (Fig30).

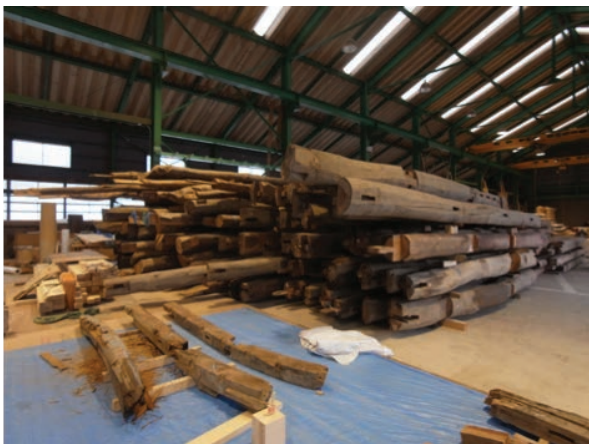
Fig33. Timber in huge storage

The timbers were put in huge storage (Fig31).

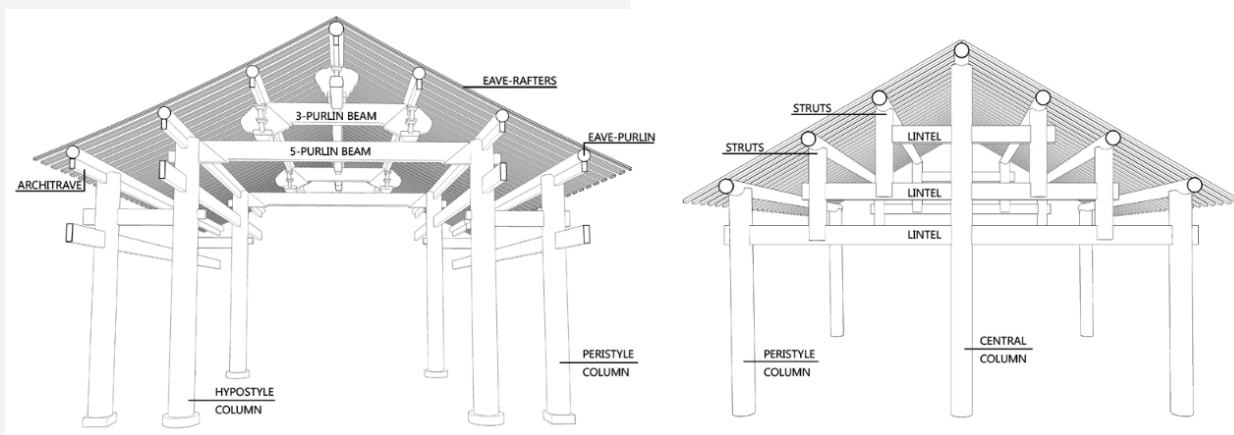
Fig.2 Two mainly kinds of the structure of the Dong buildings

The existing drum towers were mostly built from the early Qing Dynasty until the fairly recent years. Timber is the unique material used in constructing the Dong drum towers. Following the Chinese traditional categorization methodology, namely the “major carpentry” viewpoint which is based upon the structural techniques of the roof, specific drum towers are divided into two types: “Tai-liang” and “Chuan-dou” structures. The difference between these two kinds of structures is specifically the beams or lintels between the two columns (Fig 2). The structure directly leads to the different roof shapes of the drum towers, such as an overhanging gable roof, a gable-and-hip roof and a pyramidal roof. The indigenous construction techniques used by local carpenters can improve the inner space, the outer height and general façade of the tower.

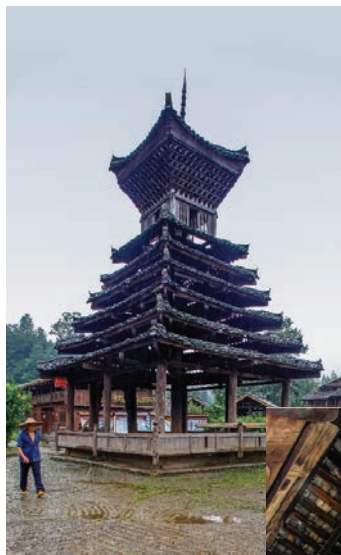
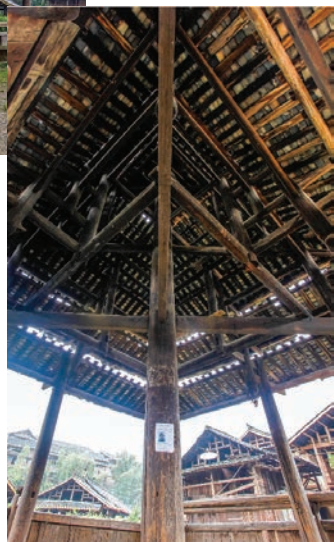
Fig.9 An Example of the Single Core-column Drum Tower (The Shu Dong Drum Tower)

The “single core-column” drum tower is recorded in literature for the first time in the Chinese Ming Dynasty. There are only three “single core-column” drum towers in the entire habitation area of the Dong minority. The method of construction is to put a core-column at the center of the plan, with eight horizontal lintels running in a radial direction from the core to the peristyle columns. The core-column reaches the top of the building and forms a structure of a multi-layer umbrella with those lintels (Fig 9).

To meet the evolving needs for good function within the drum towers, the core-column becomes an obstacle when using its inner space. The need to enlarge the inner space encouraged people to improve the structural method of the drum towers through time. In the original structure of the single core-column drum tower, the ring-columns structure was square, hexagon or octagonal in the plan, with two rings of columns (Fig 10). The ground touching core-column became the king-post after being elevated. So, this modification made it possible to promote the height of the drum tower, which was previously limited by the height of the core-column.

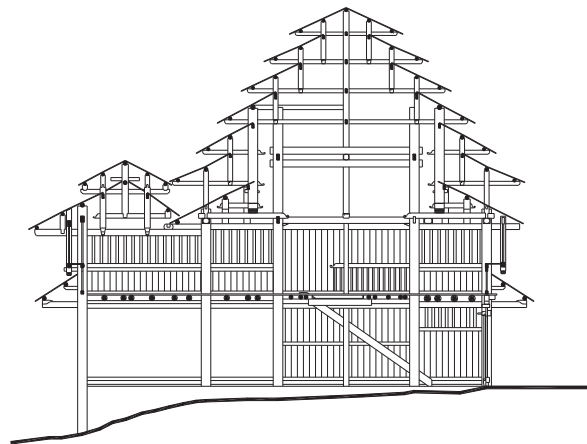
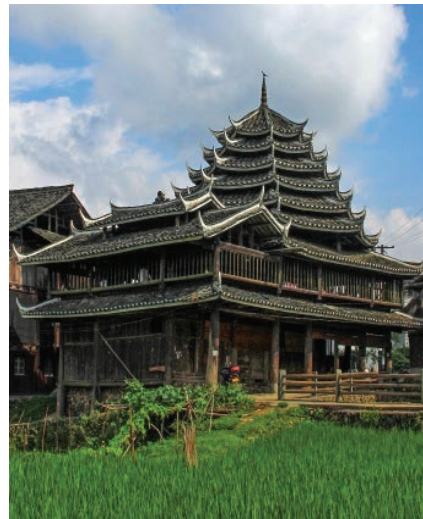
Fig.12 Heng Ling Xin drum tower

A row of columns is added to the peristyle to expand the utilization area in the Heng Ling Xin drum tower, which causes a multi-eaved overhanging gable roof emerging with the multi-eaved pyramidal roof (Fig 12).

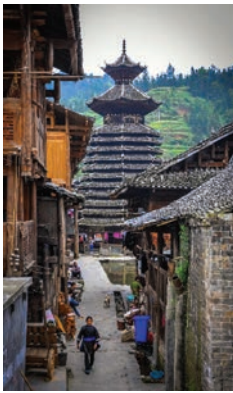
Fig14. Ji Tang drum tower

When columns are omitted in the hypostyle tower to improve the interior space, not only is the plane affected but also the framing of the roof. Specific examples are the Zeng Chong drum tower (Fig 13) and the Ji Tang drum tower (Fig 14) as shown below.

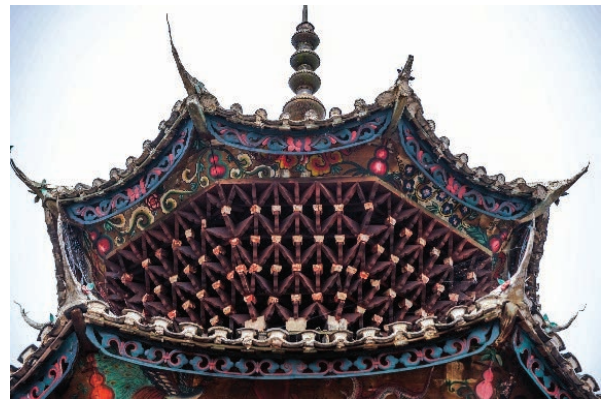
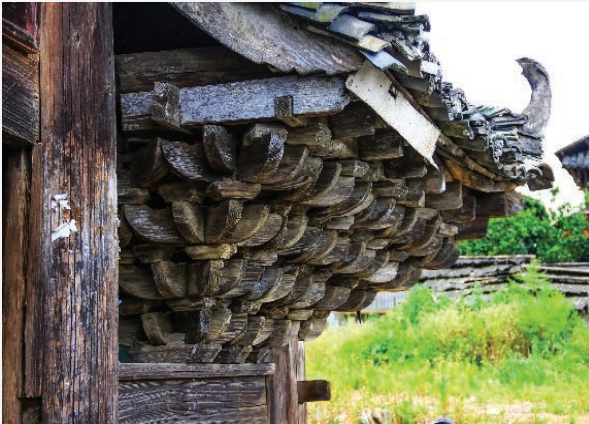
Fig.16 Tou-kung of the Dong's drum tower

The tou-kung is used to support the overhang of the top eave and also has a strong decorative effect on the drum towers (Fig 16).

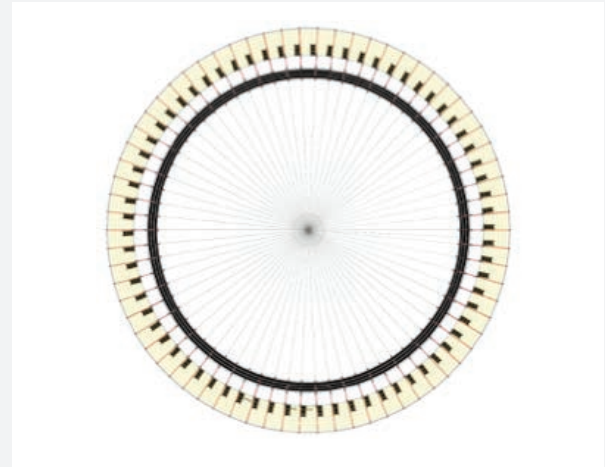
Architectural plant of Plaza de Toros “La Petatera”, Zamora Christian, Ortiz Iris Villa de Álvarez, Colima, 2016

The chain is the main element for the support holding of the monument, it is made up of the circular form supported by prop supports, transmitting the weight and the structure itself, it unites longitudinally speaking all the wooden elements and on top of it, section of stands, aisles, and stalls or seats.

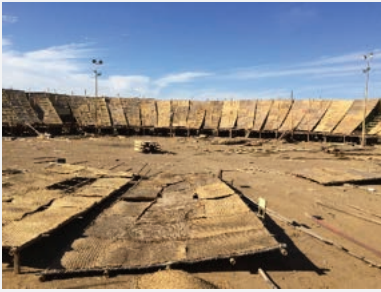
Picture 4. "Amarre de la trancas", Zamora Christian, Villa de Álvarez, Colima, February 2016.

The wooden structure is covered with natural textile fibers, forming a covering with *petates* o *tenates* (mats of palm leaves), made in the town of Gómez Farias Jalisco, brought each year to replace, just the ones that are not in good conditions.

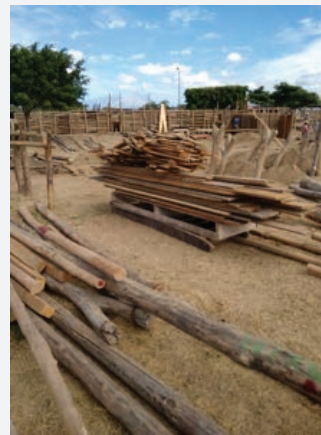
Picture 7. The process of construction, Ivonne Calvillo, Iris Ortiz. Villa de Álvarez, Colima, february 2016.

Once the excavation points are done, the arrival of trucks loads with wood and petates (mats made of palm leaves) that correspond to each platform and that year by year have been stored to be used exclusively to build the Plaza de Toros “La Petatera”. The unloading begins with the right footings and posts which are the ones that are posted in each hole. The workers put the wood next to each platform making piles of wood that later will make the structure. As the days go by Mr. Desiderio Contreras lines up the posts in a way that they are radially aligned to the center of the bullring, this is done a “*puro ojo*”<sup>27</sup> with the end post that will serve as axes to align the ones in the middle. In each platform the same alignment procedure is done fitting the fork support to receive the support or milestone.

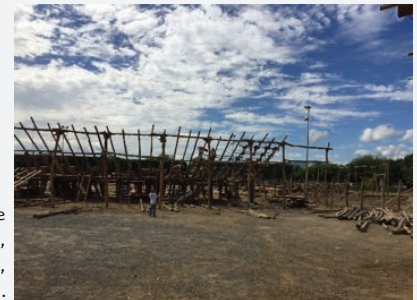
Picture 8. The structure in process, Ivonne Calvillo, Villa de Álvarez, Colima, february 2016.

The work is organized in crews, while some rest others continue the following tasks. Ones the majority of the post are aligned and dug in the sills are risen using system pulleys with ropes. The work must be done in a group of work since each platform is a complement of a whole and there cannot be any error of leveling, tying or dig in because it can harm the whole structure. Mr. Desiderio Contreras has been responsible for 24 years of the handcraft monument.

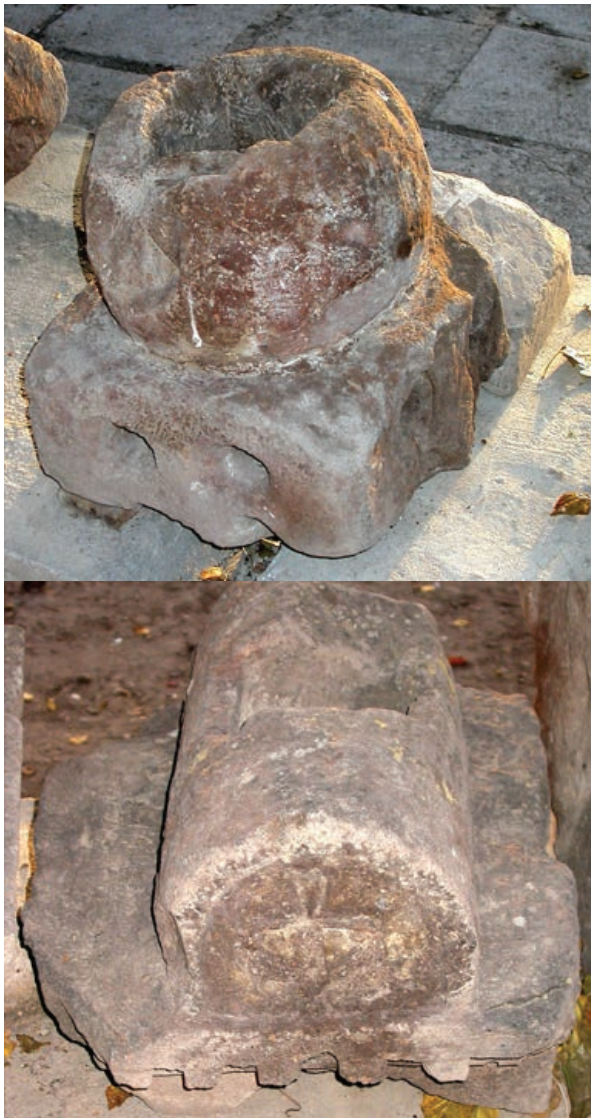
o4 - Column's capitals that had timber element as the main structure found in Dvin site.

In the archaeological site of Dvin (V-XIII century AD) there are column bases and capitals that had unequivocally, as the main structure, a timber element. (Fig.o4)

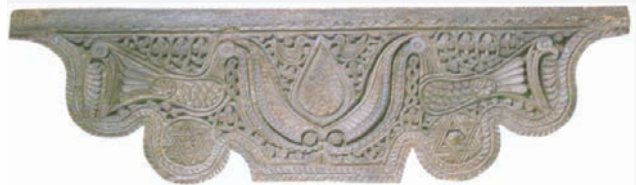
o5 - Wooden Armenian capital of 874.

Other important ancient wood works are, always by way of example: a wooden carved capital of 874 AD belonging to the Church of the Holy Mother of God (Surp Astvatsatsin) on Lake Sevan (Fig.o5); a walnut panel, preserved in a private collection in London, carved in 1188, belonging to the Church of Holy Cross (Sourp Nshan) in Haghpat; the walnut carved door of 1212 from the Church of St. John the Baptist (Surp Hovhannes Karapet Vank) in Mush destroyed by the Turkish army in 1915 and now in a private collection in Canada; the southern walnut door of 1486, belonging to the Church of the Holy Apostles (Surp Arakelots) on Lake Sevan.<sup>7</sup> (Fig.o6)

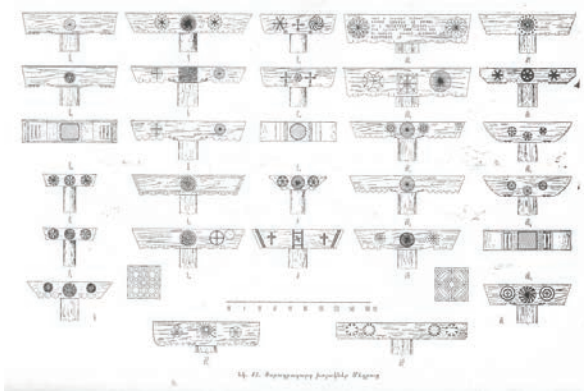
08 - Wooden capitals drawings from Papukhian N., The vernacular architecture of Syunik, 1972.

Very helpful was the study, published in 1972 by Papukyan, a real forerunner on the structural characteristics of wood in the Syunik region. (Fig.08) But scholars are still too few in relation to the large amount of work to be done before it is too late.

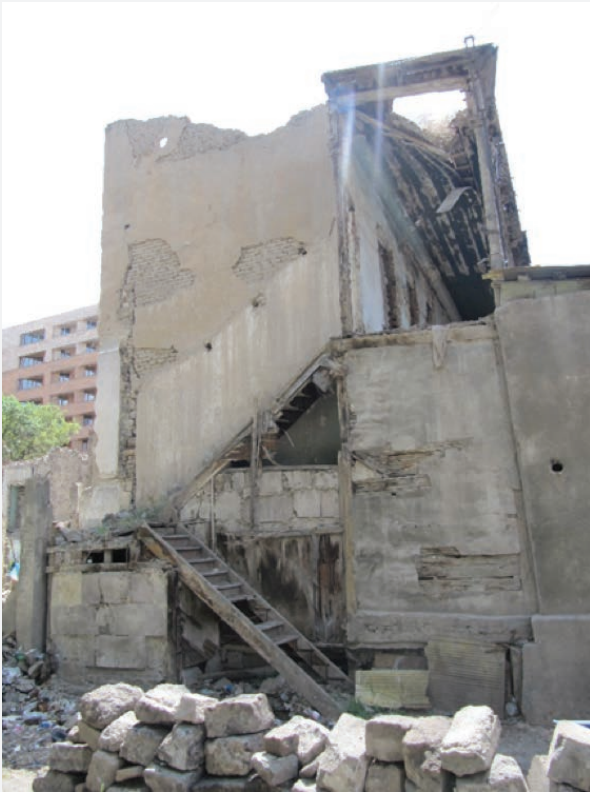
10 - Example of architectural "improvement" in Yerevan. A portion of the beautiful Afrikyan house. Picture taken on June 2014 before the complete demolition of the old building occurred on July 2014.

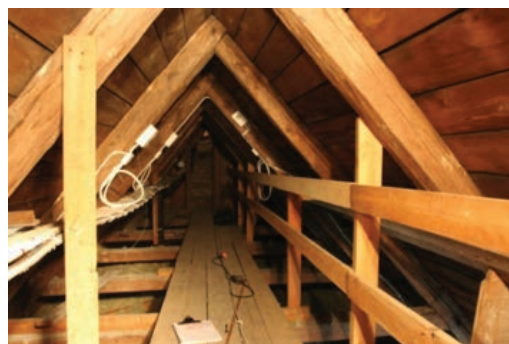
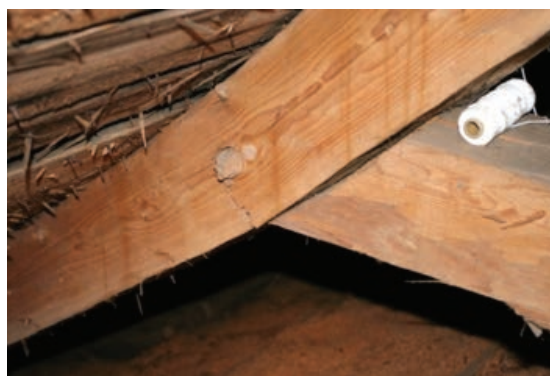
Figure 1 Threats to historic church roof trusses. a) Insidious, successive changes that transform the attic as a historic setting. b) Structural problems (the picture shows a material failure in a rafter). The dominating problem is the one where the trusses have lost their horizontal support. This leads to large stresses in rafters. c) Rot. d) Trusses are covered in insulation and become difficult to inspect.

- Successive, insidious transformations of the attics as historical settings. Gangways, lighting equipment, cables and alarm installations are frequently insensibly installed.
- Design-related structural problems. These are unusual but can have large consequences.
- Moisture and its extreme consequence rot. Rot often leads to structural problems. Choosing repair measures typically means that one has to choose between preserving the historic setting and the structural behavior and preserving the historic material.
- Insulation: structures are covered in a way that makes inspection impossible.

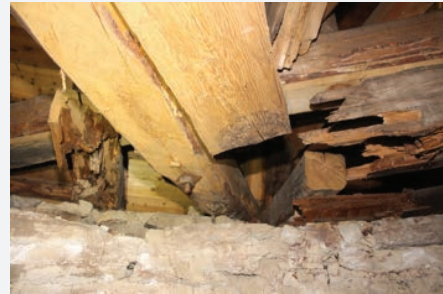
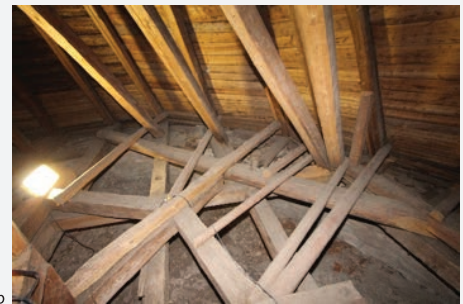
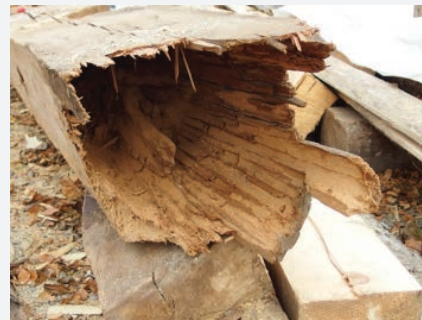
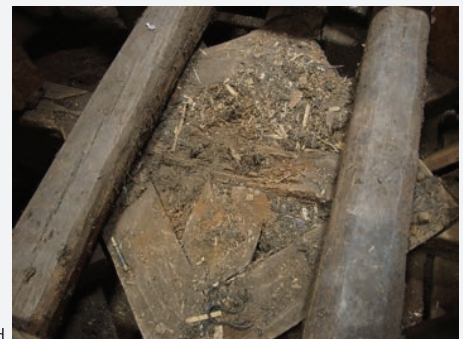
Figure 3 Skörstorp church. a) Rot damages. b) Some of the old repair measures. c) Wall plates were found to be more damaged than first assumed. d) Part of the beam system damaged by rot. Photo a, b and d: Carl Thelin. Photo c: author.

existence of damage by rot. Some of the beam ends and wall plates were entirely destroyed by real-rot fungus as well as some of the lower rafter ends. The central beam in the beam system was rotten in the middle and was leaning against the vault. There was a system of partially inefficient repair measures. These were at least a few decades old, suggesting that some of the damages had been there for a long time

The system of beams have an important role in keeping the lower ends of rafters in place and preventing their slipping. When beams are severely damaged there is a risk that (larger) horizontal forces come to act on the walls of the church. The walls of Skörstorp church are cracked in a way that suggest that they might have been pushed outwards by the roof structure - or by the vault. The question was raised whether the spire had come to lean on vault.

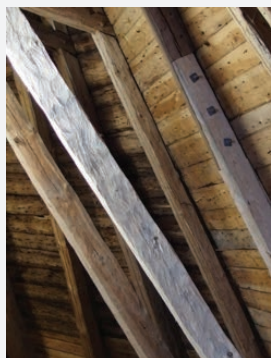
Figure 4 a) Repair measures: a new part (in the foreground) and a spliced rafter. b) New wall plates and new rafter ends. The picture was taken when the whole structure was lifted by jacks in order for one of the beams to be replaced.

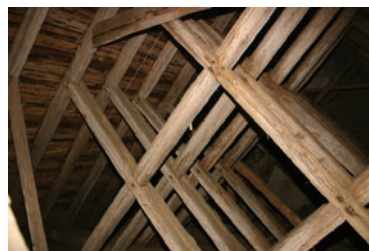
Figure 5 Marka church, roof trusses above the nave. Photo: Carl Thelin.

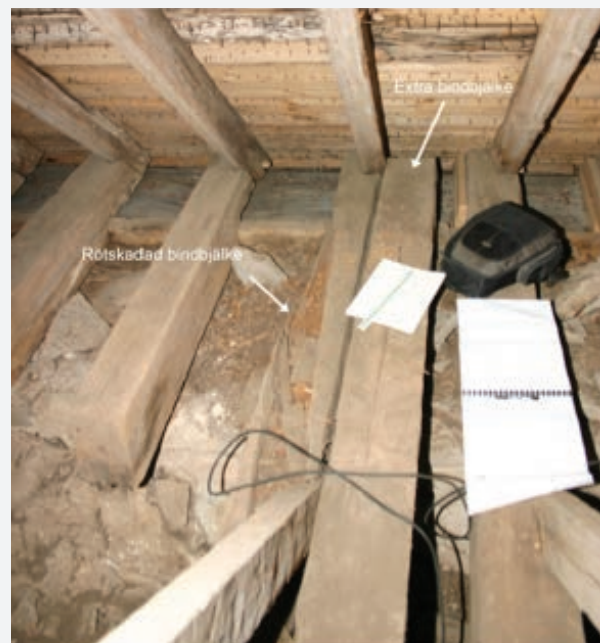
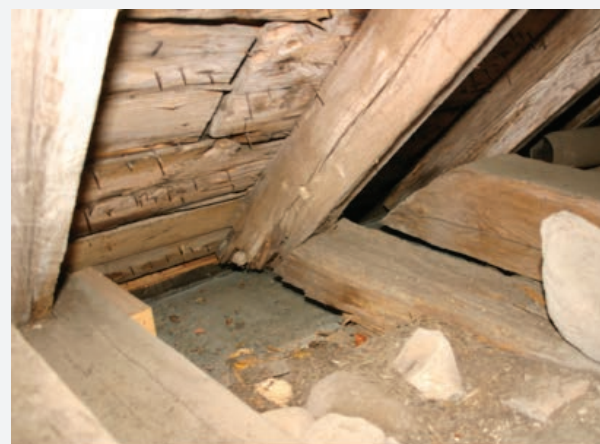
Figure 6 Marka church. a) and b) Rot damages. c) Tie beams have been cut off and struts removed where vaults are built in. Extra parts have been added to compensate for lost ones. Photos: Carl Thelin.

Measures like the ones in Skörstorp could be prescribed, where rotted parts are cut off and the remaining parts repaired with new timber. As damages in Marka church are spread over the attic, repairs will probably be visible from almost every part of the room. Also, a large amount of medieval material will be removed.

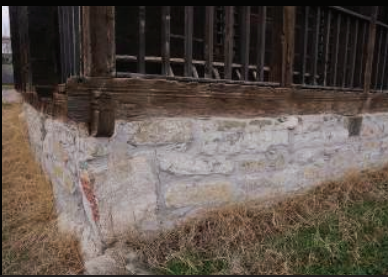
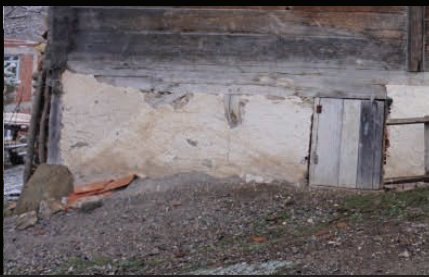
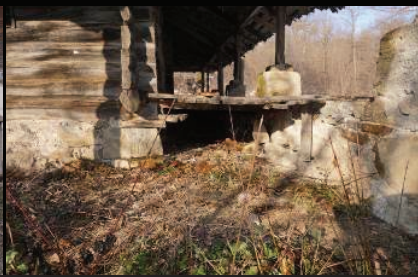
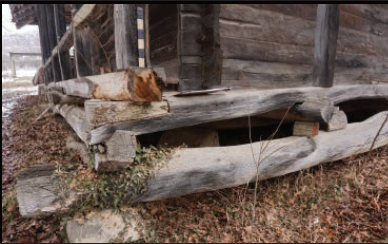
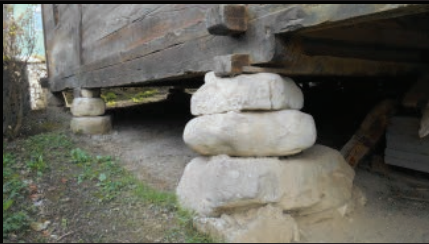
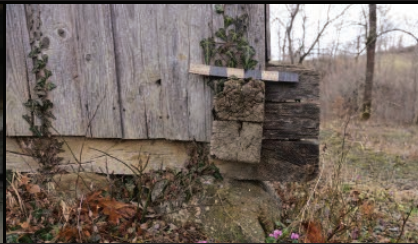
BEKDEMİR MOSQUE		ALAGOMLEK KOYU MOSQUE		TATARMUSLU MOSQUE

DERE MOSQUE		ÇAKALLI MOSQUE****		KOSACA MOSQUE			
<p>* Given measurements indicate distances between earth and ground beam where the slope angle is widest (north-south direction).</p> <p>** Most of the mosques located in the flat terrain. However, Bekdemir and Alagomlek mosques were documented as removed in the past.</p> <p>*** conglomerate, agglomerate, sandstone, volcanic rock – andesite</p>				<p>**** Footing stones were built without mortar by placing one or more stones according to the available materials to create the required height.</p> <p>- <b>Abbreviations:</b> M (Mosque) G (Ground) F (Floor) S.A (Slope Angle)</p>

Due to rainy climatic conditions of Kavak, solutions were created as to protect wood material from the humidity in time. The principle one is to lift the buildings from the ground by isolated footing stones or masonry walls, which has also subbase function, to prevent wood materials’ moisture deterioration. Stone material species used for the basis have been identified as conglomerate, agglomerate, sandstone, volcanic rocks and marble. [Table 1]
