# PRINCIPIOS PARA LA CONSERVACIÓN DE LA MADERA EN ESTRUCTURAS HISTÓRICAS : EL DEBATE Symposium and Discussion of the Updating of the PRINCIPLES FOR THE PRESERVATION OF HISTORIC TIMBER STRUCTURES (1999)

**PRINCIPIOS PARA LA CONSERVACIÓN  
DE LA MADERA EN ESTRUCTURAS HISTÓRICAS : EL DEBATE**

Symposium and Discussion of the Updating of the  
**PRINCIPLES FOR THE PRESERVATION  
OF HISTORIC TIMBER STRUCTURES (1999)**

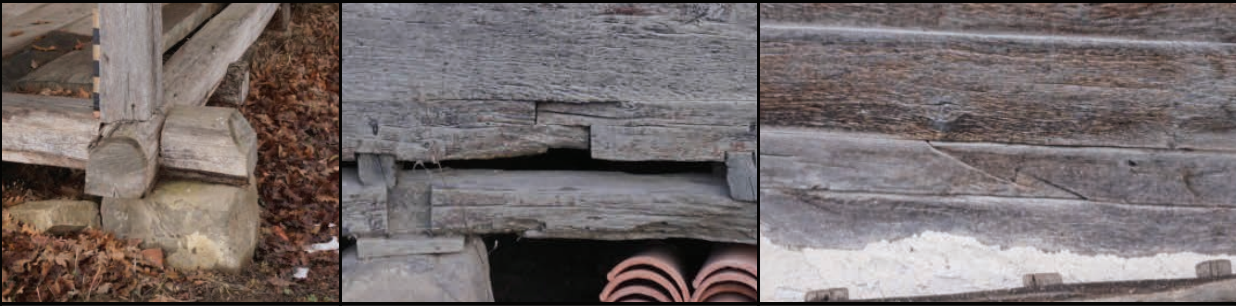
<p>Cross lap technique (Dere Mosque)</p> <p>Half Lap Technique (Cakalli Mosque)</p> <p>Jupiter Technique (Alagomlek Mosque) ****</p>						
<p>* min-max dimensions are taken on-site measurements and calculated on photos for inaccessible levels.  ** indicates the longest single wood element's length used in the mosque.  *** by using half-round logs  **** This technique was detected also in reconstruction work of Kutluca Mosque in Ordu. [9]  - <b>Abbreviations:</b> M (Mosque) W (Width of Timber) H (Height of Timber) L (Length of Timber)  <b>JOINT T</b> (Joint Technique) <b>JOINT L</b> (Joint Length)</p>

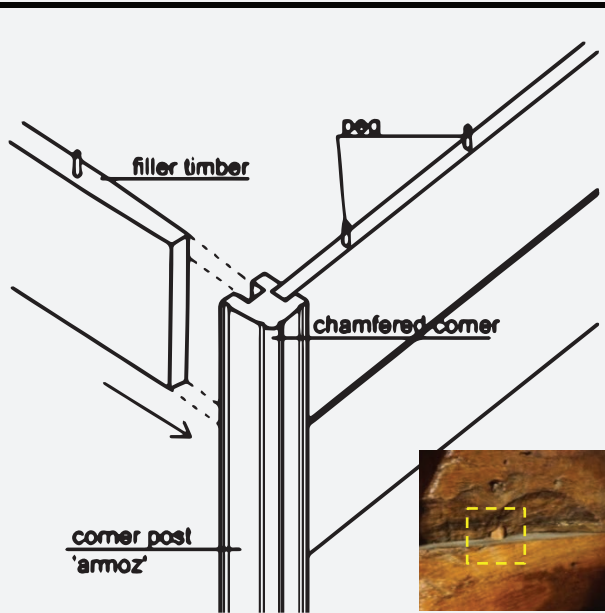
Corner Wooden Post ( <i>armoz</i> ) Detail	Peg Detail**	Corner Post	Wooden Diagonals
<p>* This technique was only used for Cakalli Mosque.</p> <p>** Pegs used in Cakalli Mosque are in cylindrical shape while the other mosques' pegs are in rectangular shape.</p>

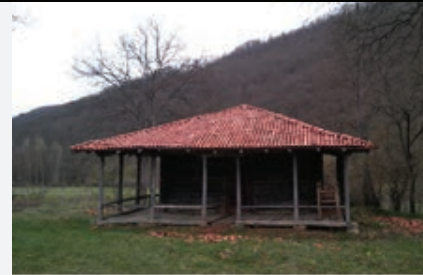
<p>Dere Mosque's Roof</p>

constructed wide as to avoid rainwater damage. It is observed in the field study Tatarmuslu mosques' original wooden rafters have drip edges (Table 8). For roof construction oak, pine and chestnut woods were used. As roof covers, mission (*alaturka*) and Marseilles (French) tiles exist today. However, in some previous studies, wood roof cover (*hartama*) usage was stated for these mosques.

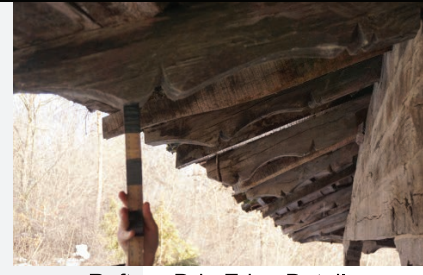
<p>Rafter - Drip Edge Detail Tatarmuslu Mosque</p>
