TRADITIONAL BUILDING INVENTORY - NEPAL

An initiative to document traditional buildings to facilitate culturally sensitive rebuilding process in Post-Earthquake recovery process in Nepal.

A TRADITIONAL NEWAR BUILDING AT THANKOT

KAT/2017/PI/H6

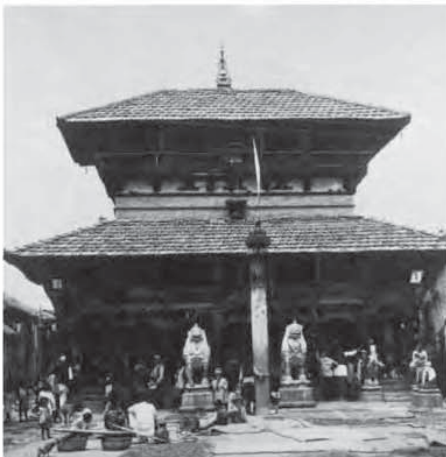
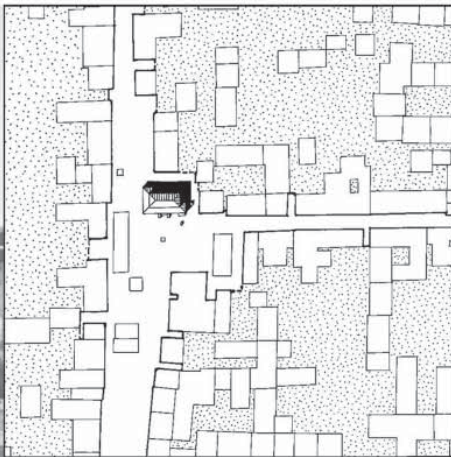
Brahmāyaṇī

This large two-storey temple is built on a rectangular plan. The entrance to the sanctum is marked by three doorways, each with a torana of Garuda. Directly below the roofs of both storeys is a latticed window-balcony. The struts depict the Matrikas. In the courtyard are images of Vishnu, Ganesh, Mahakal, a small stupa, a pair of lions and a pillar. The temple was built during the seventeenth century and renovated in 1701, and again by the local people in 1936. The priest is either a Maharjan or a Mali. Its festival is on Marga-shukla-purnima.

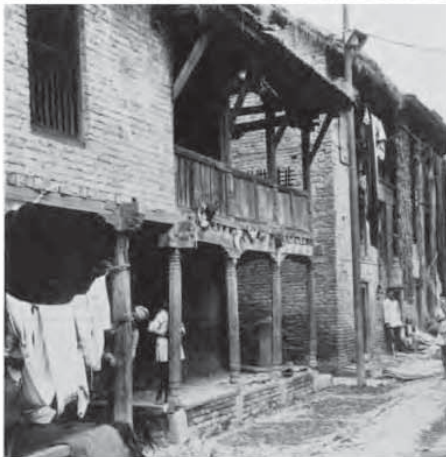
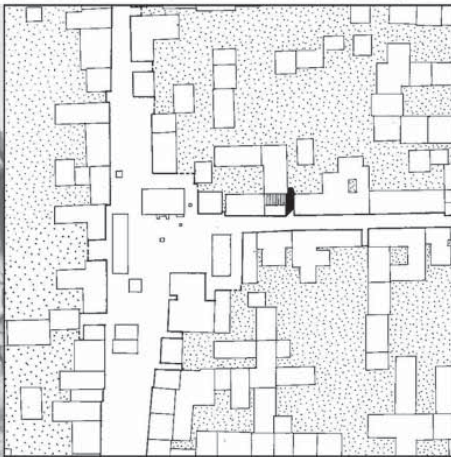
Navadurgā

This is a plain brick Shakta temple. The woodwork on the pillars, doors, windows and struts is very simple. It was built during the nineteenth century and renovated by the local people after 1934. The priests are a Maharjan and a Mali. Its festival is on Marga-shukla-purnima.

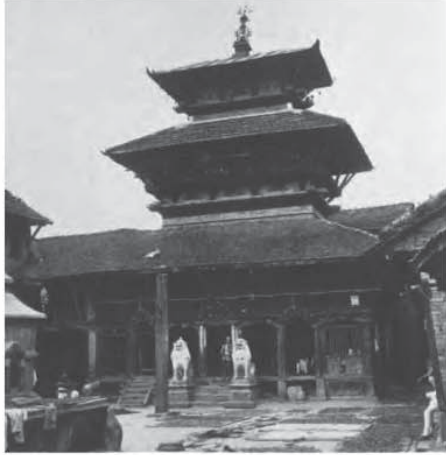
Bālkumārī

The entrance to this large three-storey temple is marked by three doorways, each with a torana of Balkumari. The facade contains much latticed woodwork and struts which depict the Matrikas. The first two roofs are made of tile and the third one is of metal. In the courtyard are images of Ganesh, Mahakal, Sukhavati, Lokeshvar, Balkumari, Nasadyo, two lions, a chaitya, a mandal, and a pillar with a peacock. According to the inscription, the temple was built by Amiraj Kajhit with the help of the local people. It was renovated in 1792 and again in 1934. The priest is an Achajo. Its festival is on Marga-shukla-purnima.

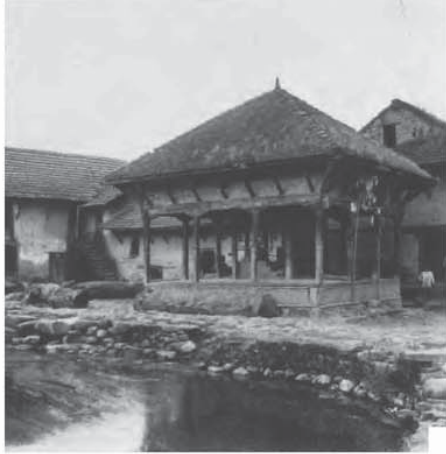
Bhairav

This square brick temple has a completely open sanctum. Wooden columns support the tile roof above. The struts are carved with various deities. Near the temple are images of Hathukvan Bhairab and a metal face of Bhairab. The temple was built during the early twentieth century and renovated by the local people after 1934. The priest is either a Maharjan or a Mali. Its festival is on Marga-shukla-purnima.

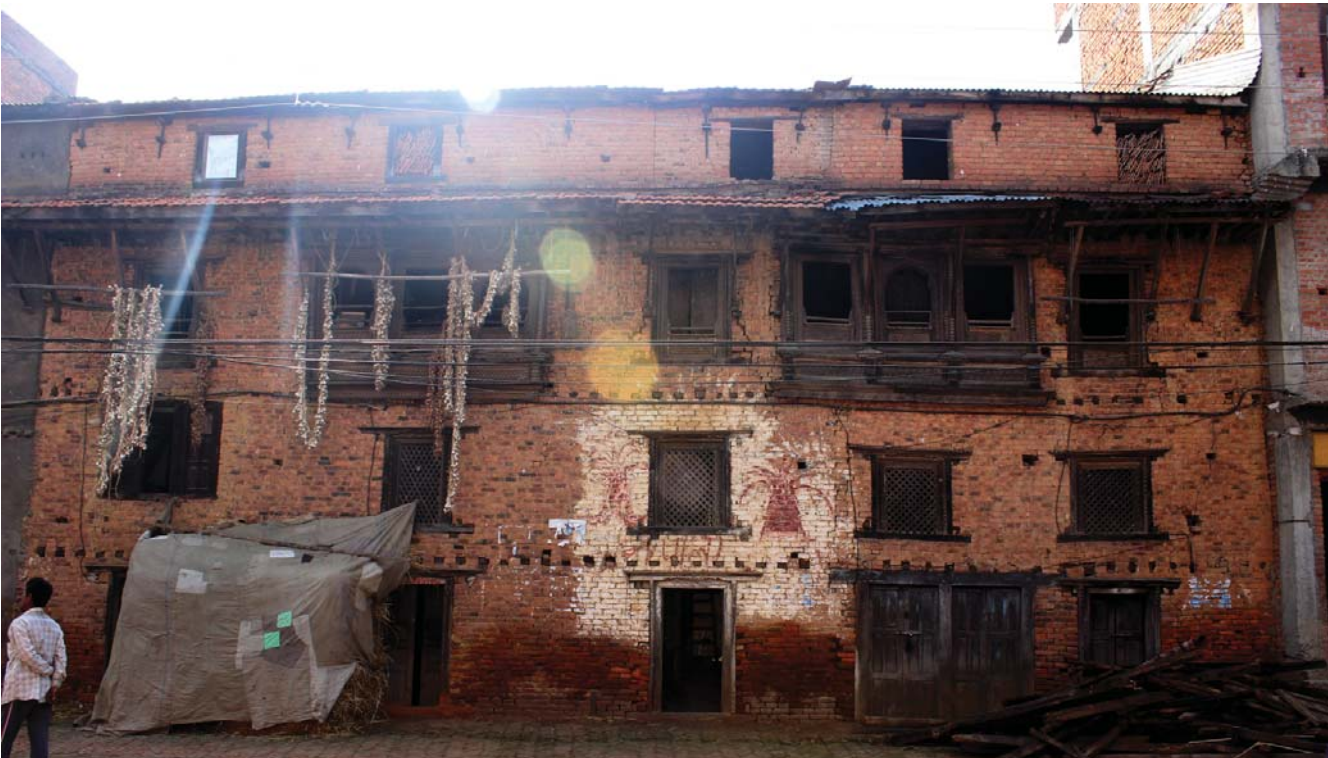
The front facade of ku: chen, Thecho. This house is unique with two sajhyan flanking the central axis of the symmetry.

This house is a unique example as the façade is almost double of an ordinary Newar house. There is a double Sanjhyan, with cusped arches, flanked by single bay windows. The attic is raised and new windows are included for brighter interiors, however the roof tiles have been replaced by CGI sheets.

Since there are multiple ownership issues, the house owners want to demolish the house and build in modern style or there is a possibility of new construction of some parts of the house only as other members are already living in a new house outside of traditional settlement. At present we can see house extension by three of the owners in the rear land .

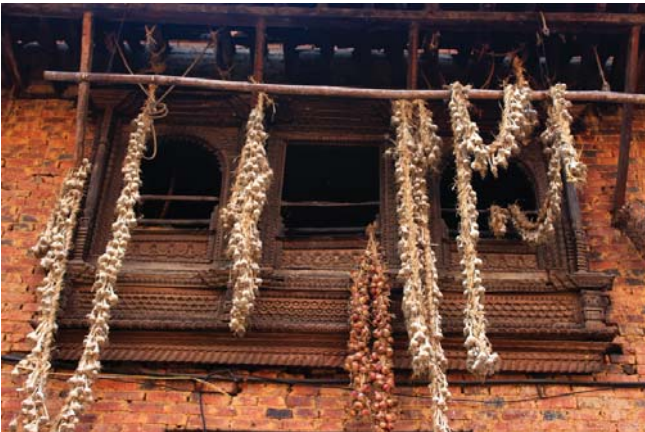
The three bay window, in the second floor has rectangular opening in the centre flanked by openings with cusped arches. The lower plank apron has floral patterns.

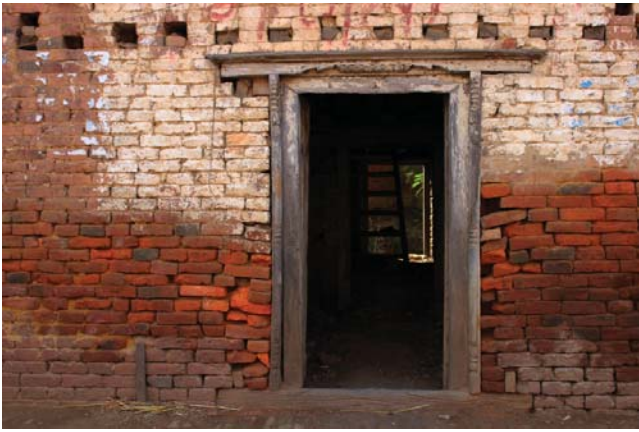
The brick texture and the carved wooden door are one of the character defining elements of a Newar house.

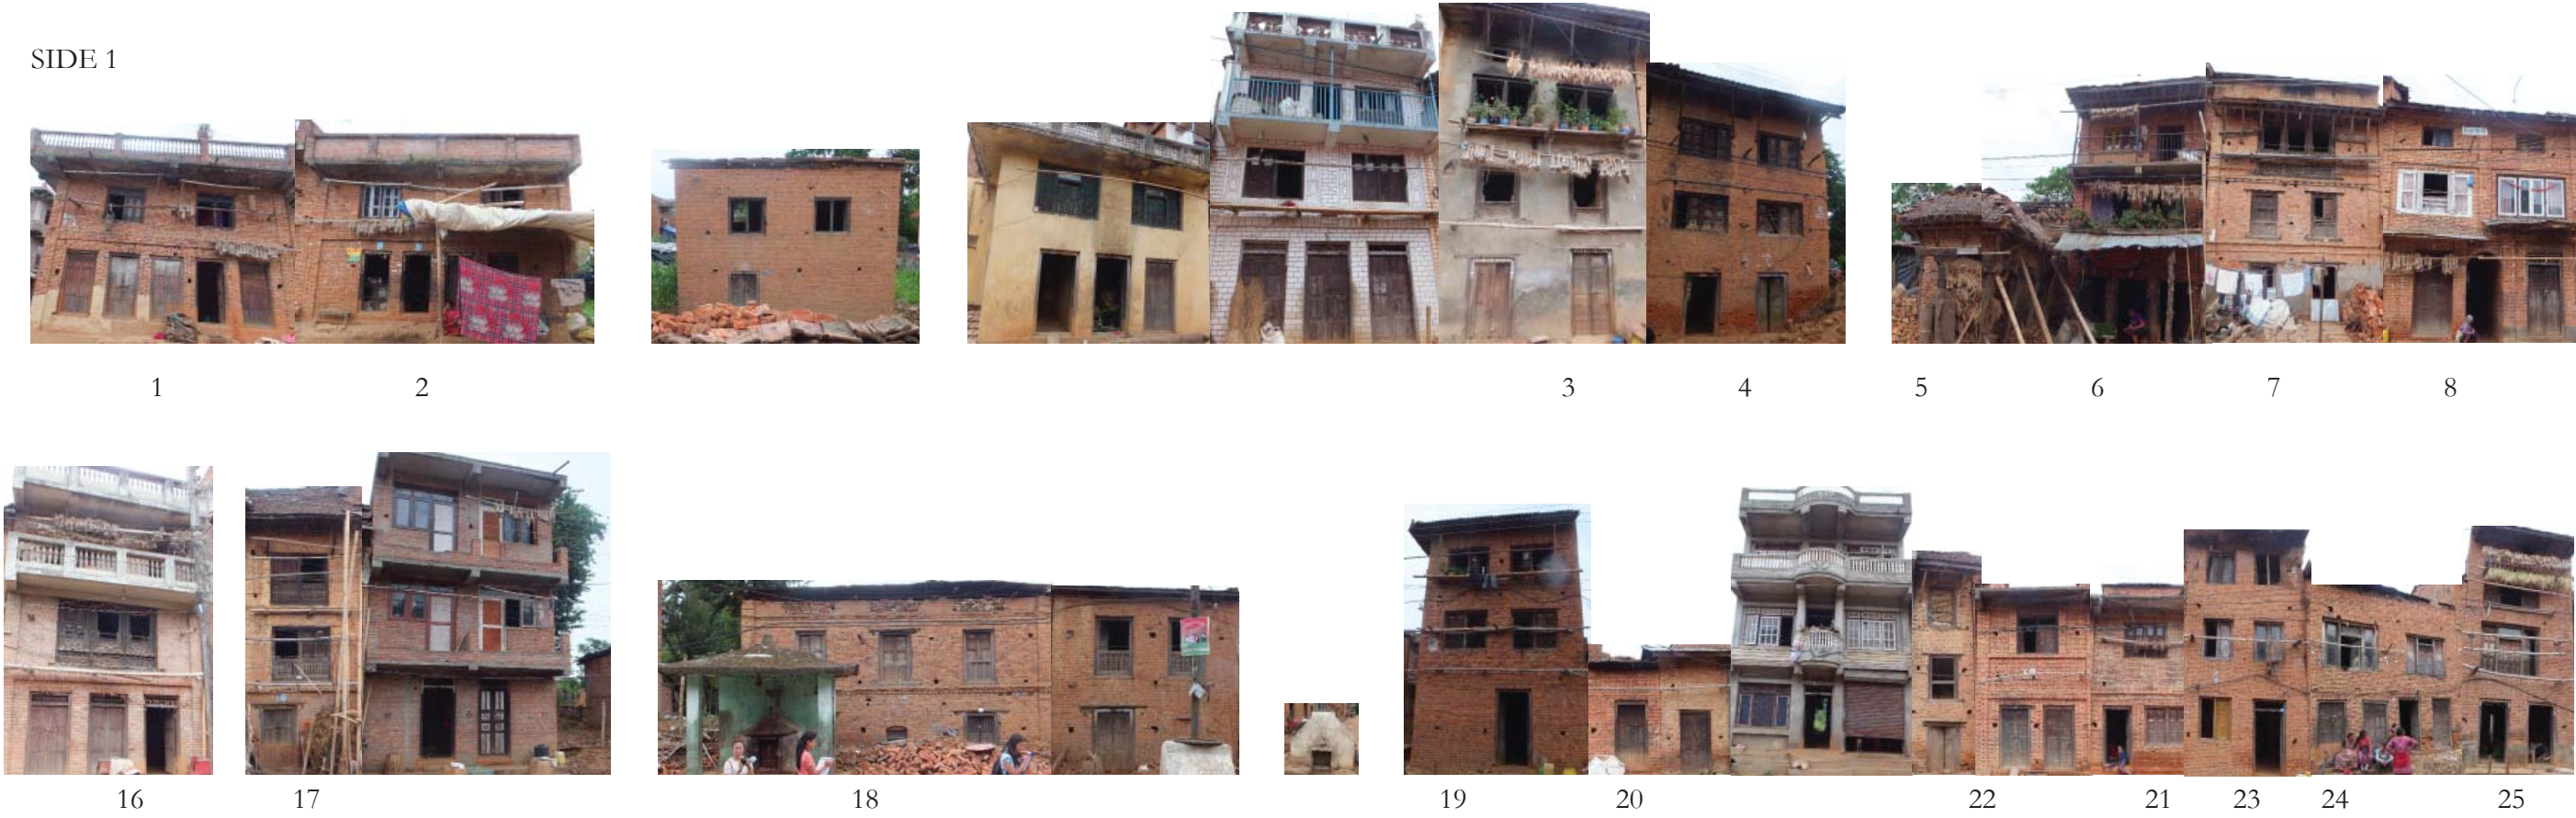
SIDE 1

Pyangaon
Map of the settlement with its 76 three-storeyed houses lined up along a wide street. The buildings behind the front row serve storage purposes.
Source: mapped by M. Bertrand, 1972, Toffin 1977, p. 34

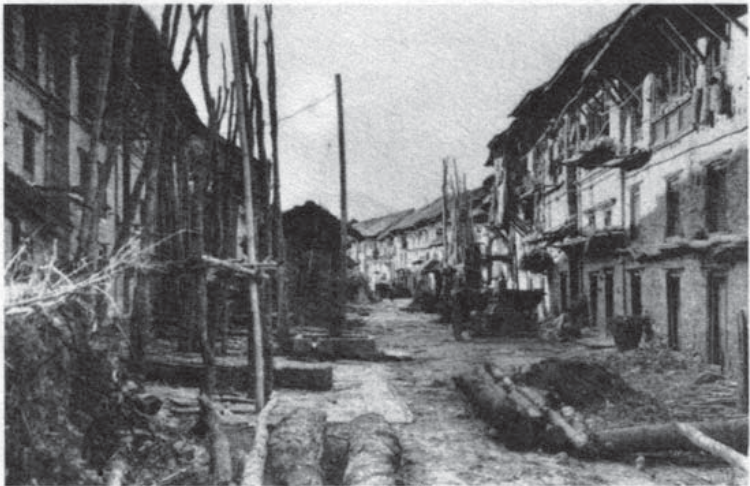
A view along the main street, which opens up to attain the look of a square. Scaffolds are constructed for corn to dry from September to December.
Photograph G. Toffin, January 1976

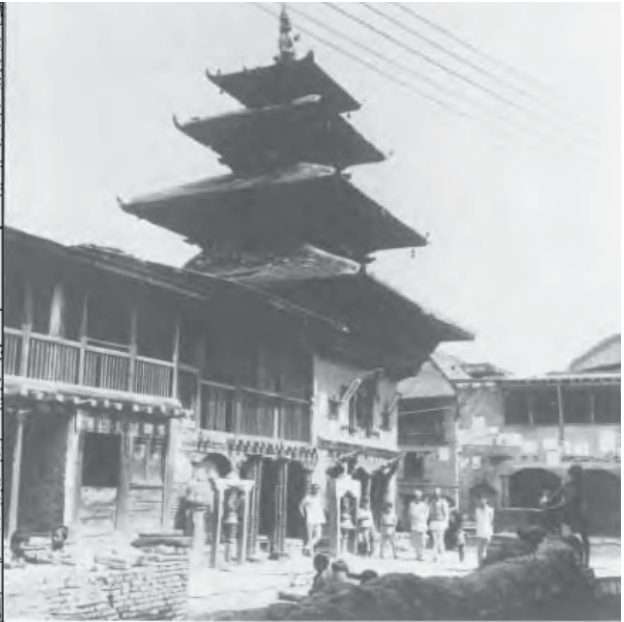
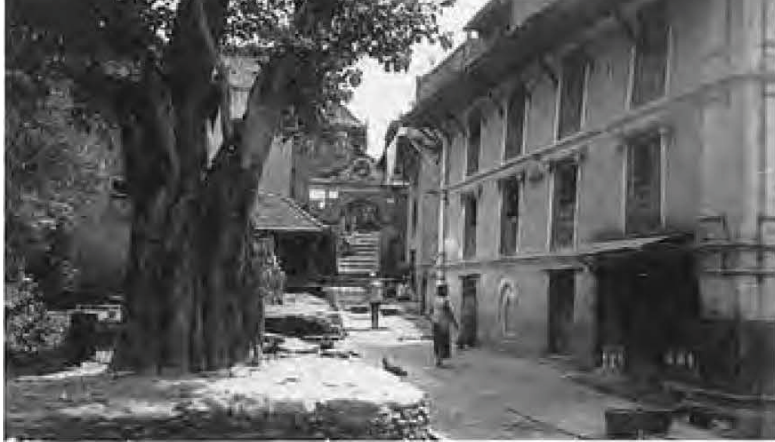
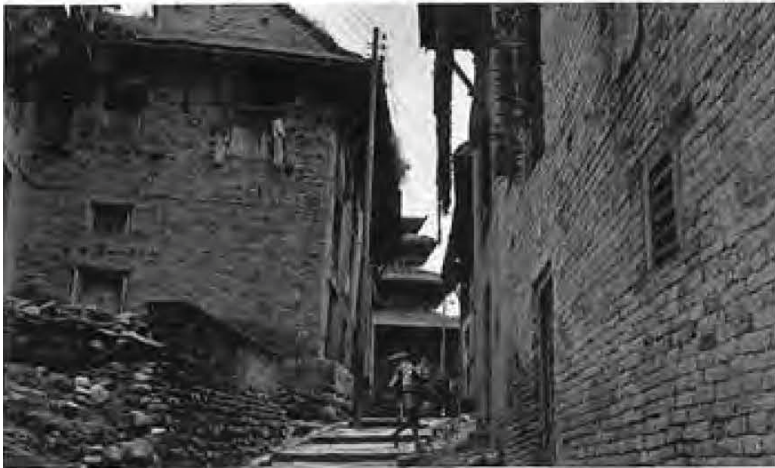
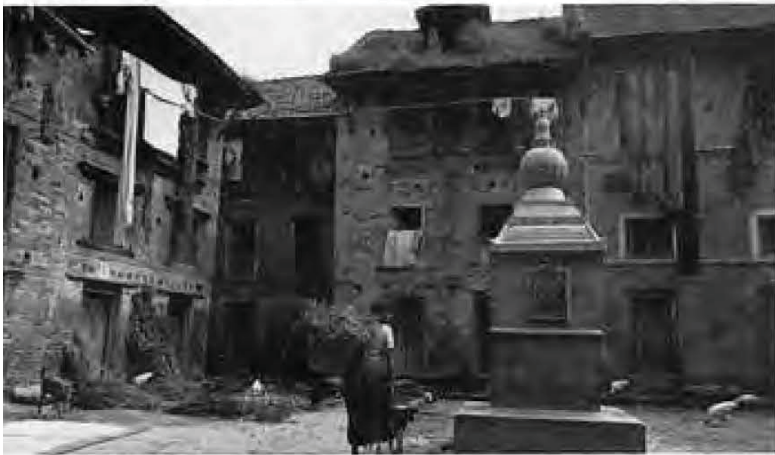
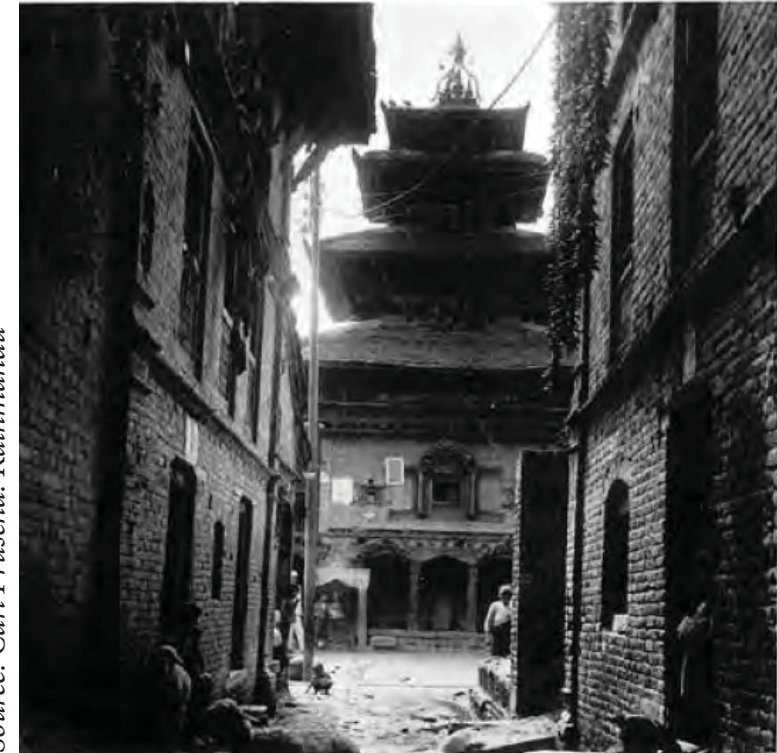
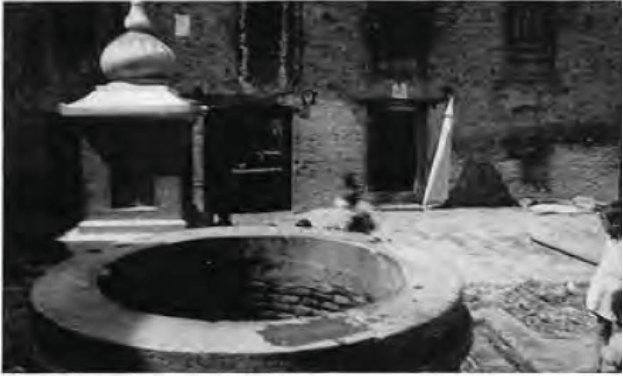
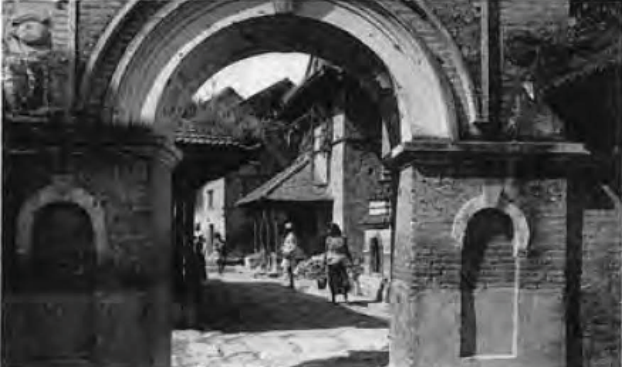
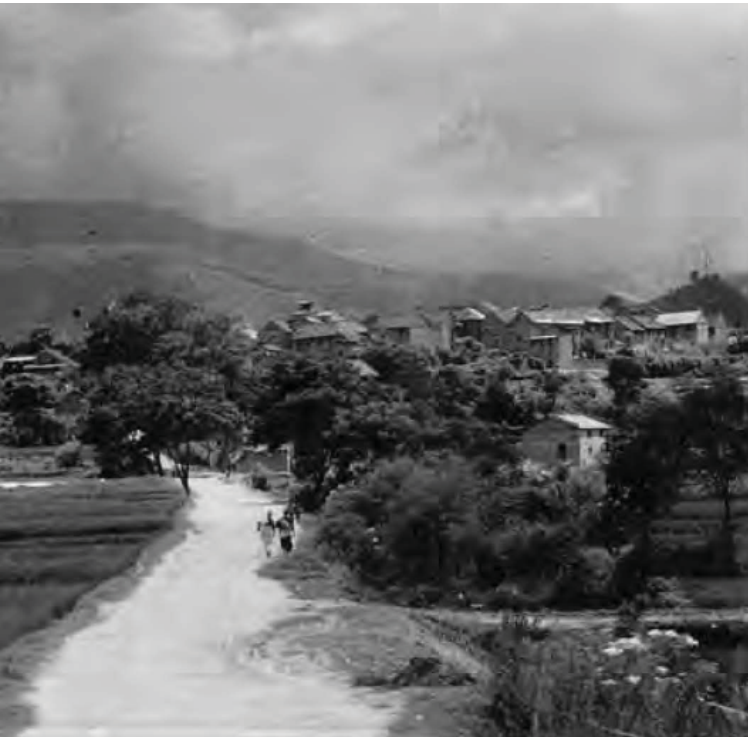
Harisiddhi Bhawani Temple

This large four-storey temple is made of brick. The entrance on the ground floor has two carved toranas. The first storey has a carved window frame with a torana. The four tile roofs are supported by figure struts which represent the Saptamatrikas and the Ashtamatrikas. Inside the temple are fifteen copper boxes, three makondos, five vadyas, and an image of Harasiddhi. The temple was built by King Kavindra Jaya Pratapamalla and was renovated in 1726 by King Jagajjaya. The priest is a Maharjan. Its festival is on Phalgun-purnima and Manshir-purnima.

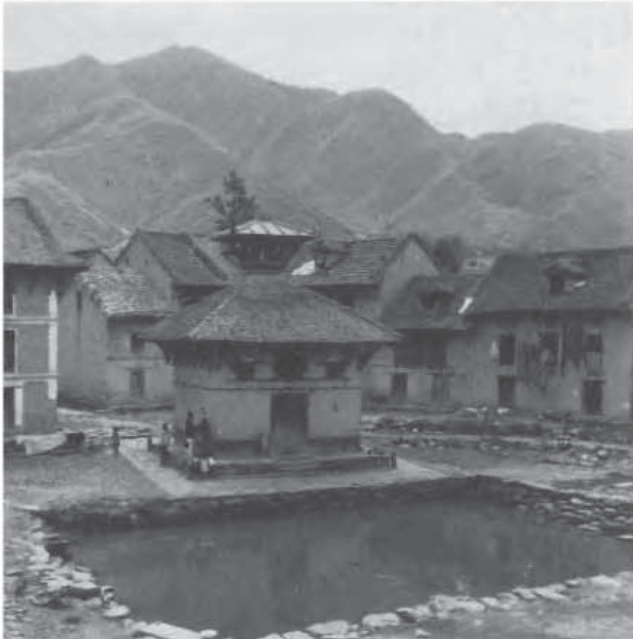
C/Kp-1

Location	DEVAKUNG TOL, KISIPIDI
Style	TWO-STOREY TEMPLE
Constructed	18TH CENTURY
Renovated	AFTER 1934
Deity	KALIKA MAI
Sect	SHAKTA
Records	1731 AND 1792

This two-storey brick temple is built on a brick base. The doorway is plain. The only decorative features are the two latticed windows above the door. Plain struts support both the tile roof and the upper metal roof. Inside the temple are images of Padmapani Lokeshvar, Indrayani, Mahakal, and Bhagwati. The temple was built during the eighteenth century and renovated by its guthi after 1934. According to the inscription, a golden image and a gajura were dedicated in 1792 and some utensils were dedicated in 1731. In front of the temple is a large water tank. The priest is a Shreshtha. Its festival is celebrated during the horse festival.

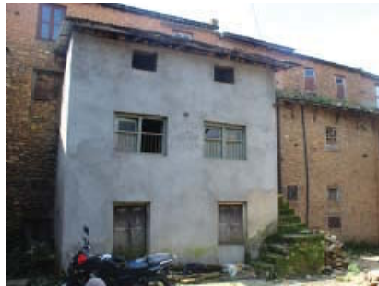
GUTHI

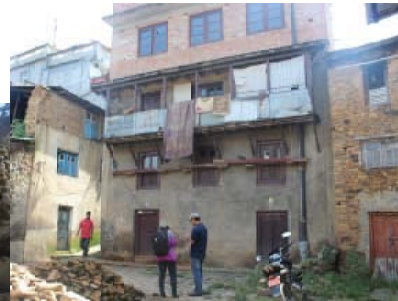
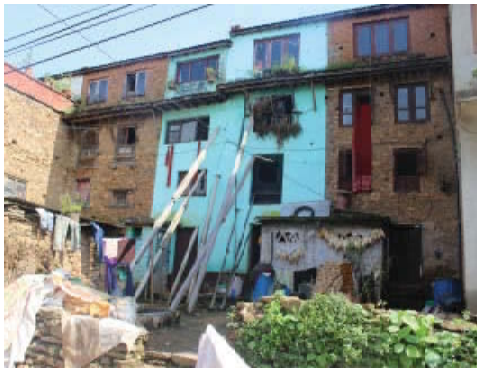
13

HALF DAMAGED
