The Chilean adobe as a seismic vernacular technology, the study of the “Norte Chico” area

A. Rivera Vidal

Escuela de Construcción en Tierra ECoT, Santiago, Chile

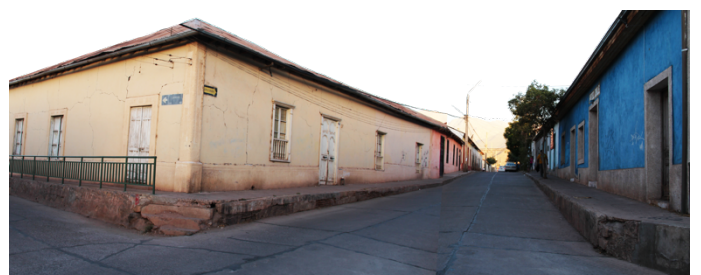
Figure 1. Continuous façade at the urban area of Combarbalá after the 2015 earthquake. (Credits: Amanda Rivera, 2016)

The religious buildings are located mostly in urban areas but with isolated construction typologies. While the houses are also located in urban as well as rural areas, the urban dwellings are composed of several units attached one to another, making one constructive unit (Fig.1). There are also different typologies in rural settlement. First the *casonas patronales* are the landowners houses that are isolated and built around an interior courtyard. It acts as an independent structural unit. There are also smaller houses much more compact and related to farming activities that also had their own independent structural unit.

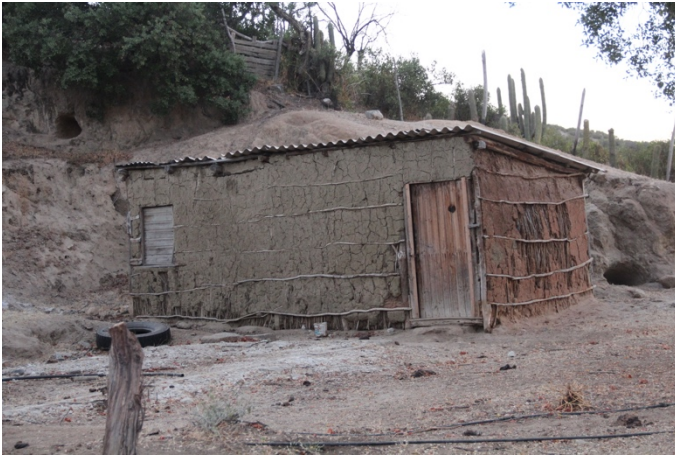
Figure 2. *Quincha* of the “Norte Chico” with medium size branches as structure. (Credits: Amanda Rivera, 2016)

The *quincha* or wattle-and-daub construction is a technique built with a main structure of medium-sized branches with thinner branches from local bushes which were filled in with a mix of mud and straw. It is the main native constructive typology, used by the *diaguitas* (Fig.2).

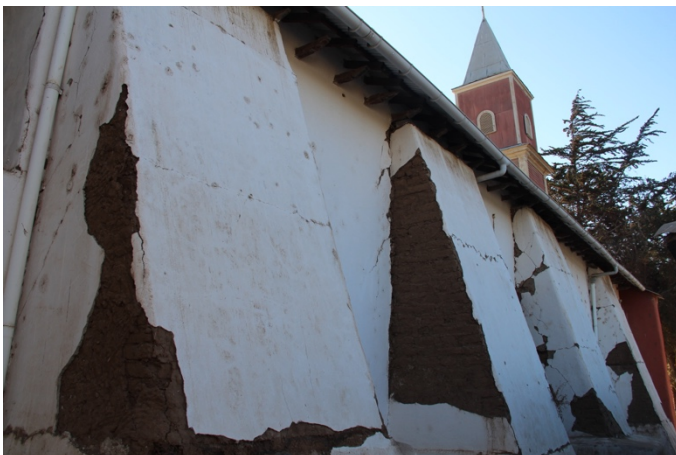
Figure 5. One of the few buildings with counterforts in the area. San Antonio del Mar church of Barraza built in 1795 (Credits: Amanda Rivera 2016)

The counterforts were the first elements of reinforcements that can be observed in the traditional construction to counteract the effort of the earthquakes, supporting the walls in the dynamic moments, and avoiding their overturning to the outside. These stability devices have been used in great length walls which lack interior support elements. This feature is found mainly in the central nave of churches (Fig.5).

The counterforts are the continuity of the wall to the exterior in their perpendicular direction. It must be united to the rest of the wall as in two perpendicular walls: in each one of its threads. It generally has, an angle that generates a push towards the wall. This lowers the centre of gravity of the wall, reducing its fragility.

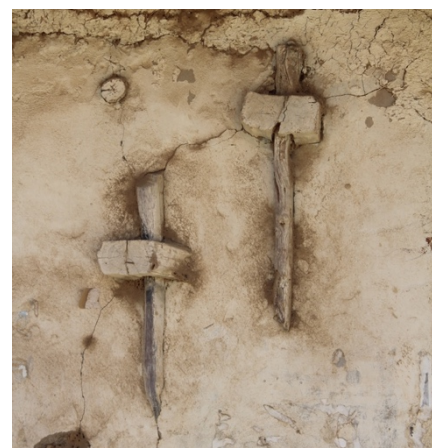
Figure 6. Trabas: Wooden pieces to join perpendicular walls in the town of Cogotí 18 (Credits: Amanda Rivera, 2016)

Las trabas are specific wooden elements (Fig. 6) used to support the joining of other wooden elements of the construction, such as mezzanines and roof structures, with the outer adobe walls. Within the reinforcements are the most precarious devices and made with the smaller woods, which means less access to reinforcement resources. They can be found perpendicular to the wall, where the element crosses the wall and on the inside is attached to the structure of wood or mezzanine. Or when it is the same roofed wood or between the floor that crosses the wall and it is hooked with a piece of wood of a smaller section to avoid its displacement. These *trabas* have also been observed in diagonal positions, where an element independent of the wooden structure is arranged as a square and is hooked in the same way by a wood of smaller section in both outer points. This system is of great vulnerability, especially when the pieces of wood are exposed, they are in permanent exposure to water and xylophages, which generates their frequent rotting and finally, added to the absence of maintenance, its disappearance in the reinforcement system.

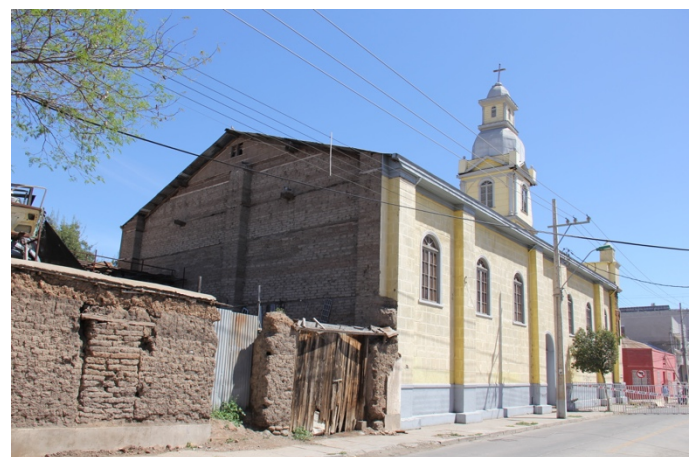
Figure 8. Corazón de María church in Ovalle. Case with mass, counterforts and horizontal ladders. State after the earthquake of 2015 (Credits: Amanda Rivera, 2015)

This system represents the greatest technology present in the adobe construction of the area and even after many great earthquakes has verified its efficiency in the dynamic moment. It is hard to find earthen masonry in the area without the horizontal ladders, and even in modest dwellings these horizontal ladders are present. Even when many of the others seismic strategies are not present. The most common finding is the mass and the reinforcement strategies together, but the counterforts as a stability strategy, are only present in some larger structures such as churches. Most of them are based on the horizontal ladder strategy (Fig.8-9).

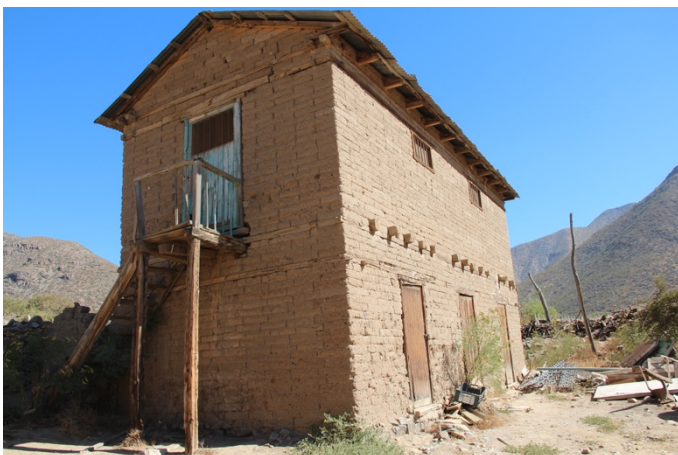
Figure 9. Rural two-floor house in Monte Patria. Case with mass and horizontal ladders. State after the earthquake of 2015 (Credits: Amanda Rivera, 2016)

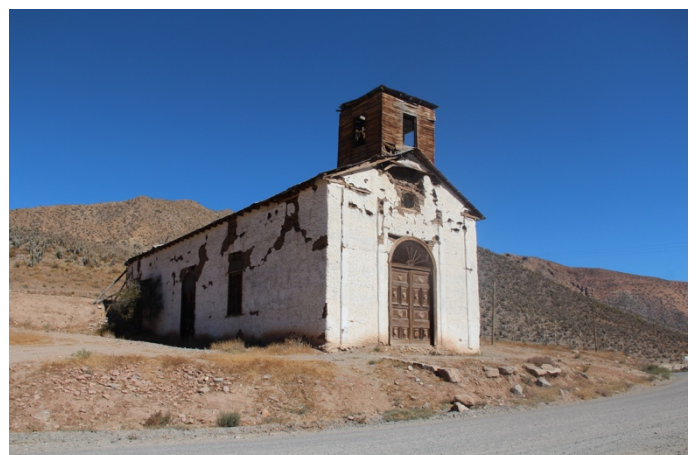
Figure 10. Rural abandoned church in Río Hurtado. Case with mass and horizontal ladders. State after the earthquake of 2015 (Credits: Amanda Rivera, 2016)

- Problems of humidity and water from the interior to the exterior of the buildings, generally in bathrooms and kitchens. This erodes the structure of the masonry walls of earth, even reaching to rot and to undo the structures of the wooden reinforcement inside the walls.
- Changes to the original configuration, great opening and in inadequate locations that weaken the structural system.
- Separation of perpendicular walls, caused by the inefficiency of the anchoring system and reinforcement of the corners, mainly due to the presence of xylophages and the rotting of wooden elements because of their Exposition.
- Absence of maintenance that provokes quickly deterioration process, the most typical the presence of excessive humidity (Fig. 10).
