Patricia Marchante, Amanda Rivera Vidal

Characterization of Traditional Coatings in Earthen Vernacular Architecture in the Limarí Valley: Their Role in the Conservation of Built Heritage in Chile

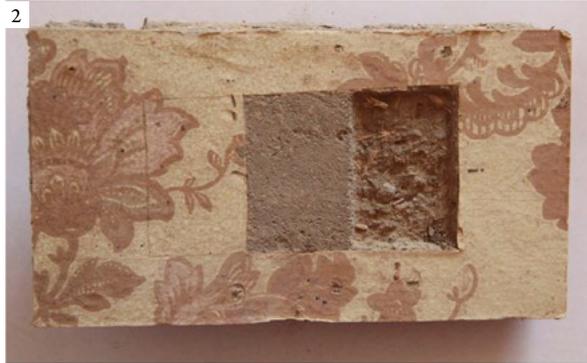
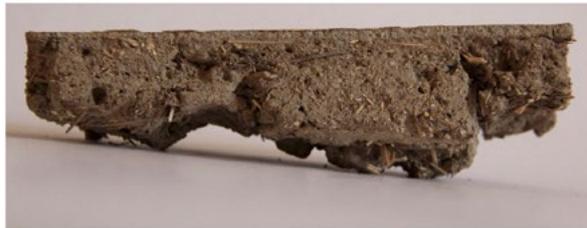
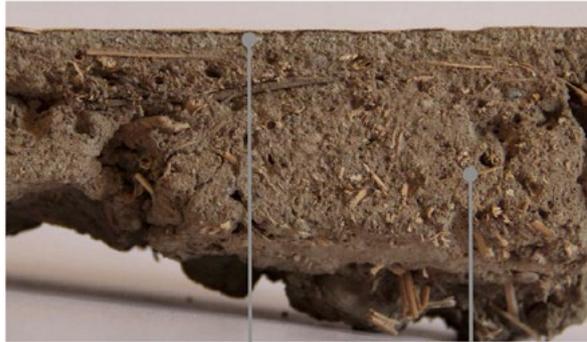
Figure 2: Indoor finish sample from the Contreras family house in Carén (CAR02D). Top: whole sample (13 × 18 cm) with stratigraphic survey showing the different layers of earthen render and wallpaper. Middle and bottom: section showing 4 mm of earth and sand plaster (*enlucido*) and 30 mm of *enfoscado* plaster with earth and fiber

Enlucido: 4 mm of soil and sand plaster

Enfoscado plaster: 30mm of soil and fiber

From these buildings, samples of 10 × 18 cm were taken from the walls (Fig. 2), of variable thickness depending on

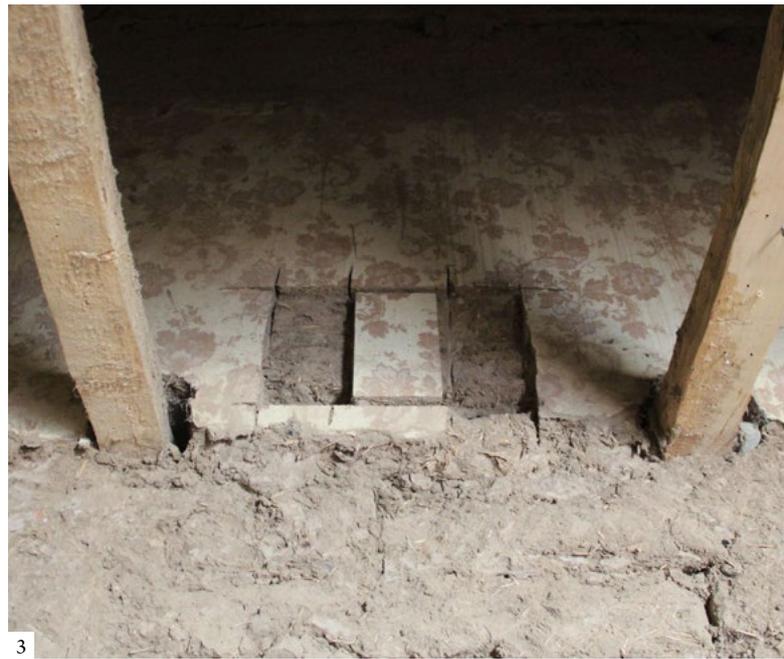
Figure 3: Extraction of a sample (13 × 18 cm) from the adobe wall of a house in Carén (CAR02D)

the coating depth, as far as the structural substrate (Fig. 3). Thirty samples were taken and thirteen cases selected from six buildings. The samples were used to identify the coating systems, from the first layer to the finish.

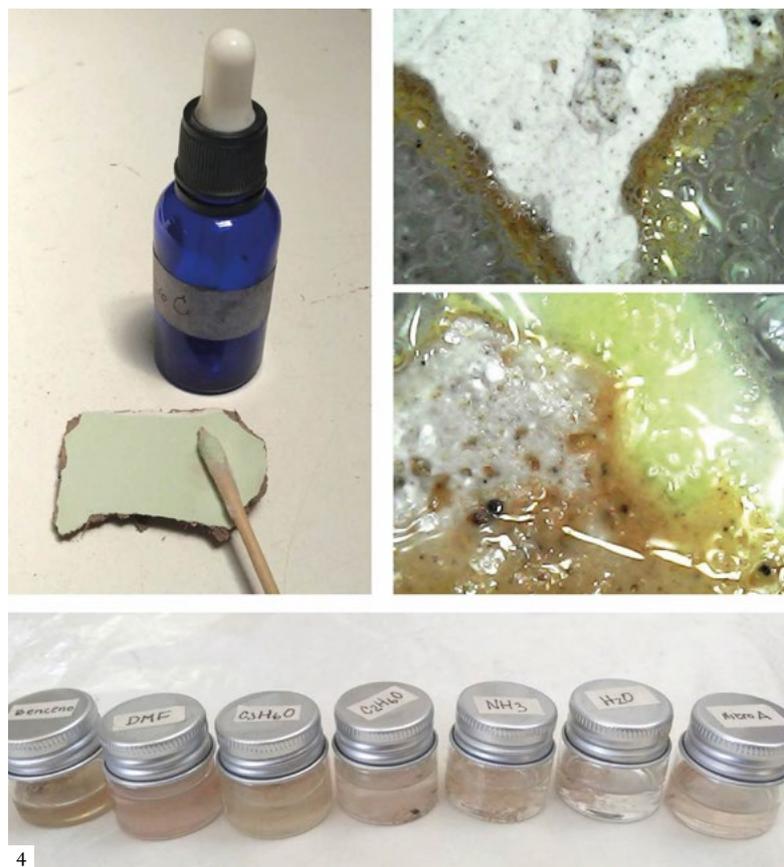
Figure 4: Physico-chemical tests. Top right: Test with nitrobenzene (Nitro C) on the CAR02A sample, with immediate solubility confirming that the paint layer is vinyl (latex). Top right: 1000x microscopic image of a phosphoric acid test on the OVA02A sample with high oxide reaction and redox (third layer), confirming that the pigments are bonded to lime. Bottom: Solubility test on the fifth layer of the CAR02B sample, with a clear reaction to organic solvents confirming that this is vinyl latex with a high calcium carbonate content (Manuel Concha)

Earthen layers of render were characterized by observing their texture, composition, and thickness, confirmed by optical microscopy. The finishing layer of each sample was subjected to stratigraphic analysis, microscopy and physico-chemical tests (Fig. 4).

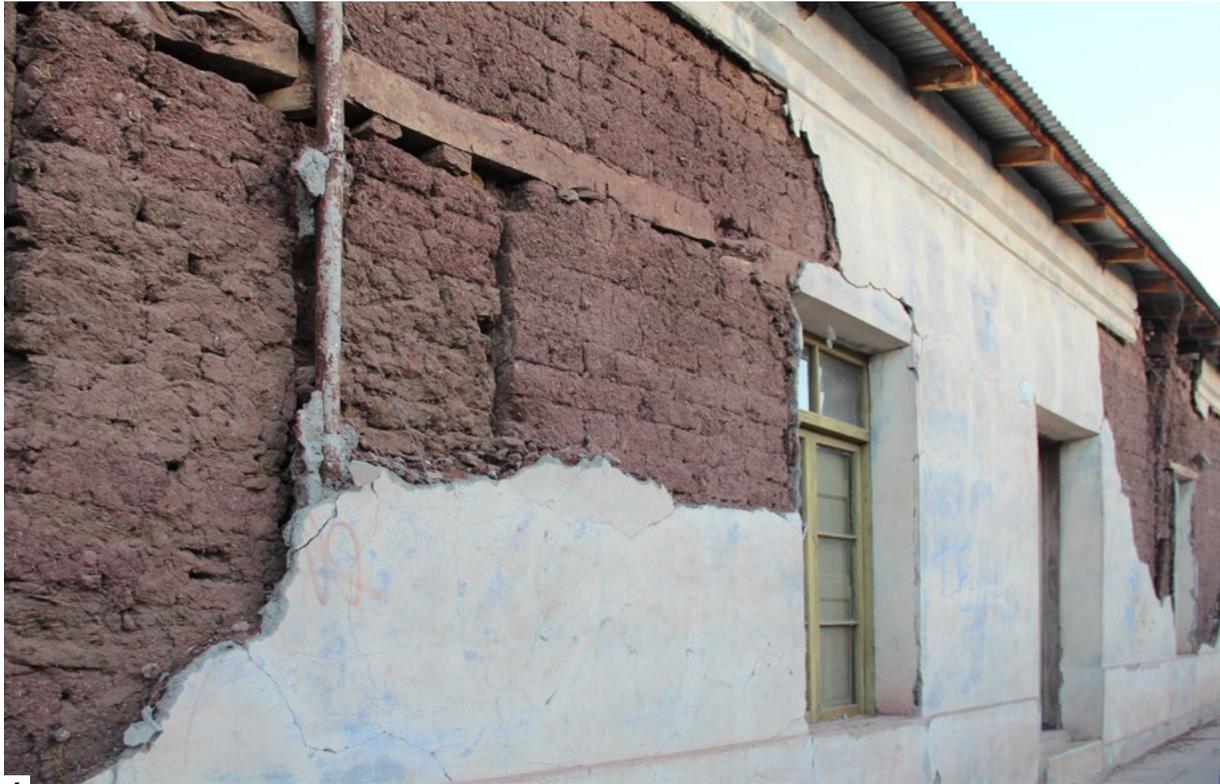
5

Figure 5: Adobe house in Combarbalá

The technique found most widely is adobe masonry (Fig. 5), with cuboid blocks of unfired earth laid with a header bond, where the block length becomes the wall thickness

(Muñoz and Rivera 2017). Various block sizes were found, typically $55 \times 30 \times 10$ cm, $40 \times 20 \times 10$ cm, $60 \times 40 \times 10$ cm or $60 \times 30 \times 10$ cm, resulting in walls with thicknesses of 50-70 cm in smaller structures, and thicker ones in larger structures (Marchante and Rivera 2020).

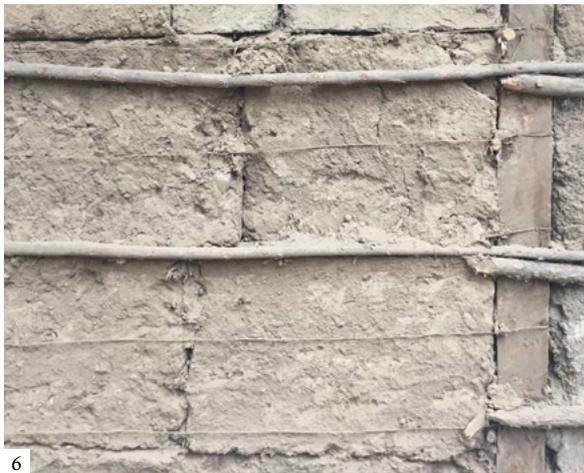
6

Figure 6: *Pandereta* hybrid wood-and-earth system with external branches and metal wire for containment, Tulahuén

Timber frameworks are infilled with adobe blocks laid on edge, locally called *adobe en pandereta* (Guzmán 1979) (Fig. 6), confined in the wall by containing elements (Rivera 2017). The *quincha* technique (Fig. 7) involves a main structure of wood, a secondary structure traditionally of plant matter, and a filling of earth and fiber. In the cases studied, willow branches were arranged vertically and

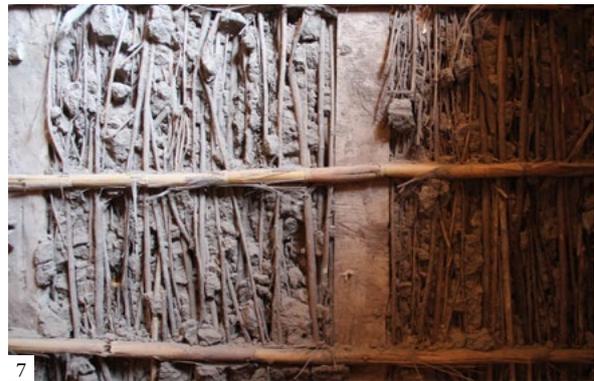
7

Figure 7: *Quincha* hybrid wood-and-earth system infilled with branches and earth, confined with external horizontal canes, Carén

contained by horizontal elements anchored to the main structure, infilled with an earth-and-fiber mixture. In both *pandereta* and *quincha* structures the external confinement elements are made of sawn wood, local cane, branches of various local trees, and metal wires.

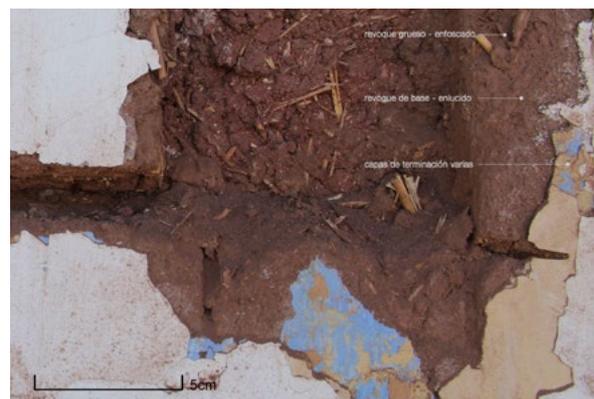
Figure 9: Layers of the finishing system: adobe wall structure, first layer of earth and straw (*enfoscado*), second layer of an earth and sand mixture (*enlucido*), and various finishing plasters. Combarbalá, sample COMB02A

With all structural techniques, the coating system has two layers of earthen render and a finishing coat (Fig. 9). In the finishing layer, variations in materials were found by period, place, wall function, and state of upkeep.

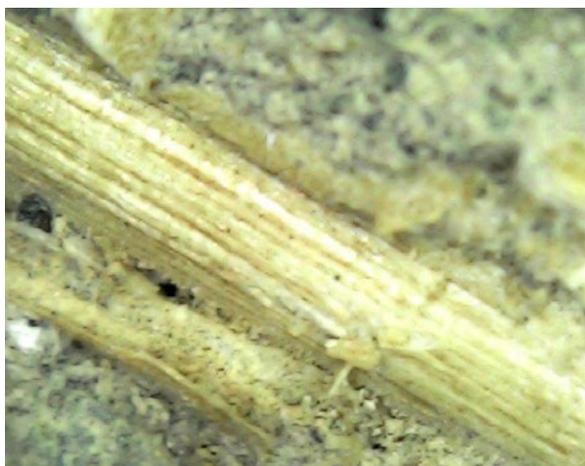
Figure 11: 1000x microscopic image of the earth and fiber layer of the CAR02A sample (Manuel Concha)

The wheat straw fibers in the first plaster layer (Fig. 11) serve to reduce cracking (as the clayey earth tends to fissure), and

is also thought to give greater resistance against horizontal and diagonal movements caused by frequent earthquakes. The fibers must also help this layer adhere to the structure (Lima and Faria 2016), which is especially important in composite structures. In this layer one also often finds pebbles and even fruit stones that may have been mixed into the mortar.

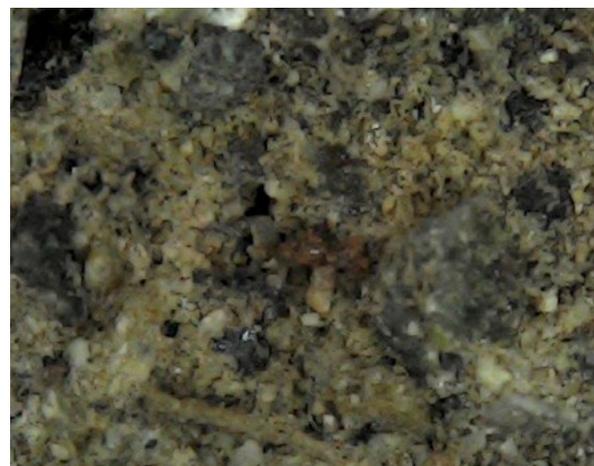
Figure 12: 1000x microscopic image of the earth and sand layer of the COM02B sample, where the layer is uniform (Manuel Concha)

it contains sand but not straw (Fig. 12). The sand grains allow the surface to be worked evenly and stabilize the clayey earth, preventing fissuring. But it results in a plaster with little surface cohesion due to its low clay content, and which easily sheds sand when rubbed. The subsequent layers provide a firmer finish.

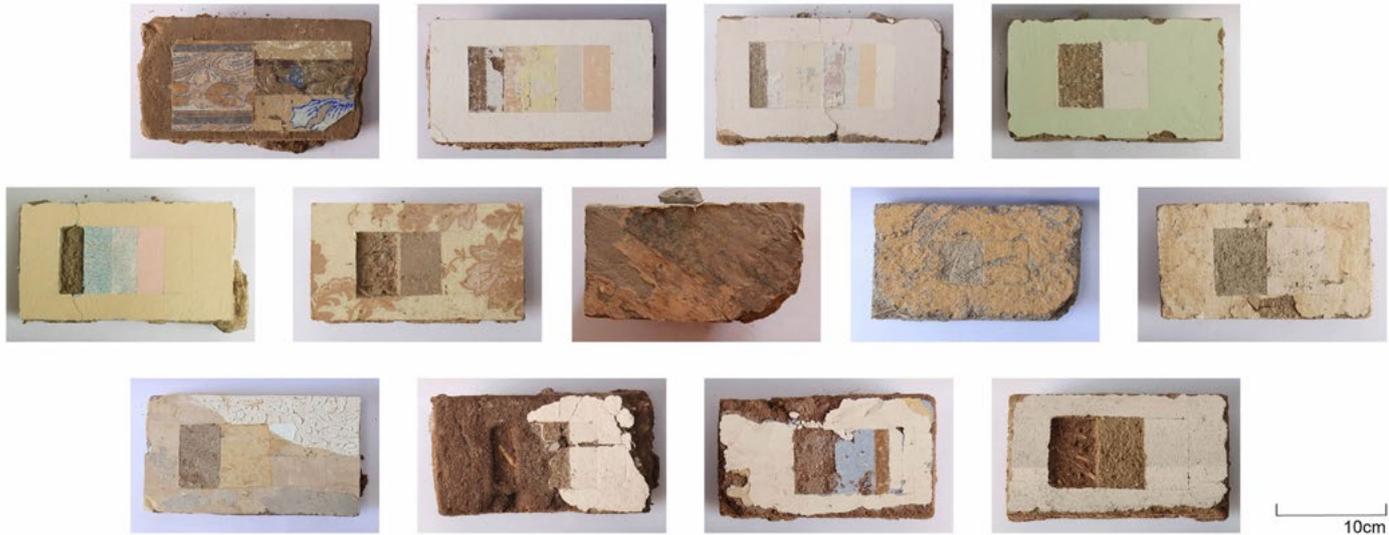
Figure 14: Stratigraphic survey of the 13 samples. From top left: BARR01B, OVA02A, OVA02C, CAR02A, CAR02B, CAR02D, CAR02G, CAR03A, CAR03B, COMB01A, COMB01B, COMB02A, COMB02B

used in interior renovations of the late twentieth century. But in areas with fewer economic resources and/or less access to industrialized materials, lime and pigments continue to be used (Fig. 14).

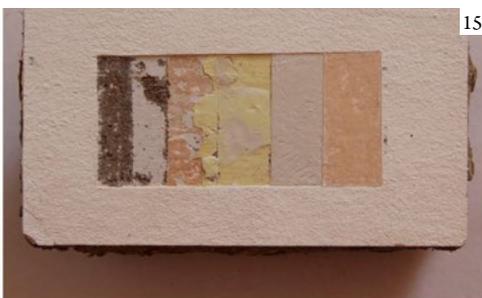
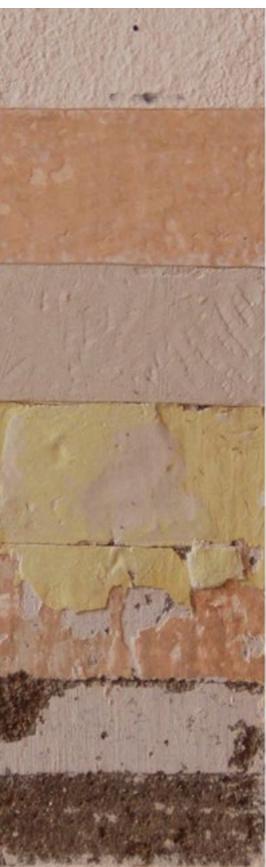
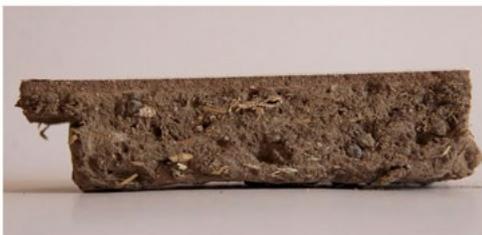
Figure 15: Indoor finish from the Corazón de María Convent in Ovalle (OVA02A). Left and top right: stratigraphic survey showing different layers of lime finishings and vinyl paints. Right center and bottom: section showing 5 mm of an earth and sand plaster (*enlucido*) and 35 mm of *enfoscado* with earth and fiber.

Enlucido: 5 mm of soil and sand plaster
Enfoscado plaster: 35mm of soil and fiber

Lime has been employed since colonial times, both in mortars and in paints, for interior and exterior coatings (Figs. 15 and 16). This is the oldest finishing material commonly used up to the early twentieth century.

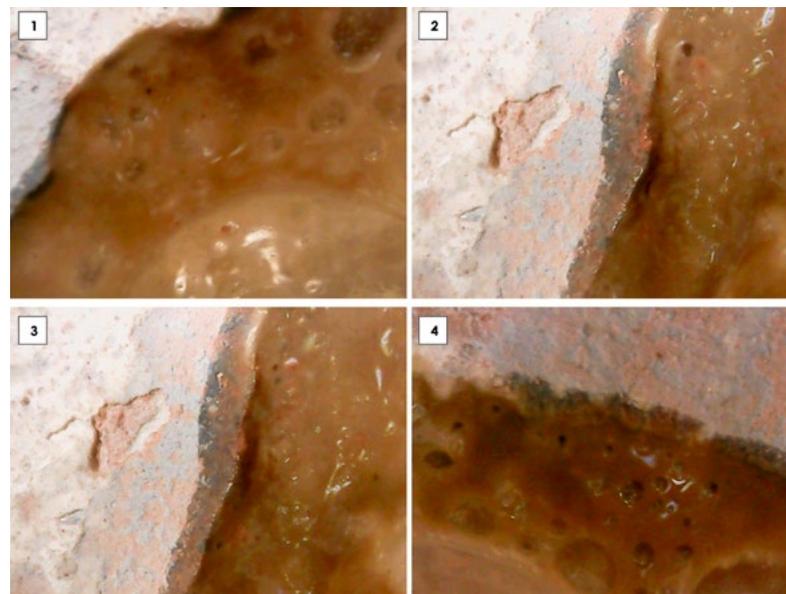
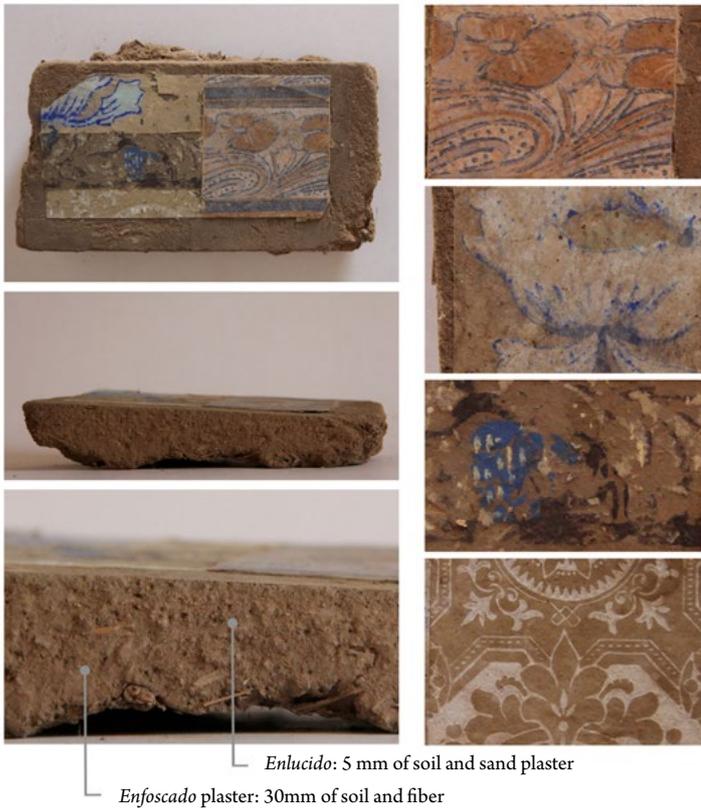
Figure 17: Indoor finish from an abandoned *hacienda* estate in Barraza (BARR01B) with various wallpaper layers. Right from bottom: the white first paper and blue second paper are printed and hand painted from approx. 1850-1930; the third must have been manufactured around 1950. The last is a thicker stamped wallpaper. Left top: whole sample with paper finishes and stratigraphic survey. Left center and bottom: section showing 5 mm of an earth and sand plaster (*enlucido*) and 30 mm of *enfoscado* with earth and fiber

On interior walls, the use of wallpaper dates back to the early nineteenth century (Figs. 17 and 18). Wallpapers have evolved over time and their manufacturing period can be identified by the paper type and the technique applied. The oldest were made with plant fibers and could be printed and painted by hand. Industrially printed mixed-fiber papers (plant-based and synthetic) have been used since the 1950s.

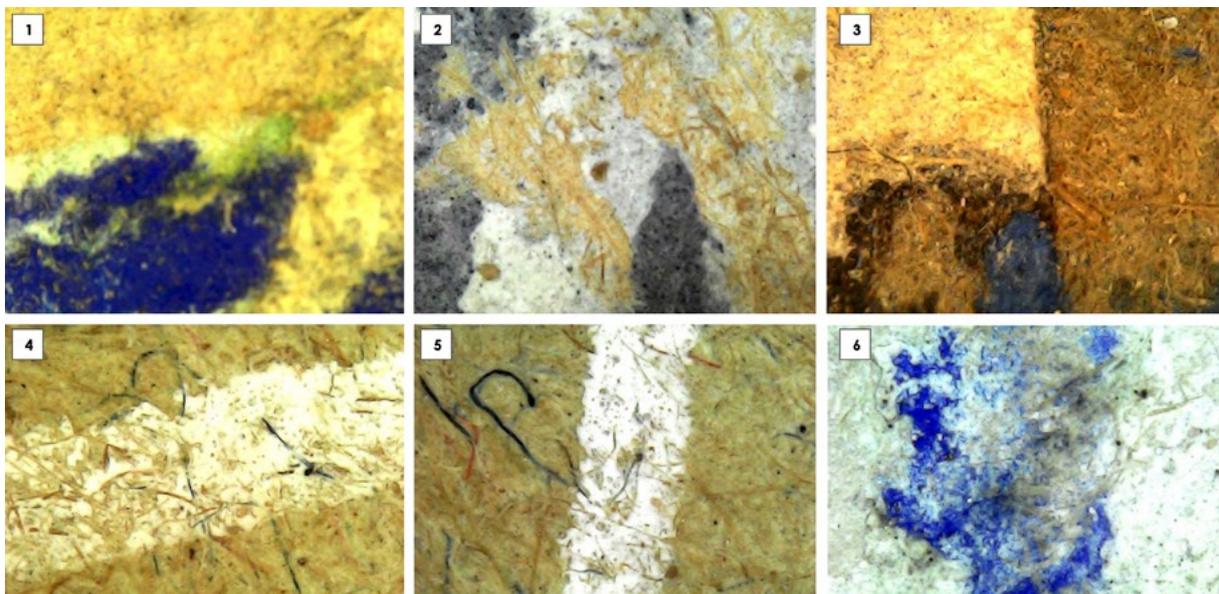
Figure 18: 1000x microscopic images of wallpapers in the BAR01B sample, with fibers and mineral pigments agglutinated with aqueous polymer (Manuel Concha)

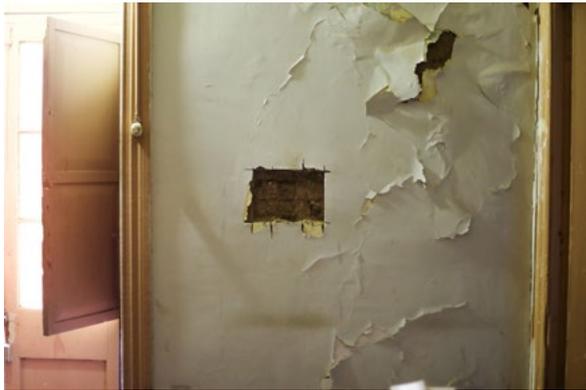
Figure 19: Detachment of synthetic paint layers due to damp retained in the wall. Pathology found in a wall at the Corazón de Maria Convent in Ovalle in 2019

Although all of these materials can still be used, since the second half of the twentieth century they have been largely replaced by cement, gypsum plasters, *pasta muro*, and synthetic paints. As to durability, there are layers of lime and pigments that are probably more than two centuries old over earthen plasters and which still adhere. In the stratigraphic survey of our samples, these layers were difficult to separate due to being quite firmly attached both to the earthen layer and to each other. Latex paints, by contrast, are often detached from the base and are easily removed (Fig. 19).
