THE GIANT BUDDHAS OF BAMMIYAN
SAFEGUARDING THE REMAINS

THE GIANT BUDDHAS OF BAMMIYAN

SAFEGUARDING THE REMAINS

edited by Michael Petzet

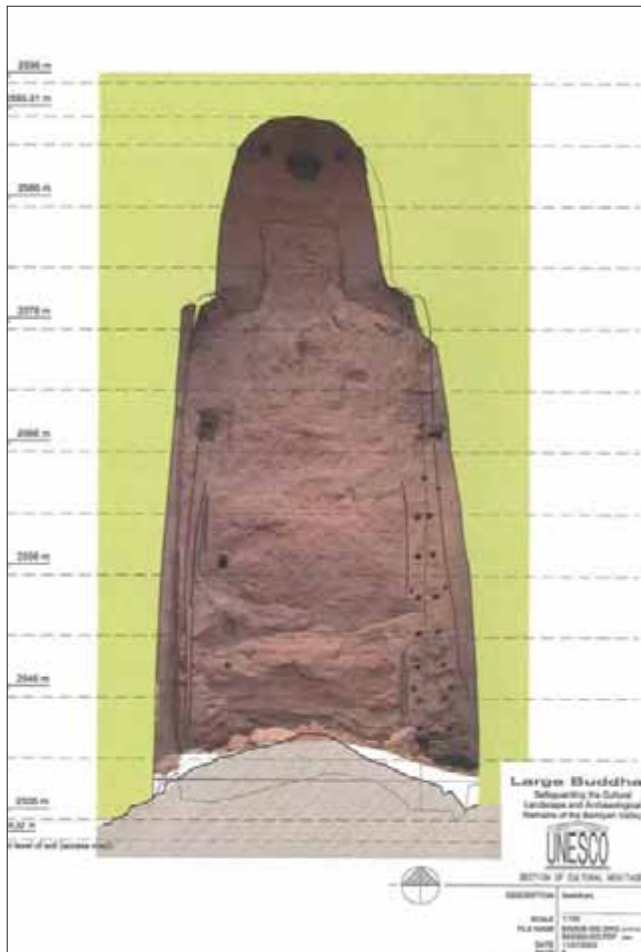
Western Buddha, measurements of the back wall (A. Fahim, M. Santana)

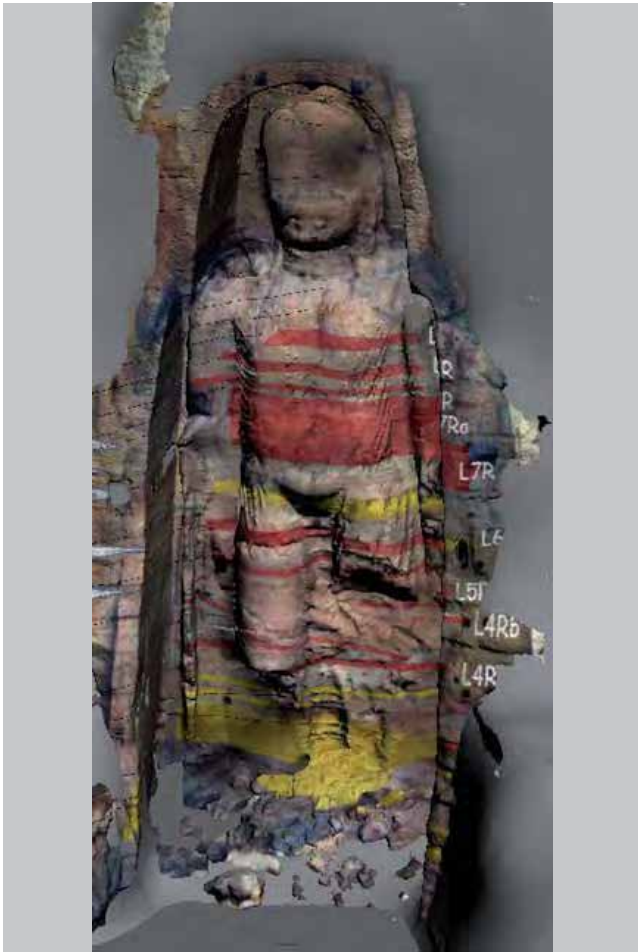
Western Buddha, tentative geological reference profile (M. Urbat)

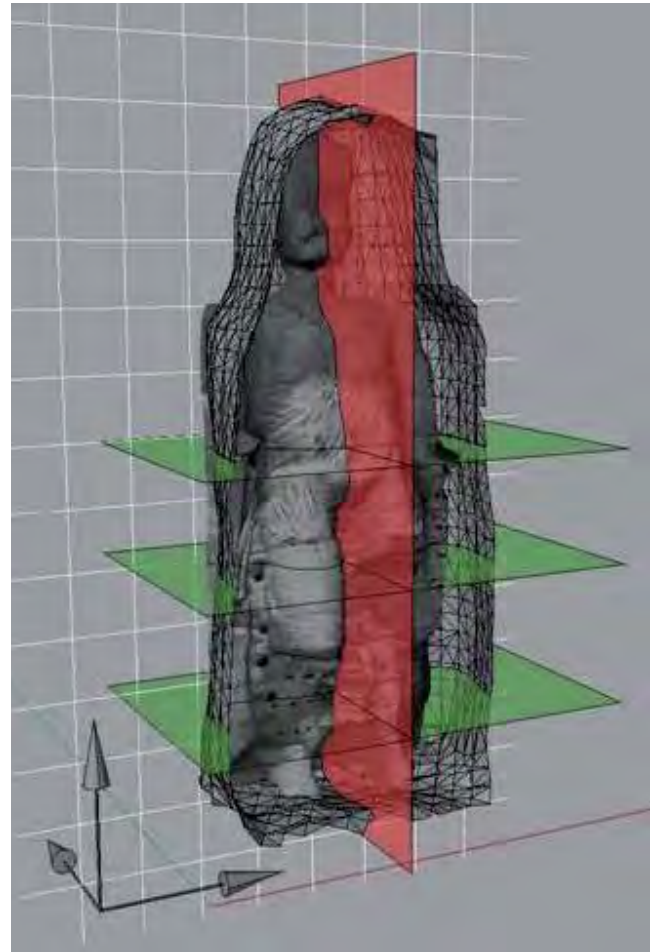
Western Buddha, tentative sections of the original structure

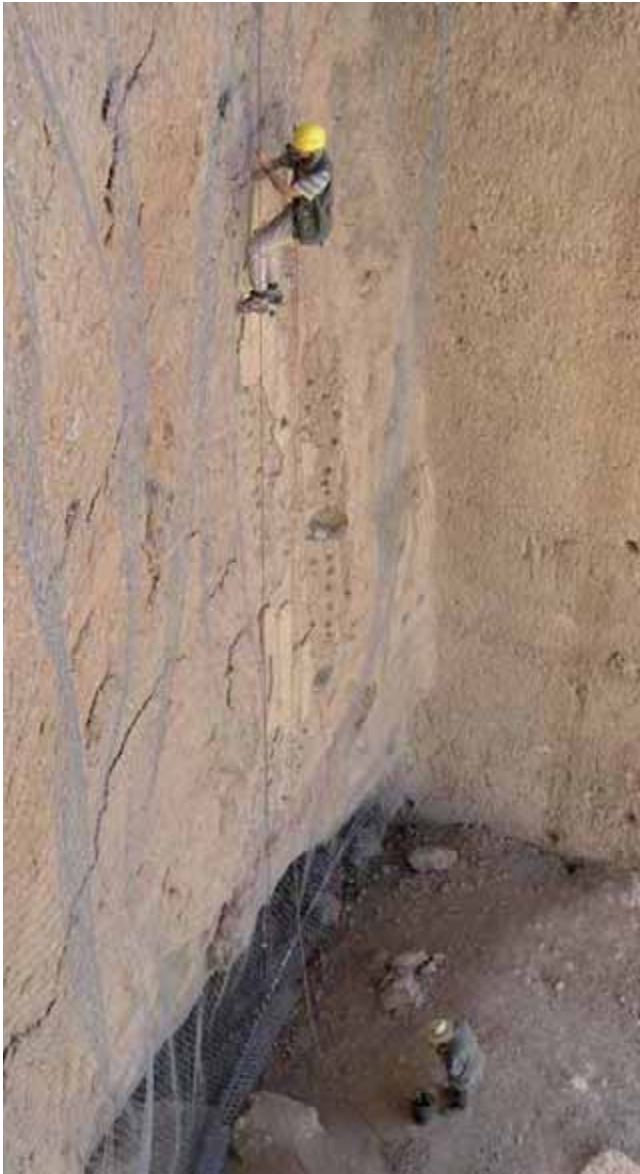
△ Clay plaster fragments in situ at the Eastern Buddha: loosened after the explosions, partly detached from the rock surface and in danger of falling off

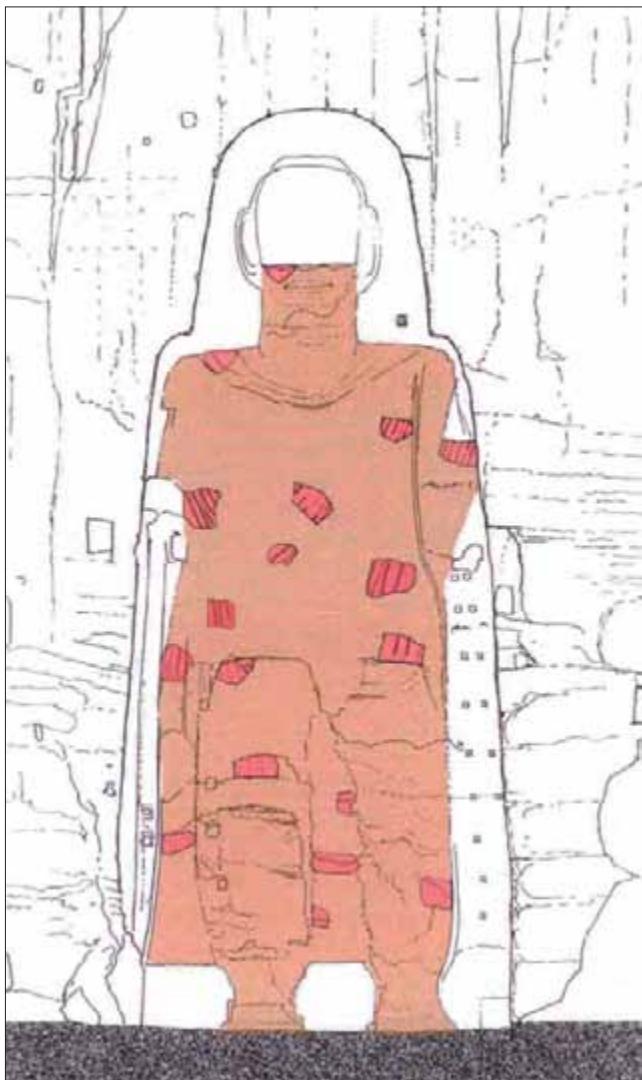
◁▽ Proposals by Prof. Fritz Wenzel for an anastylis of the Western Buddha (Büro für Baukonstruktionen, Karlsruhe)

After the different studies of variations, we would like to recommend the proposal with the recessed masonry-work representing the Buddhas, with fragments inserted and protruding by the thickness of a rock. This solution allows the unambiguous distinction between original parts and reconstruction, and manufacturing the reconstructed parts from local brick and suitable lime mortar.

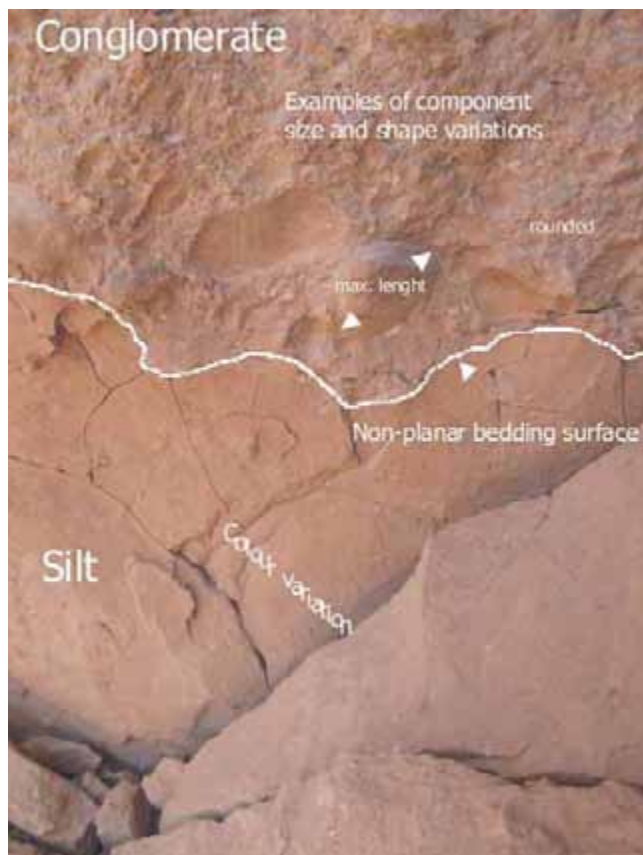
Fig. 6. Illustration of various sedimentological characteristics employed in the pattern matching approach.

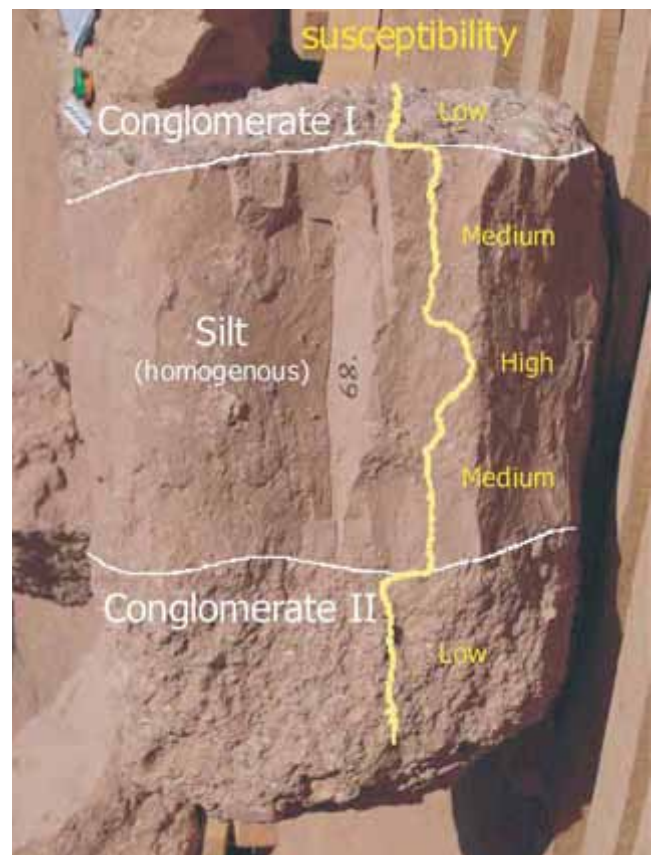
Fig. 7. Schematized magnetic susceptibility variation to illustrate typical variations in between the various lithologies (detrital) and within lithologically homogenous layers (diagenetic). Both features are useful for the pattern matching approach.

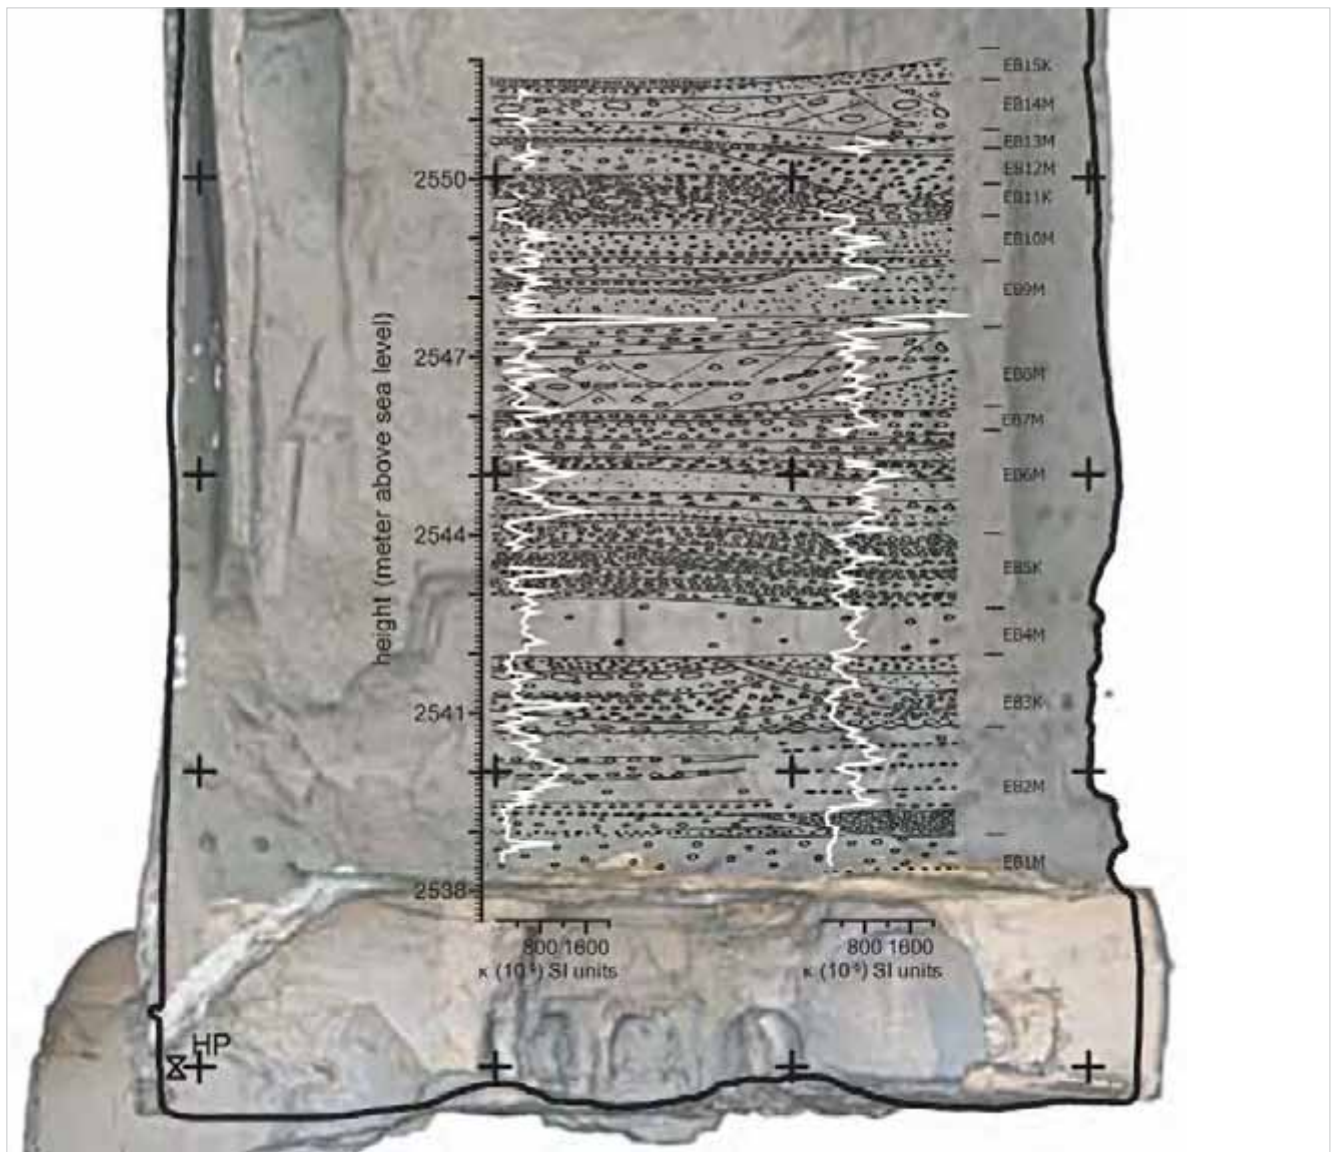
Fig. 4. Schematic of the eastern Buddha niche lithology indicating the results of the two magnetic susceptibility profiles. Major lithological units shown in more detail in figure 3. Height is in meters above sea level, profiles start at 2538.4 m.a.s.l. levelled from the reference point BP1 at 2535 m.a.s.l. Background 3D scan is courtesy of RWTH Aachen group.

Magnetic susceptibilities (with κ around 50×10^{-5} SI units) are on the same order as was noted for the Western Buddha sedimentary succession and display an equally distinct variation with the lithology (figs. 3 and 4).

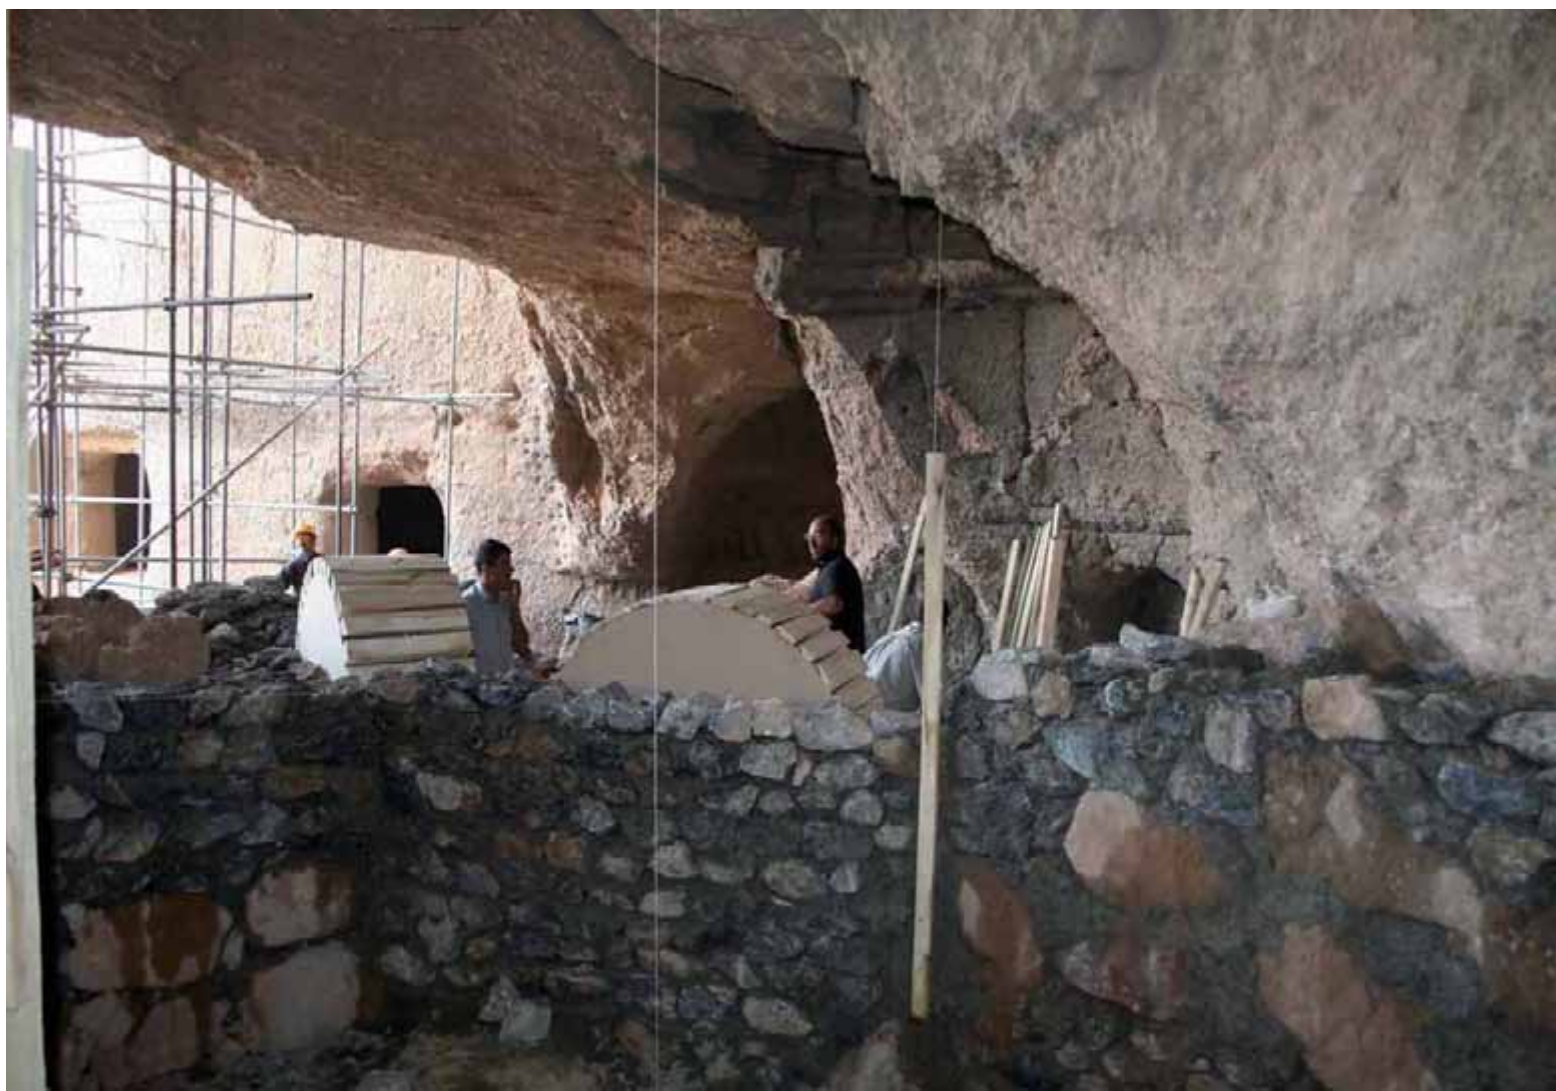
Fig. 9. Eastern Buddha niche, damage assessment of the back wall

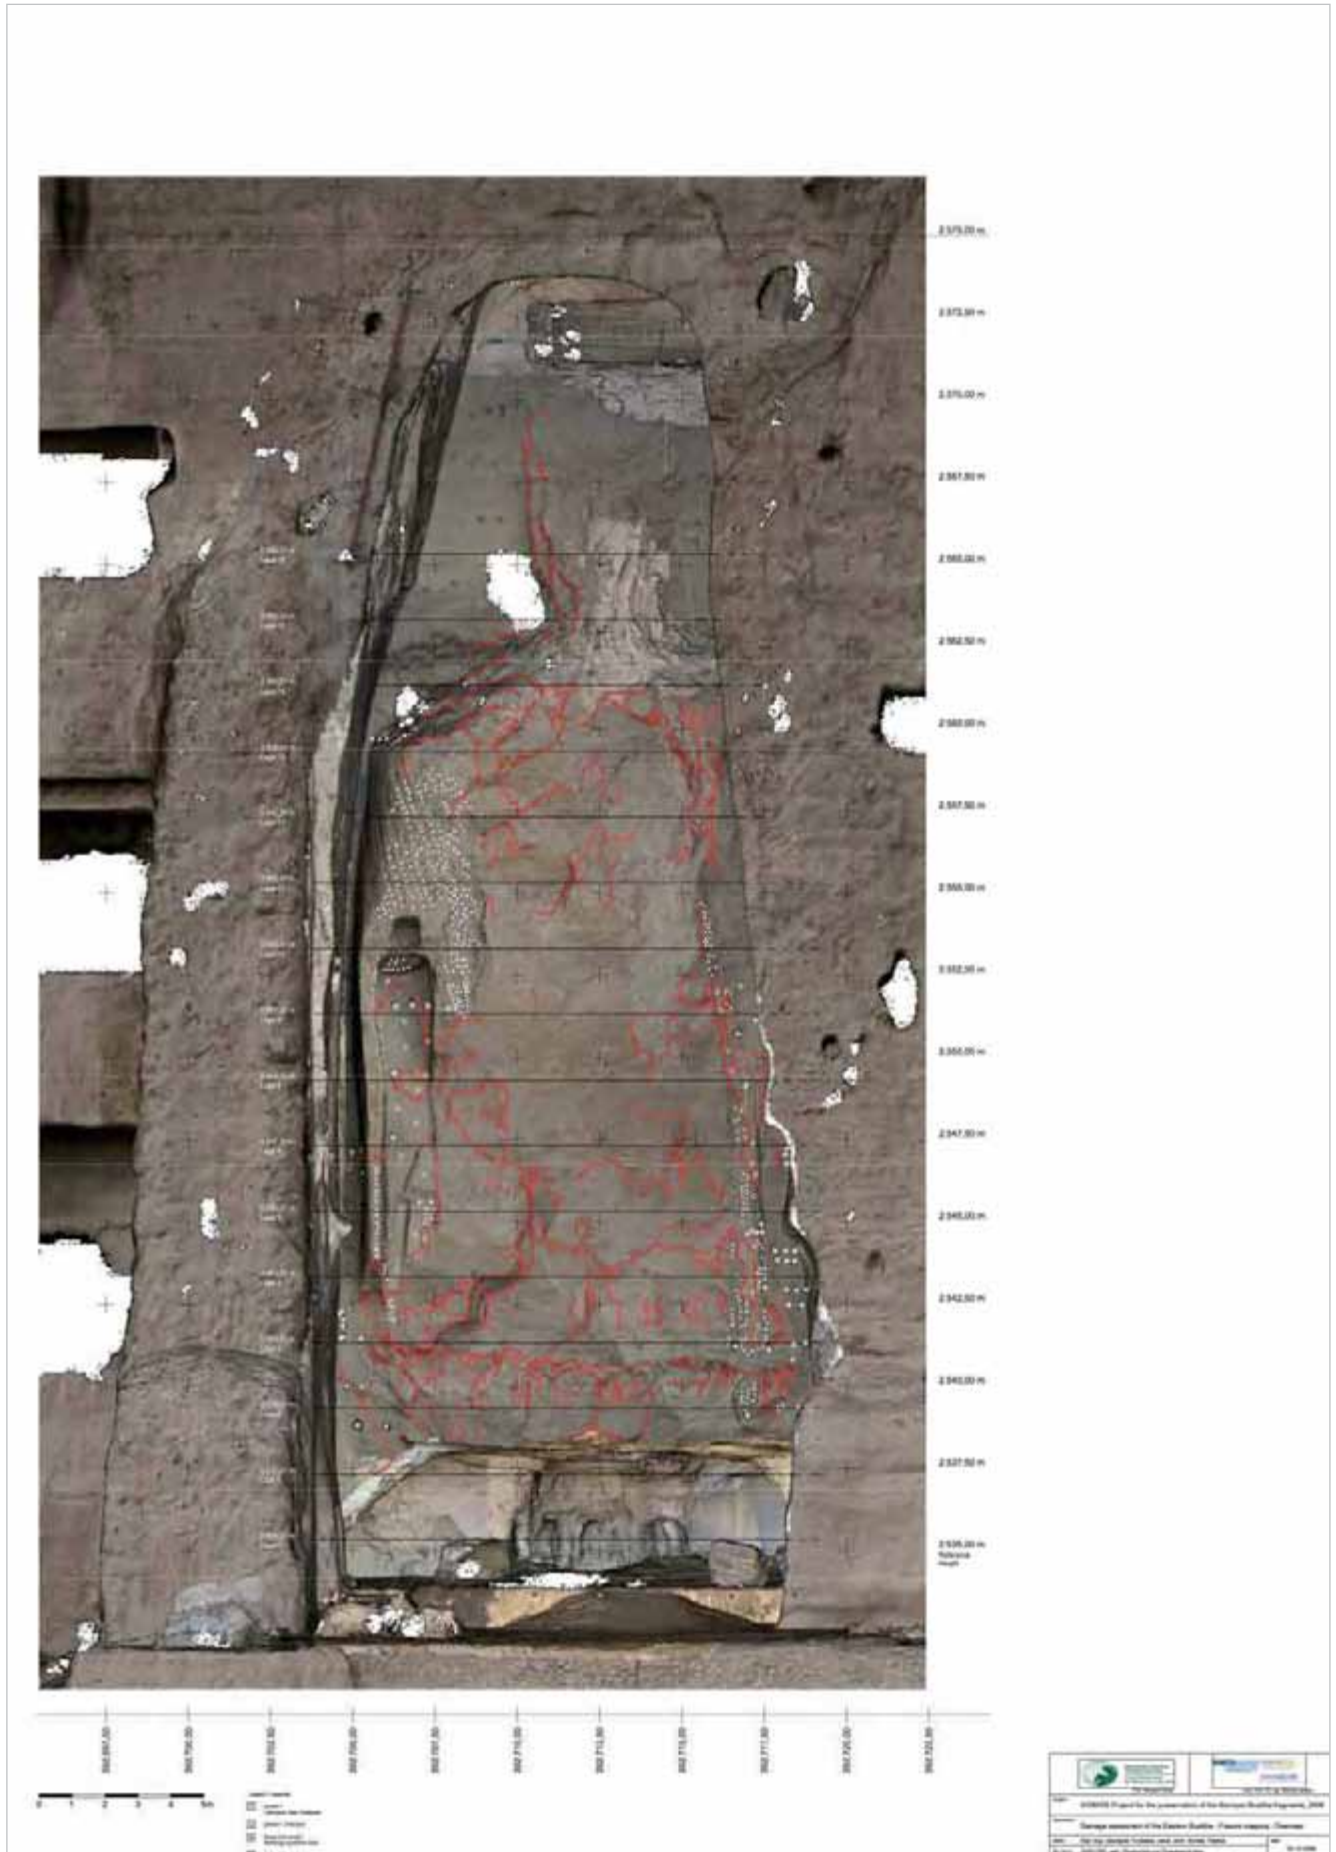
Fig. 10. Eastern Buddha niche, 3D laser scan, showing idealized reconstruction (blue line), original statue surface (green), back wall discontinuities (red)

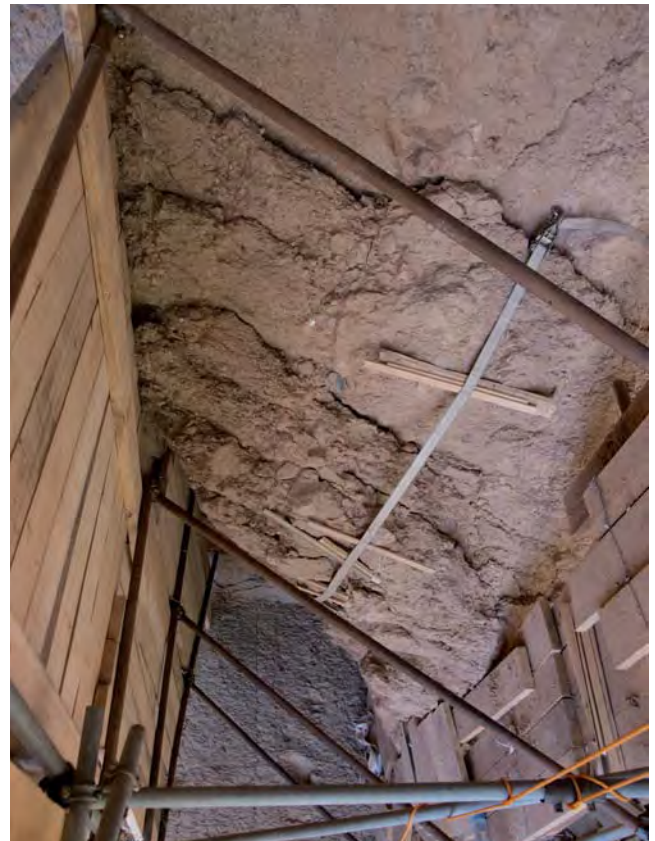
Bracket-like cantilevers are added to the scaffold so that the niche's back wall can be reached

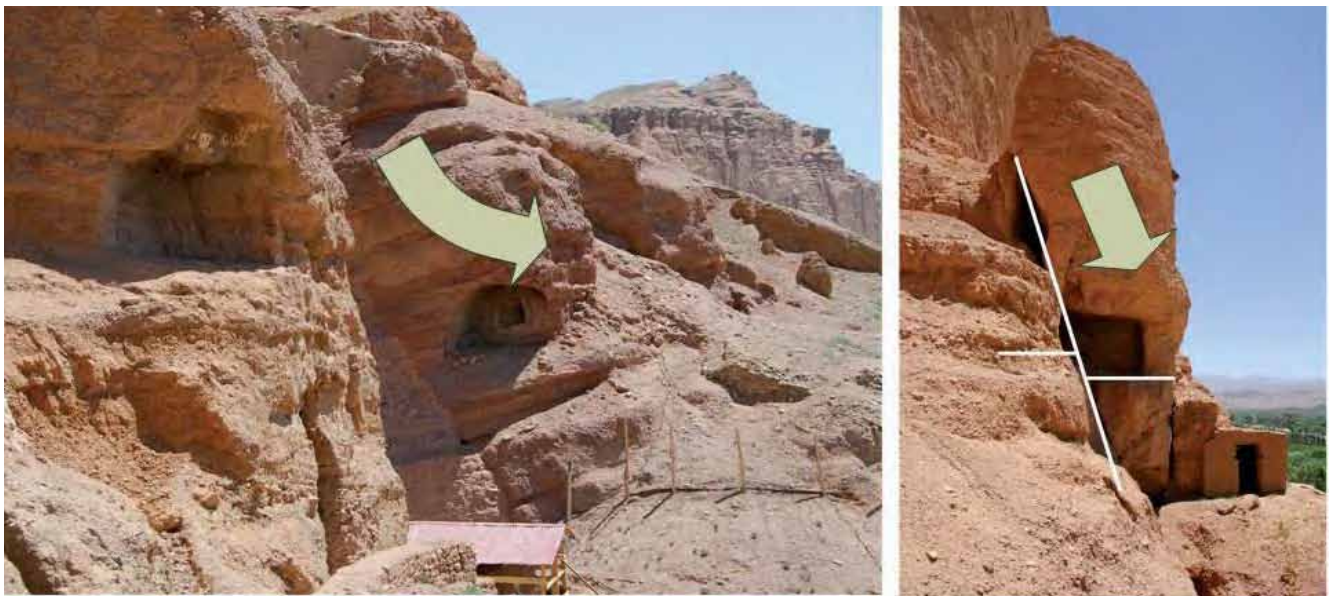
Fig. 6. Rock slides affecting the caves inhabited since the 6th century AD

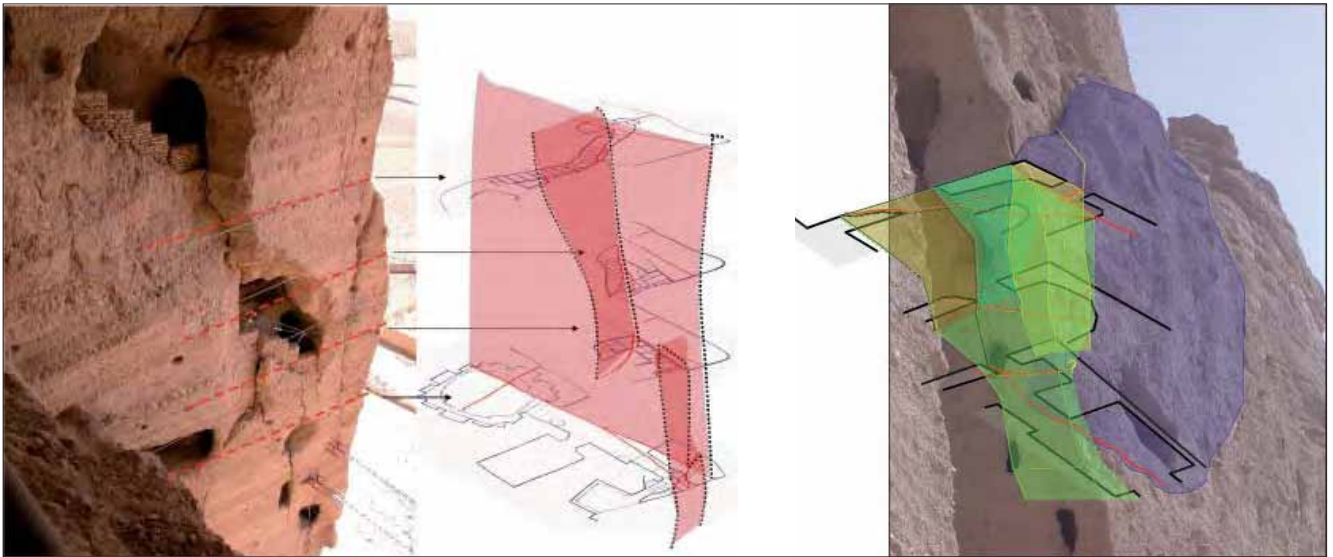
△ Fig. 10. Pattern of existing discontinuities at four different stories (left) and reconstructed unstable blocks in the upper east side of the Eastern Giant Buddha niche (right)

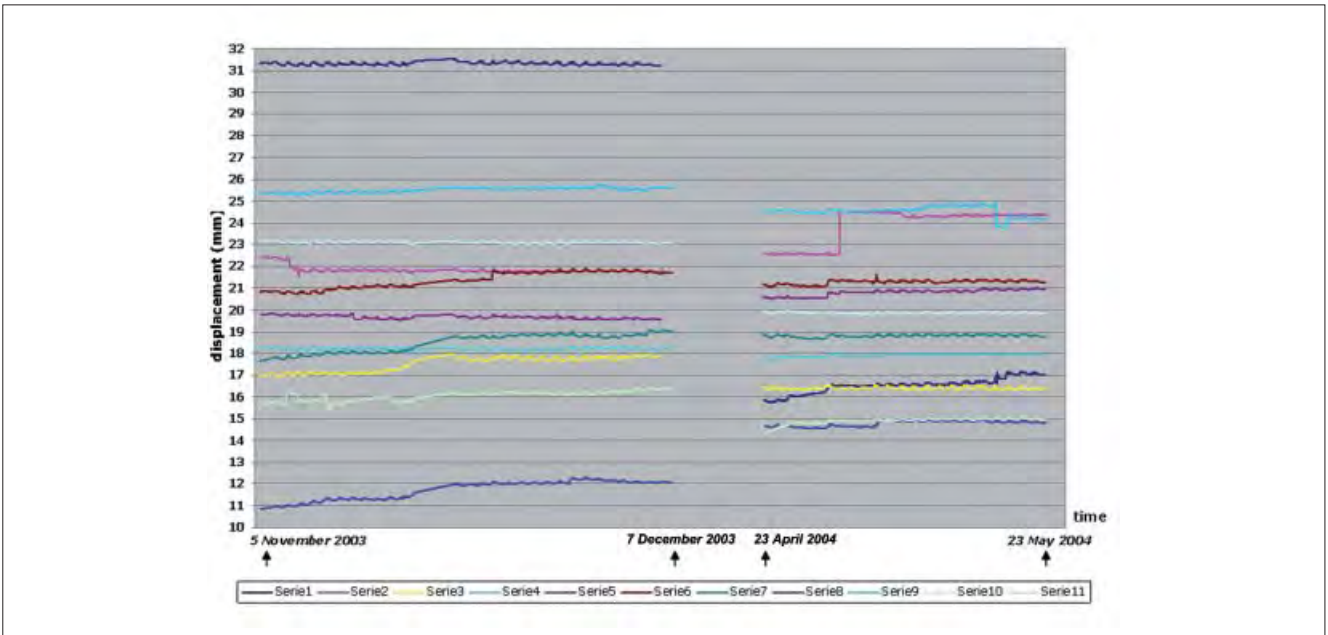
Fig. 23. Time evolution of the 11 extensometers operating in the period 5–7 December 2003 and 23 April – 23 May 2004 in the eastern wall of the niche, and showing no remarkable movements on the cliff. Some minor steps were caused by climbers, who hit the gauge placed on the cliff

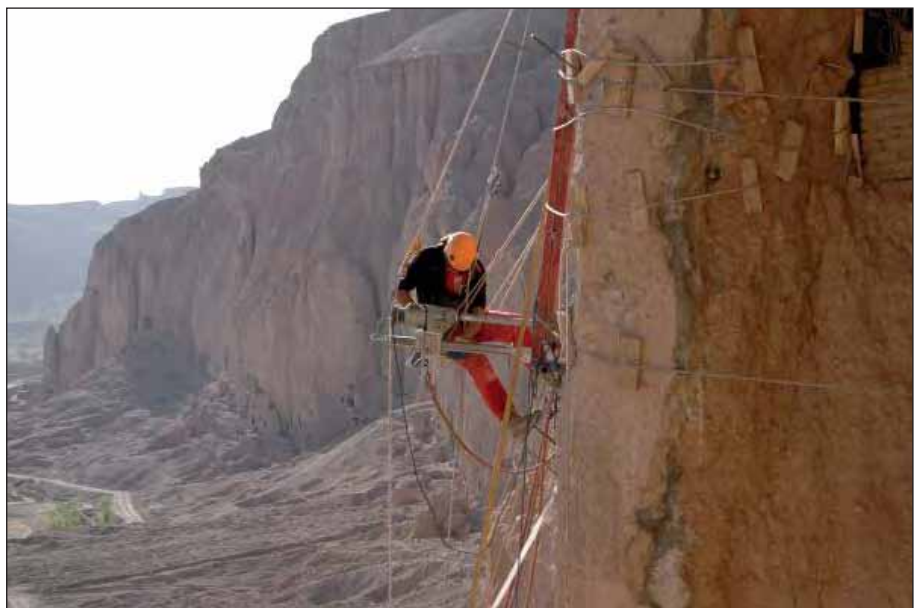
Fig. 29. Drilling for the setting of nails ▷

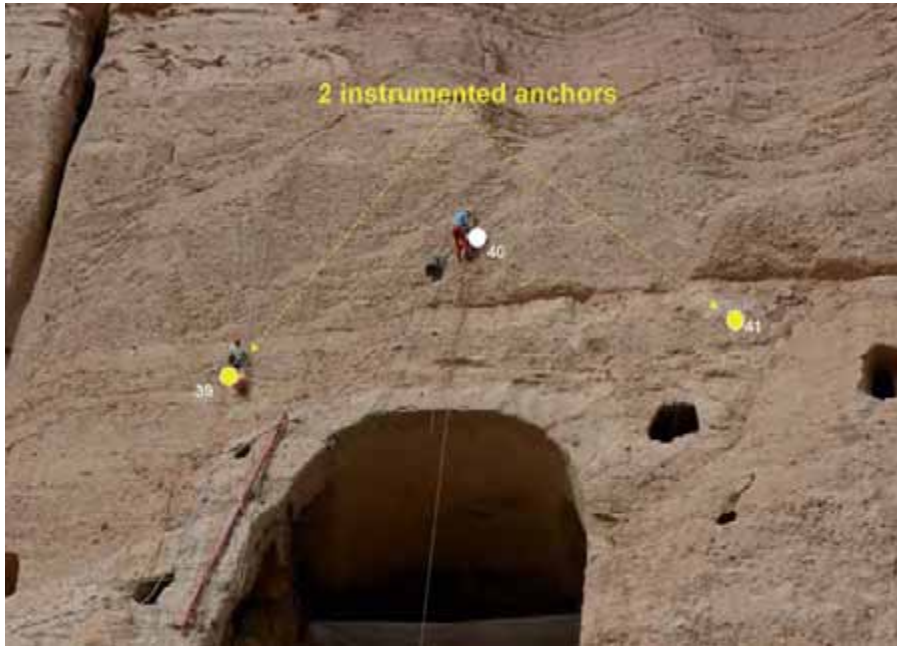
◁ Fig. 30. Position of anchors on top of the niche. The yellow ones are monitored with 10 strain gauges

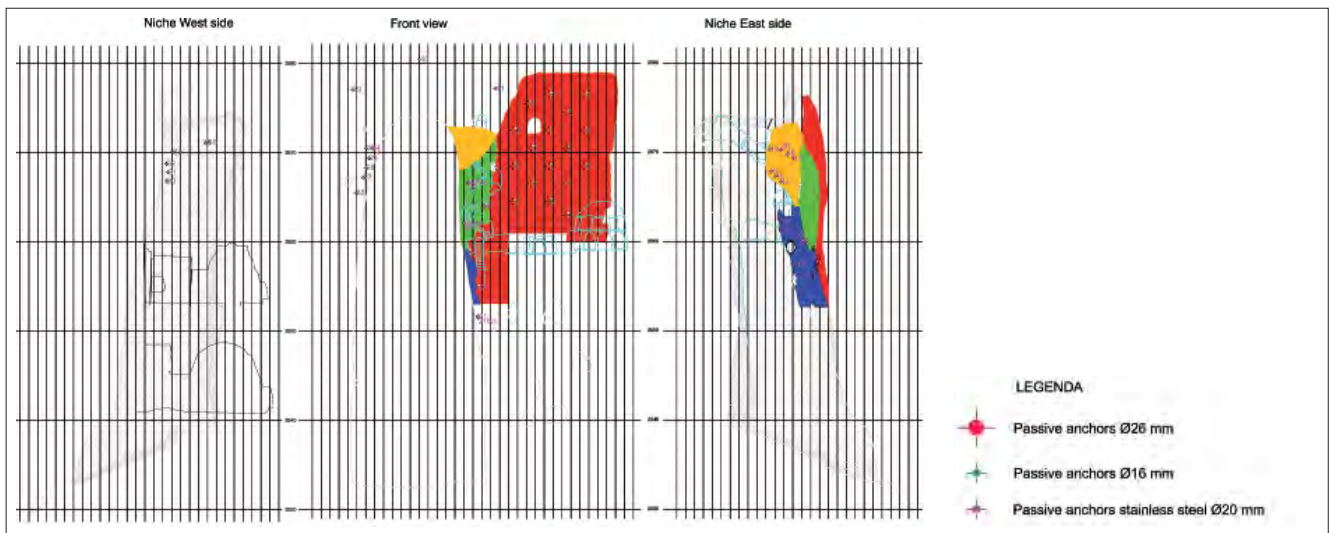
△ Fig. 32. Typology, position and length of executed anchors and nails (red is for passive anchors, pre-grouted, with diameter = 26 mm and length 15 m.; violet is for stainless steel passive anchors with diameter = 26 mm and a length 5–10 m.; green is for short passive anchors with diameter = 16 mm and length about 5 m, placed on the internal side of the niche (topographic data from Pasco, 2003)

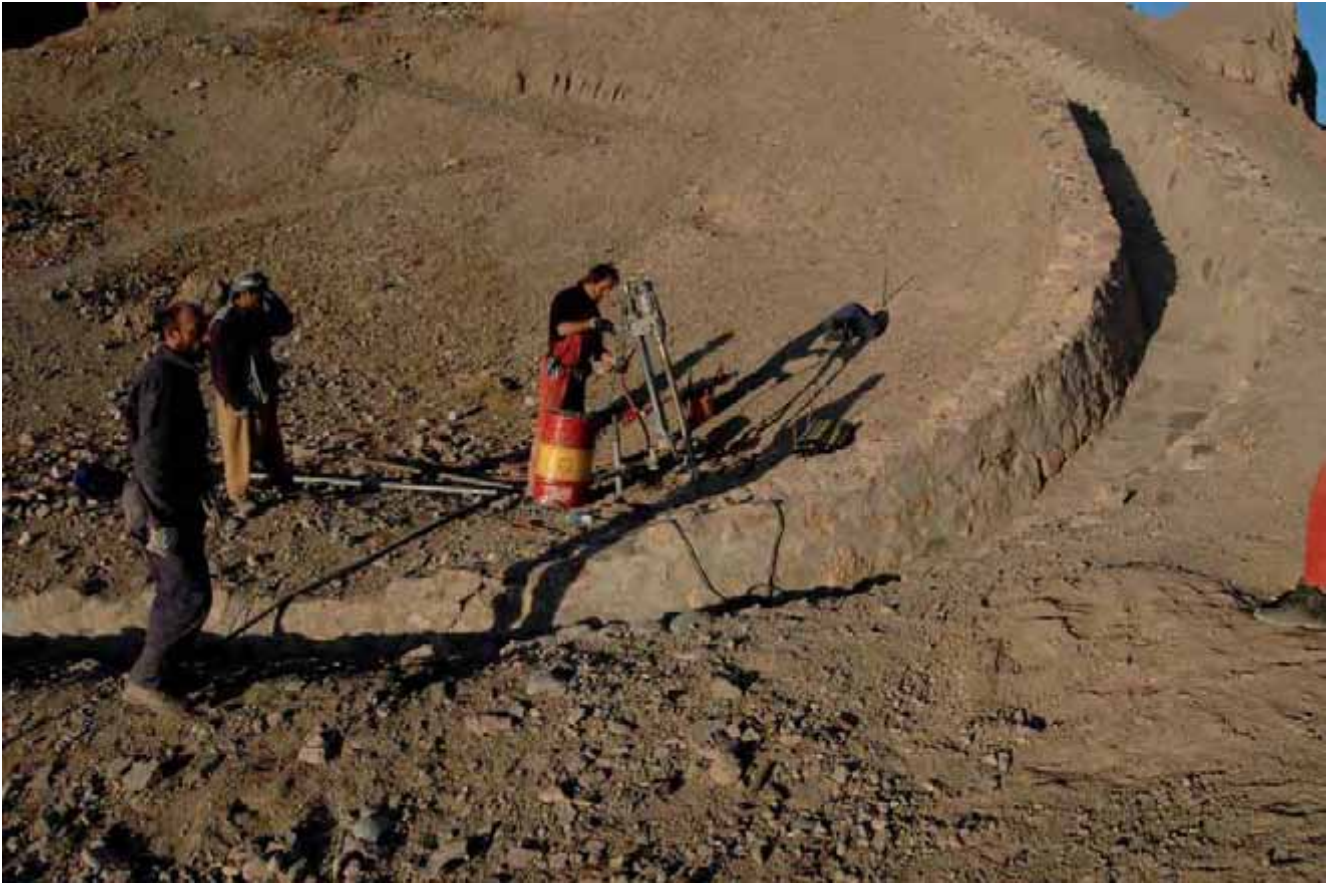
Fig. 35. Detail of the grouting from the top of the cliff

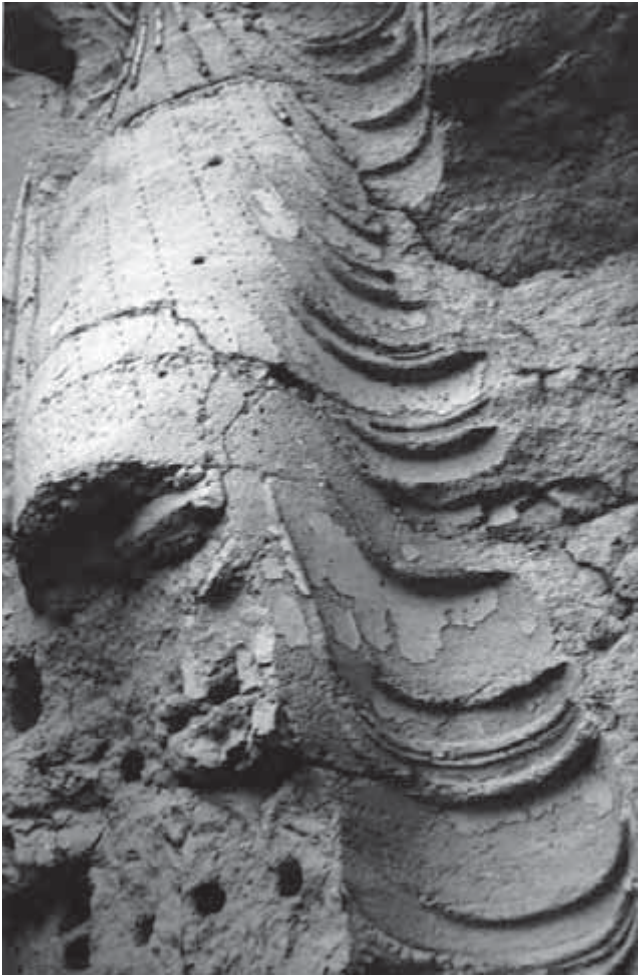
Fig. 6. Western Buddha, detail of right leg in 1965 [ASI] and sketch demonstrating the system with wooden pegs and ropes [Tarzi 1977, vol. 2. p. 117]

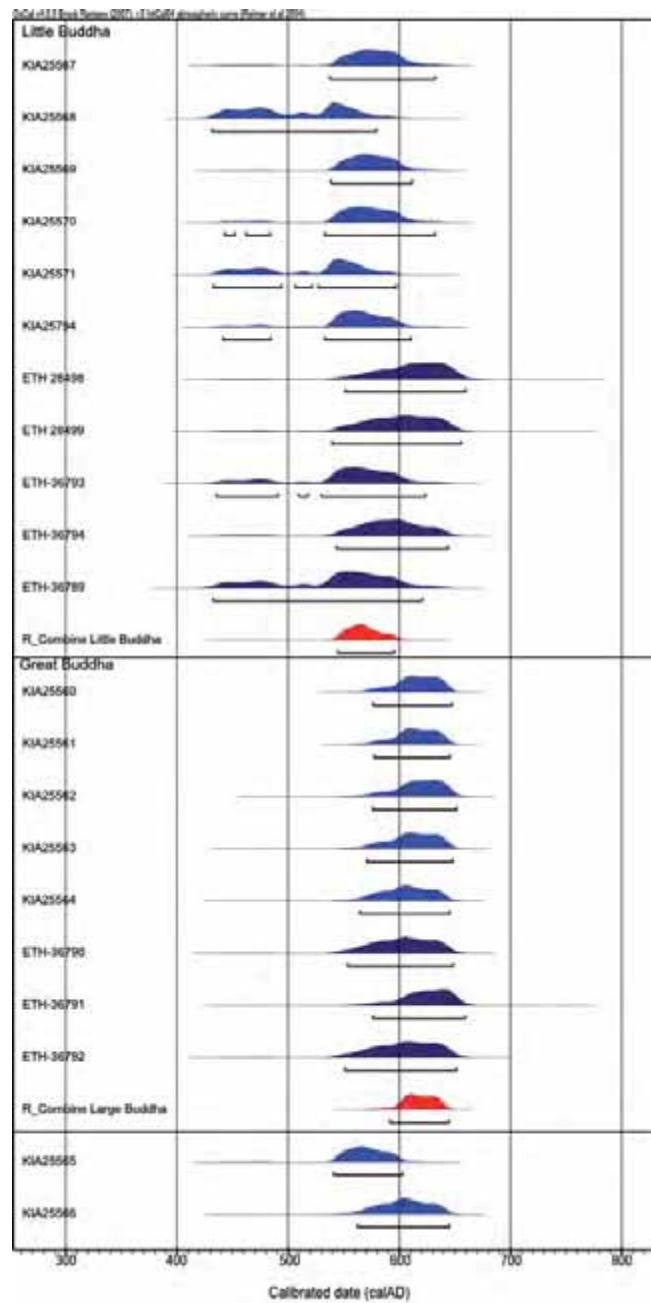
Fig. 2. Calibrated sample ages. Light blue colours refer to samples measured in the Leibniz Laboratory, Kiel, and dark blue colours to measurements done at ETH, Zürich. The red coloured field gives the product of the probability distributions vs. calendar age of the samples from the Eastern Buddha and the Western Buddha.

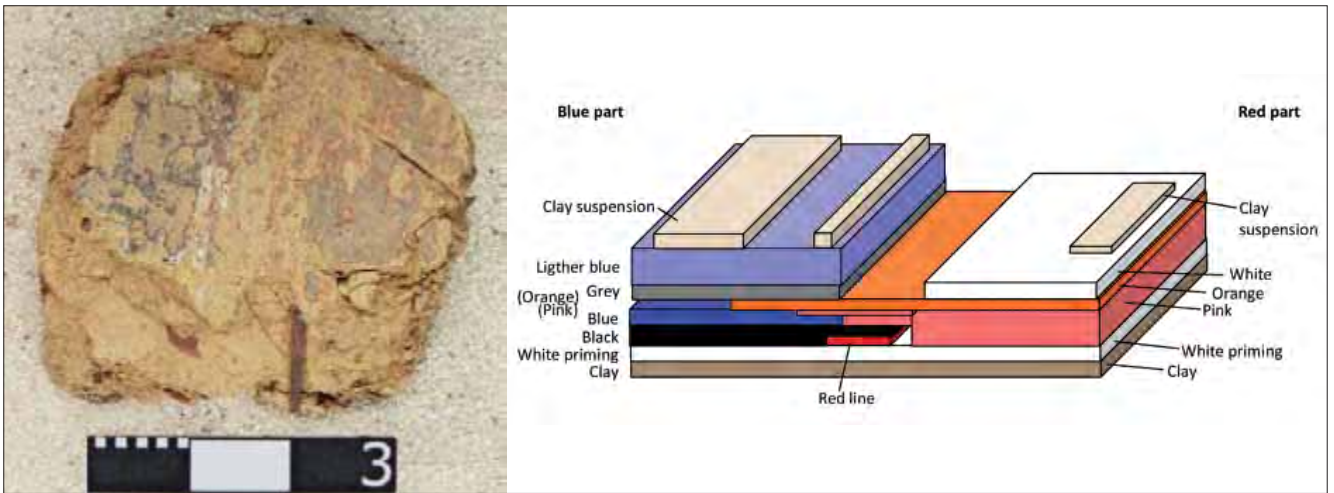
Fig. 13. Layer sequence: Eastern Buddha, transition of blue area (group 5) to red area (group 1)

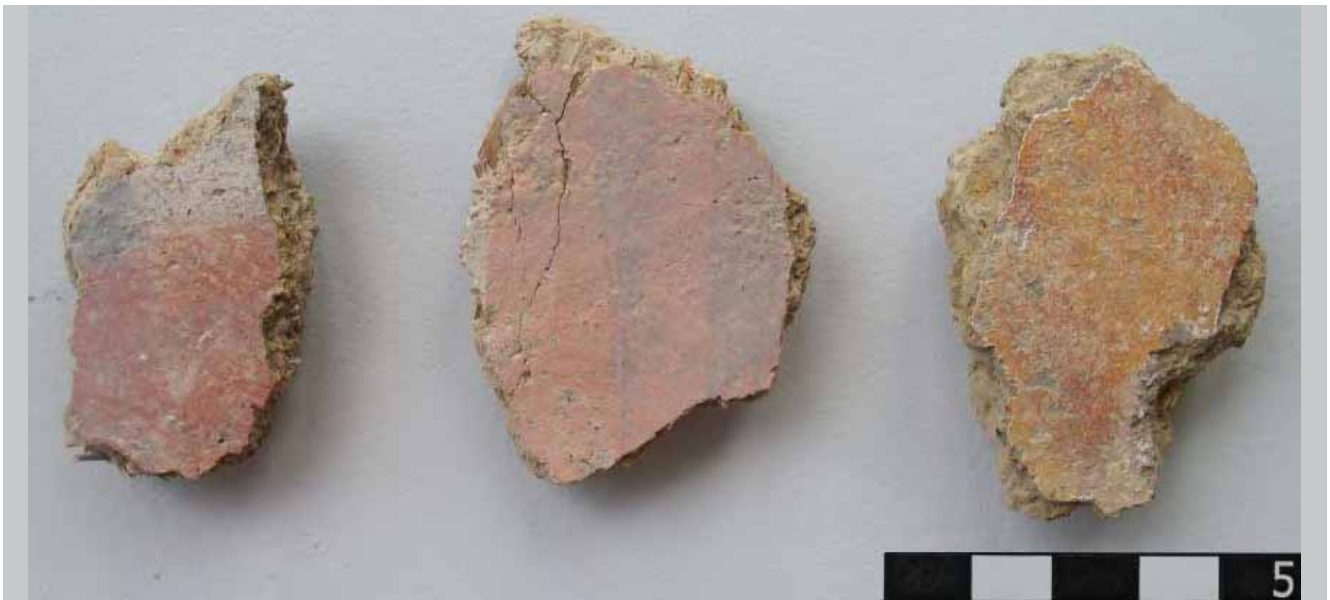
Fig. 18. Fragments with several colours from Western Buddha, samples ID 65, 66 and 93 left to right [Blänsdorf]

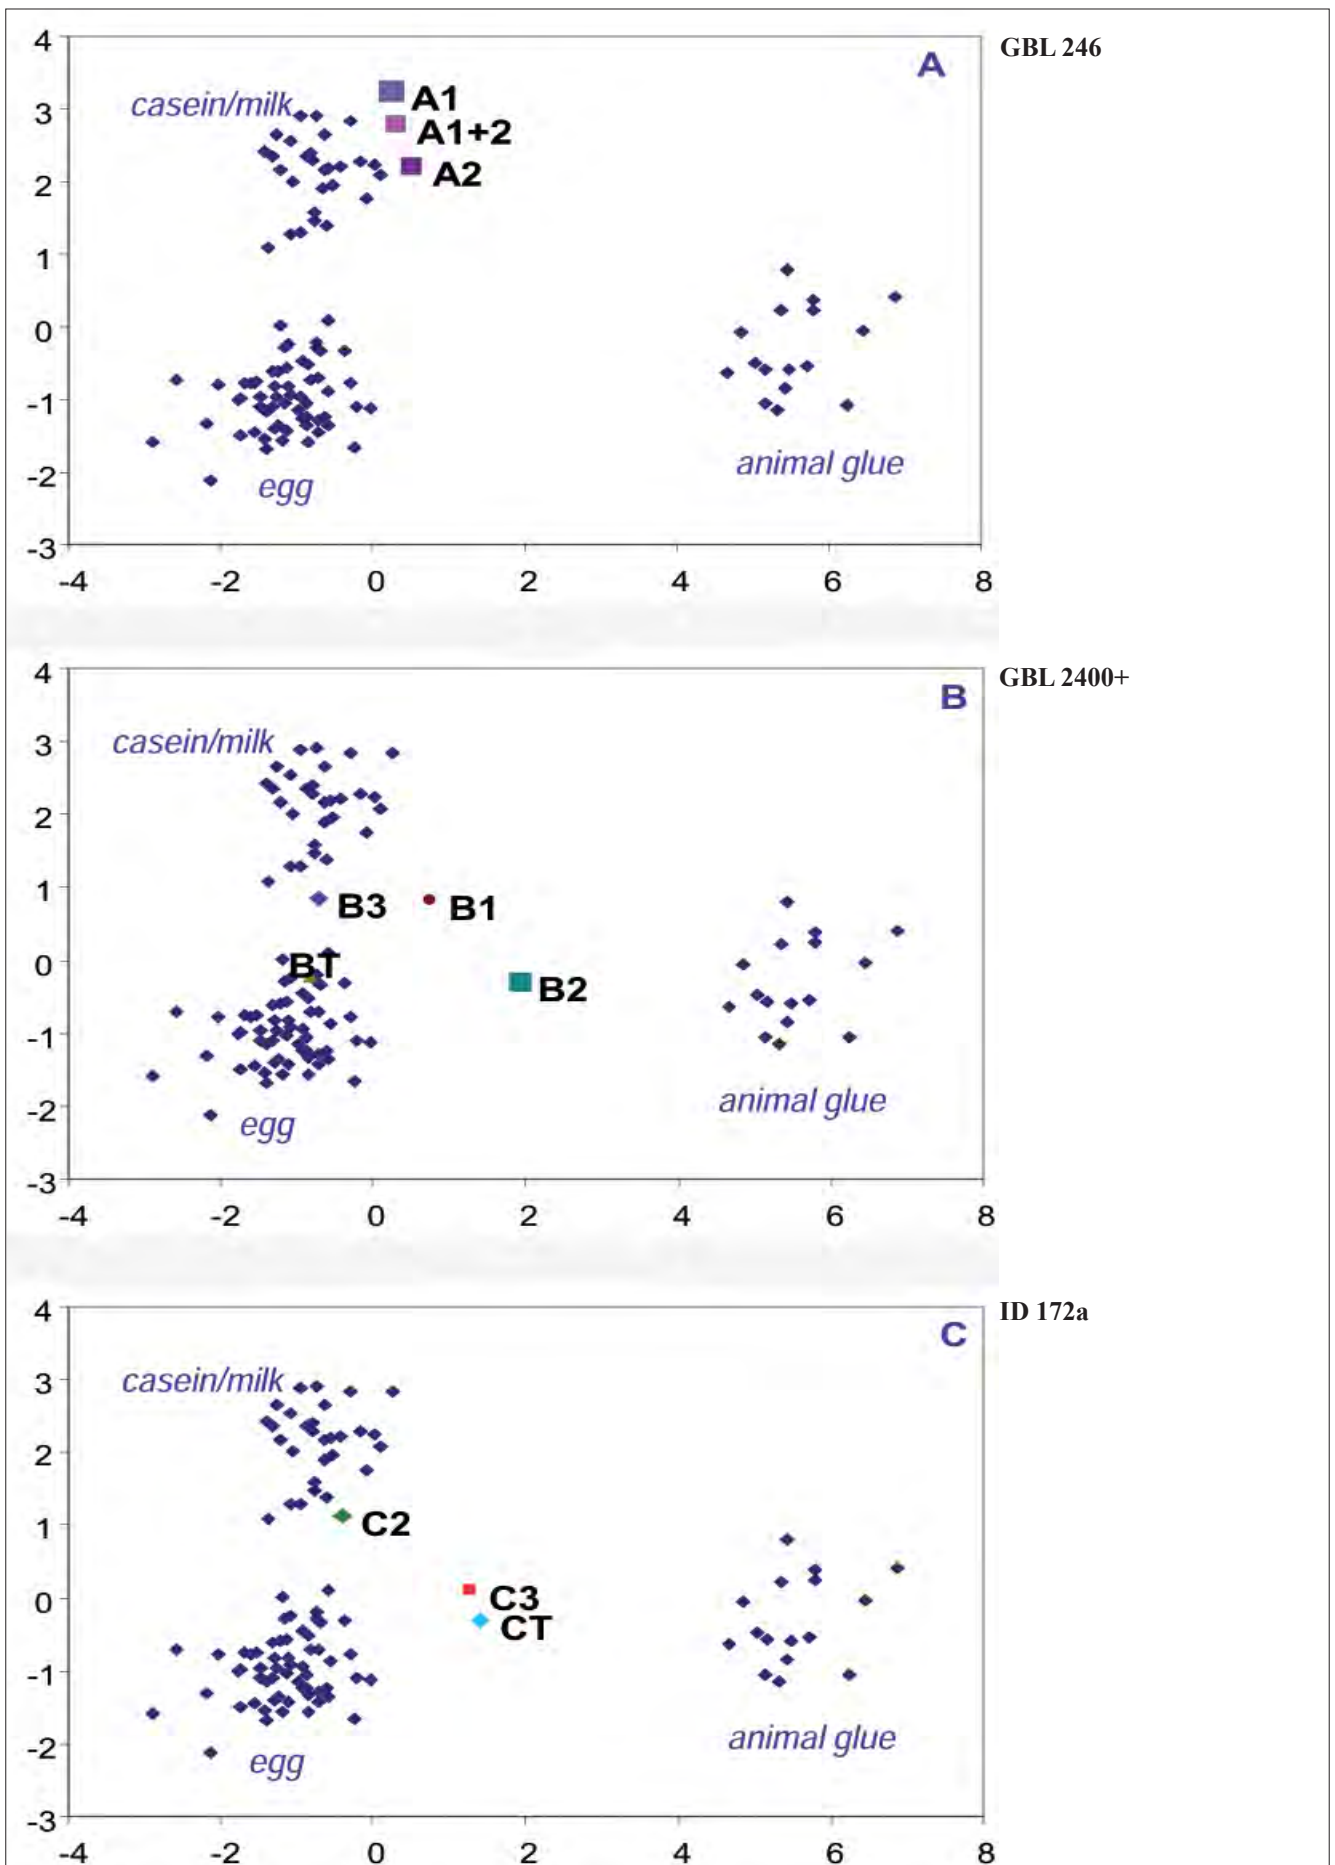
Fig. 3. PCA score plots (A, B, C) of GBL 246, GBL 2400+ and ID 172a
