HISTORICAL POLAR BASES – PRESERVATION AND MANAGEMENT

This publication is compiled and edited for
the International Polar Heritage Committee of ICOMOS by :

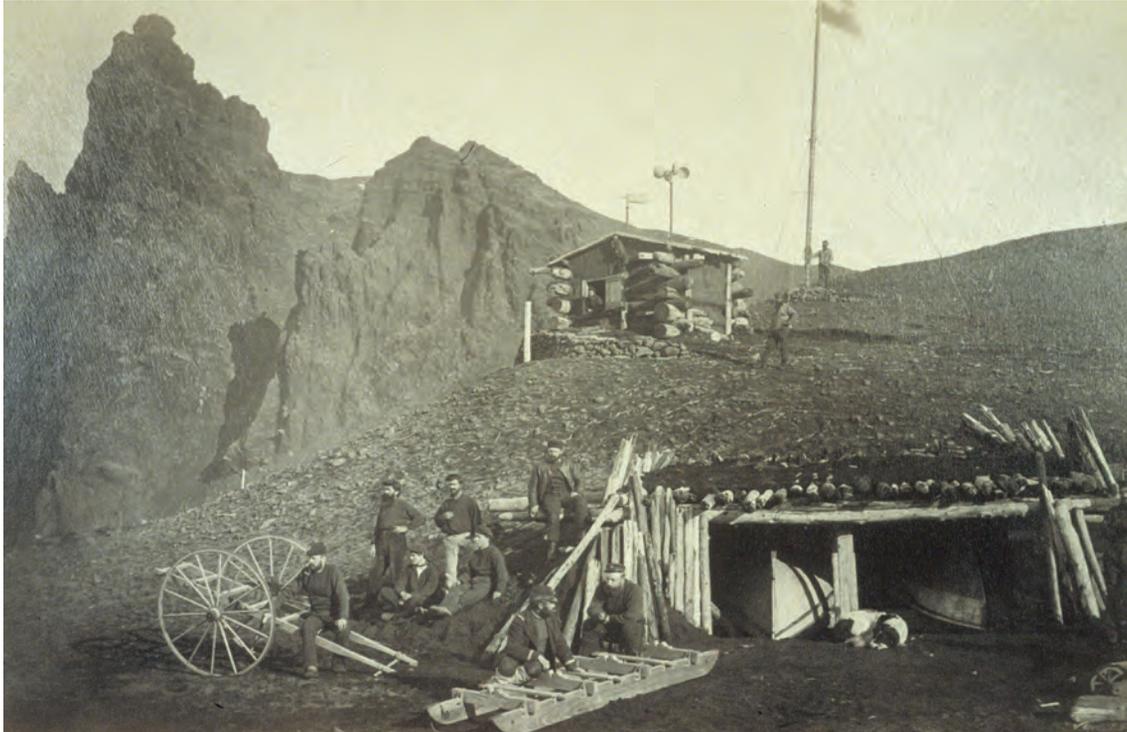
The remains of these buildings at "Østerrik-eren" nearest the sea have been destroyed by wave erosion in the last few years. Photo by the IPY expedition 1882-83 from Barr 2003.

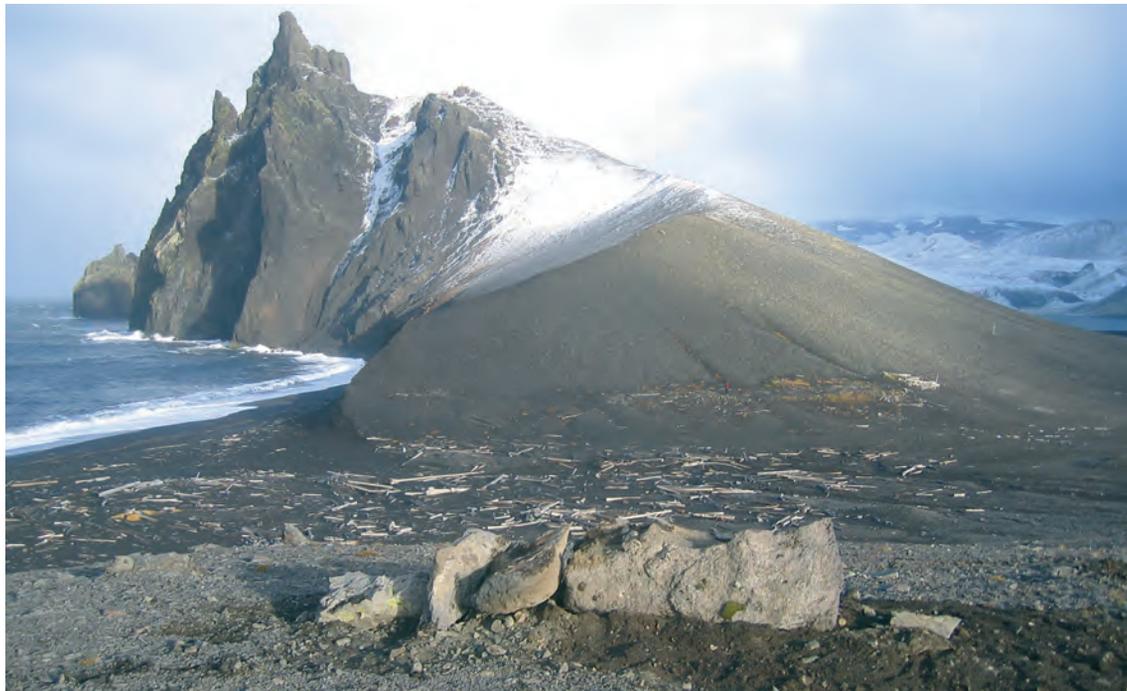
The remains of "Østerrikeren" can be seen near the base of the slope in centre picture. To the left the eroded edge of the site. Photo: Susan Barr 2007

the fact that Jan Mayen has been a difficult place to visit and tourism has been very restricted. This is changing as international arctic cruise activity develops, but the new protection regime will provide a strong measure of control and sanction. A greater threat for "Østerrikeren" right now is the increasing erosion of the coastal side of the site as less sea ice and more wind and wave action eat away at the loose lava sand. A couple of the outbuildings that are clearly seen on a photograph from 1883 have been washed away in the last few years and this natural process is impossible to curb. The main area of the station is luckily less exposed and should survive for some time to come.

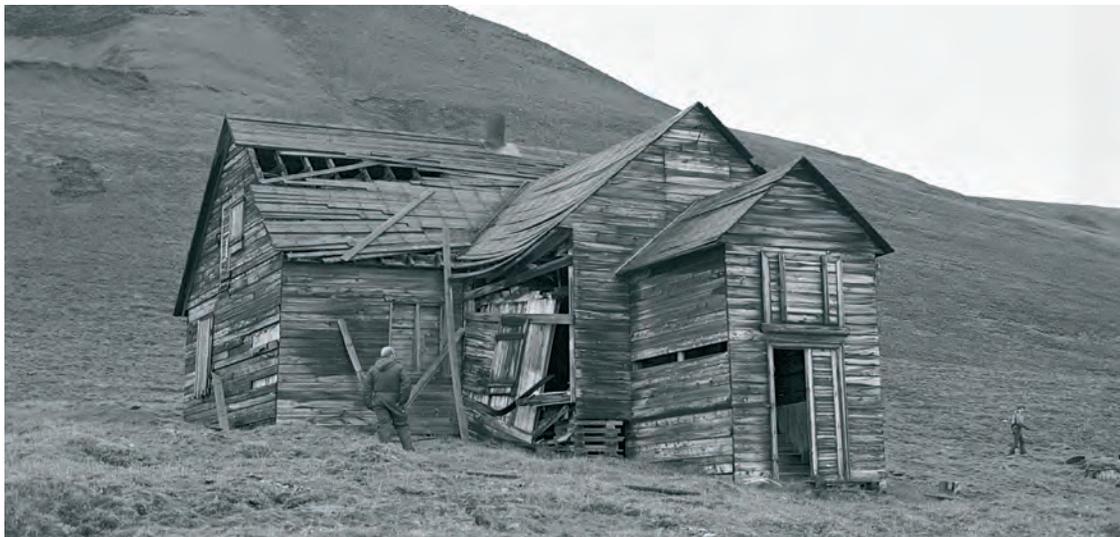
The IPY base at Kapp Thordsen, "Svenskhuset", in 1982 just before restoration work began.
Photo: Susan Barr

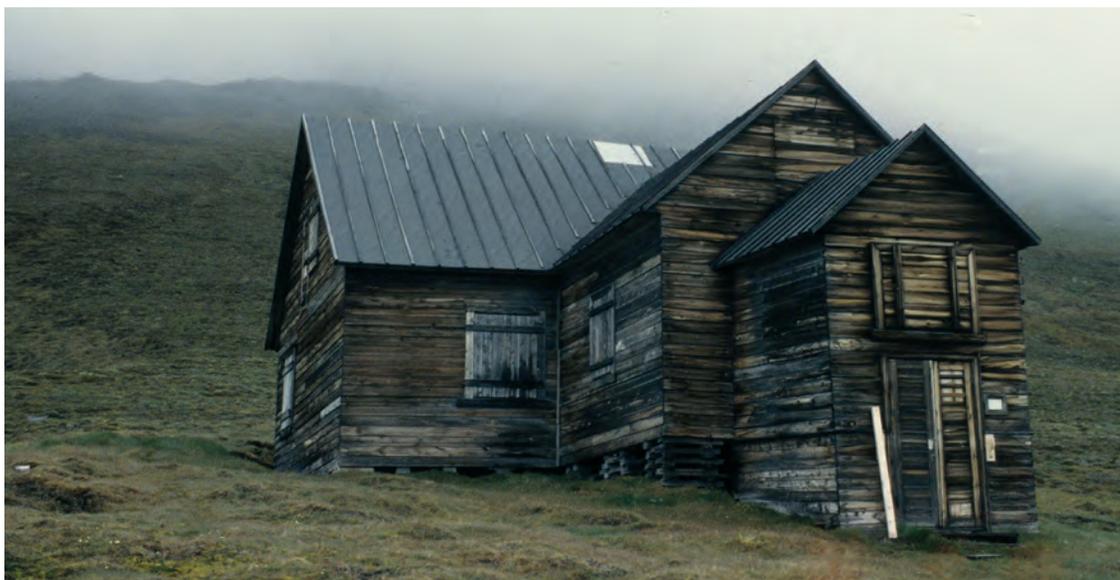
"Svenskhuset" with new roofing and the walls restored.
Photo: Susan Barr 1987

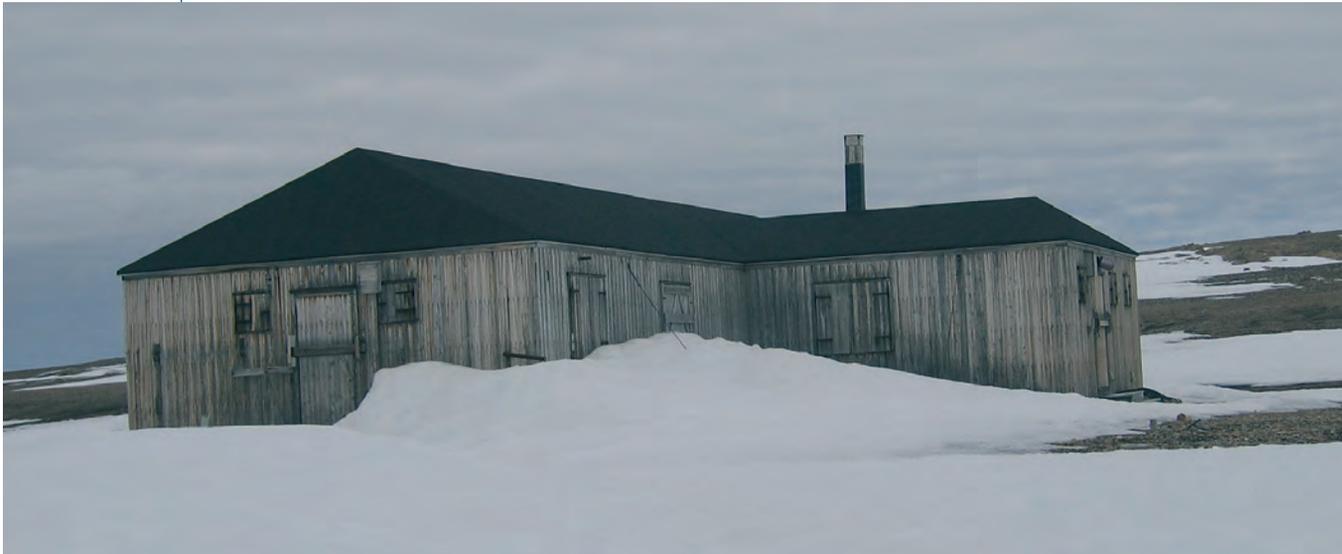
The main building and living accommodation at the Kinnvika station. Photo: Susan Barr 2006

by dogsleds in order to establish the station. The building still stands today and is used as an emergency shelter. It experiences extreme winter conditions and occasionally suffers snow and ice damage, but apart from normal maintenance, it has not been given any special priority as a cultural heritage monument. Its use today ensures that it is kept in reasonably good condition and its protected status ensures that it is not purposefully destroyed or changed.

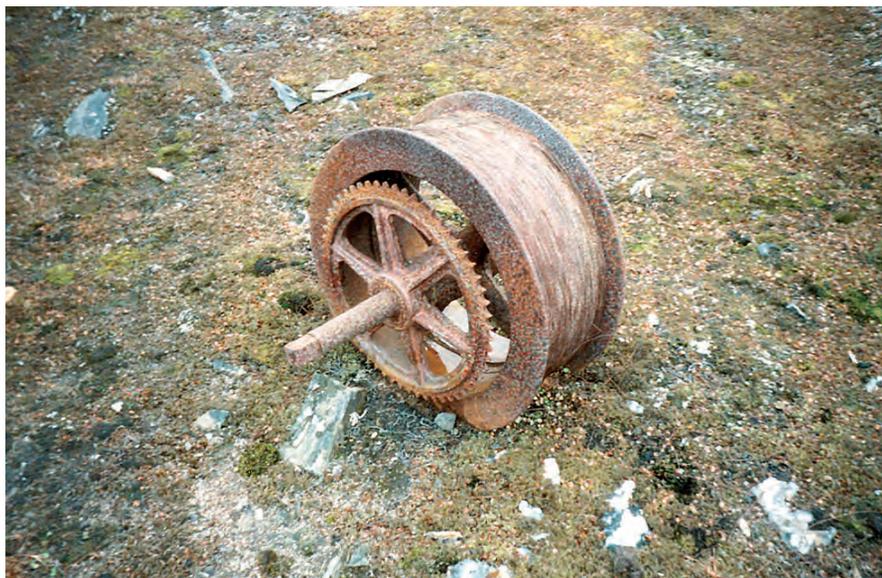
Roll of piano
wire for captive
balloon ascents
at the site of
the German
geophysical
observatory at
Ebeltofthamna
in 2000.
Photo: Cornelia
Lüdecke

piano wire for captive balloon ascents reminds us of this important era (Fig. 1). It is said that in 1915 the huts were removed to Ny-Ålesund, the coal-mining settlement nearby, a usual thing to do in a region where no trees are growing.

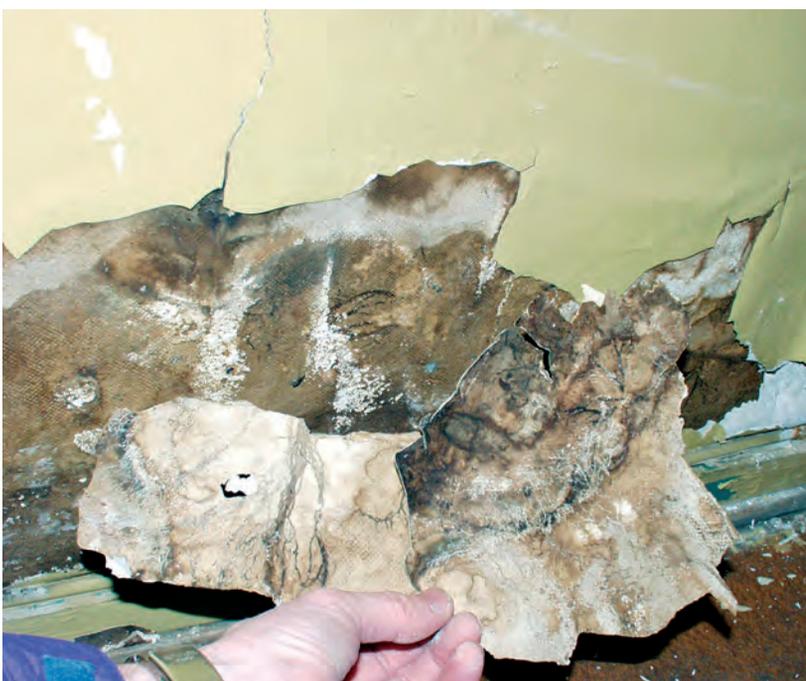
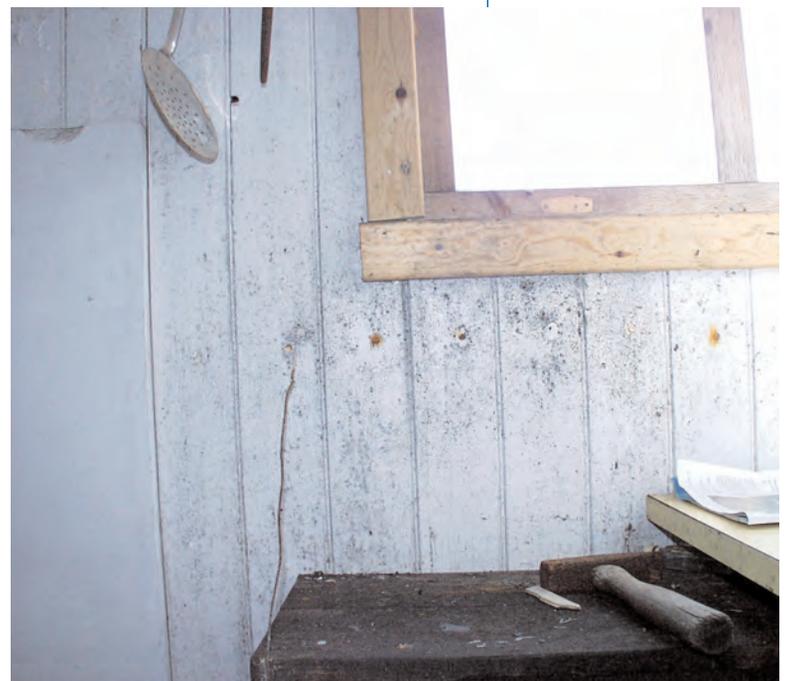
Left:
Extensive growth of *Coniophora puteana* is caused by moisture from the ground.

Under:
Mould growth on surfaces inside the hunting cabin. Both photos: Johan Mattsson

The survey showed that there were three sources for the moisture problems: high relative humidity/condensation, leakages and water from the ground. The most extensive problem was caused by the humidity in the ground. Both due to melting of snow and permafrost, the floors and lower part of the walls were standing wet for long periods. Furthermore, it has been common to cover the lower part of the walls with soil in order to insulate and increase the temperature indoors. As long as the soil is frozen, it does not cause any moisture problems. However, during summer months, the upper part of the soil is thawing and the water is penetrating into the walls where fungal growth can occur.

The survey and sampling showed an extensive occurrence of wood-decay fungi in connection with the wooden constructions. In the 54 wooden samples, the species *Leucogyrophana mollis* was found in 34 cases. *Coniophora puteana* was found in two samples and a species in the family *Corticaceae* in one sample. Soft-rot was found in 29 samples.

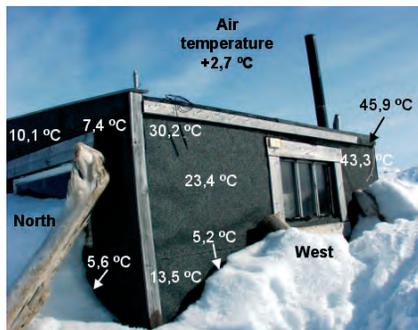
The former office building (*Transporten*) had several structural damages. The damage was most extensive at the lower part of the external walls, where the cladding and structural elements were decayed by brown-rot fungi. The building was originally constructed on pillars, so both the floor construction and the walls were protected from soil contact. However, later addition of soil up against the walls in order to gain a warmer floor and walls during winter time, created favourable growth conditions for bio-deterioration. The damage had developed through several years, mainly due to a combination of wet soil against the walls and lack of maintenance.

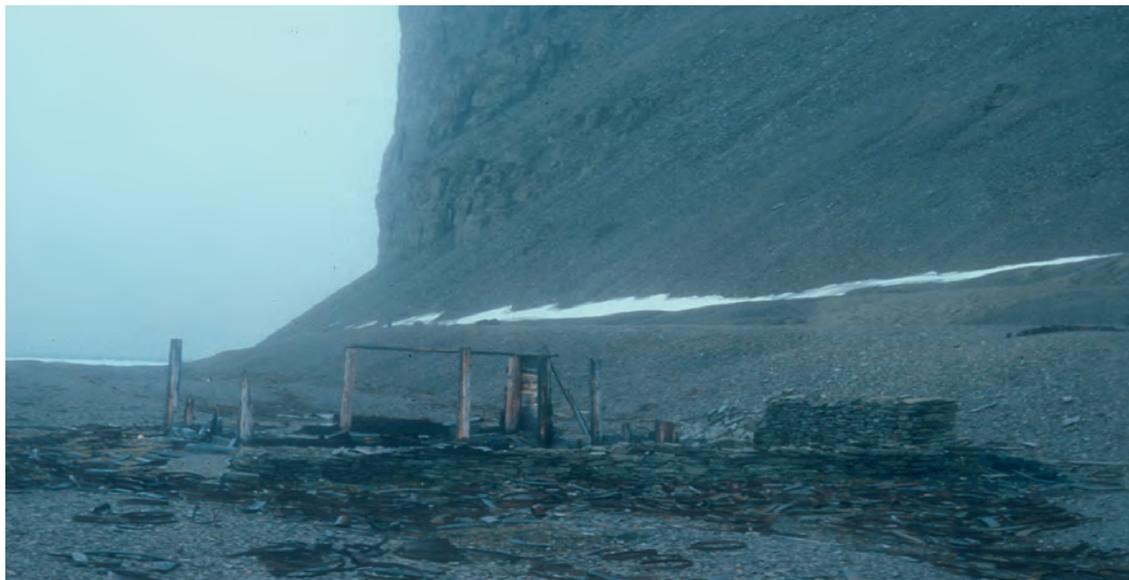
The remains of Northumberland House at Beechey Island built in 1852 by members of the Belcher squadron during a Franklin rescue expedition. Photo: R.A. Blanchette

In 1852, Sir Edward Belcher led a squadron of five ships in search of the lost expedition of Sir John Franklin. During the expedition a wooden shore depot of supplies was erected on Beechey Island by the crew of the *North Star* under Commander W. J. S. Pullen. This building, called Northumberland House, represents some of the oldest introduced wood in the Canadian High Arctic. The building was still intact during a visit by the Captain Allen Young in the *Pandora* in 1875 (Young 1879) but deterioration has taken a significant toll on the structure and only ruins currently remain of the original building and contents. In addition to Northumberland

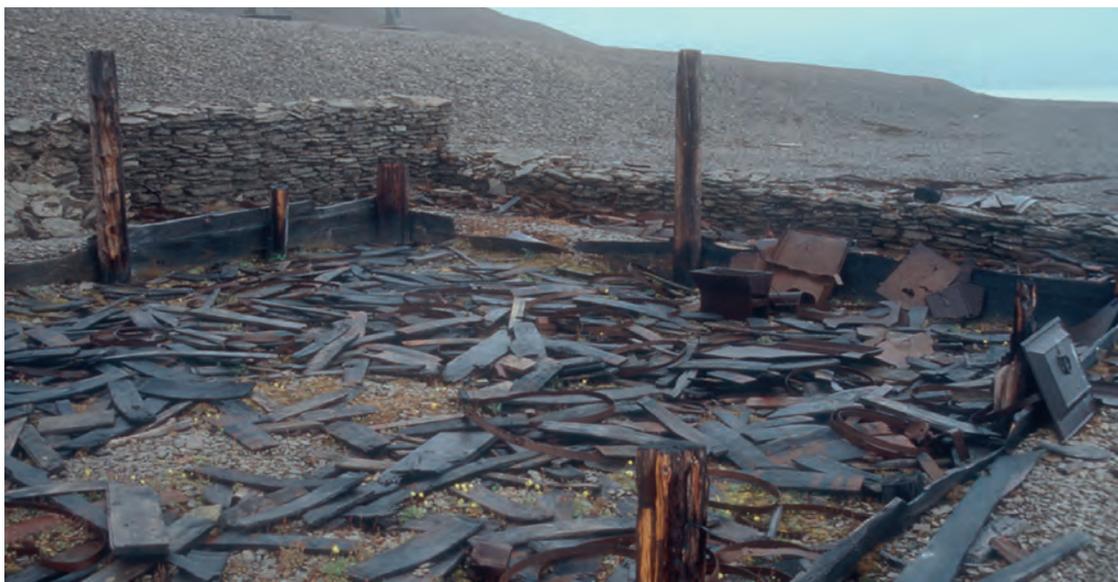
Wall boards, posts and various wooden artifacts associated with Northumberland House. This wood at Beechey Island is some of the oldest wood introduced into the Arctic by European explorers. Extensive decay is present in the wood and decay fungi are actively causing degradation. Photo: R.A. Blanchette

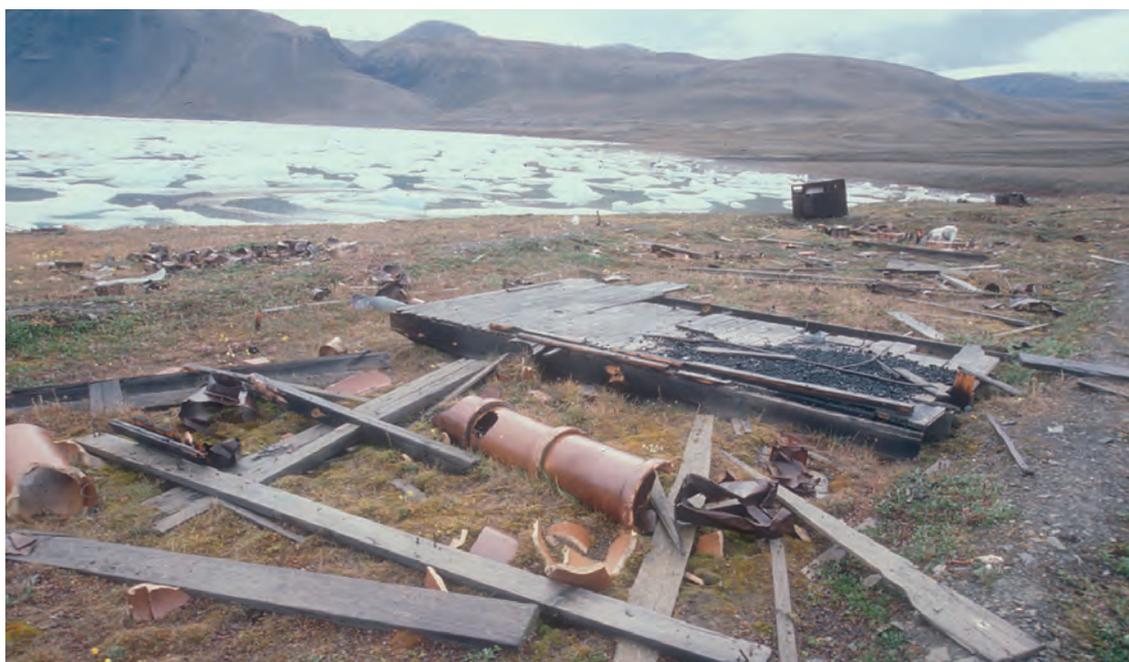
Little remains of the original Fort Conger due to dismantling by Peary and his expedition crew members in 1901 to make smaller dwellings for overwintering. Parts of the Fort's wooden floor, miscellaneous timbers and many artifacts are still at the site. Photo: R.A. Blanchette

numbers of the house posts and wall boards are on the ground within and around the location of the original structure. The structural wood present at the site is spruce, hard pine (most likely *Picea abies* and *Pinus sylvestris*) and oak. Some woods are affected by salt deterioration and have white defibrated surfaces. This type of non-biological degradation occurs in wood of historic huts at other polar locations and has been well described from the expedition huts located in the Ross Sea Region of Antarctica (Blanchette et al. 2002). It is caused by the corrosion of wood cells due to the chemical attack on lignin. Salts migrate into wood and accumulate resulting in the chemical degradation of the middle lamella between cells (the cementing material that holds cells together) and cells separate. Over time the cells on the wood surfaces become defibrated and detach. This process is relatively slow and gradually erodes the wood. Of greater importance is the destruction of wood by wood decay fungi. All woods have evidence of decay and many are affected with advanced stages of decay. There are several types of wood decay that occur throughout the world but only one form of degradation was found. This decay was characterized by cavities forming inside the secondary walls of wood cells and is commonly referred to as soft rot. Other types of wood decay, normally found in temperate regions of the world, were not found. Isolations from the decayed wood produced cultures that were identified by sequenc-

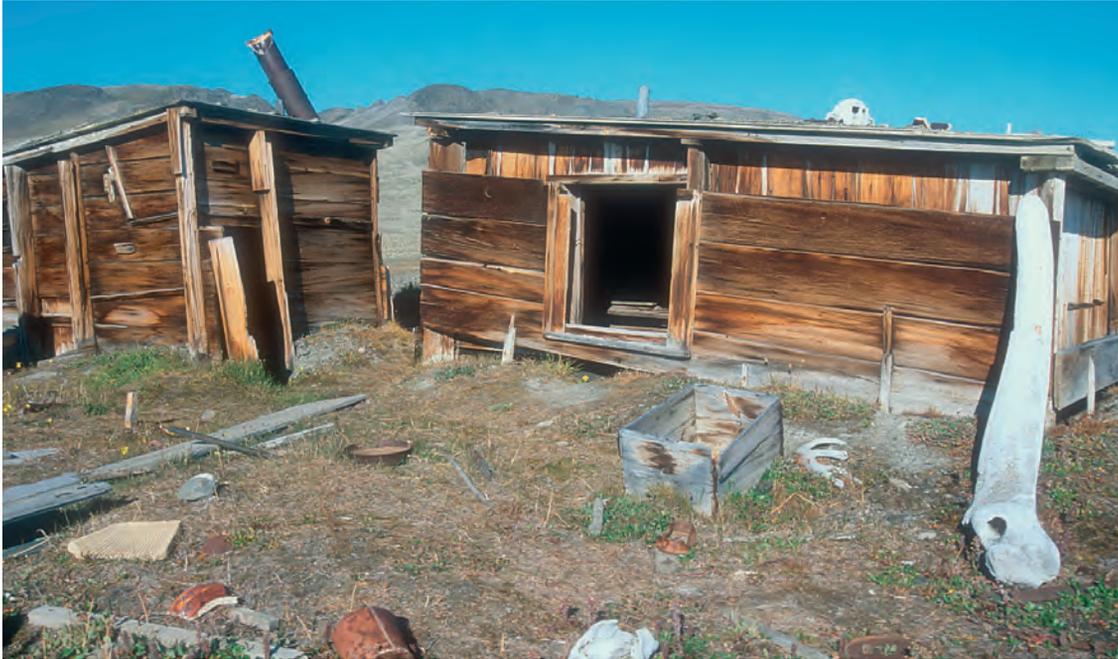
Structures built by Peary and his crew using wood from Fort Conger. Few people know that these historic structures are still present on the shores of Lady Franklin Bay and relatively little information has been published about them. Hut used by Matthew Henson is on right and T. S. Dedrick's hut is at left.

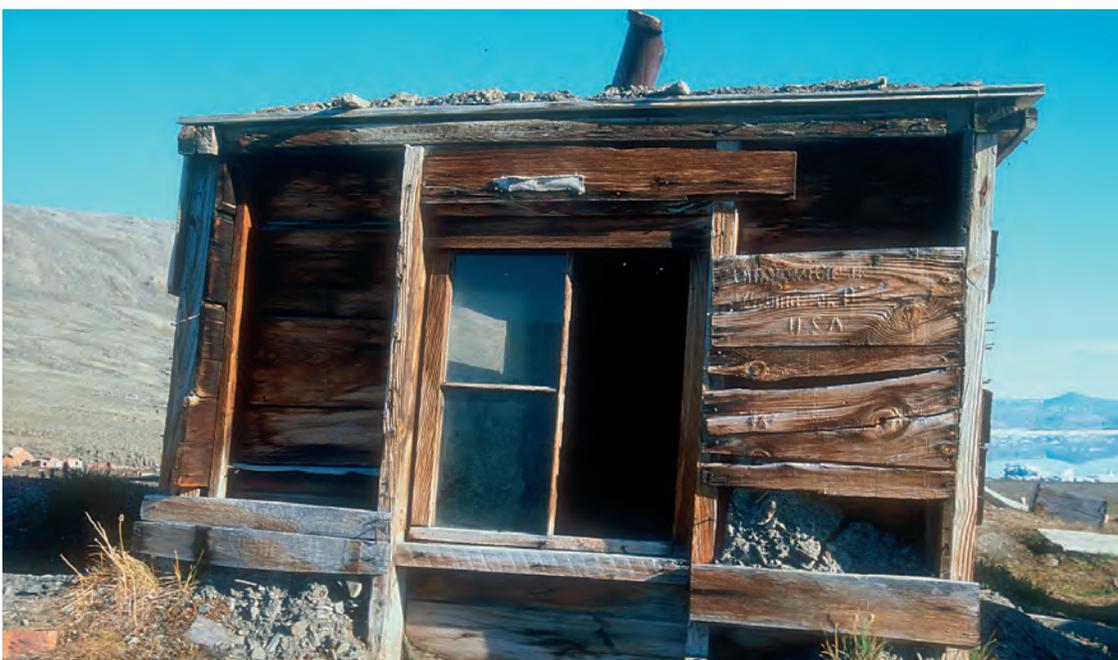
The Dedrick hut at Fort Conger. All three hut structures used by the Peary expedition have had serious deterioration over the past decades and the degradation processes continue unabated. Outer boards of the hut's multi-layered wall construction have blown off, windows and doors are open and the roof has blown off one hut. Non-biological deterioration (wind erosion and salt corrosion) as well as decay by wood destroying fungi has severely affected the wood in the huts.

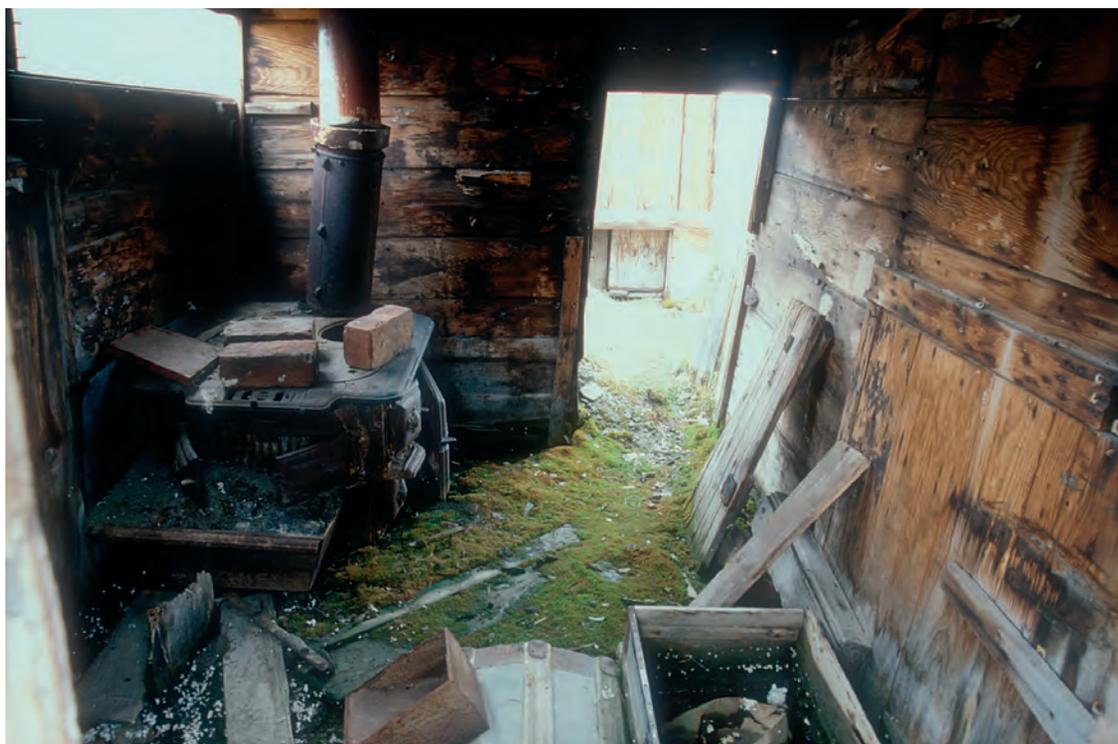
The remains inside the Dedrick hut showing stove and other materials that were left. The huts were built low into the ground which has resulted in moisture accumulation and very wet conditions inside the hut. Conditions are favorable for decay and soft rot fungi have caused extensive degradation in the wooden structure and wooden artifacts. Photo: R.A. Blanchette

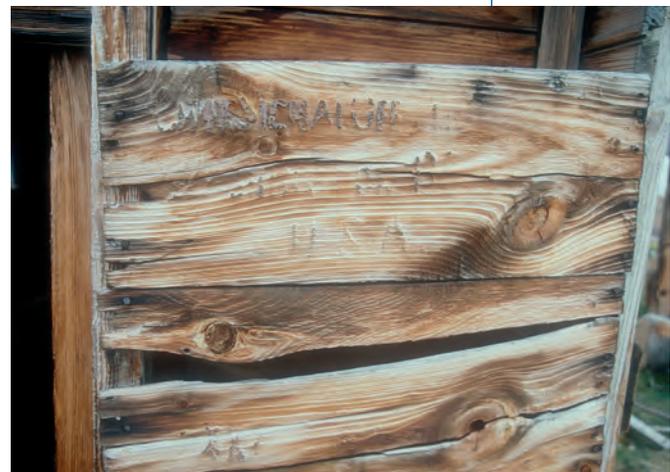
The effects of wind erosion on outer boards of Dedrick's hut cause deep grooves in the wood. The less dense earlywood cells of the wood are eroded faster than the latewood cells resulting in a grooved appearance. An inscription, "CHIEF SIGNAL OFFICER/WASHINGTON DC USA" placed on this reused wood during the Greely expedition (1881) has partially resisted the effects of the wind.

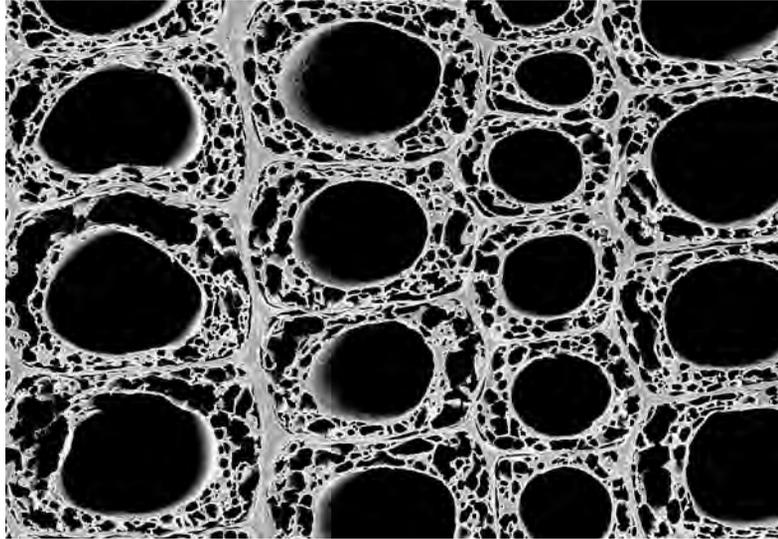
Effects of wood decay by soft rot fungi in pine timber from Fort Conger. Cross section of wood cells shows the destructive attack by the fungus causing many cavities inside the wood cell walls. Wood strength is severely compromised in advanced stages of decay. Photo: Benjamin Held

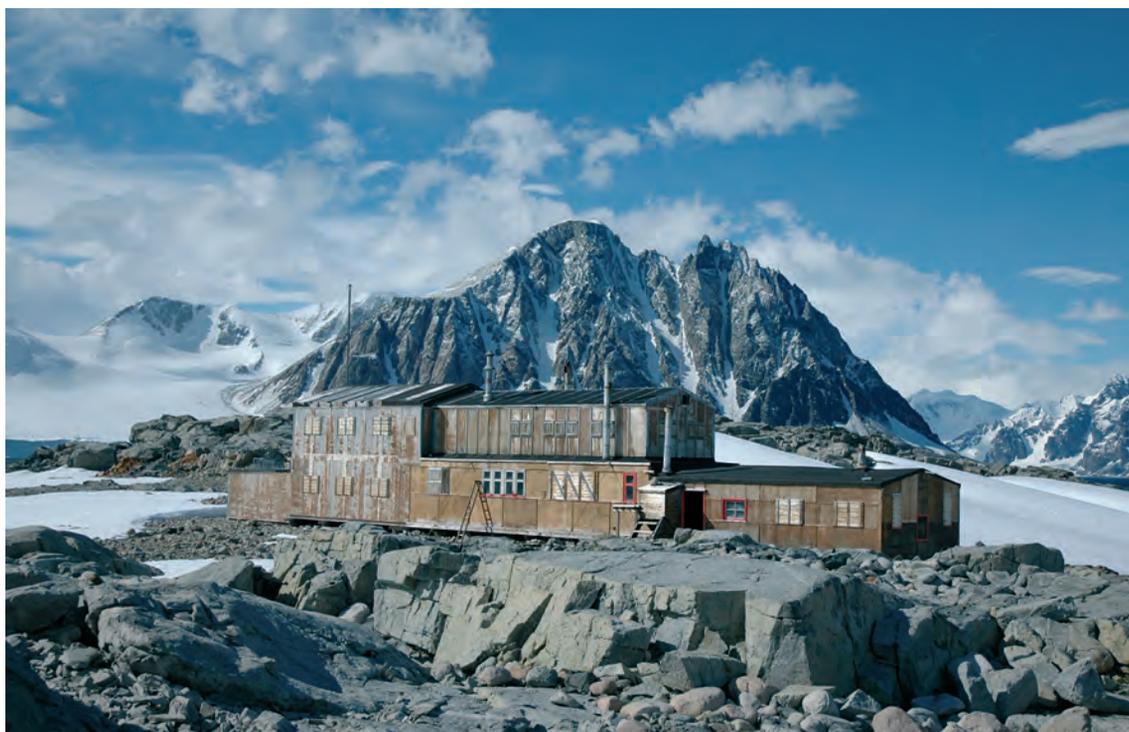
The British Base at Stonington Island. Photo: Michael Morrison

Stonington? Chris Cochran recommended the Stonington base for historic designation following a very similar set of criteria to those adopted a year later at Seoul – but the events, the individual, the scientific research and the exploration that he uses to justify the historic designation are all in fact associated with the earlier hut on the site which was burnt down in 1975 and where only a few charred fragments remain. What remains to justify the designation is that this hut, built in four stages between 1960 and 1972, is representative of bases of that period and that it represents a departure from the timber framed huts of the 1950s in that it has a lightweight steel frame and plywood cladding panels.

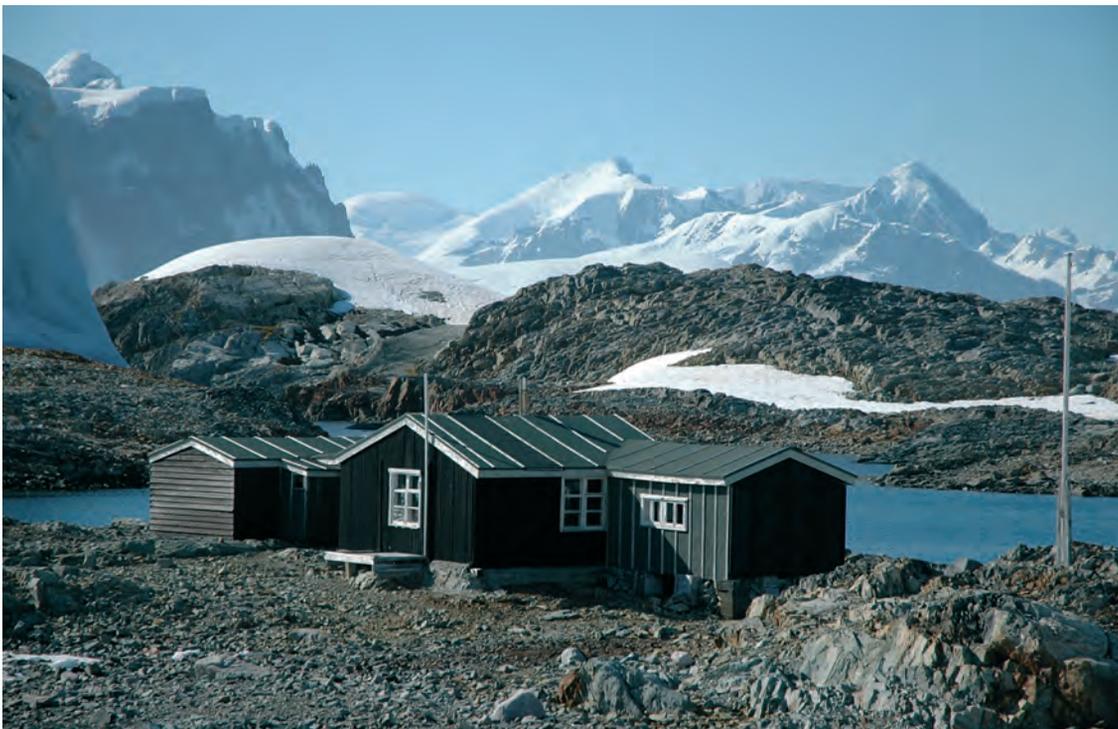
The hut known as 'Wordie House' next to the old British Base 'Faraday' – now the Ukrainian base Vernadsky. Photo: Michael Morrison

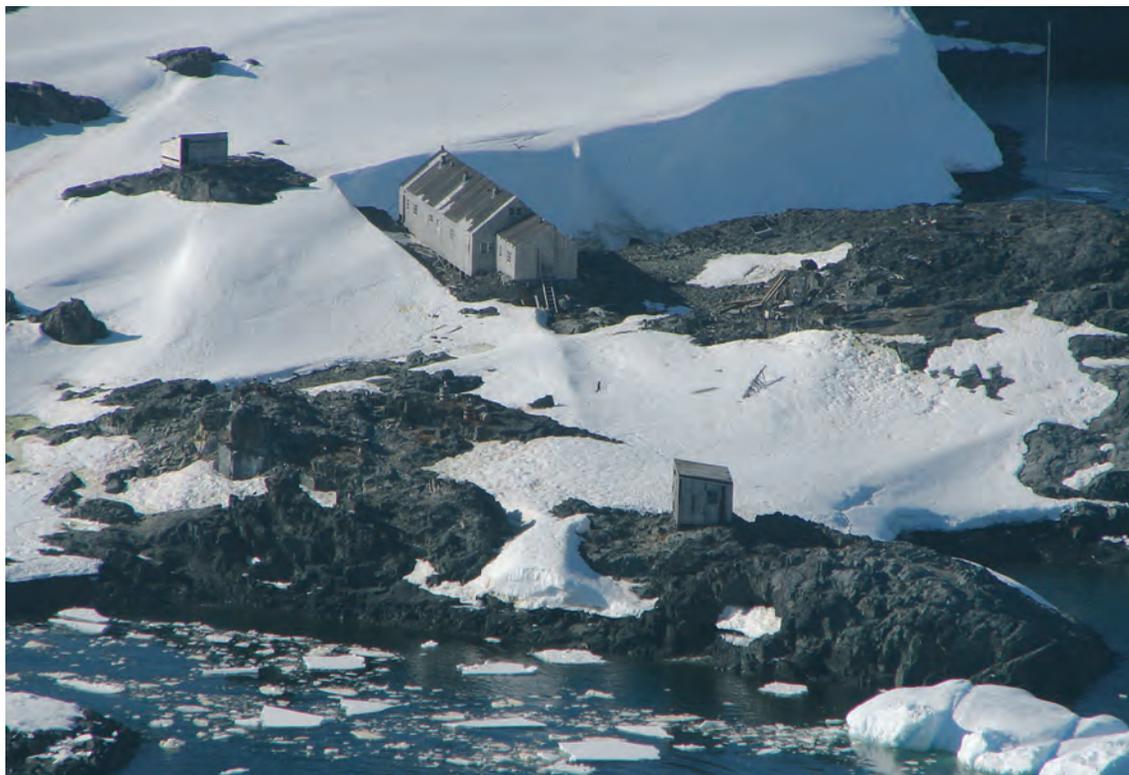
The hut on
Detaille Island
with the landing
place and
emergency
stores hut in the
foreground and
a dog kennel
top left. Photo:
Michael Morrison

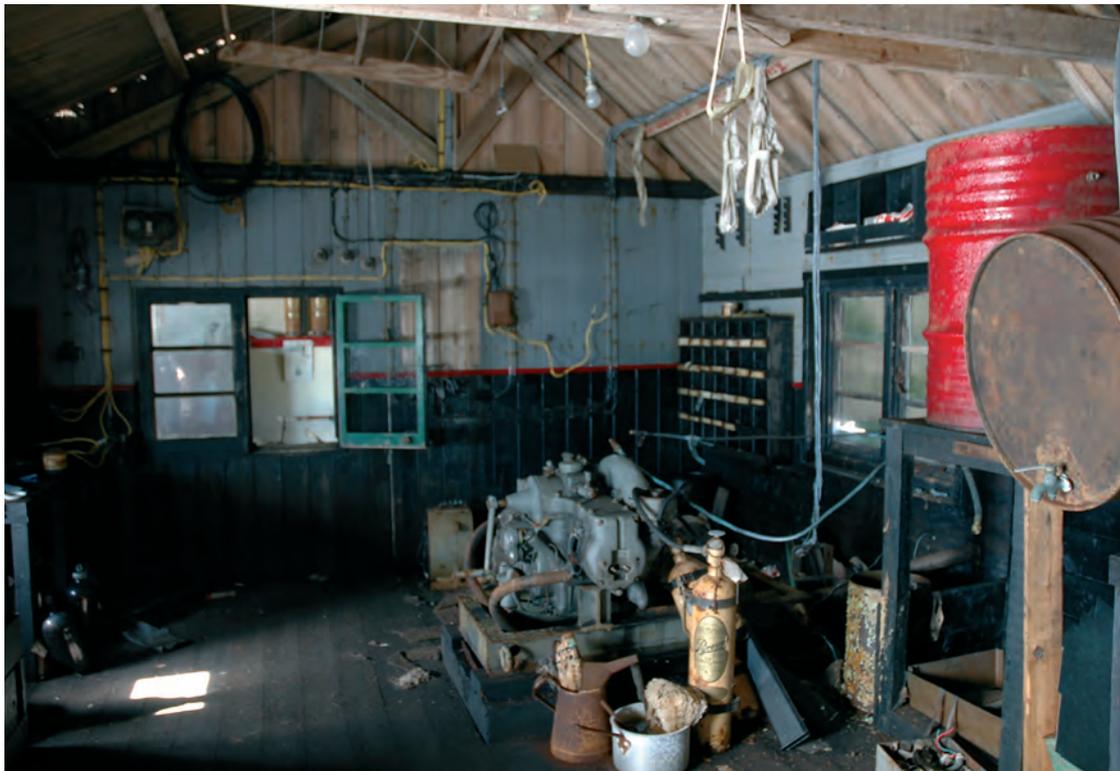
The Generator
House at Detaille
Island. Photo:
Michael Morrison

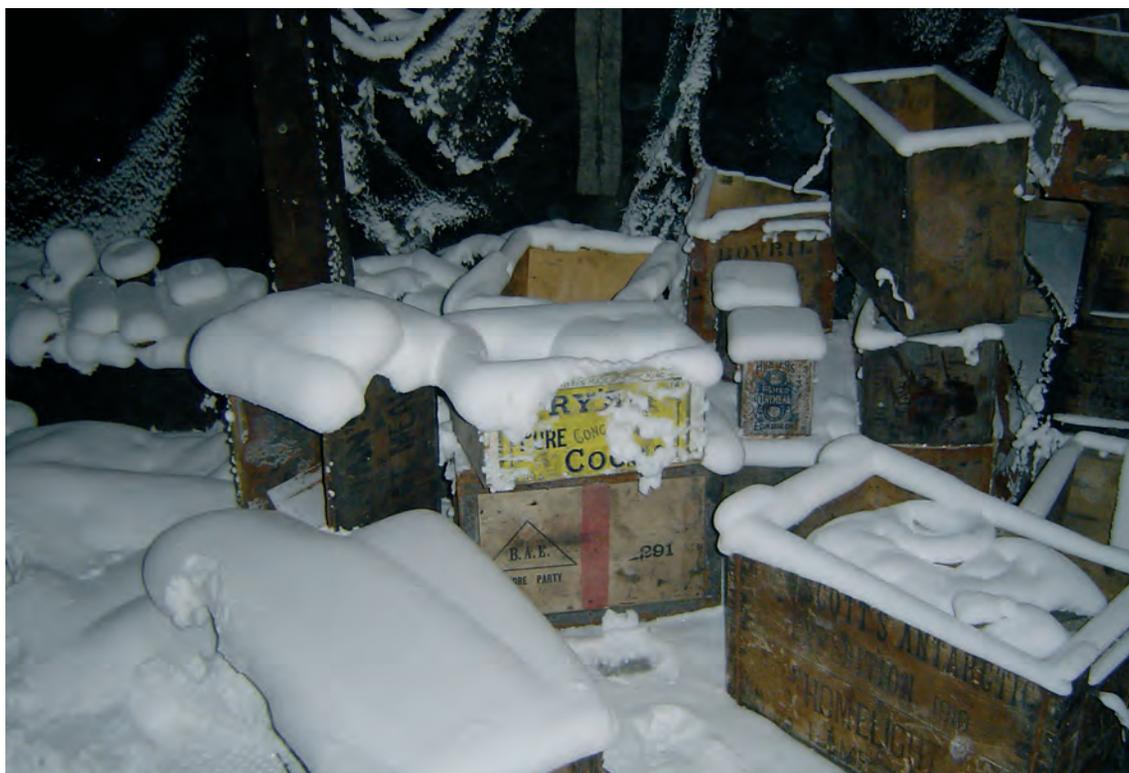
Snow accumulation in the interior of *Discovery* Hut, August 2007.
Photo: Roberta Farrell.

Ultraviolet (UV) light, iron corrosion products, salts and other caustic compounds cause a deterioration that progresses from wood surfaces to inner regions of the wood. UV light may cause a selective attack of lignin and hemicellulose resulting in a defibration of the wood. Over time a gradual loss of the outer wood cells takes place and the surface gradually erodes away. Salt accumulations in wood cause chemical erosion of the lignified middle lamella and alterations to cellulose within the secondary walls. This chemical attack has only recently been described and the conditions for its occurrence elucidated.² Damage may occur quickly where large concentrations of salt are in contact with moist wood or very slowly as low concentrations of salt accumulate in wood after evaporation. The diffuse nature of the damage throughout the wood, lack of fungal mycelia and selective attack on the lignified middle lamellae suggest deterioration of the surface layers of the wood are affected by this attack. Although the exact process of salt deterioration in wood is not fully understood, it is apparent that the high salt concentrations cause a chemical reaction to take place in which the hemicellulose and lignin in the middle lamella is degraded.² This is exhibited in affected woods by a defibration of surface fibers, giving the wood surface a fuzzy appearance. There are many locations at all three huts that are affected by salt deterioration. All of these locations involve moisture absorption from melt water in pools on the ground, or by the melting of snow from the roof dripping directly on to the hut walls or artifacts², or from melting snow, which enters the huts during the winter.

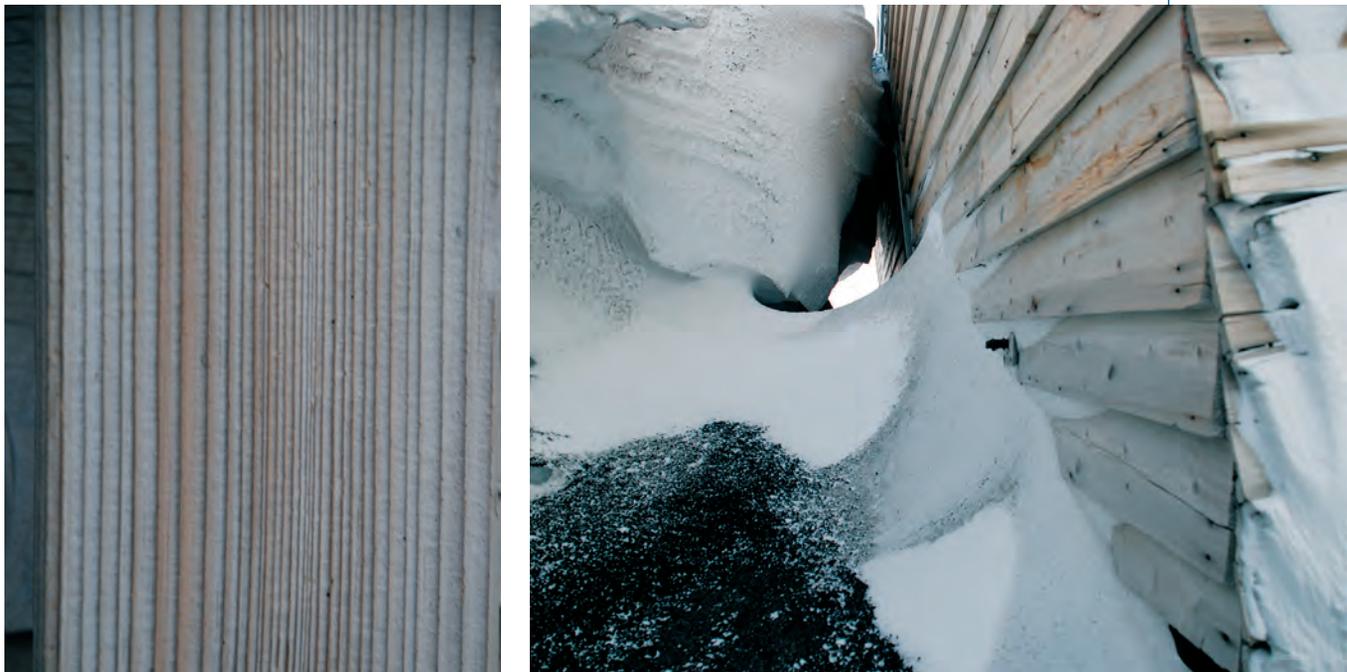
Evidence of affected wood at Terra Nova hut at Cape Evans: on the right it shows at the base of the exterior walls with the furrowed appearance of the wood surface due to salt erosion and on the left the evidence of selective removal of thin-walled earlywood cells.
Photos: Roberta Farrell.

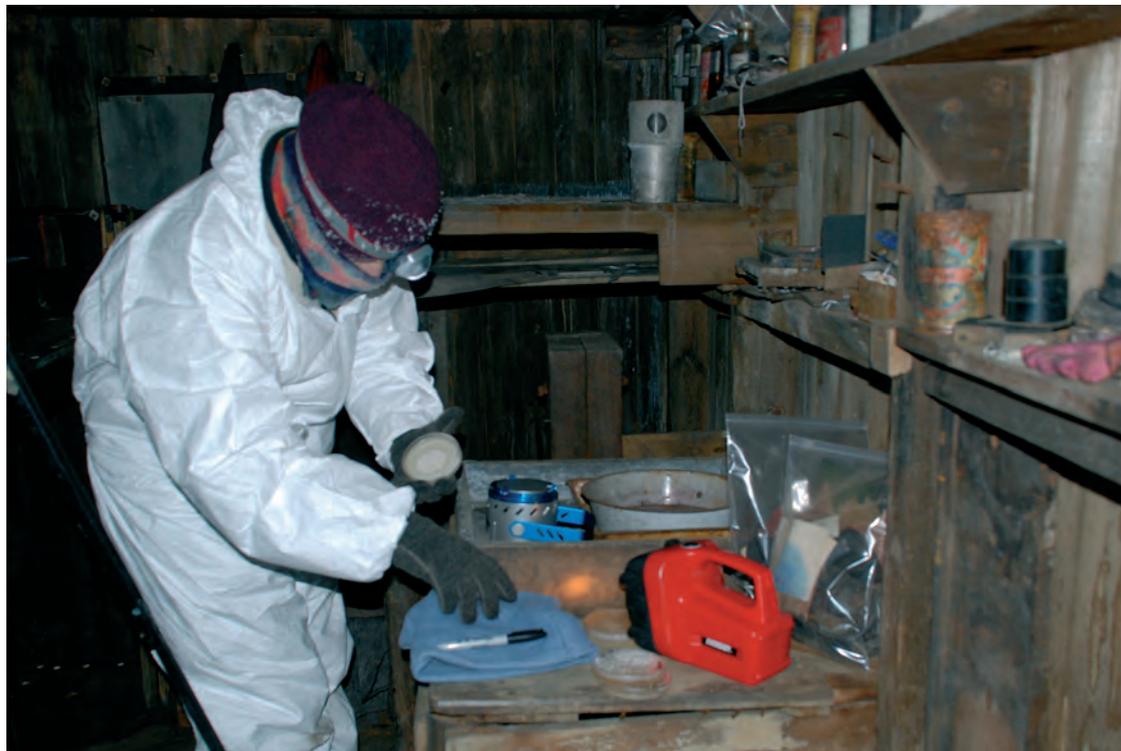
Fig. 4:
Testing for
aerial spores
using a Merck
MAS-100 Eco®
in *Terra Nova*
Hut, August
2007. Photo:
Phillipa Barn.

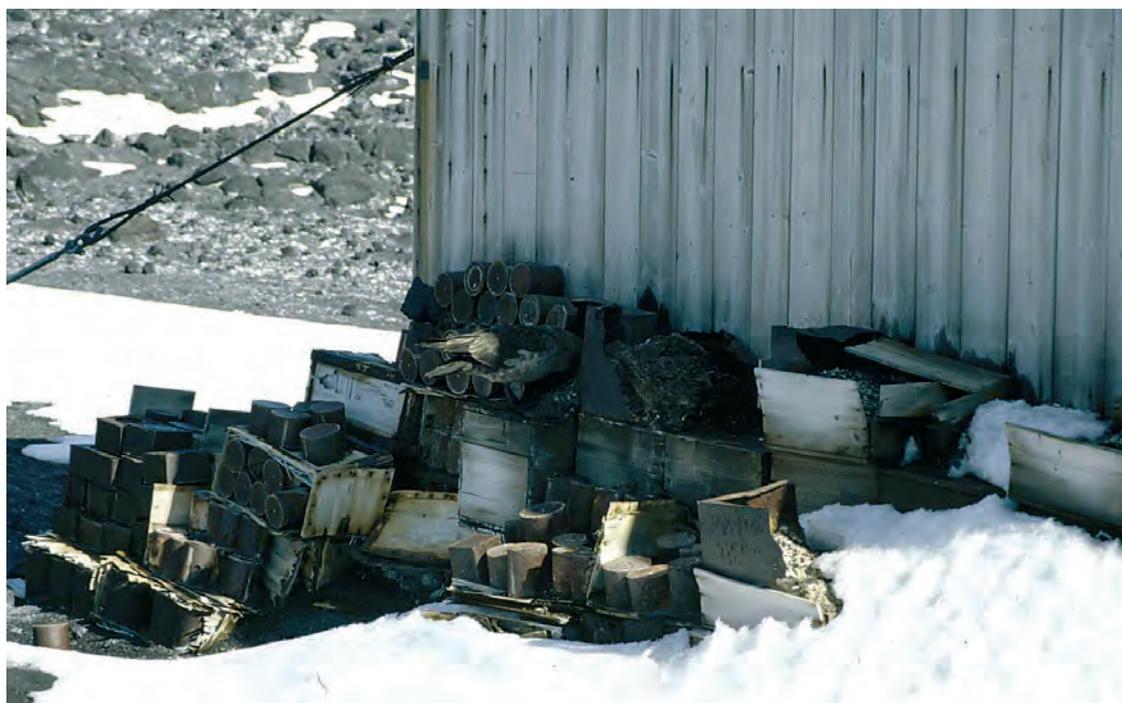
Decaying food stores exterior to *Nimrod* Hut at Cape Royds prior to conservation efforts. Photo: Roberta Farrell.

Decaying stores around the hut are degrading the environment, as shown in Figure 4, and under current environmental protocols for Antarctica intervention to prevent further pollution is imperative. Fuel depots with unused containers of petroleum products, asbestos materials, and diverse chemicals were also left at the huts^{9, 10}.

The joint collaboration found high concentrations of polyaromatic hydrocarbons in soils under and around the historic fuel depots. Asbestos materials within the huts have been identified and extensive amounts of fragmented asbestos were found littering the ground around the Cape Evans hut. These materials are continually abraded and fragmented as tourists walk over them and the coarse scoria breaks and grinds down the materials. Although these areas are important historic sites protected by international treaties, the hazardous waste materials left by the early explorers should be removed and remedial action has been proposed to restore the site to as pristine a condition as possible.

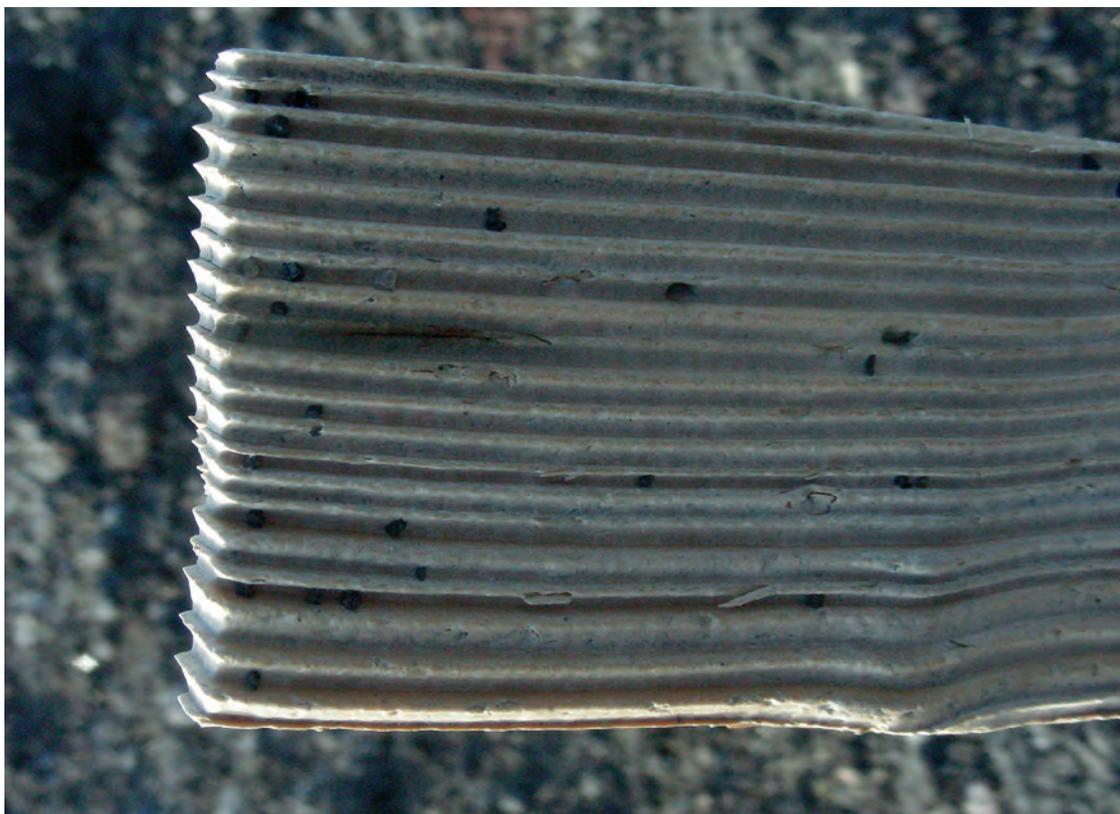
Wood damaged
by wind and
scoria erosion
Cape Evans.
Photo: AHT 2007

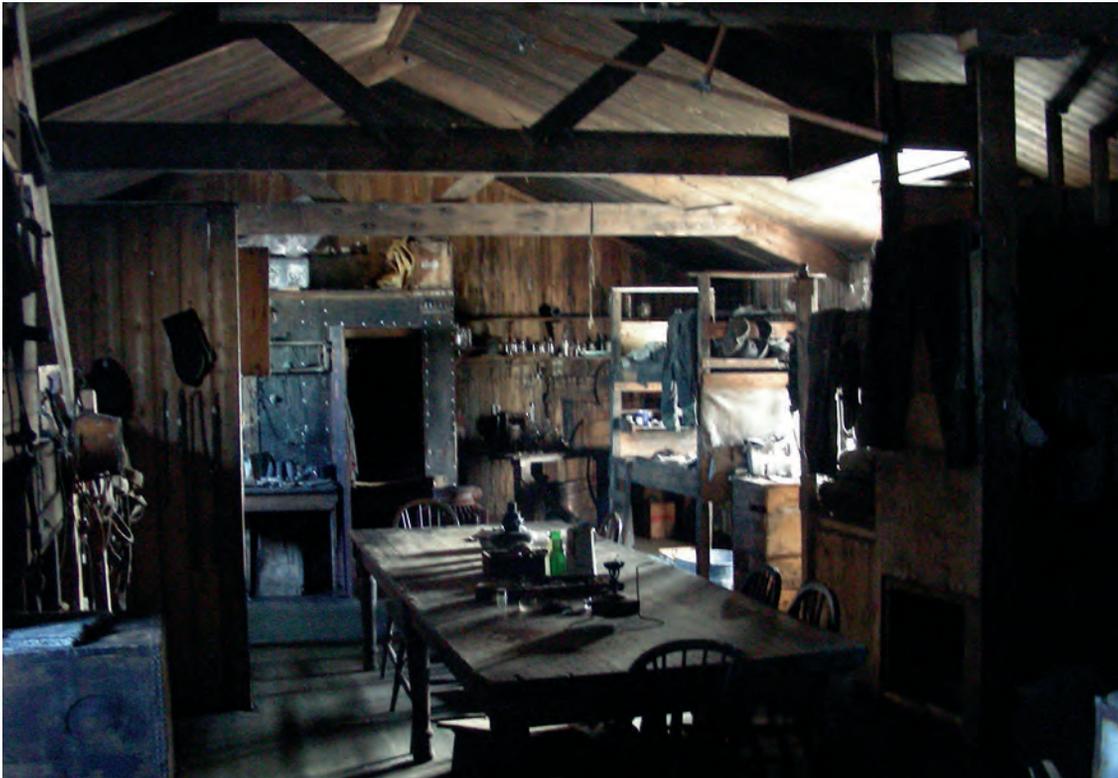
Interior of
Scott's hut Cape
Evans before
the removal of
artefacts for
conservation.
Photo: AHT 2007
