HISTORICAL POLAR BASES – PRESERVATION AND MANAGEMENT

This publication is compiled and edited for
the International Polar Heritage Committee of ICOMOS by :

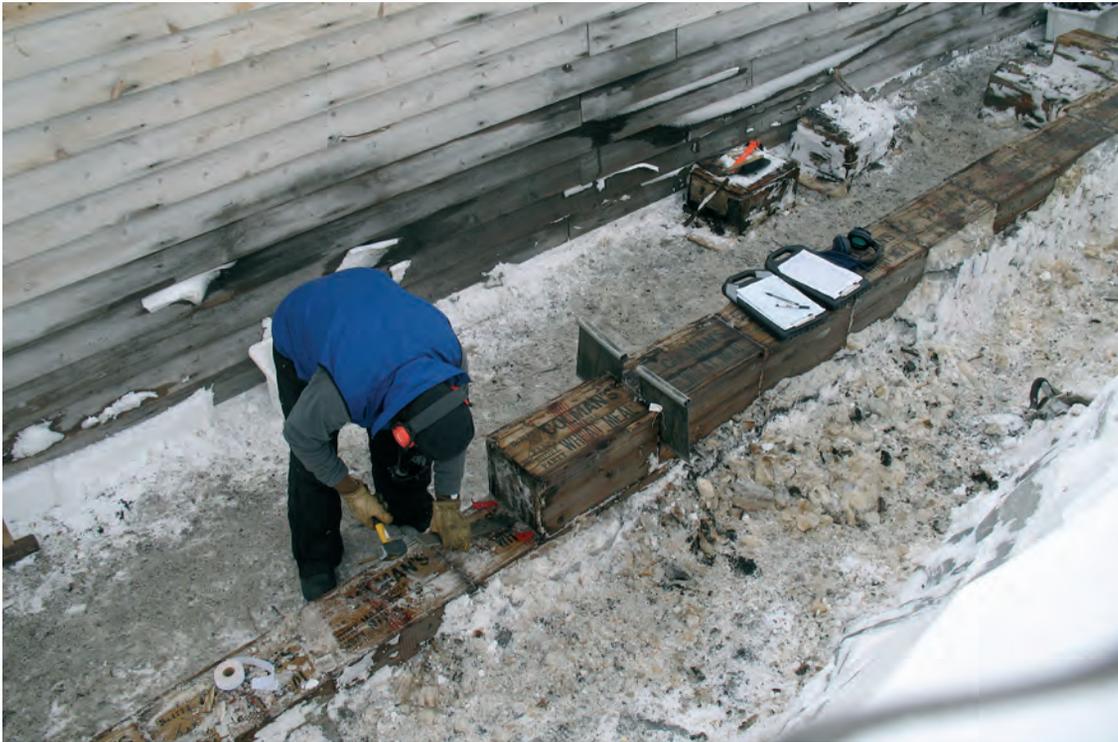
Author separating venesta boxes from Bowers annex, Cape Evans, for removal and conservation. The boxes are frozen together which necessitates the use of wedges, metal plates and club hammers.
Photo: AHT 2007

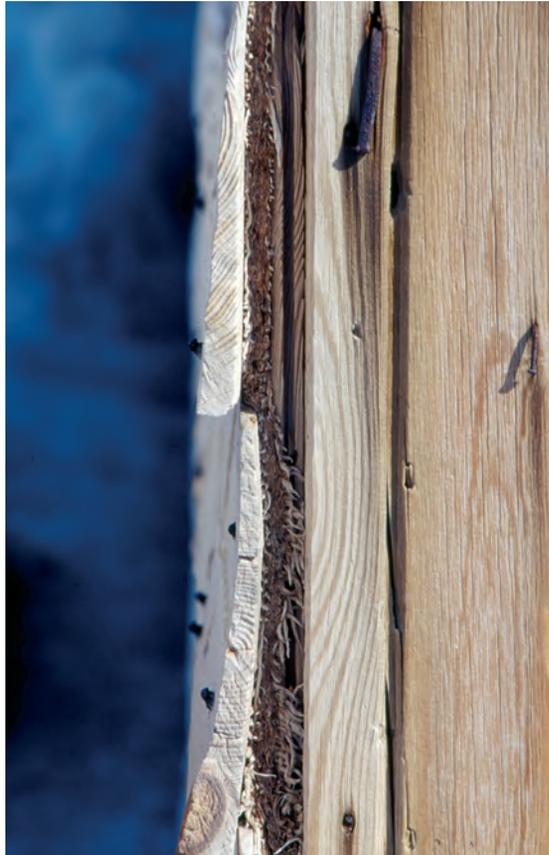
Details
of insulation,
Cape Evans hut.
Photo: Adam
Wild 2001

Scott’s attempts at insulating the Cape Evans hut were equally inventive. The timber frame was lined with six layers of material. On the inside face of the framing there are two layers of vertical tongue-and-groove boarding with insulation between, while on the outside face there is one layer of tongue-and-groove boarding, then insulation, then finally weatherboards (figure 3). The insulation consists of layers of shredded seaweed sandwiched between linings of Hessian, known as Gibson Quilting.

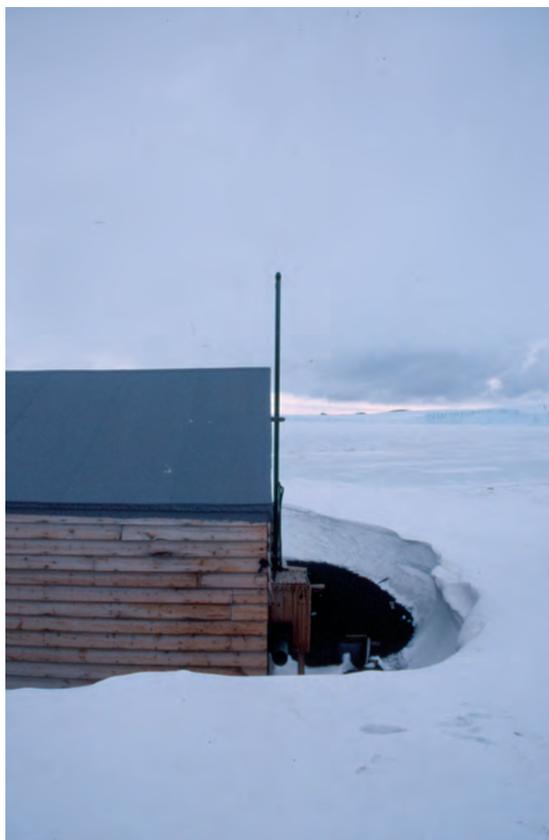
Wind scoop
Cape Evans hut.
Photo: Adam
Wild 2001

panes in the windows of the science lab area. These have been exposed to the prevailing southeast winds for nearly 100 years. The consequent opacity of the glass allows the transmittance of a soft light into the space enhancing the qualities of the space and testifying to the patina that speaks of Ruskin's "voicefulness" of age and presents a vision of truth and myth. Truth has past, present and future readings.

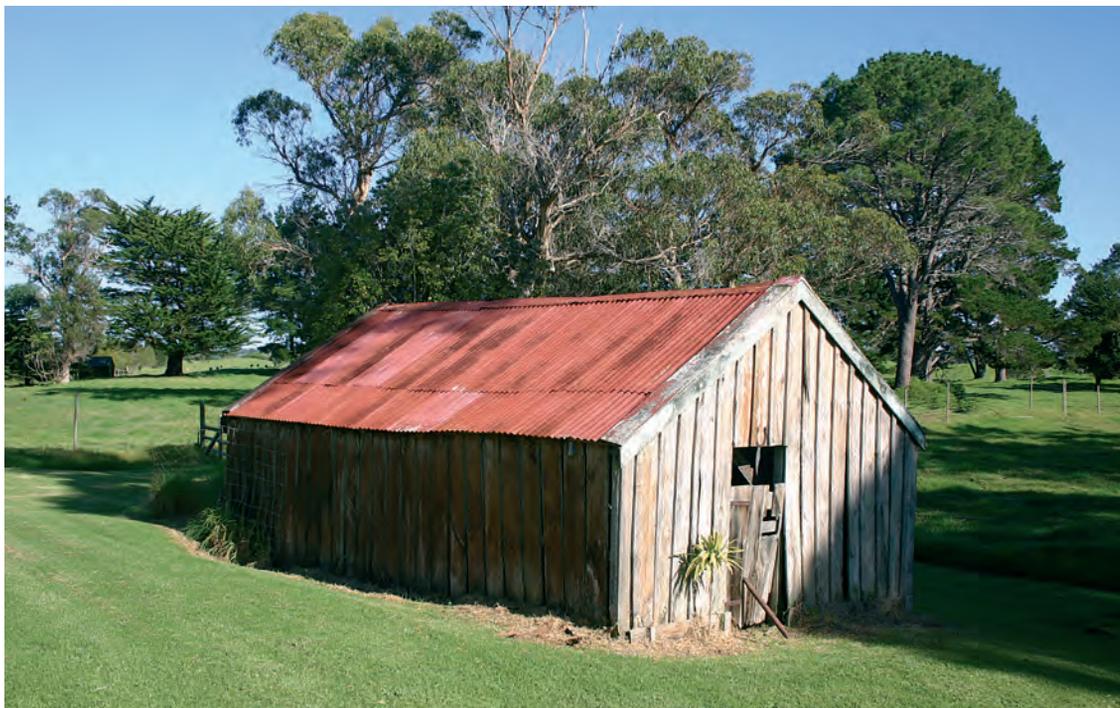
Smithy,
Wagener
Subritzky
Homestead
(1862). Photo:
Archifact Ltd
2004

The Wagener-Subritzky homestead in New Zealand includes a pioneering family's smithy dating from 1860-62. The original and surviving timber structure is cobbled from a variety of at-hand materials (much like the stables at Cape Evans) and has been left intact. In 1969 the family, having retired the homestead to the role of a museum, erected an ingenious outer shell to protect the original structure until they could find a way (and a means) of repairing the original building. The issue ahead of us is two-fold: how to survey this complex structure and, based on that survey, how to describe how to conserve them accurately. The scanned model (below) describes the complexities of both the original and the later structures.

Our model clearly shows the two structures, provides detail of the fittings and surviving equipment in situ and gives important record to the imperfections, the *spirit*, of this place. We can now make informed and appropriate responses to its conservation. The furnace and its bellows are still in place (see centre of figure 7) as are many of the tools used and products resulting from the work of the smithy. This technology scientifically records form and fabric contributing to the richness and interpretation of the place. The model also gives opportunity for the virtual visitor as this is a place whose fragility means that public access is impossible.

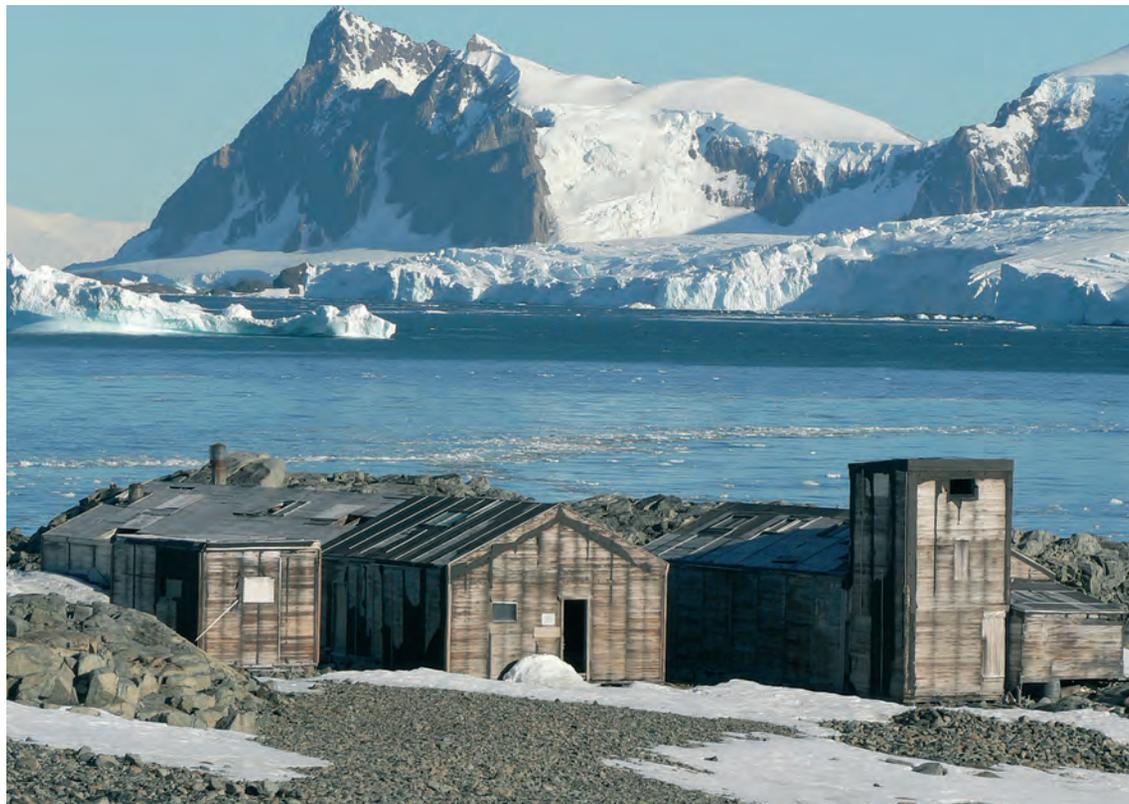
Fig. 2. The Main Building showing collapsing floor built by British Antarctic personnel from Base E. This floor was built 4 feet above the original floor and covers historic artifacts, debris and ice. Photo: Brett Arenz

been placed in a hole cut into the floor. The Main Building received the greatest modification of all three buildings as the original floor was apparently covered with a thick layer of ice when the British returned to Stonington in 1957 so they built another floor four feet above the original. A partitioning wall was constructed on the eastern side of the building which houses a room with the original floor. A large portion of the main building was used for storage and for seal processing as seal meat was used to feed the dogs on the sledging teams. Consequently the interior of the main building is filled with seal carcasses in addition to ice and other debris. The British-constructed floor is also collapsing in many areas making the interior of this building hazardous to enter (Fig. 2). There is a broken door on the north side of the building, and an entrance in the roof on the south side which provides entry via a ramp to the collapsing floor. The door on the eastern side of the building leading to the room with the original floor has broken off in the last 15 years, apparently due to corroded hinges. There is also a large number of missing roof timbers and wall slats on the building with many more timbers missing on the main building than the two other buildings (Fig. 3).

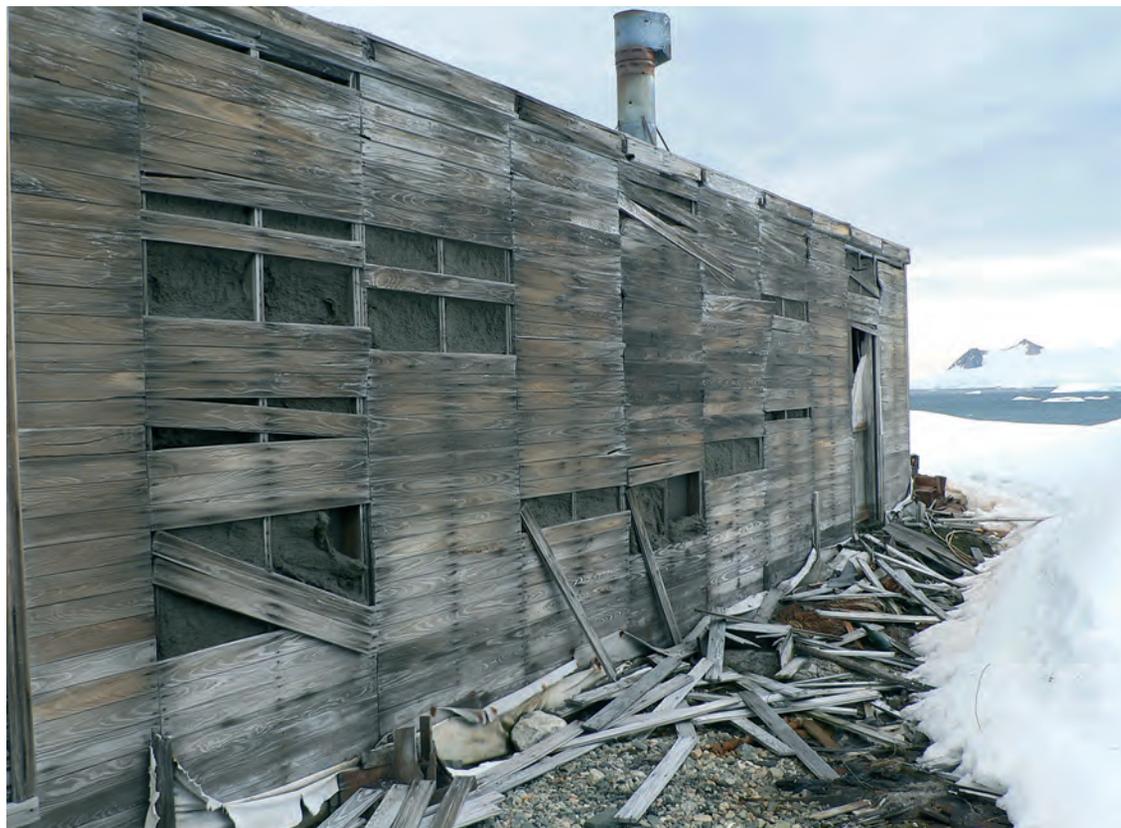
Fig. 3. Exterior north wall of the Main Building showing the loss of many wall boards. Photo: Brett Arenz

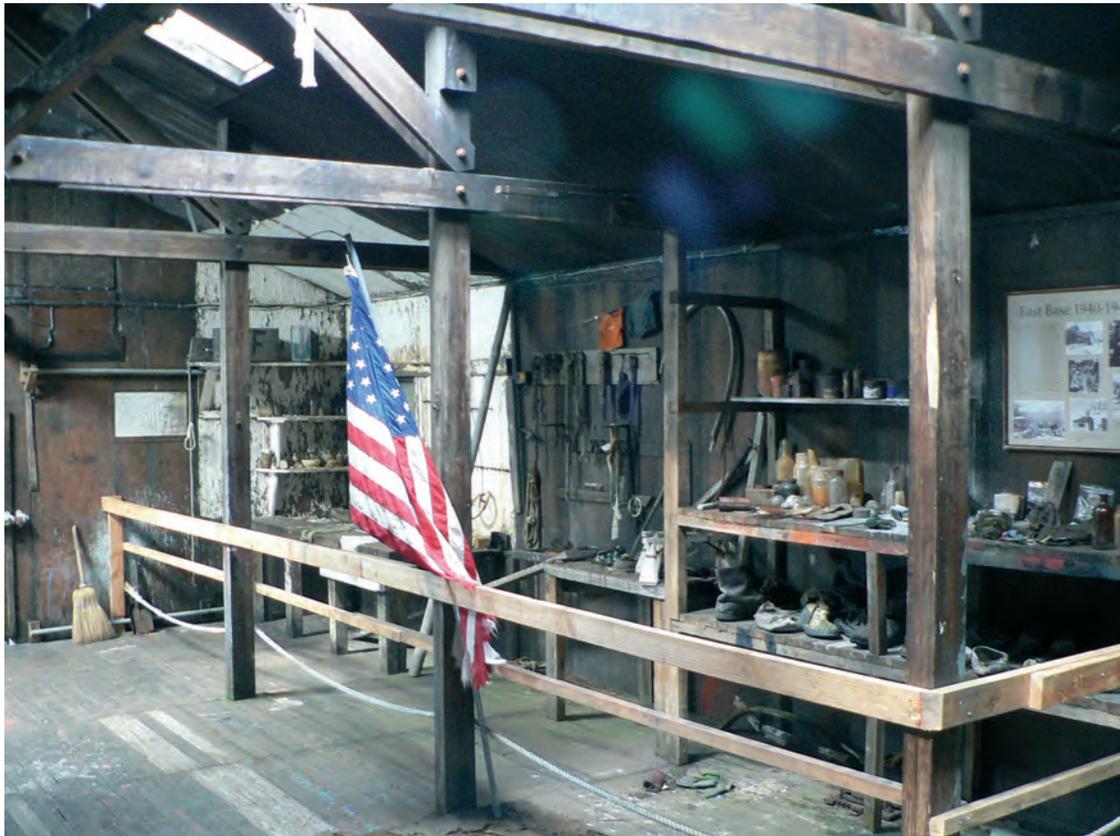
Fig. 4. Inside the Science Building showing the artifact display set up by the 1992 conservation team. Photo: Brett Arenz

The Science Building and Ronne Hut are in relatively good condition compared to the Main Building. Because they were comparably weather tight, the conservators in 1992 chose the Science Building to set up a museum type display of artifacts that had been found outside (Fig. 4). These artifacts were from both the 1941 USAS and 1947 RARE Expeditions. Additionally, there are some materials, such as sledging flags and dog harnesses, from the time after 1948 when the British occupied the structures. A cache was also made in the Ronne Hut for additional artifacts that the 1992 conservation crew thought deserved additional protection.

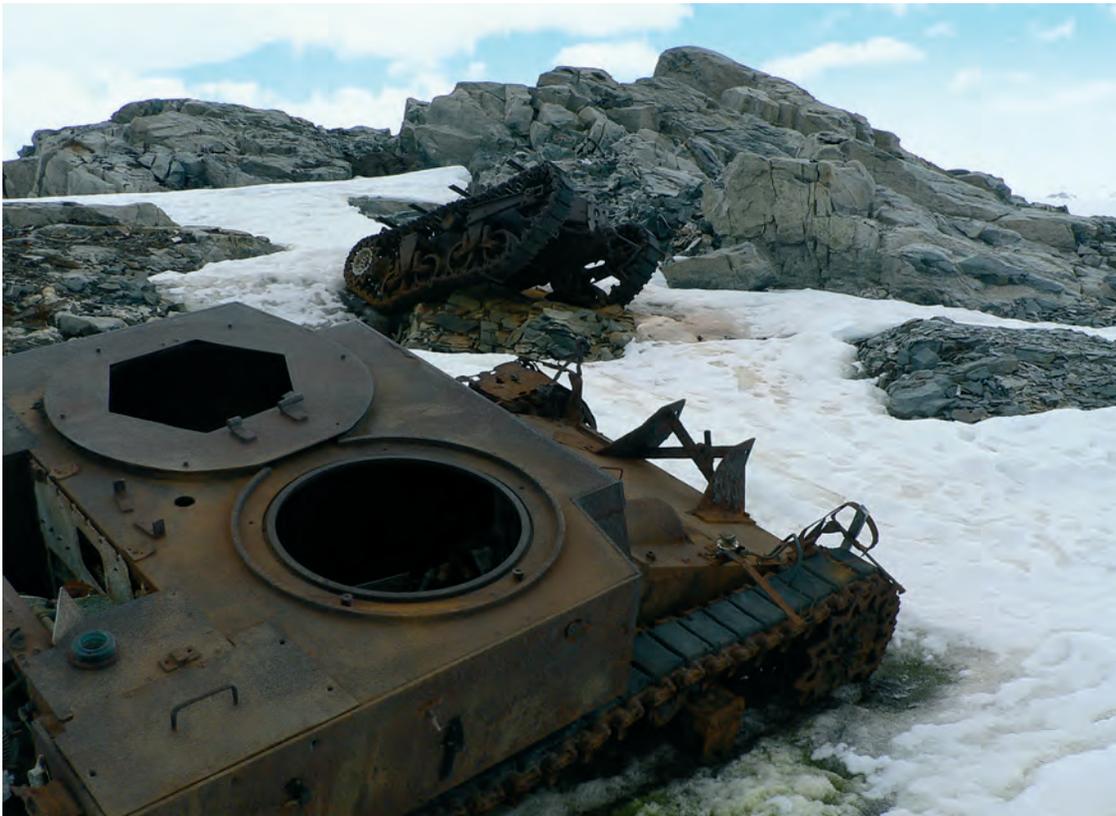
Fig. 5.
Stonington
Island has many
large artifacts
remaining from
the 1941 expe-
dition including
a World War I
era tank with
tractor (in back-
ground). Photo:
Brett Arenz
